- **Appendix 6.3 Hedgerow Impact Study**

BENCHMARK HEDGEROW STUDIES

| Project: | North South 400kV Interconnection Development |
| Title: | Benchmark Hedgerow Studies |

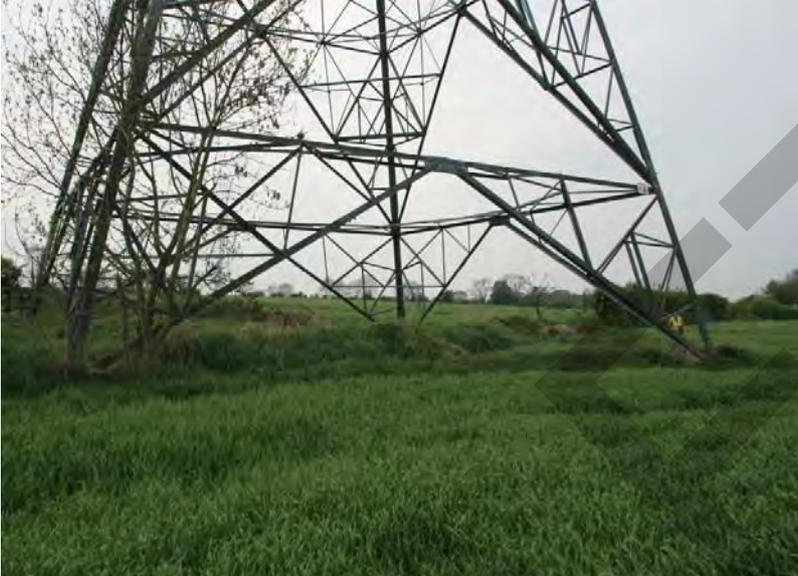
| Location Tower Nos. | Tower Type | Land use | General description hedgerow at tower location | General Description of hedgerow either side of tower location | Fauna describe (all) | NRA Evaluation hedgerow overall | Description of differences at tower location relative to either side of tower |
|---|---|---|---|--|--|---|--|
| 1 | Angle | Arable | 80M of hedgerow permanently removed as tower located at the meeting point of 3 hedgerows. No recovery noted. Grassy verge species present which are indicators of species poor neutral grassland habitat. | Robust species poor Managed hedgerow on bank. Woody species include hawthorn (dominant) and ash. Climbers incl. Ivy, rose and bramble. No woody ground flora. No ditch. Arable farmland. | Abandoned badger outlier sett at hedgerow to north. Bat survey conducted under tower noted Soprano and Common pipistrelle foraging along existing hedgerow under towers i.e. gap in hedge was not proving to be a barrier. Breeding territorial passerines birds noted including yellowhammer and blackbird nest near tower. | Low | Significant gap at tower location as hedge gone |

| Location Tower Nos. | Plate | Description |
|---|--|---|
| 1 | | <p>Angle tower with entire hedge removed and no significant recovery. Note existing managed hedgerow in background. This tower is located at the junction of 2 "low value" hedgerows.</p> |

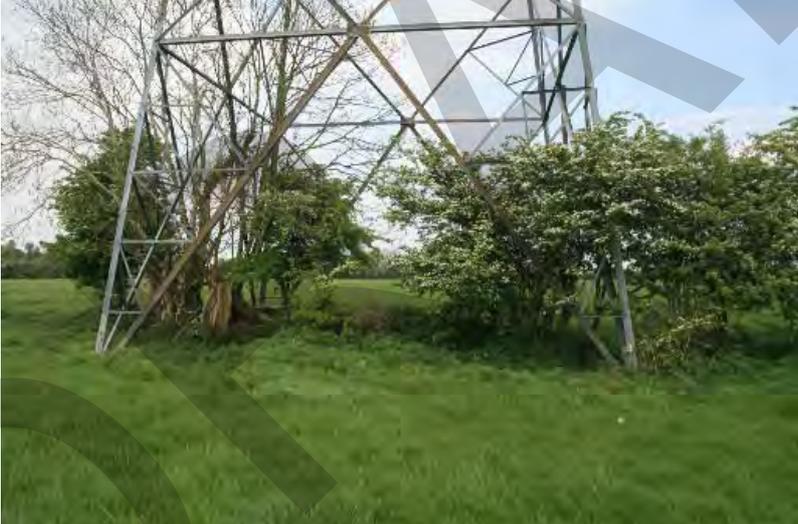
| Location Tower Nos. | Tower Type | Land use | General description hedgerow at tower location | General Description of hedgerow either side of tower location | Fauna describe (all) | NRA Evaluation hedgerow overall | Description of differences at tower location relative to either side of tower |
|---|---|---|---|--|--|---|--|
| 2 | Intermediate | Arable and livestock | Some elder and hawthorn trees remain under tower | Defunct species poor unmanaged hedgerow. Woody species include hawthorn (dominant) and ash. Climbers incl. Ivy, rose and bramble. No wood ground flora. No ditch. Arable and livestock (either side) | Bat survey conducted under tower. Individual Common and Soprano pipistrelle were noted foraging along existing hedgerow under towers i.e. gap in hedge was not proving to be a barrier. | Low | Hedgerow broadly retained under tower though less woody vegetation. Hedgerow generally grazed by sheep and not livestock proof |

| Location Tower Nos. | Plate | Description |
|---|--|---|
| 2 | | <p>Intermediate tower with limited woody vegetation recovery. Vegetation was pollarded rather than completely removed during construction.</p> <p>Hedgerow either side has low evaluation and is heavily grazed by sheep preventing recovery/ re-establishment.</p> |

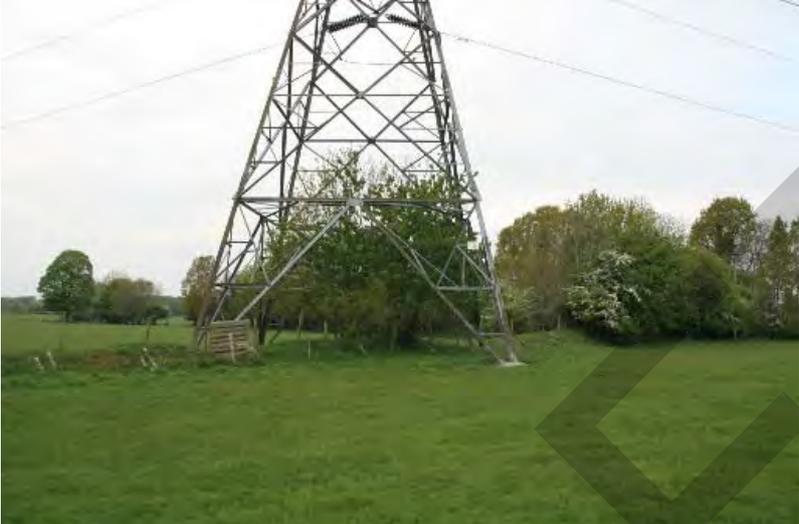
| Location Tower Nos. | Tower Type | Land use | General description hedgerow at tower location | General Description of hedgerow either side of tower location | Fauna describe (all) | NRA Evaluation hedgerow overall | Description of differences at tower location relative to either side of tower |
|---|---|---|---|--|--|---|--|
| 10 | Angle | Livestock | 35m of hedgerow permanently removed under tower, remnant cherry and ash pollards remain. | Treeline of cherry ash with hawthorn blackthorn understory. No significant climber or woody field layer. Sheep grazed. | Passerines. Bat survey conducted (close by) confirmed Common Pipistrelle actively foraging under powerline and along described hedgerow | Low | Significant gap at tower location as hedge gone |

| Location Tower Nos. | Plate | Description |
|---|---|--|
| 10 | | <p>Intermediate tower with limited woody vegetation recovery. Some woody vegetation was pollarded rather than completely removed during construction.</p> <p>Hedgerow either side has low evaluation and is heavily grazed by sheep preventing recovery/ re-establishment.</p> |

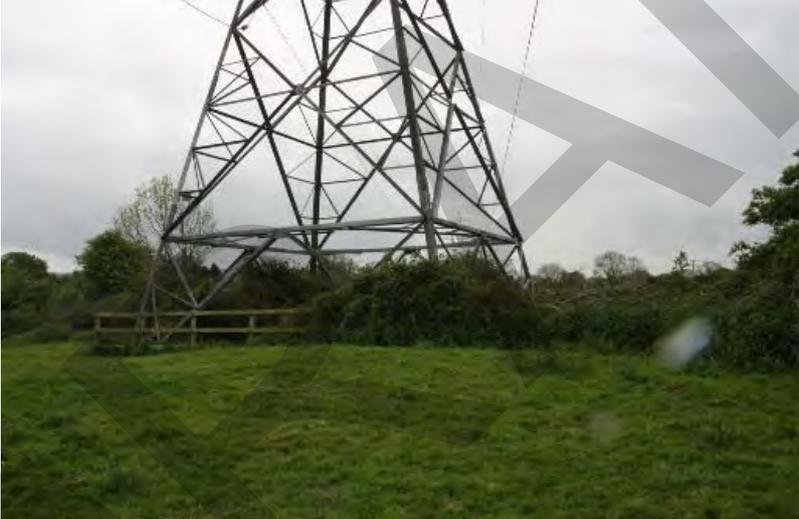
| Location Tower Nos. | Tower Type | Land use | General description hedgerow at tower location | General Description of hedgerow either side of tower location | Fauna describe (all) | NRA Evaluation hedgerow overall | Description of differences at tower location relative to either side of tower |
|---|---|---|---|--|--|---|--|
| 11 | Angle | Livestock | Tower base surrounded by wood fence. Hedgerow (30m) replaced by bramble thicket. | Species poor hawthorn and elder unmanaged hedgerow. Damaged cattle. Some woodland ground flora. Livestock | Rabbits, passerines | Moderate | Loss of woody hedgerow species at tower location. Dense brambles maintain connectivity |

| Location Tower Nos. | Plate | Description |
|---|---|--|
| 11 | | <p>Moderate value hedgerow. Tower base surrounded by wood fence. Hedgerow (30m) replaced by bramble thicket. Note fencing, to keep livestock out, allows some woody vegetation to re-establish</p> |

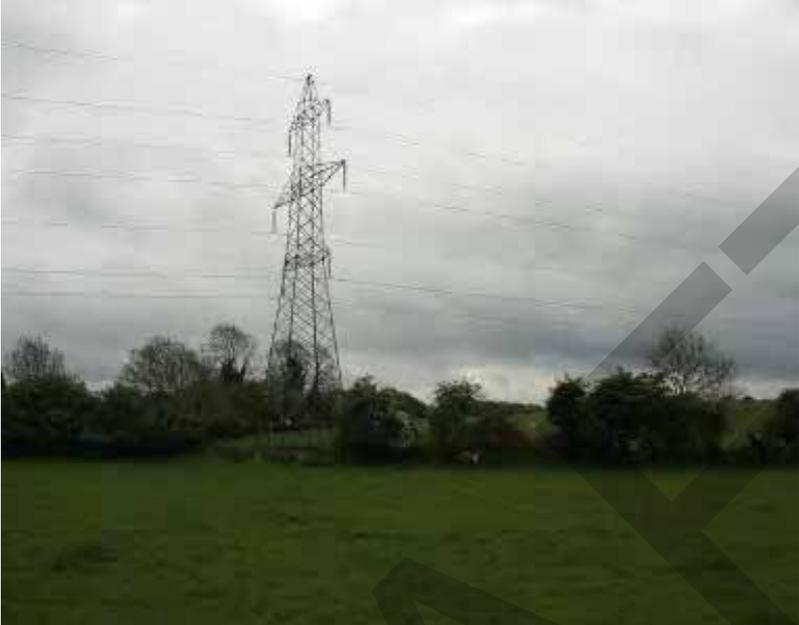
| Location Tower Nos. | Tower Type | Land use | General description hedgerow at tower location | General Description of hedgerow either side of tower location | Fauna describe (all) | NRA Evaluation hedgerow overall | Description of differences at tower location relative to either side of tower |
|---|---|---|---|--|--|---|--|
| 12 | Intermediate | Livestock | Hedgerow completely removed at 7m wide gap. | Species poor (rose, ivy, bramble, ash hawthorn) some woodland flora (e.g. viola, primula). Long term managed. Damaged by cattle. | Rabbits, passerines. No bat activity noted in this area during survey. | Moderate | Loss of woody hedgerow species at tower location. |

| Location Tower Nos. | Plate | Description |
|---|--|---|
| 12 | | <p>Moderate value Hedgerow with section completely removed at 7m wide gap where tower located</p> |

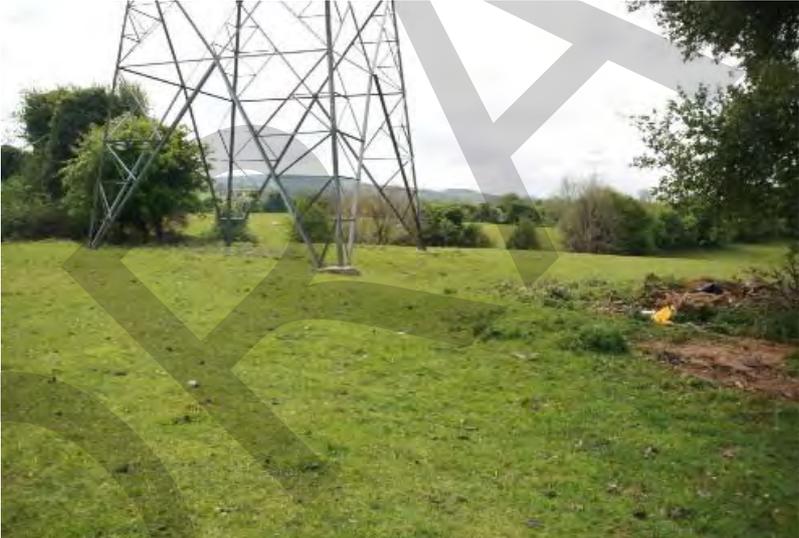
| Location Tower Nos. | Plate | Description |
|---|--|---|
| 13 | | <p>Hedgerow completely removed at 25m wide gap where intermediate tower located. No reinstatement</p> |

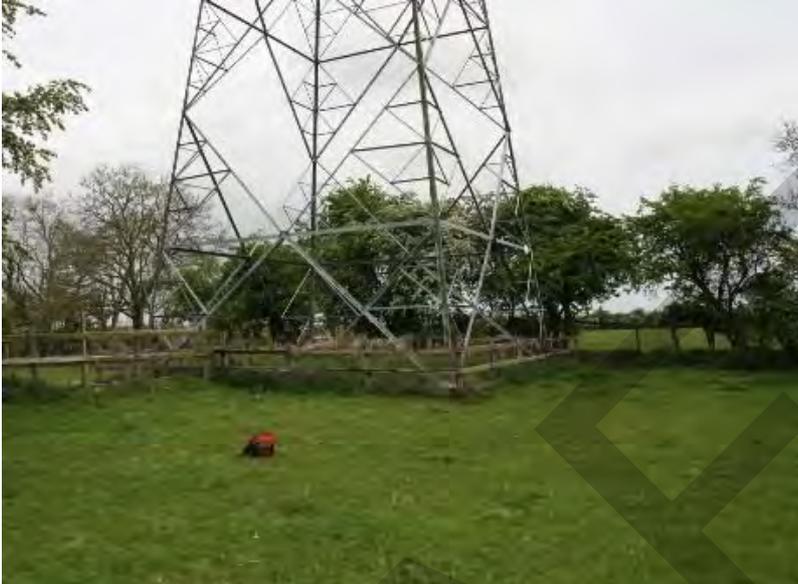
| Location Tower Nos. | Plate | Description |
|---|--|---|
| 14 | | <p>Hedgerow completely removed at 12 m wide gap where intermediate tower located. No reinstatement. Fenced off</p> |

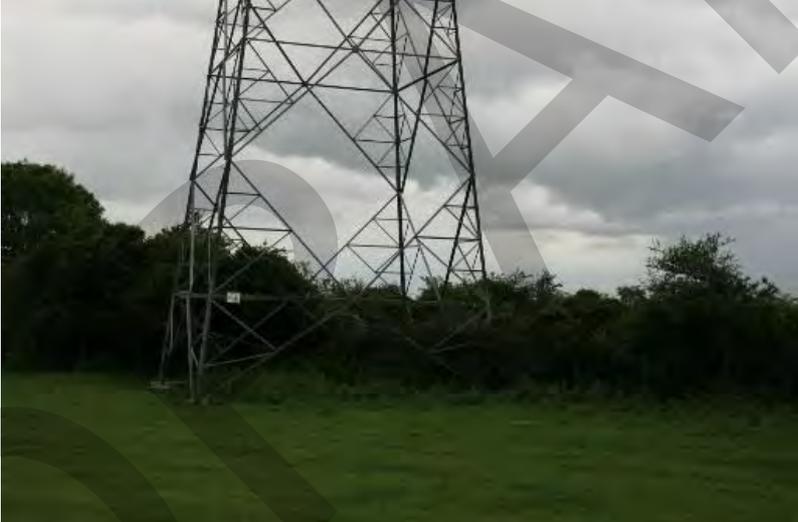
| Location Tower Nos. | Plate | Description |
|---|--|---|
| 17 | | <p>Hedgerow connectivity retained at gap where tower straddles low hedgerow. Change in dominant woody vegetation with establishment of relatively vigorous pioneer woody plant growth under tower.</p> |

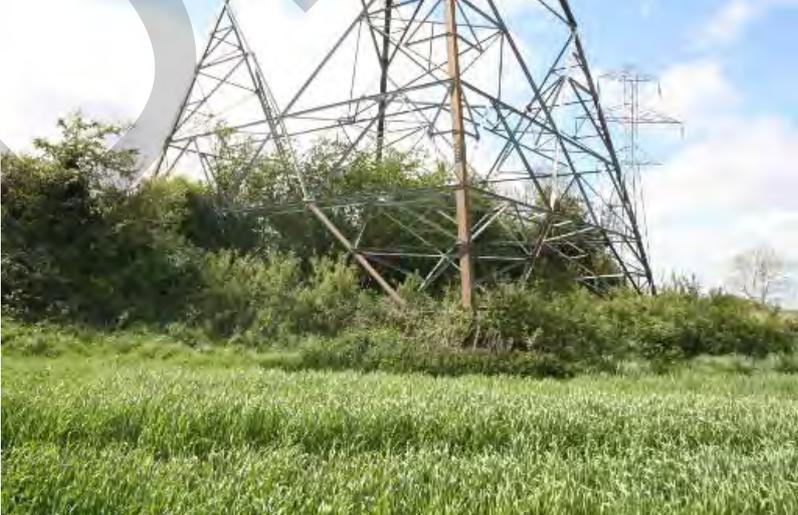
| Location Tower Nos. | Plate | Description |
|---|--|---|
| 22 | | <p>Moderate value hedgerow. No real difference under tower besides trimming. Re-establishment of hazel, ivy, elder, hawthorn, blackthorn and bramble thicket under tower. Notably hedgerow and rank grassland wider at tower location</p> |

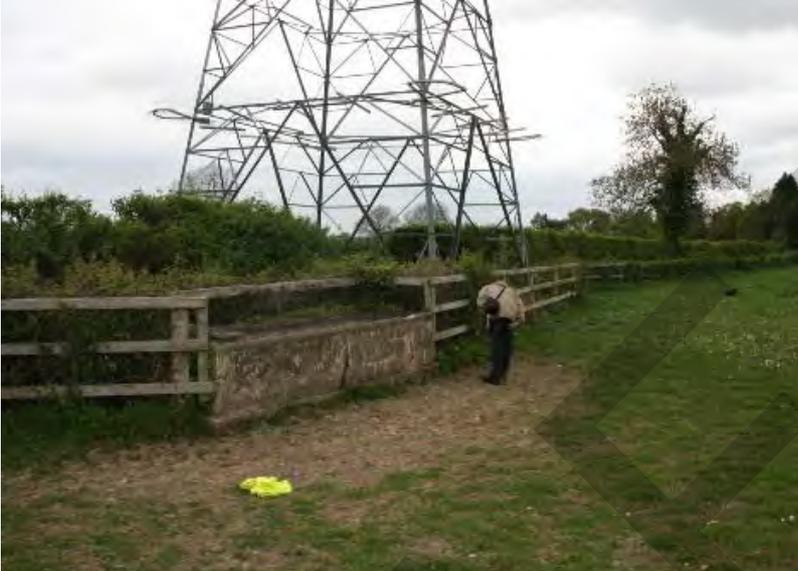
| Location Tower Nos. | Plate | Description |
|---|--|--|
| 25 | | <p>Moderate value hedgerow. Loss of woody hedgerow species at 7 m gap with no significant hedgerow re-establishment</p> |

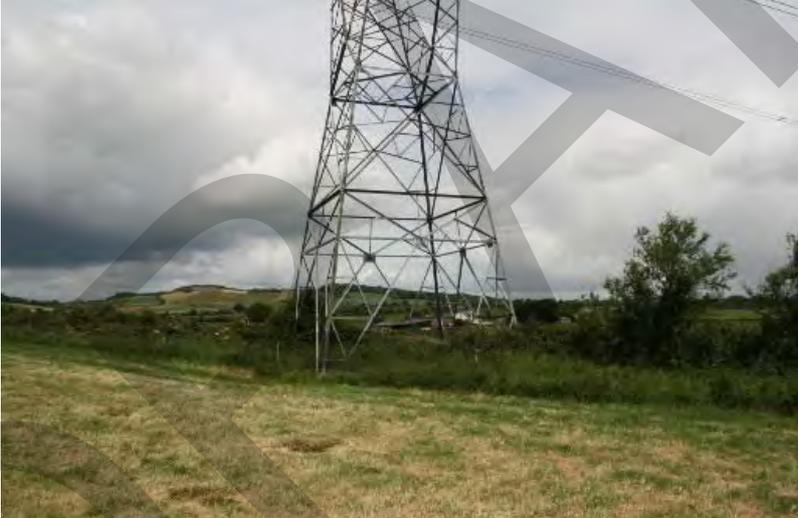
| Location Tower Nos. | Plate | Description |
|---|--|--|
| 29 | | <p>Tower straddles a low managed hedgerow. Hedgerow structure largely retained</p> |

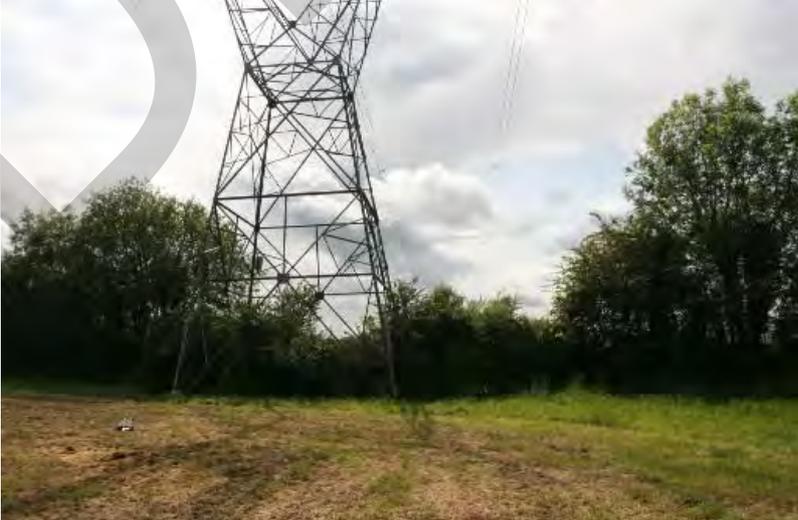
| Location Tower Nos. | Tower Type | Land use | General description hedgerow at tower location | General Description of hedgerow either side of tower location | Fauna describe (all) | NRA Evaluation hedgerow overall | Description of differences at tower location relative to either side of tower |
|---|---|---|---|---|---|---|---|
| 33 | Intermediate | Livestock (meadows) | Tower straddles robust managed (sides only trimmed) hedgerow. Species rich with woodland ground flora. Noted that tower allows hedgerow to widen at the tower location. Hedgerow structure largely retained but height is lower (<4m) under the tower | Tall straggling semi mature ash dominates. Relatively species rich (blackthorn, ash, hawthorn, willow, gorse, honeysuckle, bramble, rose, ivy and privet). Some woodland ground flora (including primrose and lords and ladies) | Birds include common passerines. Rabbits. | High | Hedgerow has re-established or was not completely cleared. Hedgerow is wider at tower location. |

| Location Tower Nos. | Plate | Description |
|---|--|--|
| 33 | | <p>Intermediate tower straddling retained "High" value hedgerow. Note height of hedgerow below line (c.a. 3 – 4m) which is much lower than hedgerow either side.</p> |

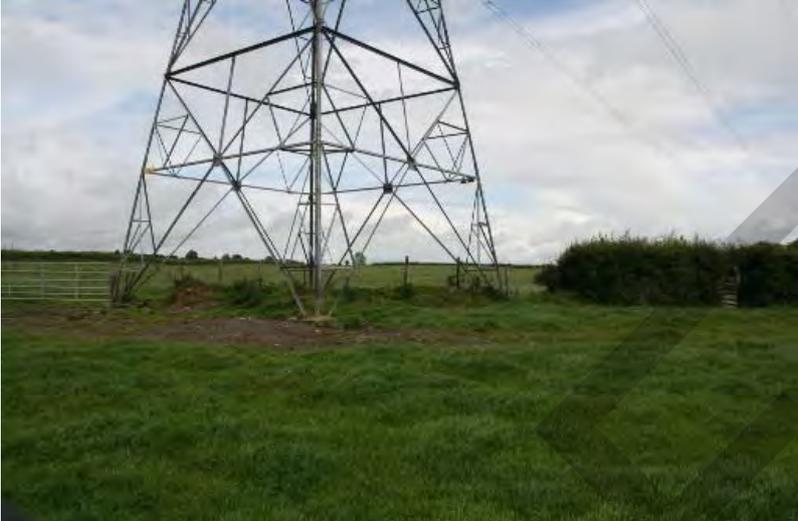
| Location Tower Nos. | Plate | Description |
|---|--|--|
| 37 | | <p>20m of hedgerow permanently removed under tower.</p> |

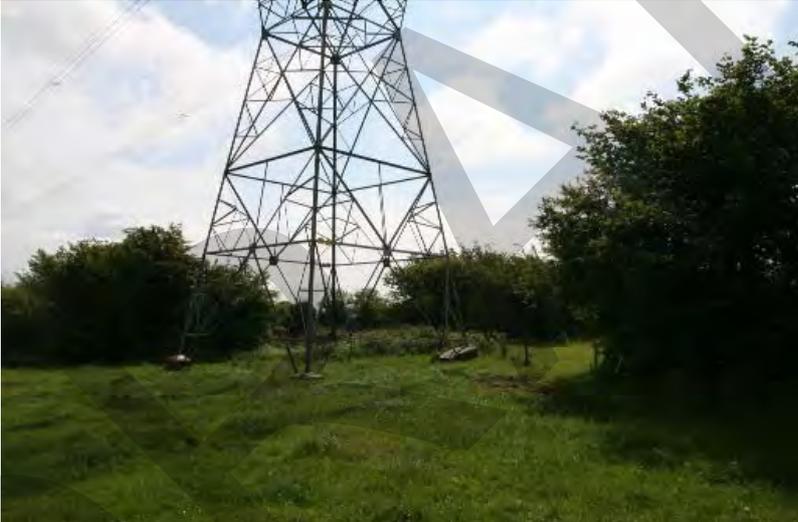
| Location Tower Nos. | Plate | Description |
|---|--|--|
| 38 | | <p>Intermediate tower in gap where hedgerow permanently removed and access track retained. High value species rich hedgerow either side.</p> |

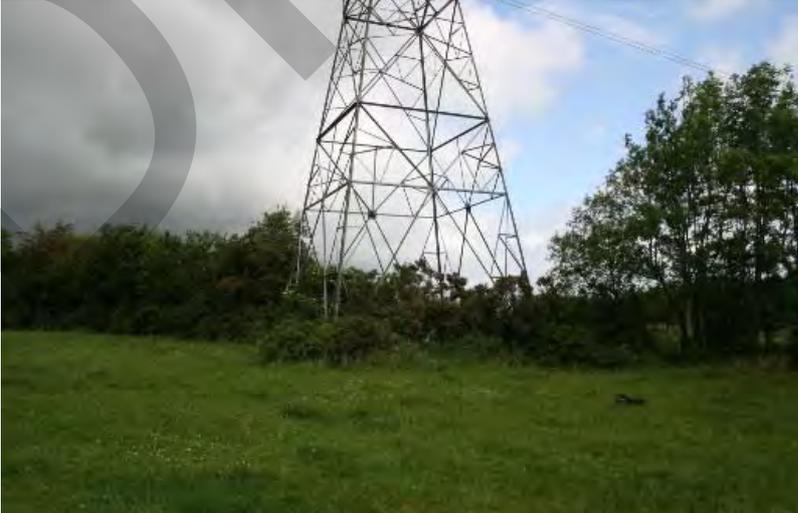
| Location Tower Nos. | Plate | Description |
|---|--|--|
| 39 | | <p>Intermediate tower with disturbed ground species (gorse, bramble) dominating tower gap. High value hedgerow either side of tower has different woody vegetation to that under tower</p> |

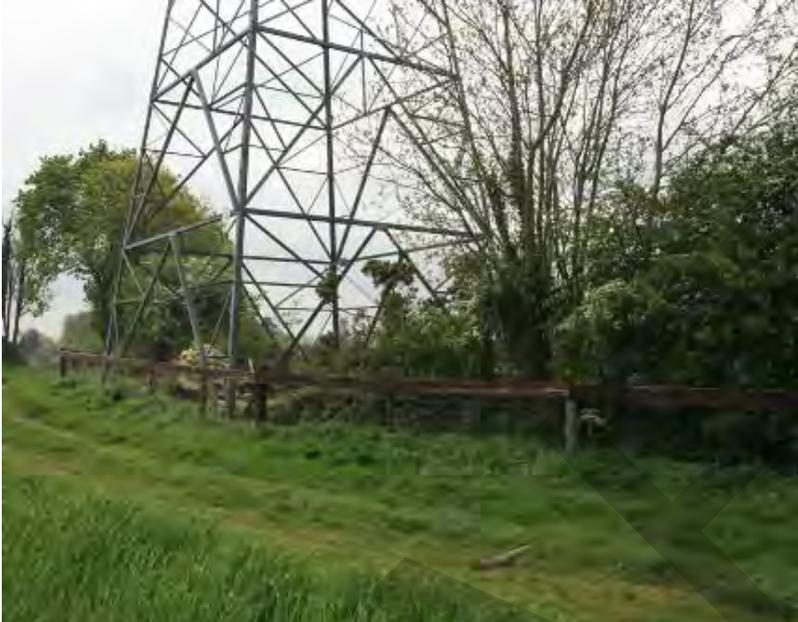
| Location Tower Nos. | Tower Type | Land use | General description hedgerow at tower location | General Description of hedgerow either side of tower location | Fauna describe (all) | NRA Evaluation hedgerow overall | Description of differences at tower location relative to either side of tower |
|---|---|---|--|--|---|---|---|
| 40 | intermediate | Arable and livestock | Hedgerow effectively gone at tower location (c.a. 10m). Low bramble and gorse at tower base. No taller woody vegetation compared to surrounds. More gappy 25-50% compared to either side (<5%) | South east of tower. Un-managed hedgerow. Woody species include hawthorn (dominant) blackthorn and ash. Climbers incl. Ivy, rose and bramble. No wood ground flora. No ditch | Breeding bird species noted (yellowhammer, chaffinch, goldfinch, long-tailed tit, blackbird). Heron noted flying through conductors. Bat survey conducted under tower. Individual Common and Soprano pipistrelle noted foraging along existing hedgerow under tower i.e. gap in hedge was not proving to be a barrier. A bat survey was conducted under 2 towers exiting the substation and the vicinity of the substation. Common pipistrelle in particular were noted feeding along woody vegetation edge, including under powerline and along treelines closeby. A minimum of 5 Common pipistrelle, 1 Soprano pipistrelle, 1 leisler and 2 unidentified bat (species) were noted close to powerline infrastructure. They were attracted by mature tree lines and woodland edge. 3 deer spp. and grasshopper warbler were noted adjacent to powerlines. No evidence of avoidance or forage corridor loss noted due to the presence of powerlines and substation infrastructure. | Moderate | Hedgerow effectively removed at tower location (c.a. 10m). Low bramble and gorse at tower base. No taller woody vegetation compacted surrounds. More gappy 25-50% compared to either side (<5%) |

| Location Tower Nos. | Plate | Description |
|---|---|---|
| 40 | | Hedgerow effectively gone at tower location (c.a. 10m). Low bramble and gorse at tower base. No taller woody vegetation compared to hedgerow either side. |
