- **Appendix 6.3 Hedgerow Impact Study**

## BENCHMARK HEDGEROW STUDIES

SEPTEMBER 2011

<b>Client:</b>	EirGrid Plc
<b>Project:</b>	North South 400kV Interconnection Development
<b>Title:</b>	Benchmark Hedgerow Studies

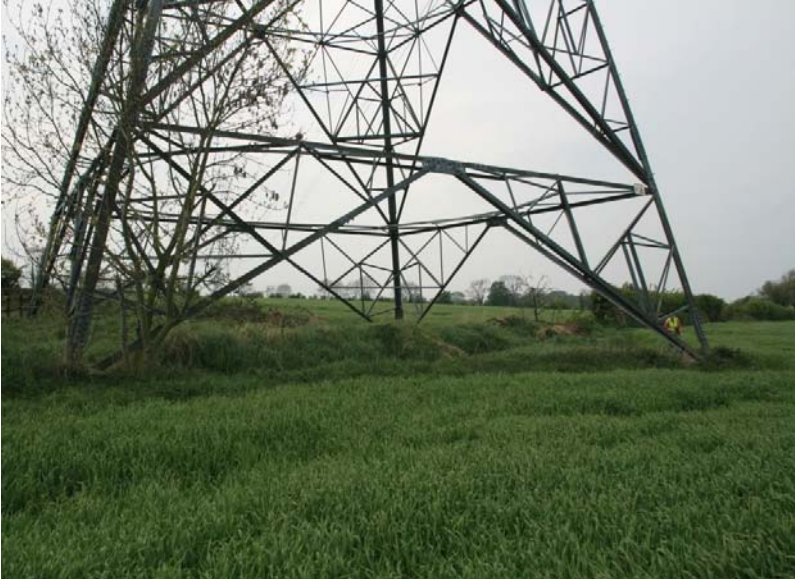
<p>Angle tower with entire hedge removed and no significant recovery. Note existing managed hedgerow in background. This tower is located at the junction of 2 "low value" hedgerows.</p>
2

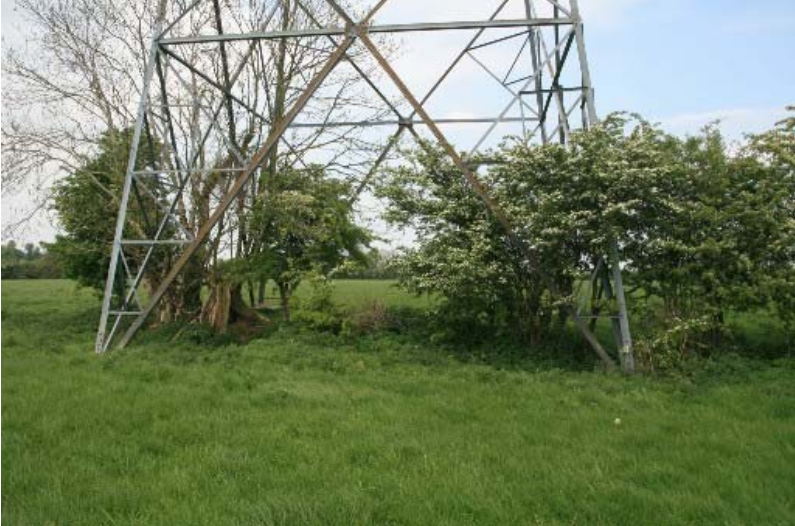
<p>Intermediate tower with limited woody vegetation recovery. Vegetation was pollarded rather than completely removed during construction.</p> <p>Hedgerow either side has low evaluation and is heavily grazed by sheep preventing recovery/ re-establishment.</p>

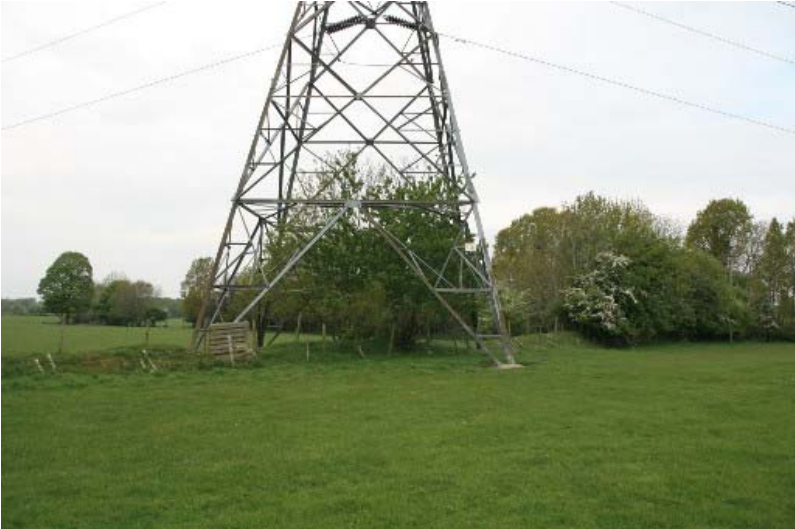
<p>Intermediate tower with limited woody vegetation recovery. Some woody vegetation was pollarded rather than completely removed during construction.</p> <p>Hedgerow either side has low evaluation and is heavily grazed by sheep preventing recovery/ re-establishment.</p>
11

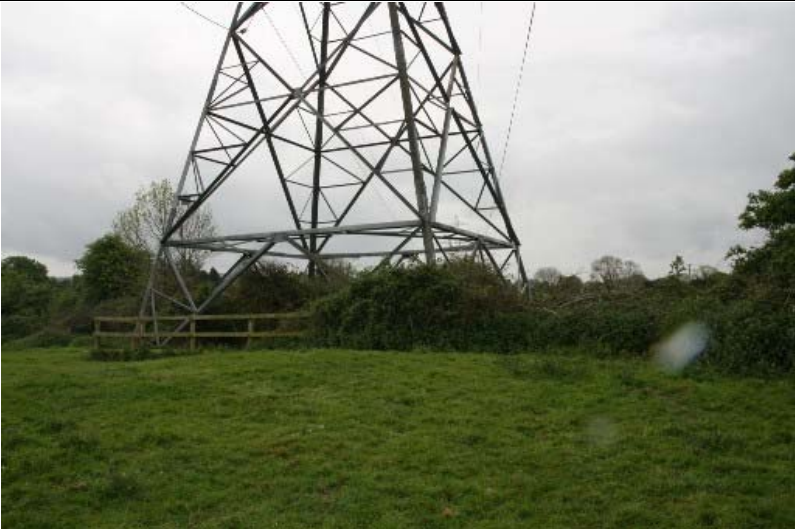
11	Angle	Livestock	Tower base surrounded by wood fence. Hedgerow (30m) replaced by bramble thicket.	Species poor hawthorn and elder unmanaged hedgerow. Damaged cattle. Some woodland ground flora. Livestock	Rabbits, passerines	Moderate	Loss of woody hedgerow species at tower location. Dense brambles maintain connectivity
12	Intermediate	Livestock	Hedgerow completely removed at 7m wide gap.	Species poor (rose, ivy, bramble, ash hawthorn) some woodland flora (e.g. viola, primula). Long term managed. Damaged by cattle.	Rabbits, passerines. No bat activity noted in this area during survey.	Moderate	Loss of woody hedgerow species at tower location.

<p>Moderate value hedgerow. Tower base surrounded by wood fence. Hedgerow (30m) replaced by bramble thicket. Note fencing, to keep livestock out, allows some woody vegetation to re-establish</p>

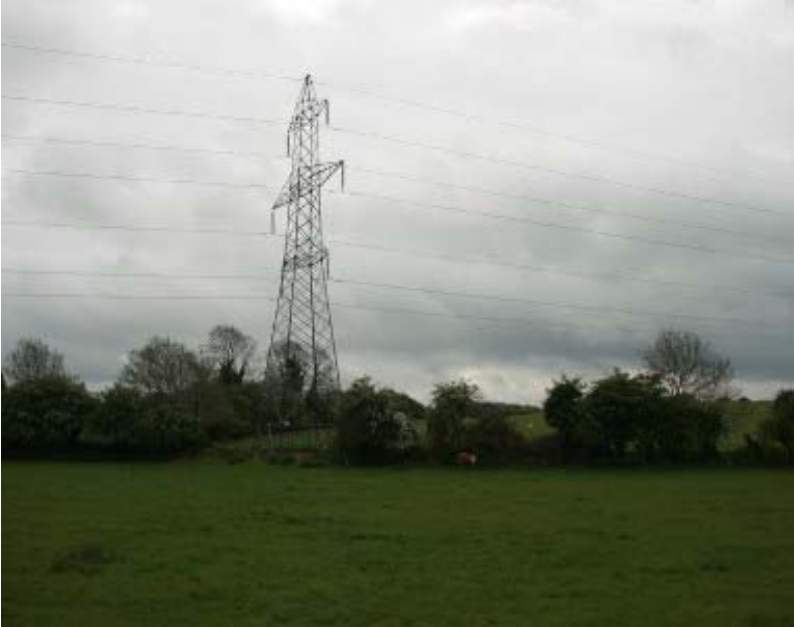
<p>Moderate value Hedgerow with section completely removed at 7m wide gap where tower located</p>
13

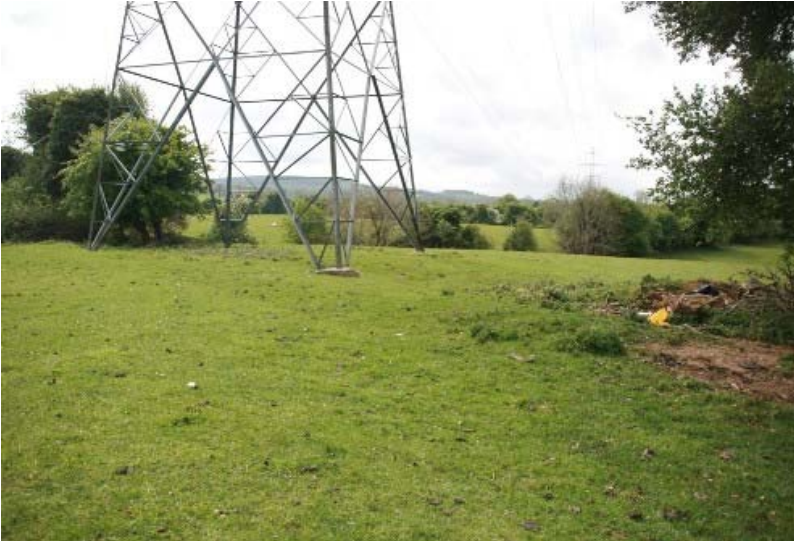
<p>Hedgerow completely removed at 25m wide gap where intermediate tower located. No reinstatement</p>

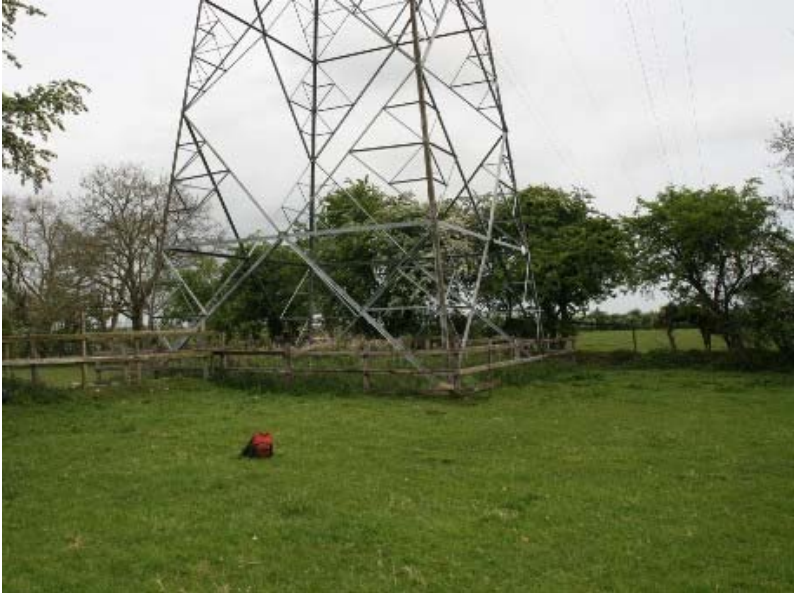
<p>Hedgerow completely removed at 12 m wide gap where intermediate tower located. No reinstatement. Fenced off</p>
17

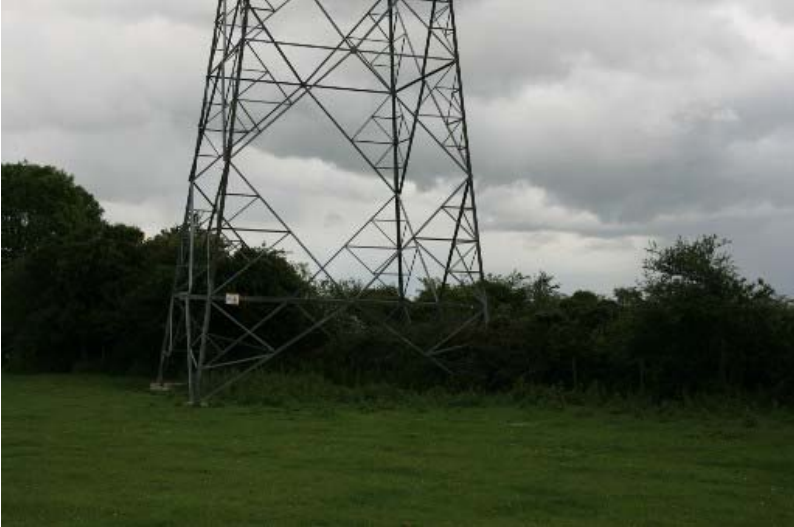
17	Intermediate	Arable	Re-establishment gorse, ivy, elder, hawthorn, blackthorn and bramble thicket under tower	Unmanaged hedgerow dominated by hawthorn, elder, ash and gorse. Grazed sheep, agricultural weeds at field layer. Arable	None	Moderate	Change in dominant woody vegetation with establishment of relatively vigorous pioneer woody plant growth under tower. Hedgerow connectivity retained.
22	Angle	Arable	Re-establishment of hazel, ivy, elder, hawthorn, blackthorn and bramble thicket under tower. Notably hedgerow and rank grassland wider at tower location	Unmanaged dense relatively species rich hedgerow. Some large mature standards present. Agricultural and plant verge species predominate ground flora. Arable	Rabbit, passerines	Moderate	No real difference besides trimming. Re-establishment of hazel, ivy, elder, hawthorn, blackthorn and bramble thicket under tower. Notably hedgerow and rank grassland wider at tower location

<p>Hedgerow connectivity retained at gap where tower straddles low hedgerow. Change in dominant woody vegetation with establishment of relatively vigorous pioneer woody plant growth under tower.</p>
22

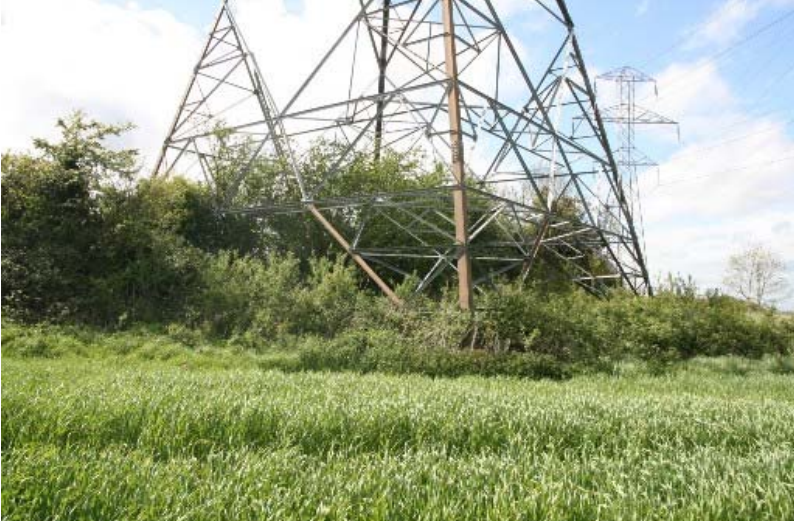
<p>Moderate value hedgerow. No real difference under tower besides trimming. Re-establishment of hazel, ivy, elder, hawthorn, blackthorn and bramble thicket under tower. Notably hedgerow and rank grassland wider at tower location</p>

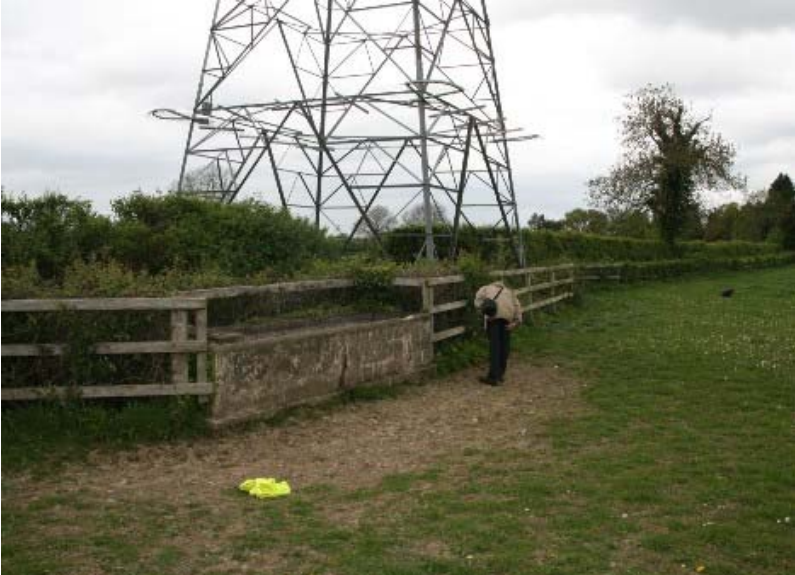
25	Intermediate	Livestock	7m gap with main woody vegetation (hawthorn) gone. Dense briars as fenced off. Fenced at tower location means remnant hedgerow wider than surrounding at tower location.	Managed (trimmed) species rich (woody) hedgerow.	Rabbit, passerines (including yellowhammer)	Moderate	Loss of woody hedgerow species at 7 m gap with no significant hedgerow re-establishment
29	Intermediate	Livestock (meadows)	Tower straddles low managed hedgerow. Hedgerow structure largely retained	Relatively species poor (woody) managed hedgerow. Agricultural weeds (ground flora).	Passerines (including yellowhammer)	Low	No significant impact - hedge re-established/ not completely cleared

<p>Moderate value hedgerow. Loss of woody hedgerow species at 7 m gap with no significant hedgerow re-establishment</p>
29

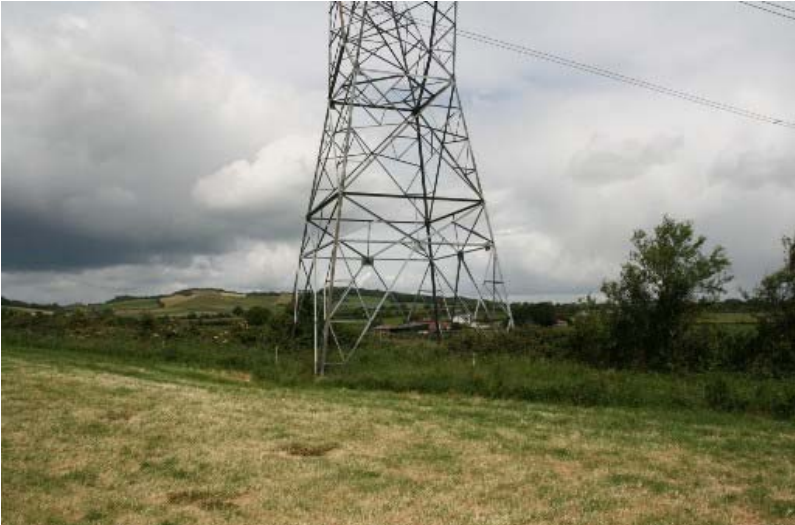
<p>Tower straddles a low managed hedgerow. Hedgerow structure largely retained</p>
33

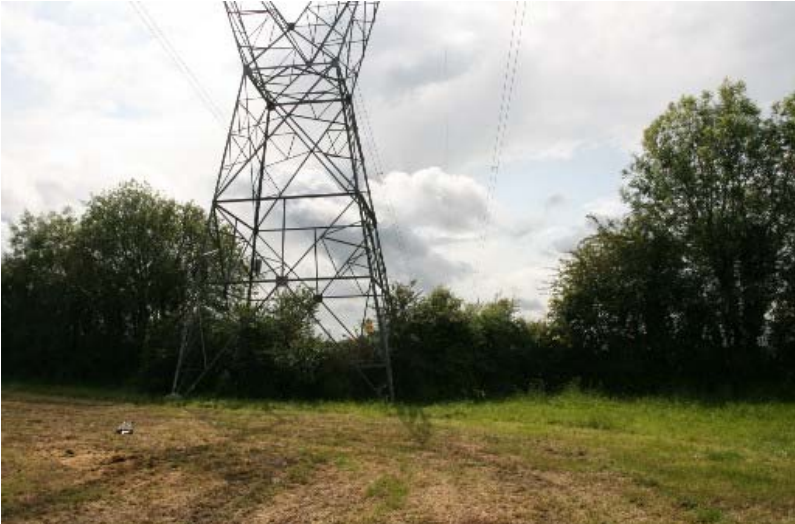
<p>Intermediate tower straddling retained "High" value hedgerow. Note height of hedgerow below line (c.a. 3 – 4m) which is much lower than hedgerow either side.</p>

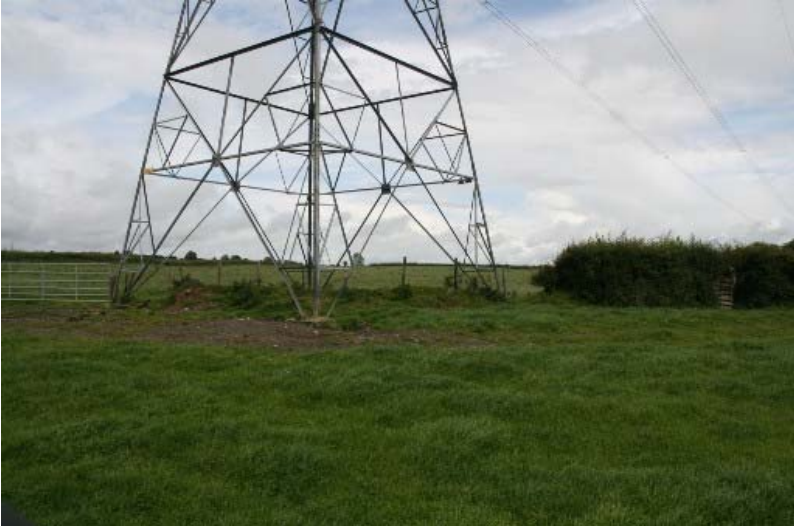
37	Intermediate	Livestock	20m of hedgerow permanently removed under tower.	hedgerow either side of tower is managed and species poor (hawthorn dominated)	None close to tower	Low	Loss of woody hedgerow species as 20m of hedgerow permanently removed under tower. No recovery/reinstatement
38	Intermediate	Livestock (meadows)	20 - 30m of hedgerow permanently removed under tower. (Includes an access track). The tower is located at the meeting point 3 hedgerows meaning larger impact.	Robust unmanaged narrow species rich (woody and ground flora) hedgerow. Species include alder, spindle, rose, blackthorn, hazel, hawthorn, ivy and holly. hedgerow is located on a townland boundary	Birds include common passerines.	High	Loss of woody hedgerow species as 20 - 30m of hedgerow permanently removed under tower. (Including an access track).
39	Intermediate	Livestock (meadows)	Hedgerow at tower location dominated by pioneer woody species of disturbed ground. Tower means hedgerow wider at this location	Species rich hedgerow either side of tower (willow, ash, hazel, ivy, blackthorn, gorse, hawthorn and elder)	Birds include common passerines.	High	Change in hedgerow plant community at tower location includes pioneer woody species of disturbed ground. Hedgerow wider at tower location

<p>20m of hedgerow permanently removed under tower.</p>
38

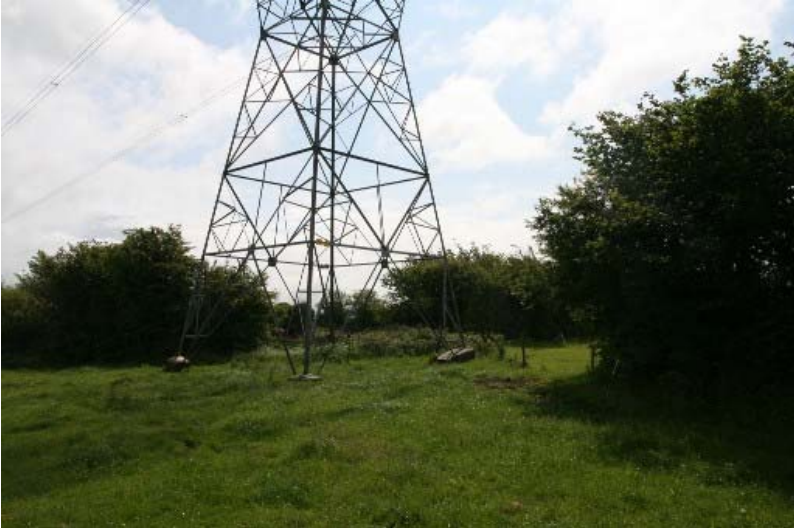
<p>Intermediate tower in gap where hedgerow permanently removed and access track retained. High value species rich hedgerow either side.</p>
39

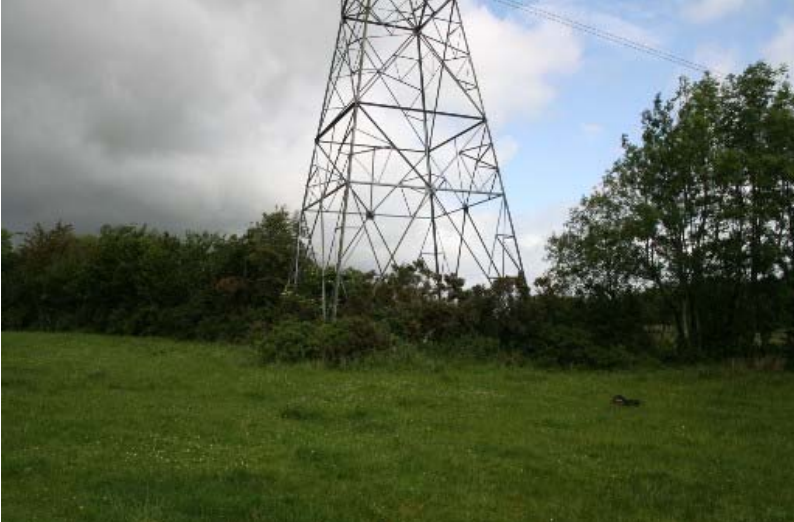
<p>Intermediate tower with disturbed ground species (gorse, bramble) dominating tower gap. High value hedgerow either side of tower has different woody vegetation to that under tower</p>

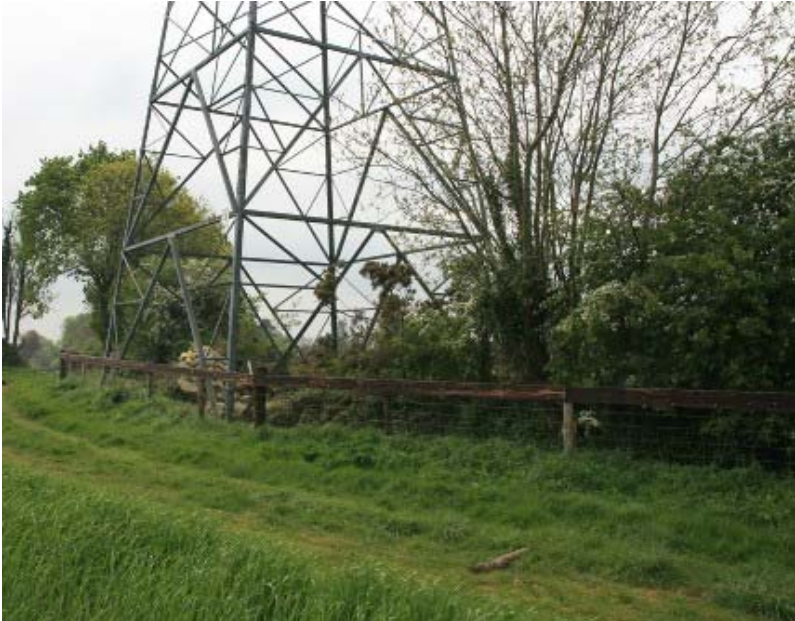
<p>Hedgerow effectively gone at tower location (c.a. 10m). Low bramble and gorse at tower base. No taller woody vegetation compared to hedgerow either side.</p>
