Kilmainham, Mountmellick, County Laois.

13th January 2021

RE: Your Case Number: ABP-308844-20 and Planning Authority Reference Number: 10/5

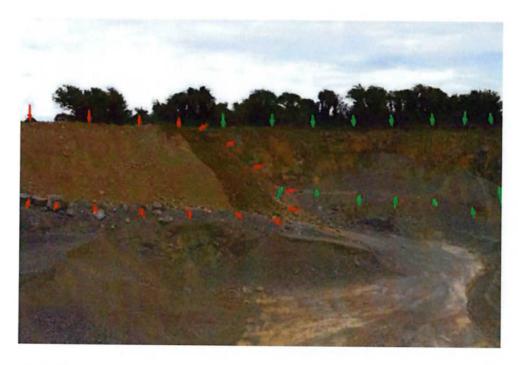
Photo 1: Red arrows indicate the new entrance built in 2014. The green arrows indicate the partial extent of the eastern boundary, as blasted, excavated and removed. (2014)

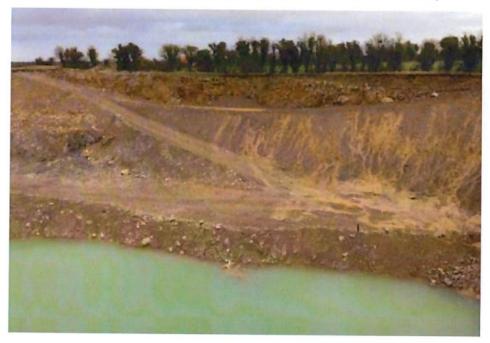
Photo 2: New entrance and haul roads, which were constructed on site. (2014)

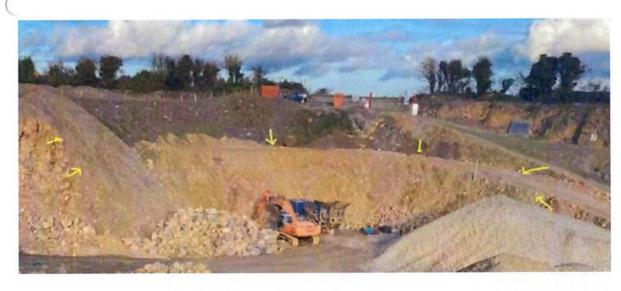
Photo 5: Further and additional construction works. Note all the area from and including that under fence all the way over to include all the entrance in the above photo is newly constructed ground. (November 2020)

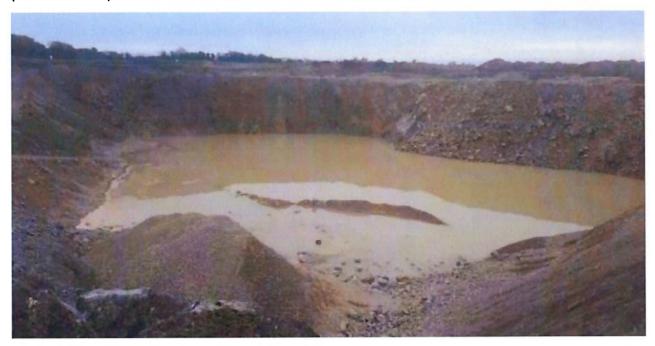
Photo 6: After a quarry blast (2019)

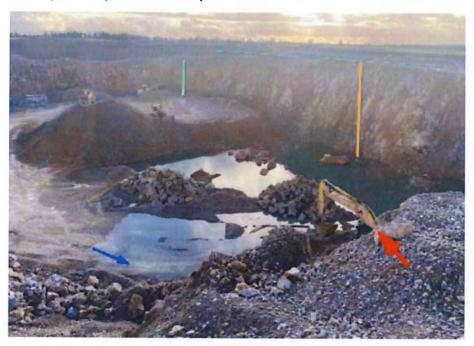
As I understand it Section 10 of the final grant of planning clearly requires the developer <u>not to evacuate</u> <u>within two meters of the highest water table on-site</u>. Today, a vast portion of the site rests in water and prior to the building of new haul roads (extending several metres in length * width * height), building new boundaries (extending several metres in L*W*H), a completely new entrance (several metres in

Photo 12: Recent work on-site. Note the differences in the bench heights – the digger (red arrow) is excavating rock from below the water (blue arrow shows tracks under the water). GREEN c. the benchdrop to the quarry floor, BLUE – tyre tracks, RED – digger down excavating, ORANGE c. bench-drop to the area being dug-out by the digger, CYAN line is the face[s] most recently drilled and blasted. (November 2020)

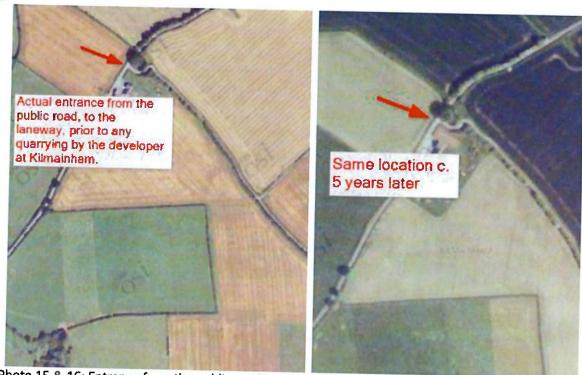
Photo 15 & 16: Entrance from the public road onto the laneway prior to any quarrying at Kilmainham by the developer. The changes are not unexplained in the planning documents. (2000, 2005 OSi orthophotography)

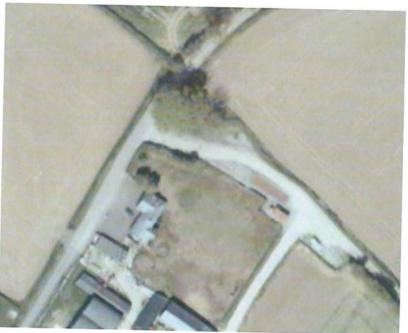
Photo 17: Entrance (early 2019, OSI orthophotography) showing office & weighbridge at that time
