Ref. No.: 125/20
Question: Are the roof repair works comprising re-slating the side (east) aisle of the Church of the Assumption (a protected structure) exempt development?
Decision: 26th January 2021
4 Weeks: 22nd February 2021

SECTION 5 REFERRAL

RE: Conservation Report / Opinion on Roof Repair works comprising re-slatting the side (east) aisle of the Church of the Assumption, 67 Booterstown Avenue, Blackrock, Co. Dublin, a Protected Structure.

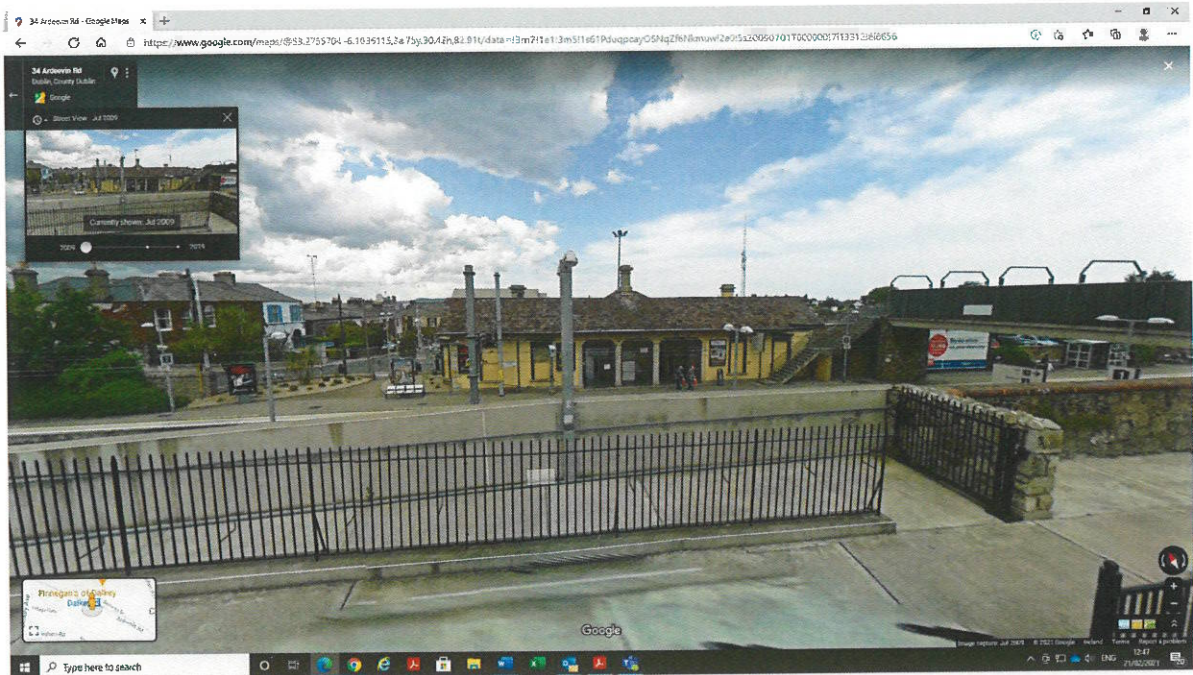
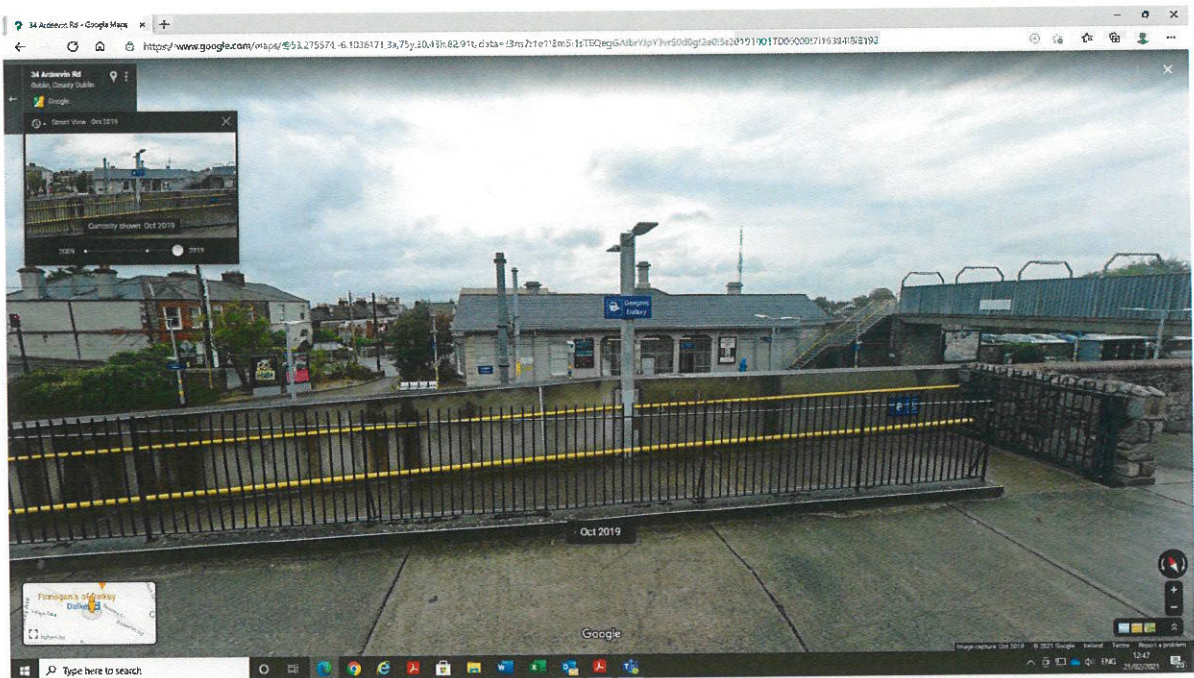
Dalkey DART Station: Google Streetview Image July 2009

Dalkey DART Station: Google Streetview Image October 2019

Note: The roof of Dalkey DART station has been re-slatted with new slates of a different colour and the elevation has also been re-rendered. There is a clear difference between the colour old and new slates.

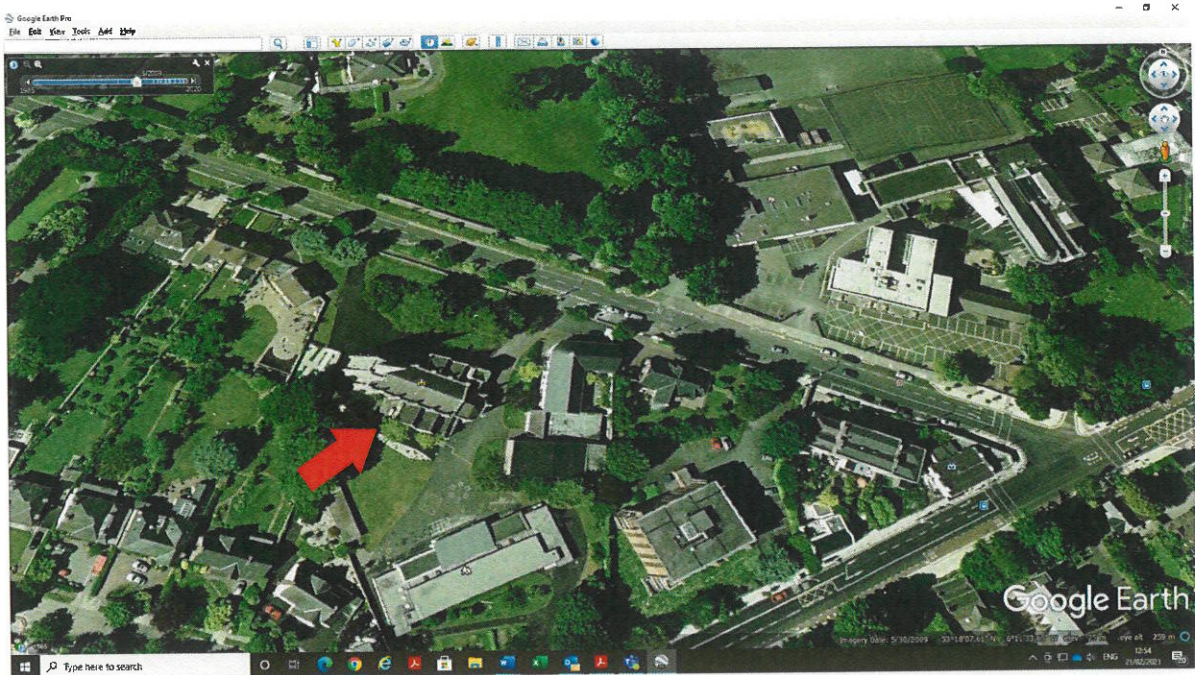
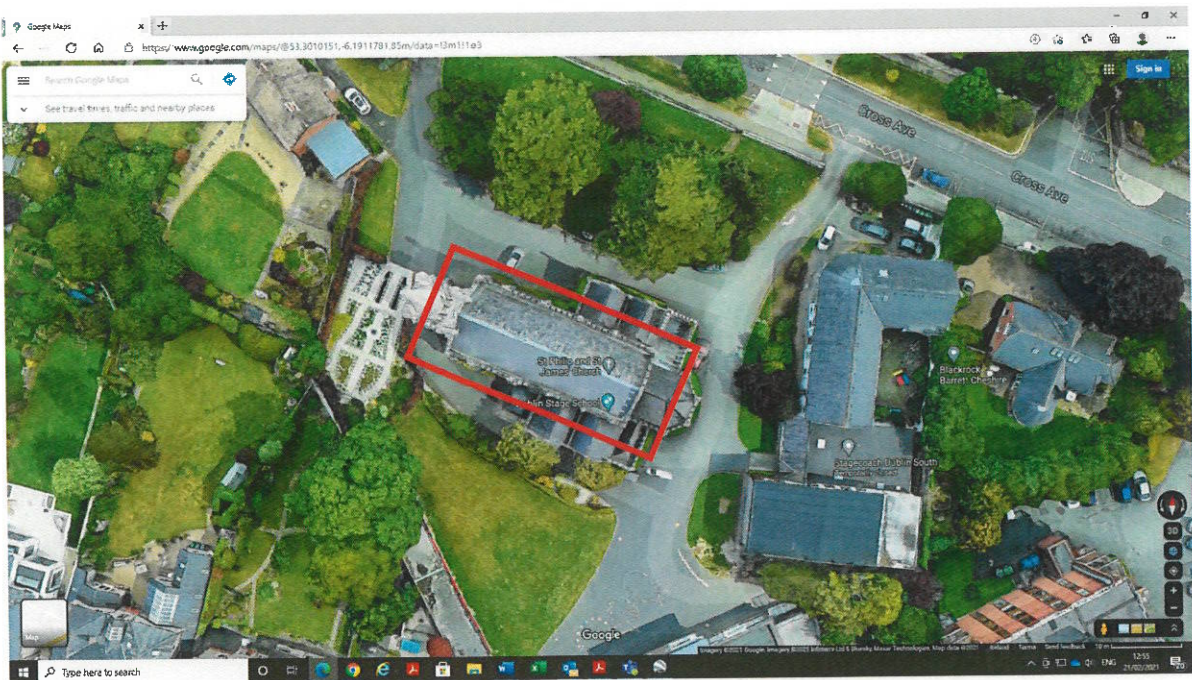
The Select Vestry of St. Philip and St. James: Google Earth Image May 2009

The Select Vestry of St. Philip and St. James: Google Maps Image late 2010's

Note: The red box highlights the roof of the nave of the church. The southern side of the roof has been replaced and there is a clear difference between the colour of the new slates and the old ones.

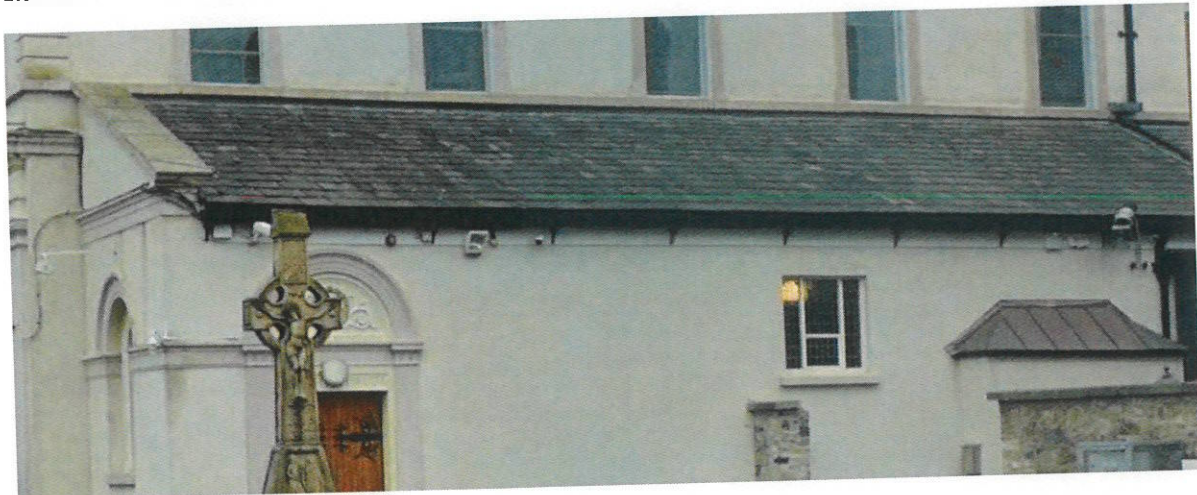
Street View-Oct 2019 ©Google 2021.

Based on a comparison between on the Google Map image above, showing the roof before the work was carried out, with those taken after the roof was re-slatted, it would appear, that the average size of the original slates is not materially different to the replacement slates and that replacement battens were placed at similar centres. Whilst the original slates varied considerably in size, the

visual grain of the roof is determined by the averages sized ones and that has been matched by the new slates. The new slates are natural with a similar texture to the original ones and will fade as they weather in time, as did the original.

The above Google Maps image shows the side aisle roof as seen from the ground before the work was done. Given the angle from which this roof is visible from the ground it is unlikely that the difference in the size and thickness of the slates is noticeable; the visual impact is of minimal to negligible effect.

The condition of the slates retained on site indicates that the day for making "the decision to re-roof", for "the full replacement covering, versus the accumulation of incremental costs" had come and the urgency to proceed with this work was evident when a falling slate just missed a person standing outside the side aisle which abuts the path to the Parish Centre entrance, an access route that is in constant use. Loose /slipped slates are visible in the Google Maps image above.

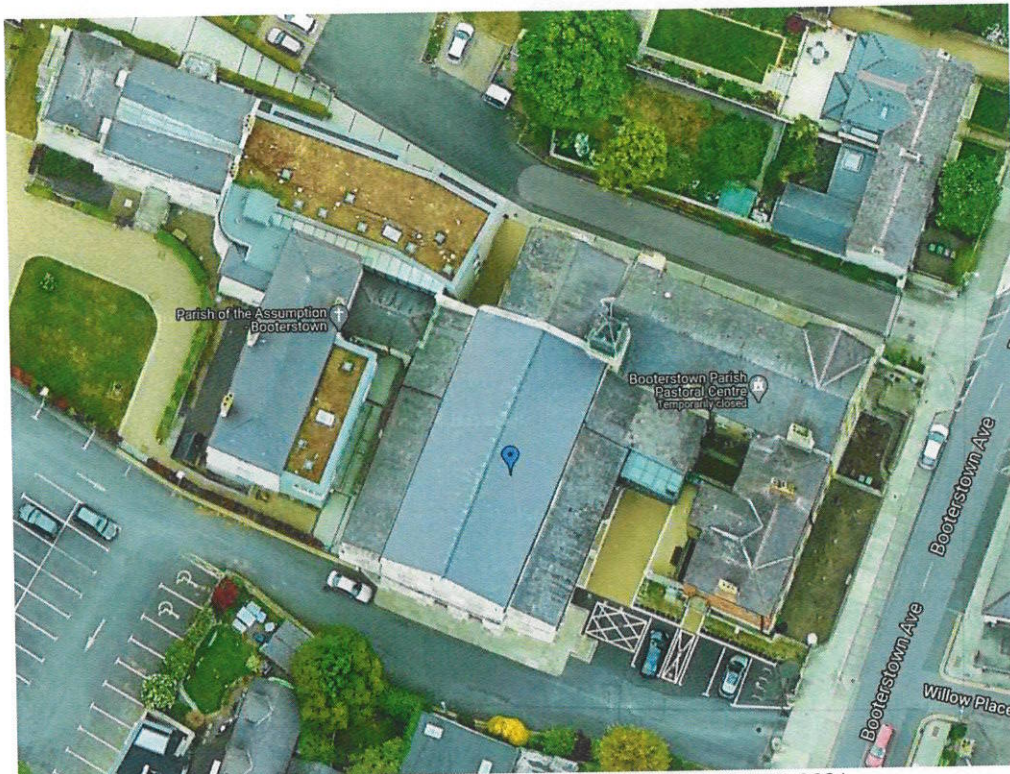
Satellite image © Infoterra LTD & Bluesky Maxar Technologies Map data © 2021

The colour of natural materials varies. Recently quarried Blue Bangors would look different to those originally used, being a natural material taken from different parts of the quarry at different times. The new slates will fade as they weather. A minor change to the colour of a building element does not significantly change the character and appearance of the overall building. Reference to the above Google Maps satellite image shows that the main roof of the Church also has a darker colour slate, where slates appear to be consistent with in terms of colour.

It is accepted that there is a difference in colour and that it is evident when looking at the side aisle roof that it has been recently re-slatted but it is not accepted that this would constitute a material change that would materially affect the character or appearance of the Church. Further, it is expected that given time to weather, the appearance of the new slates will become less obvious.
