An  
Coimisiún  
Pleanála

## Internal Technical Note

**ABP-321181-24**

Demolition of a farm building and the construction of a new farm building. An NIS was submitted with Further Information at application stage.

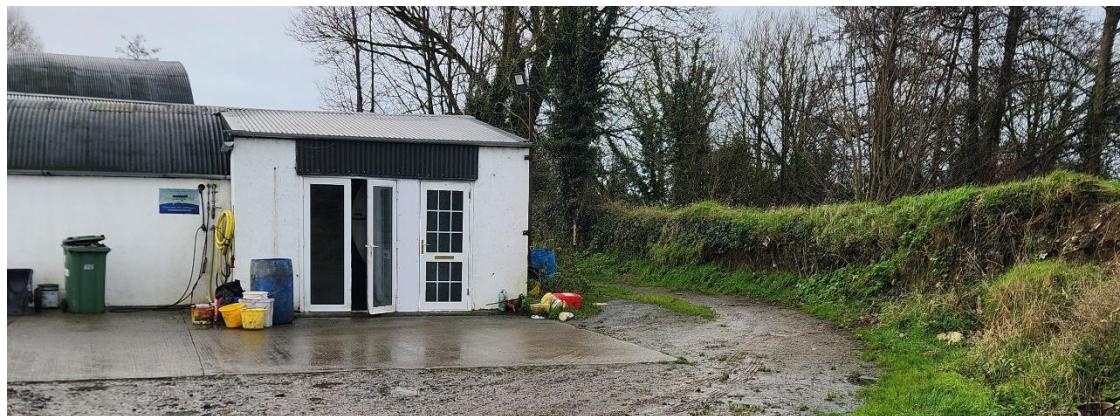
**Photo 1** Vegetated earth bank along western boundary of the site. Looking south. Milking parlour in view. Newport river behind earth bank

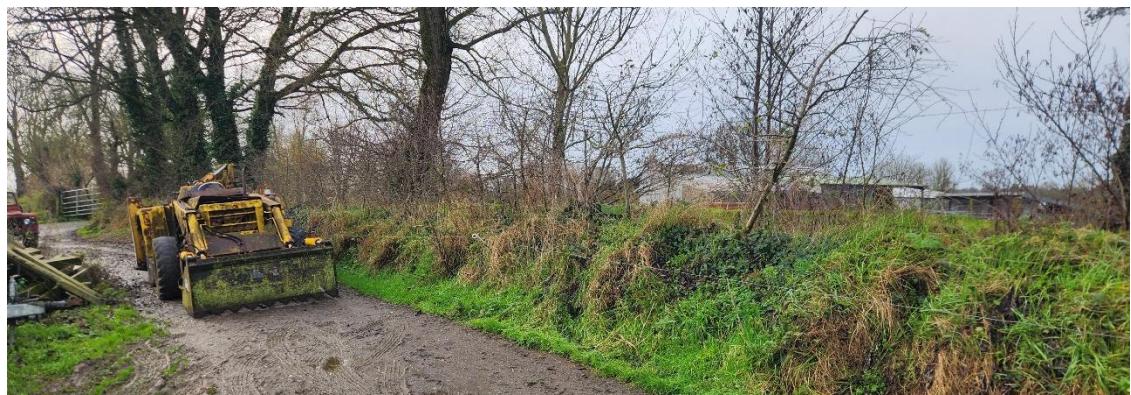
**Photo 2** Vegetated earth bank along western boundary of the site. Looking south/south-west. "Gap" in earth bank can be seen in far background behind machinery. Access to the Newport River through the gate

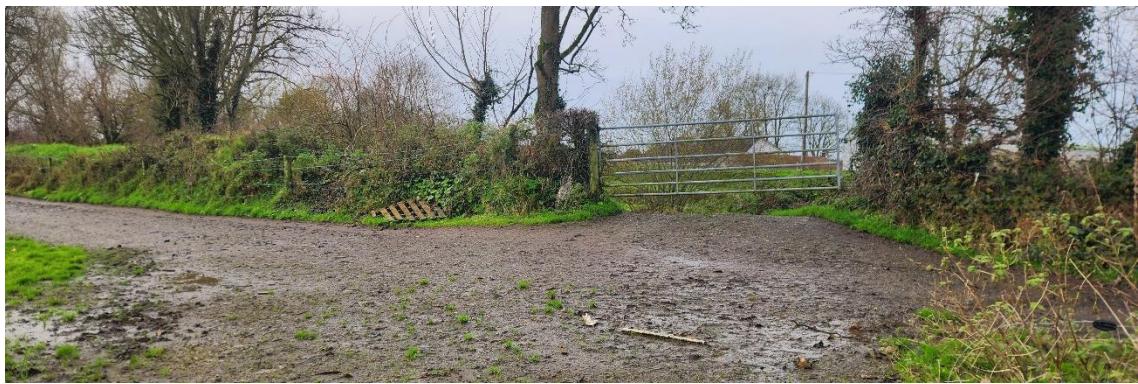
2.3.1. I visited the site on 3<sup>rd</sup> December 2025. I observed the vegetated earth bank which runs along the western boundary of the site. The access track runs inside the earth bank within the site. The Newport River is located on the other side of the earth bank, to the east. There is a “gap” in the earth bank to the south west of the site where there is a gate but no hedging. This “gap” is not located within the development site boundary and is not directly affected by the development. Access to the river through the gate is possible. However, the ground levels at the “gap” are higher than the surrounding ground levels within the site, therefore any surface water

in the site will be contained and will not enter the Newport River. See photos below in Appendix 1. I note that much of the site is concreted, in particular where the main works will be and the ground levels adjacent to the farm shed which will be demolished slope to the east (away from the river). Therefore, I can confirm that there is no surface water pathway between the site and the Newport River.

**Photo 3.** Looking west from site to the “Gap” in earth bank. Access to the Newport River through the gate. Ground levels rise at the gate.

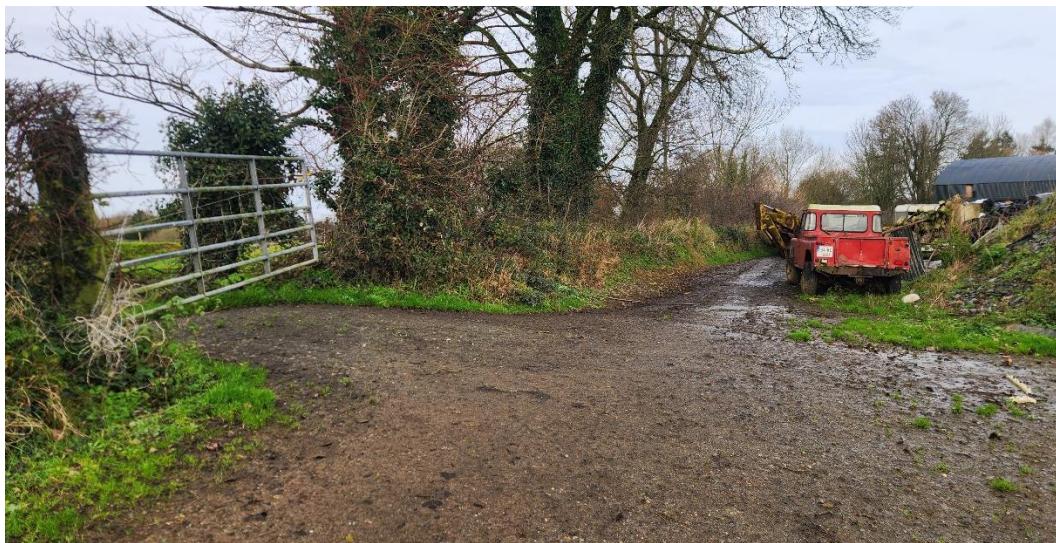
**Photo 4.** Looking north from site. “Gap” in earth bank along western boundary can be seen. Ground levels rise at the gate.

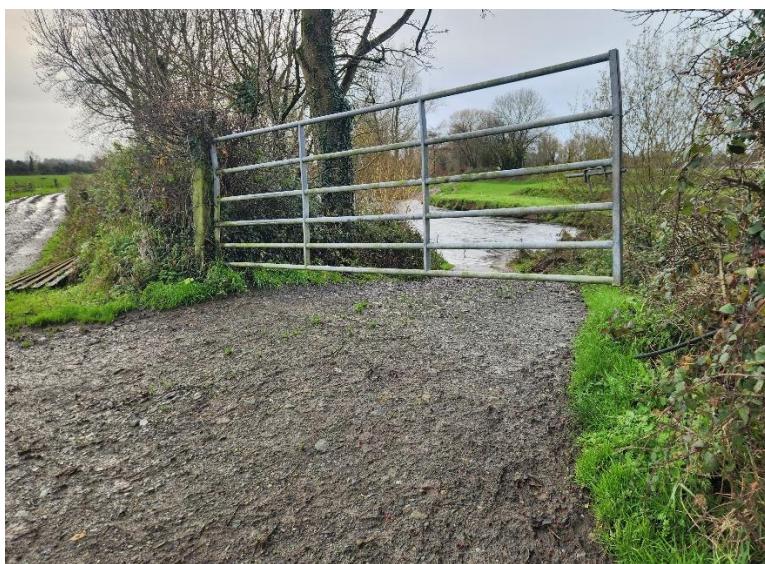
**Photo 5.** Looking south/south-west from site. The ground levels rise up from the site to the gate and reduce back down to the river.

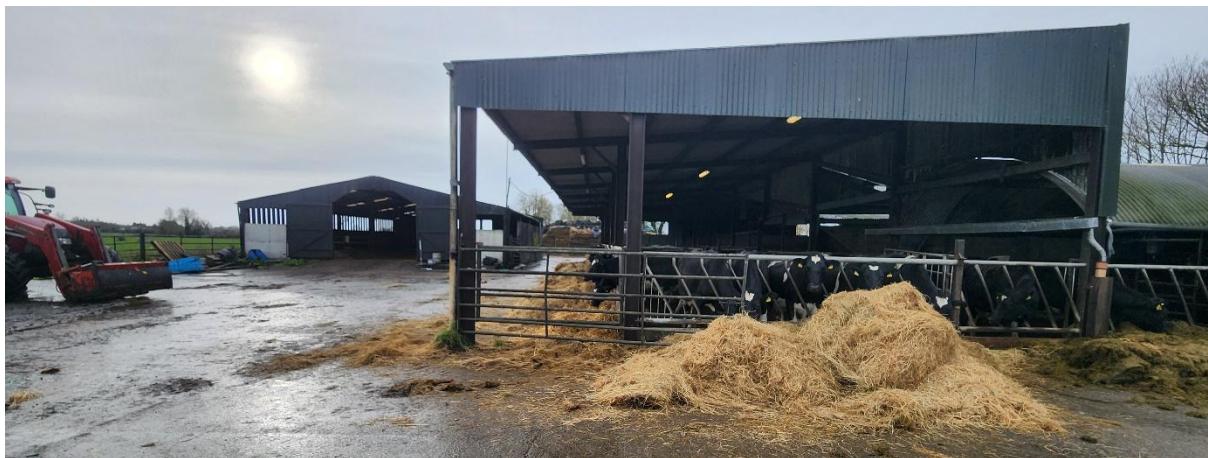
**Photo 5.** Looking south. Farm shed on left hand side of photo to be demolished. Note farmyard is concreted.

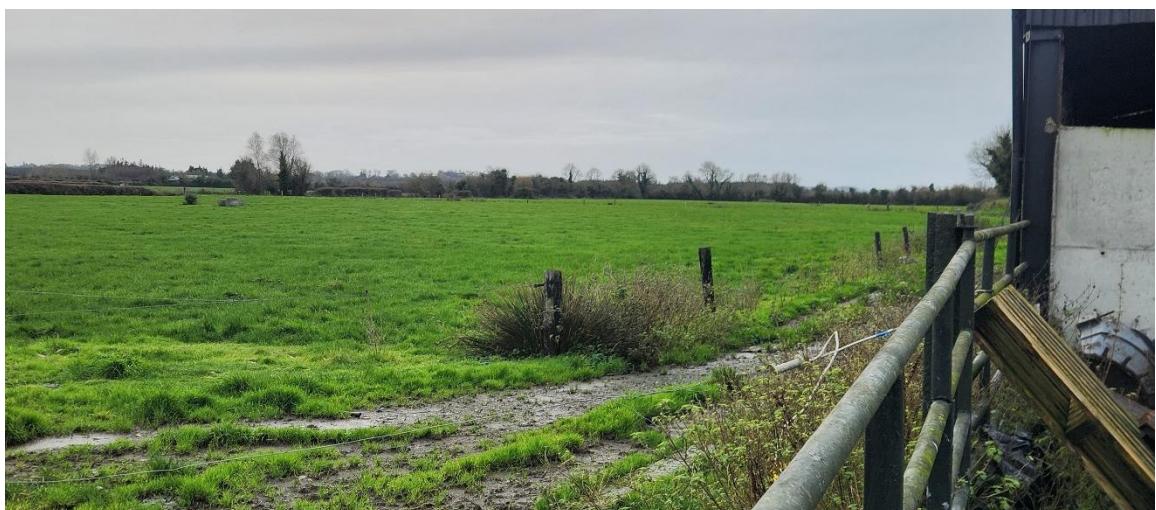
**Photo 5.** Looking south/south-east from site. Farm shed on right hand side of photo to be demolished. The ground levels (left-hand side of photo) are lower to the east of the site, away from the river.

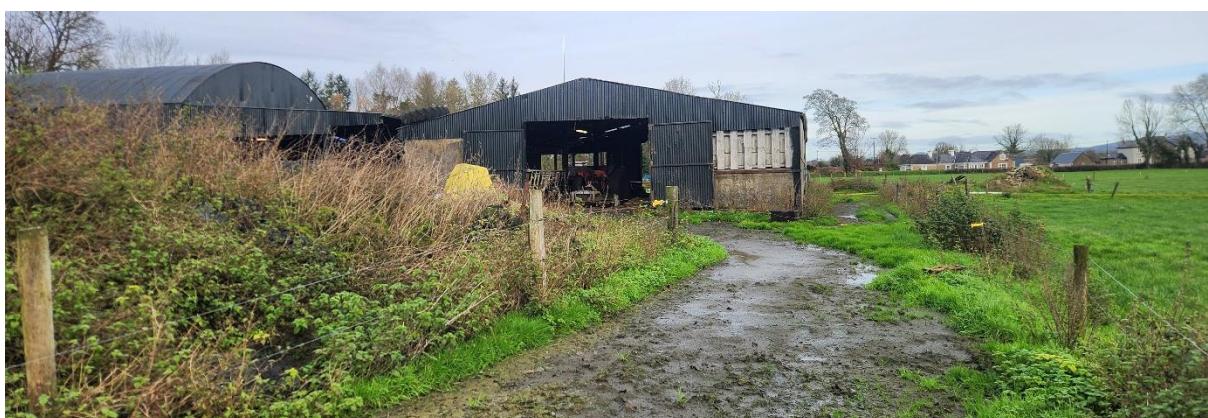
**Photo 6.** Looking north. Farm shed in foreground to be demolished. The ground levels (right hand side of photo) are lower to the east of the site, away from the river.
