Cork Line Level Crossings – XC201 Ground Investigation

Client: Irish Rail

Report No.: OCB19-135-1

Report No.: OCB19-135-1
Project title: Cork Line Level Crossings – XC201
Client: Irish Rail
Client's Representative: JACOBS

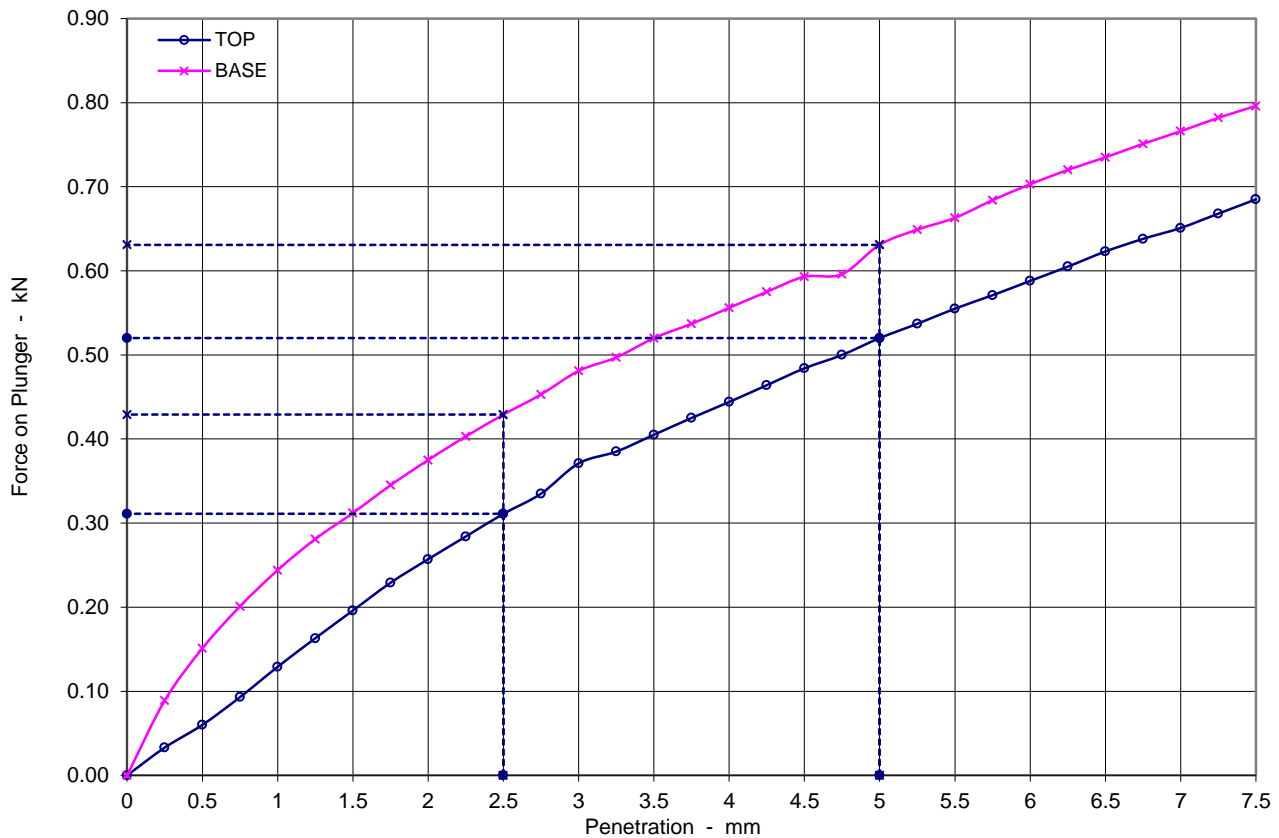
Sample Details:	SAMPLE ID:	Hole No	XC201-TP01
		Sample Depth (m)	0.50 - 1.00
	SOCO202010024	Sample Type and No	D1
		Specimen Ref	1

Soil description	Brown slightly sandy gravelly CLAY.
------------------	-------------------------------------

Test Conditions		
Sample Retained on 20 mm sieve	%	17

Sample Conditions		
Initial Moisture Content	%	12.0
Bulk Density	Mg/m³	1.97
Dry Density	Mg/m³	1.77
Moisture Content - TOP	%	11.0
Moisture Content - BASE	%	12.0

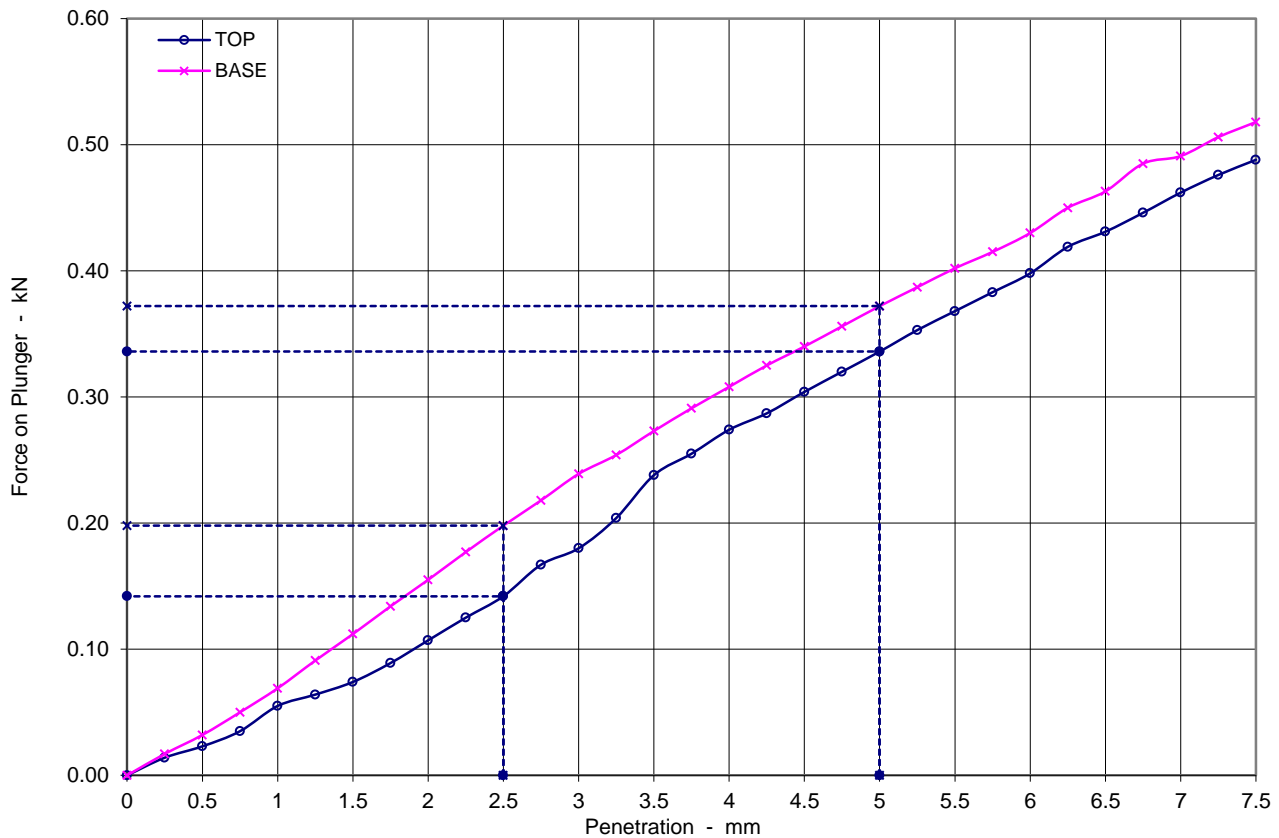
Sample Details:	SAMPLE ID:	Hole No	XC201-TP04
		Sample Depth (m)	2.00 - 2.50
	SOCO2020100233	Sample Type and No	B8
		Specimen Ref	1

Soil description	Brown slightly sandy slightly gravelly CLAY.
------------------	--

Test Conditions		
Sample Retained on 20 mm sieve	%	0

Sample Conditions		
Initial Moisture Content	%	10.0
Bulk Density	Mg/m³	2.12
Dry Density	Mg/m³	1.92
Moisture Content - TOP	%	10.0
Moisture Content - BASE	%	10.0

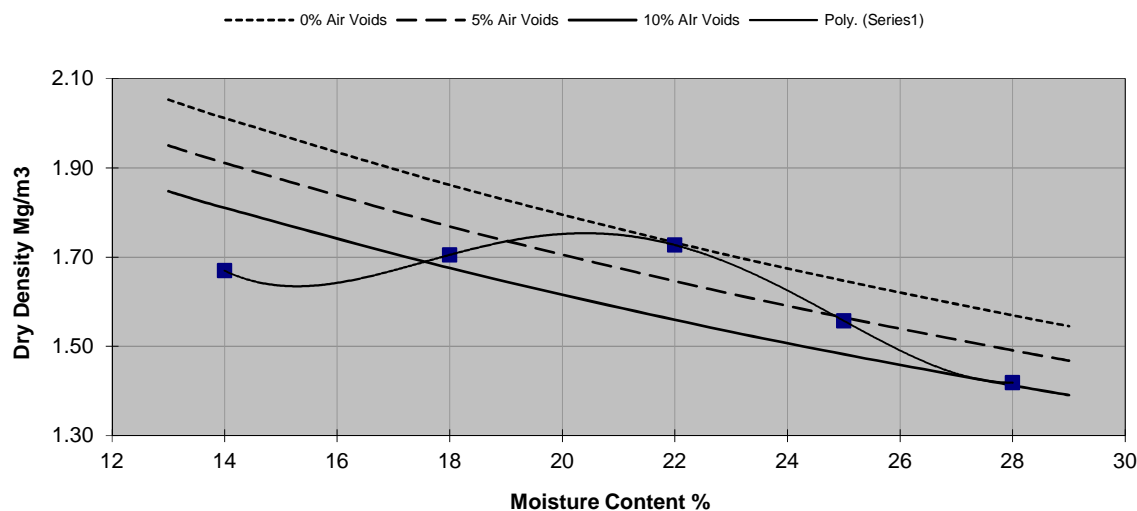
Bulk Density: Mg/m ³	1.90	2.01	2.11	1.95	1.82
Moisture Content: %	14	18	22	25	28
Dry Density: Mg/m ³	1.67	1.71	1.73	1.56	1.42

Maximum Dry Density (Mg/m³)
Optimum Moisture Content (%)

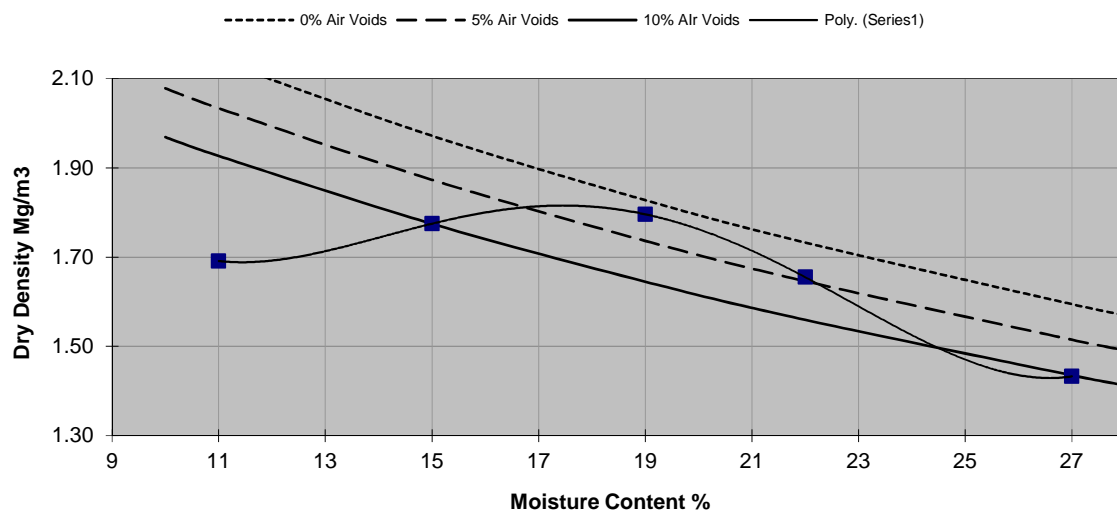
Bulk Density: Mg/m ³	1.88	2.04	2.13	2.03	1.81
Moisture Content: %	11	15	19	22	27
Dry Density: Mg/m ³	1.69	1.77	1.80	1.65	1.43

Maximum Dry Density (Mg/m³)
Optimum Moisture Content (%)

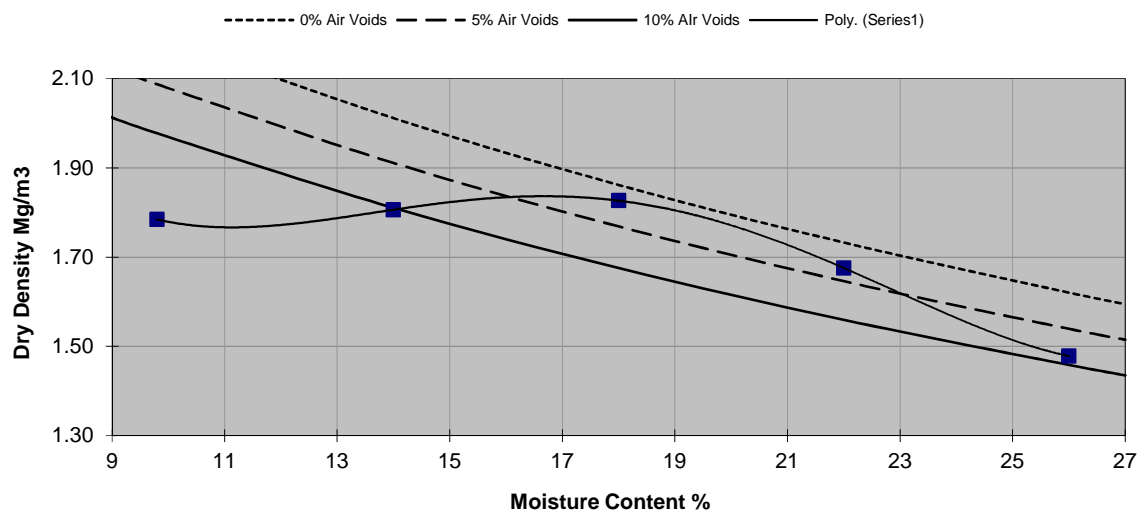
Bulk Density: Mg/m ³	1.96	2.07	2.16	2.04	1.86
Moisture Content: %	9.8	14	18	22	26
Dry Density: Mg/m ³	1.78	1.81	1.83	1.68	1.48

Maximum Dry Density (Mg/m³)
Optimum Moisture Content (%)

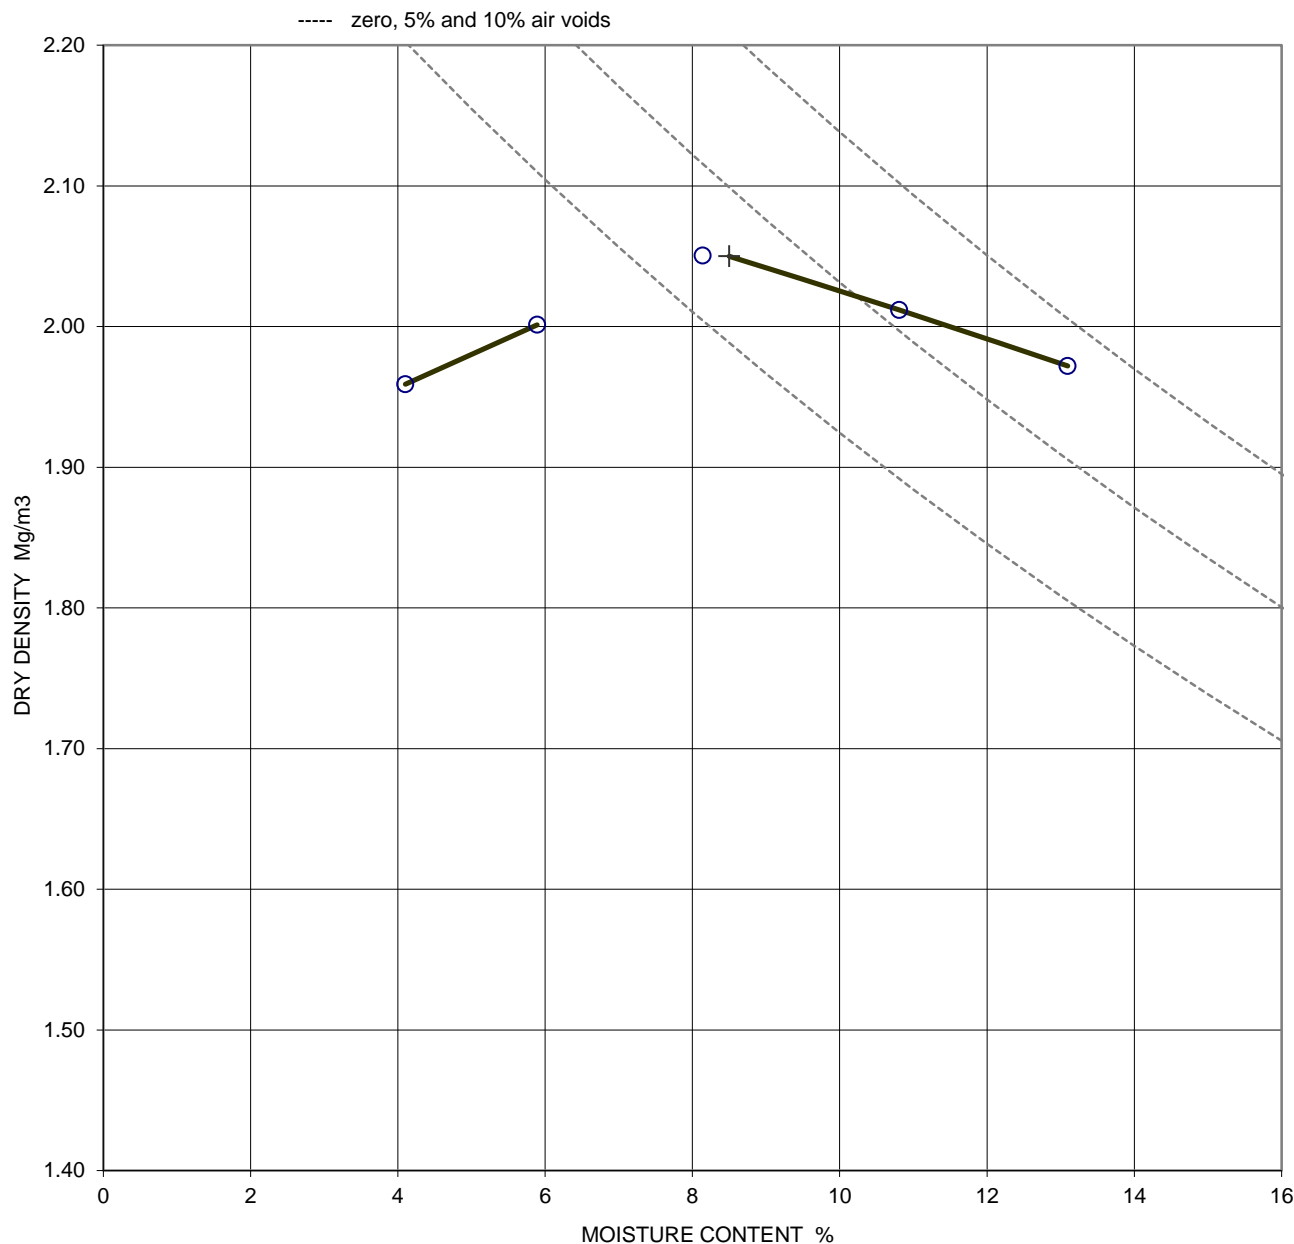
Sample Details:	SAMPLE ID:	Hole No	XC211-CP02
		Sample Depth (m BGL)	3.00 - 4.00
	SOCO2020100654	Sample Type and No	B11
		Specimen Ref

Soil description Brown slightly sandy slightly gravelly CLAY.

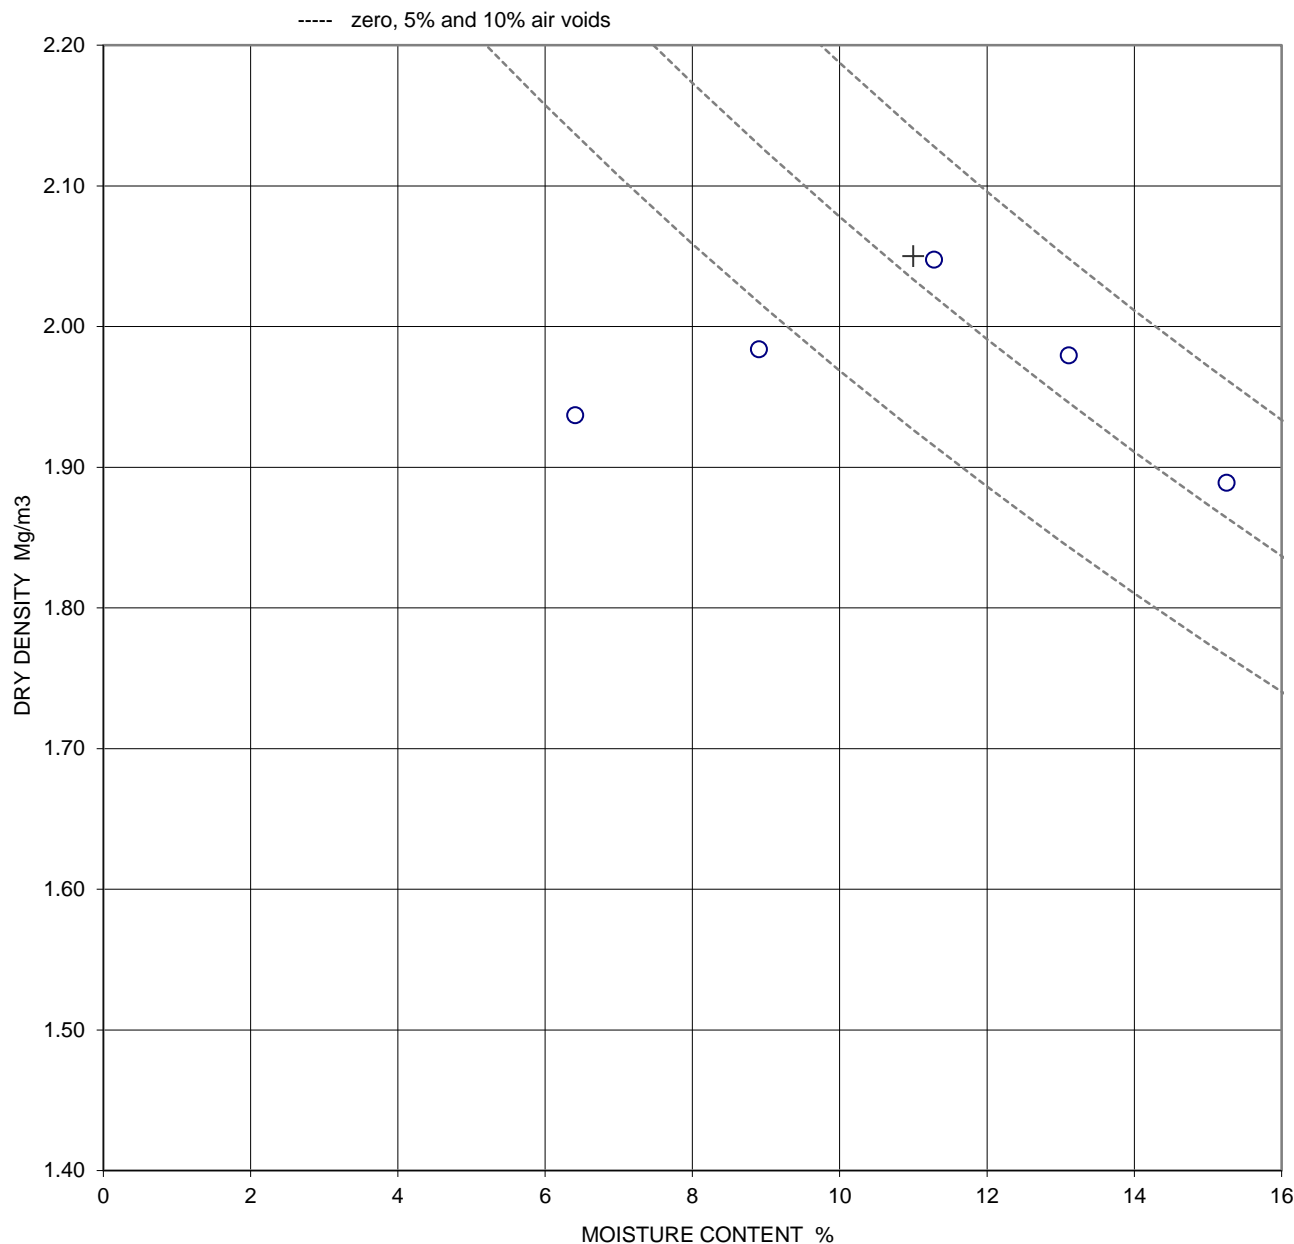
Sample Details:	SAMPLE ID:	Hole No	XC211-CP02
	SOCO2020100656	Sample Depth (m BGL)	4.00 - 5.00
		Sample Type and No	B13
		Specimen Ref

Soil description	Brown slightly sandy slightly gravelly CLAY.
------------------	--

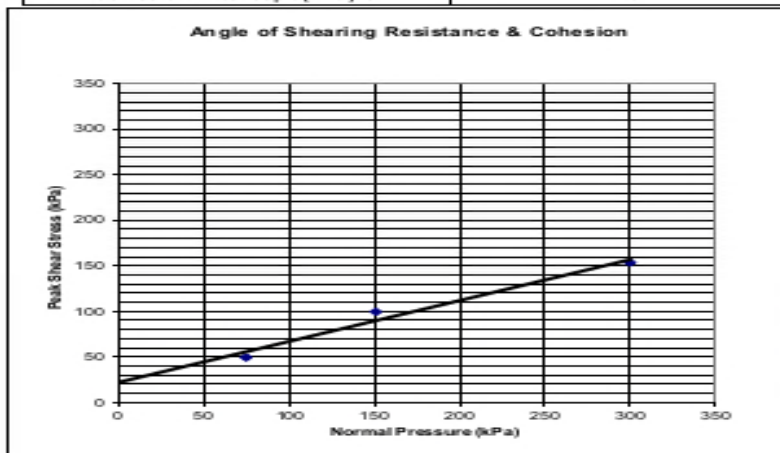
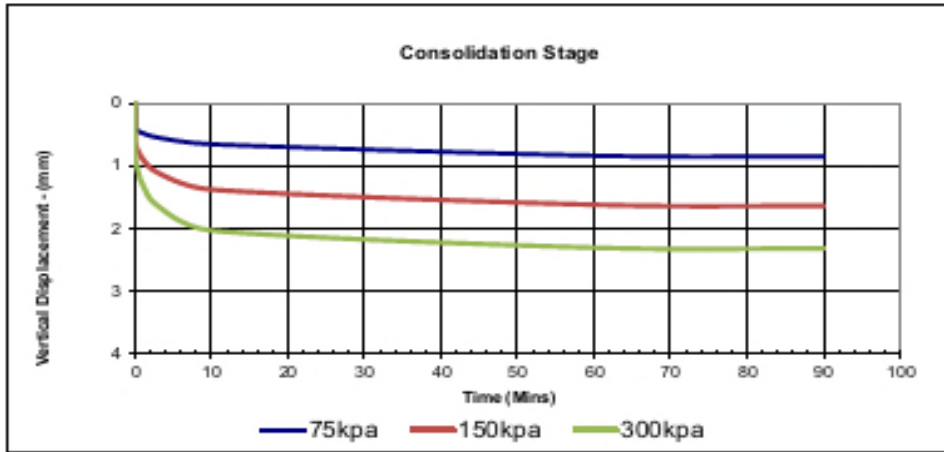
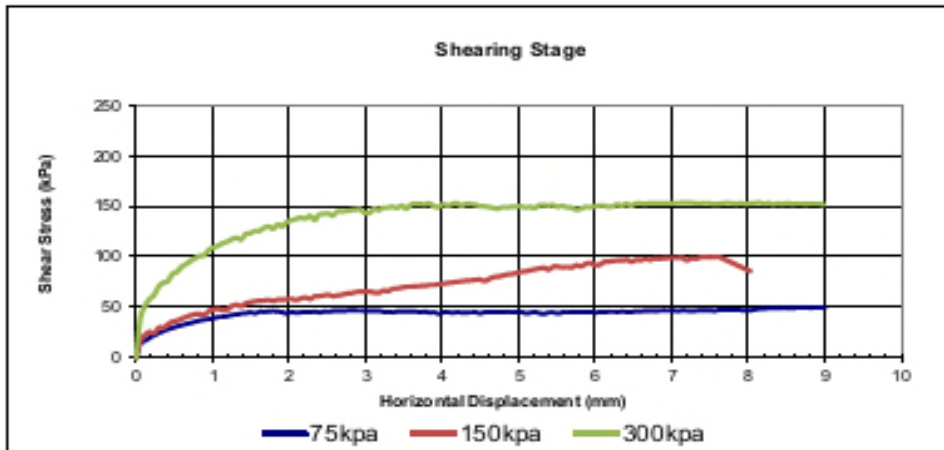
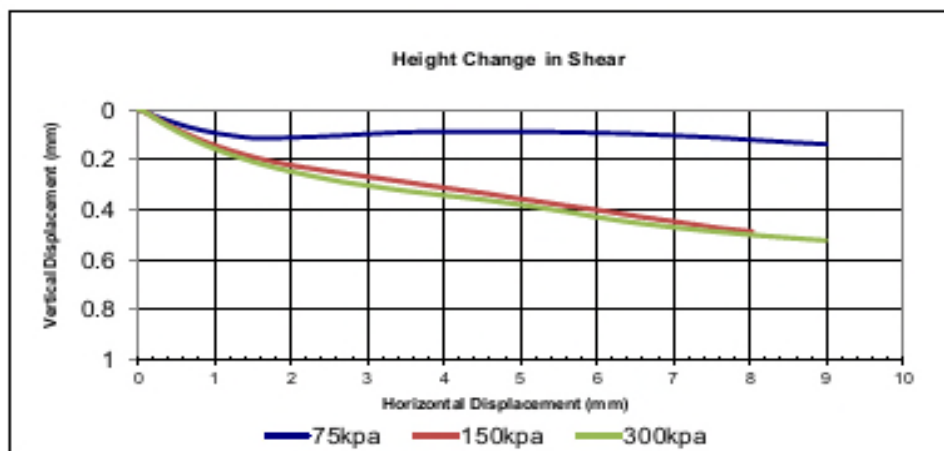
Initial Condition			
	1	2	3
Normal Pressure (kPa)	75	150	300
Height (mm)	20.39	20.20	20.37
Width (mm)	59.9	59.9	59.9
Bulk Density (Mg/m ³)	2.07	2.09	2.07
Dry Density (Mg/m ³)	1.80	1.82	1.80
Moisture Content (%)	15	15	15
Voids Ratio	0.469	0.457	0.475
Degree of Saturation	84.8	87.0	83.7
Shearing Stage			
Rate of Displacement (mm/min)	0.03	0.03	0.03
Peak Shear Stress (kPa)	49.4	99.6	153.5
Displacement at Peak Stress (mm)	8.9	7.6	8.1
Final Condition			
Bulk Density (Mg/m ³)	2.28	2.40	2.42
Dry Density (Mg/m ³)	1.90	2.03	2.09
Moisture Content (%)	20	18	16
Angle of Shearing Resistance ($^{\circ}$) ϕ'	24.0		
Cohesion Intercept (kPa) c'	22.0

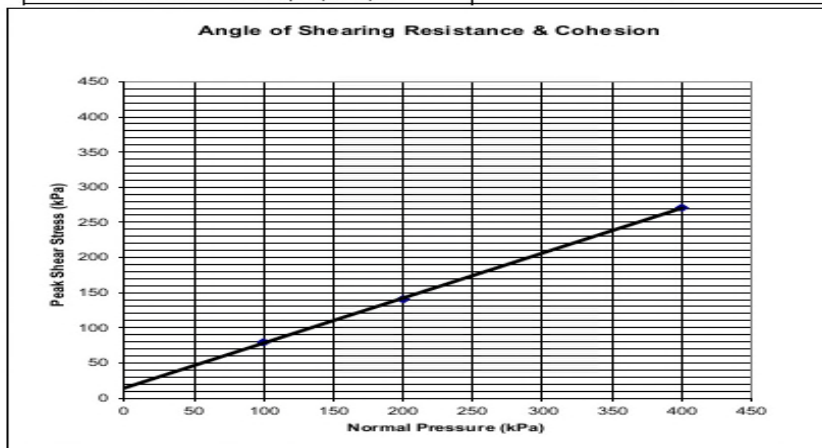
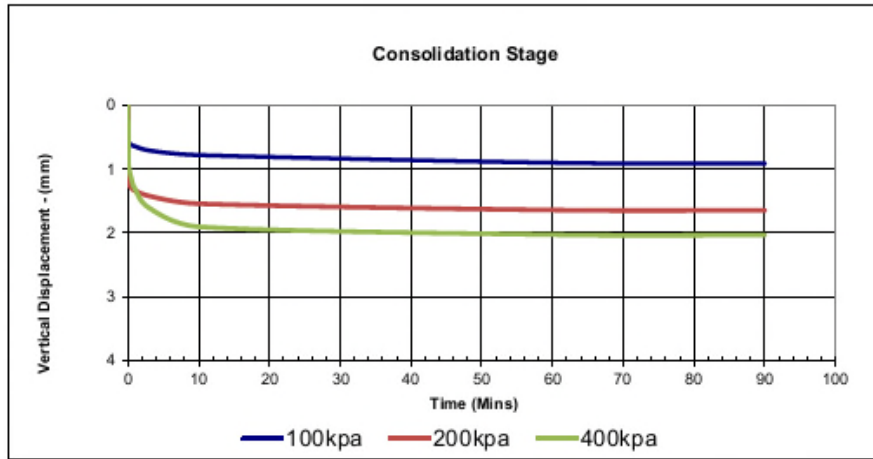
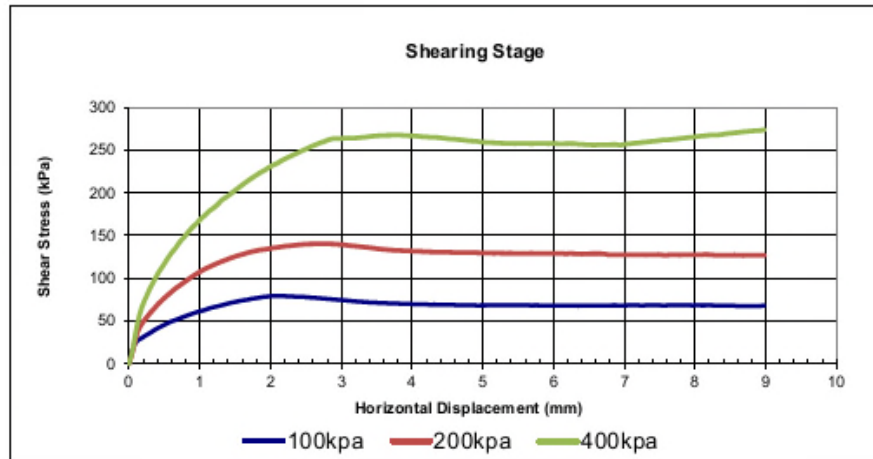
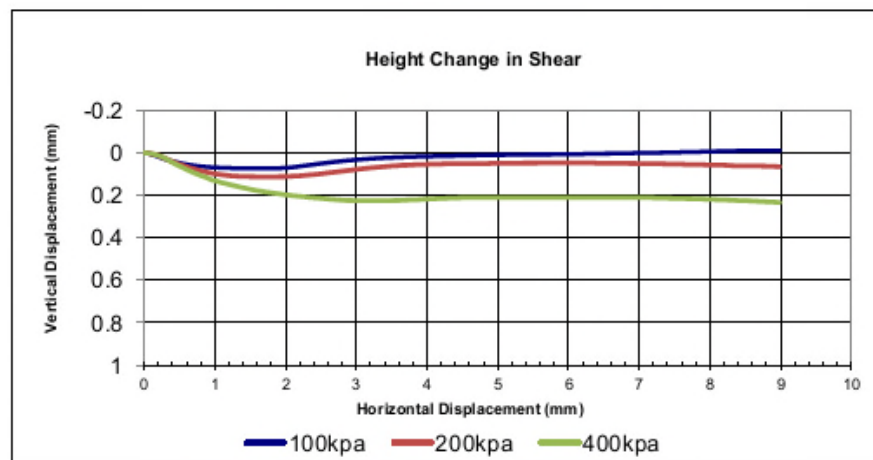
Initial Condition			
	1	2	3
Normal Pressure (kPa)	100	200	400
Height (mm)	20.60	20.23	20.77
Width (mm)	59.9	59.9	59.9
Bulk Density (Mg/m ³)	2.24	2.26	2.21
Dry Density (Mg/m ³)	2.03	2.04	1.99
Moisture Content (%)	10	11	11
Voids Ratio	0.303	0.301	0.329
Degree of Saturation	87.3	96.8	88.5
Shearing Stage			
Rate of Displacement (mm/min)	0.03	0.03	0.03
Peak Shear Stress (kPa)	79.4	140.4	270.7
Displacement at Peak Stress (mm)	2.0	2.7	9.0
Final Condition			
Bulk Density (Mg/m ³)	2.40	2.49	2.44
Dry Density (Mg/m ³)	2.13	2.23	2.24
Moisture Content (%)	13	12	9
Angle of Shearing Resistance (°) ϕ'	32.5		
Cohesion Intercept (kPa) c'	14.0

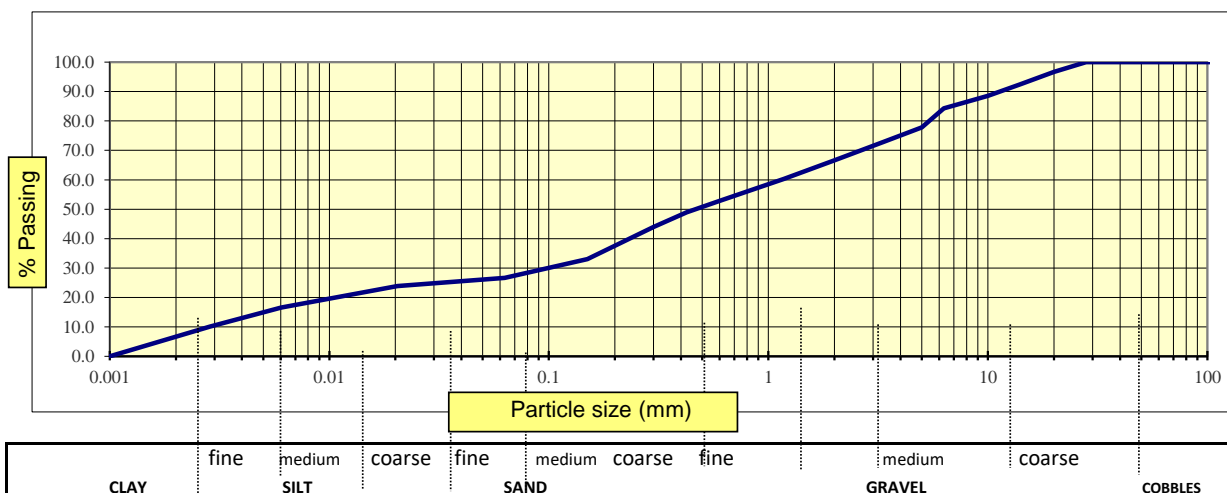
BS Sieve Size	% Passing	Specification
125 mm	100	
100 mm	100	
90 mm	100	
75 mm	100	
63 mm	100	
50 mm	100	
37.5 mm	100	
28 mm	100	
20 mm	97	
14 mm	92	
10 mm	89	
6.3 mm	84	
5 mm	78	
3.35 mm	73	
2 mm	67	
1.18 mm	60	
0.6 mm	53	
0.425 mm	49	
0.3 mm	44	
0.15 mm	33	
0.063 mm	27	
0.0205 mm	24	
0.0060 mm	17	
0.0029 mm	10

Tested in accordance with BS 1377: Part 2 : 1990 Clause 3.2, 9.2 and 9.5

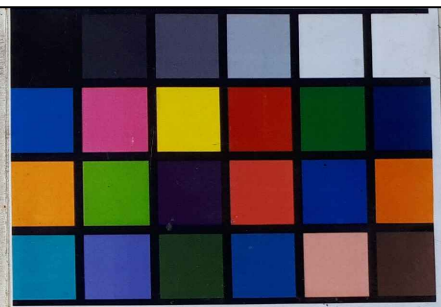
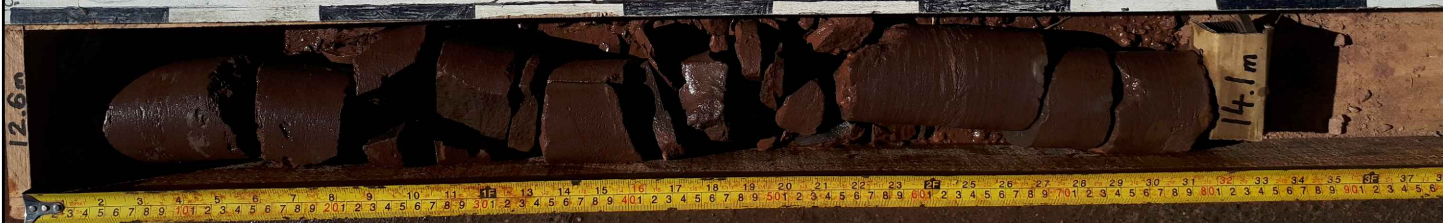
Job Name: IARNÓD ÉIREANN
CORK LINE
Job No.: 19-135
BH: XC215-CP/RC01

Depth: 12.6 to 14.1 m
Box: 3 of 3
Date: 18/8/20
Depth To: 14.1 m
