**Environmental Impact Assessment Report (EIAR)
Tailings Facility Embankment Buttress**

**Appendix 13
Cultural Heritage Appendices and Figures**

Appeal Reference Number: ABP-315173-22

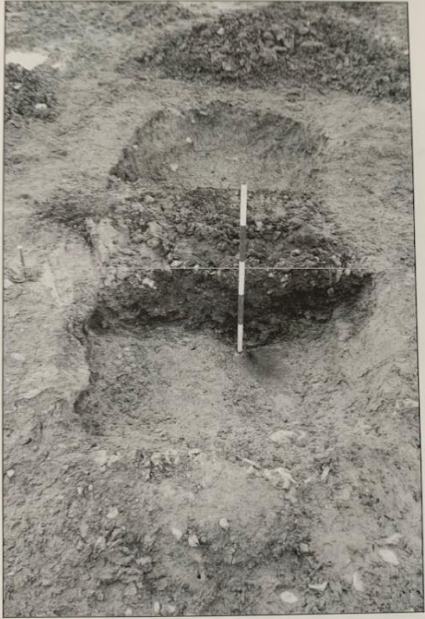
<p>Section through trough of <i>fulacht fiadh</i> at Randalstown.</p>
Source	Database of Irish Excavation Reports [online]. Available at: https://excavations.ie/report/1999/Meath/0004613/

At least four fulachta fiadh were excavated at Randalstown, along with a number of pits probably associated with their use. These conform to the general size range of other excavated troughs. There was surviving evidence for a wood lining in the trough in Area 2, with indirect evidence for a lining in the troughs in Areas 1 and 4. The fills of the trough in Areas 2 and 3 indicate a gradual silting-up over time, whereas the troughs in Areas 1 and 4 contained a homogeneous fill suggesting backfill in one operation. The presence of such a concentration of fulachta fiadh is a strong indication of significant Bronze Age activity in the immediate area and reinforces the evidence found at Simonstown for a densely populated prehistoric landscape.

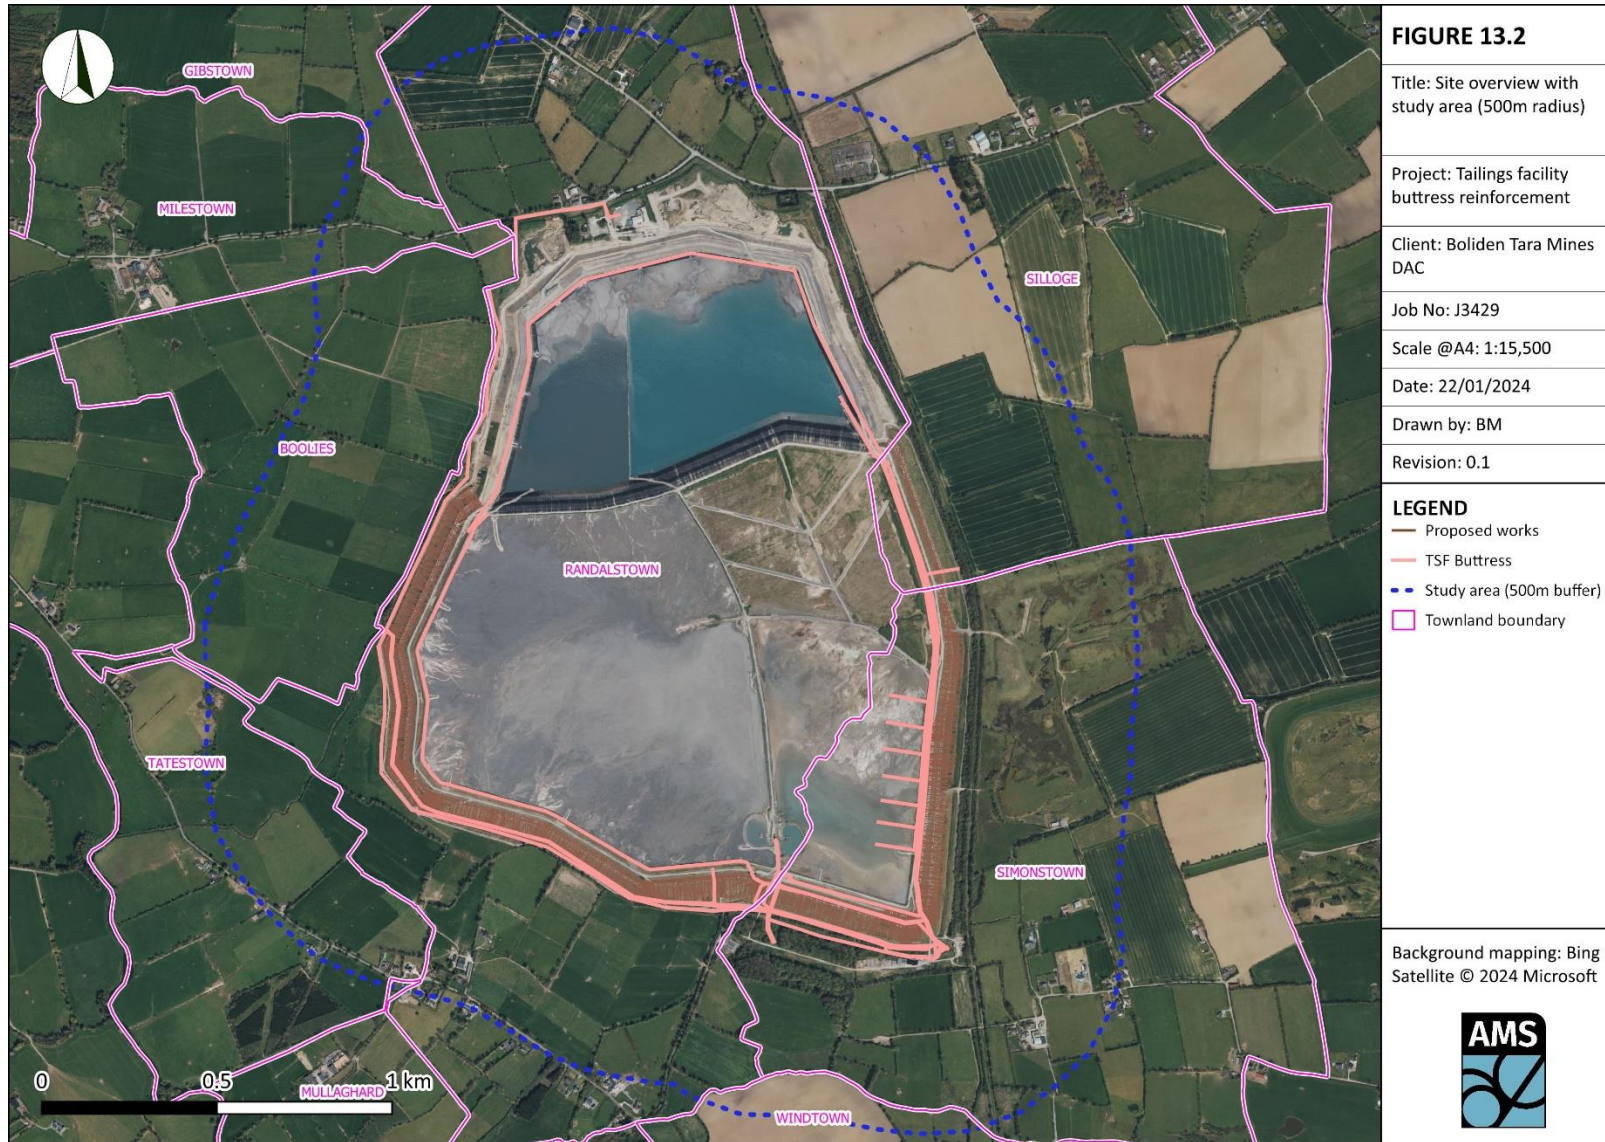
FIGURE 13.2

Title: Site overview with study area (500m radius)

Figure 13.2: Site overview with study area (500m radius).
