CHAPTER 6 BIODIVERSITY

FERS was commissioned by Boliden Tara Mines DAC (BTM) to undertake the Biodiversity Chapter of Environmental Impact Assessment Report with regards to proposed buttressing works to be undertaken on a section of the dam walls of the Randallstown Tailings Storage Facility. These works are proposed to be undertaken with a view to increasing the Factor of Safety associated with the dam walls. It is important to note that owing to time limitations the Biodiversity Chapter was prepared outside of the optimal window for undertaking ecological surveys. Notwithstanding this FERS has been undertaking ecological surveys at the Randallstown Tailings Facility since 2006 on a regular basis and the objective of the site visits undertaken to inform this Biodiversity Chapter, although undertaken in November, was to assess the site for any significant changes to the biodiversity resource known to be present.

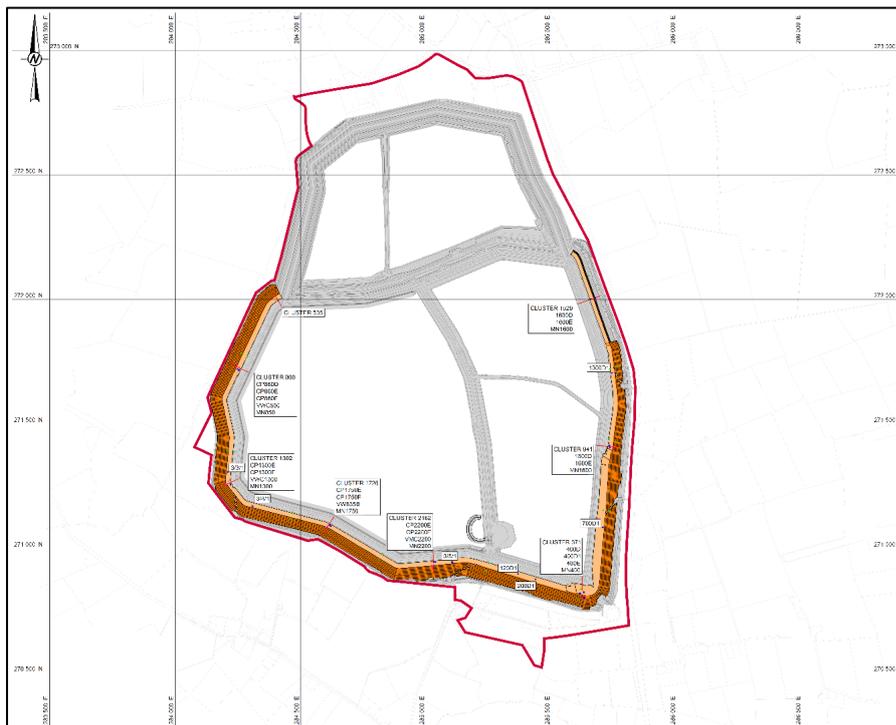
The Tailings Facility is located approximately 3 km north of the mine site in Navan and encloses an area of c. 250 Hectares. The facility is constructed as a ring-dike configuration with Stages 1,2,3,4 and 5 enclosed by earth fill embankment walls constructed from locally sourced natural materials. It is proposed to construct a buttress to sections of the existing embankment walls to increase their strength thus reducing the risk of failure. Stage 6 is composite lined facility.

Figure 6.1: Tailings Facility layout plan

The Tailings Facility is located approximately 3 km north of the mine site in Navan and encloses an area of c. 250 Hectares. The facility is constructed as a ring-dike configuration with Stages 1,2,3,4 and 5 enclosed by earth fill embankment walls constructed from locally sourced natural materials. It is proposed to construct a buttress to sections of the existing embankment walls to increase their strength thus reducing the risk of failure. Stage 6 is composite lined facility.

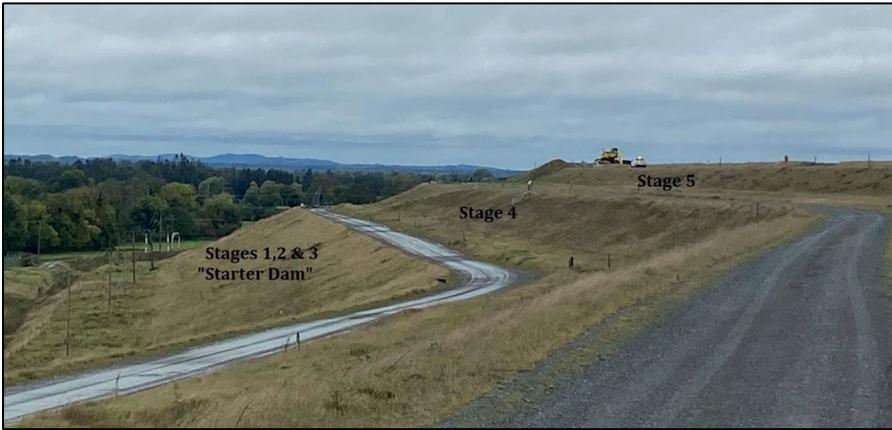
Figure 6.2: Embankments side profile

Refer to Figures 6.2, 6.3 and 6.4

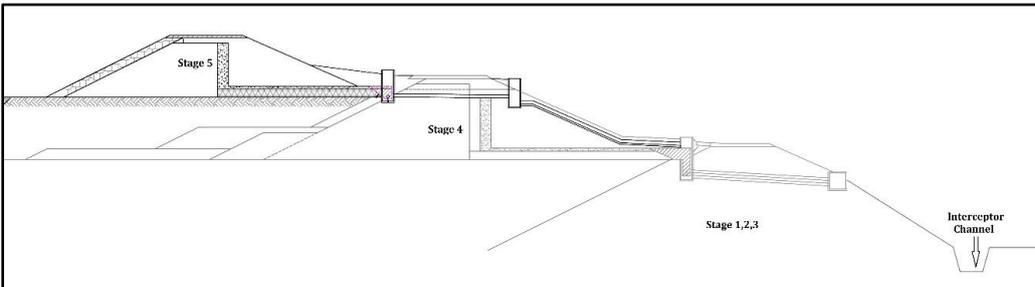
Figure 6.3: Cross section – extant facility embankment

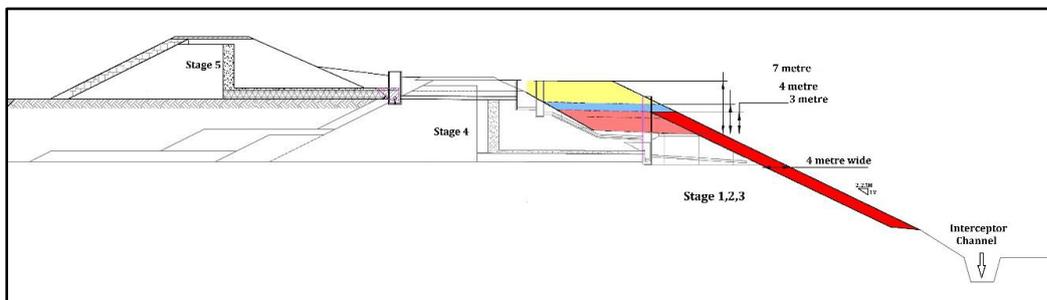
The proposed buttress, to be constructed on the downstream slope of and at the crest of the Stage 1, 2 and 3 starter Embankments, see Figure 6.4, will provide additional support to the Stage 4 dam embankment wall in order to increase the overall stability of the upstream raises i.e. Stage 4 and Stage 5.

Figure 6.4: Cross section – facility embankment with buttress

- The minimum required FoS of 1.5 is achievable for all static and seismic loading conditions and all failure surface locations when the peak undrained strength of the tailings was considered.
- In order to meet the FOS of 1.1 for the residual undrained strength scenario the analysis indicated that a 4 m wide buttress to the starter dam is required for the majority of the perimeter wall. At the starter dam crest level, the height of the buttress will vary between 3 and 7 m.

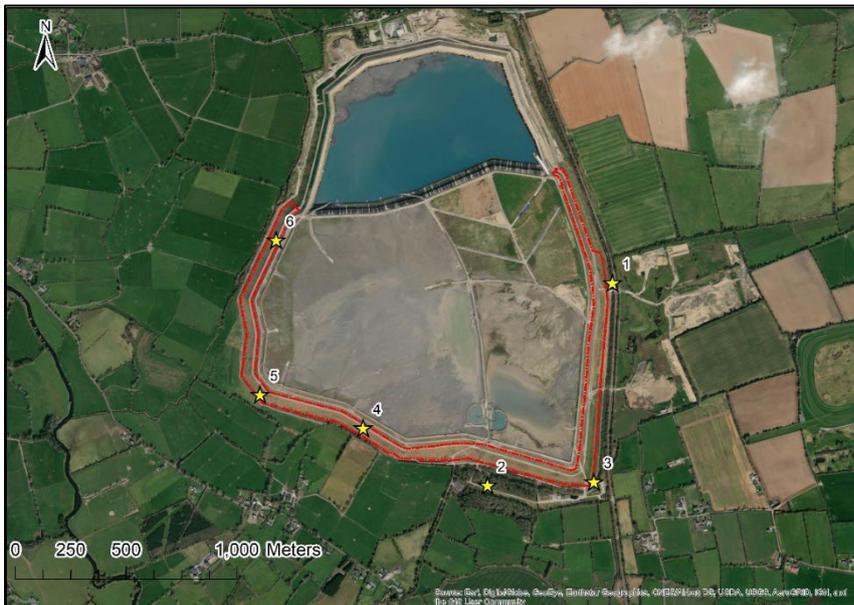
- Six infrared trail cameras (Bushnell Core DS No Glow, Bushnell Aggressor No Glow) were deployed around the site between the 23rd of June 30th of 2021 in order to identify “hot spots” of mammal activity where there was evidence observed of regularly utilised wildlife trails, or where it was suspected that mammals may pass. The locations of the six trail cameras deployed is illustrated in Figure 6.9.

Figure 6.9: Location of trail cameras deployed 23/06 – 29/06 2021

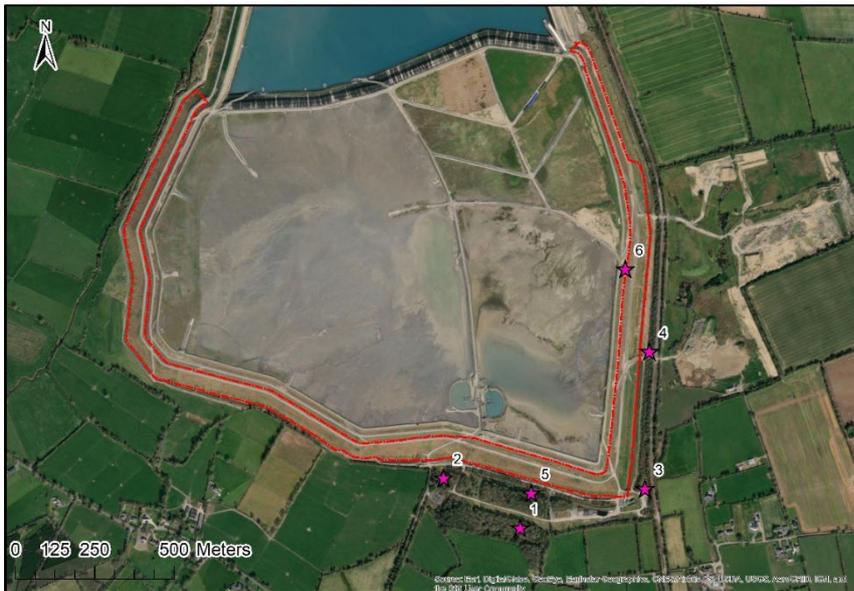
Figure 6.10: Location of trail cameras deployed 01/07 - 29/07 2021

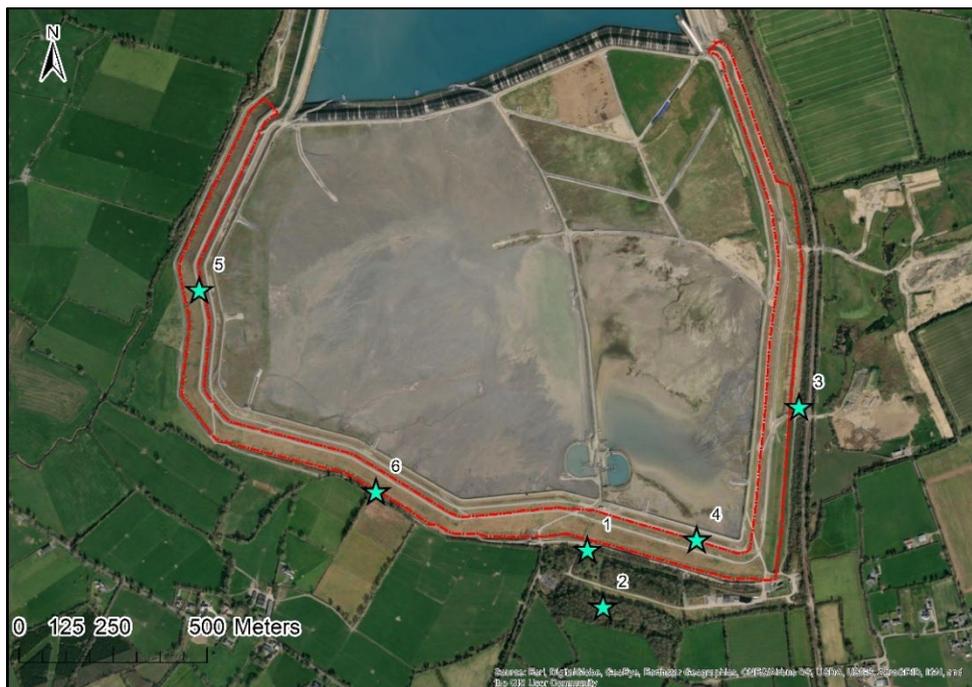
- Six static units were deployed at strategic points in order to determine “hot spots” of bat activity during the period 30/06/21 – 06/07/21 (see Figure 6.11). The results of this informed the emergence and dawn surveys;
- During the emergence and dawn survey, four static units were deployed for the night in order to assess bat activity throughout the night (see Figure 6.12) in conjunction with the dawn/emergence surveys.

Figure 6.11: Location of six Petterson D500x Units deployed (30/06/21- 06/07/21)

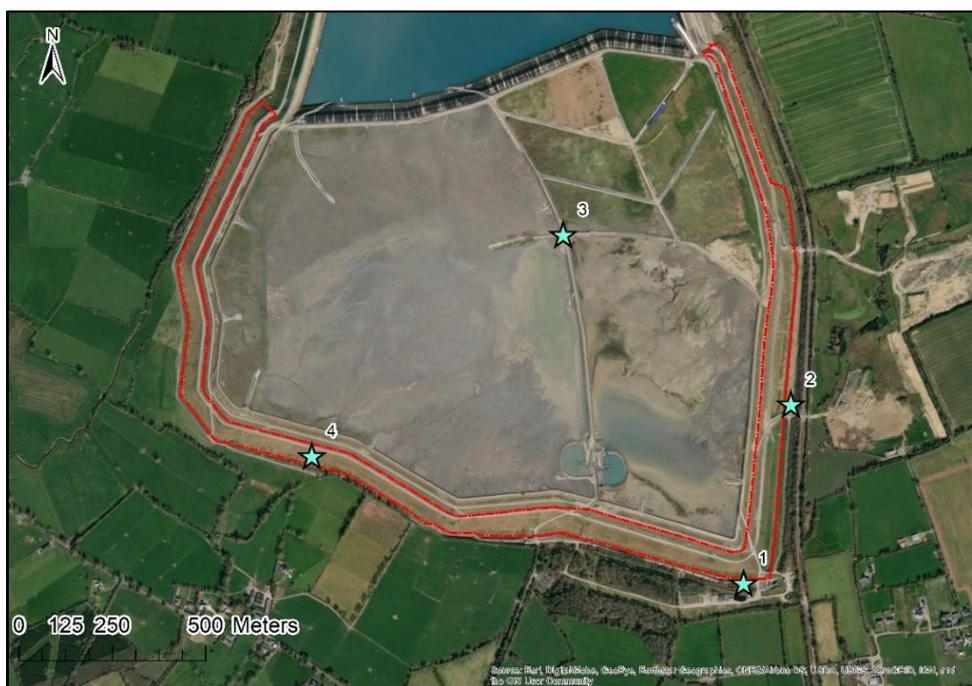
Figure 6.12: Location of four Petterson D500x Units deployed during emergence/dawn survey (29/07/21- 30/07/21)

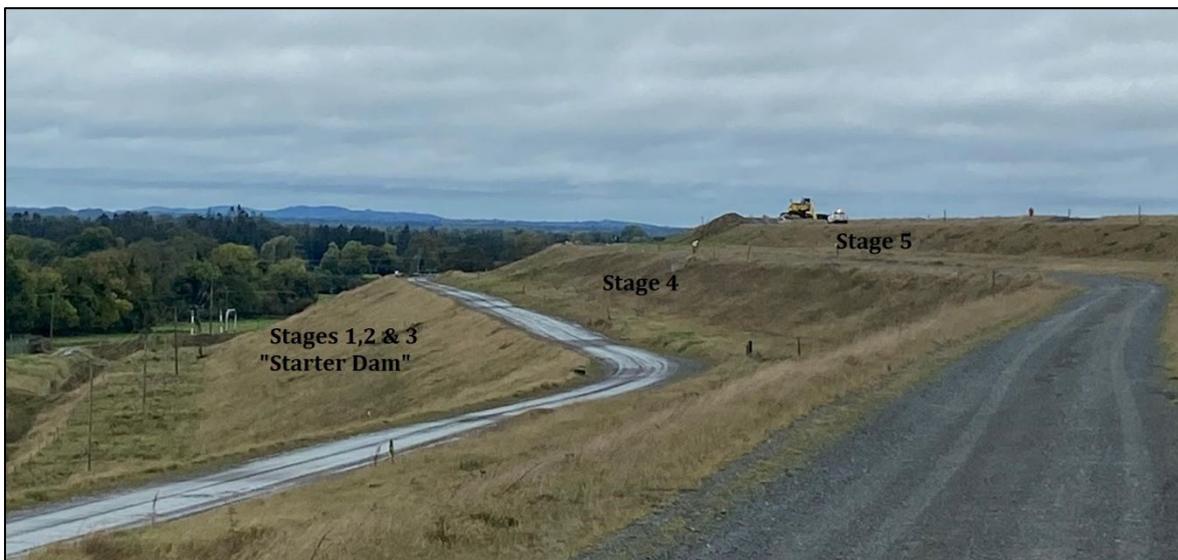
- Stages 1, 2 and 3 were built at ground level to a height of c.12 metres;
- Stages 4 and 5 where upstream vertical raises over Stages 1,2 and 3; and
- Stage 6 is a lateral extension to the north of stages 1,2,3,4 & 5.

Figure 6.13: Stages 1 to 5 Embankments – side profile

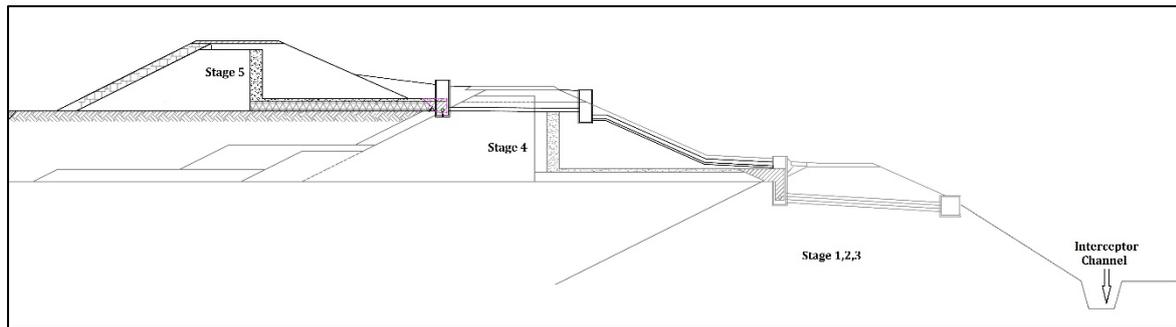
Figure 6.14: Cross-section of existing facility embankment

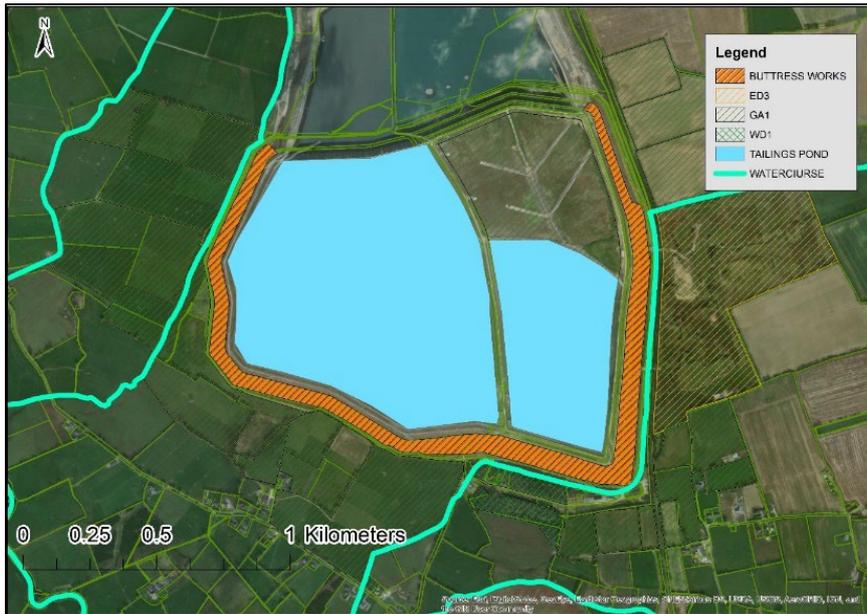
The habitats occurring in the immediate vicinity of the proposed buttress works are largely improved agricultural grassland. The Simonstown borrow pit occurs to the East and there is an area of Mixed Broadleaved Woodland along the south eastern border of the proposed buttress works. There is also a corridor associated with the Navan-Kingscourt railway line to the East of the proposed buttress works (the new Boyne Valley to Lakelands (BVL) greenway is now located on this railway line). The Yellow River and Simonstown stream both occur proximate to the proposed buttress works. The works, will however, be limited to between the interceptor ditch and the crest of the Stage 4 Dam (Figure 6.16). There will only be direct impacts on the habitat occurring on the embankments, which comprises semi-natural grassland of a mosaic of types, depending on the existing environmental conditions. For example, in the vicinity of the Interceptor Ditch, areas of wet grassland (GS4) occur, while on south-facing slopes the grassland could be categorised as GS1, and indeed a high number of orchids, including Common Spotted Orchid and Bee Orchid occur here.

Figure 6.15: Habitats in the vicinity of the buttressing works

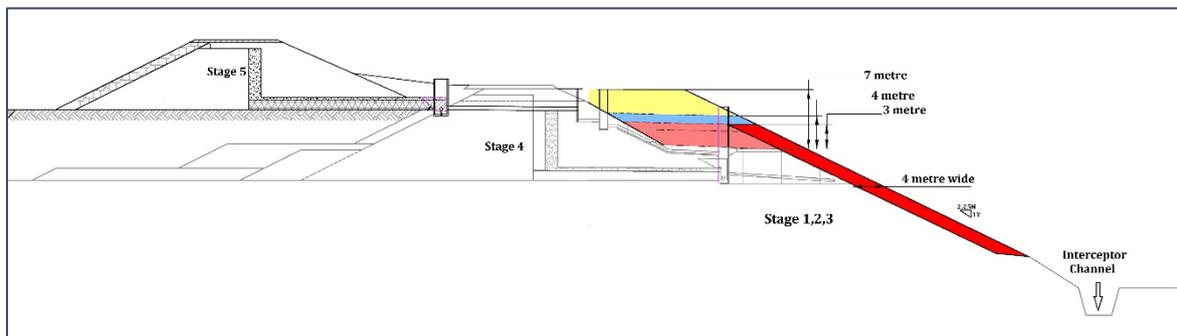
Figure 6.16: Cross section illustrating the extent of the proposed buttressing works

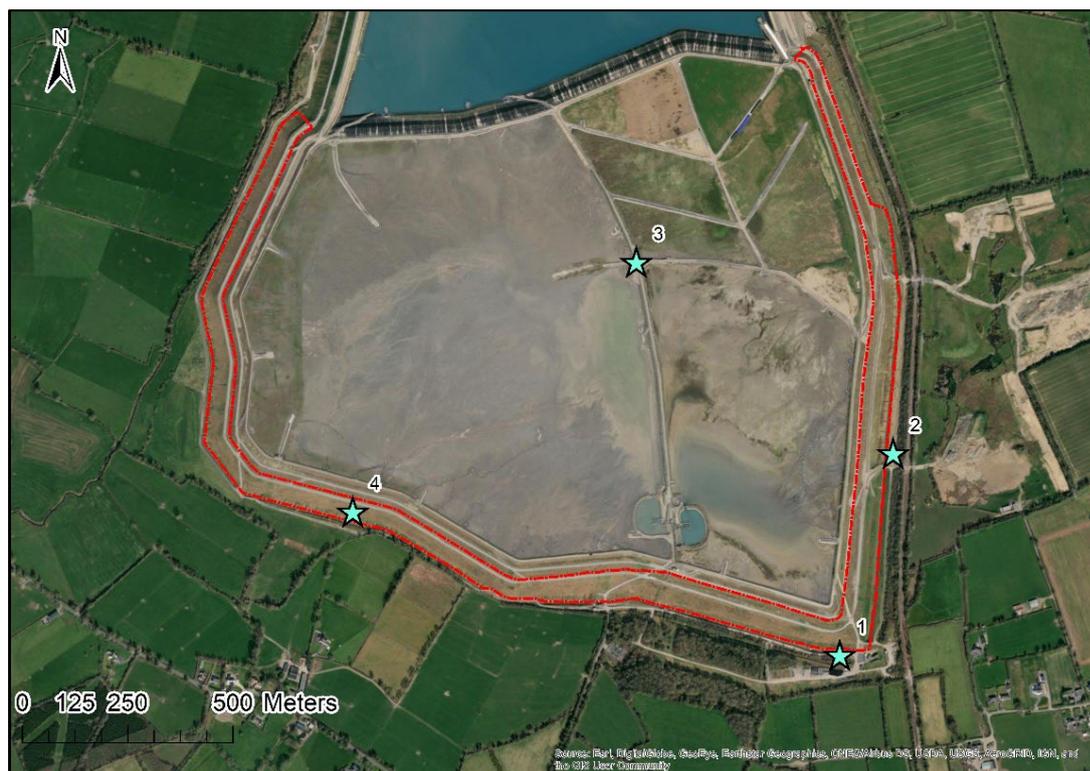
An emergence/dawn survey was undertaken on the night of the 29th of July/morning of 30th of July by Dr Patrick Moran utilising hand-held bat detectors (Pettersson D1000X and EM3+) and a thermal imaging scope (Pulsar Helion XP50). The weather conditions were optimal for bat surveying throughout the survey. The surveyor stayed on site during the night. Although all habitats occurring were surveyed, the effort was concentrated in those areas in which static monitors had indicated most activity. In addition, four static units were deployed for the duration of the emergence and dawn surveys to assess activity over the entire night (see Figure 6.33).

Figure 6.33: Location of four Pettersson D500x Units deployed during emergence/dawn survey (29/07/21-30/07/21)

The variation in species diversity and numbers observed during the dawn/emergence surveys was reflected in the results from the static monitors deployed over-night. While Units (2), (3) and (4) recorded relatively low levels of activity, activity was high in the vicinity of the wooded area in the south eastern corner of the TSF (Unit (1)).

Unit (1) was located along a path, with wooded habitat present on both sides at the south eastern corner of the TSF at some distance from the dam walls. Most activity was observed during the dawn/emergence surveys in this vicinity. A total of 380 bat passes of five species were recorded at this location –

Unit (3) was located within open habitat near at the top of the TSF dam. No bat activity was observed here during the emergence/dawn survey. A total of 43 bat passes of three species were recorded –

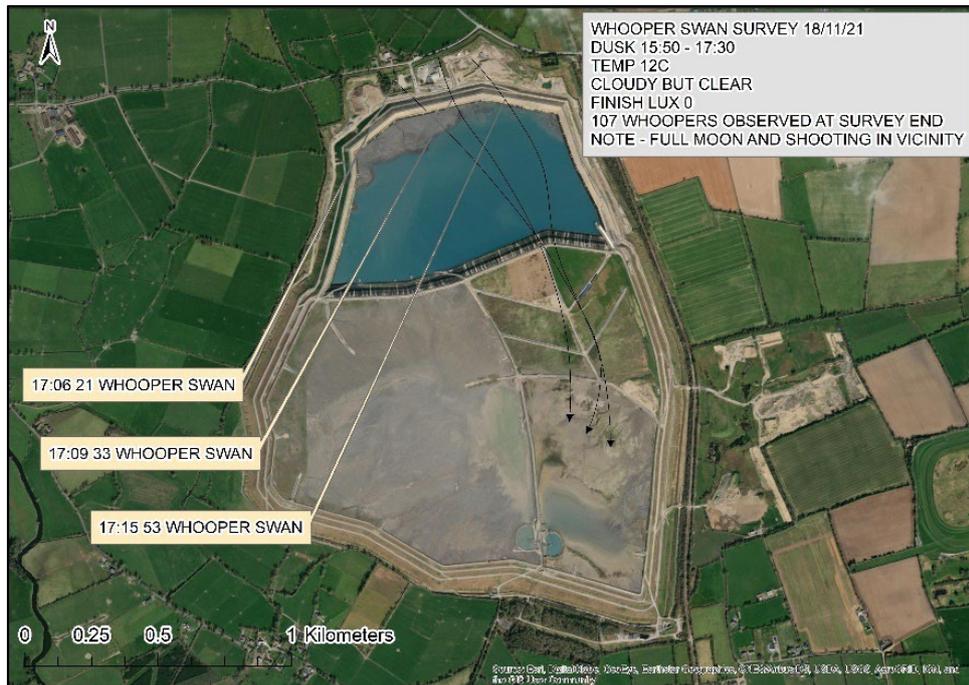
Figure 6.40: Whooper Swan survey November Dusk Count max 107 Whooper

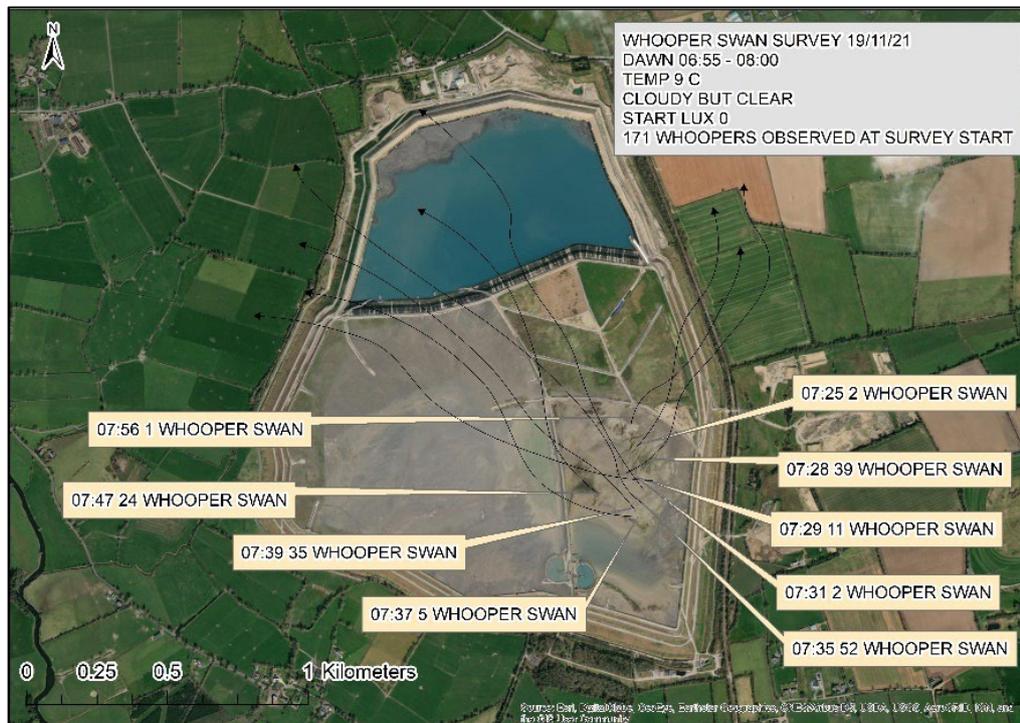
Figure 6.41: Whooper Swan survey November Dawn Count max 171 Whooper

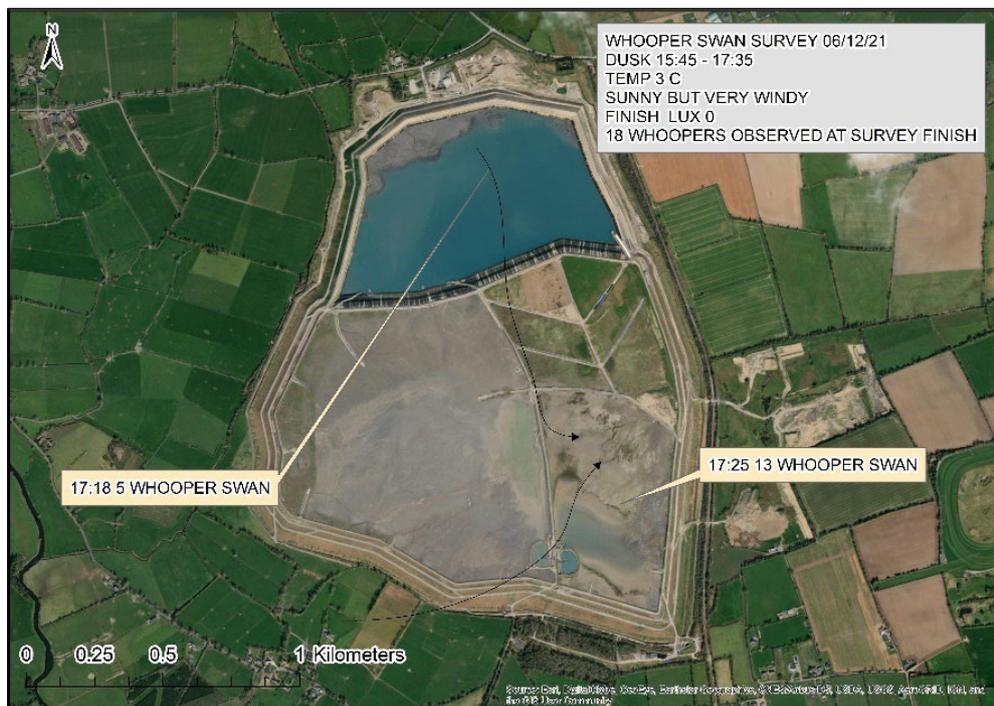
Figure 6.42: Whooper Swan survey December Dusk Count max 18 Whooper

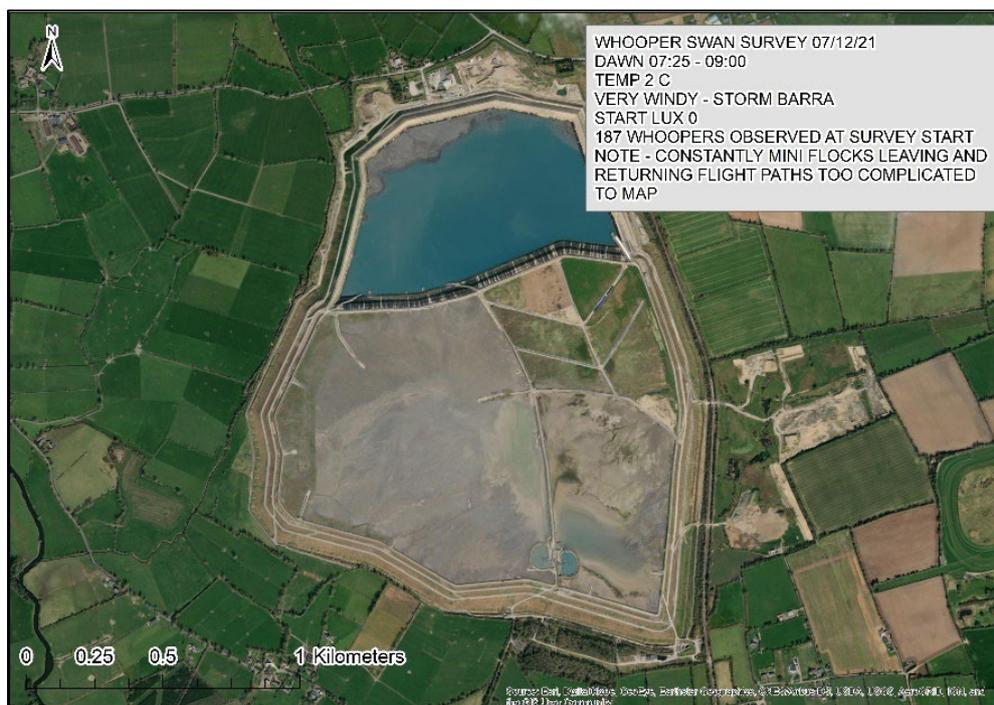
Figure 6. 43: Whooper Swan survey December Dawn Count max 187 Whooper – during Storm Barra – flight paths too complicated to map.
