# **ENVIRONMENTAL IMPACT ASSESSMENT REPORT**

## **APPENDICES**

**Additional Information response (Planning Ref. SD22A/0333)**

**EdgeConneX Ireland Ltd.  
Data Centre (DUB06)  
Ballymakaily**

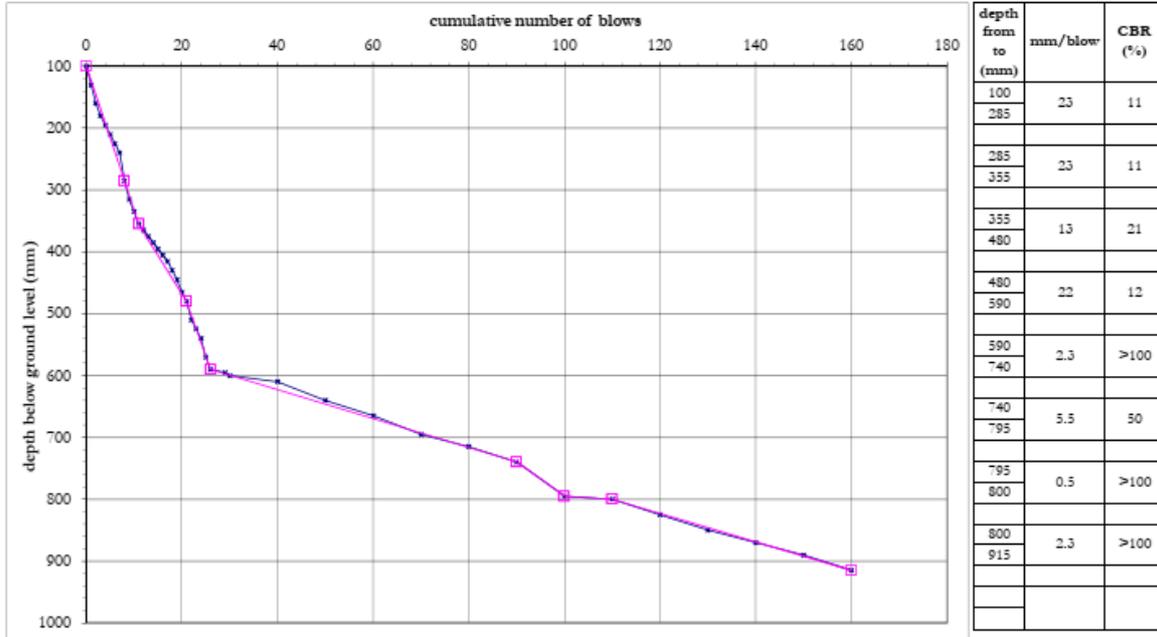
Causeway Geotech Ltd  
 Dynamic Cone Penetrometer (DCP) test results and estimated CBR  
 Project: Lands at Ballymakailly  
 Test Number: TP03

CBR estimated using TRL Road Note 8:  
 $\text{Log CBR} = 2.48 - 1.057 \text{ Log (mm/blow)}$   
 Project No: 18-0827  
 Date: 25-Jul-18

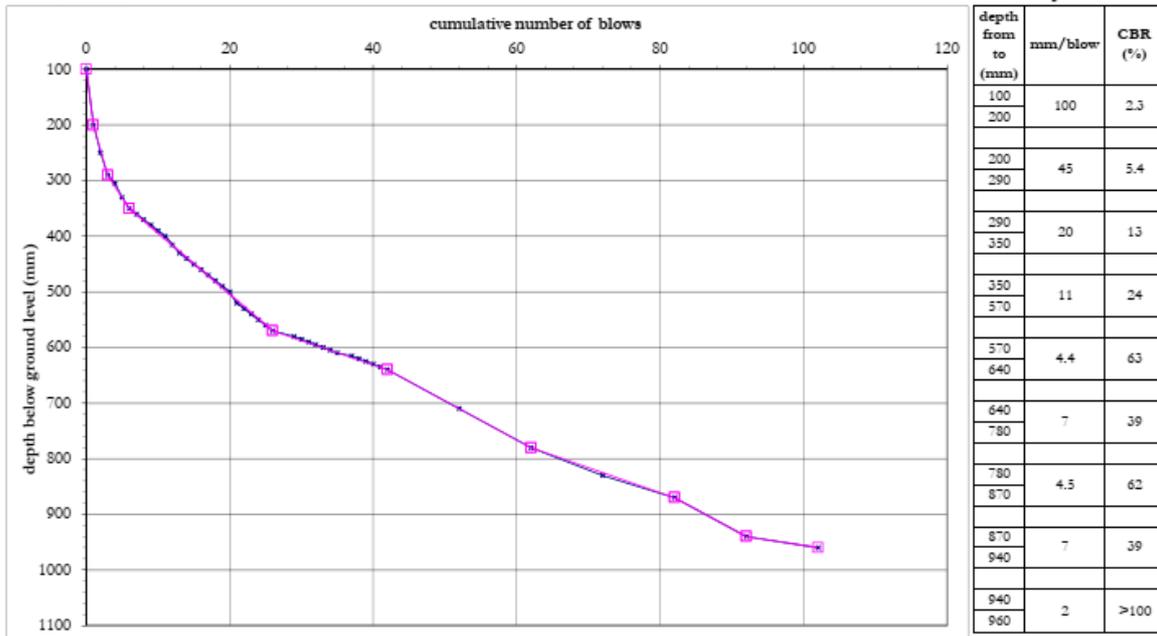
Causeway Geotech Ltd  
 Dynamic Cone Penetrometer (DCP) test results and estimated CBR  
 Project: Lands at Ballymakailly  
 Test Number: TP04

CBR estimated using TRL Road Note 8:  
 $\text{Log CBR} = 2.48 - 1.057 \text{ Log (mm/blow)}$   
 Project No: 18-0827  
 Date: 25-Jul-18

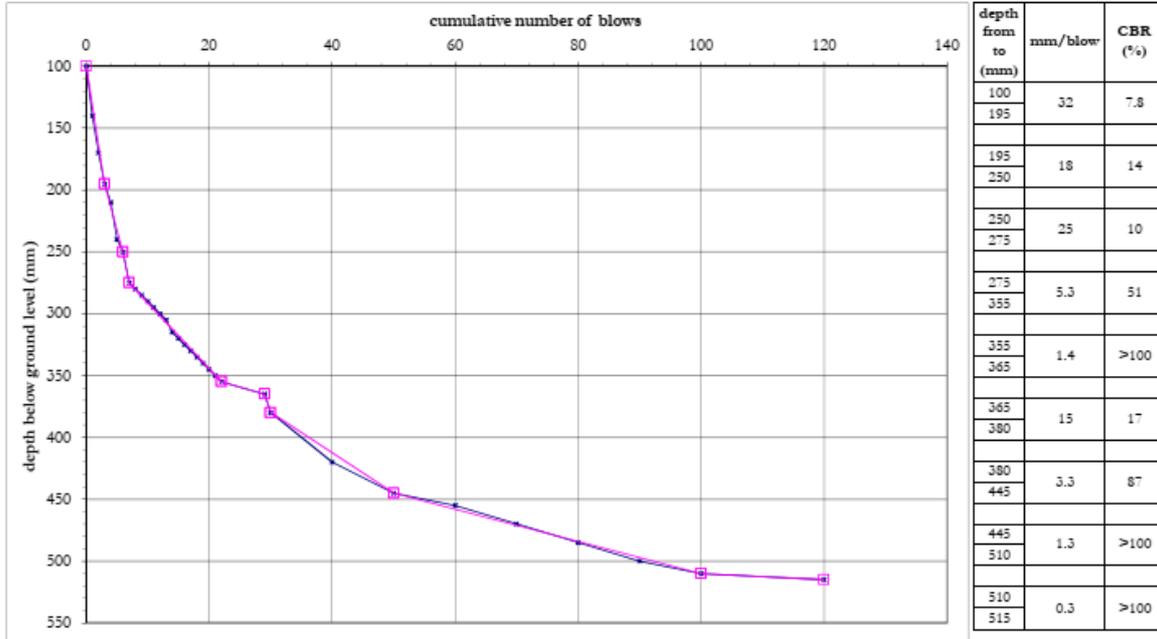
Causeway Geotech Ltd  
 Dynamic Cone Penetrometer (DCP) test results and estimated CBR  
 Project: Lands at Ballymakailly  
 Test Number: TP07

CBR estimated using TRL Road Note 8:  
 $\text{Log CBR} = 2.48 - 1.057 \text{ Log (mm/blow)}$   
 Project No: 18-0827  
 Date: 25-Jul-18

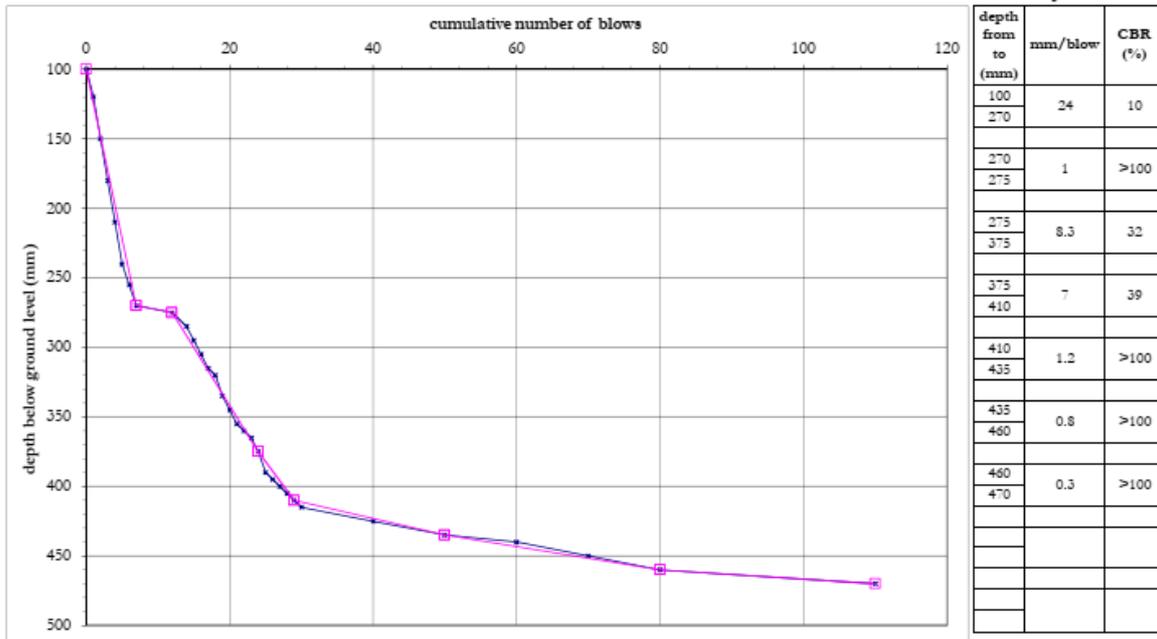
Causeway Geotech Ltd  
 Dynamic Cone Penetrometer (DCP) test results and estimated CBR  
 Project: Lands at Ballymakailly  
 Test Number: TP08

CBR estimated using TRL Road Note 8:  
 $\text{Log CBR} = 2.48 - 1.057 \text{ Log (mm/blow)}$   
 Project No: 18-0827  
 Date: 25-Jul-18

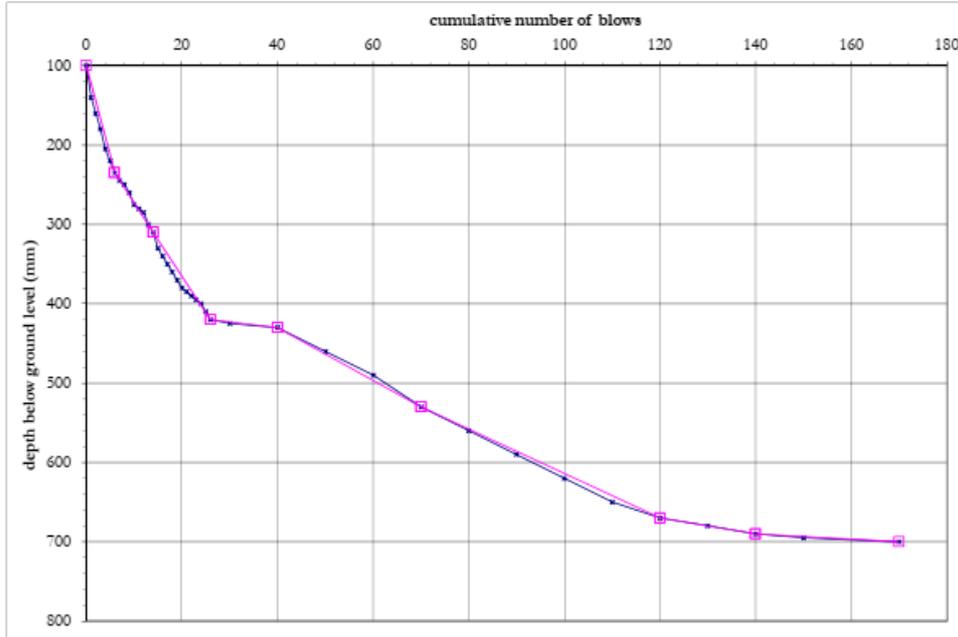
Causeway Geotech Ltd  
 Dynamic Cone Penetrometer (DCP) test results and estimated CBR  
 Project: Lands at Ballymakailly  
 Test Number: TP11

CBR estimated using TRL Road Note 8:  
 $\text{Log CBR} = 2.48 - 1.057 \text{ Log (mm/blow)}$   
 Project No: 18-0827  
 Date: 25-Jul-18

depth from to (mm)	mm/blow	CBR (%)
100	23	11
235		
235	9.4	28
310		
310	9.2	29
420		
420	0.7	>100
430		
430	3.3	85
530		
530	2.8	>100
670		
670	1	>100
690		
690	0.3	>100
700

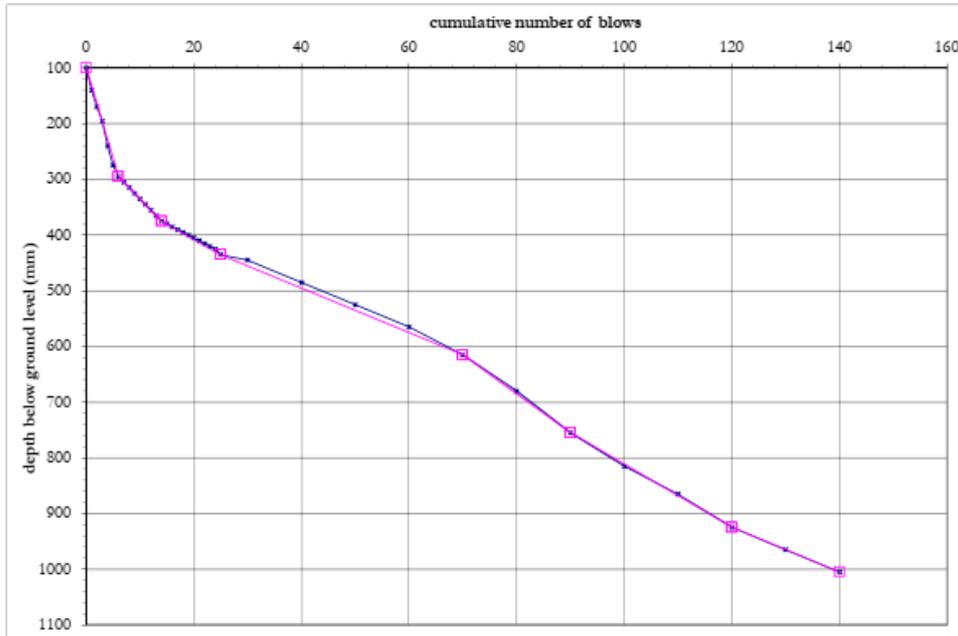
Causeway Geotech Ltd  
 Dynamic Cone Penetrometer (DCP) test results and estimated CBR  
 Project: Lands at Ballymakailly  
 Test Number: TP12

CBR estimated using TRL Road Note 8:  
 $\text{Log CBR} = 2.48 - 1.057 \text{ Log (mm/blow)}$   
 Project No: 18-0827  
 Date: 25-Jul-18

depth from to (mm)	mm/blow	CBR (%)
100	33	7.6
295		
295	10	26
375		
375	5.5	50
435		
435	4	70
615		
615	7	39
755		
755	5.7	48
925		
925	4	70
1005

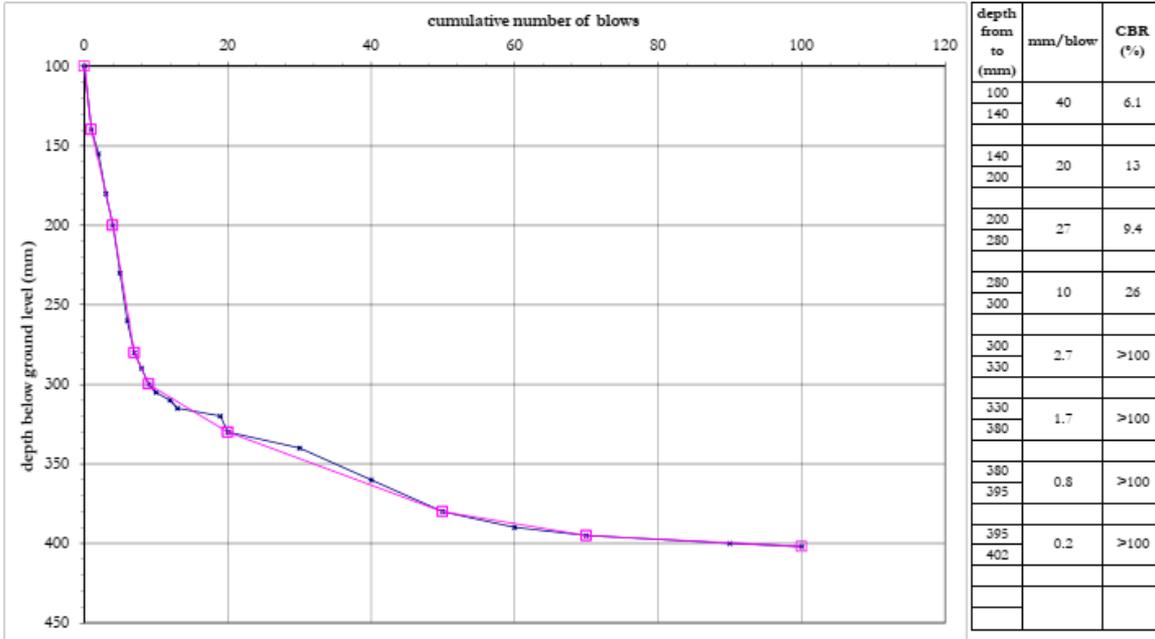
Causeway Geotech Ltd  
 Dynamic Cone Penetrometer (DCP) test results and estimated CBR  
 Project: Lands at Ballymakailly  
 Test Number: TP13

CBR estimated using TRL Road Note 8:  
 $\text{Log CBR} = 2.48 - 1.057 \text{ Log (mm/blow)}$   
 Project No: 18-0827  
 Date: 25-Jul-18

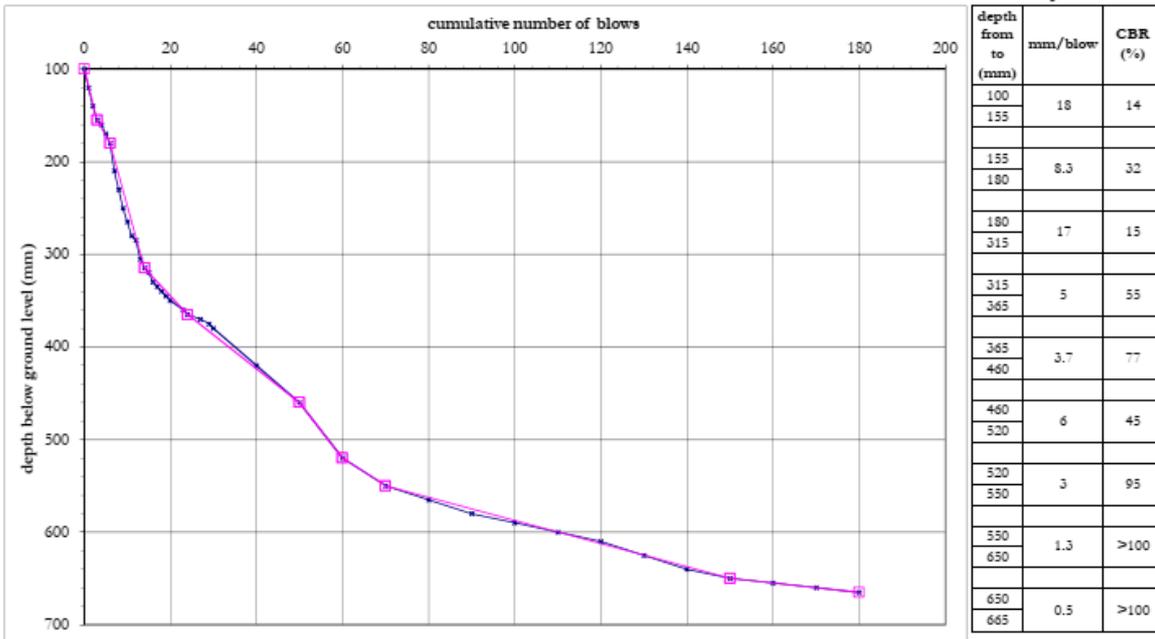
Causeway Geotech Ltd  
 Dynamic Cone Penetrometer (DCP) test results and estimated CBR  
 Project: Lands at Ballymakailly  
 Test Number: TP14

CBR estimated using TRL Road Note 8:  
 $\text{Log CBR} = 2.48 - 1.057 \text{ Log (mm/blow)}$   
 Project No: 18-0827  
 Date: 25-Jul-18

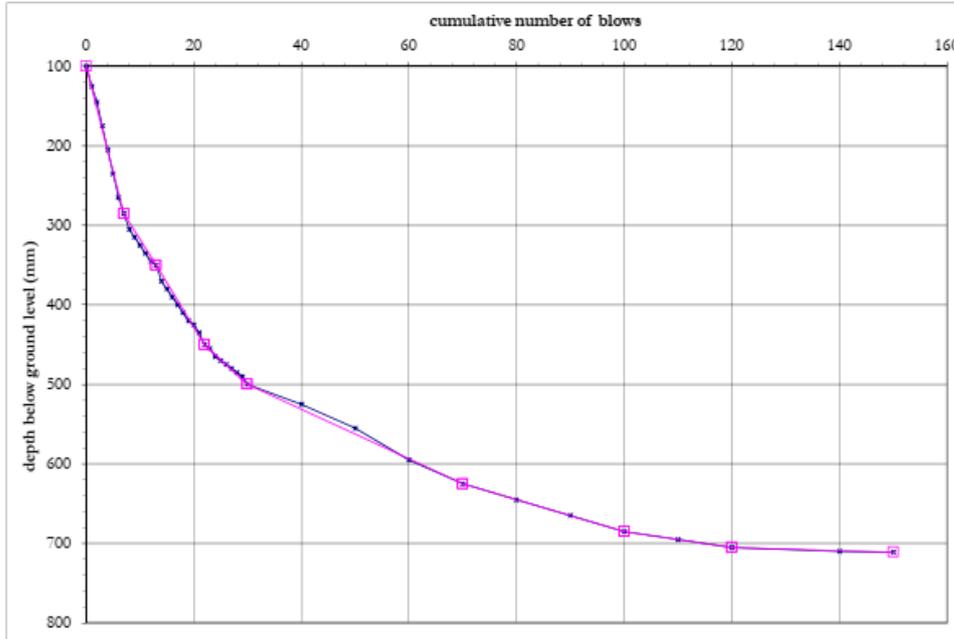
**Project:** Lands at Ballymakailly  
**Test Number:** TP19

**Causeway Geotech Ltd**  
**Dynamic Cone Penetrometer (DCP) test results and estimated CBR**

depth from to (mm)	mm/blow	CBR (%)
100	26	9.5
285		
285	11	24
350		
350	11	24
450		
450	6.3	44
500		
500	3.1	91
625		
625	2	>100
685		
685	1	>100
705		
705	0.2	>100
711

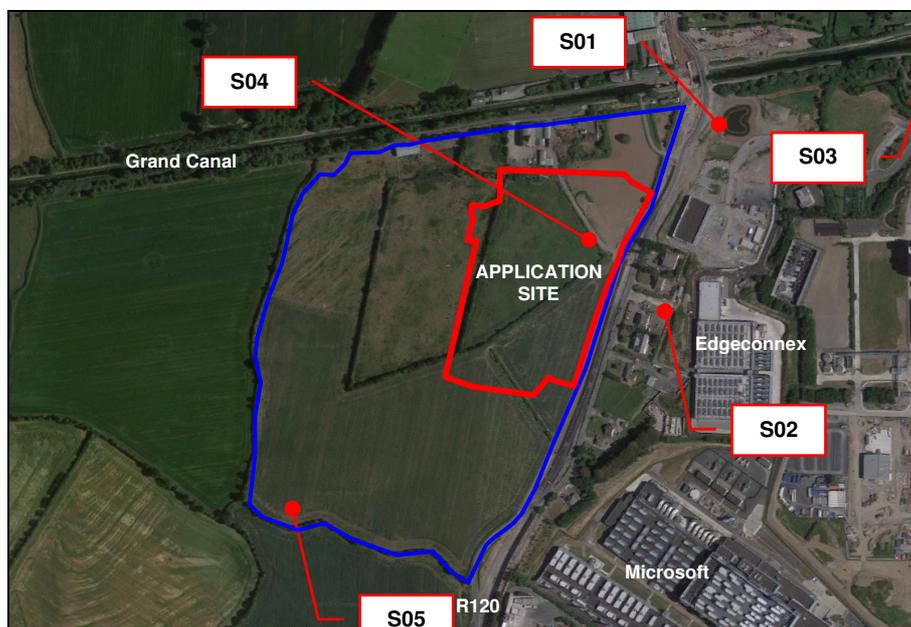
**Figure A** Noise monitoring locations (Source: Bing Maps)

- Location S04** Located in the north eastern concern of the development lands. This location is considered to be representative of noise levels currently experienced in the vicinity of the residential properties on the Royal Canal to the north.

- Location S05** Located in the south western concern of the development lands. The location is considered to be representative of noise levels currently experienced in the vicinity of the halting site located to the south west at some 200 m distance.

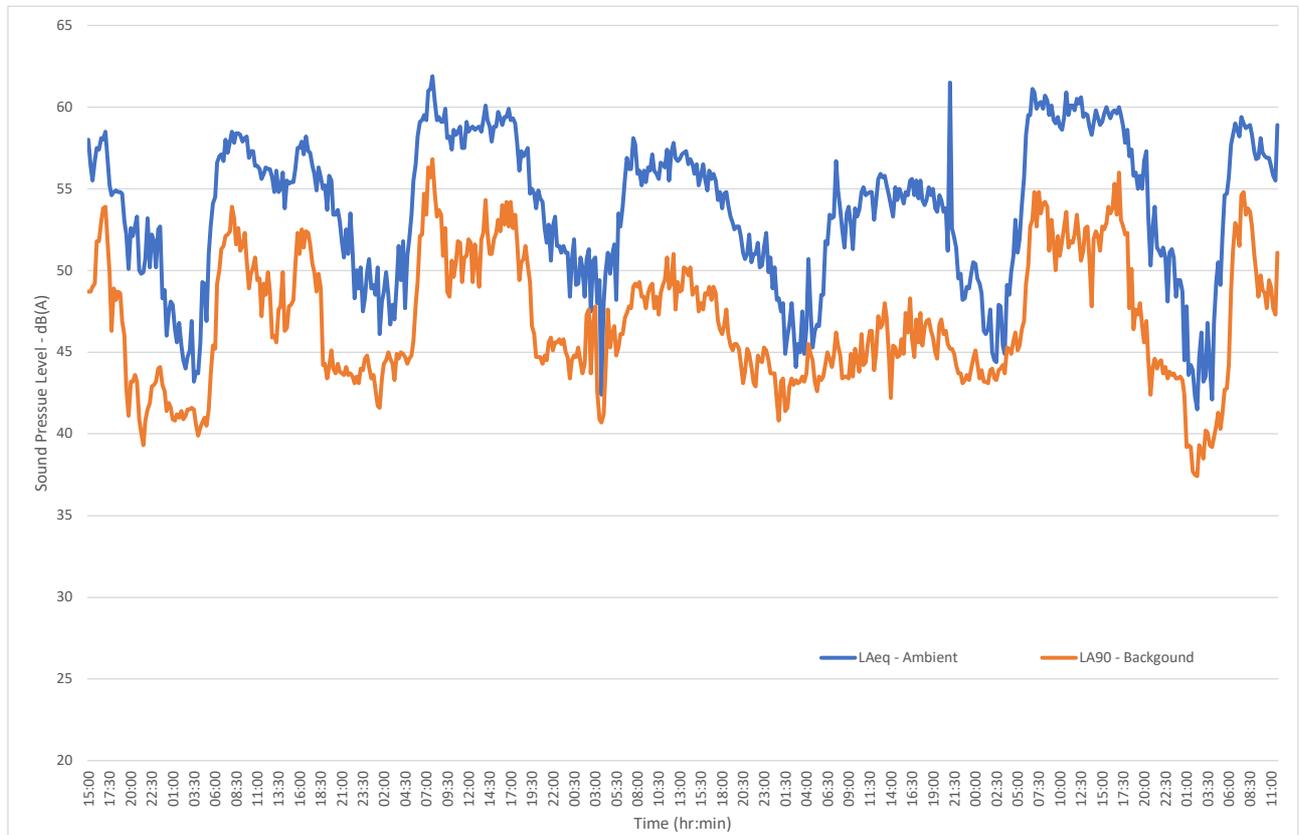
Figure B Unattended Noise Monitoring – Location S04

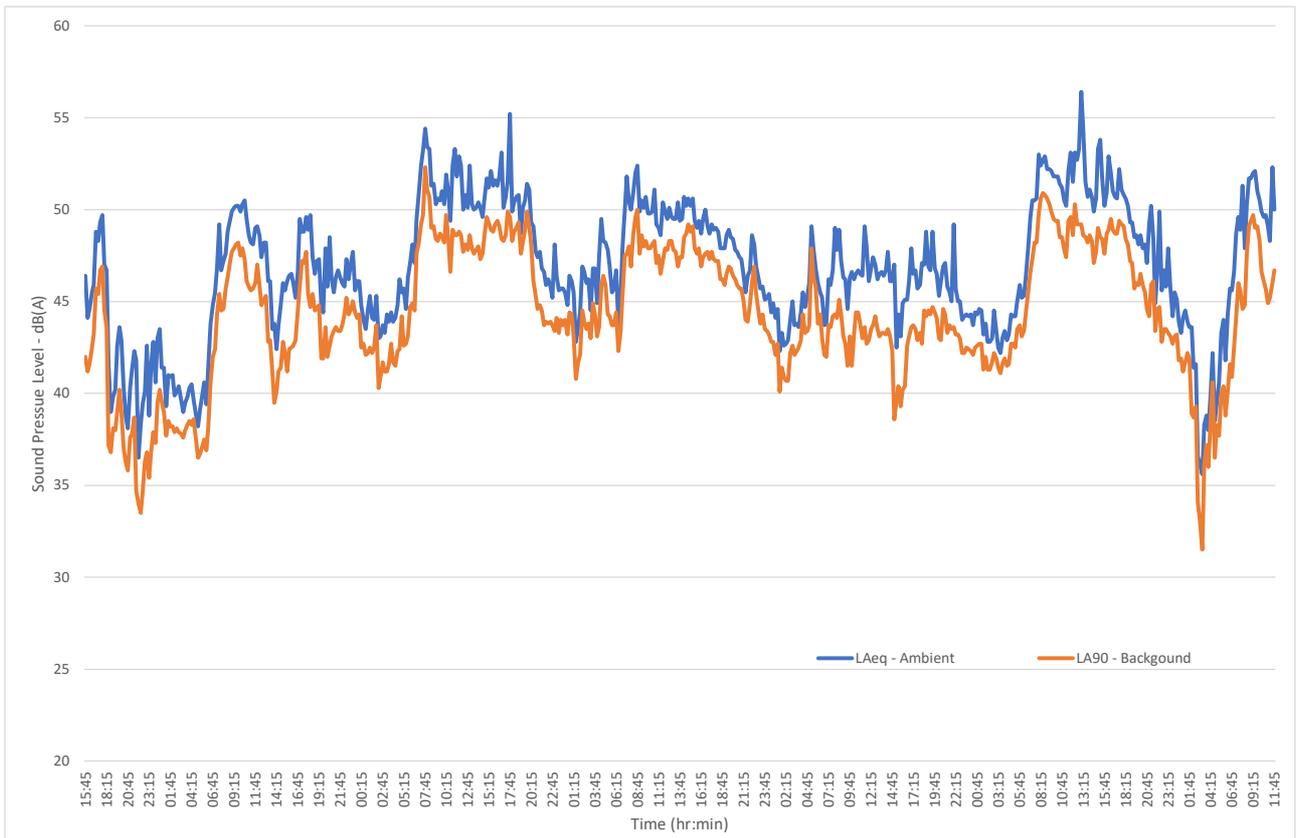
Figure C Unattended Noise Monitoring – Location S05

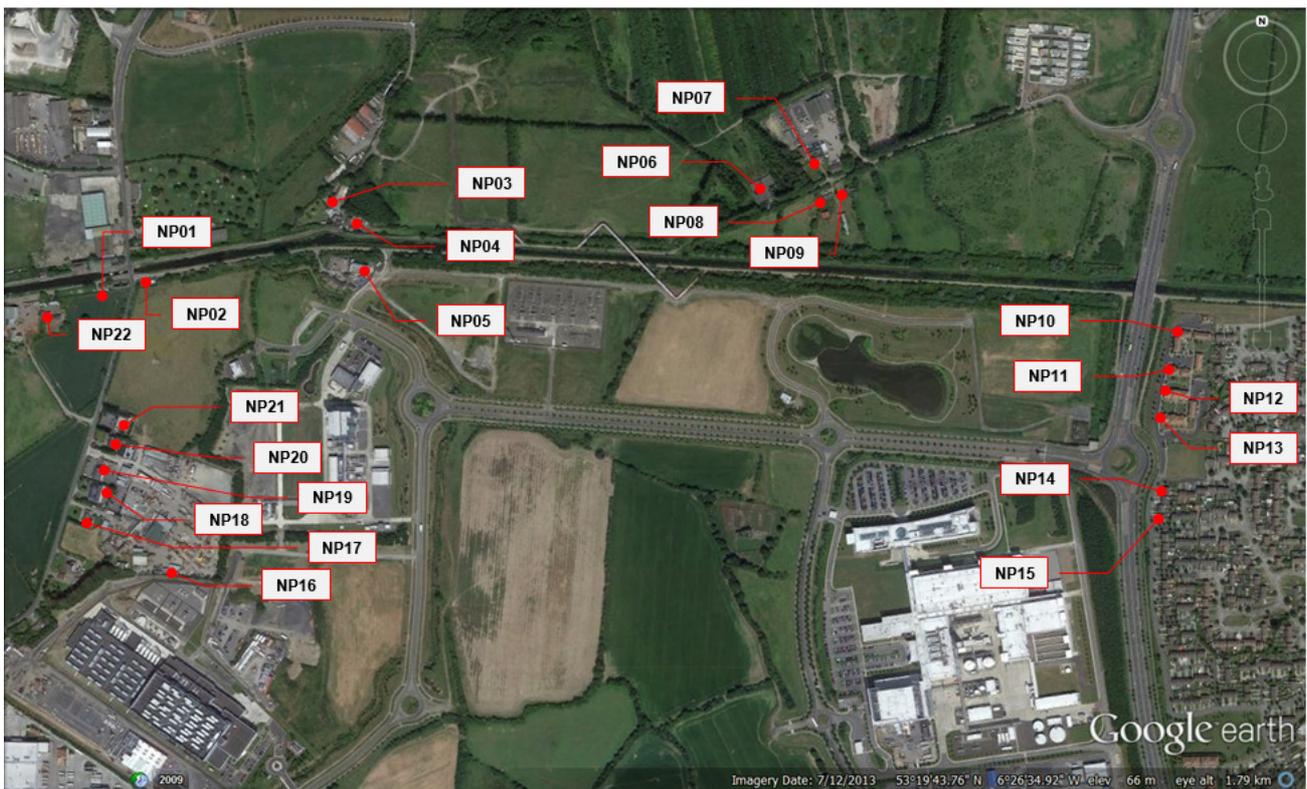
**Figure A** Sensitive receptors

Nearby sensitive properties in the vicinity of the proposed development are summarised in Figure A below:

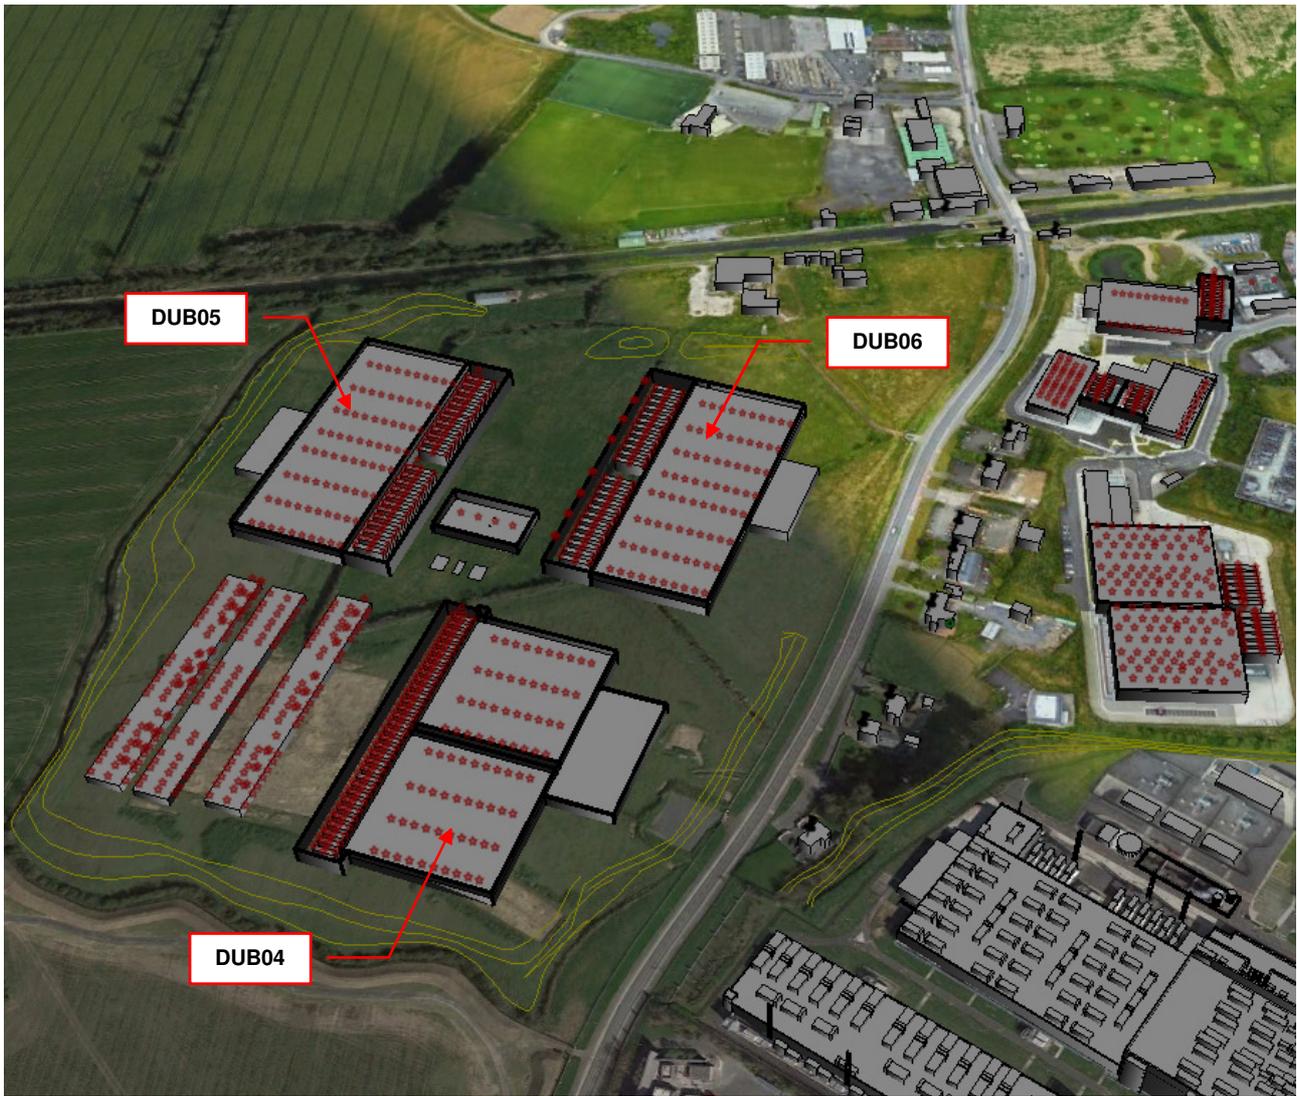
Figure A presents a 3D render of the developed site noise model.

Figure A Images of Developed Noise Model

Note in relation to the emergency diesel generators screening to these elements of plant are to be formed from an acoustic louvre which offers the following sound insertion loss. The height of the screen is at least 0.5m above the top of the generator installations to be located to their north, west and south.

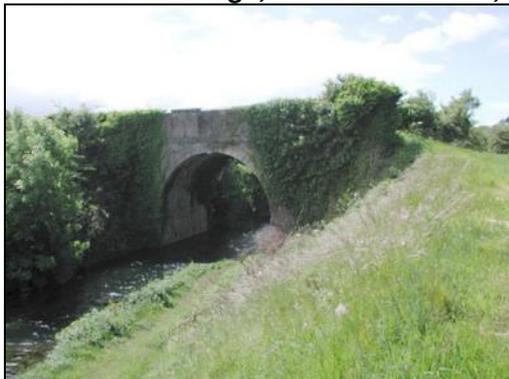
**Gollierstown Bridge, GOLLIERSTOWN, Milltown, DUBLIN**

This noticeably elevated bridge is a fine example of the canal bridges to be found on the Grand Canal. It is all the more stunning due to its remote location and idyllic setting amongst the lush natural environment.

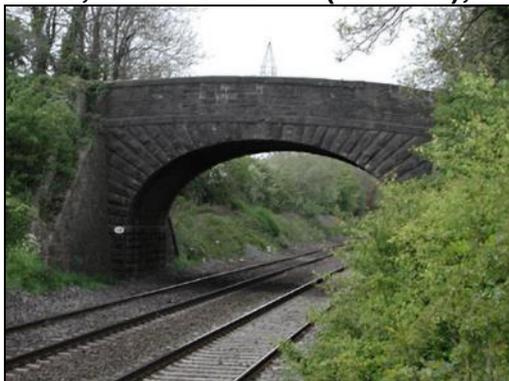
**R120, ADAMSTOWN (NE. BY.), DUBLIN**

<b>Reg No</b>	<b>11204051</b>
Rating	Regional
Categories of Special Interest	Architectural, Technical
Original Use	Bridge
In Use As	Bridge
Date	1900 - 1930
Coordinates	303016, 232768
Date Recorded	16/05/2002
Date Updated	--/--/--

This handsome road bridge is an integral part of the railway network, built to a standard design with well-executed stonework and a graceful arch.

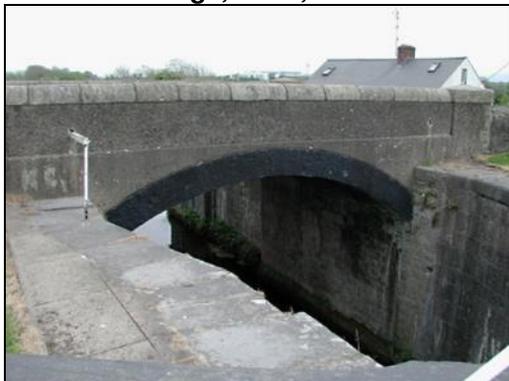
**12th Lock Bridge, R120, BALLYMAKAILY, DUBLIN**

<b>Reg No</b>	<b>11204052</b>
Rating	Regional
Categories of Special Interest	Architectural, Technical
Original Use	Bridge
In Use As	Bridge
Date	1760 - 1780
Coordinates	302981, 232234
Date Recorded	16/05/2002
Date Updated	--/--/--

This bridge, though widened, retains much original fabric and remains a valuable element in this group of canal structures including the lock gates and mill buildings.

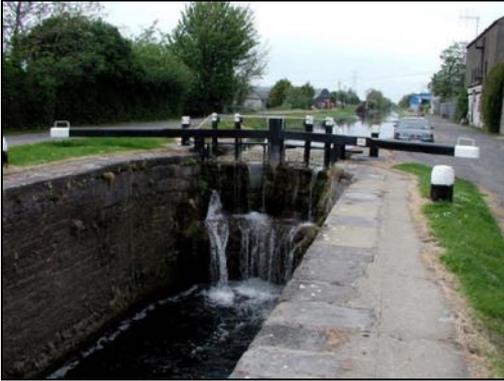
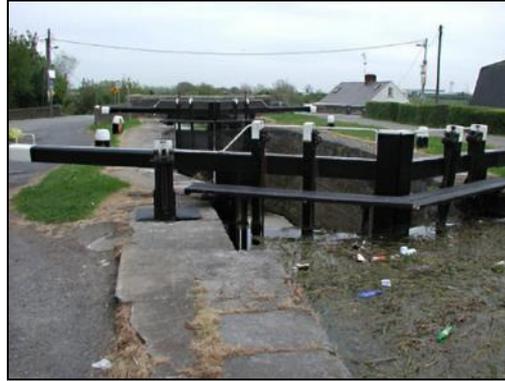
**12th Lock, R120, BALLYMAKAILY, DUBLIN**

<b>Reg No</b>	<b>1204053</b>
Rating	Regional
Categories of Special Interest	Architectural, Technical
Original Use	Lock
In Use As	Lock
Date	1760 - 1780
Coordinates	302957, 232232
Date Recorded	16/05/2002
Date Updated	--/--/--

A good example of a standard-type eighteenth-century canal lock, enhanced by its setting among such a rich group of canal structures.

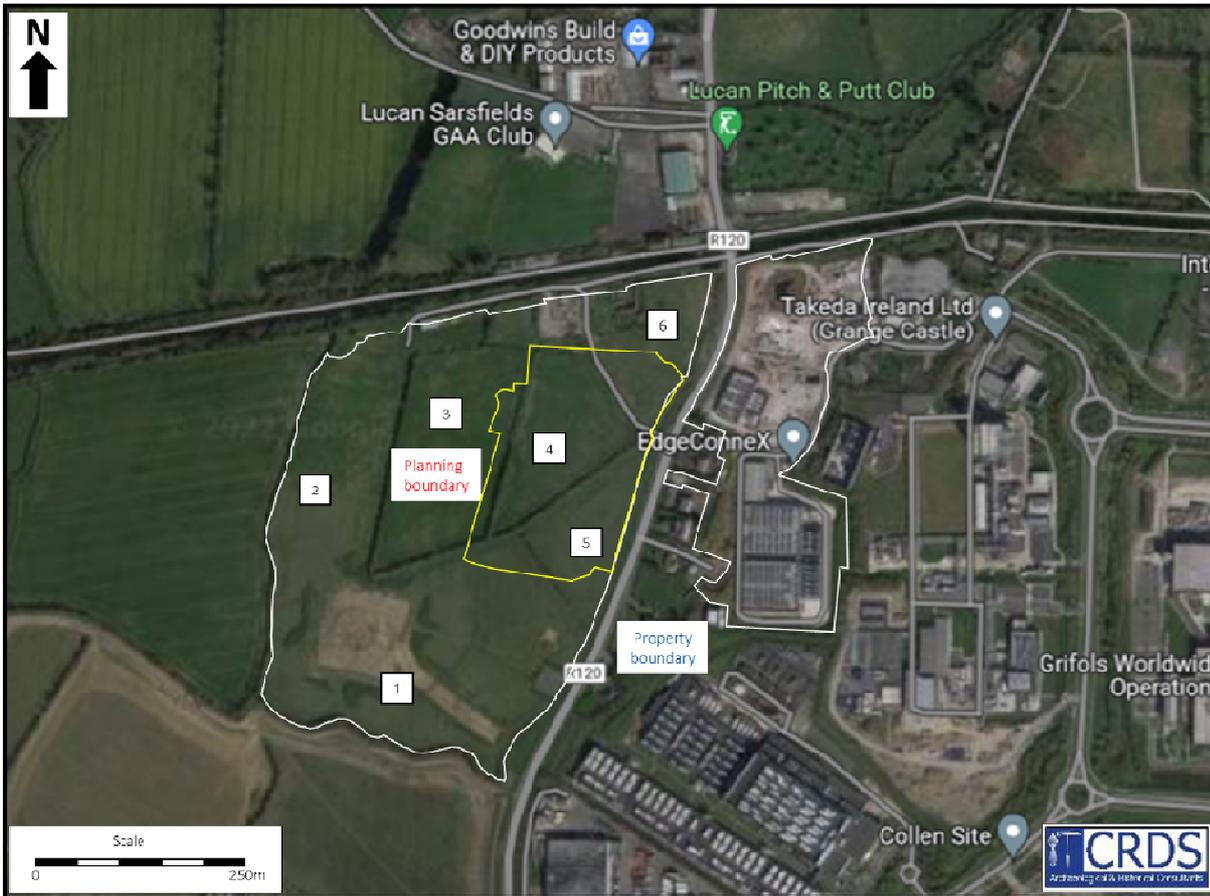
Figure 6 Aerial Photographic extract showing site and field numbers noted in field survey (source: Google Maps 2022).

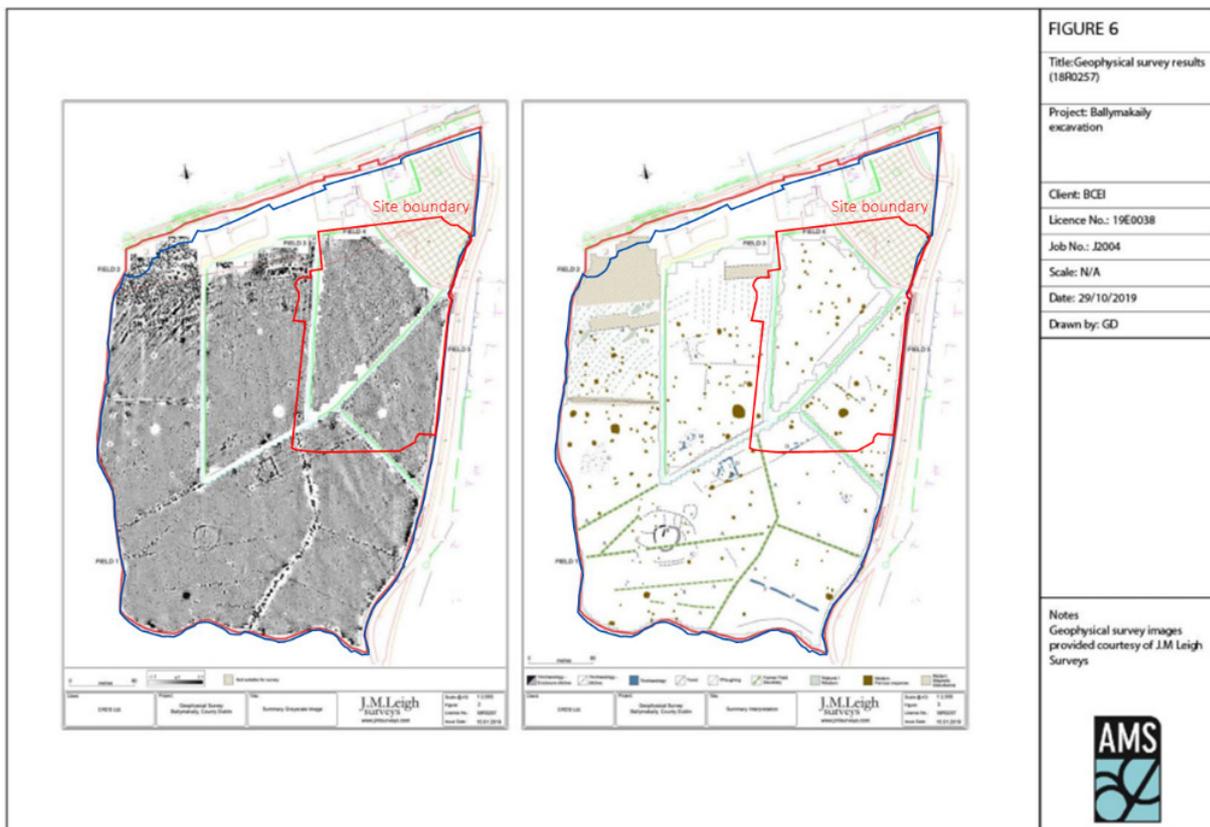
Figure 7 Results of Geophysical Survey of the site (undertaken by JM Leigh Surveys; license no 18R0257)

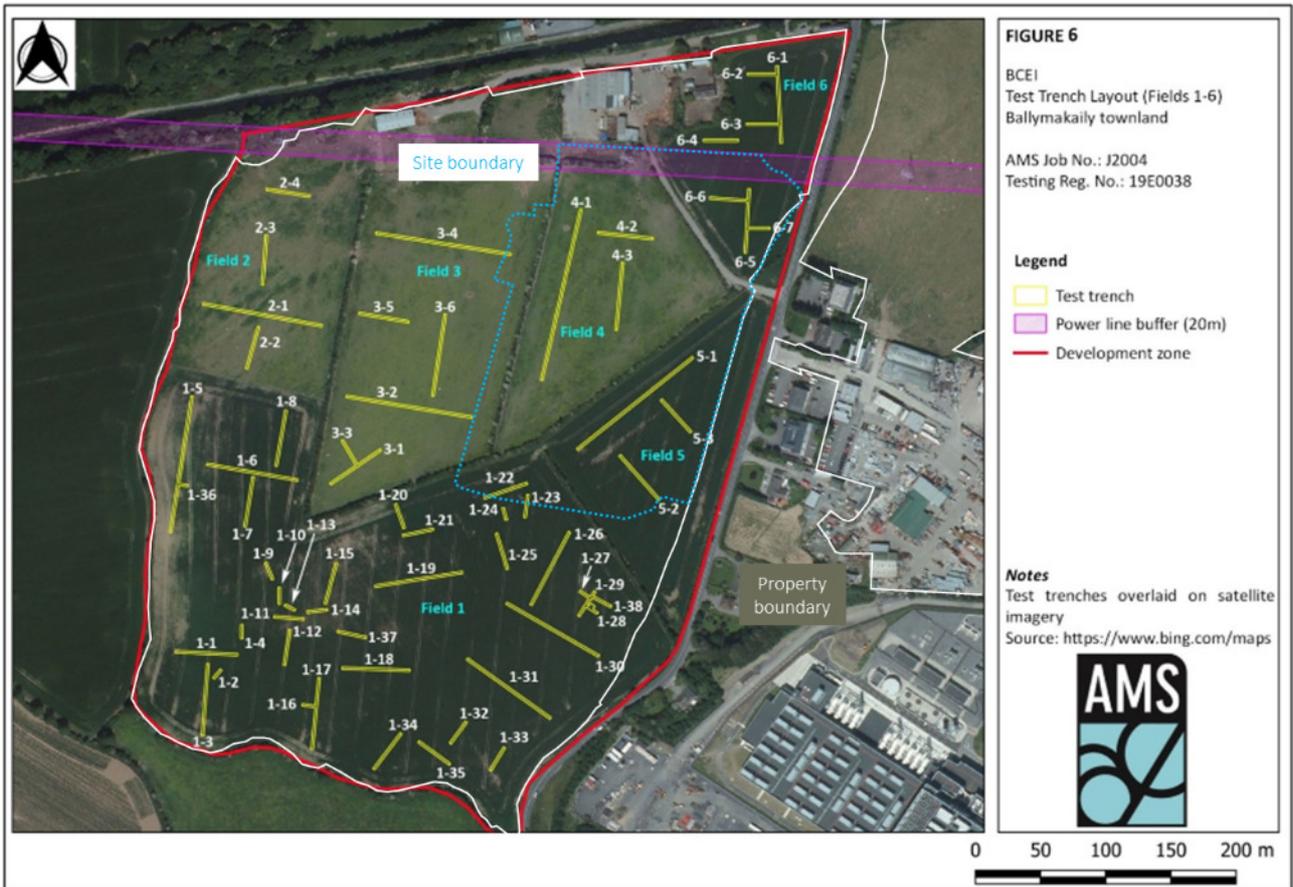
Figure 8 Archaeological testing of the site (undertaken by AMS Ltd; license no 19E0038)

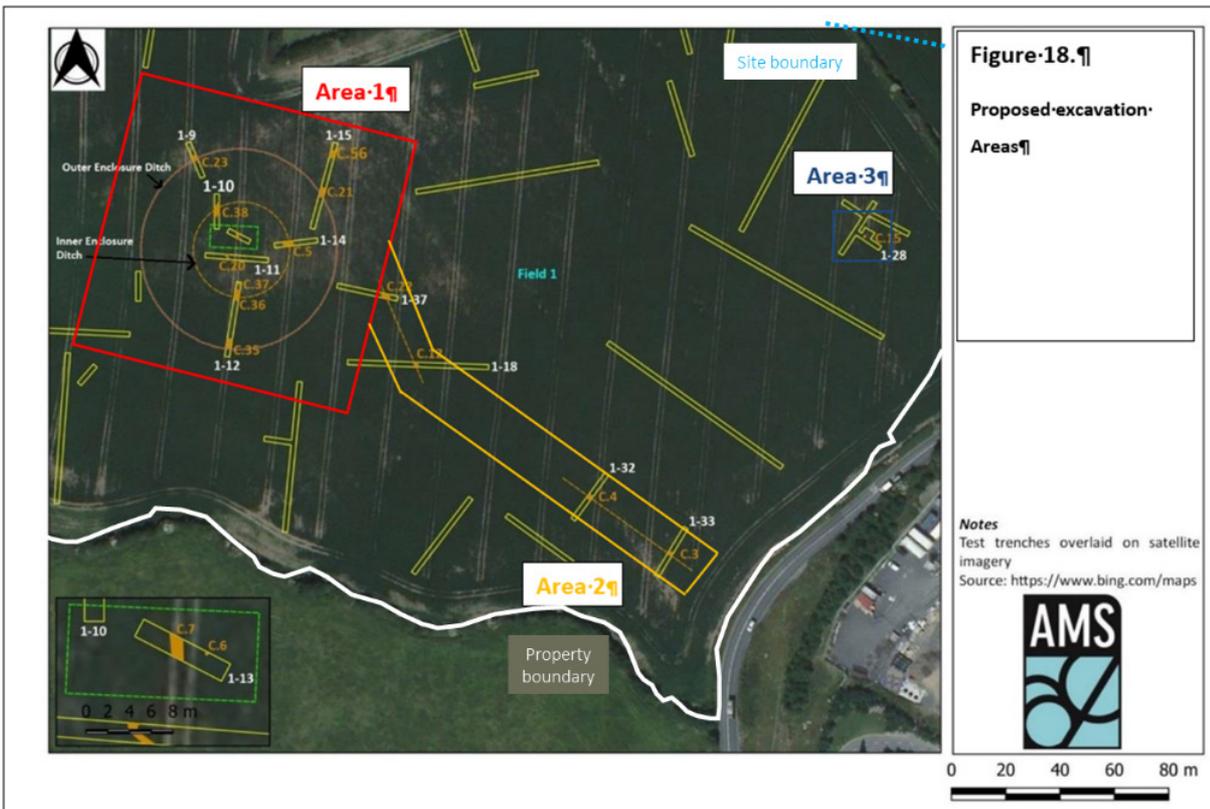
Figure 9 Archaeological areas identified during testing (undertaken by AMS Ltd; license no 19E0038)

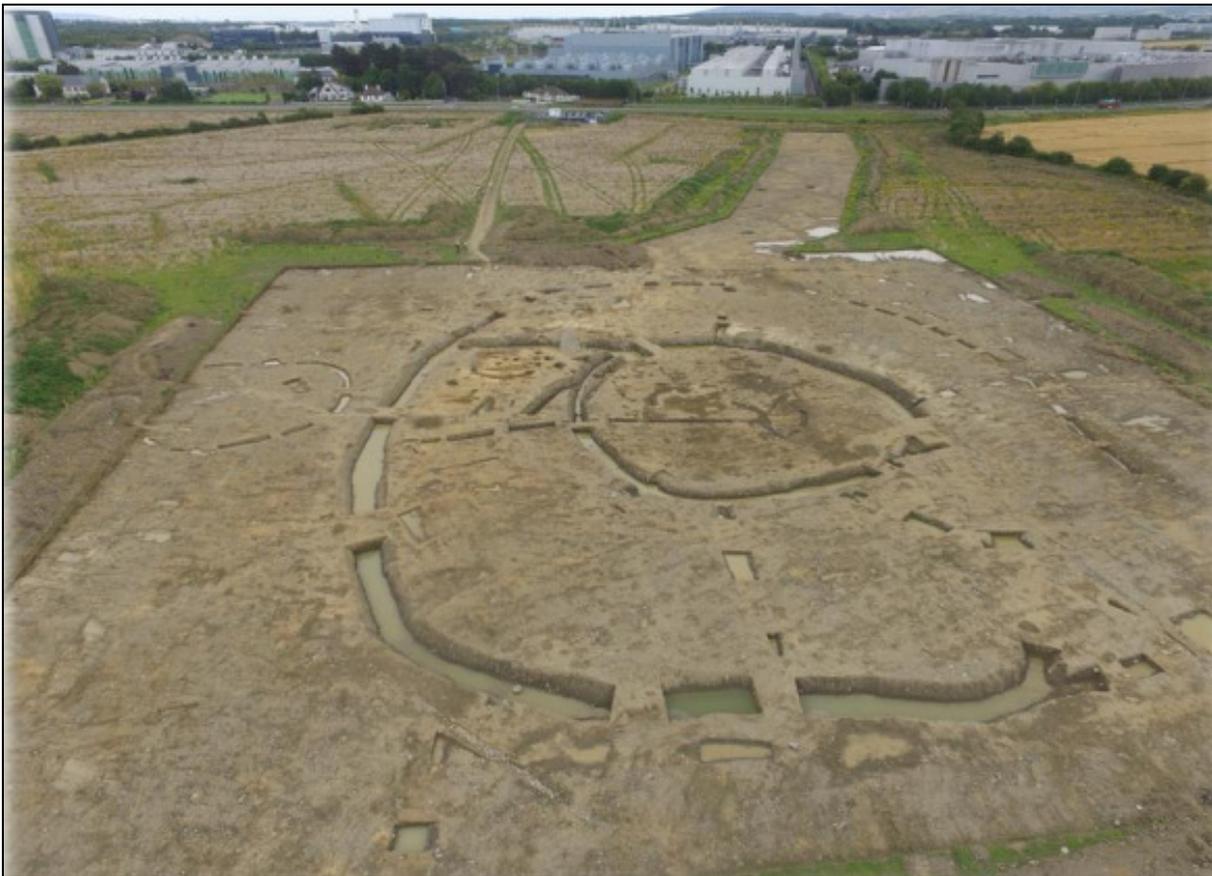
Figure 10 Area photograph of archaeological features identified in Areas 1-3 under excavation (undertaken by AMS Ltd; license no 19E0038)

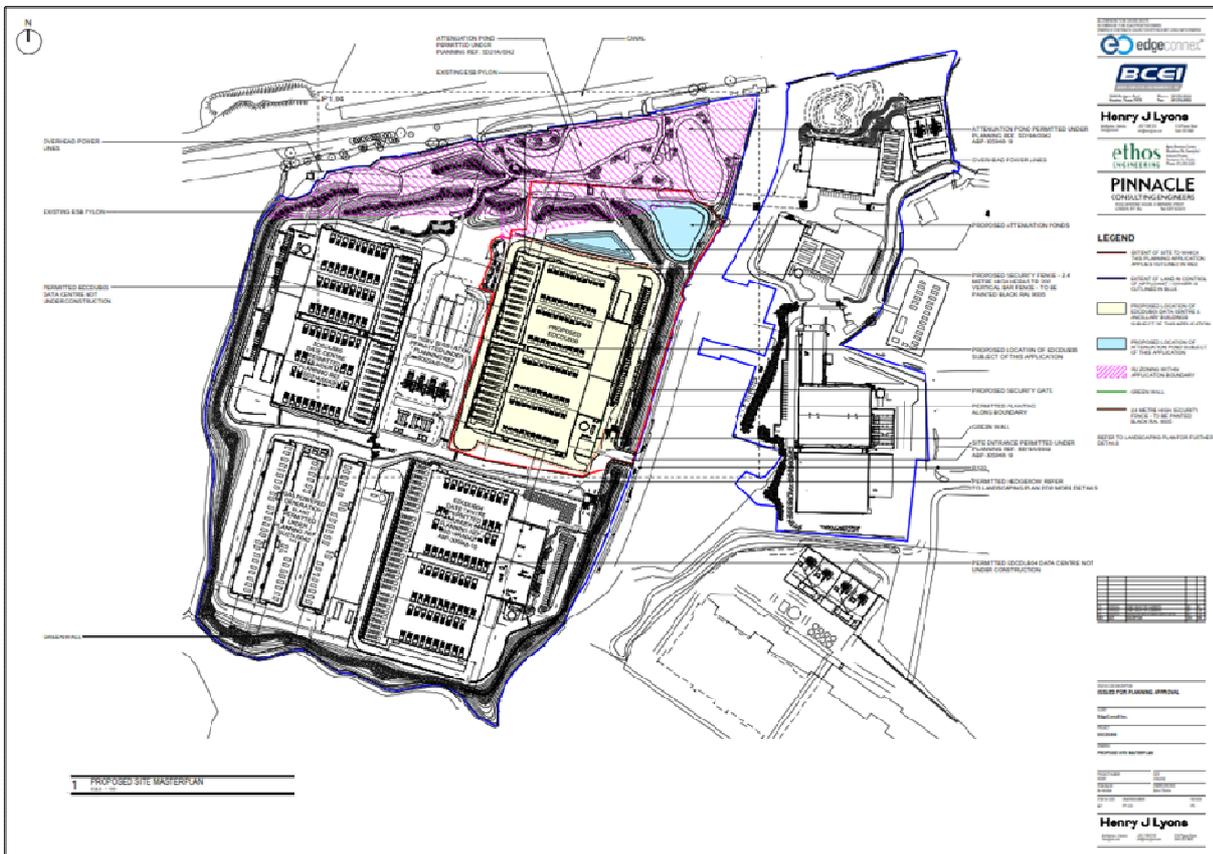
Figure 11 Plan of the proposed development.
