Road Safety Audit Stage F Report (Part 2)

National Roads Authority
Galway City Transport Project
Road Safety Audit Stage F (Part 2)

Issue 2 | 3 September 2015

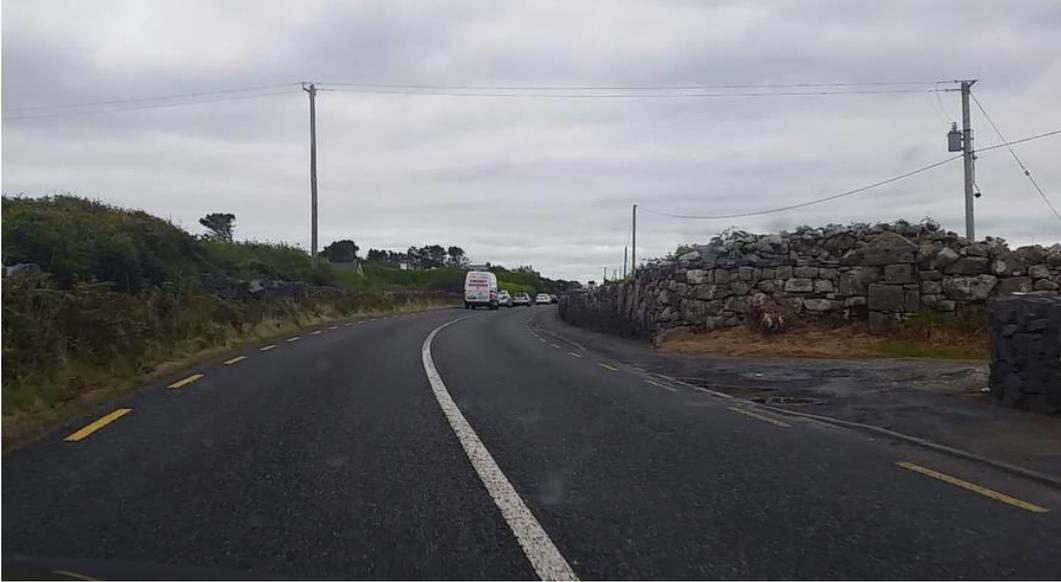
Figure 2: Domestic Access on R336

Issue: There is a domestic and agricultural access located in close proximity to the proposed R336 roundabout (refer to figures 2 and 3). The Auditors are concerned that vehicles exiting the roundabout will be gaining speed and may not expect vehicles to enter/exit these accesses. This may lead to sudden braking which could

result in rear end shunt or side swipe type collisions with the vehicles exiting the accesses.

Recommendation: The existing accesses should be relocated in order to improve visibility to and from the accesses.

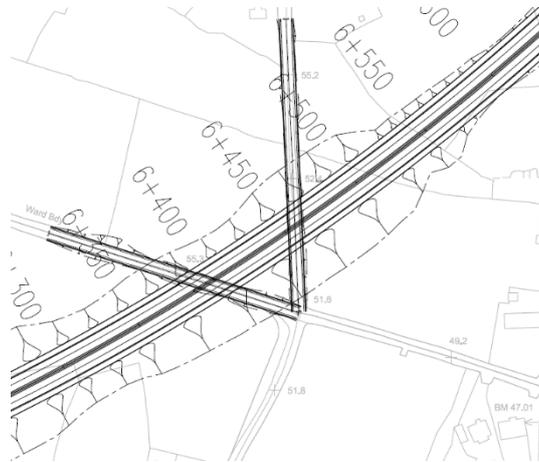
Figure 4: Proposed junction at Rahoan Road

Issue: A crossroad type junction is proposed at Ragoon Road. The Auditors are concerned that junctions of this type can pose a serious collision risk to road users due to the see through issue. This junction may also be complicated due to the reduced visibility from the north as a result of the proposed underbridge. A junction of this type could potentially lead to sudden braking which could result in rear end shunt type collisions or may also lead to side swipe type collisions between passing road users.

Recommendation: The junction type should be changed to a staggered junction.

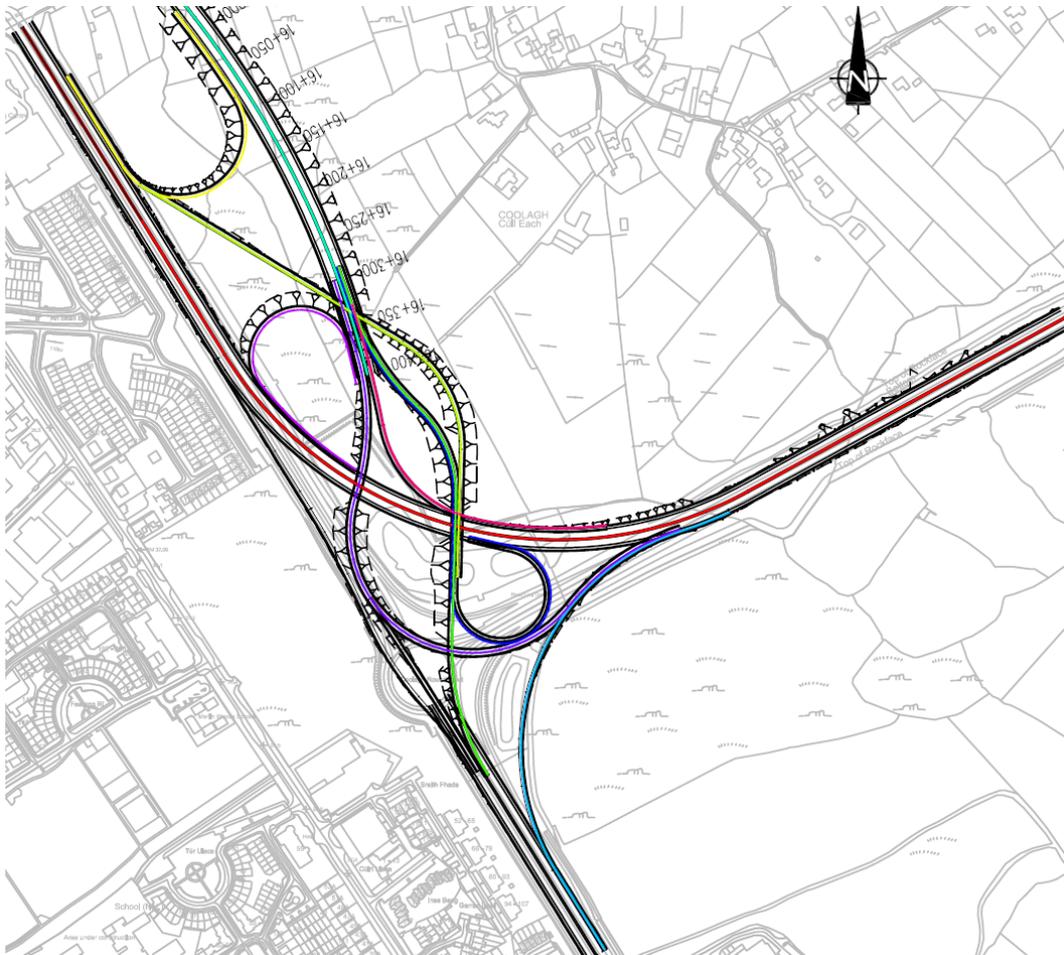
Figure 5: Proposed N6 Interchange

Issue A: The design presented for audit shows the existing N6 at Coolagh being realigned and terminating at the existing signalised junction at Briarhill (see figure 5 – red route). Road users will not expect the N6 to terminate at a signalised junction which could increase the likelihood of rear end shunt type collisions at this location.

Issue B: It is the Auditors opinion that the reduction of the expressway to a single lane in order to join the eastbound N6 (see figure 5 – pink route) could cause a collision hazard as road users will not expect the expressway to reduce to a single lane having travelled unobstructed for ~12km.

Issue C: The merge lane to the N6 westbound from the existing N6 (see figure 5 – yellow route) begins in close proximity to the signalised junction at Briarhill. This could increase the likelihood of rear end shunt or side swipe type collisions on the approach to the merge should a road user attempt to change lanes within the distance available.

Issue D: The merge lane to the N6 eastbound from the existing R446 (see figure 5 – purple loop route) is in close proximity to the expressway merge to the eastbound

N6 (see figure 5 – pink route). Successive merges such as these can pose collision risks to road users on the N6 mainline as well as those joining the N6 mainline.

Issue E: The Auditors are unsure as to how the proposed expressway link to the R446 south, proposed expressway link to the N6 west and proposed N6 at Briarhill to the R446 south (see figure 5 – green, dark blue and lime green routes) will operate as the design includes various lane gains, lane drops and level differences. A combination of all of these factors could prove confusing for road users which could increase the likelihood of collisions throughout the interchange.

Issue F: The design of the R446 northbound merges with the westbound expressway (see figure 5 – purple route) and northbound N6 (see figure 5 – red route) do not appear to have been completed and the merge with the purple route appears to be quite severe and on a curve.

Recommendation: The design of the N6 free flow junction should be readdressed in order to minimise its complexity and to decrease the potential confusion that may be caused to road users.
