### **BD02 River Corrib Bridge**

Galway County Council  
**N6 Galway City Ring Road**  
River Corrib Bridge

GCOB-4.04-020-012

Issue 4 | 23 October 2017

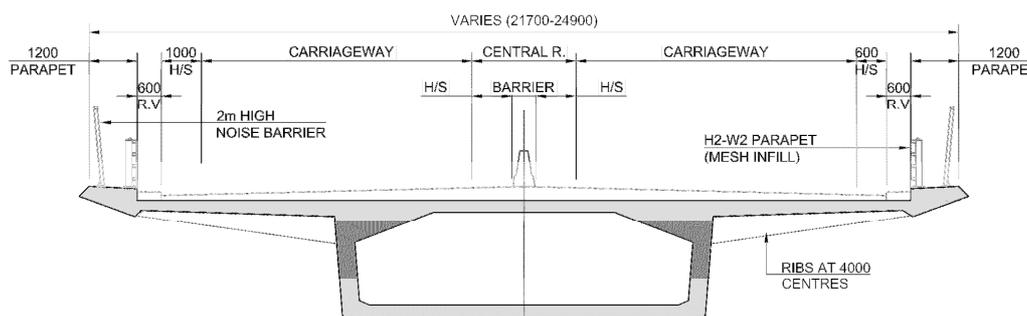
**Figure 2.3: Superstructure Cross-Section at River Crossing**

The proposed cross section of the bridge deck is given in the drawing GCOB-1700-D-S08-04-002 in Appendix B and summarised in Table 2.2 below. Noise barriers, at each side of the bridge, are located outside the working width of the vehicle parapet.

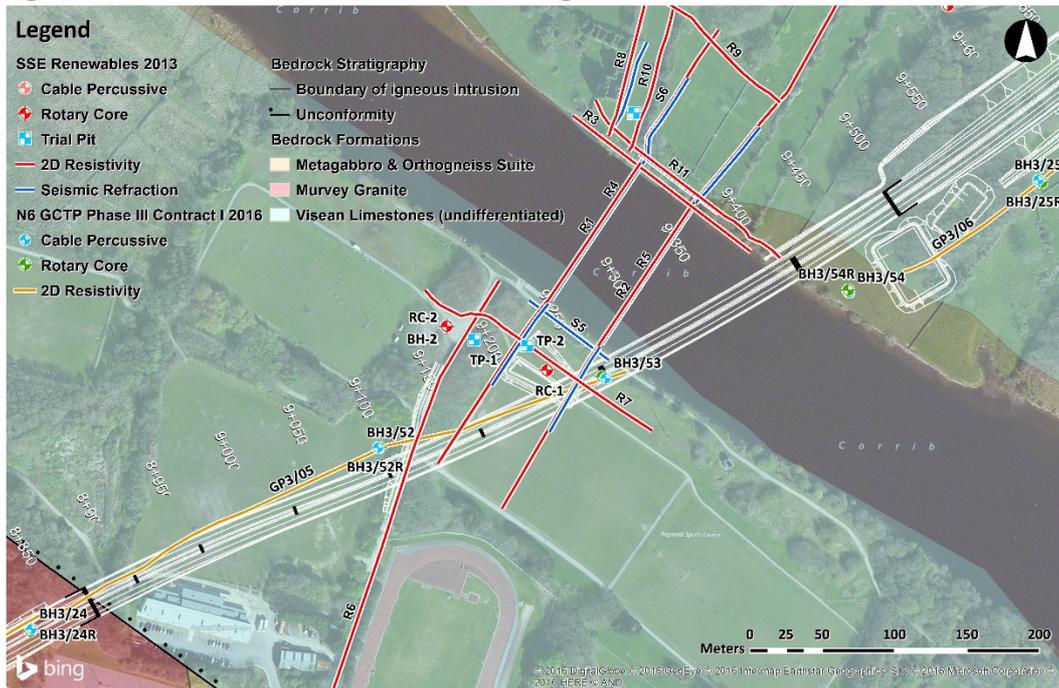
**Figure 2.4: Plan Location of Ground Investigations**

The plan location of the ground investigation is provided in Figure Error! Reference source not found.2.4.

Karst activity in limestone is noted in the general vicinity of the structure. On the limestone side of the unconformity line, indicated in **Figures 2.4 and 2.5**, there is a zone of low resistivity that is up to 40m wide, greater than 20m in depth and extends to the ground surface. The anomalous zone of low resistivity is indicative of a weathered zone or karst zone with clay infill and is presented in **Figure 2.6**. East of the low resistivity anomalous feature the geology sharply reverts to high resistivity, typical of competent limestone, but the rock topography increasingly deepens being buried by thicker overburden so that at the River Corrib the rock head is between 5.0 to 15m below ground level.

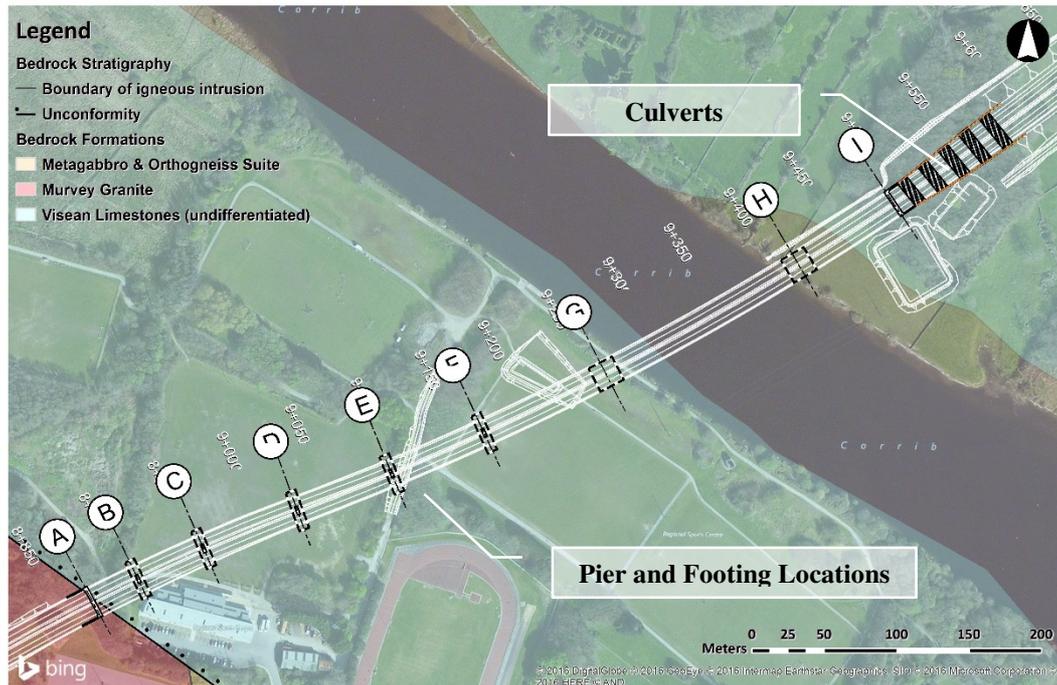
**Figure 2.5: Foundation Location Plan**

The bridge abutments, pier locations, and culverts are used as reference points in the sub sections below and are presented in **Figure 2.5** along with the bedrock geology.

Ground conditions of note were encountered at some of the foundation locations (presented in **Figure 2.5**) and these are further discussed below.

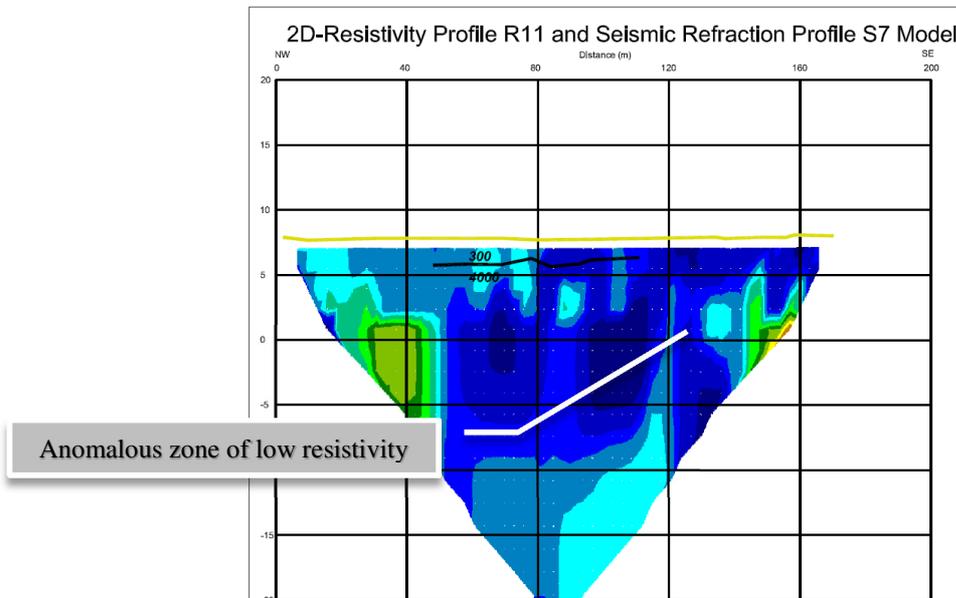
**Figure 2.7: Resistivity Profile R11**

Resistivity profile R11 (SSE Renewable GI 2013), which is located on the eastern bank of the river, highlighted a developing anomaly as it approaches the alignment and eastern bank pier. This particular zone is shown in **Figure 2.7**. BH 3/54, adjacent to the end of the resistivity profile R11, indicated two 250mm clay infilled fractures at 6.1m and 11.3m below ground level.

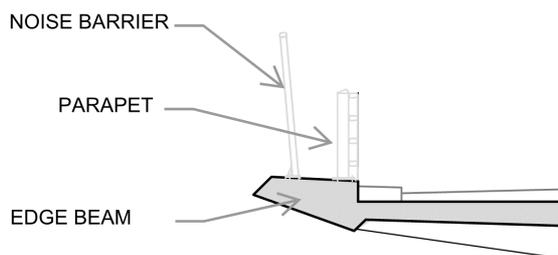
**Figure 3.1** Edge detail

The detail of the bridge deck, and in particular of the leading cantilevered edge, is defined by a profiled concrete upstand supporting the parapet railing and noise barrier. The concrete upstand incorporates inclined edges that present as a sharper and more striking edge profile that in turn supports the metal railing and the acoustic barrier. The acoustic barrier is inclined outwards and made of transparent material (glass). The transparent material affords a visual lightness, and by being inclined outwards, it will minimise reflection of skylight and maintain its transparent appearance. See **Figure 3.1** for details regarding the edge detailing.

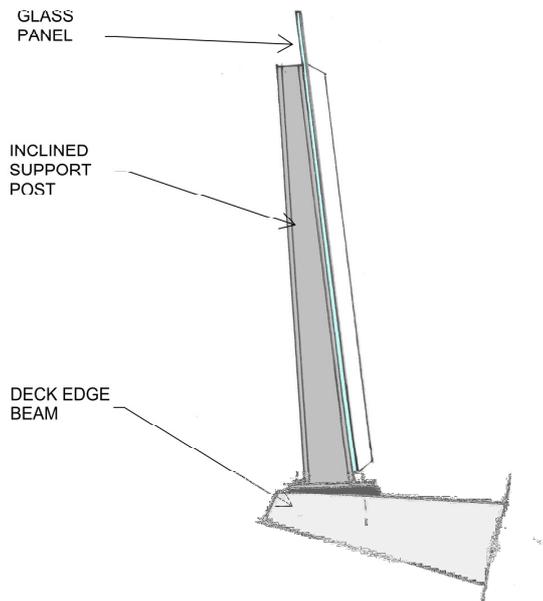
**Figure 3.2 Noise Barrier Typical Arrangement**

A 2m high noise barrier is to be provided along the full length of the bridge, on both sides of the structure, as indicated in **Figure 3.2** below. The noise barrier will be position behind the parapet on the deck edge beam. The panel material will be toughened glass; where appropriate local frosting or patterns will be provided on the glass. The support posts will be inclined to the vertical plane, and will consist of painted steelwork or aluminium, typically at 2m centres. The posts and the arrangement of the noise barrier shall be given the appropriate architectural treatment for the dominant location of this element.

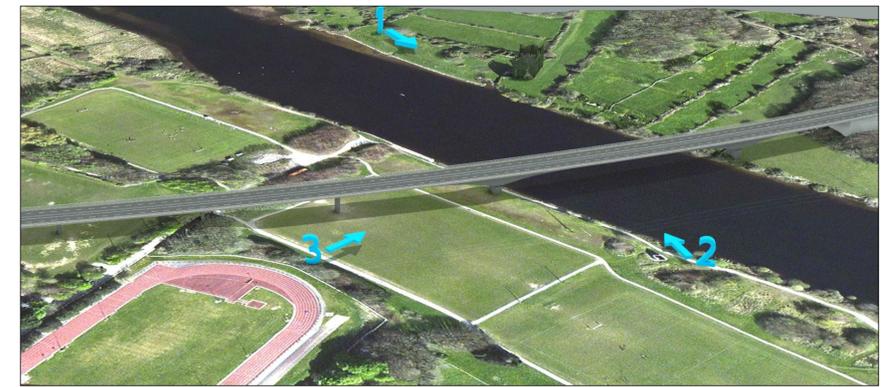
AERIAL VIEW ON PROPOSED BRIDGE  
SCALE: N.T.S

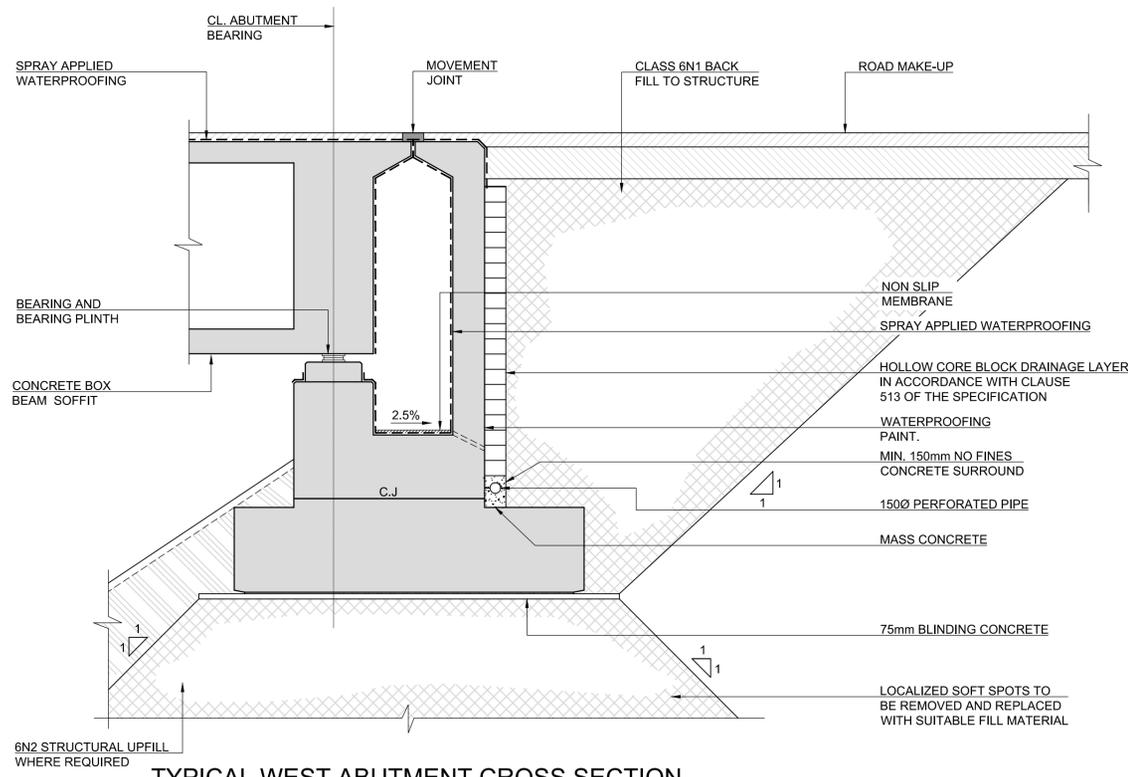
**TYPICAL WEST ABUTMENT CROSS SECTION**  
SCALE: 1:50

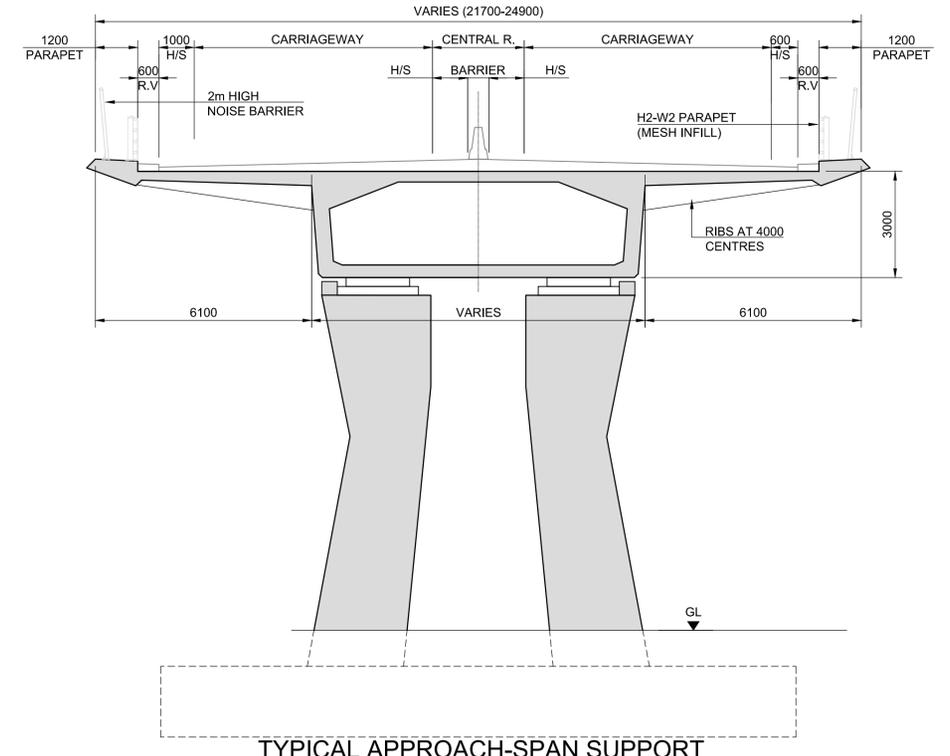
**TYPICAL APPROACH-SPAN SUPPORT**  
SCALE: 1:100

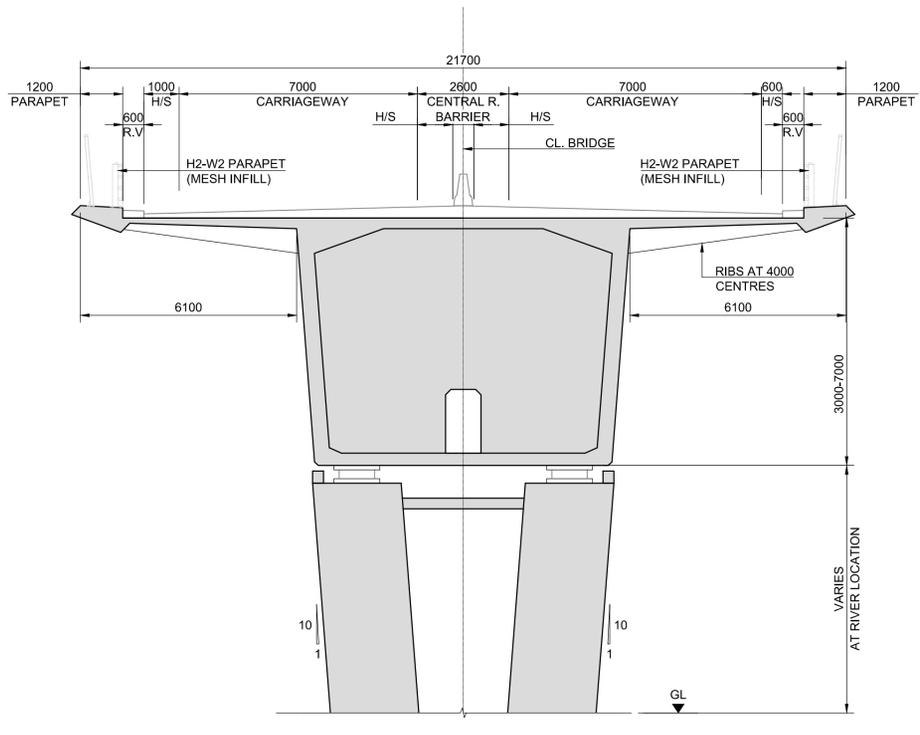
**TYPICAL MAIN-SPAN CROSS SECTION**  
SCALE: 1:100

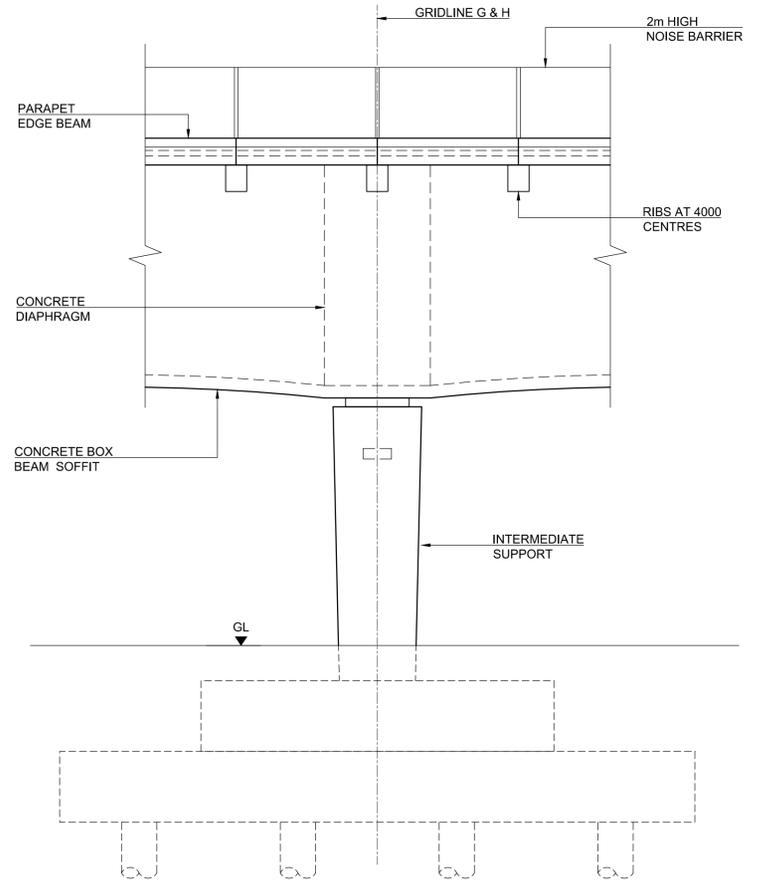
**TYPICAL MAIN-SPAN INTERMEDIATE SUPPORT ELEVATION**  
SCALE: 1:100

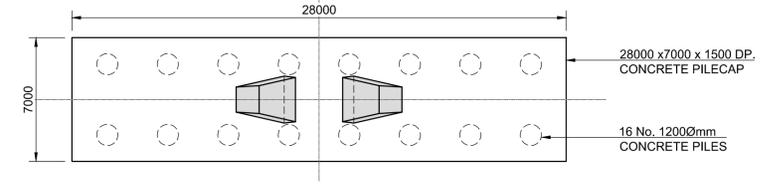
**PLAN ON TYPICAL INTERMEDIATE SUPPORT FOUNDATION**  
SCALE: 1:200

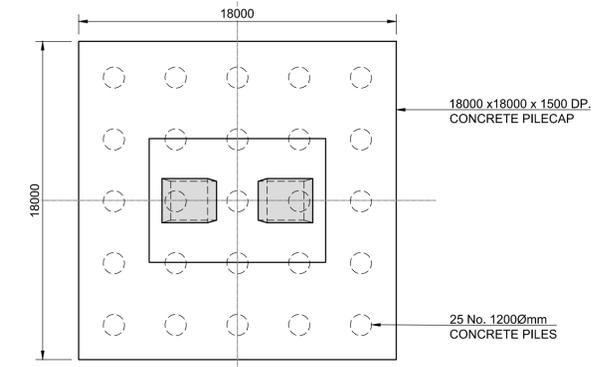
**PLAN ON TYPICAL MAIN-SPAN INTERMEDIATE SUPPORT FOUNDATION**  
SCALE: 1:200

The bridge intermediate support foundations will consist of reinforced concrete piles founded on rock. Refer to GCOB-1700 D-S08-04-001 to 002 in Appendix B for further information.

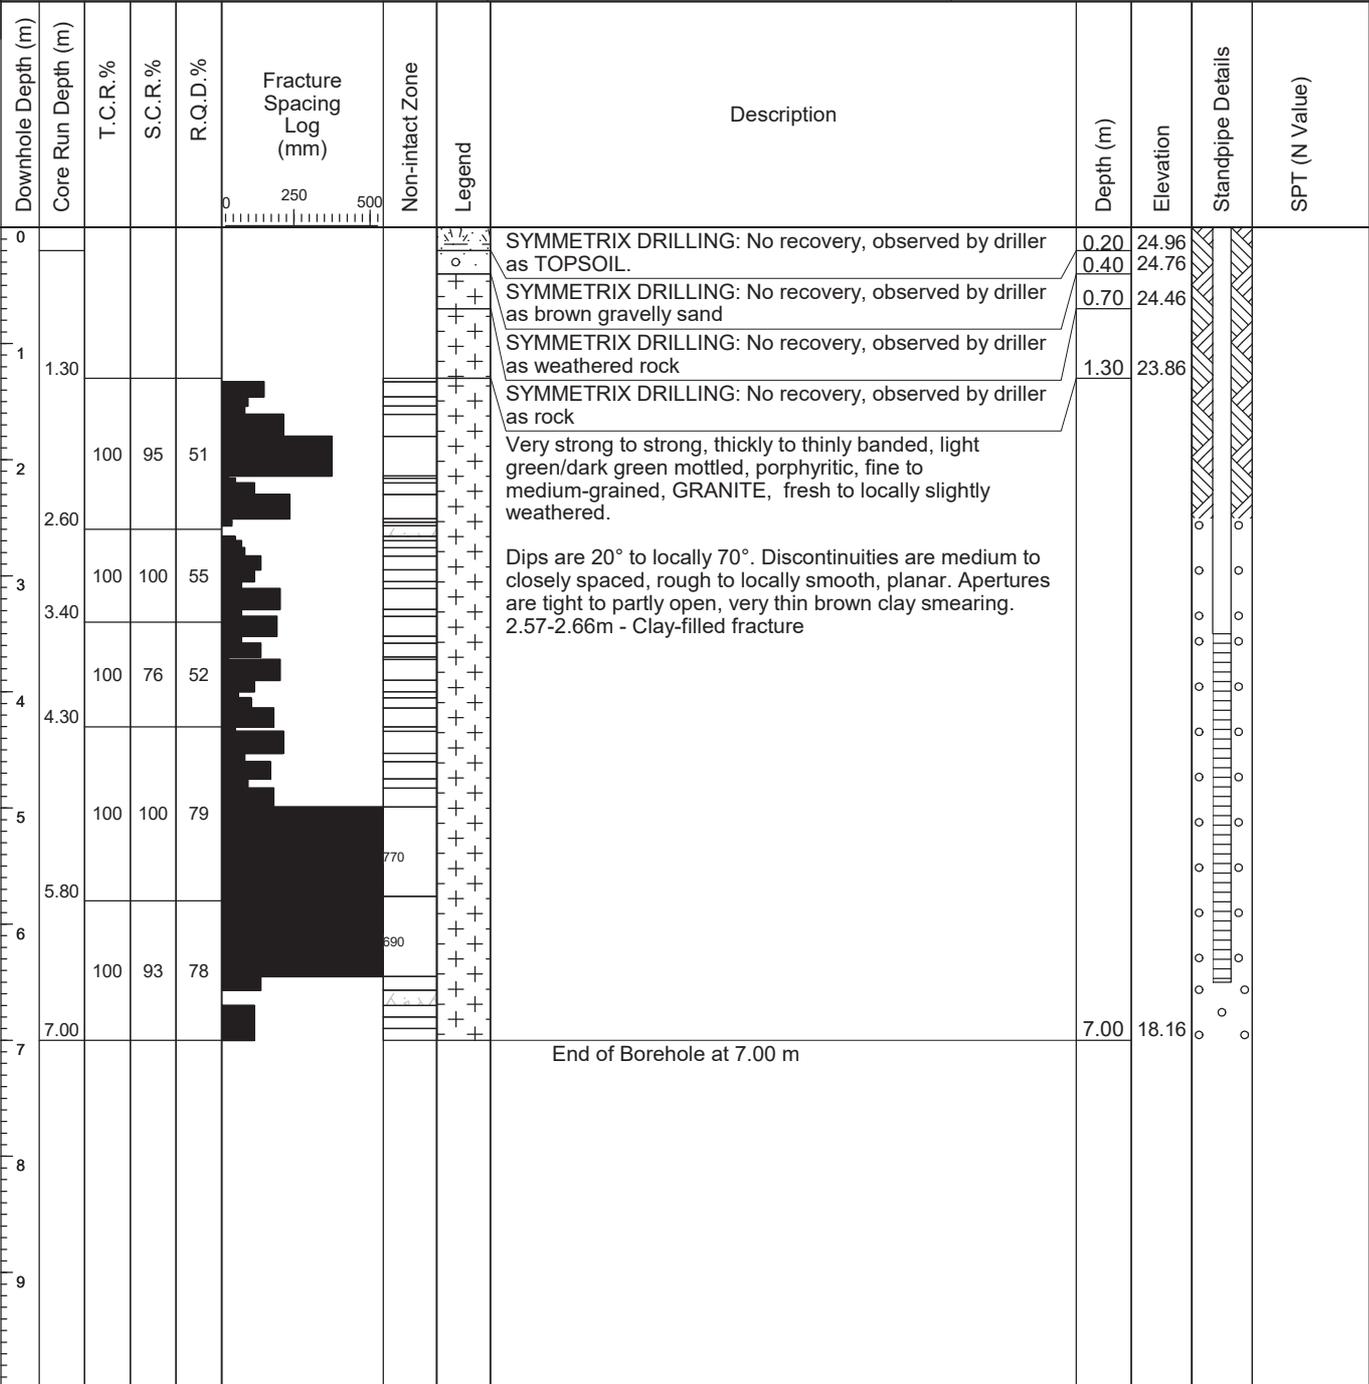
<b>CONTRACT</b> N6 Galway City Transport Project - Phase 3		<b>DRILLHOLE NO</b> BH3/24R
<b>CO-ORDINATES</b> 528,036.05 E 727,520.61 N		<b>SHEET</b> Sheet 1 of 1
<b>GROUND LEVEL (mOD)</b> 25.16	<b>RIG TYPE</b> Knebel	<b>DATE DRILLED</b> 03/03/2016
<b>CLIENT</b> Galway County Council	<b>FLUSH</b> Air/Mist	<b>DATE LOGGED</b> 03/03/2016
<b>ENGINEER</b> ARUP	<b>INCLINATION (deg)</b> -90	<b>DRILLED BY</b> S. Petersen
	<b>CORE DIAMETER (mm)</b> 80	<b>LOGGED BY</b> D. O'Shea

<b>REMARKS</b> Hole cased 0.00-1.30m.					<b>WATER STRIKE DETAILS</b>					
					Water Strike	Casing Depth	Sealed At	Rise To	Time (min)	Comments
										No water strike recorded
<b>INSTALLATION DETAILS</b>					<b>GROUNDWATER DETAILS</b>					
					Date	Hole Depth	Casing Depth	Depth to Water	Comments	
Date	Tip Depth	RZ Top	RZ Base	Type						
03-03-16	6.50	2.50	7.00	50mm SP

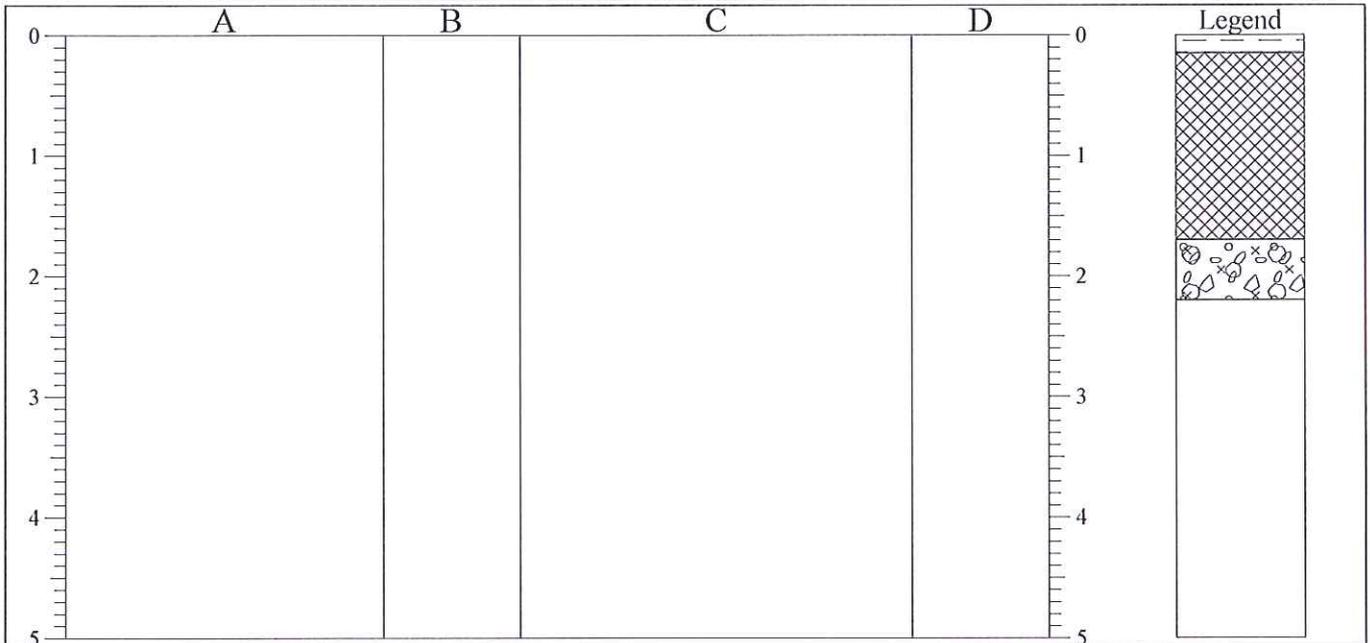
Project Galway Wind Park - River Corrib Crossing			Location Co Galway		TRIAL PIT No <b>TP-1</b>
Job No	Date 22-10-13 22-10-13	Ground Level (m) 9.29	Co-Ordinates ( ) E 128,376.4 N 227,694.7		
Engineer RBL		GROUNDWATER STRIKES	Water strikes: 1st: dry 2nd: 3rd:	Rose to (@ 20 min.): Sealed at:	Sheet Rev. 1 of 1

STRATA				SAMPLES & TESTS			
Depth	No	DESCRIPTION	In Situ Tests	Water	Depth (m)	No	Remarks/Tests
0.00-0.15		TOPSOIL: Brown slightly sandy CLAY.					
0.15-1.70		MADE GROUND: Brown silty gravelly SAND with kerb stones bricks timber and with medium cobble content and low boulder content. Cobbles and boulders are subrounded and subangular.			1.20-1.30	B1	
1.70-2.20		Grey silty very sandy medium GRAVEL with high cobble content. Cobbles are subangular.			2.00-2.20	B2	
2.20		TP terminated at 2.20m bgl - obstruction.

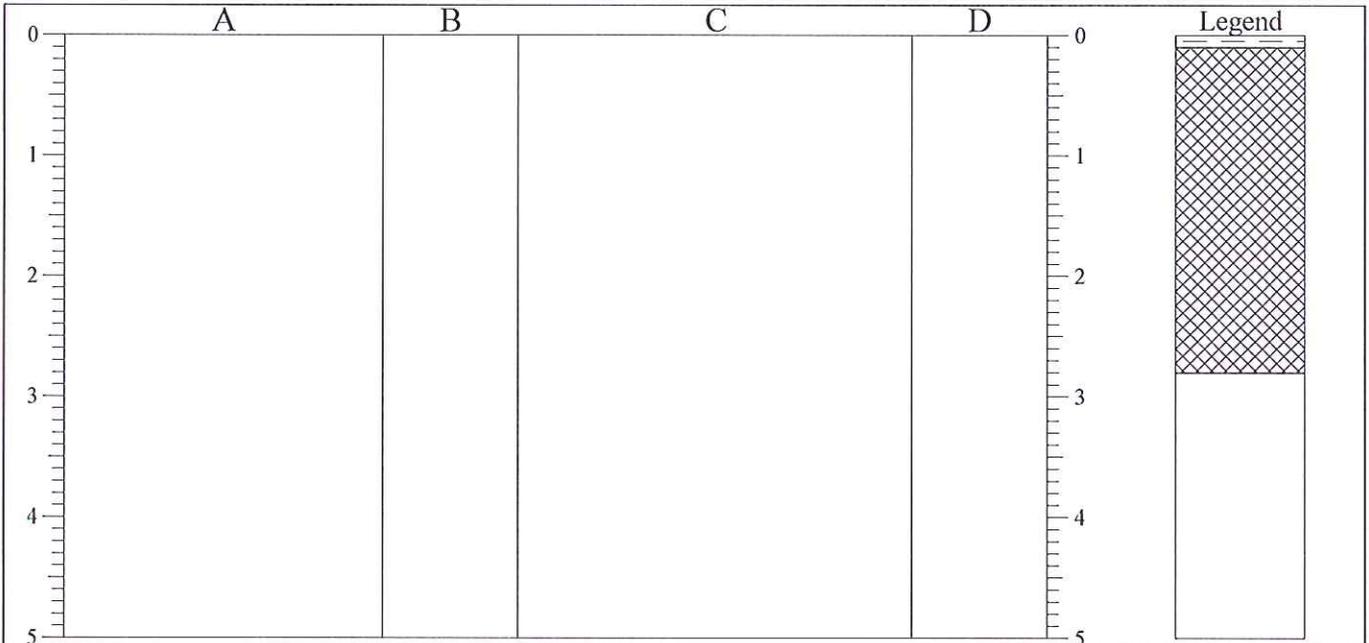
Project Galway Wind Park - River Corrib Crossing			Location Co Galway		TRIAL PIT No <b>TP-2</b>
Job No	Date 22-10-13 22-10-13	Ground Level (m) 9.57	Co-Ordinates () E 128,412.9 N 227,690.6		
Engineer RBL		GROUNDWATER STRIKES	Water strikes: 1st: 1.80m 2nd: 3rd:	Rose to (@ 20 min.): Sealed at:	Sheet Rev. 1 of 1

STRATA				SAMPLES & TESTS			
Depth	No	DESCRIPTION	In Situ Tests	Water	Depth (m)	No	Remarks/Tests
0.00-0.10		TOPSOIL: Brown slightly sandy CLAY.					
0.10-2.80		MADE GROUND: Grey silty very sandy coarse GRAVEL with medium cobble content and low boulder content. Cobbles and boulders are subrounded and subangular.			1.00-1.10	B1	
1.80		1.80m: becoming moist.		↓	2.00-2.10	B2	
2.80		TP terminated at 2.80m bgl. Sidewall collapse - unable to keep TP open.			2.70-2.80	B3

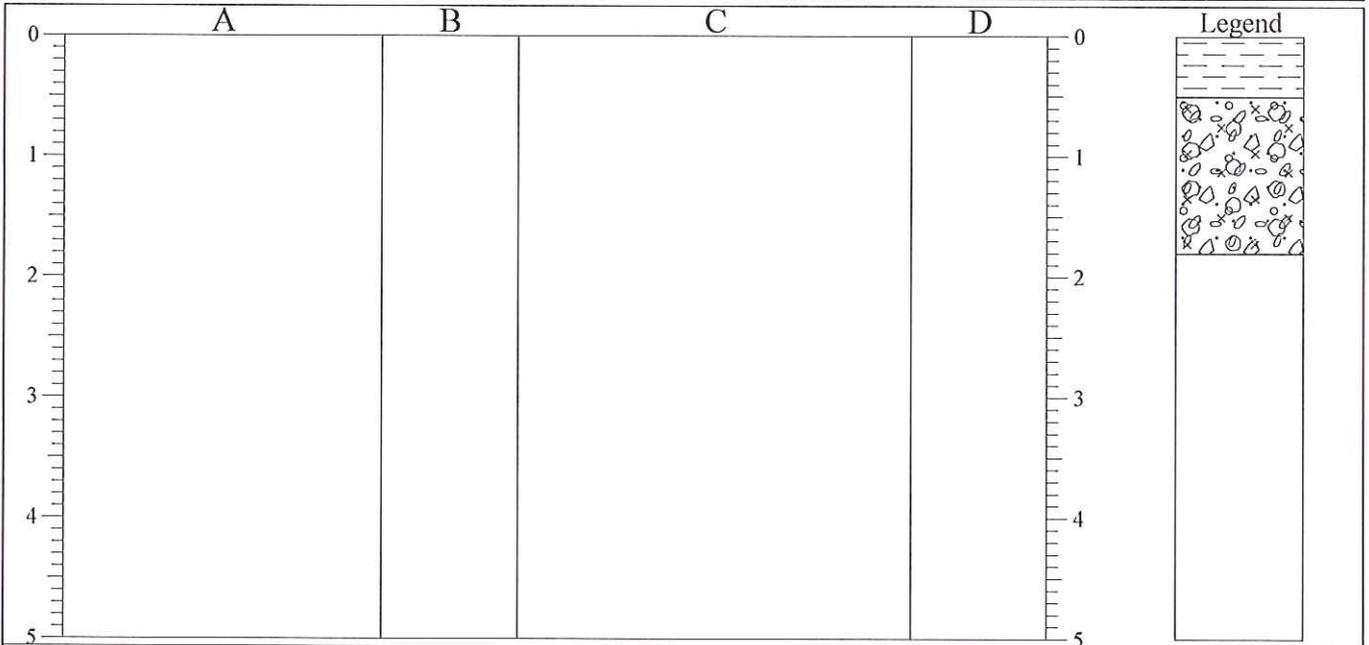
Project Galway Wind Park - River Corrib Crossing			Location Co Galway		TRIAL PIT No <b>TP-3</b>
Job No	Date 30-10-13 30-10-13	Ground Level (m) 9.30	Co-Ordinates () E 128,486.7 N 227,852.6		
Engineer RBL		GROUNDWATER STRIKES	Water strikes: 1st: dry 2nd: 3rd:	Rose to (@ 20 min.): Sealed at:	Sheet Rev. 1 of 1

STRATA				SAMPLES & TESTS			
Depth	No	DESCRIPTION	In Situ Tests	Water	Depth (m)	No	Remarks/Tests
0.00-0.50		TOPSOIL: Brown slightly sandy CLAY with roots.					
0.50-1.80	0.70	Light brown very silty very sandy medium GRAVEL with high cobble content and medium boulder content. Cobbles are angular and subangular. Boulders are subangular. 1 No boulder x600mm x 550mm x950mm in size. 0.70m: Possible archaeological structure as noted by archaeologist.			1.00-1.10	B1	
1.80		TP terminated at 1.80m bgl - obstruction as possible rock.			1.70-1.80	B2

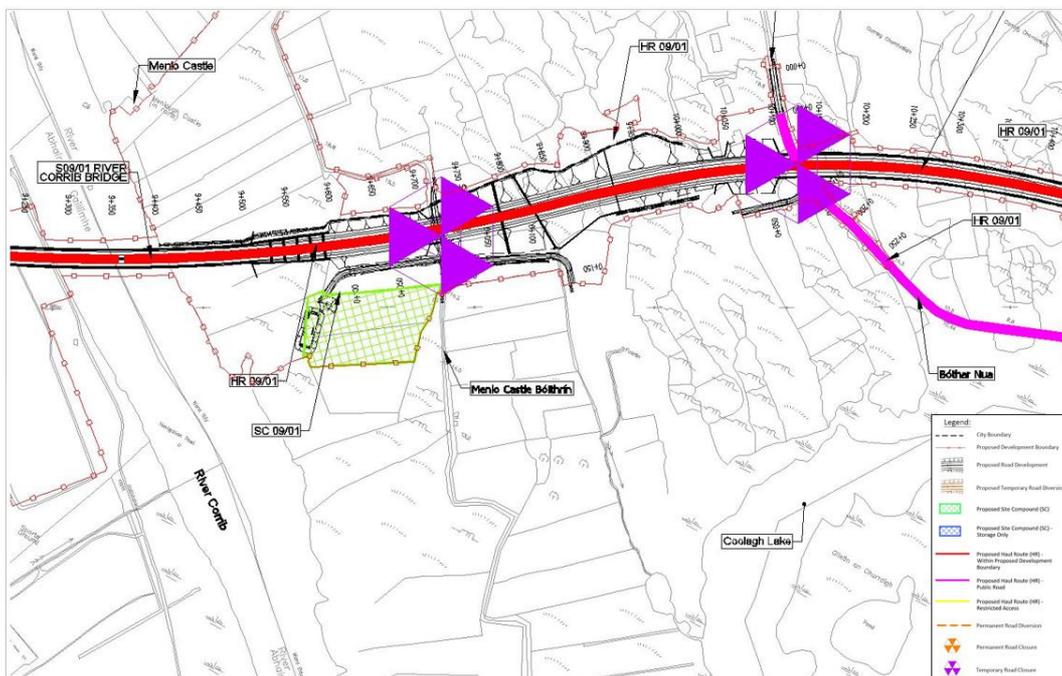
**Figure 2.1: Eastern Bank Access and Site Compound**

Site access for the eastern river bank will be provided by the haul route, HR 09/01, via Bóthar Nua, as shown in **Figure 2.1**. The site compound, SC 09/01, for the River Corrib Bridge on the eastern river bank is located to the south of the proposed road development, as shown in **Figure 2.1** below. In addition, Lackagh Quarry site compound, SC 11/01, may also be used for storage and larger works requirements such as rock crushing etc.
