**Cork Line Level Crossings Project –
XC215 Shinanagh, Co. Cork
Targeted Archaeological Test Excavations**

Prepared for Iarnród Éireann by Ian Russell

18th December 2020

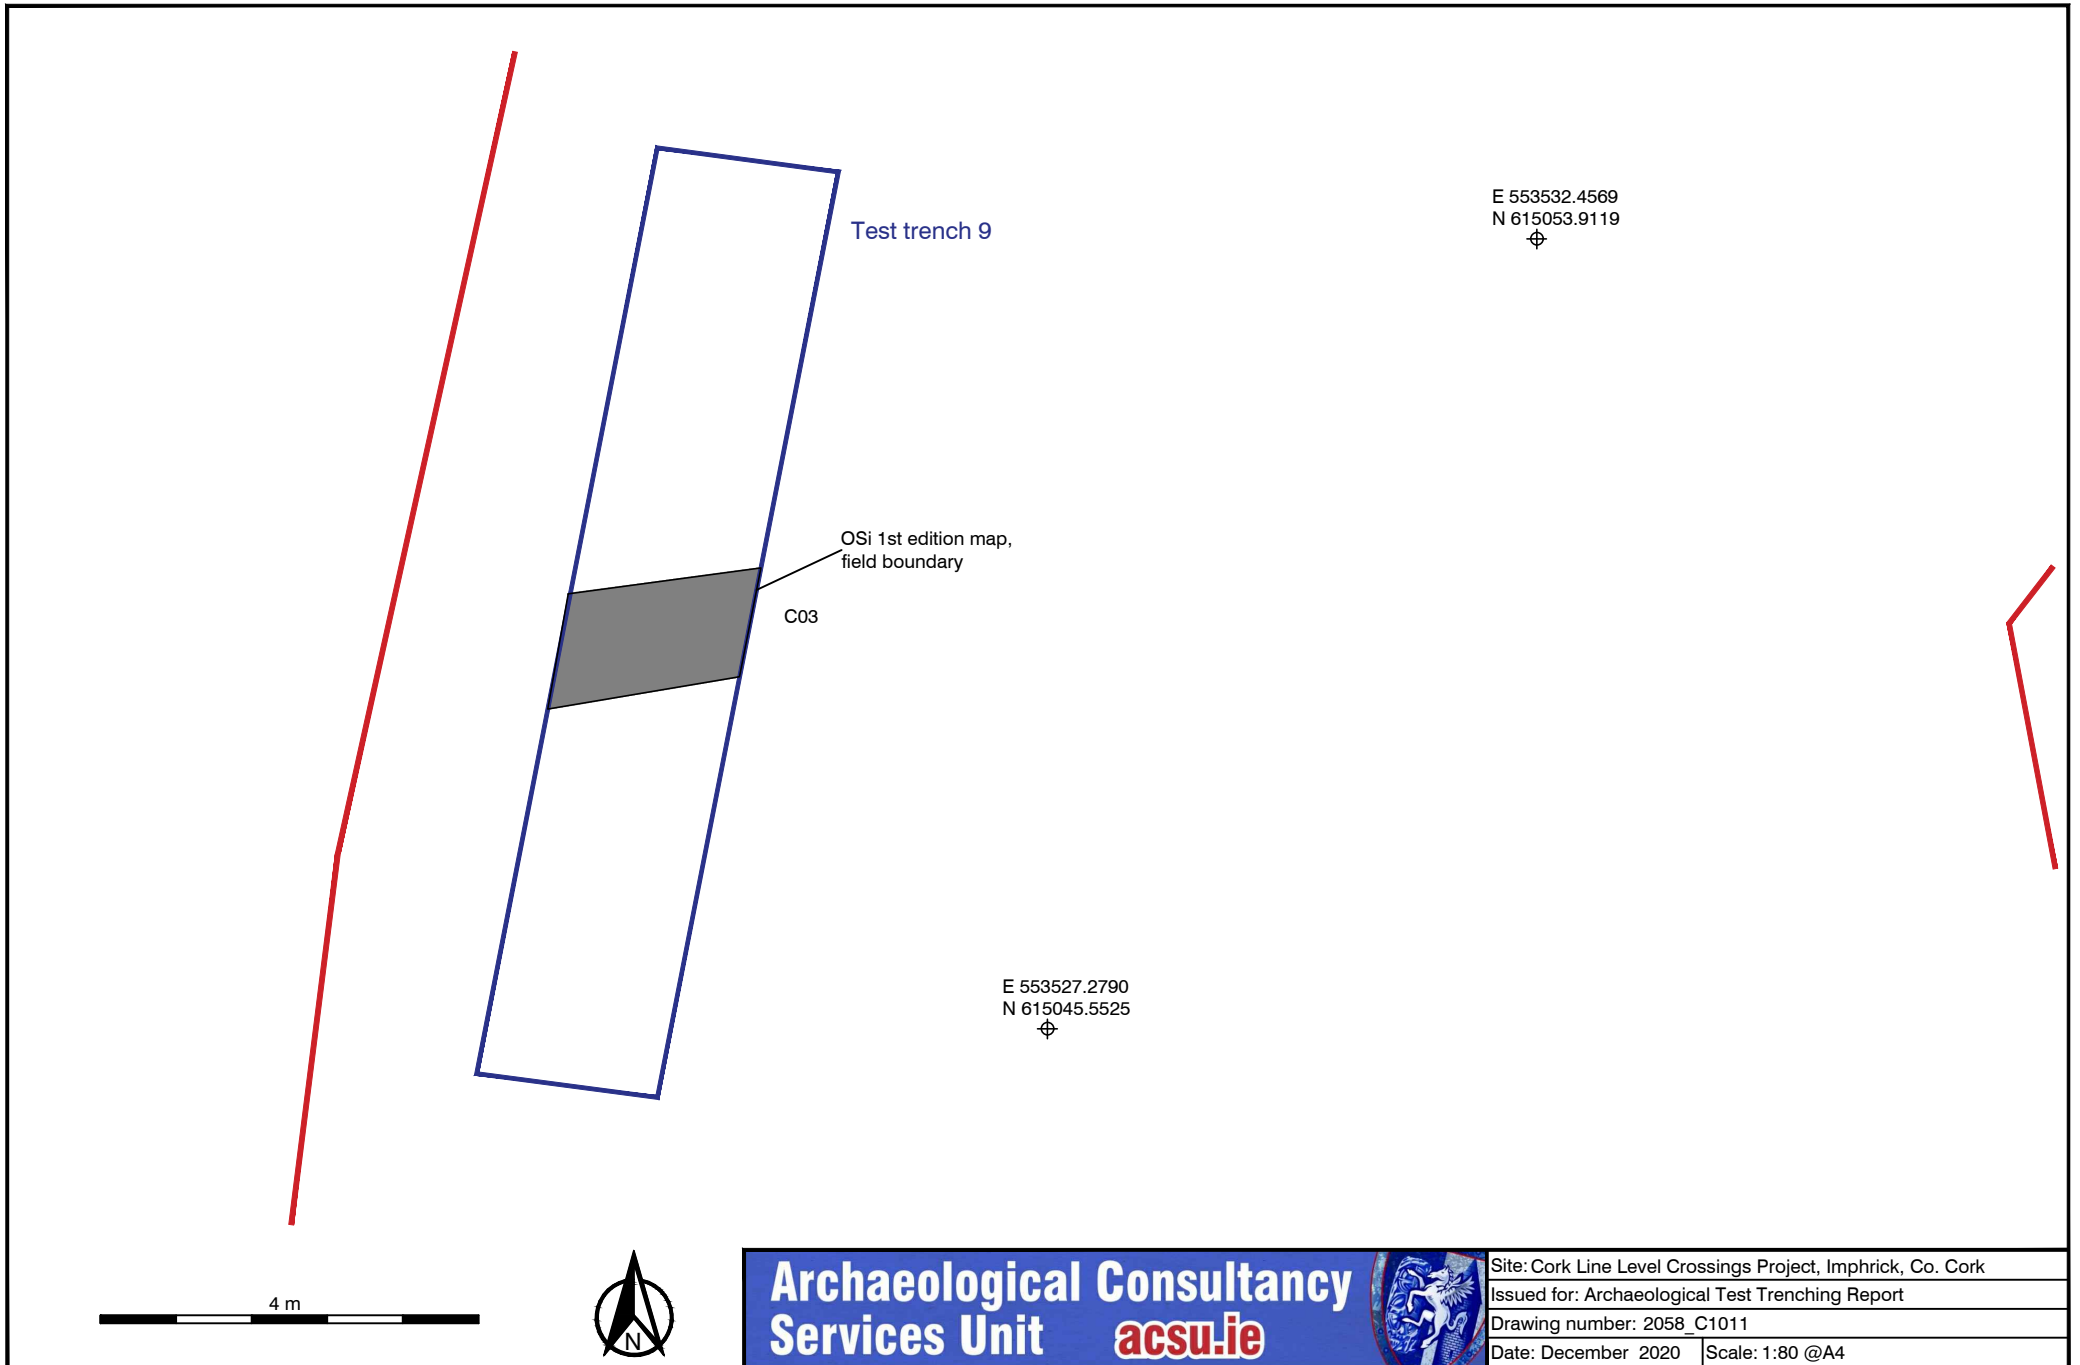
Figure 11: Detail of test trench 9

In **Test Trench 9** (Figure 11) an east-west ditch C3 was exposed, and measured 1.2m in width and was 0.25m deep. The ditch was V-shaped, and filled by C92 that consisted of a pale greyish brown sandy clay. Ditch C3 accounts for a trend noted in the geophysical survey. The ditch aligns with a field boundary shown on the 1st Edition Ordnance Survey Map of 1840 (Figure 23a). It is therefore assumed to be of 19th-century date and not of archaeological significance.

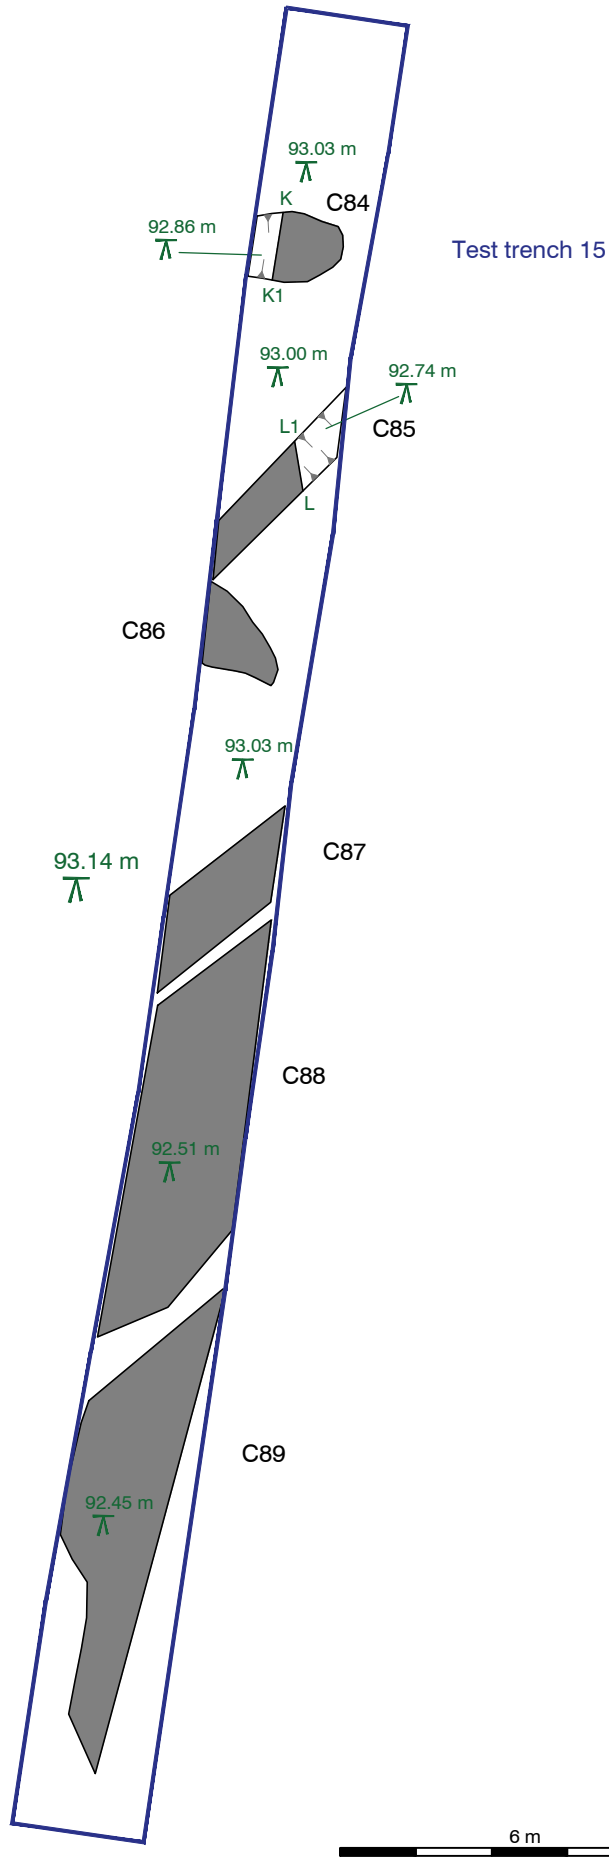
Figure 15: Detail of test trench 15

In total one pit was exposed in Field 2, in **Test Trench 15** (C84). C84 was partially exposed, oval in shape, measured 1.4m in length, 1.1m in width and was 0.15m deep (Figure 15, 21, Plate 38, 40). The south side was steep while the north was more gradual, and it was filled by C90 that consisted of a brownish-grey sandy clay with inclusions of charcoal, small to medium stones and decaying stones. Pit C84 accounts for Anomaly 15, which represented a series of anomalies interpreted as a probable burnt/fired deposit by Target.

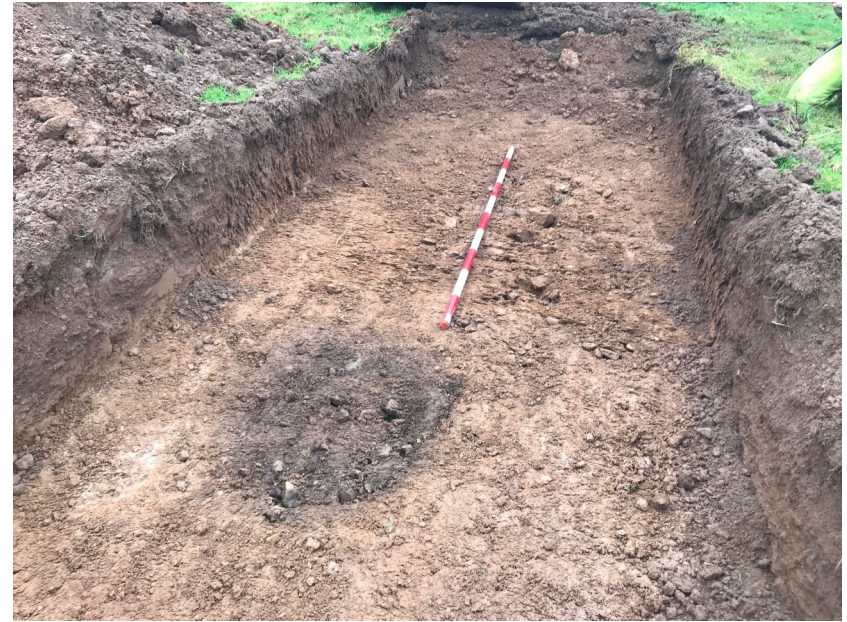
Plate 2: Test Trench 1, following removal of C95, showing C53, C52, facing east

In **Test Trench 1** an oval, charcoal-rich pit C52 was exposed (Figure 7, 20, Plates 2-4) measuring 0.9m by 0.8m, c. 0.14m deep with a single fill C54 that consisted of dark greyish black sandy clay with frequent inclusions of charcoal and small to medium fire-cracked stones. A soil sample was taken for possible radiocarbon dating (Sample 2). This pit was similar to pit C8 exposed in Test Trench 2.

It is recommended that three samples be sent for radiocarbon dating as outlined above (Pit C52 (S2), Ditches C115 (S7) and C112 (S8)) subject to approval by the client. Should these be carried out, the results of the Radiocarbon dates, will be submitted to the relevant authorities upon receipt as a supplementary appendix to this report.

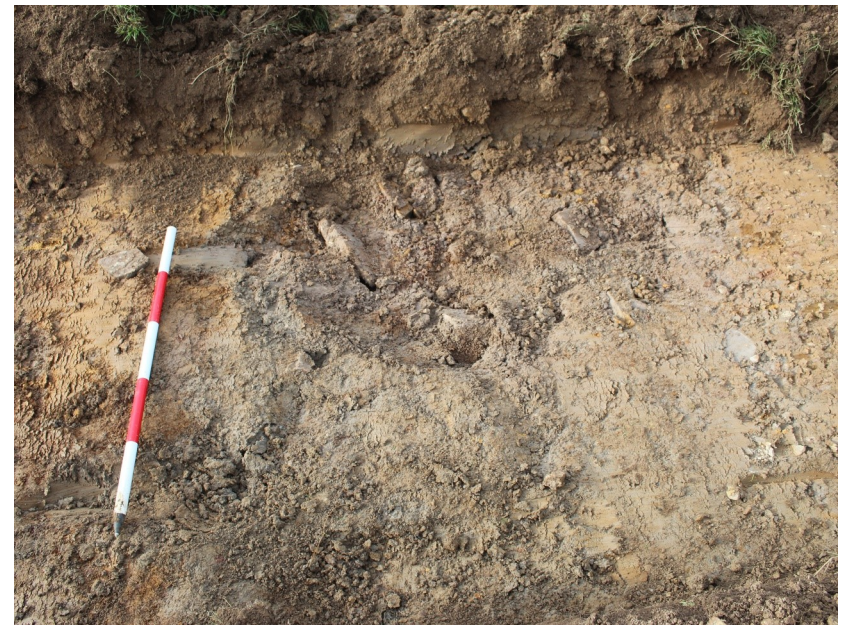
Plate 28: Test Trench 12, ditch C80, facing west

In **Test Trench 12** (Figure 13) two ditches were exposed (C80, C81). Ditch C81 was east-west aligned, it measured 1.3m in width, and was filled by C83 a sterile grey silty clay with decaying stone inclusions (Plate 27). Ditch C81 accounts for an anomaly labelled as field boundary by Target, and aligns with a field boundary depicted on the 1st Edition Ordnance Survey 1840 map. It is therefore assumed to be of 19th-century date and not of archaeological significance.
