Cork Line Level Crossings – XC201 Ground Investigation

Client: Irish Rail

Report Date: 25th November 2020

Report No.: OCB19-135-1

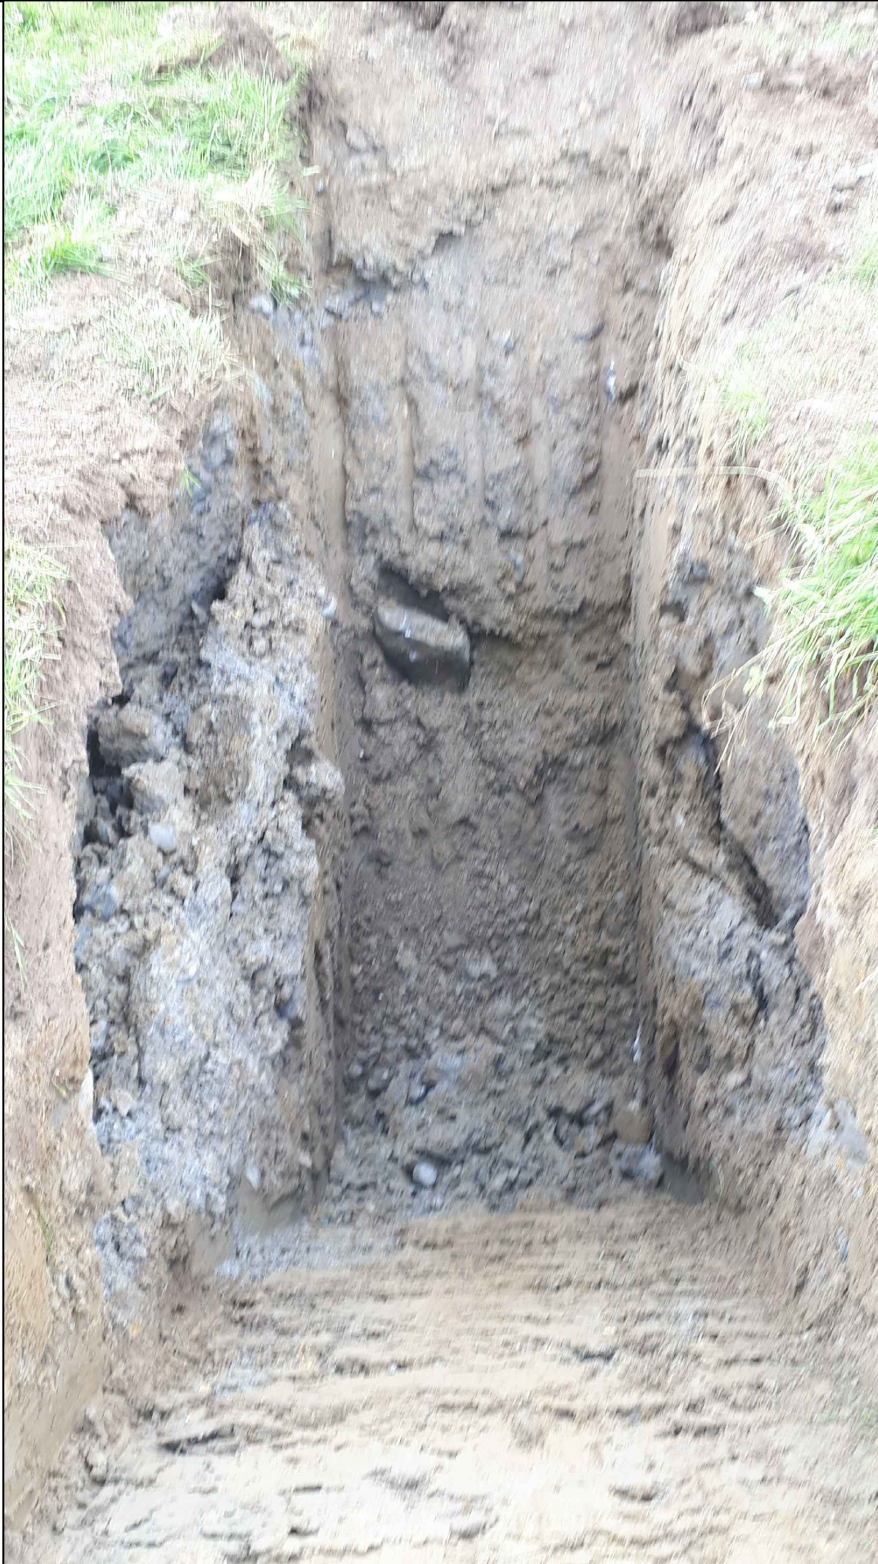
T.PIT3
	Trial Pit Photographs
Client:	Iarnród Éireann
Engineer:	Jacob's
Date:	July 2020

Remarks Hand Vane Tests attempted unsuccessfully due to relatively high granular content. Trial Pit terminated at 3.30m due to a large boulder in the south-west corner obstructing further excavation.	Water Strikes:		Stability: Sides spalling
	Struck at (m):	Remarks:	
	2.40		Width: 1.40
		Length: 5.60
