Iarnród Éireann
Cork Line Level Crossings
XC215 (19-135-4)

T.PIT5
	Trial Pit Photographs
Client:	Iarnród Éireann
Engineer:	Jacob's
Date:	February 2020

Appendix F

Appendix G

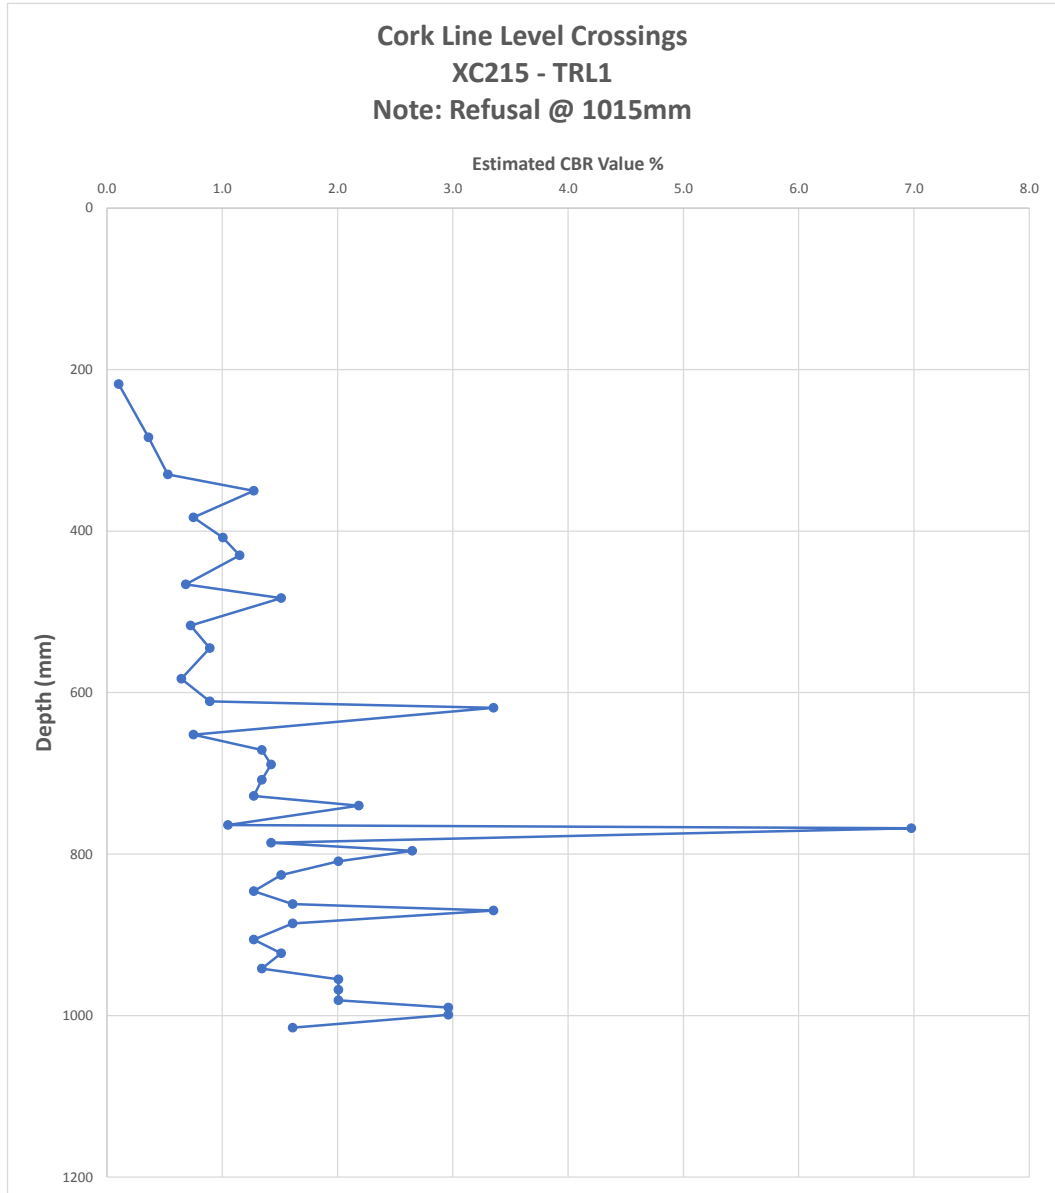
Location	XC215 - TRL1	Job No	19-135
----------	--------------	--------	--------

Cork Line Level Crossings - Irish Rail
 Transport Research Laboratory - Dynamic Cone Penetrometer Data

No. of Blows	READING (mm)	Penetration/blow (mm)	DEPTH	CBR %
1	932	218	218	0.1
2	866	66	284	0.4
3	820	46	330	0.5
4	800	20	350	1.3
5	767	33	383	0.7
6	742	25	408	1.0
7	720	22	430	1.2
8	684	36	466	0.7
9	667	17	483	1.5
10	633	34	517	0.7
11	605	28	545	0.9
12	567	38	583	0.6
13	539	28	611	0.9
14	531	8	619	3.4
15	498	33	652	0.7
16	479	19	671	1.3
17	461	18	689	1.4
18	442	19	708	1.3
19	422	20	728	1.3
20	410	12	740	2.2
21	386	24	764	1.0
22	382	4	768	7.0
23	364	18	786	1.4
24	354	10	796	2.6
25	341	13	809	2.0
26	324	17	826	1.5
27	304	20	846	1.3
28	288	16	862	1.6
29	280	8	870	3.4
30	264	16	886	1.6
31	244	20	906	1.3
32	227	17	923	1.5
33	208	19	942	1.3
34	195	13	955	2.0
35	182	13	968	2.0
36	169	13	981	2.0
37	160	9	990	3.0
38	151	9	999	3.0
39	135	16	1015	1.6
40

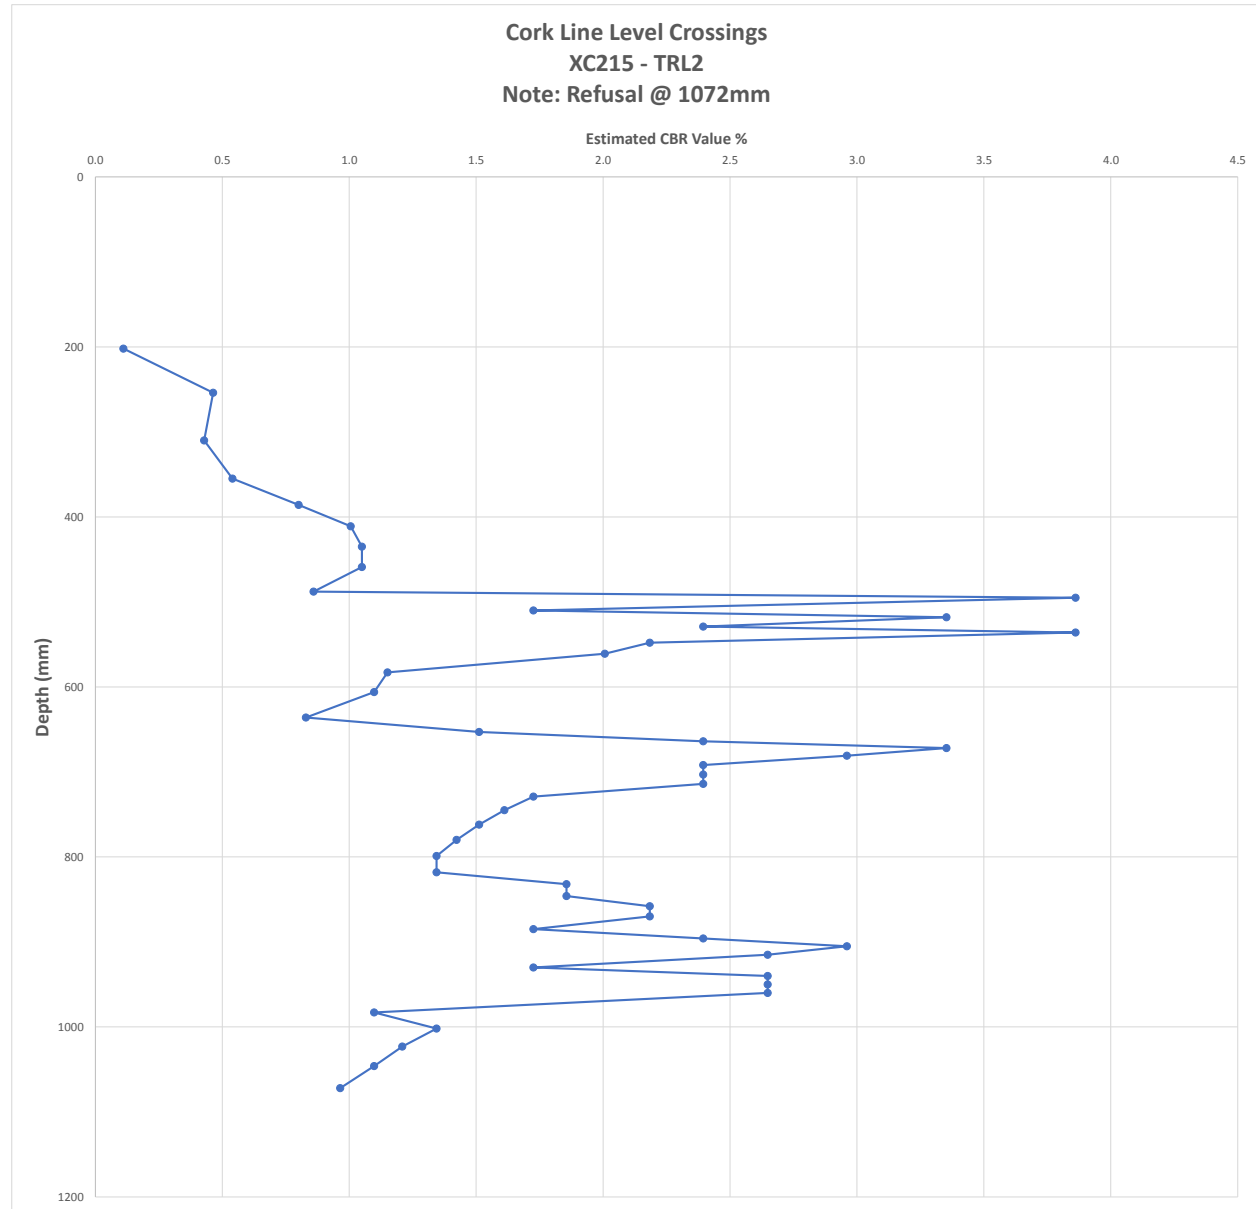
Location	XC215 - TRL2	Job No	19-135
----------	--------------	--------	--------

Cork Line Level Crossings - Irish Rail
 Transport Research Laboratory - Dynamic Cone Penetrometer Data

No. of Blows	READING (mm)	Penetration/blow (mm)	DEPTH	CBR %
1	948	202	202	0.1
2	896	52	254	0.5
3	840	56	310	0.4
4	795	45	355	0.5
5	764	31	386	0.8
6	739	25	411	1.0
7	715	24	435	1.0
8	691	24	459	1.0
9	662	29	488	0.9
10	655	7	495	3.9
11	640	15	510	1.7
12	632	8	518	3.4
13	621	11	529	2.4
14	614	7	536	3.9
15	602	12	548	2.2
16	589	13	561	2.0
17	567	22	583	1.2
18	544	23	606	1.1
19	514	30	636	0.8
20	497	17	653	1.5
21	486	11	664	2.4
22	478	8	672	3.4
23	469	9	681	3.0
24	458	11	692	2.4
25	447	11	703	2.4
26	436	11	714	2.4
27	421	15	729	1.7
28	405	16	745	1.6
29	388	17	762	1.5
30	370	18	780	1.4
31	351	19	799	1.3
32	332	19	818	1.3
33	318	14	832	1.9
34	304	14	846	1.9
35	292	12	858	2.2
36	280	12	870	2.2
37	265	15	885	1.7
38	254	11	896	2.4
39	245	9	905	3.0
40	235	10	915	2.6
41	220	15	930	1.7
42	210	10	940	2.6
43	200	10	950	2.6
44	190	10	960	2.6
45	167	23	983	1.1
46	148	19	1002	1.3
47	127	21	1023	1.2
48	104	23	1046	1.1
49	78	26	1072	1.0
50

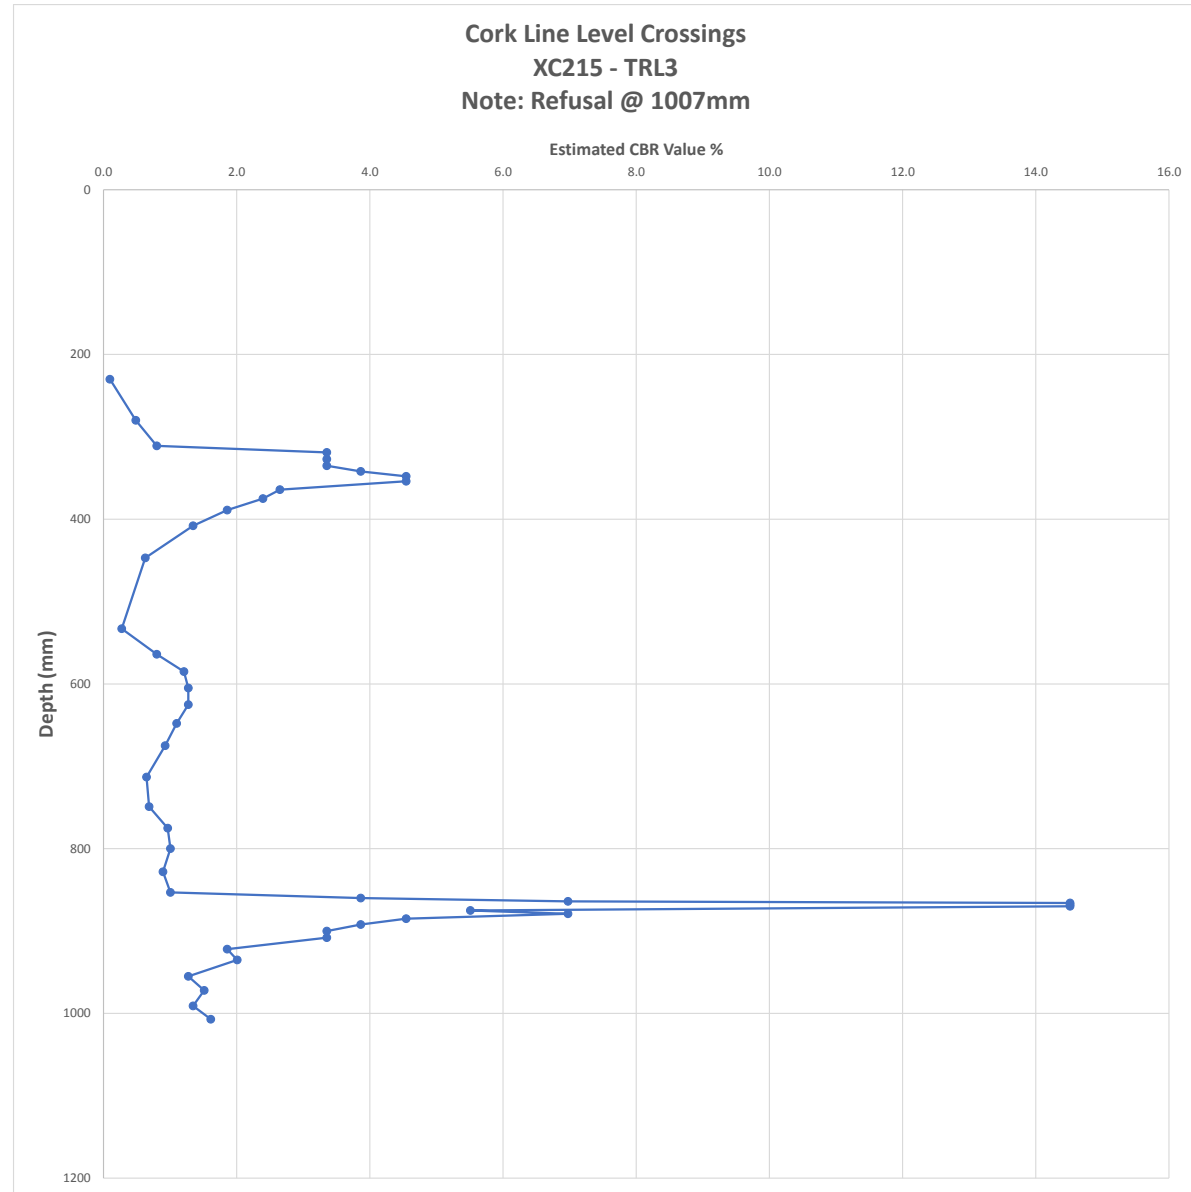
Location	XC215 - TRL3	Job No	19-135
----------	--------------	--------	--------

Cork Line Level Crossings - Irish Rail
 Transport Research Laboratory - Dynamic Cone Penetrometer Data

No. of Blows	READING (mm)	Penetration/blow (mm)	DEPTH	CBR %
1	920	230	230	0.1
2	870	50	280	0.5
3	839	31	311	0.8
4	831	8	319	3.4
5	823	8	327	3.4
6	815	8	335	3.4
7	808	7	342	3.9
8	802	6	348	4.5
9	796	6	354	4.5
10	786	10	364	2.6
11	775	11	375	2.4
12	761	14	389	1.9
13	742	19	408	1.3
14	703	39	447	0.6
15	617	86	533	0.3
16	586	31	564	0.8
17	565	21	585	1.2
18	545	20	605	1.3
19	525	20	625	1.3
20	502	23	648	1.1
21	475	27	675	0.9
22	437	38	713	0.6
23	401	36	749	0.7
24	375	26	775	1.0
25	350	25	800	1.0
26	322	28	828	0.9
27	297	25	853	1.0
28	290	7	860	3.9
29	286	4	864	7.0
30	284	2	866	14.5
31	282	2	868	14.5
32	280	2	870	14.5
33	275	5	875	5.5
34	271	4	879	7.0
35	265	6	885	4.5
36	258	7	892	3.9
37	250	8	900	3.4
38	242	8	908	3.4
39	228	14	922	1.9
40	215	13	935	2.0
41	195	20	955	1.3
42	178	17	972	1.5
43	159	19	991	1.3
44	143	16	1007	1.6
45

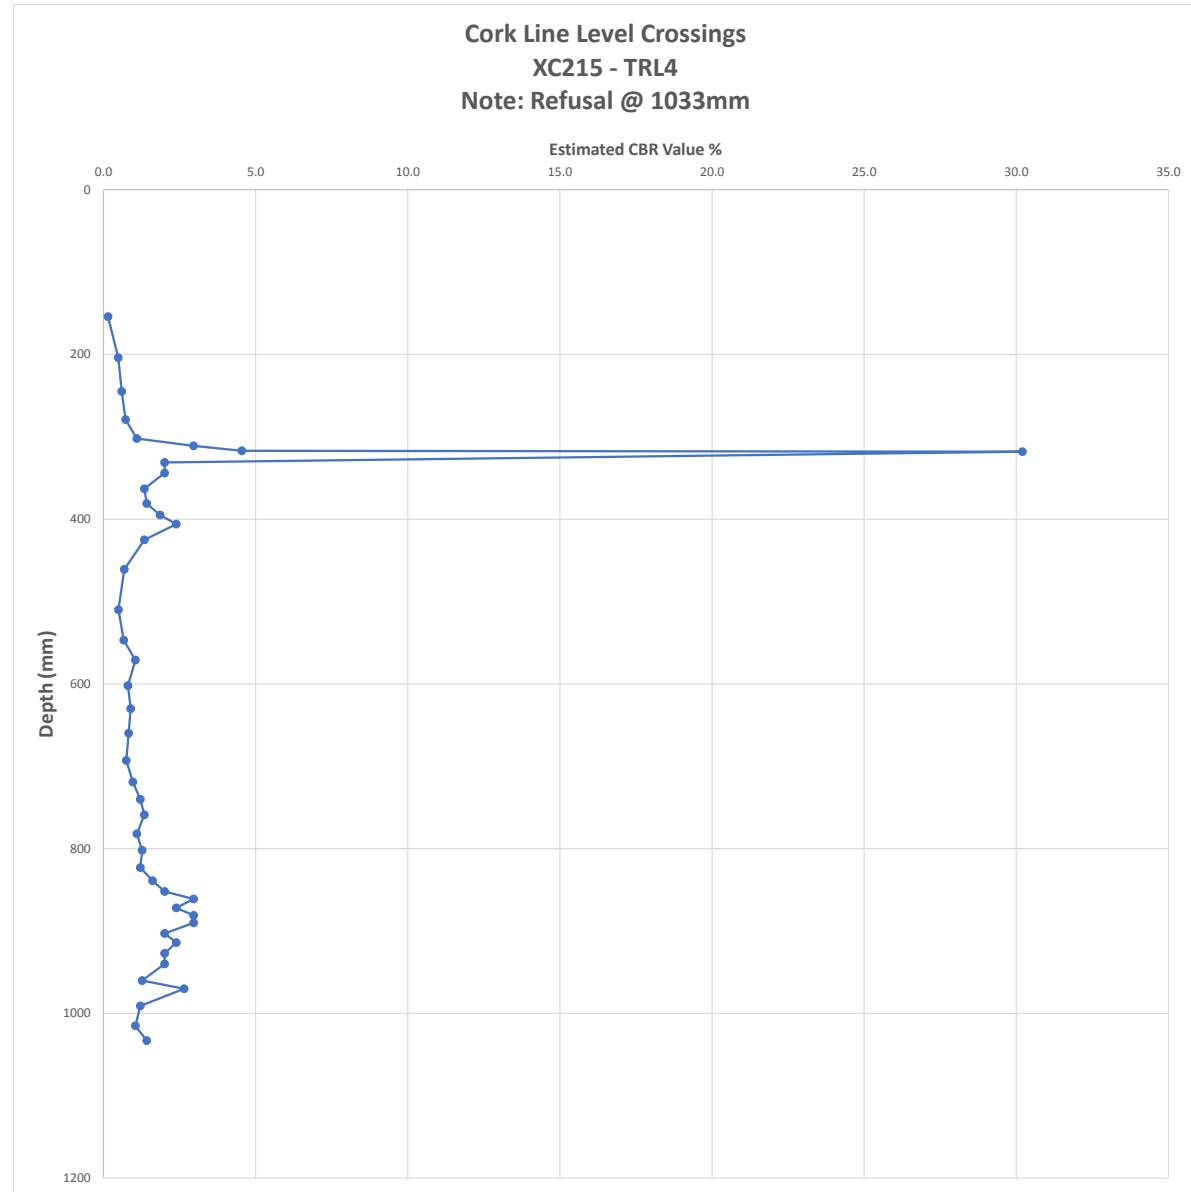
Location	XC215 - TRL4	Job No	19-135
----------	--------------	--------	--------

Cork Line Level Crossings - Irish Rail
 Transport Research Laboratory - Dynamic Cone Penetrometer Data

No. of Blows	READING (mm)	Penetration/blow (mm)	DEPTH	CBR %
1	996	154	154	0.1
2	946	50	204	0.5
3	905	41	245	0.6
4	871	34	279	0.7
5	848	23	302	1.1
6	839	9	311	3.0
7	833	6	317	4.5
8	832	1	318	30.2
9	819	13	331	2.0
10	806	13	344	2.0
11	787	19	363	1.3
12	769	18	381	1.4
13	755	14	395	1.9
14	744	11	406	2.4
15	725	19	425	1.3
16	689	36	461	0.7
17	640	49	510	0.5
18	603	37	547	0.7
19	579	24	571	1.0
20	548	31	602	0.8
21	520	28	630	0.9
22	490	30	660	0.8
23	457	33	693	0.7
24	431	26	719	1.0
25	410	21	740	1.2
26	391	19	759	1.3
27	368	23	782	1.1
28	348	20	802	1.3
29	327	21	823	1.2
30	311	16	839	1.6
31	298	13	852	2.0
32	289	9	861	3.0
33	278	11	872	2.4
34	269	9	881	3.0
35	260	9	890	3.0
36	247	13	903	2.0
37	236	11	914	2.4
38	223	13	927	2.0
39	210	13	940	2.0
40	190	20	960	1.3
41	180	10	970	2.6
42	159	21	991	1.2
43	135	24	1015	1.0
44	117	18	1033	1.4
45

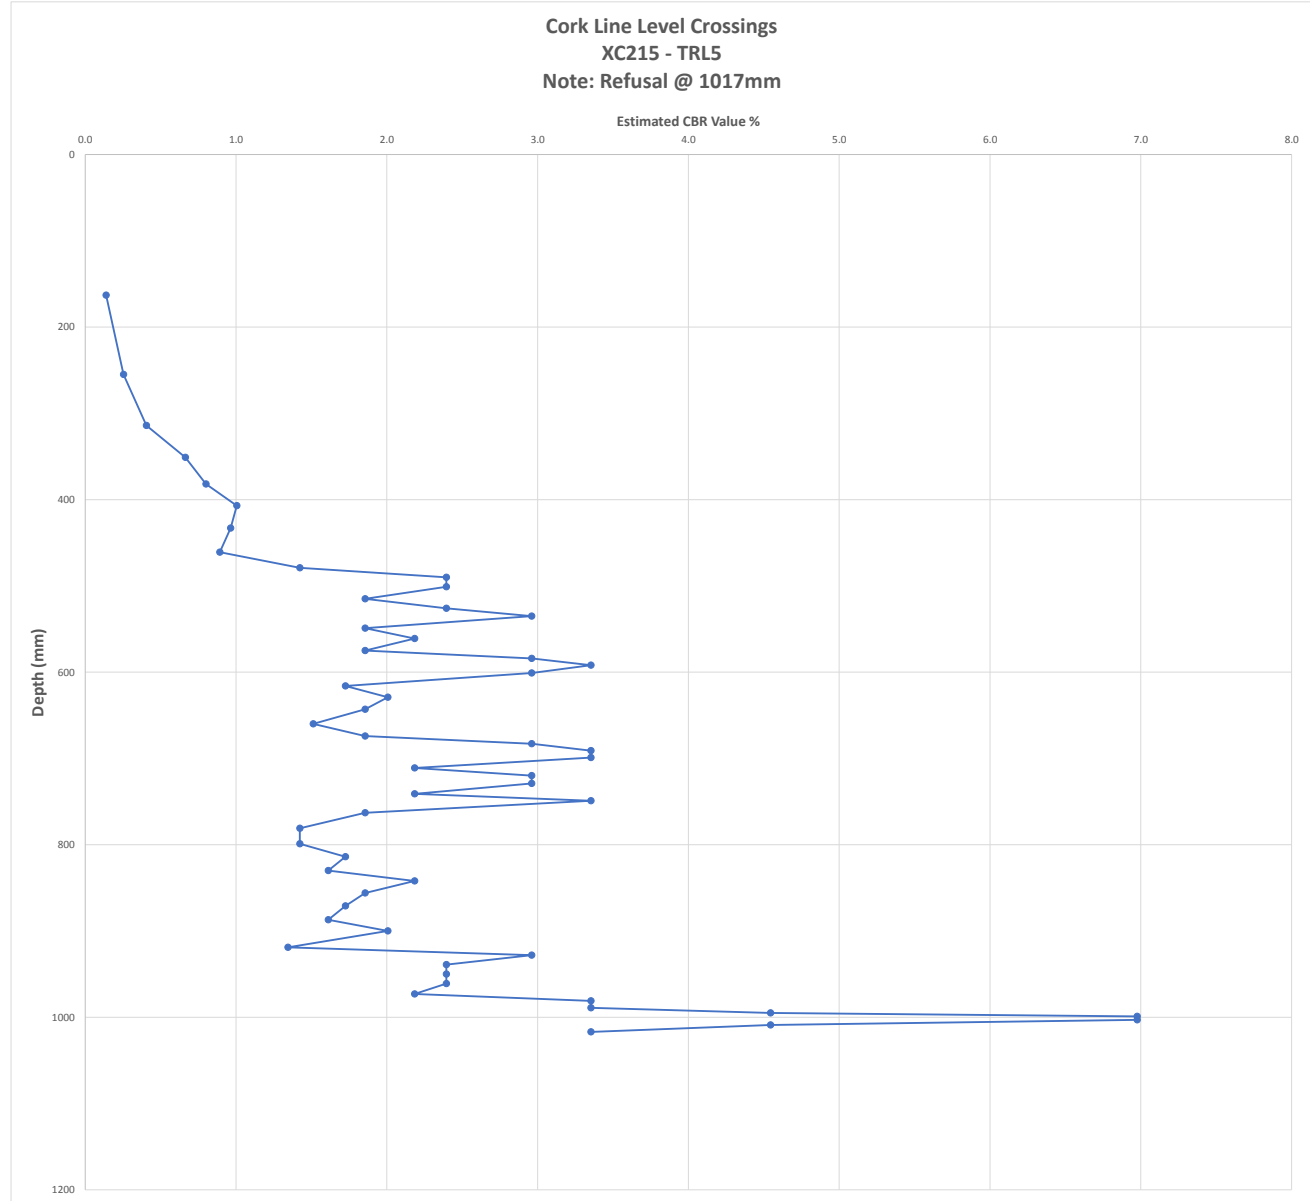
Location	XC215 - TRL5	Job No	19-135
----------	--------------	--------	--------

Cork Line Level Crossings - Irish Rail
 Transport Research Laboratory - Dynamic Cone Penetrometer Data

No. of Blows	READING (mm)	Penetration/blow (mm)	DEPTH	CBR %
1	987	163	163	0.1
2	895	92	255	0.3
3	836	59	314	0.4
4	799	37	351	0.7
5	768	31	382	0.8
6	743	25	407	1.0
7	717	26	433	1.0
8	689	28	461	0.9
9	671	18	479	1.4
10	660	11	490	2.4
11	649	11	501	2.4
12	635	14	515	1.9
13	624	11	526	2.4
14	615	9	535	3.0
15	601	14	549	1.9
16	589	12	561	2.2
17	575	14	575	1.9
18	566	9	584	3.0
19	558	8	592	3.4
20	549	9	601	3.0
21	534	15	616	1.7
22	521	13	629	2.0
23	507	14	643	1.9
24	490	17	660	1.5
25	476	14	674	1.9
26	467	9	683	3.0
27	459	8	691	3.4
28	451	8	699	3.4
29	439	12	711	2.2
30	430	9	720	3.0
31	421	9	729	3.0
32	409	12	741	2.2
33	401	8	749	3.4
34	387	14	763	1.9
35	369	18	781	1.4
36	351	18	799	1.4
37	336	15	814	1.7
38	320	16	830	1.6
39	308	12	842	2.2
40	294	14	856	1.9
41	279	15	871	1.7
42	263	16	887	1.6
43	250	13	900	2.0
44	231	19	919	1.3
45	222	9	928	3.0
46	211	11	939	2.4
47	200	11	950	2.4
48	189	11	961	2.4
49	177	12	973	2.2
50	169	8	981	3.4
51	161	8	989	3.4

52	155	6	995	4.5
53	151	4	999	7.0
54	147	4	1003	7.0
55	141	6	1009	4.5
56	133	8	1017	3.4
57

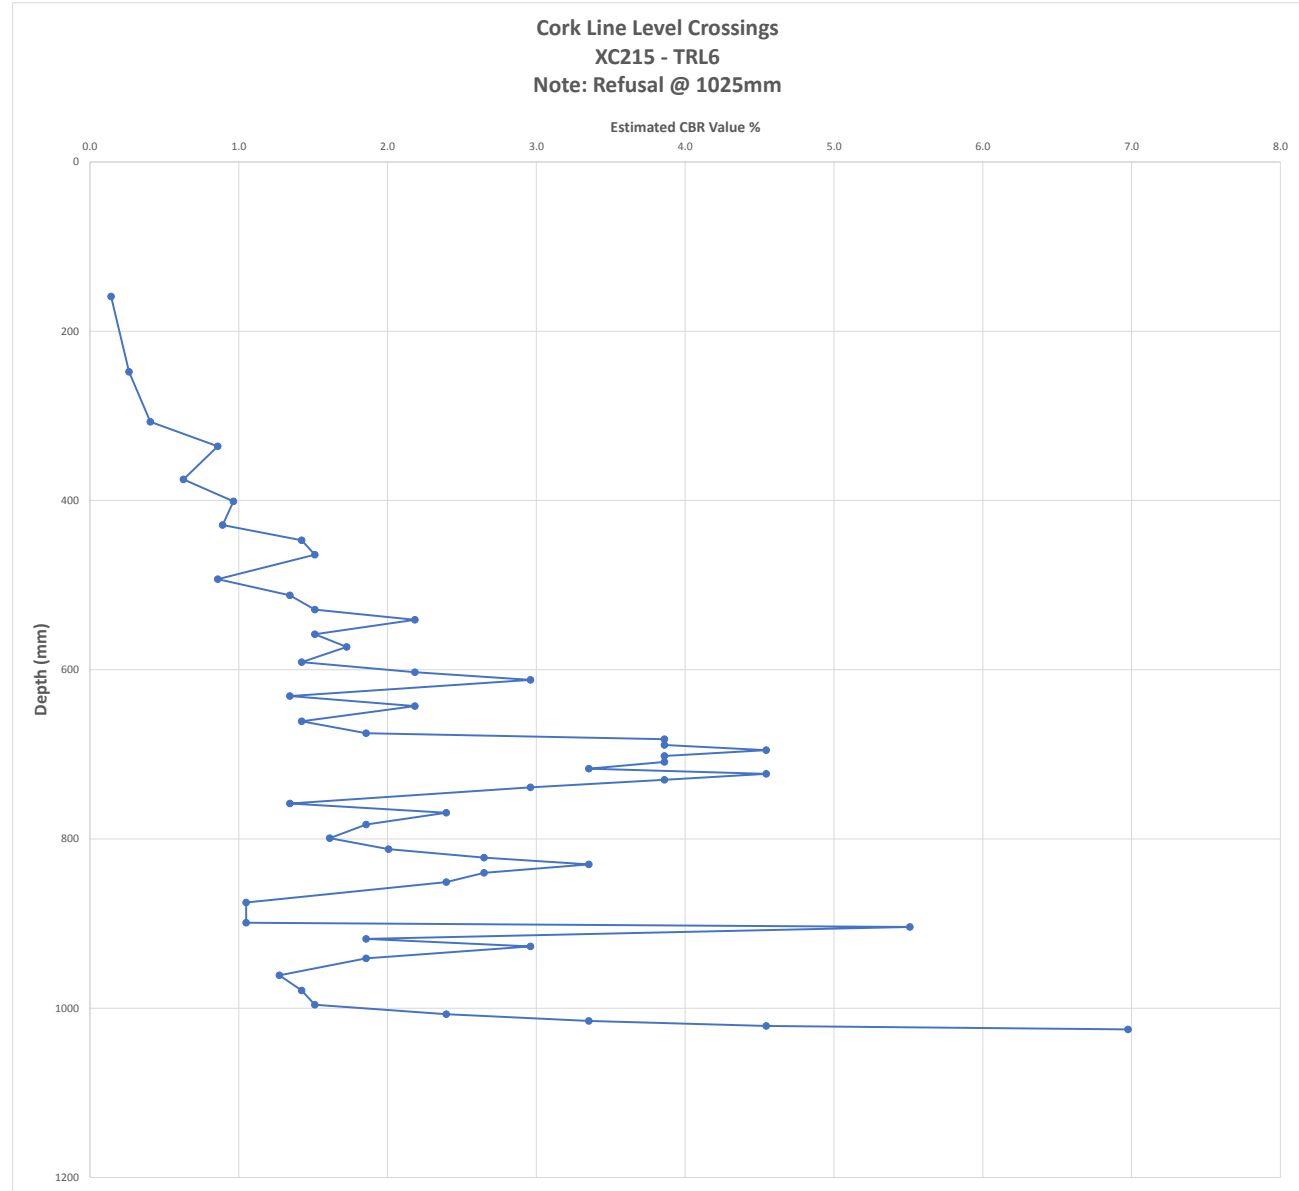
Location	XC215 - TRL6	Job No	19-135
----------	---------------------	--------	--------

Cork Line Level Crossings - Irish Rail
 Transport Research Laboratory - Dynamic Cone Penetrometer Data

No. of Blows	READING (mm)	Penetration/blow (mm)	DEPTH	CBR %
1	991	159	159	0.1
2	902	89	248	0.3
3	843	59	307	0.4
4	814	29	336	0.9
5	775	39	375	0.6
6	749	26	401	1.0
7	721	28	429	0.9
8	703	18	447	1.4
9	686	17	464	1.5
10	657	29	493	0.9
11	638	19	512	1.3
12	621	17	529	1.5
13	609	12	541	2.2
14	592	17	558	1.5
15	577	15	573	1.7
16	559	18	591	1.4
17	547	12	603	2.2
18	538	9	612	3.0
19	519	19	631	1.3
20	507	12	643	2.2
21	489	18	661	1.4
22	475	14	675	1.9
23	468	7	682	3.9
24	461	7	689	3.9
25	455	6	695	4.5
26	448	7	702	3.9
27	441	7	709	3.9
28	433	8	717	3.4
29	427	6	723	4.5
30	420	7	730	3.9
31	411	9	739	3.0
32	392	19	758	1.3
33	381	11	769	2.4
34	367	14	783	1.9
35	351	16	799	1.6
36	338	13	812	2.0
37	328	10	822	2.6
38	320	8	830	3.4
39	310	10	840	2.6
40	299	11	851	2.4
41	275	24	875	1.0
42	251	24	899	1.0
43	246	5	904	5.5
44	232	14	918	1.9
45	223	9	927	3.0
46	209	14	941	1.9
47	189	20	961	1.3
48	171	18	979	1.4
49	154	17	996	1.5
50	143	11	1007	2.4
51	135	8	1015	3.4

52	129	6	1021	4.5
53	125	4	1025	7.0
54

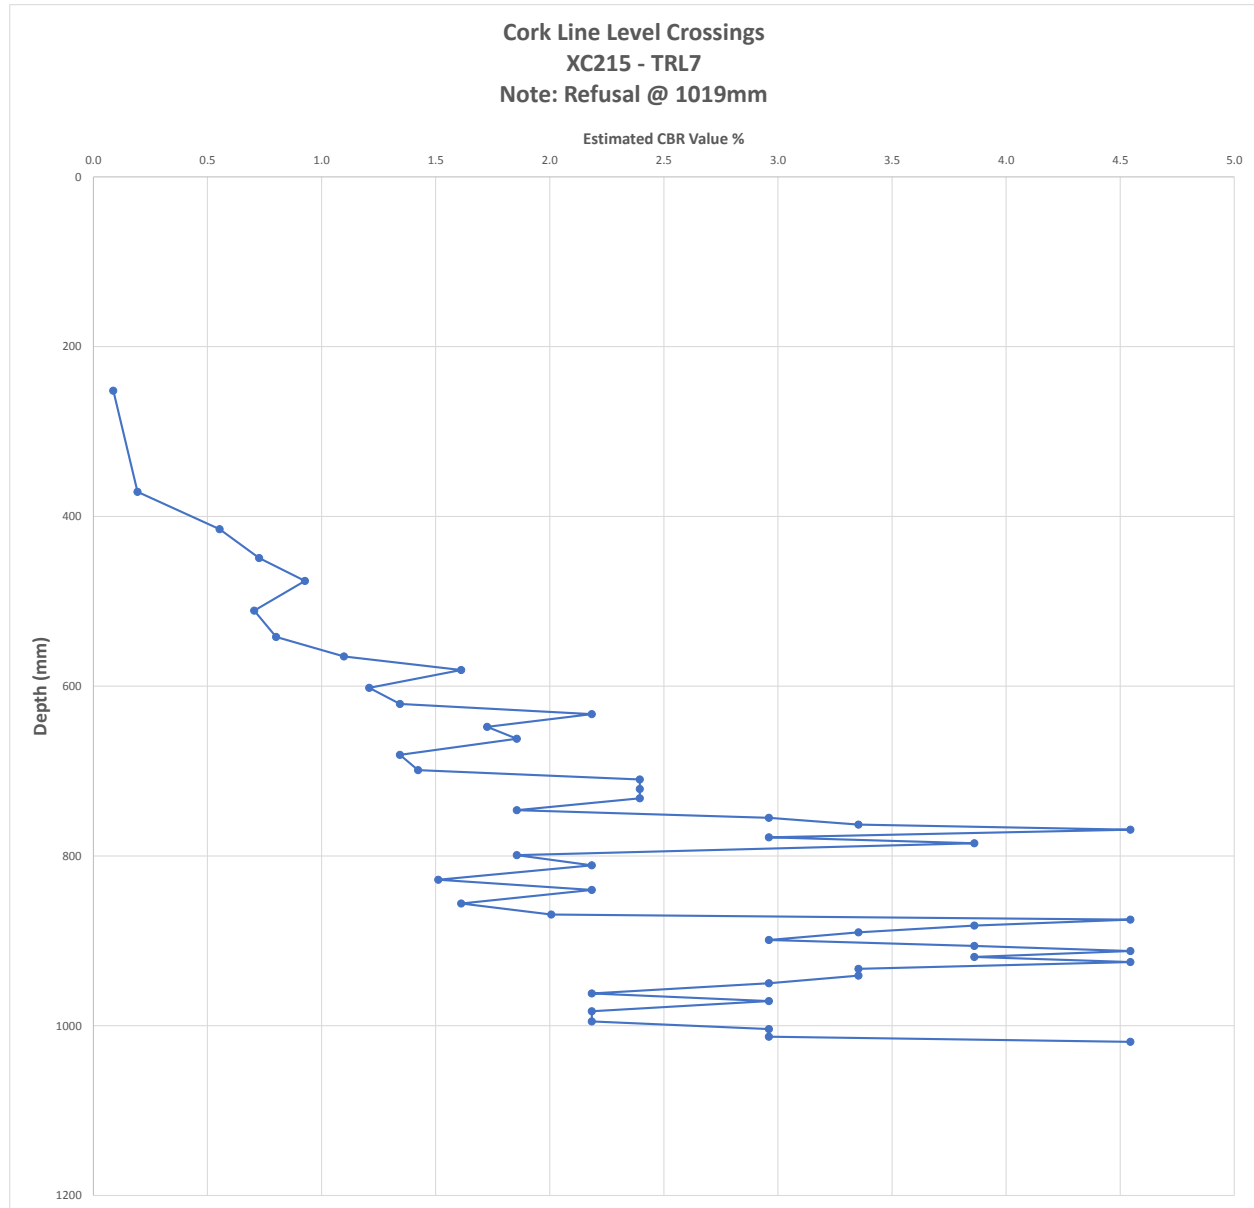
Location	XC215 - TRL7	Job No	19-135
----------	--------------	--------	--------

Cork Line Level Crossings - Irish Rail
 Transport Research Laboratory - Dynamic Cone Penetrometer Data

No. of Blows	READING (mm)	Penetration/blow (mm)	DEPTH	CBR %
1	898	252	252	0.1
2	779	119	371	0.2
3	735	44	415	0.6
4	701	34	449	0.7
5	674	27	476	0.9
6	639	35	511	0.7
7	608	31	542	0.8
8	585	23	565	1.1
9	569	16	581	1.6
10	548	21	602	1.2
11	529	19	621	1.3
12	517	12	633	2.2
13	502	15	648	1.7
14	488	14	662	1.9
15	469	19	681	1.3
16	451	18	699	1.4
17	440	11	710	2.4
18	429	11	721	2.4
19	418	11	732	2.4
20	404	14	746	1.9
21	395	9	755	3.0
22	387	8	763	3.4
23	381	6	769	4.5
24	372	9	778	3.0
25	365	7	785	3.9
26	351	14	799	1.9
27	339	12	811	2.2
28	322	17	828	1.5
29	310	12	840	2.2
30	294	16	856	1.6
31	281	13	869	2.0
32	275	6	875	4.5
33	268	7	882	3.9
34	260	8	890	3.4
35	251	9	899	3.0
36	244	7	906	3.9
37	238	6	912	4.5
38	231	7	919	3.9
39	225	6	925	4.5
40	217	8	933	3.4
41	209	8	941	3.4
42	200	9	950	3.0
43	188	12	962	2.2
44	179	9	971	3.0
45	167	12	983	2.2
46	155	12	995	2.2
47	146	9	1004	3.0
48	137	9	1013	3.0
49	131	6	1019	4.5
50

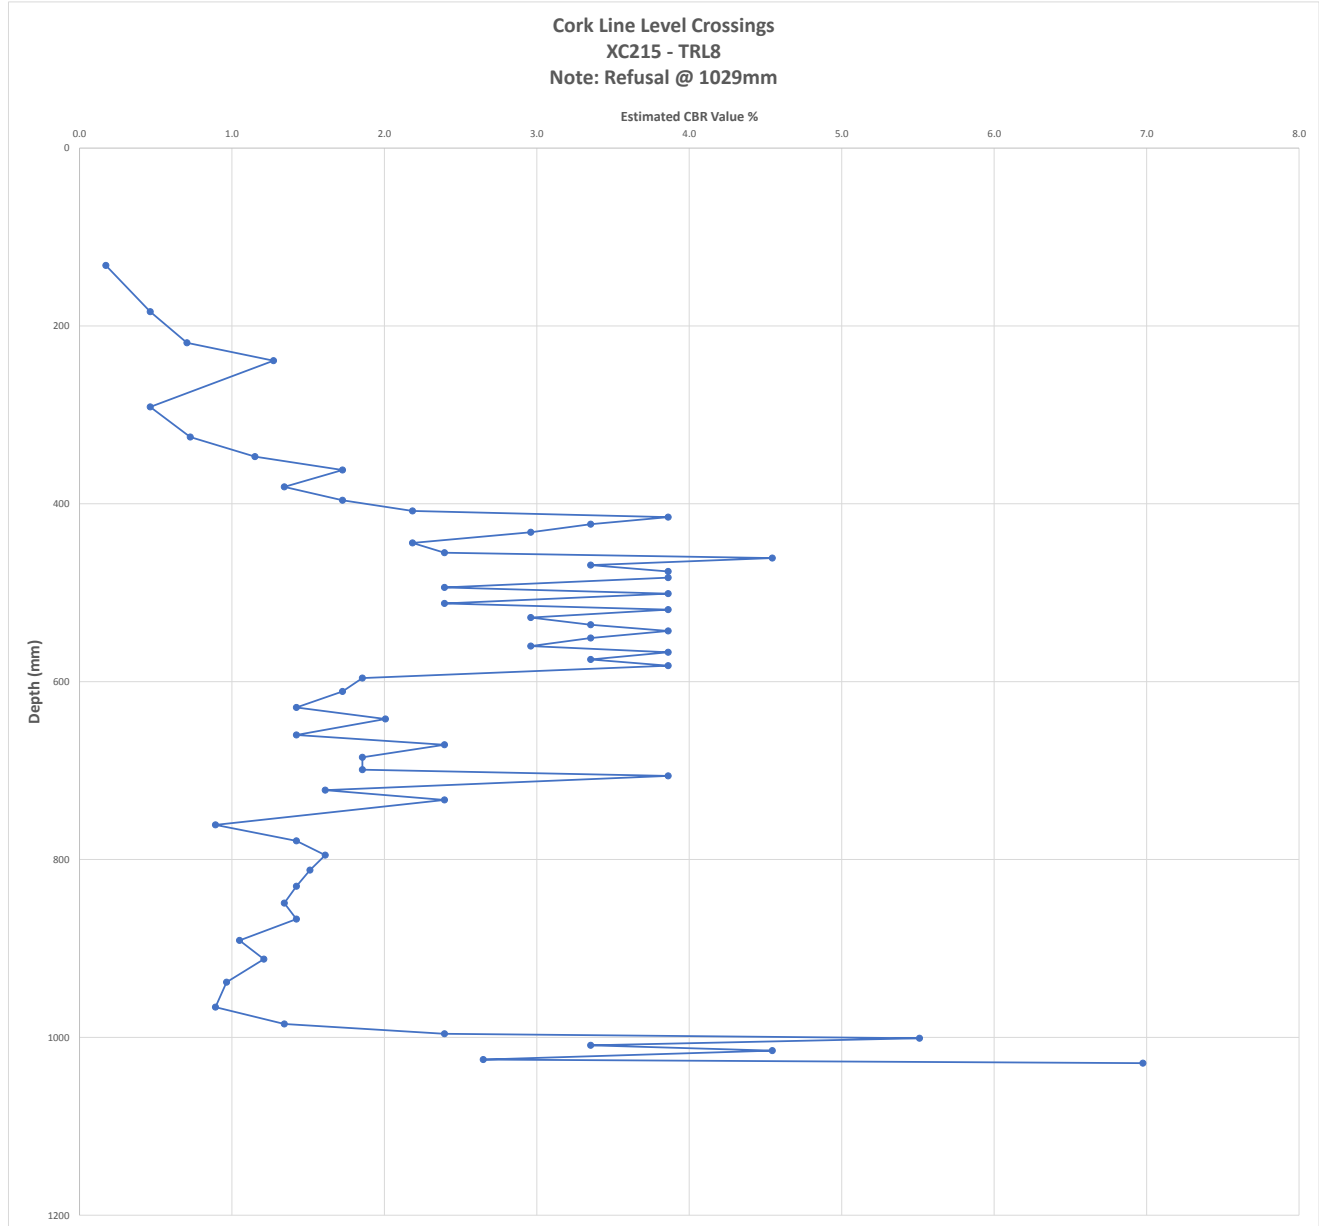
Location	XC215 - TRL8	Job No	19-135
----------	--------------	--------	--------

Cork Line Level Crossings - Irish Rail
 Transport Research Laboratory - Dynamic Cone Penetrometer Data

No. of Blows	READING (mm)	Penetration/blow (mm)	DEPTH	CBR %
1	1018	132	132	0.2
2	966	52	184	0.5
3	931	35	219	0.7
4	911	20	239	1.3
5	859	52	291	0.5
6	825	34	325	0.7
7	803	22	347	1.2
8	788	15	362	1.7
9	769	19	381	1.3
10	754	15	396	1.7
11	742	12	408	2.2
12	735	7	415	3.9
13	727	8	423	3.4
14	718	9	432	3.0
15	706	12	444	2.2
16	695	11	455	2.4
17	689	6	461	4.5
18	681	8	469	3.4
19	674	7	476	3.9
20	667	7	483	3.9
21	656	11	494	2.4
22	649	7	501	3.9
23	638	11	512	2.4
24	631	7	519	3.9
25	622	9	528	3.0
26	614	8	536	3.4
27	607	7	543	3.9
28	599	8	551	3.4
29	590	9	560	3.0
30	583	7	567	3.9
31	575	8	575	3.4
32	568	7	582	3.9
33	554	14	596	1.9
34	539	15	611	1.7
35	521	18	629	1.4
36	508	13	642	2.0
37	490	18	660	1.4
38	479	11	671	2.4
39	465	14	685	1.9
40	451	14	699	1.9
41	444	7	706	3.9
42	428	16	722	1.6
43	417	11	733	2.4
44	389	28	761	0.9
45	371	18	779	1.4
46	355	16	795	1.6
47	338	17	812	1.5
48	320	18	830	1.4
49	301	19	849	1.3
50	283	18	867	1.4
51	259	24	891	1.0

52	238	21	912	1.2
53	212	26	938	1.0
54	184	28	966	0.9
55	165	19	985	1.3
56	154	11	996	2.4
57	149	5	1001	5.5
58	141	8	1009	3.4
59	135	6	1015	4.5
60	125	10	1025	2.6
61	121	4	1029	7.0

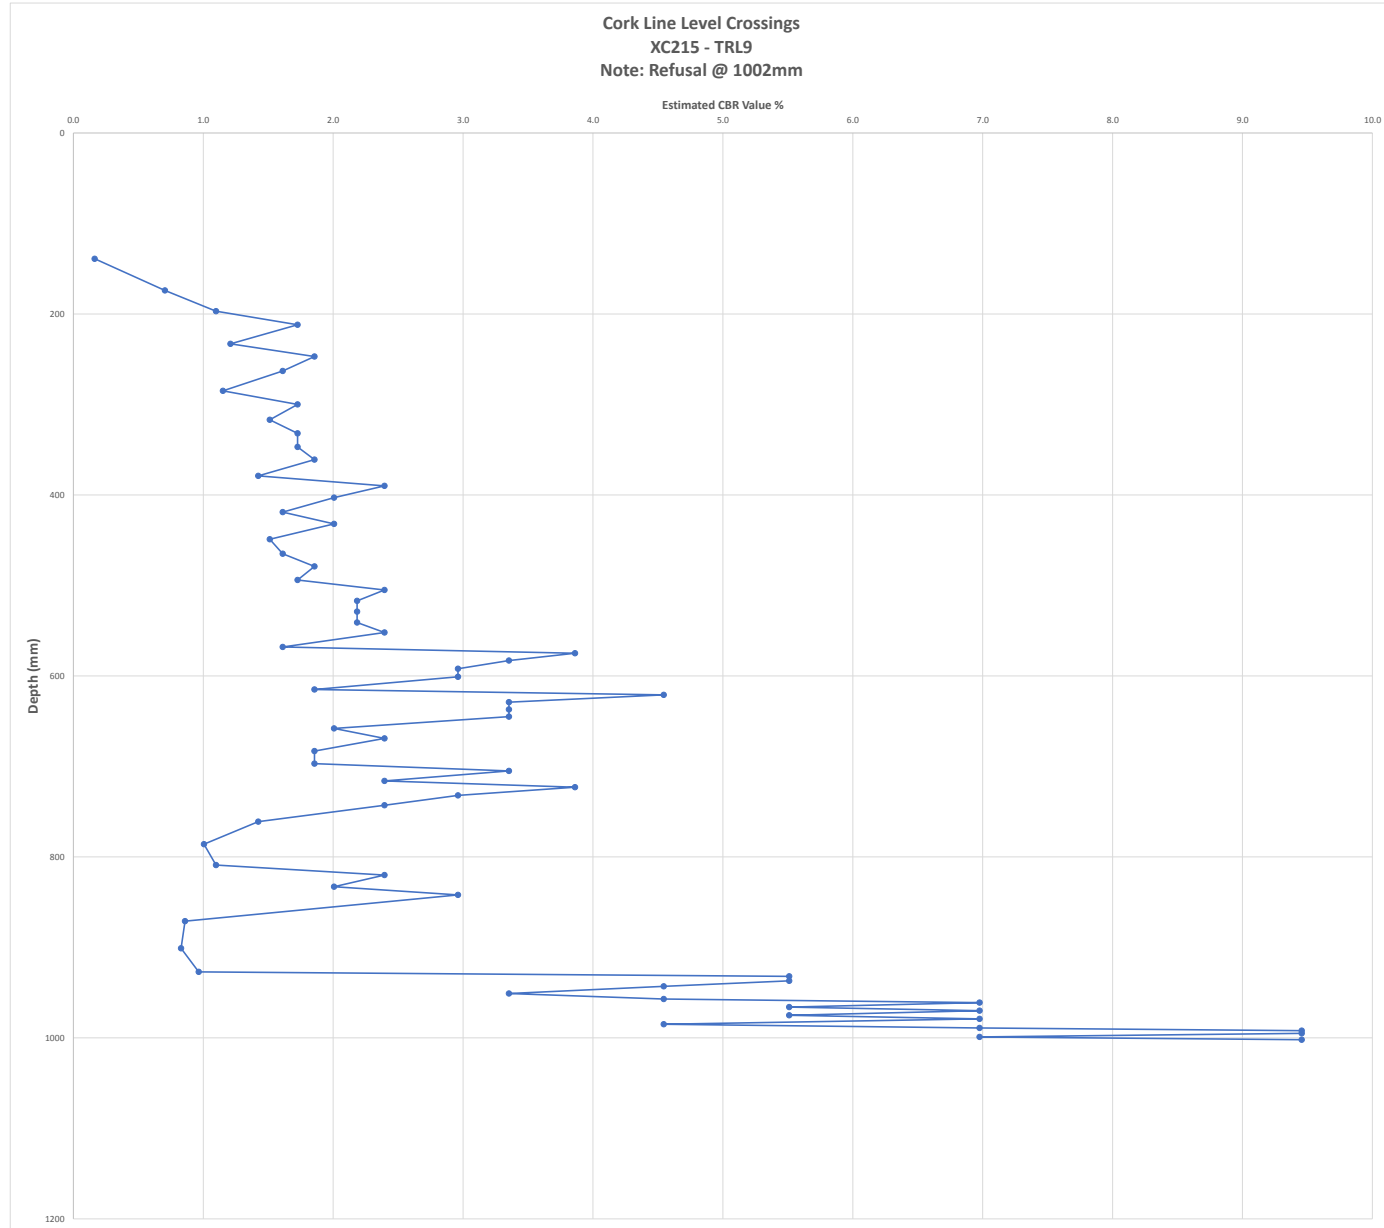
Location	XC215 - TRL9	Job No	19-135
----------	---------------------	--------	--------

Cork Line Level Crossings - Irish Rail
 Transport Research Laboratory - Dynamic Cone Penetrometer Data

No. of Blows	READING (mm)	Penetration/blow (mm)	DEPTH (mm)	CBR %
1	1011	139	139	0.2
2	976	35	174	0.7
3	953	23	197	1.1
4	938	15	212	1.7
5	917	21	233	1.2
6	903	14	247	1.9
7	887	16	263	1.6
8	865	22	285	1.2
9	850	15	300	1.7
10	833	17	317	1.5
11	818	15	332	1.7
12	803	15	347	1.7
13	789	14	361	1.9
14	771	18	379	1.4
15	760	11	390	2.4
16	747	13	403	2.0
17	731	16	419	1.6
18	718	13	432	2.0
19	701	17	449	1.5
20	685	16	465	1.6
21	671	14	479	1.9
22	656	15	494	1.7
23	645	11	505	2.4
24	633	12	517	2.2
25	621	12	529	2.2
26	609	12	541	2.2
27	598	11	552	2.4
28	582	16	568	1.6
29	575	7	575	3.9
30	567	8	583	3.4
31	558	9	592	3.0
32	549	9	601	3.0
33	535	14	615	1.9
34	529	6	621	4.5
35	521	8	629	3.4
36	513	8	637	3.4
37	505	8	645	3.4
38	492	13	658	2.0
39	481	11	669	2.4
40	467	14	683	1.9
41	453	14	697	1.9
42	445	8	705	3.4
43	434	11	716	2.4
44	427	7	723	3.9
45	418	9	732	3.0
46	407	11	743	2.4
47	389	18	761	1.4
48	364	25	786	1.0
49	341	23	809	1.1
50	330	11	820	2.4
51	317	13	833	2.0

52	308	9	842	3.0
53	279	29	871	0.9
54	249	30	901	0.8
55	223	26	927	1.0
56	218	5	932	5.5
57	213	5	937	5.5
58	207	6	943	4.5
59	199	8	951	3.4
60	193	6	957	4.5
61	189	4	961	7.0
62	184	5	966	5.5
63	180	4	970	7.0
64	175	5	975	5.5
65	171	4	979	7.0
66	165	6	985	4.5
67	161	4	989	7.0
68	158	3	992	9.5
69	155	3	995	9.5
70	151	4	999	7.0
71	148	3	1002	9.5

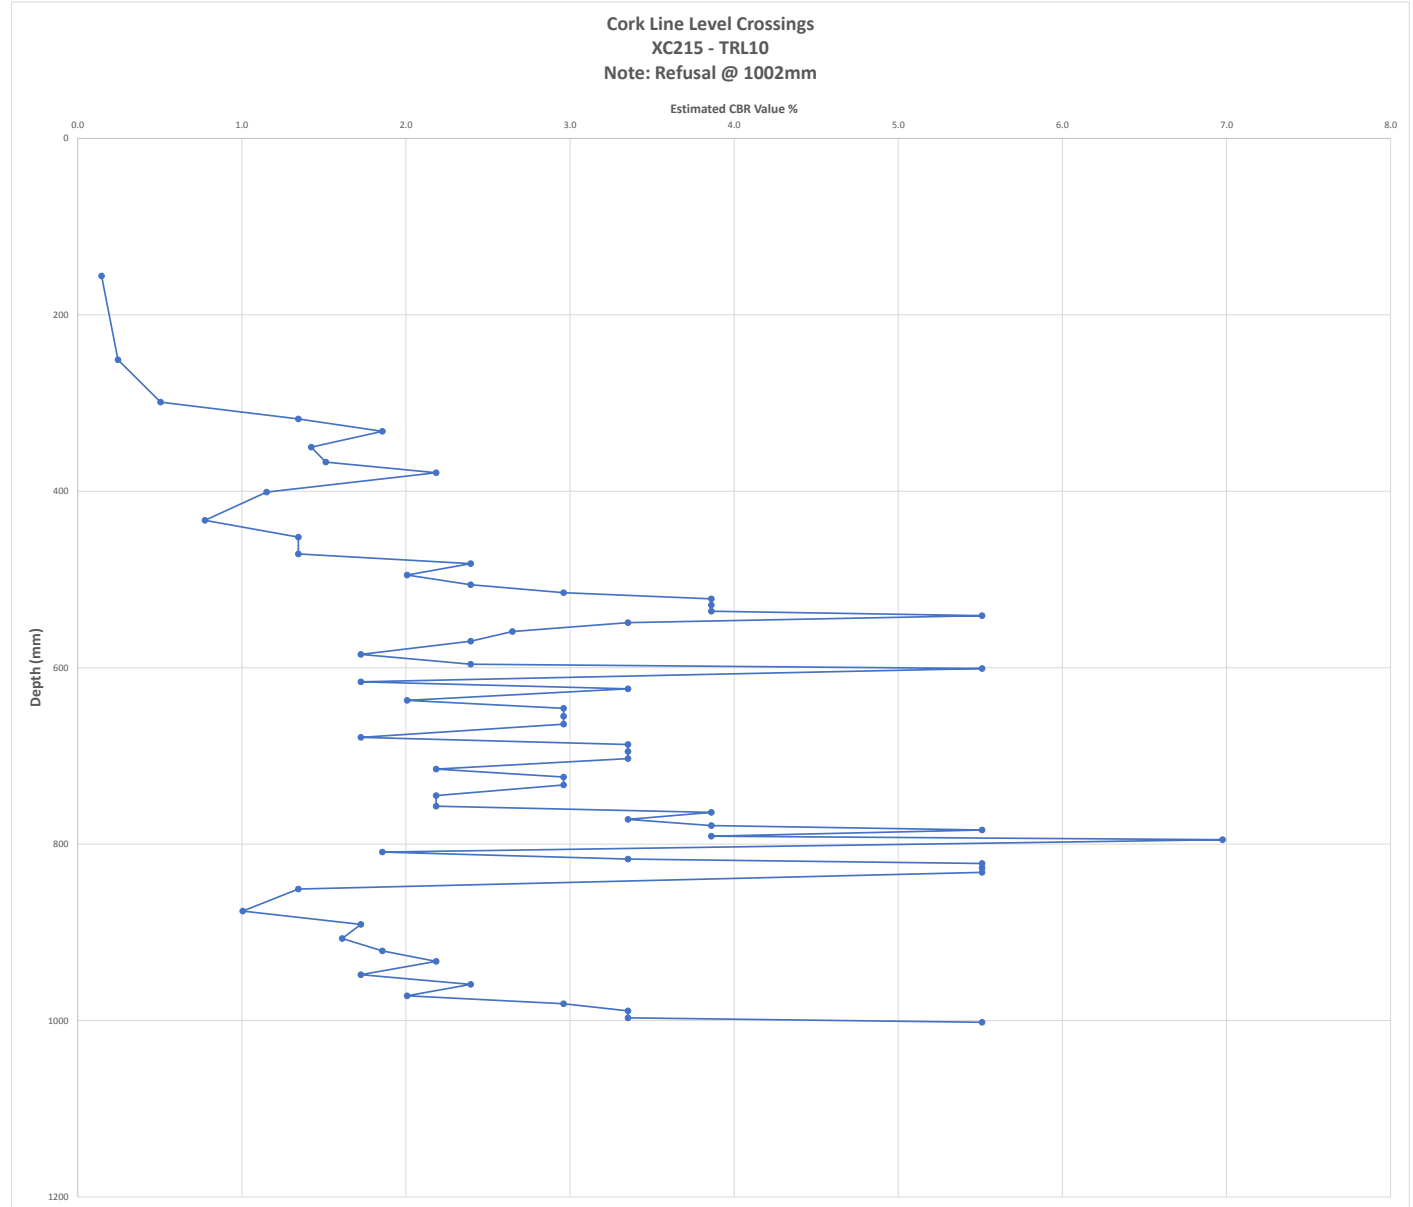
Location	XC215 - TRL10	Job No	19-135
----------	----------------------	--------	--------

Cork Line Level Crossings - Irish Rail
 Transport Research Laboratory - Dynamic Cone Penetrometer Data

No. of Blows	READING (mm)	Penetration/blow (mm)	DEPTH	CBR %
1	994	156	156	0.1
2	899	95	251	0.2
3	851	48	299	0.5
4	832	19	318	1.3
5	818	14	332	1.9
6	800	18	350	1.4
7	783	17	367	1.5
8	771	12	379	2.2
9	749	22	401	1.2
10	717	32	433	0.8
11	698	19	452	1.3
12	679	19	471	1.3
13	668	11	482	2.4
14	655	13	495	2.0
15	644	11	506	2.4
16	635	9	515	3.0
17	628	7	522	3.9
18	621	7	529	3.9
19	614	7	536	3.9
20	609	5	541	5.5
21	601	8	549	3.4
22	591	10	559	2.6
23	580	11	570	2.4
24	565	15	585	1.7
25	554	11	596	2.4
26	549	5	601	5.5
27	534	15	616	1.7
28	526	8	624	3.4
29	513	13	637	2.0
30	504	9	646	3.0
31	495	9	655	3.0
32	486	9	664	3.0
33	471	15	679	1.7
34	463	8	687	3.4
35	455	8	695	3.4
36	447	8	703	3.4
37	435	12	715	2.2
38	426	9	724	3.0
39	417	9	733	3.0
40	405	12	745	2.2
41	393	12	757	2.2
42	386	7	764	3.9
43	378	8	772	3.4
44	371	7	779	3.9
45	366	5	784	5.5
46	359	7	791	3.9
47	355	4	795	7.0
48	341	14	809	1.9
49	333	8	817	3.4
50	328	5	822	5.5
51	323	5	827	5.5
52	318	5	832	5.5

53	299	19	851	1.3
54	274	25	876	1.0
55	259	15	891	1.7
56	243	16	907	1.6
57	229	14	921	1.9
58	217	12	933	2.2
59	202	15	948	1.7
60	191	11	959	2.4
61	178	13	972	2.0
62	169	9	981	3.0
63	161	8	989	3.4
64	153	8	997	3.4
65	148	5	1002	5.5

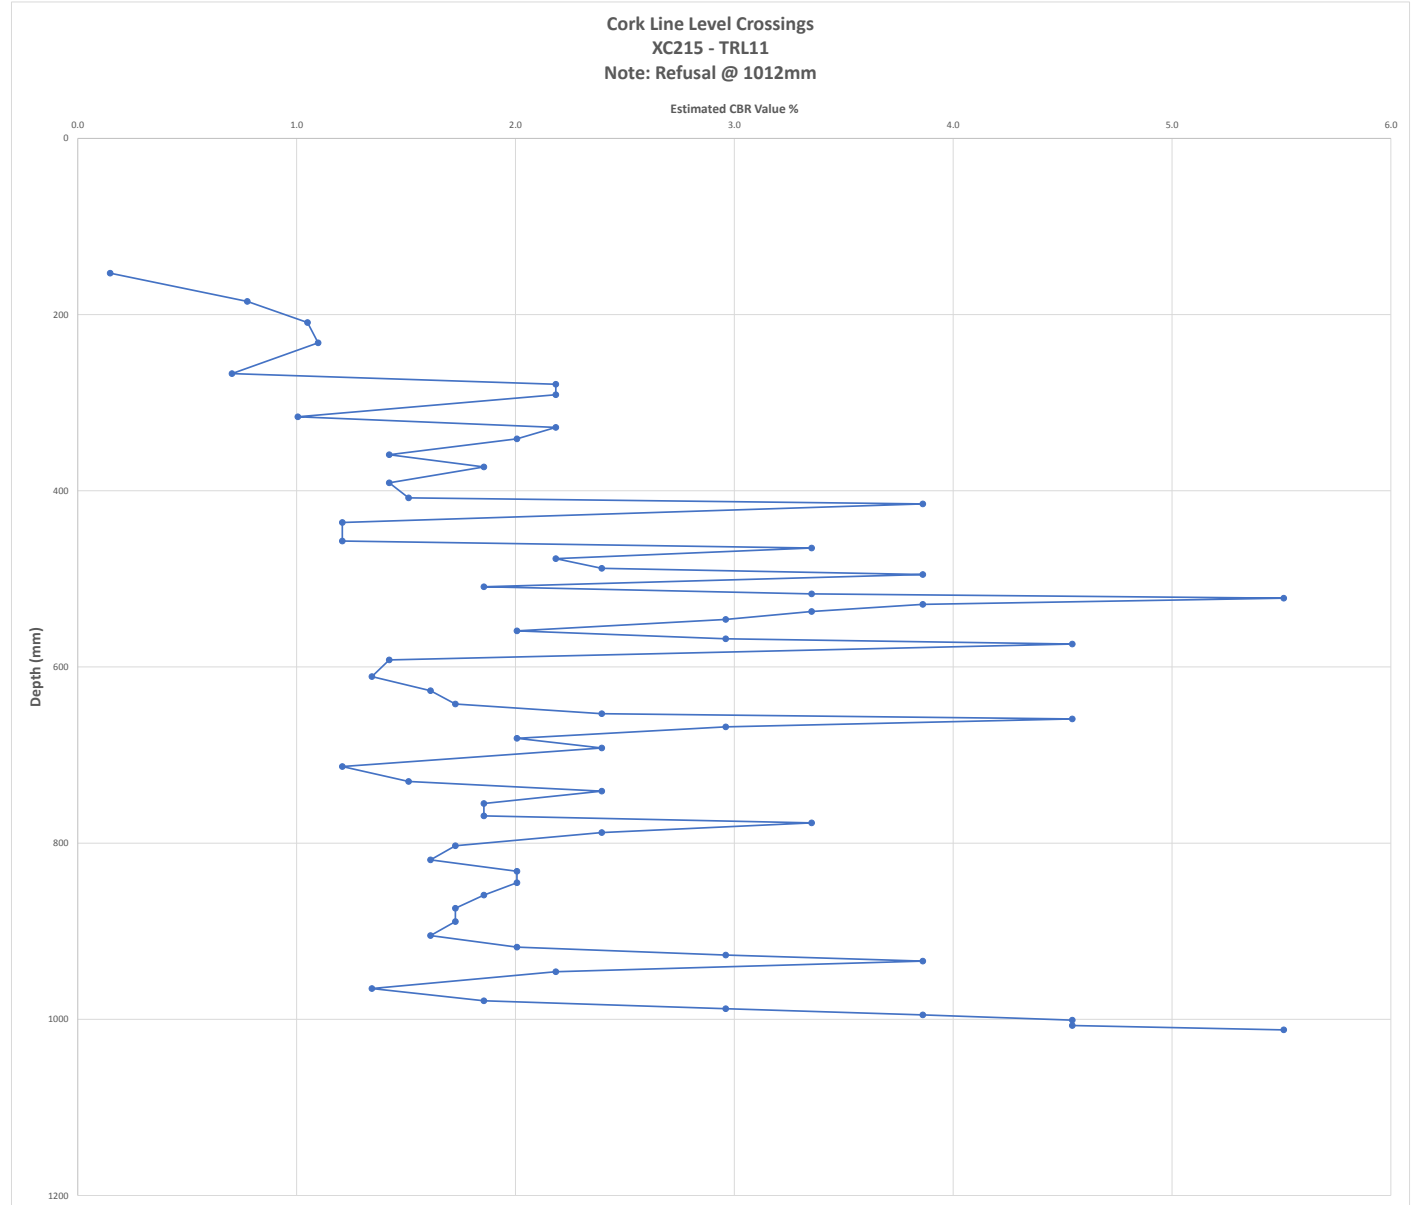
Location	XC215 - TRL11	Job No	19-135
----------	----------------------	--------	--------

Cork Line Level Crossings - Irish Rail
 Transport Research Laboratory - Dynamic Cone Penetrometer Data

No. of Blows	READING (mm)	Penetration/blow (mm)	DEPTH	CBR %
1	997	153	153	0.1
2	965	32	185	0.8
3	941	24	209	1.0
4	918	23	232	1.1
5	883	35	267	0.7
6	871	12	279	2.2
7	859	12	291	2.2
8	834	25	316	1.0
9	822	12	328	2.2
10	809	13	341	2.0
11	791	18	359	1.4
12	777	14	373	1.9
13	759	18	391	1.4
14	742	17	408	1.5
15	735	7	415	3.9
16	714	21	436	1.2
17	693	21	457	1.2
18	685	8	465	3.4
19	673	12	477	2.2
20	662	11	488	2.4
21	655	7	495	3.9
22	641	14	509	1.9
23	633	8	517	3.4
24	628	5	522	5.5
25	621	7	529	3.9
26	613	8	537	3.4
27	604	9	546	3.0
28	591	13	559	2.0
29	582	9	568	3.0
30	576	6	574	4.5
31	558	18	592	1.4
32	539	19	611	1.3
33	523	16	627	1.6
34	508	15	642	1.7
35	497	11	653	2.4
36	491	6	659	4.5
37	482	9	668	3.0
38	469	13	681	2.0
39	458	11	692	2.4
40	437	21	713	1.2
41	420	17	730	1.5
42	409	11	741	2.4
43	395	14	755	1.9
44	381	14	769	1.9
45	373	8	777	3.4
46	362	11	788	2.4
47	347	15	803	1.7
48	331	16	819	1.6
49	318	13	832	2.0
50	305	13	845	2.0
51	291	14	859	1.9

52	276	15	874	1.7
53	261	15	889	1.7
54	245	16	905	1.6
55	232	13	918	2.0
56	223	9	927	3.0
57	216	7	934	3.9
58	204	12	946	2.2
59	185	19	965	1.3
60	171	14	979	1.9
61	162	9	988	3.0
62	155	7	995	3.9
63	149	6	1001	4.5
64	143	6	1007	4.5
65	138	5	1012	5.5

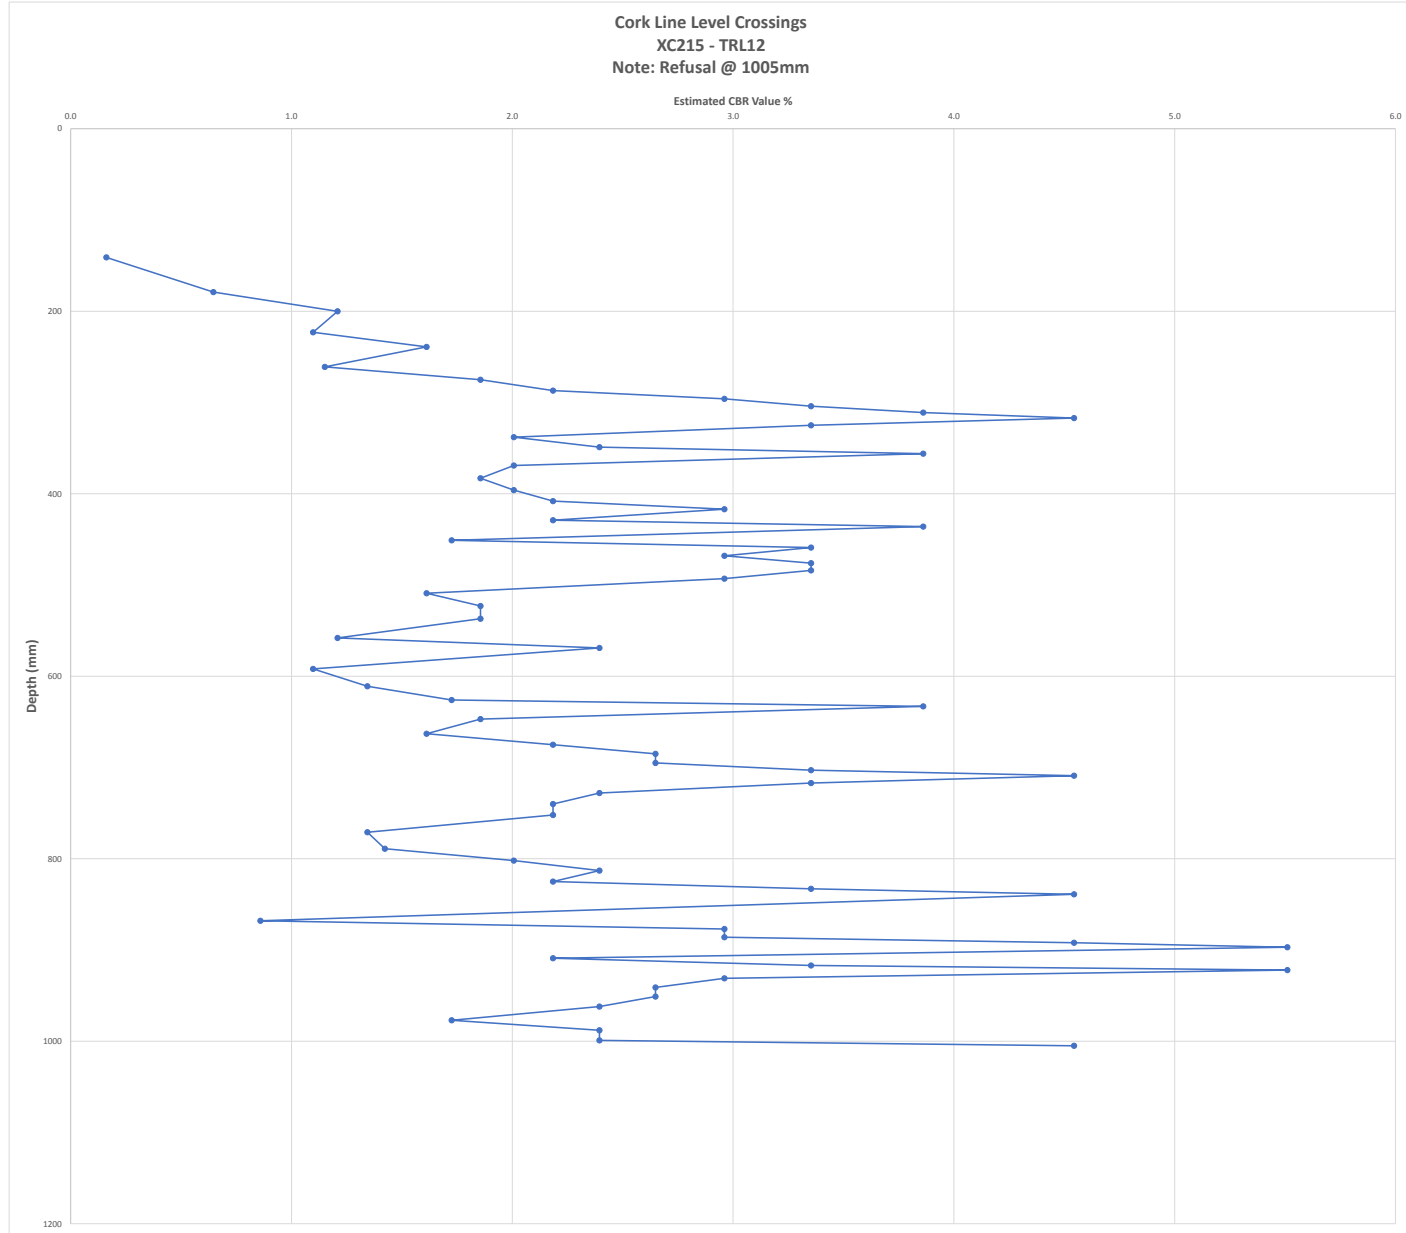
Location	XC215 - TRL12	Job No	19-135
----------	---------------	--------	--------

Cork Line Level Crossings - Irish Rail
 Transport Research Laboratory - Dynamic Cone Penetrometer Data

No. of Blows	READING (mm)	Penetration/blow (mm)	DEPTH	CBR %
1	1069	141	141	0.2
2	971	38	179	0.6
3	950	21	200	1.2
4	927	23	223	1.1
5	911	16	239	1.6
6	889	22	261	1.2
7	875	14	275	1.9
8	863	12	287	2.2
9	854	9	296	3.0
10	846	8	304	3.4
11	839	7	311	3.9
12	833	6	317	4.5
13	825	8	325	3.4
14	812	13	338	2.0
15	801	11	349	2.4
16	794	7	356	3.9
17	781	13	369	2.0
18	767	14	383	1.9
19	754	13	396	2.0
20	742	12	408	2.2
21	733	9	417	3.0
22	721	12	429	2.2
23	714	7	436	3.9
24	699	15	451	1.7
25	691	8	459	3.4
26	682	9	468	3.0
27	674	8	476	3.4
28	666	8	484	3.4
29	657	9	493	3.0
30	641	16	509	1.6
31	627	14	523	1.9
32	613	14	537	1.9
33	592	21	558	1.2
34	581	11	569	2.4
35	558	23	592	1.1
36	539	19	611	1.3
37	524	15	626	1.7
38	517	7	633	3.9
39	503	14	647	1.9
40	487	16	663	1.6
41	475	12	675	2.2
42	465	10	685	2.6
43	455	10	695	2.6
44	447	8	703	3.4
45	441	6	709	4.5
46	433	8	717	3.4
47	422	11	728	2.4
48	410	12	740	2.2
49	398	12	752	2.2
50	379	19	771	1.3
51	361	18	789	1.4

52	348	13	802	2.0
53	337	11	813	2.4
54	325	12	825	2.2
55	317	8	833	3.4
56	311	6	839	4.5
57	282	29	868	0.9
58	273	9	877	3.0
59	264	9	886	3.0
60	258	6	892	4.5
61	253	5	897	5.5
62	241	12	909	2.2
63	233	8	917	3.4
64	228	5	922	5.5
65	219	9	931	3.0
66	209	10	941	2.6
67	199	10	951	2.6
68	188	11	962	2.4
69	173	15	977	1.7
70	162	11	988	2.4
71	151	11	999	2.4
72	145	6	1005	4.5
73
