Iarnród Éireann
Cork Line Level Crossings
XC215 (19-135-4)

T.PIT5
	Trial Pit Photographs
Client:	Iarnród Éireann
Engineer:	Jacob's
Date:	February 2020

Appendix F

Appendix G

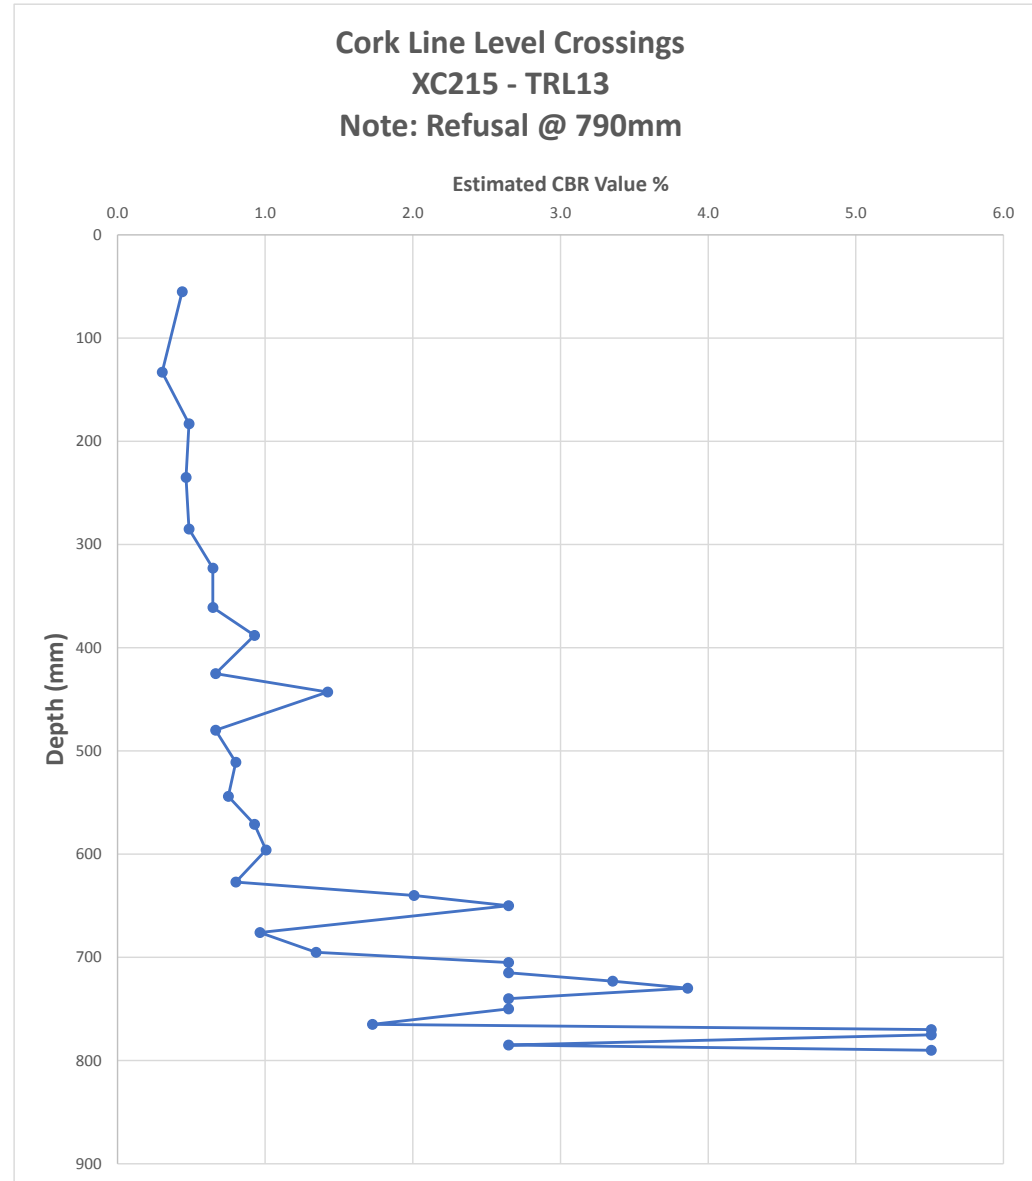
Location	XC215 - TRL13	Job No	19-135
----------	----------------------	--------	--------

Cork Line Level Crossings - Irish Rail
Transport Research Laboratory - Dynamic Cone Penetrometer Data

No. of Blows	READING (mm)	Penetration/blow (mm)	DEPTH	CBR %
1	995	55	55	0.4
2	917	78	133	0.3
3	867	50	183	0.5
4	815	52	235	0.5
5	765	50	285	0.5
6	727	38	323	0.6
7	689	38	361	0.6
8	662	27	388	0.9
9	625	37	425	0.7
10	607	18	443	1.4
11	570	37	480	0.7
12	539	31	511	0.8
13	506	33	544	0.7
14	479	27	571	0.9
15	454	25	596	1.0
16	423	31	627	0.8
17	410	13	640	2.0
18	400	10	650	2.6
19	374	26	676	1.0
20	355	19	695	1.3
21	345	10	705	2.6
22	335	10	715	2.6
23	327	8	723	3.4
24	320	7	730	3.9
25	310	10	740	2.6
26	300	10	750	2.6
27	285	15	765	1.7
28	280	5	770	5.5
29	275	5	775	5.5
30	265	10	785	2.6
31	260	5	790	5.5
32	260	0	790	
33	260	0	790	
34

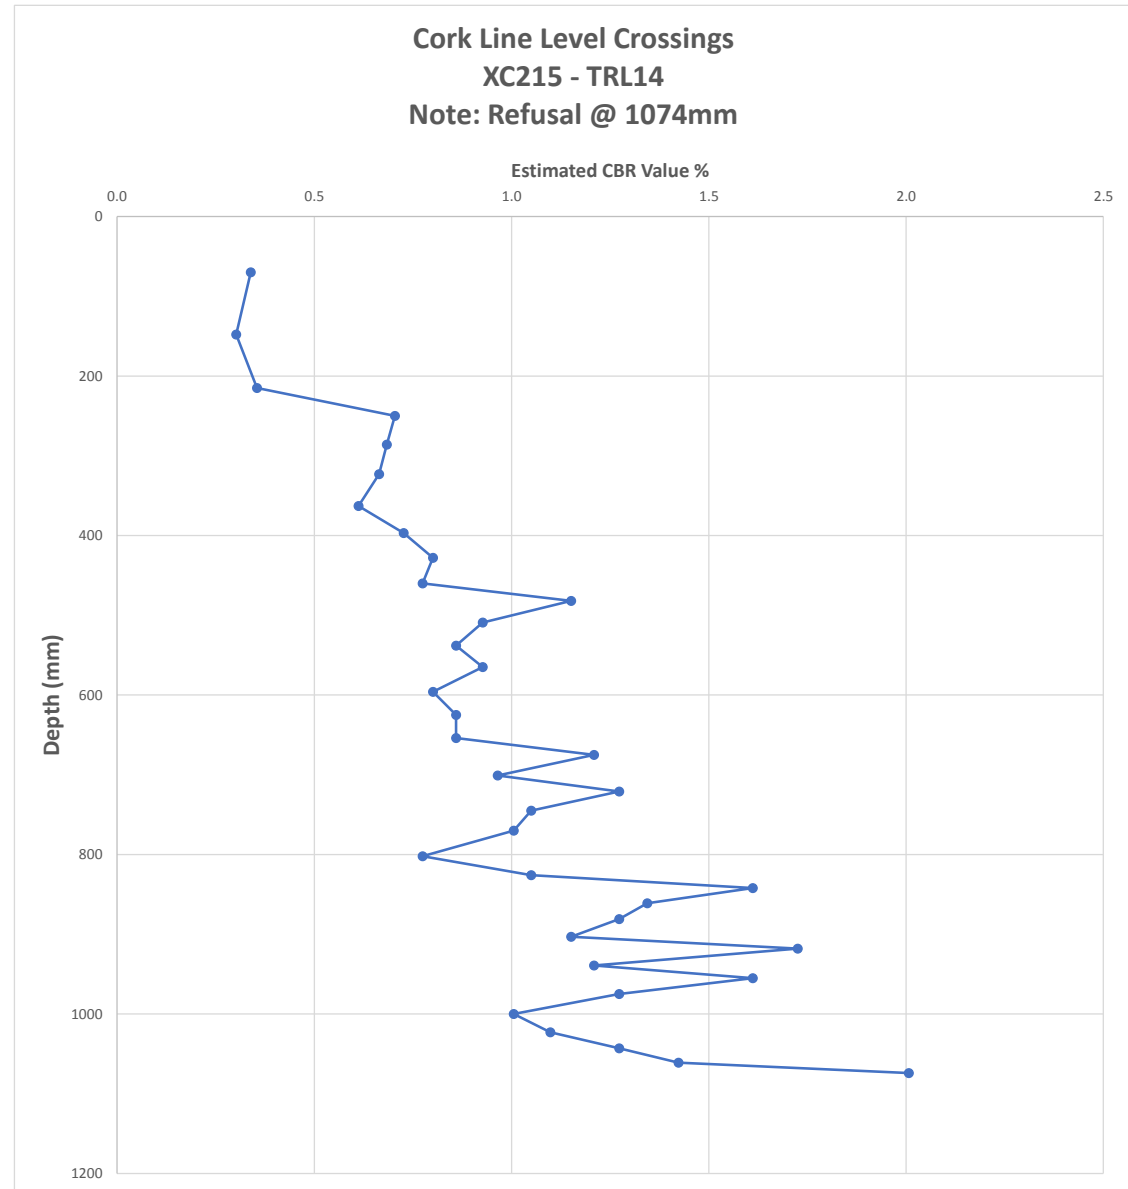
Location	XC215 - TRL14	Job No	19-135
----------	---------------	--------	--------

Transport Research Laboratory - Dynamic Cone Penetrometer Data

No. of Blows	READING (mm)	Penetration/blow (mm)	DEPTH	CBR %
1	1040	70	70	0.3
2	962	78	148	0.3
3	895	67	215	0.4
4	860	35	250	0.7
5	824	36	286	0.7
6	787	37	323	0.7
7	747	40	363	0.6
8	713	34	397	0.7
9	682	31	428	0.8
10	650	32	460	0.8
11	628	22	482	1.2
12	601	27	509	0.9
13	572	29	538	0.9
14	545	27	565	0.9
15	514	31	596	0.8
16	485	29	625	0.9
17	456	29	654	0.9
18	435	21	675	1.2
19	409	26	701	1.0
20	389	20	721	1.3
21	365	24	745	1.0
22	340	25	770	1.0
23	308	32	802	0.8
24	284	24	826	1.0
25	268	16	842	1.6
26	249	19	861	1.3
27	229	20	881	1.3
28	207	22	903	1.2
29	192	15	918	1.7
30	171	21	939	1.2
31	155	16	955	1.6
32	135	20	975	1.3
33	110	25	1000	1.0
34	87	23	1023	1.1
35	67	20	1043	1.3
36	49	18	1061	1.4
37	36	13	1074	2.0
38

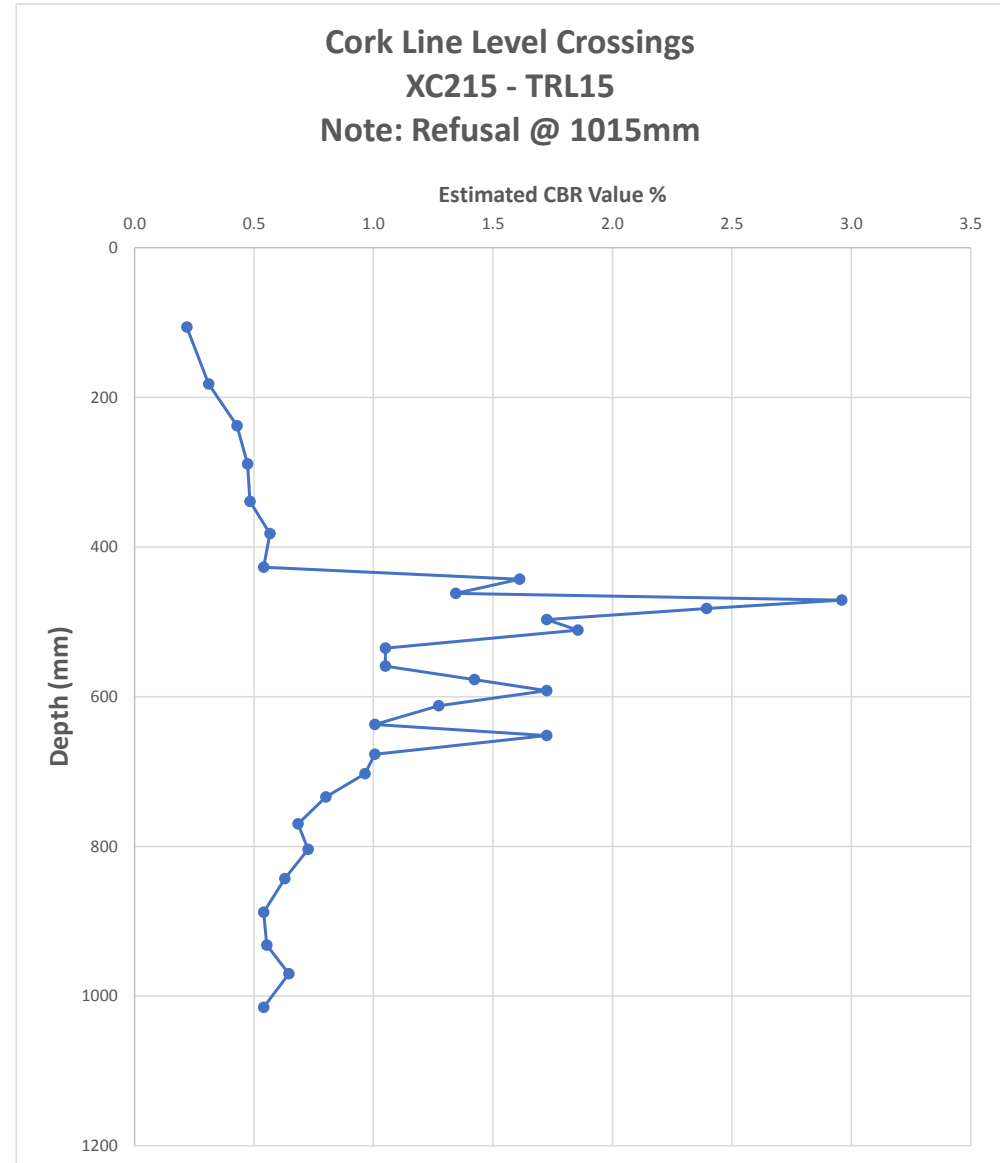
Location	XC215 - TRL15	Job No	19-135
----------	----------------------	--------	--------

Transport Research Laboratory - Dynamic Cone Penetrometer Data

No. of Blows	READING (mm)	Penetration/blow (mm)	DEPTH	CBR %
1	931	106	106	0.2
2	855	76	182	0.3
3	799	56	238	0.4
4	748	51	289	0.5
5	698	50	339	0.5
6	655	43	382	0.6
7	610	45	427	0.5
8	594	16	443	1.6
9	575	19	462	1.3
10	566	9	471	3.0
11	555	11	482	2.4
12	540	15	497	1.7
13	526	14	511	1.9
14	502	24	535	1.0
15	478	24	559	1.0
16	460	18	577	1.4
17	445	15	592	1.7
18	425	20	612	1.3
19	400	25	637	1.0
20	385	15	652	1.7
21	360	25	677	1.0
22	334	26	703	1.0
23	303	31	734	0.8
24	267	36	770	0.7
25	233	34	804	0.7
26	194	39	843	0.6
27	149	45	888	0.5
28	105	44	932	0.6
29	67	38	970	0.6
30	22	45	1015	0.5
31

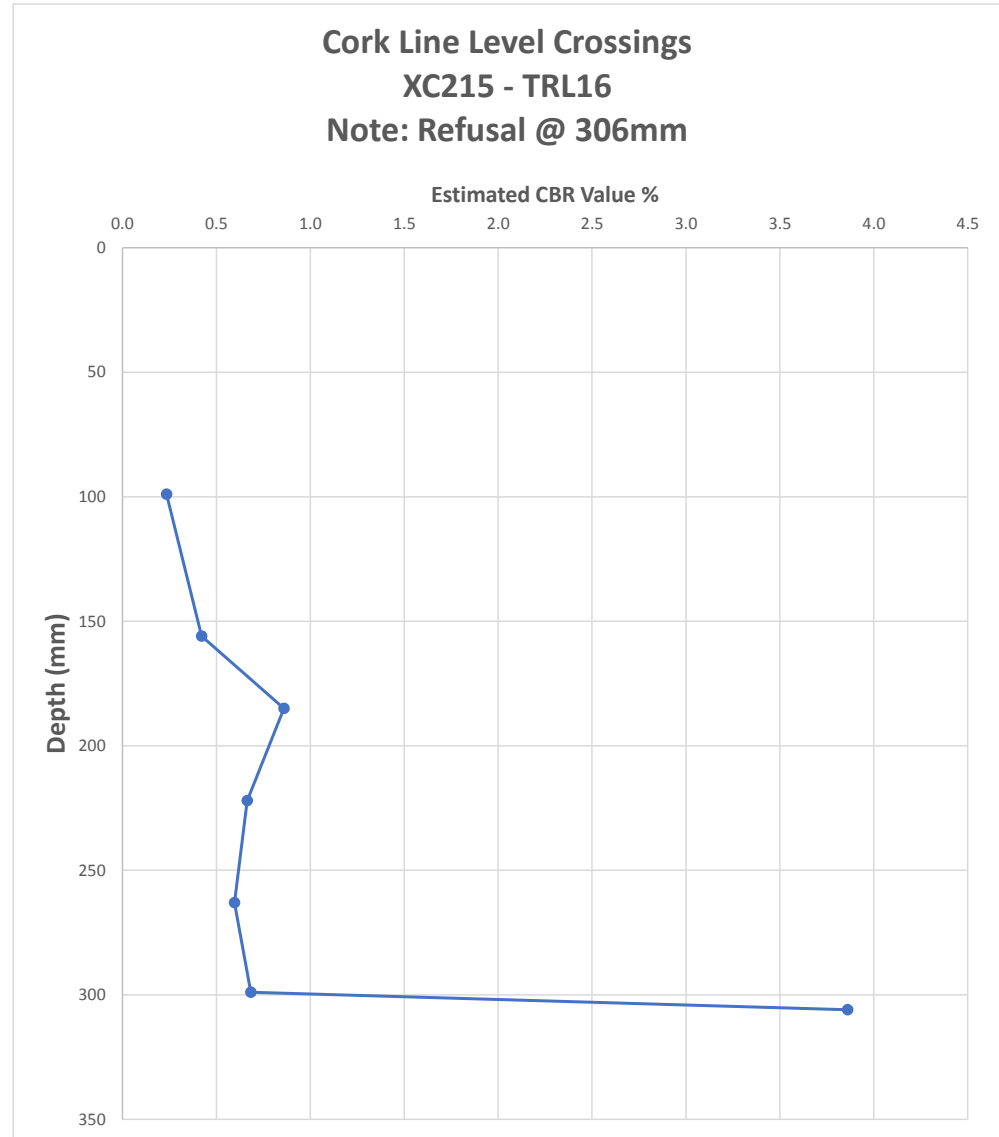
Location	XC215 - TRL16	Job No	19-135
----------	----------------------	--------	--------

Transport Research Laboratory - Dynamic Cone Penetrometer Data

No. of Blows	READING (mm)	Penetration/blow (mm)	DEPTH	CBR %
1	957	99	99	0.2
2	900	57	156	0.4
3	871	29	185	0.9
4	834	37	222	0.7
5	793	41	263	0.6
6	757	36	299	0.7
7	750	7	306	3.9
8	750	0	306	
9	750	0	306	
10

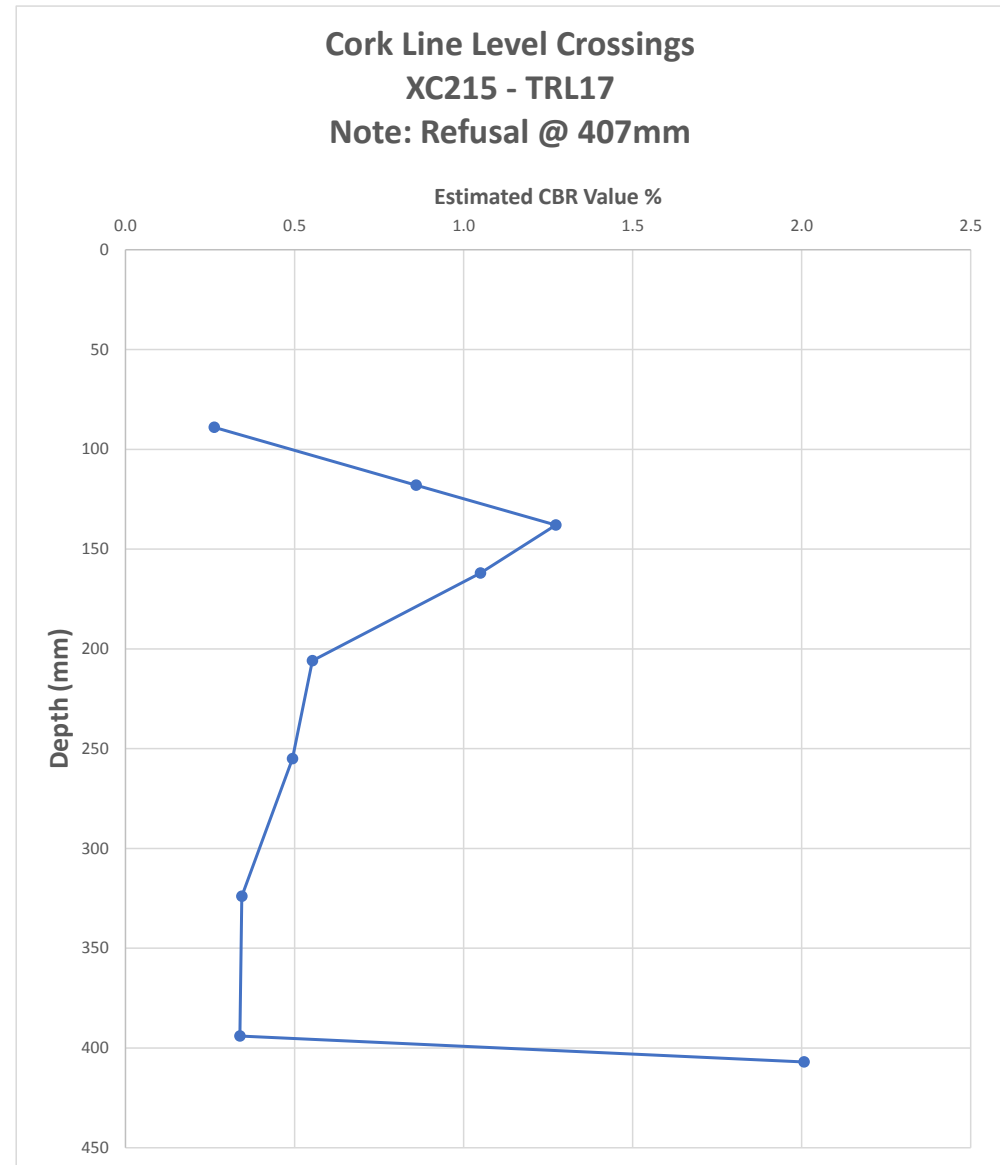
Location	XC215 - TRL17	Job No	19-135
----------	----------------------	--------	--------

Transport Research Laboratory - Dynamic Cone Penetrometer Data

No. of Blows	READING (mm)	Penetration/blow (mm)	DEPTH	CBR %
1	994	89	89	0.3
2	965	29	118	0.9
3	945	20	138	1.3
4	921	24	162	1.0
5	877	44	206	0.6
6	828	49	255	0.5
7	759	69	324	0.3
8	689	70	394	0.3
9	676	13	407	2.0
10	676	0	407	
11	676	0	407	
12

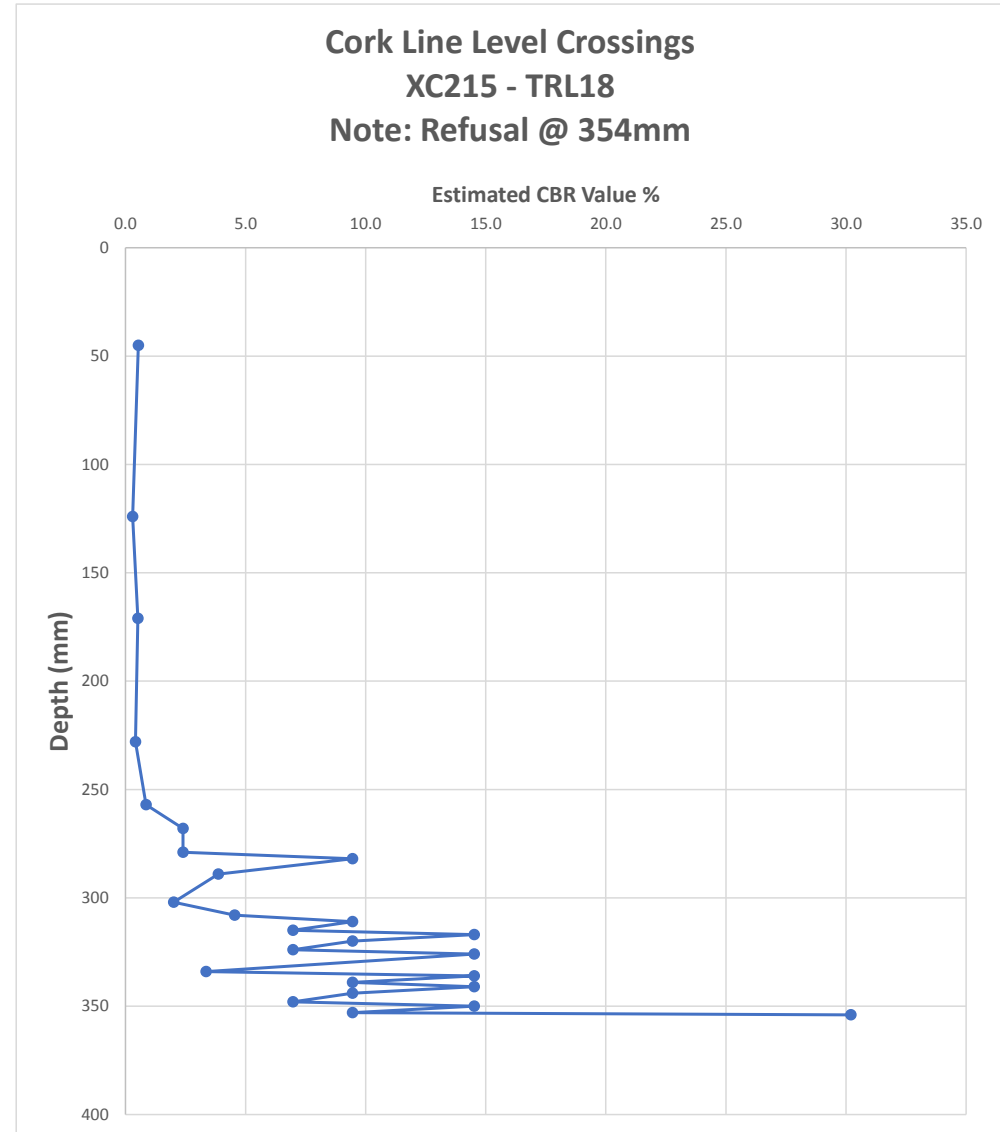
Location	XC215 - TRL18	Job No	19-135
----------	----------------------	--------	--------

Transport Research Laboratory - Dynamic Cone Penetrometer Data

No. of Blows	READING (mm)	Penetration/blow (mm)	DEPTH	CBR %
1	1060	45	45	0.5
2	981	79	124	0.3
3	934	47	171	0.5
4	877	57	228	0.4
5	848	29	257	0.9
6	837	11	268	2.4
7	826	11	279	2.4
8	823	3	282	9.5
9	816	7	289	3.9
10	803	13	302	2.0
11	797	6	308	4.5
12	794	3	311	9.5
13	790	4	315	7.0
14	788	2	317	14.5
15	785	3	320	9.5
16	781	4	324	7.0
17	779	2	326	14.5
18	771	8	334	3.4
19	769	2	336	14.5
20	766	3	339	9.5
21	764	2	341	14.5
22	761	3	344	9.5
23	757	4	348	7.0
24	755	2	350	14.5
25	752	3	353	9.5
26	751	1	354	30.2
27	751	0	354	
28	751	0	354	
29

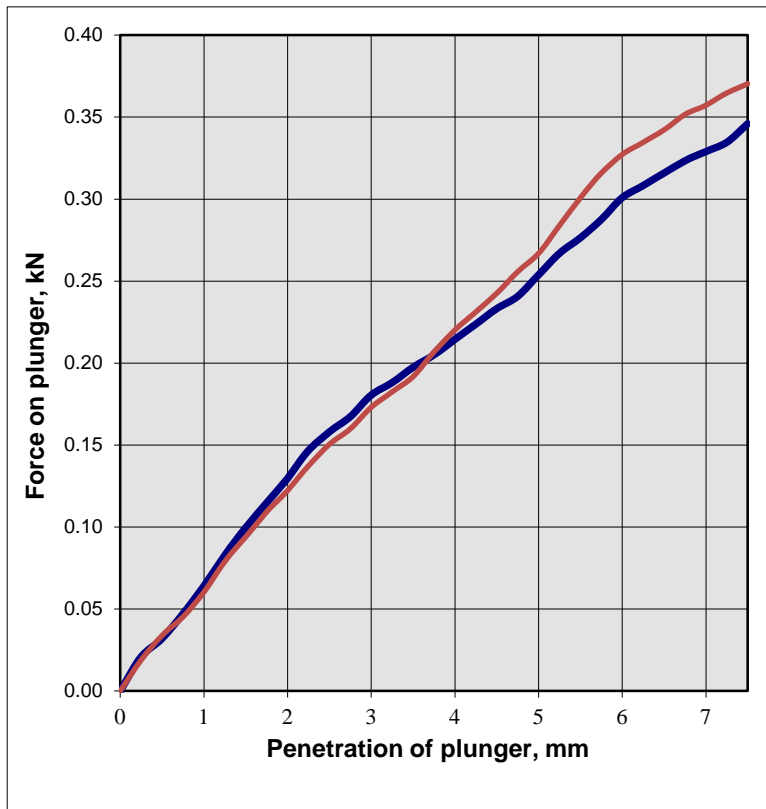
LABORATORY TEST REPORT
DETERMINATION OF CALIFORNIA BEARING RATIO - BS 1377 : Part 4 : 1990

Type of Reaction Load
Load Frame
Technician(s)
NW
Mass of Surcharge Weights
8.8Kg
Overburden Pressure
3.9kPa
Material Type
Soil
Density (Mg/m³)
2.17
Proportion of material removed from initial sample by dry mass (%)
10.9
Swell (mm)
0
Days Soaked
0
Final Swell (mm):
N/A

Penetration (mm)	Force (kN)	Standard Force (kN)	Top CBR (%)
2.5	0.16	13.2	1.2
5.0	0.25	20.0	1.3
Moisture content : %	19.5	Mean CBR value : %	1.2
Penetration (mm)	Force (kN)	Standard Force (kN)	Bottom CBR (%)
2.5	0.15	13.2	1.1
5.0	0.27	20.0	1.3
Moisture content : %	19.5	Mean CBR value : %	1.2

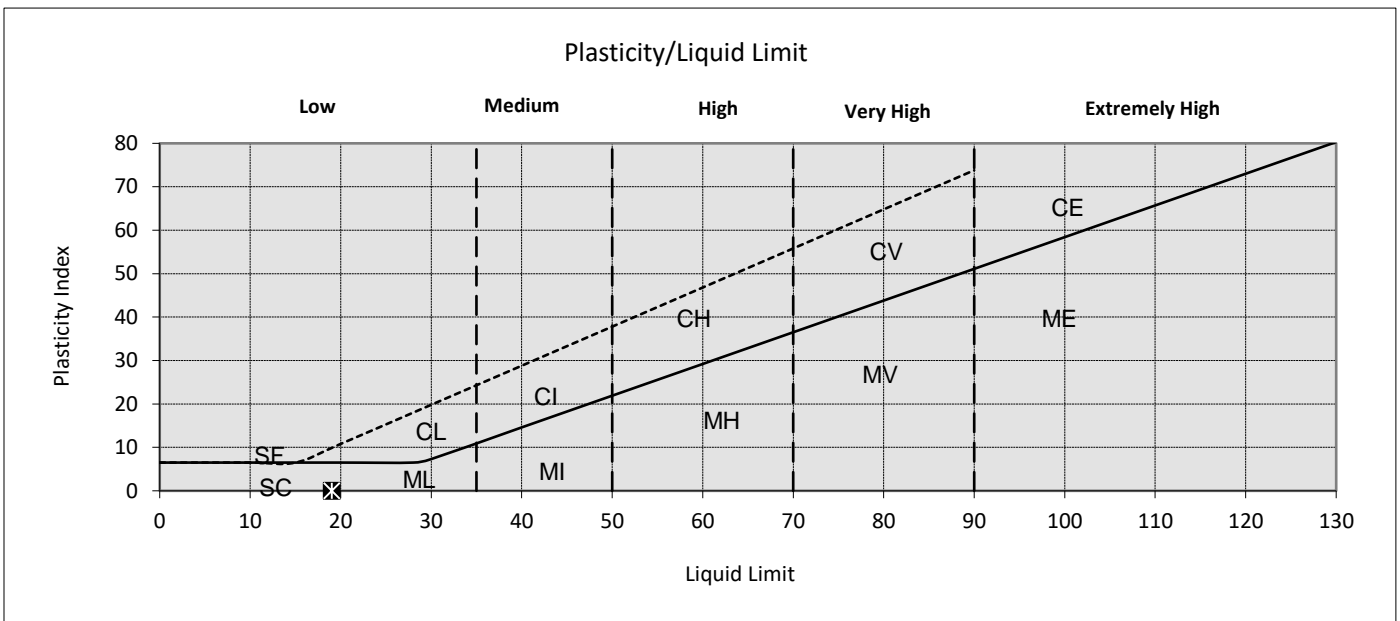
Sampling Certificate	No
Sampled By	Client
Sample Type	Bulk
Sample Preparation Method	Washed
MATERIAL	Soil
Retained 425 micron (%)	61
Natural Moisture Content (%)	18
Liquid Limit (single point)(%)	19
Plastic Limit (%)	Non-Plastic
Plasticity Index	N/A

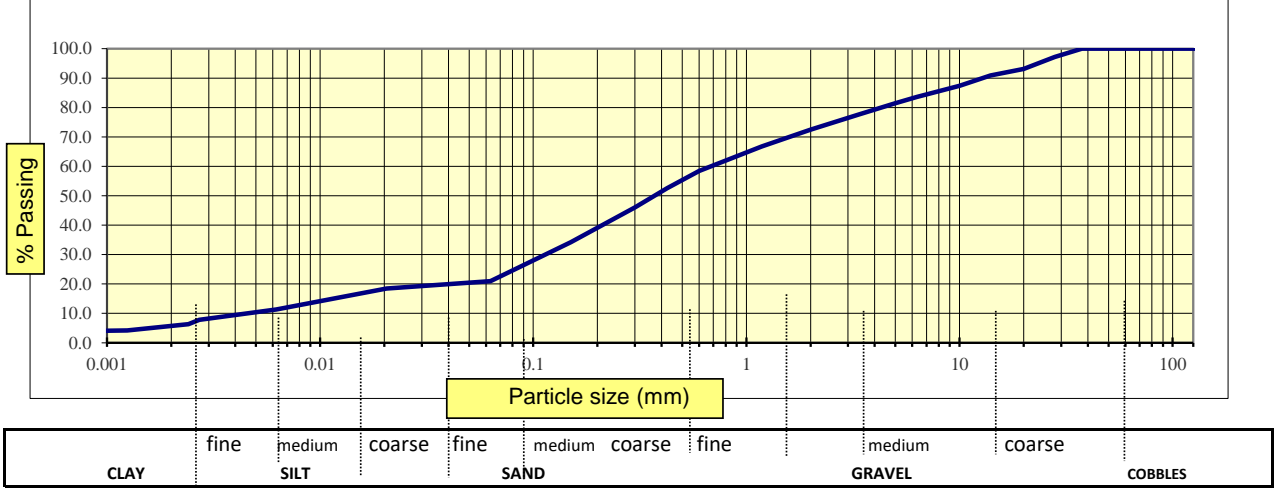
BS Sieve Size	% Passing	Specification
300 mm	100	
125 mm	100	
100 mm	100	
75 mm	100	
63 mm	100	
50 mm	100	
37.5 mm	100	
28 mm	97	
20 mm	93	
14 mm	91	
10 mm	87	
6.3 mm	84	
5 mm	81	
3.35 mm	78	
2 mm	72	
1.18 mm	67	
0.6 mm	58	
0.425 mm	53	
0.3 mm	46	
0.15 mm	34	
0.063 mm	21	
0.020 mm	18	
0.006 mm	11	
0.003 mm	8	
0.002 mm	6	
0.001 mm	4

Tested in accordance with BS 1377: Part 2 : 1990 Clause 9.2 and 9.5

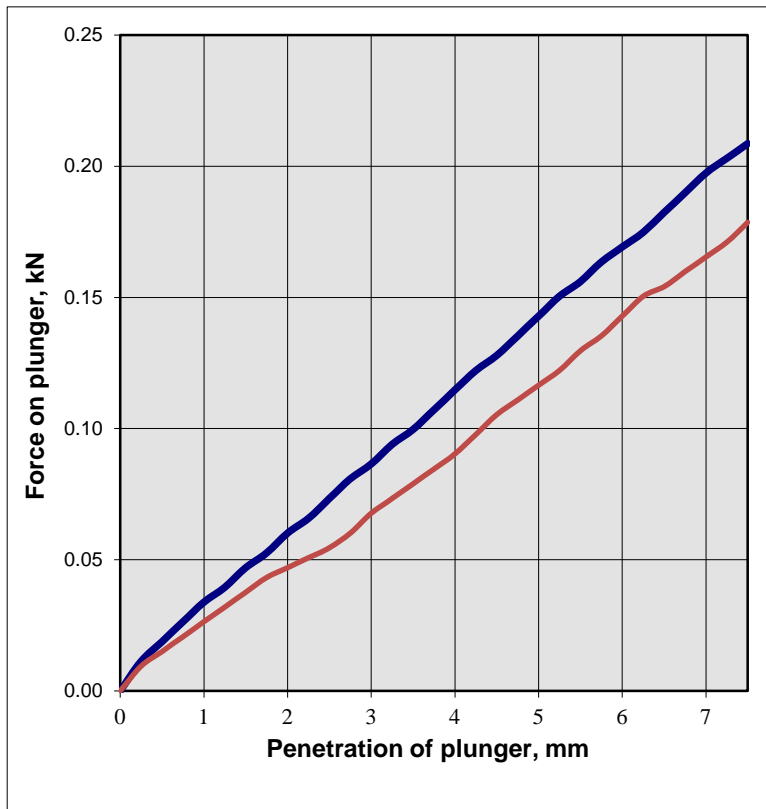
Type of Reaction Load
Load Frame
Technician(s)
NW
Mass of Surcharge Weights
8.8Kg
Overburden Pressure
3.9kPa
Material Type
Soil
Density (Mg/m³)
2.21
Proportion of material removed from initial sample by dry mass (%)
7.24
Swell (mm)
0
Days Soaked
0
Final Swell (mm):
N/A

Penetration (mm)	Force (kN)	Standard Force (kN)	Top CBR (%)
2.5	0.07	13.2	0.6
5.0	0.14	20.0	0.7
Moisture content : %	26.8	Mean CBR value : %	0.6
Penetration (mm)	Force (kN)	Standard Force (kN)	Bottom CBR (%)
2.5	0.05	13.2	0.4
5.0	0.12	20.0	0.6
Moisture content : %	26.8	Mean CBR value : %	0.5

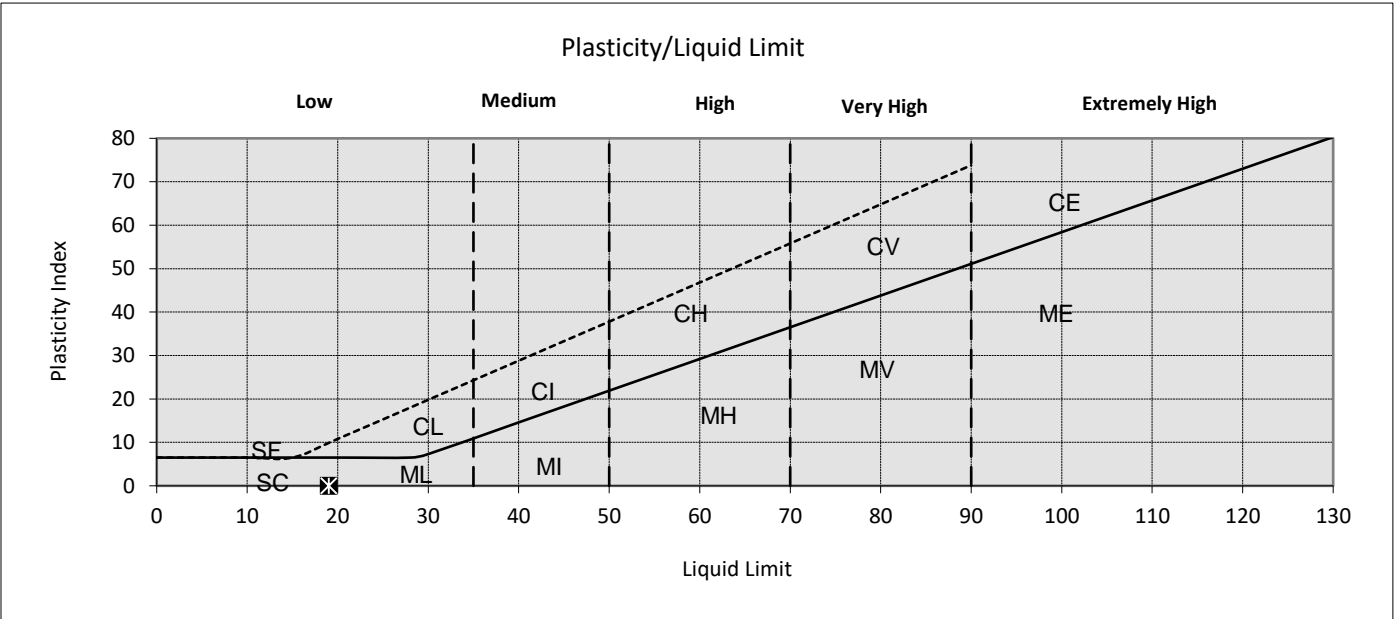
Sampling Certificate	No
Sampled By	Client
Sample Type	Bulk
Sample Preparation Method	Washed
MATERIAL	Soil
Retained 425 micron (%)	72
Natural Moisture Content (%)	28
Liquid Limit (single point)(%)	19
Plastic Limit (%)	Non-Plastic
Plasticity Index	N/A

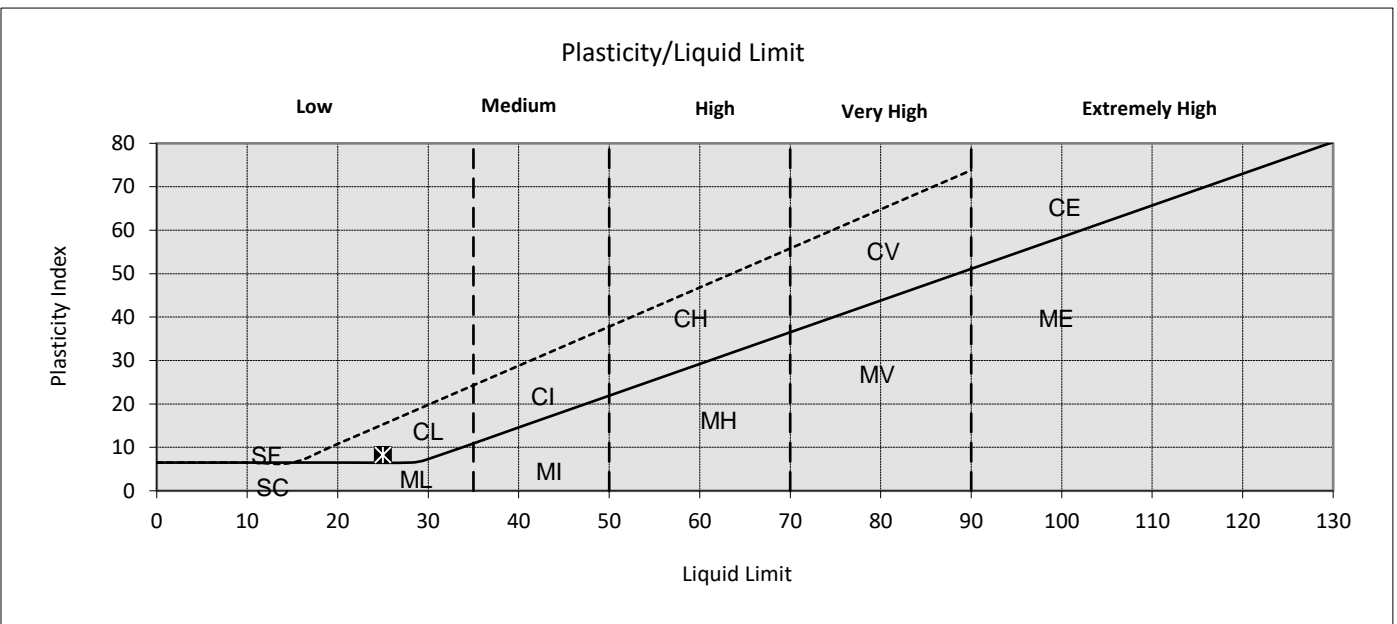
Sampling Certificate	No
Sampled By	Client
Sample Type	Bulk
Sample Preparation Method	Washed
MATERIAL	Soil
Retained 425 micron (%)	22
Natural Moisture Content (%)	10
Liquid Limit (single point)(%)	25
Plastic Limit (%)	16
Plasticity Index	8

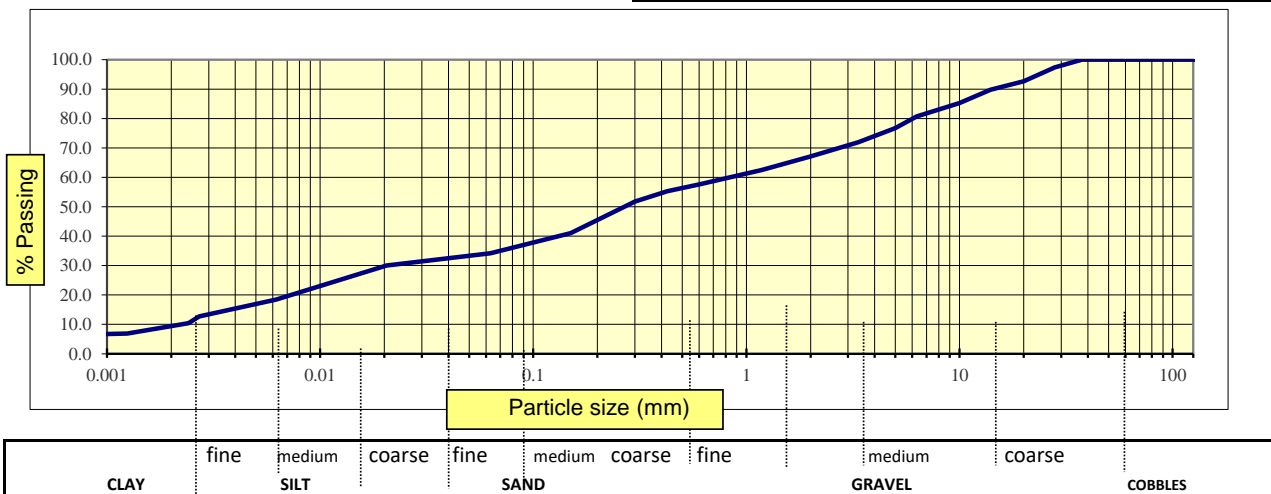
BS Sieve Size	% Passing	Specification
300 mm	100	
125 mm	100	
100 mm	100	
75 mm	100	
63 mm	100	
50 mm	100	
37.5 mm	100	
28 mm	97	
20 mm	93	
14 mm	90	
10 mm	85	
6.3 mm	81	
5 mm	77	
3.35 mm	72	
2 mm	67	
1.18 mm	63	
0.6 mm	58	
0.425 mm	55	
0.3 mm	52	
0.15 mm	41	
0.063 mm	34	
0.020 mm	30	
0.006 mm	19	
0.003 mm	13	
0.002 mm	10	
0.001 mm	7

Tested in accordance with BS 1377: Part 2 : 1990 Clause 9.2 and 9.5
