Iarnród Éireann
Cork Line Level Crossings
XC219 (19-135-5)

C.P/R.C05
	Rock Core Photographs
Client:	Iarnród Éireann
Engineer:	Jacob's
Date:	Feb-March & Jun-Sep 2020

Appendix D

Appendix E

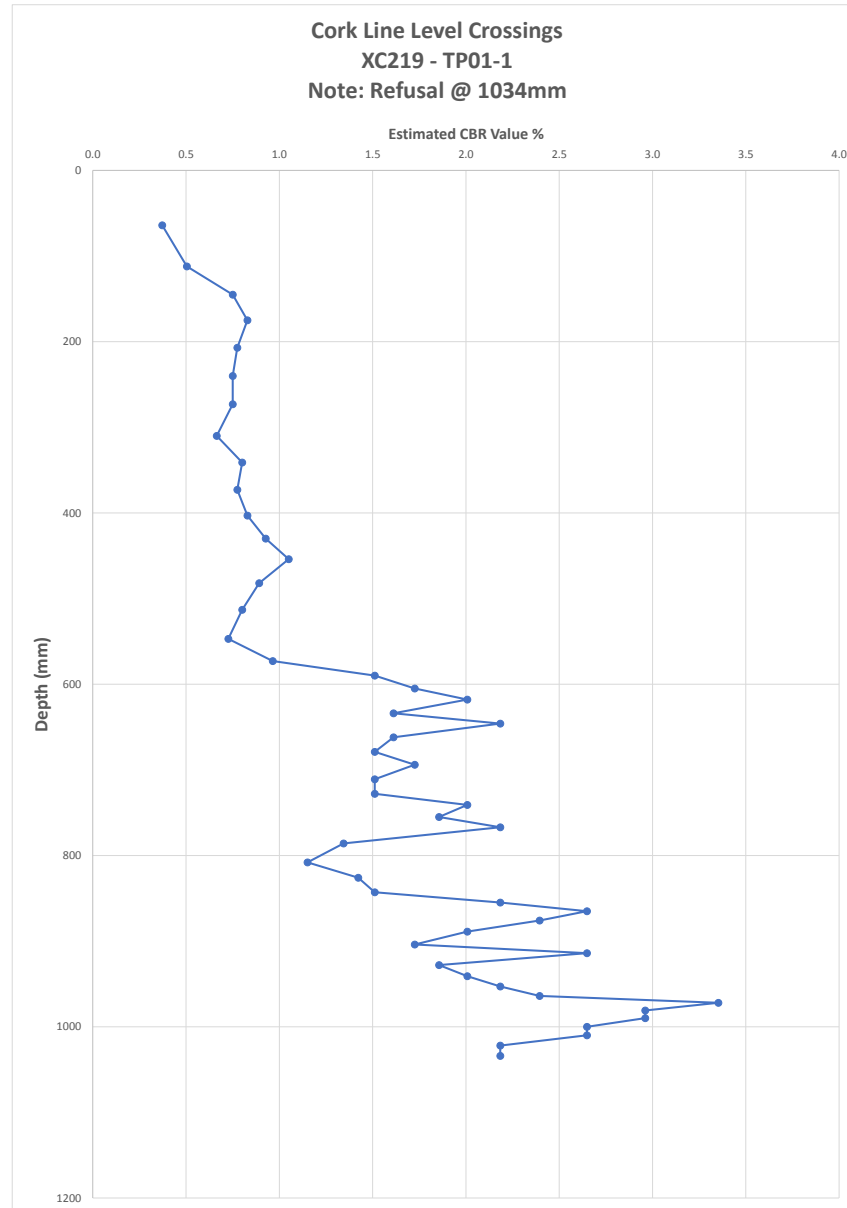
Location	XC219 - TP01-1	Job No	19-135
----------	-----------------------	--------	--------

No. of Blows	READING (mm)	Penetration/blow (mm)	DEPTH	CBR %
1	1068	64	64	0.4
2	1020	48	112	0.5
3	987	33	145	0.7
4	957	30	175	0.8
5	925	32	207	0.8
6	892	33	240	0.7
7	859	33	273	0.7
8	822	37	310	0.7
9	791	31	341	0.8
10	759	32	373	0.8
11	729	30	403	0.8
12	702	27	430	0.9
13	678	24	454	1.0
14	650	28	482	0.9
15	619	31	513	0.8
16	585	34	547	0.7
17	559	26	573	1.0
18	542	17	590	1.5
19	527	15	605	1.7
20	514	13	618	2.0
21	498	16	634	1.6
22	486	12	646	2.2
23	470	16	662	1.6
24	453	17	679	1.5
25	438	15	694	1.7
26	421	17	711	1.5
27	404	17	728	1.5
28	391	13	741	2.0
29	377	14	755	1.9
30	365	12	767	2.2
31	346	19	786	1.3
32	324	22	808	1.2
33	306	18	826	1.4
34	289	17	843	1.5
35	277	12	855	2.2
36	267	10	865	2.6
37	256	11	876	2.4
38	243	13	889	2.0
39	228	15	904	1.7
40	218	10	914	2.6
41	204	14	928	1.9
42	191	13	941	2.0
43	179	12	953	2.2
44	168	11	964	2.4
45	160	8	972	3.4
46	151	9	981	3.0
47	142	9	990	3.0
48	132	10	1000	2.6
49	122	10	1010	2.6
50	110	12	1022	2.2

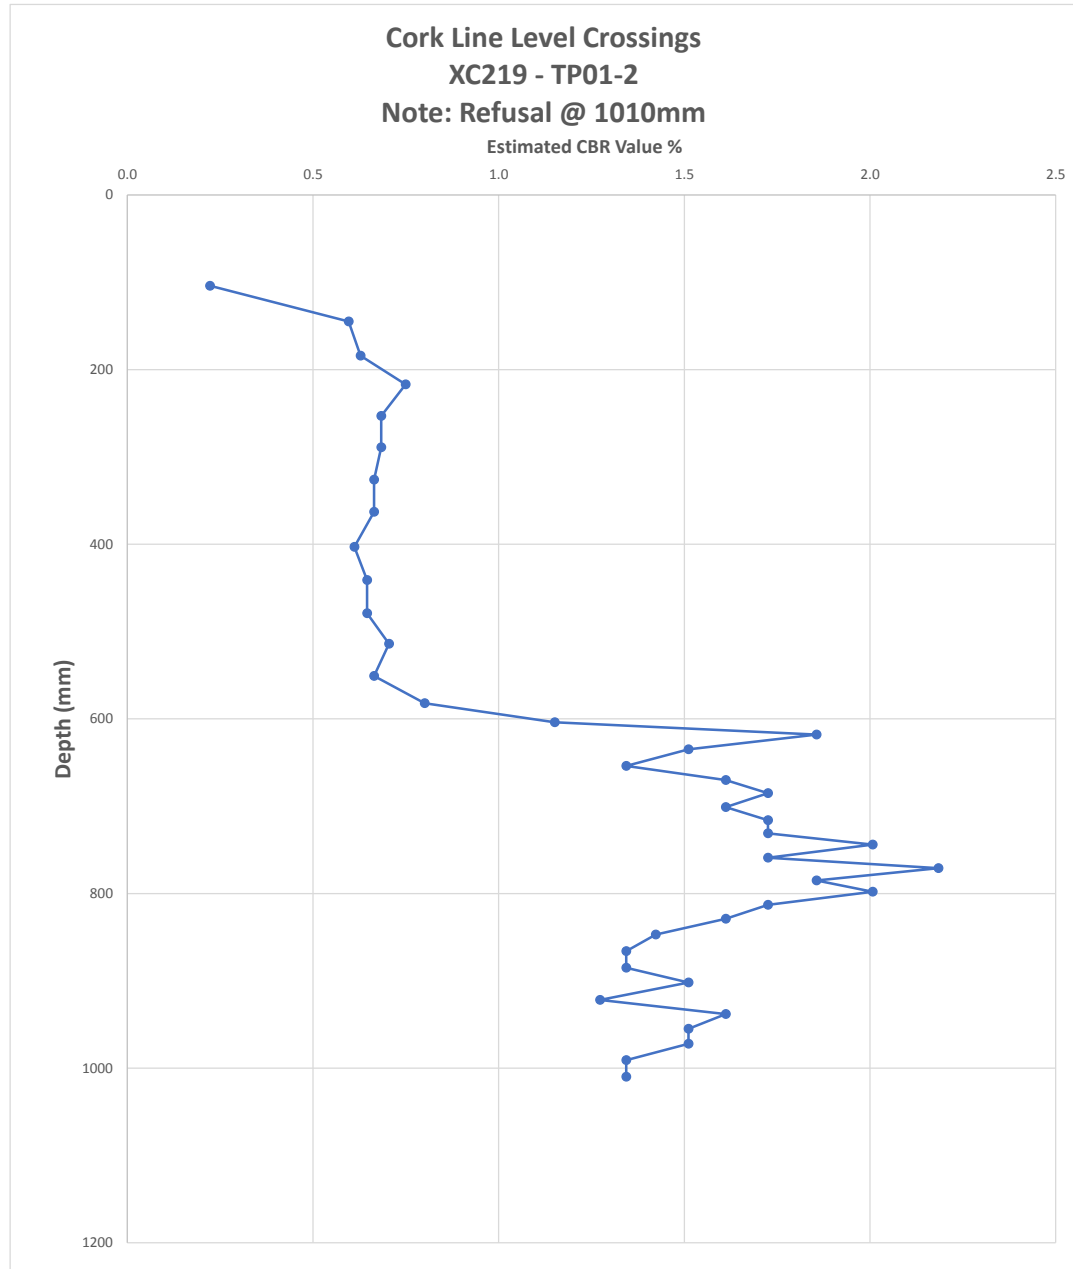
Location	XC219 - TP01-2	Job No	19-135
----------	----------------	--------	--------

No. of Blows	READING (mm)	Penetration/blow (mm)	DEPTH	CBR %
1	1021	104	104	0.2
2	980	41	145	0.6
3	941	39	184	0.6
4	908	33	217	0.7
5	872	36	253	0.7
6	836	36	289	0.7
7	799	37	326	0.7
8	762	37	363	0.7
9	722	40	403	0.6
10	684	38	441	0.6
11	646	38	479	0.6
12	611	35	514	0.7
13	574	37	551	0.7
14	543	31	582	0.8
15	521	22	604	1.2
16	507	14	618	1.9
17	490	17	635	1.5
18	471	19	654	1.3
19	455	16	670	1.6
20	440	15	685	1.7
21	424	16	701	1.6
22	409	15	716	1.7
23	394	15	731	1.7
24	381	13	744	2.0
25	366	15	759	1.7
26	354	12	771	2.2
27	340	14	785	1.9
28	327	13	798	2.0
29	312	15	813	1.7
30	296	16	829	1.6
31	278	18	847	1.4
32	259	19	866	1.3
33	240	19	885	1.3
34	223	17	902	1.5
35	203	20	922	1.3
36	187	16	938	1.6
37	170	17	955	1.5
38	153	17	972	1.5
39	134	19	991	1.3
40	115	19	1010	1.3

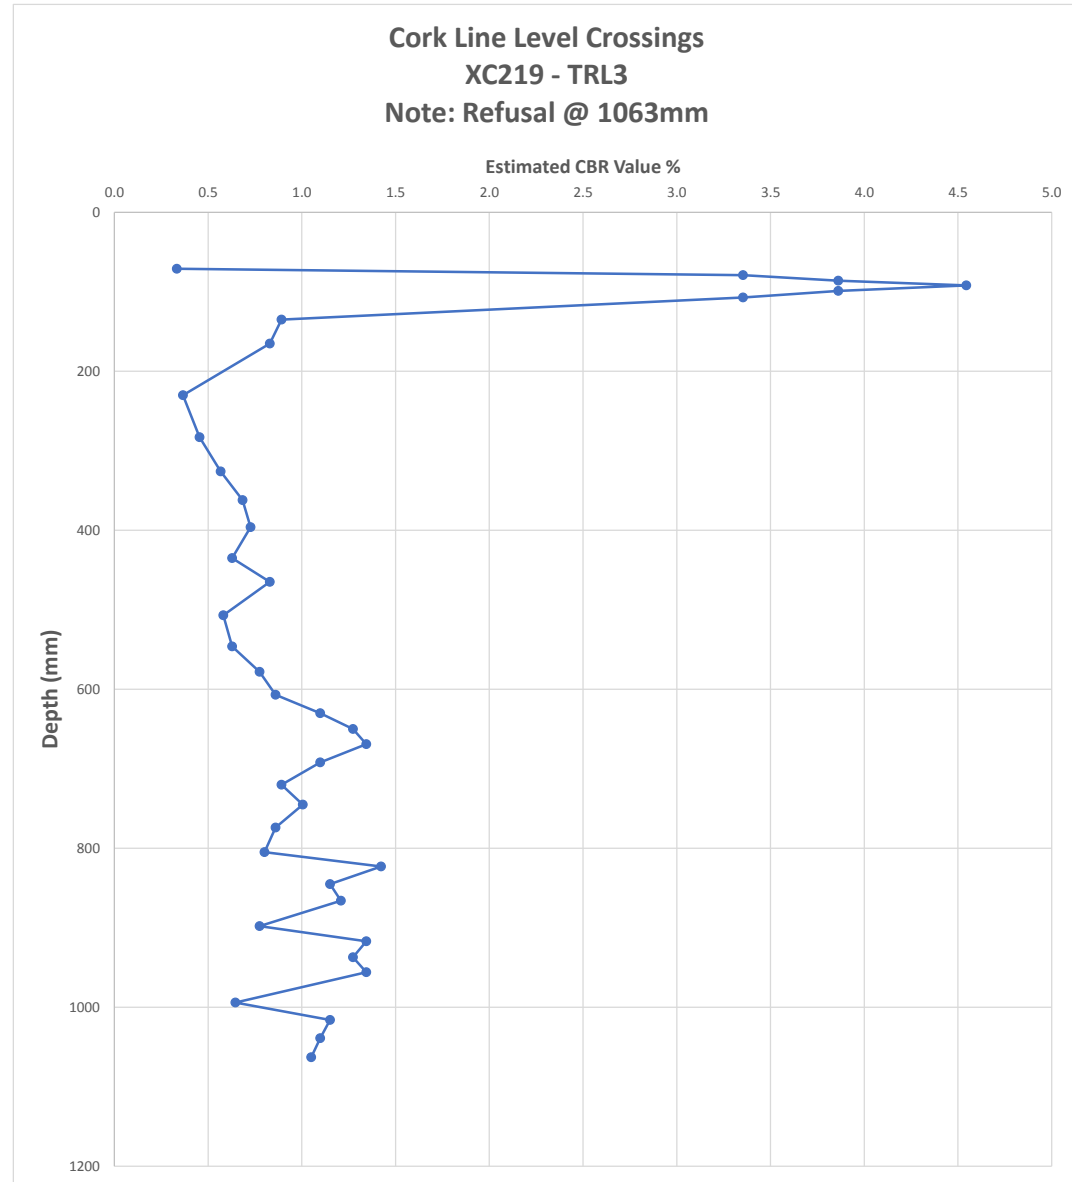
Location	XC219 - TRL3	Job No	19-135
----------	---------------------	--------	--------

No. of Blows	READING (mm)	Penetration/blow (mm)	DEPTH	CBR %
1	1079	71	71	0.3
2	1071	8	79	3.4
3	1064	7	86	3.9
4	1058	6	92	4.5
5	1051	7	99	3.9
6	1043	8	107	3.4
7	1015	28	135	0.9
8	985	30	165	0.8
9	920	65	230	0.4
10	867	53	283	0.5
11	824	43	326	0.6
12	788	36	362	0.7
13	754	34	396	0.7
14	715	39	435	0.6
15	685	30	465	0.8
16	643	42	507	0.6
17	604	39	546	0.6
18	572	32	578	0.8
19	543	29	607	0.9
20	520	23	630	1.1
21	500	20	650	1.3
22	481	19	669	1.3
23	458	23	692	1.1
24	430	28	720	0.9
25	405	25	745	1.0
26	376	29	774	0.9
27	345	31	805	0.8
28	327	18	823	1.4
29	305	22	845	1.2
30	284	21	866	1.2
31	252	32	898	0.8
32	233	19	917	1.3
33	213	20	937	1.3
34	194	19	956	1.3
35	156	38	994	0.6
36	134	22	1016	1.2
37	111	23	1039	1.1
38	87	24	1063	1.0
39

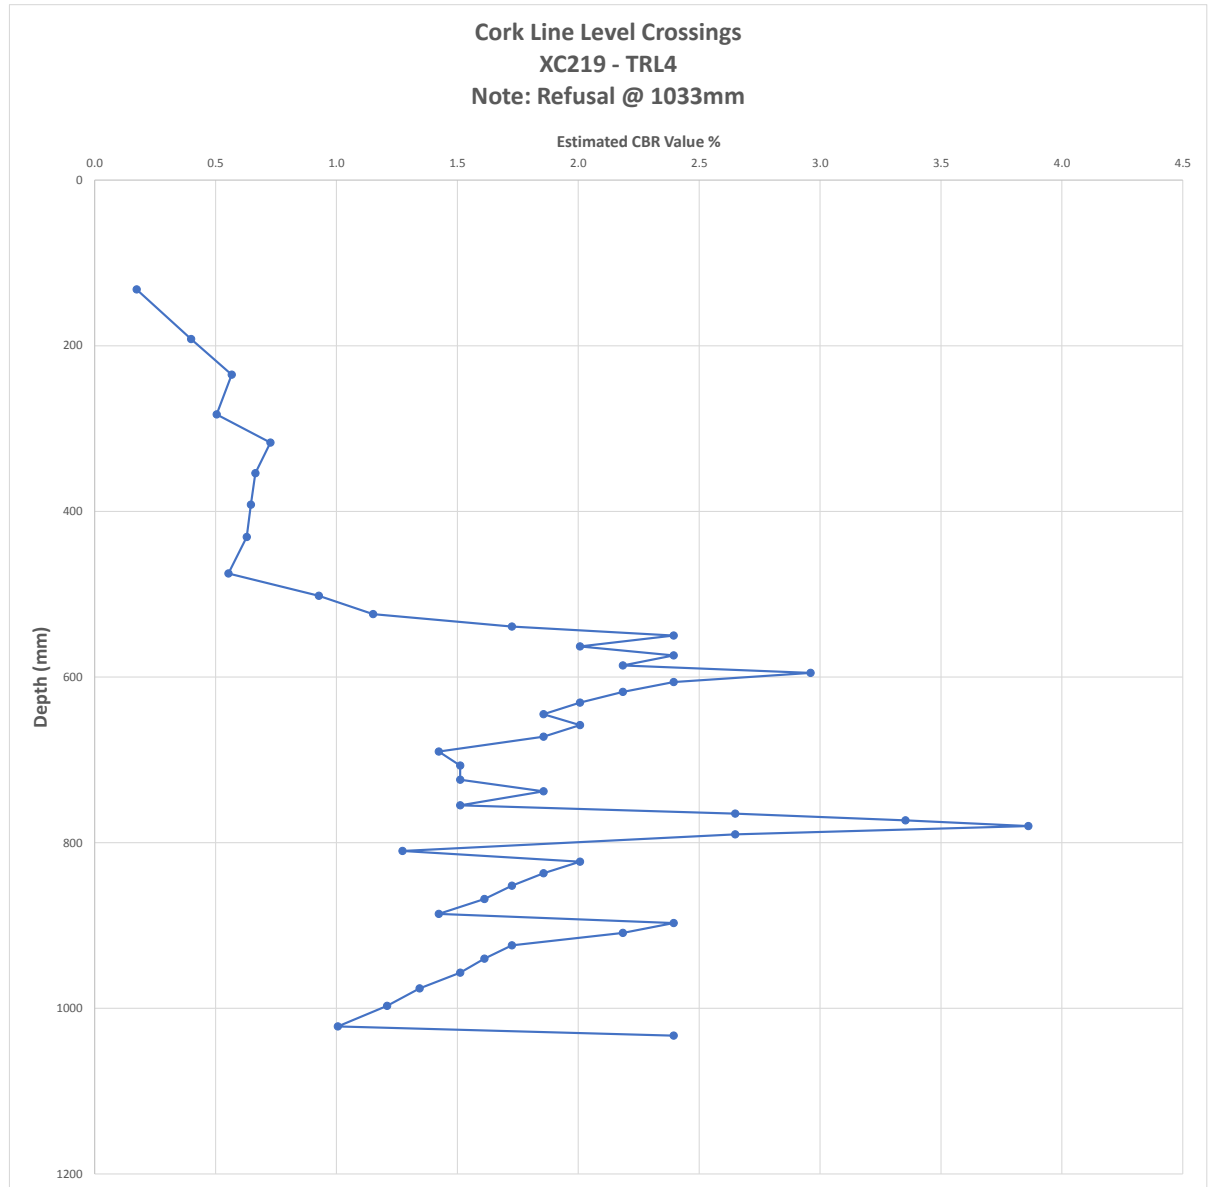
Location	XC219 - TRL4	Job No	19-135
----------	--------------	--------	--------

No. of Blows	READING (mm)	Penetration/blow (mm)	DEPTH	CBR %
1	1018	132	132	0.2
2	958	60	192	0.4
3	915	43	235	0.6
4	867	48	283	0.5
5	833	34	317	0.7
6	796	37	354	0.7
7	758	38	392	0.6
8	719	39	431	0.6
9	675	44	475	0.6
10	648	27	502	0.9
11	626	22	524	1.2
12	611	15	539	1.7
13	600	11	550	2.4
14	587	13	563	2.0
15	576	11	574	2.4
16	564	12	586	2.2
17	555	9	595	3.0
18	544	11	606	2.4
19	532	12	618	2.2
20	519	13	631	2.0
21	505	14	645	1.9
22	492	13	658	2.0
23	478	14	672	1.9
24	460	18	690	1.4
25	443	17	707	1.5
26	426	17	724	1.5
27	412	14	738	1.9
28	395	17	755	1.5
29	385	10	765	2.6
30	377	8	773	3.4
31	370	7	780	3.9
32	360	10	790	2.6
33	340	20	810	1.3
34	327	13	823	2.0
35	313	14	837	1.9
36	298	15	852	1.7
37	282	16	868	1.6
38	264	18	886	1.4
39	253	11	897	2.4
40	241	12	909	2.2
41	226	15	924	1.7
42	210	16	940	1.6
43	193	17	957	1.5
44	174	19	976	1.3
45	153	21	997	1.2
46	128	25	1022	1.0
47	117	11	1033	2.4
48

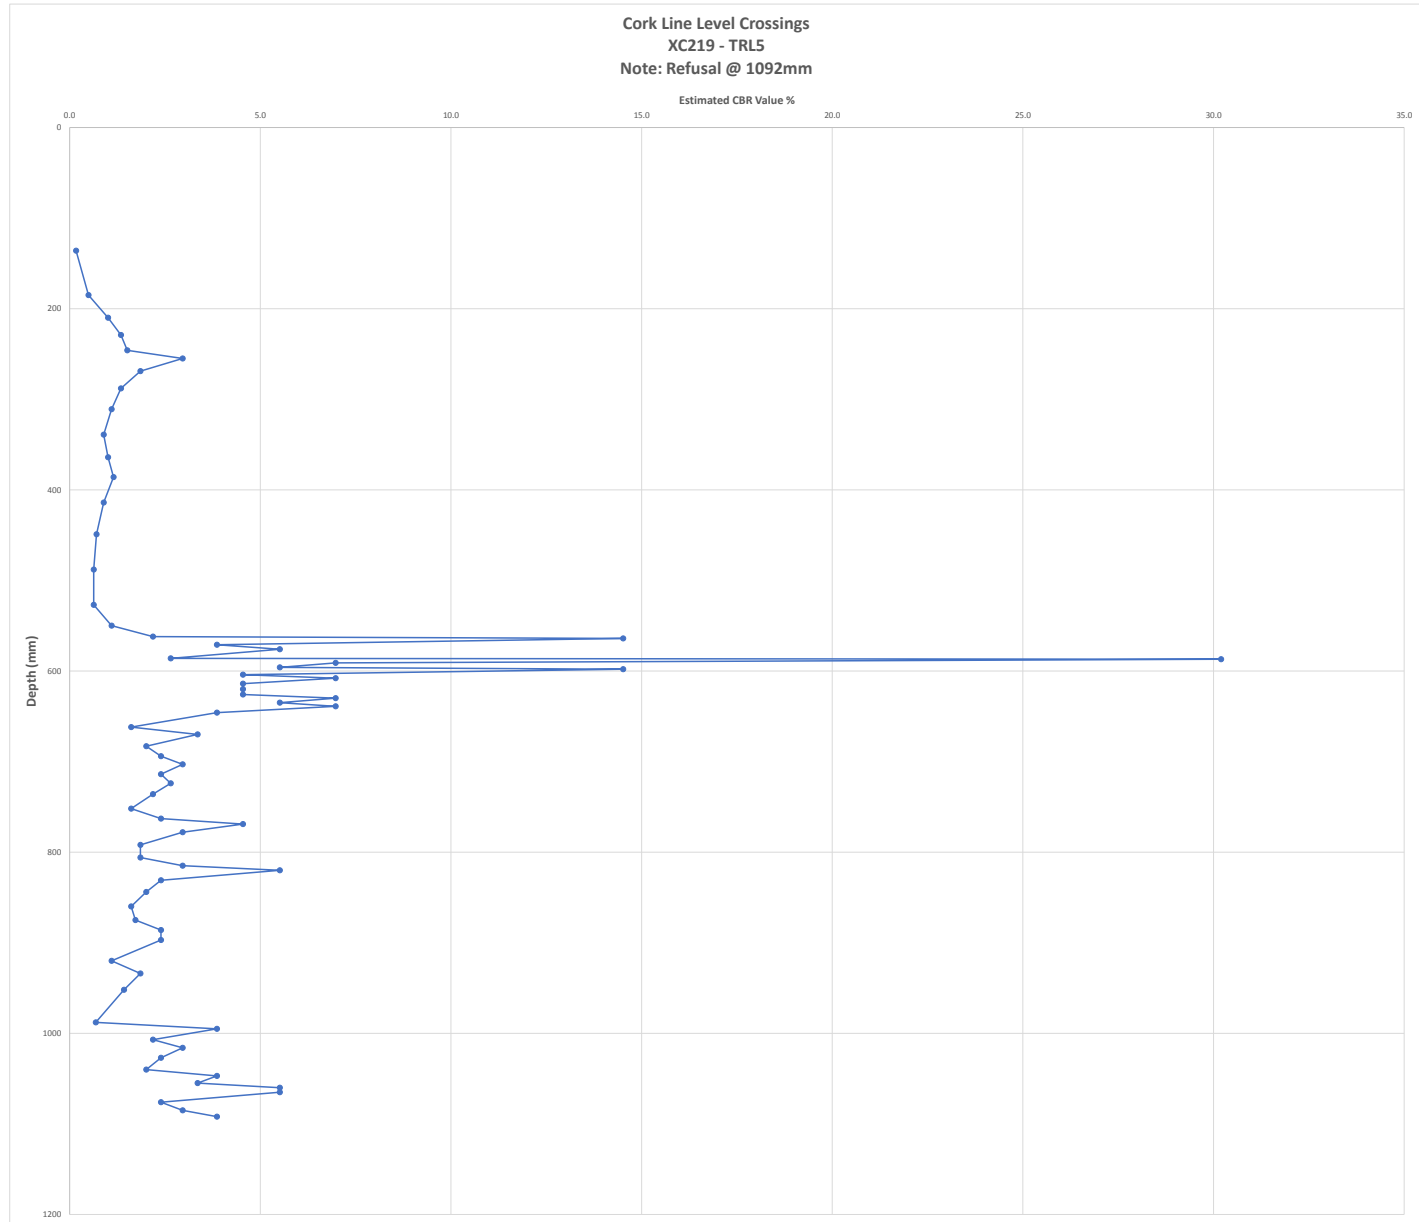
Location	XC219 - TRL5	Job No	19-135
----------	---------------------	--------	--------

No. of Blows	READING (mm)	Penetration/blow (mm)	DEPTH	CBR %
1	1014	136	136	0.2
2	965	49	185	0.5
3	940	25	210	1.0
4	921	19	229	1.3
5	904	17	246	1.5
6	895	9	255	3.0
7	881	14	269	1.9
8	862	19	288	1.3
9	839	23	311	1.1
10	811	28	339	0.9
11	786	25	364	1.0
12	764	22	386	1.2
13	736	28	414	0.9
14	701	35	449	0.7
15	662	39	488	0.6
16	623	39	527	0.6
17	600	23	550	1.1
18	588	12	562	2.2
19	586	2	564	14.5
20	579	7	571	3.9
21	574	5	576	5.5
22	564	10	586	2.6
23	563	1	587	30.2
24	559	4	591	7.0
25	554	5	596	5.5
26	552	2	598	14.5
27	546	6	604	4.5
28	542	4	608	7.0
29	536	6	614	4.5
30	530	6	620	4.5
31	524	6	626	4.5
32	520	4	630	7.0
33	515	5	635	5.5
34	511	4	639	7.0
35	504	7	646	3.9
36	488	16	662	1.6
37	480	8	670	3.4
38	467	13	683	2.0
39	456	11	694	2.4
40	447	9	703	3.0
41	436	11	714	2.4
42	426	10	724	2.6
43	414	12	736	2.2
44	398	16	752	1.6
45	387	11	763	2.4
46	381	6	769	4.5
47	372	9	778	3.0
48	358	14	792	1.9
49	344	14	806	1.9
50	335	9	815	3.0
51	330	5	820	5.5
52	319	11	831	2.4

53	306	13	844	2.0
54	290	16	860	1.6
55	275	15	875	1.7
56	264	11	886	2.4
57	253	11	897	2.4
58	230	23	920	1.1
59	216	14	934	1.9
60	198	18	952	1.4
61	162	36	988	0.7
62	155	7	995	3.9
63	143	12	1007	2.2
64	134	9	1016	3.0
65	123	11	1027	2.4
66	110	13	1040	2.0
67	103	7	1047	3.9
68	95	8	1055	3.4
69	90	5	1060	5.5
70	85	5	1065	5.5
71	74	11	1076	2.4
72	65	9	1085	3.0
73	58	7	1092	3.9
74

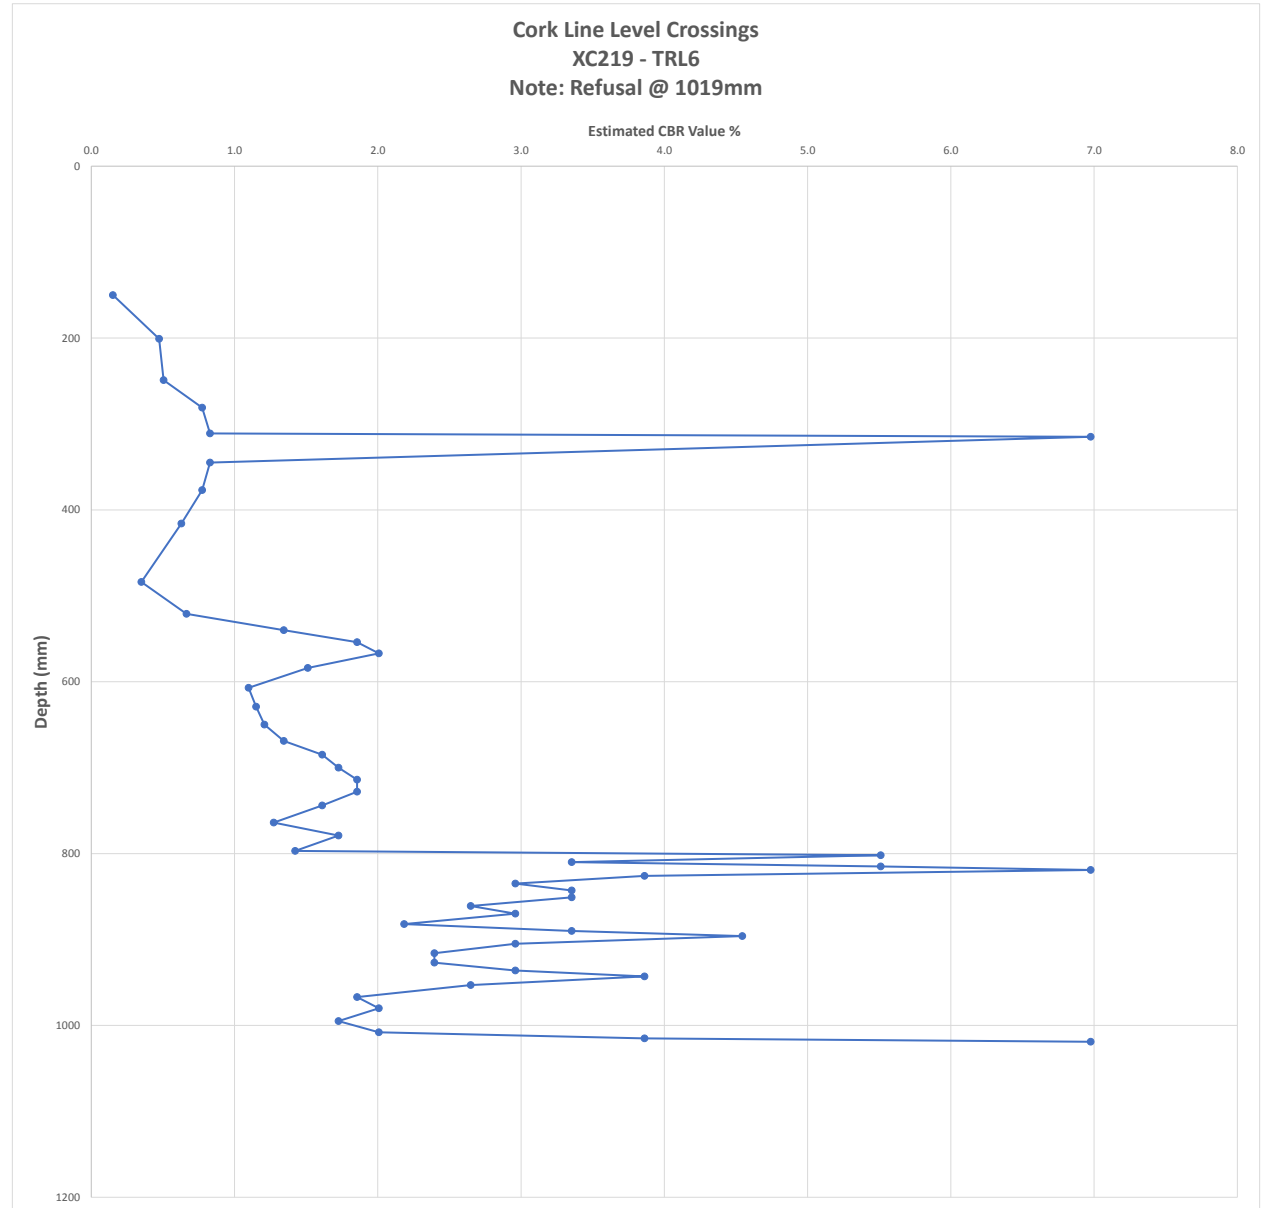
Location	XC219 - TRL6	Job No	19-135
----------	--------------	--------	--------

No. of Blows	READING (mm)	Penetration/blow (mm)	DEPTH	CBR %
1	1000	150	150	0.2
2	949	51	201	0.5
3	901	48	249	0.5
4	869	32	281	0.8
5	839	30	311	0.8
6	835	4	315	7.0
7	805	30	345	0.8
8	773	32	377	0.8
9	734	39	416	0.6
10	666	68	484	0.3
11	629	37	521	0.7
12	610	19	540	1.3
13	596	14	554	1.9
14	583	13	567	2.0
15	566	17	584	1.5
16	543	23	607	1.1
17	521	22	629	1.2
18	500	21	650	1.2
19	481	19	669	1.3
20	465	16	685	1.6
21	450	15	700	1.7
22	436	14	714	1.9
23	422	14	728	1.9
24	406	16	744	1.6
25	386	20	764	1.3
26	371	15	779	1.7
27	353	18	797	1.4
28	348	5	802	5.5
29	340	8	810	3.4
30	335	5	815	5.5
31	331	4	819	7.0
32	324	7	826	3.9
33	315	9	835	3.0
34	307	8	843	3.4
35	299	8	851	3.4
36	289	10	861	2.6
37	280	9	870	3.0
38	268	12	882	2.2
39	260	8	890	3.4
40	254	6	896	4.5
41	245	9	905	3.0
42	234	11	916	2.4
43	223	11	927	2.4
44	214	9	936	3.0
45	207	7	943	3.9
46	197	10	953	2.6
47	183	14	967	1.9
48	170	13	980	2.0
49	155	15	995	1.7
50	142	13	1008	2.0
51	135	7	1015	3.9

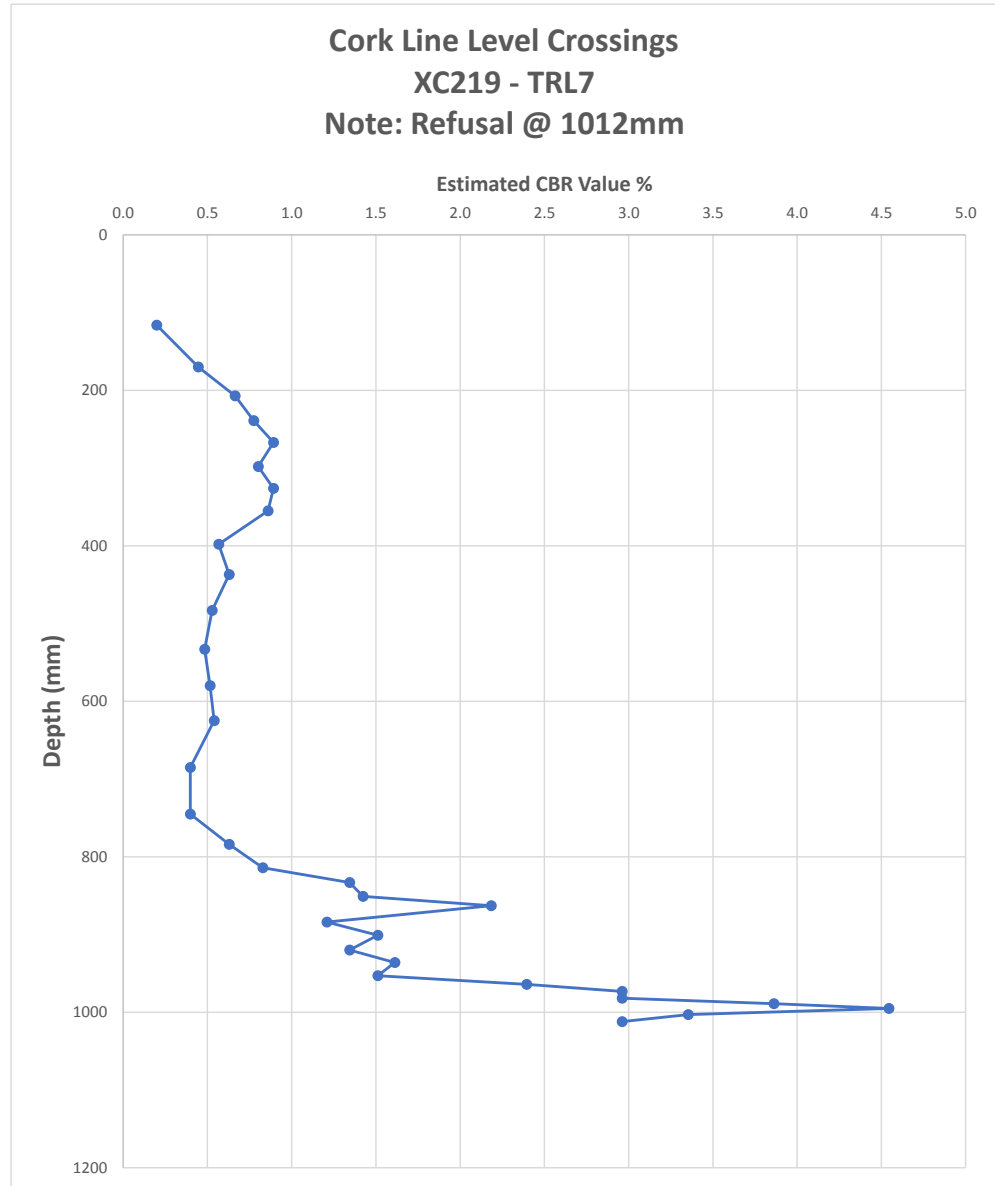
Location	XC219 - TRL7	Job No	19-135
----------	---------------------	--------	--------

No. of Blows	READING (mm)	Penetration/blow (mm)	DEPTH	CBR %
1	1034	116	116	0.2
2	980	54	170	0.4
3	943	37	207	0.7
4	911	32	239	0.8
5	883	28	267	0.9
6	852	31	298	0.8
7	824	28	326	0.9
8	795	29	355	0.9
9	752	43	398	0.6
10	713	39	437	0.6
11	667	46	483	0.5
12	617	50	533	0.5
13	570	47	580	0.5
14	525	45	625	0.5
15	465	60	685	0.4
16	405	60	745	0.4
17	366	39	784	0.6
18	336	30	814	0.8
19	317	19	833	1.3
20	299	18	851	1.4
21	287	12	863	2.2
22	266	21	884	1.2
23	249	17	901	1.5
24	230	19	920	1.3
25	214	16	936	1.6
26	197	17	953	1.5
27	186	11	964	2.4
28	177	9	973	3.0
29	168	9	982	3.0
30	161	7	989	3.9
31	155	6	995	4.5
32	147	8	1003	3.4
33	138	9	1012	3.0
34

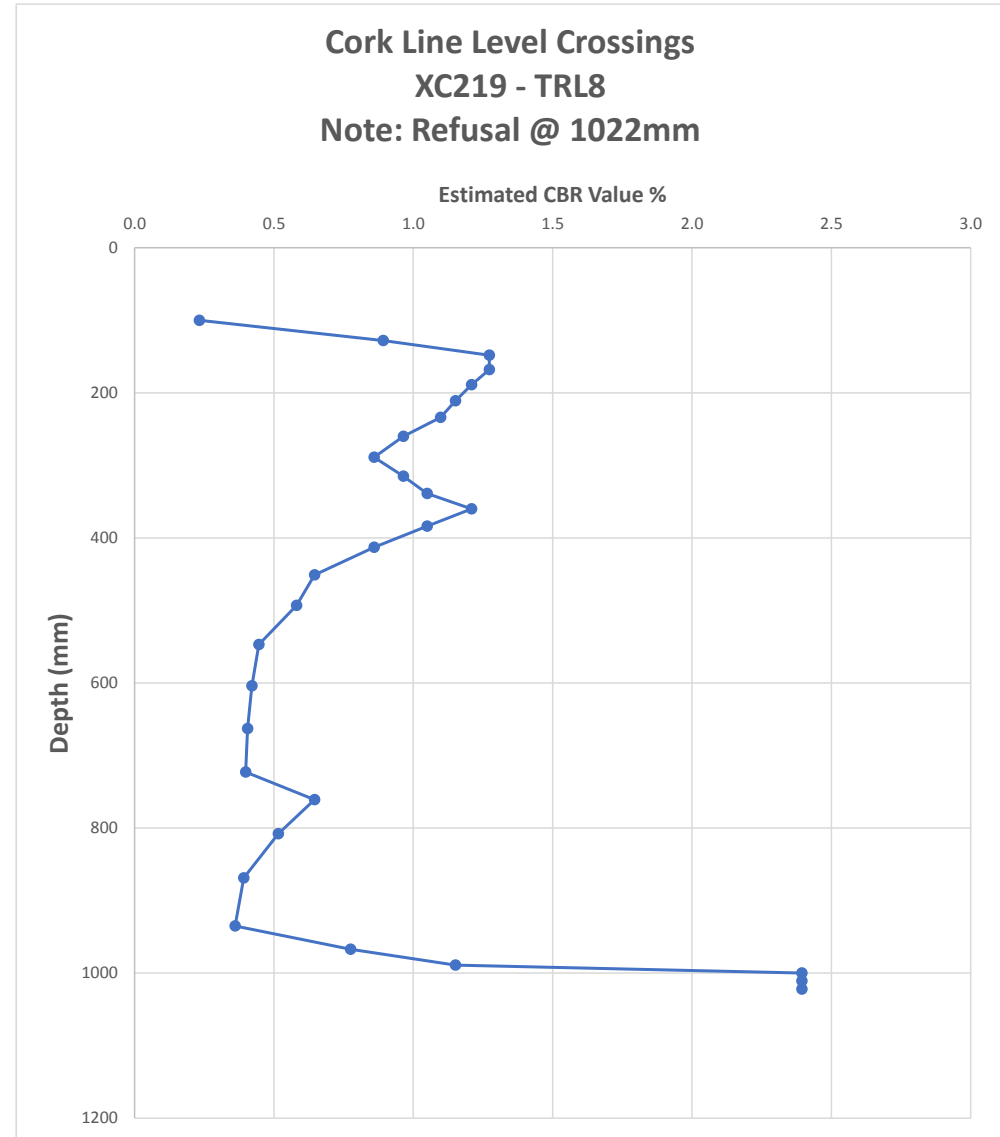
Location	XC219 - TRL8	Job No	19-135
----------	---------------------	--------	--------

No. of Blows	READING (mm)	Penetration/blow (mm)	DEPTH	CBR %
1	1050	100	100	0.2
2	1022	28	128	0.9
3	1002	20	148	1.3
4	982	20	168	1.3
5	961	21	189	1.2
6	939	22	211	1.2
7	916	23	234	1.1
8	890	26	260	1.0
9	861	29	289	0.9
10	835	26	315	1.0
11	811	24	339	1.0
12	790	21	360	1.2
13	766	24	384	1.0
14	737	29	413	0.9
15	699	38	451	0.6
16	657	42	493	0.6
17	603	54	547	0.4
18	546	57	604	0.4
19	487	59	663	0.4
20	427	60	723	0.4
21	389	38	761	0.6
22	342	47	808	0.5
23	281	61	869	0.4
24	215	66	935	0.4
25	183	32	967	0.8
26	161	22	989	1.2
27	150	11	1000	2.4
28	139	11	1011	2.4
29	128	11	1022	2.4
30

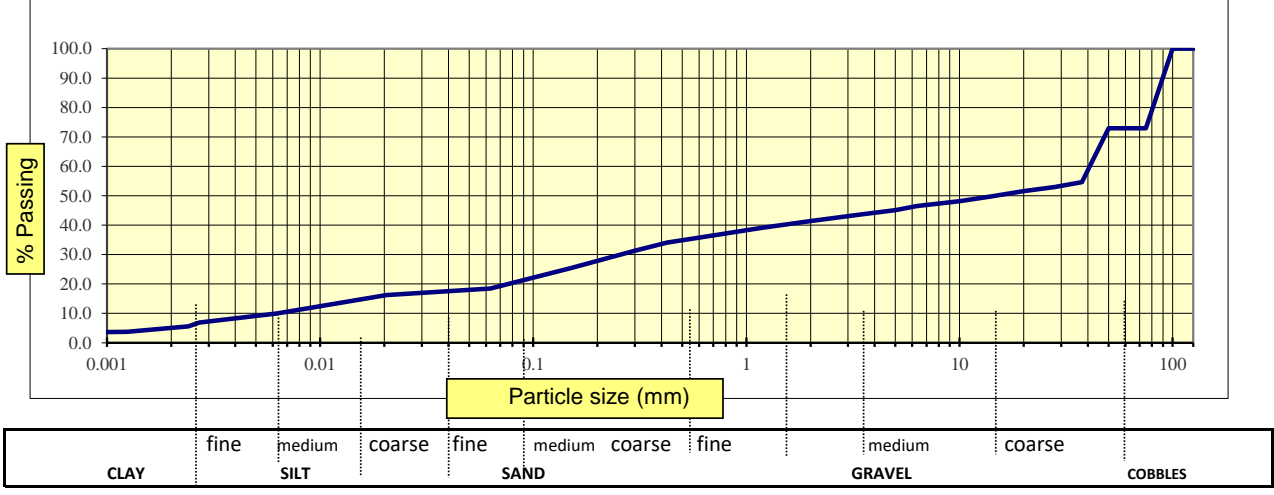
Client Ref.	XC219-CPRC02 Type B Sample 3
Location:	XC219-CPRC02 Type B Sample 3
Supplier:	Bulk
Source:	Client Info.
Depth (m):	1.2-2.0m
Sampling Reason:	Client Request
Sampled By:	Client
Specification:	Client
Preparation Method:	Without Organics Preparation
Notes:	Disturbed sample from cleanout

BS Sieve Size	% Passing	Specification
300 mm	100	
125 mm	100	
100 mm	100	
75 mm	73	
63 mm	73	
50 mm	73	
37.5 mm	55	
28 mm	53	
20 mm	52	
14 mm	50	
10 mm	48	
6.3 mm	46	
5 mm	45	
3.35 mm	44	
2 mm	41	
1.18 mm	39	
0.6 mm	36	
0.425 mm	34	
0.3 mm	31	
0.15 mm	25	
0.063 mm	18	
0.020 mm	16	
0.006 mm	10	
0.003 mm	7	
0.002 mm	6	
0.001 mm	4

Tested in accordance with BS 1377: Part 2 : 1990 Clause 9.2 and 9.5
