Iarnród Éireann  
Cork Line Level Crossings  
XC201 (19-135-1)

T.PIT4
	Trial Pit Photographs
Client:	Iarnród Éireann
Engineer:	Jacob's
Date:	July 2020

## **Appendix E**

## **Indirect CBR Test Data**

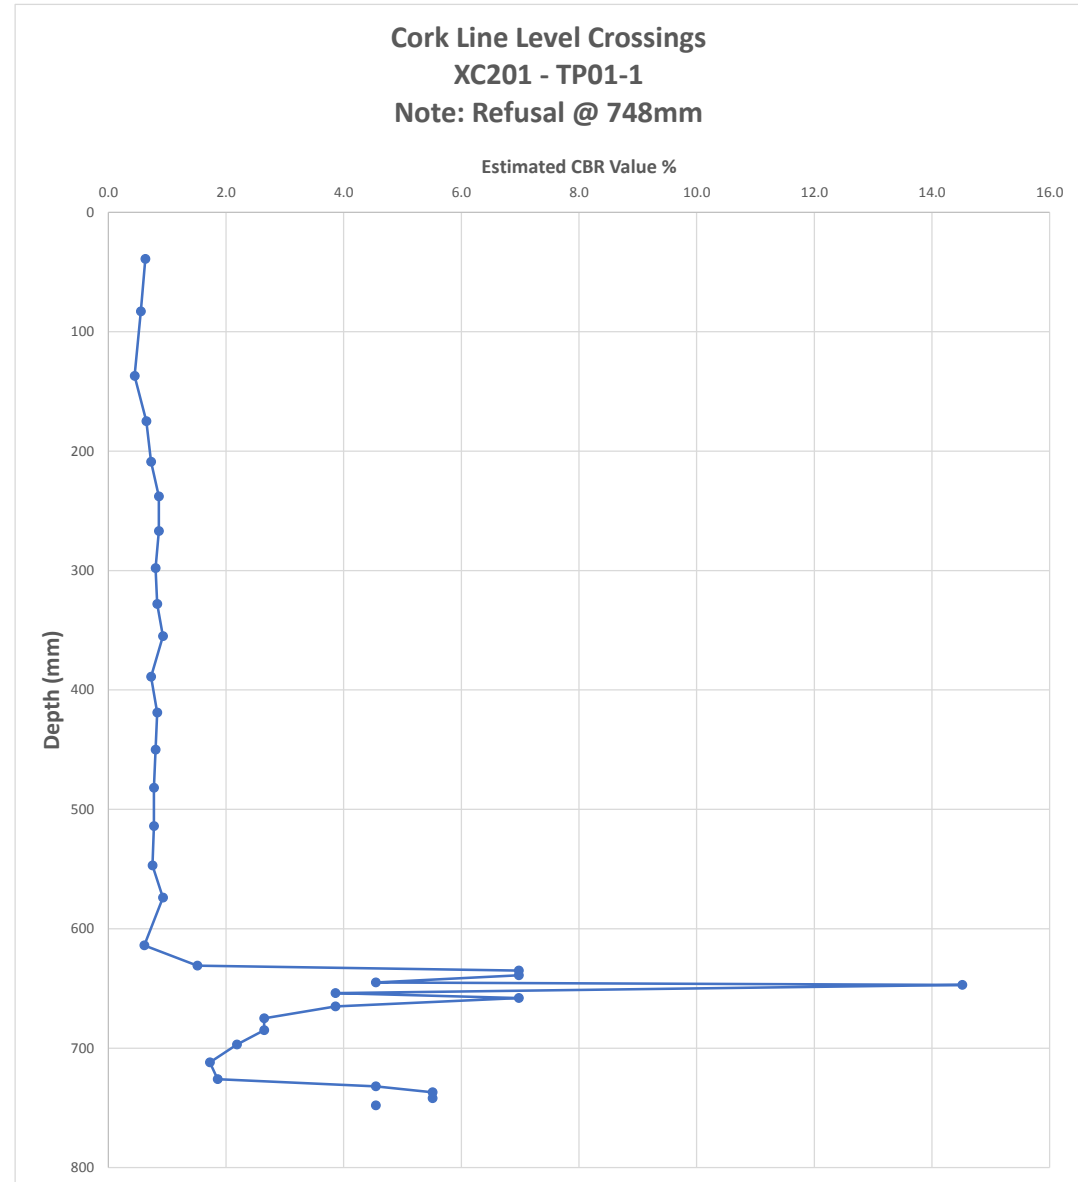
Location	XC201 - TP01-1	Job No	19-135
----------	----------------	--------	--------

No. of Blows	READING (mm)	Penetration/blow (mm)	DEPTH	CBR %
1	1101	39	39	0.6
2	1057	44	83	0.6
3	1003	54	137	0.4
4	965	38	175	0.6
5	931	34	209	0.7
6	902	29	238	0.9
7	873	29	267	0.9
8	842	31	298	0.8
9	812	30	328	0.8
10	785	27	355	0.9
11	751	34	389	0.7
12	721	30	419	0.8
13	690	31	450	0.8
14	658	32	482	0.8
15	626	32	514	0.8
16	593	33	547	0.7
17	566	27	574	0.9
18	526	40	614	0.6
19	509	17	631	1.5
20	505	4	635	7.0
21	501	4	639	7.0
22	495	6	645	4.5
23	493	2	647	14.5
24	486	7	654	3.9
25	482	4	658	7.0
26	475	7	665	3.9
27	465	10	675	2.6
28	455	10	685	2.6
29	443	12	697	2.2
30	428	15	712	1.7
31	414	14	726	1.9
32	408	6	732	4.5
33	403	5	737	5.5
34	398	5	742	5.5
35	398	0	742	
36	392	6	748	4.5
37	392	0	748	
38	392	0	748

The test results are presented in Appendix E in the form of plots of the variation with depth of the cumulative blow count. Straight lines have been fitted to the plots and the CBR for each depth range estimated using the following relationship, as proposed by DTP Interim Advice Note 73/06 (Design Guidance for Road Pavement Foundations):

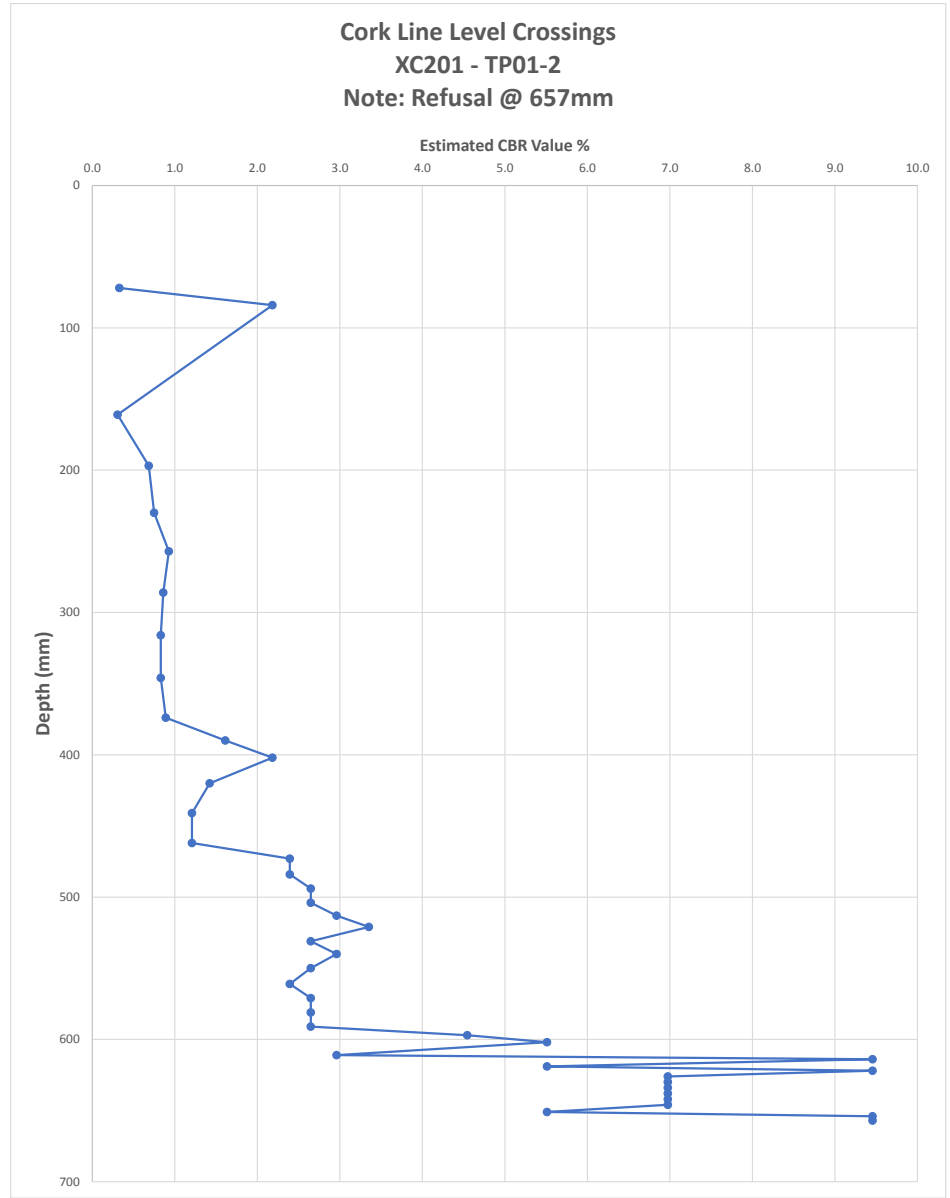
Location	XC201 - TP01-2	Job No	19-135
----------	----------------	--------	--------

No. of Blows	READING (mm)	Penetration/blow (mm)	DEPTH	CBR %
1	1068	72	72	0.3
2	1056	12	84	2.2
3	979	77	161	0.3
4	943	36	197	0.7
5	910	33	230	0.7
6	883	27	257	0.9
7	854	29	286	0.9
8	824	30	316	0.8
9	794	30	346	0.8
10	766	28	374	0.9
11	750	16	390	1.6
12	738	12	402	2.2
13	720	18	420	1.4
14	699	21	441	1.2
15	678	21	462	1.2
16	667	11	473	2.4
17	656	11	484	2.4
18	646	10	494	2.6
19	636	10	504	2.6
20	627	9	513	3.0
21	619	8	521	3.4
22	609	10	531	2.6
23	600	9	540	3.0
24	590	10	550	2.6
25	579	11	561	2.4
26	569	10	571	2.6
27	559	10	581	2.6
28	549	10	591	2.6
29	543	6	597	4.5
30	538	5	602	5.5
31	529	9	611	3.0
32	526	3	614	9.5
33	521	5	619	5.5
34	518	3	622	9.5
35	514	4	626	7.0
36	510	4	630	7.0
37	506	4	634	7.0
38	502	4	638	7.0
39	498	4	642	7.0
40	494	4	646	7.0
41	489	5	651	5.5
42	486	3	654	9.5
43	483	3	657	9.5
44	483	0	657	
45	483	0	657

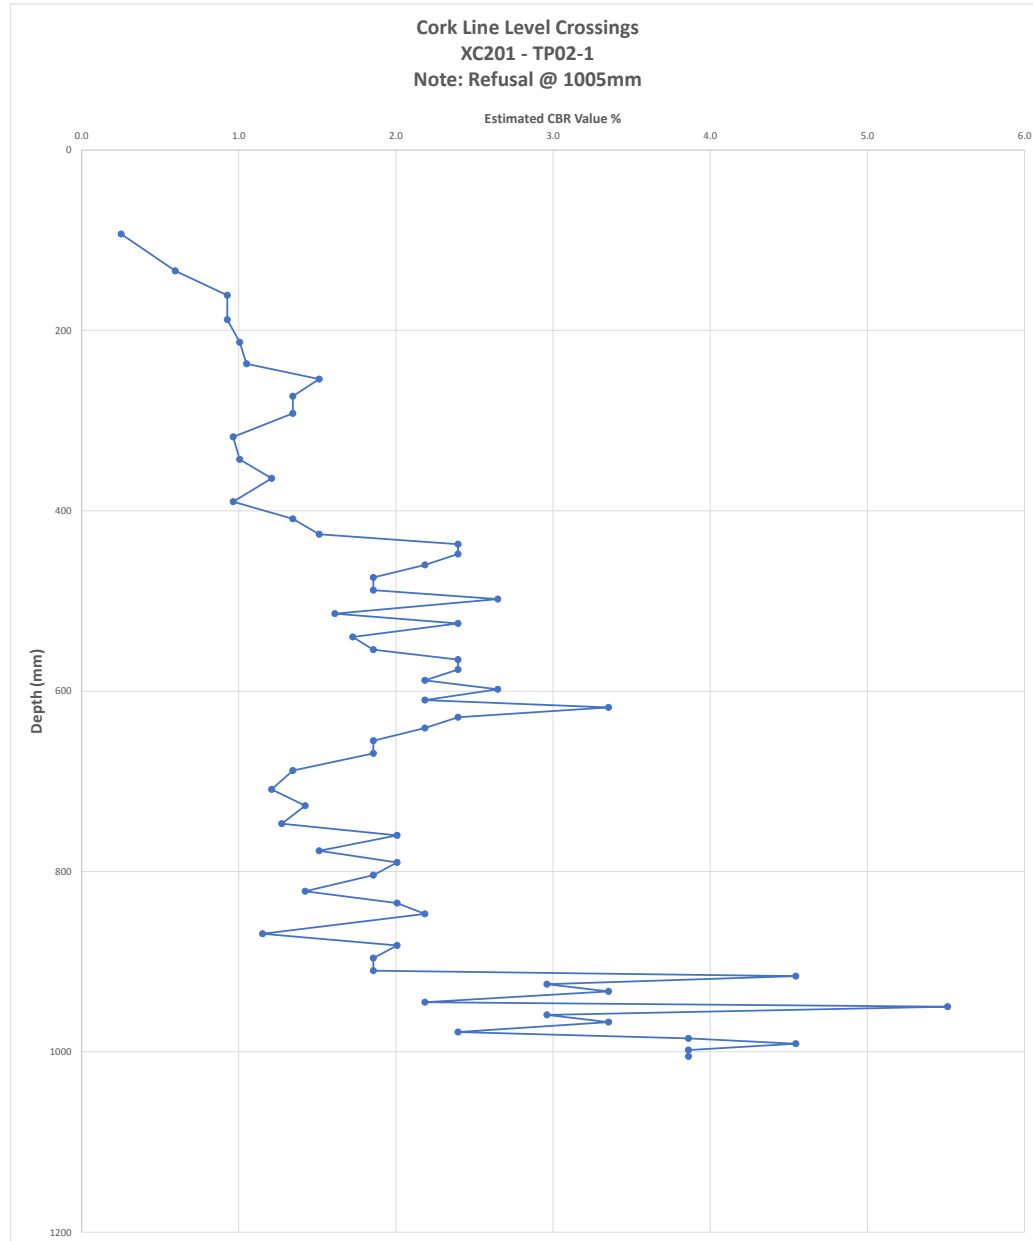
Location	XC201 - TP02-1	Job No	19-135
----------	----------------	--------	--------

No. of Blows	READING (mm)	Penetration/blow (mm)	DEPTH (mm)	CBR %
1	1030	93	93	0.3
2	989	41	134	0.6
3	962	27	161	0.9
4	935	27	188	0.9
5	910	25	213	1.0
6	886	24	237	1.0
7	869	17	254	1.5
8	850	19	273	1.3
9	831	19	292	1.3
10	805	26	318	1.0
11	780	25	343	1.0
12	759	21	364	1.2
13	733	26	390	1.0
14	714	19	409	1.3
15	697	17	426	1.5
16	686	11	437	2.4
17	675	11	448	2.4
18	663	12	460	2.2
19	649	14	474	1.9
20	635	14	488	1.9
21	625	10	498	2.6
22	609	16	514	1.6
23	598	11	525	2.4
24	583	15	540	1.7
25	569	14	554	1.9
26	558	11	565	2.4
27	547	11	576	2.4
28	535	12	588	2.2
29	525	10	598	2.6
30	513	12	610	2.2
31	505	8	618	3.4
32	494	11	629	2.4
33	482	12	641	2.2
34	468	14	655	1.9
35	454	14	669	1.9
36	435	19	688	1.3
37	414	21	709	1.2
38	396	18	727	1.4
39	376	20	747	1.3
40	363	13	760	2.0
41	346	17	777	1.5
42	333	13	790	2.0
43	319	14	804	1.9
44	301	18	822	1.4
45	288	13	835	2.0
46	276	12	847	2.2
47	254	22	869	1.2
48	241	13	882	2.0
49	227	14	896	1.9
50	213	14	910	1.9

51	207	6	916	4.5
52	198	9	925	3.0
53	190	8	933	3.4
54	178	12	945	2.2
55	173	5	950	5.5
56	164	9	959	3.0
57	156	8	967	3.4
58	145	11	978	2.4
59	138	7	985	3.9
60	132	6	991	4.5
61	125	7	998	3.9
62	118	7	1005	3.9

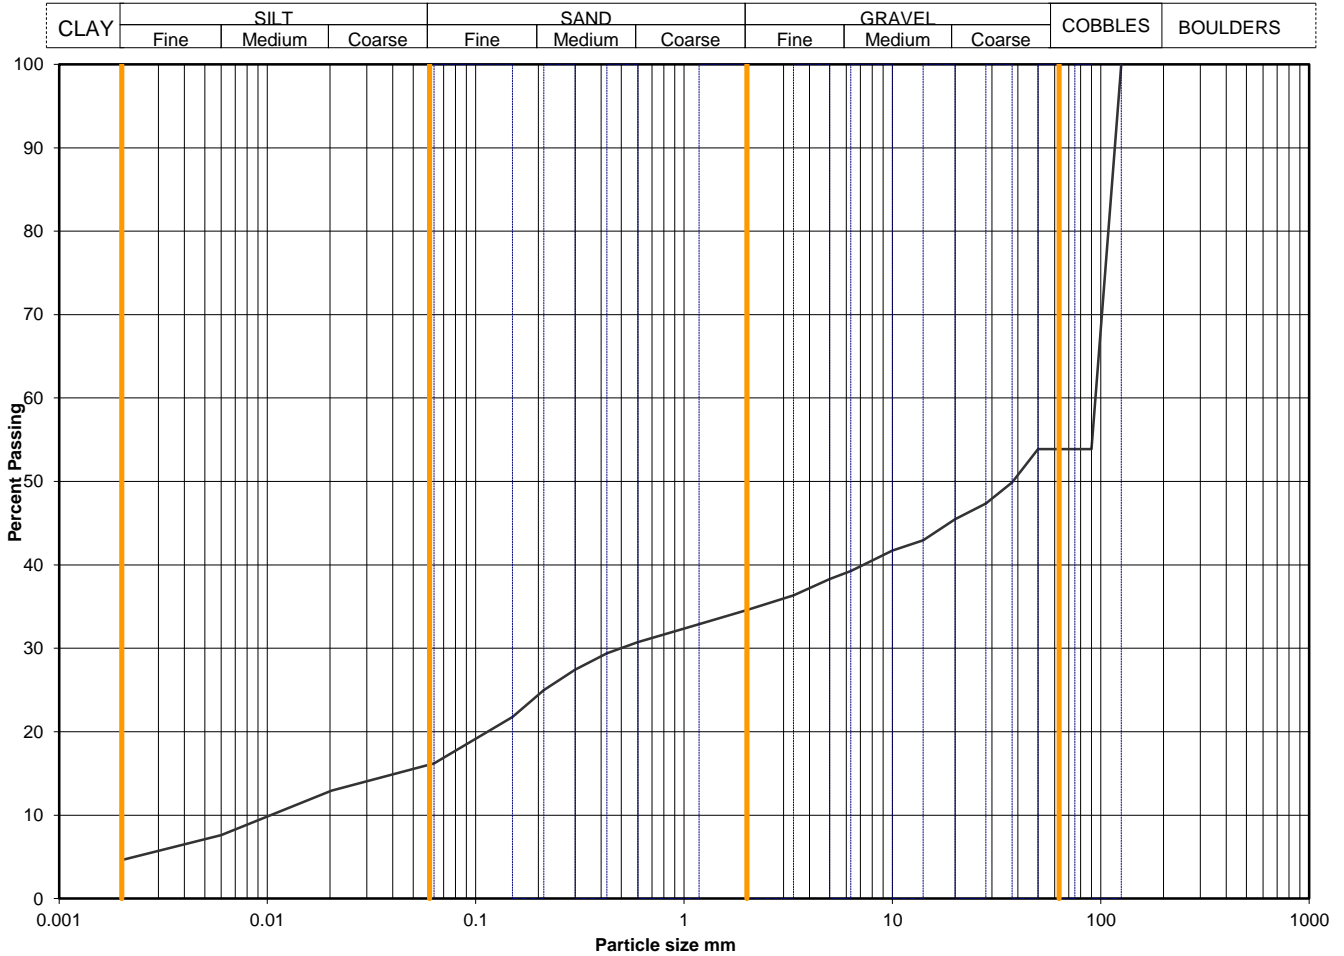
<b>Sample Details:</b>	SAMPLE ID:	Hole No	XC201-CP01
	SOCO202008042	Sample Depth (m BGL)	1.20 - 2.00
		Sample Type and No	B5
		Specimen Ref

Sieving		Sedimentation	
Particle Size mm	% Passing	Particle Size mm	% Passing
125	100	0.0203	13
90	54	0.0060	8
75	54	0.0020	5
63	54		
50	54		
37.5	50		
28	47		
20	45		
14	43		
10	42		
6.3	39		
5.0	38		
3.35	36		
2.00	35		
1.18	33		
0.600	31	Particle density, Mg/m <sup>3</sup>	
0.425	29	2.65	assumed
0.300	27	Dry mass of sample, kg	
0.212	25	7.1	
0.150	22		
0.063	16

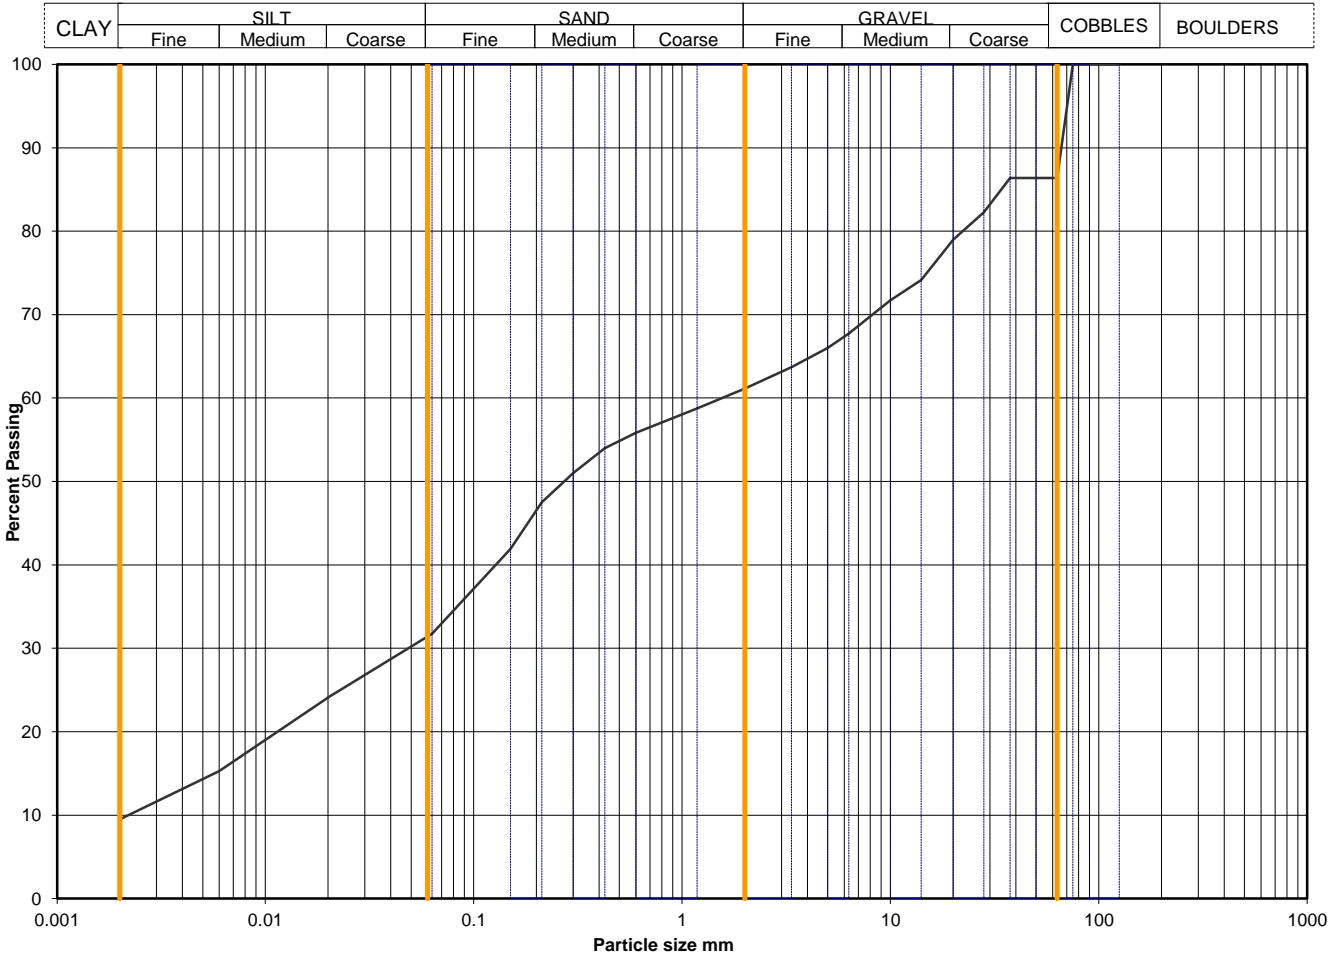
<b>Sample Details:</b>	SAMPLE ID:	Hole No	XC201-CP01A
	SOCO202008044	Sample Depth (m BGL)	2.00 - 3.00
		Sample Type and No	B7
		Specimen Ref

Sieving		Sedimentation	
Particle Size mm	% Passing	Particle Size mm	% Passing
125	100	0.0203	24
90	100	0.0060	15
75	100	0.0020	9
63	86		
50	86		
37.5	86		
28	82		
20	79		
14	74		
10	72		
6.3	68		
5.0	66		
3.35	64		
2.00	61		
1.18	59		
0.600	56	Particle density, Mg/m <sup>3</sup>	
0.425	54	2.65	assumed
0.300	51	Dry mass of sample, kg	
0.212	48	3.0	
0.150	42		
0.063	32

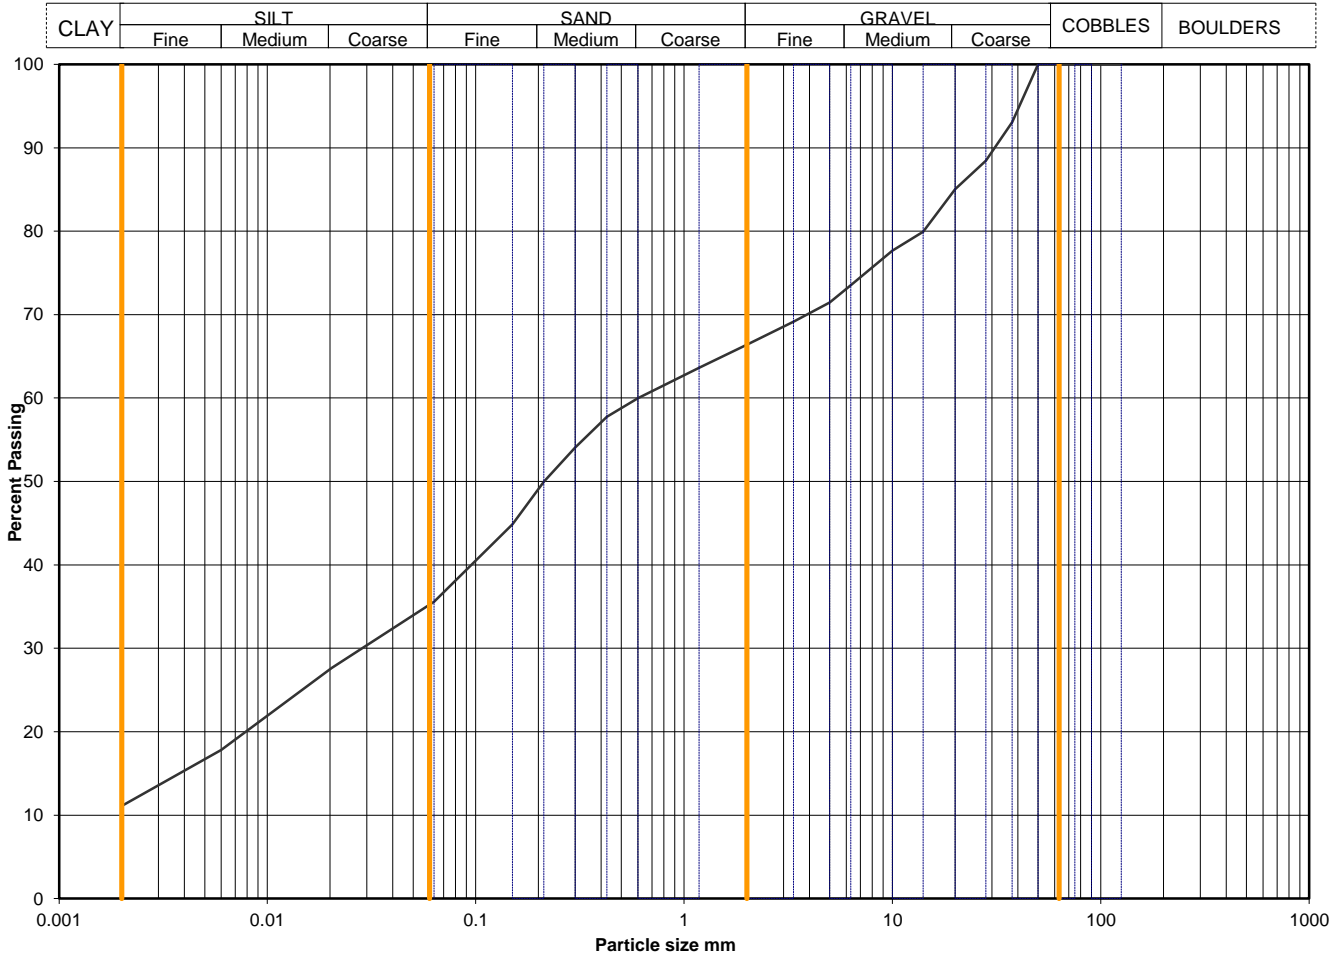
<b>Sample Details:</b>	SAMPLE ID:	Hole No	XC201-CP02
	SOCO202008046	Sample Depth (m BGL)	1.20 - 2.00
		Sample Type and No	B5
		Specimen Ref

Sieving		Sedimentation	
Particle Size mm	% Passing	Particle Size mm	% Passing
125	100	0.0203	28
90	100	0.0060	18
75	100	0.0020	11
63	100		
50	100		
37.5	93		
28	88		
20	85		
14	80		
10	78		
6.3	74		
5.0	71		
3.35	69		
2.00	66		
1.18	64		
0.600	60		
0.425	58		
0.300	54		
0.212	50		
0.150	45		
0.063	36		
		Particle density, Mg/m <sup>3</sup>	
		2.65	assumed
		Dry mass of sample, kg	
		2.9

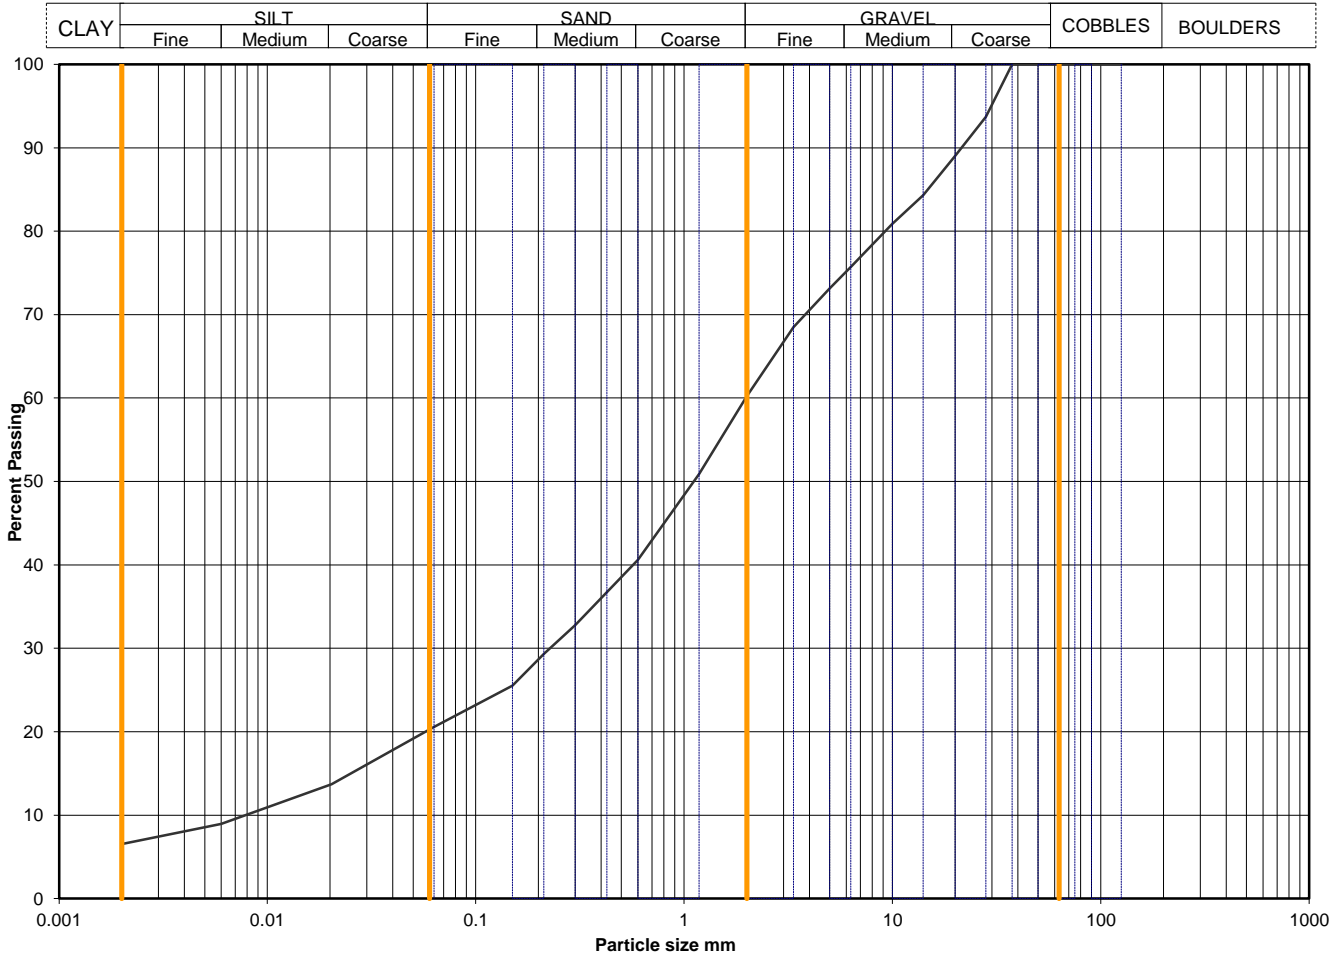
<b>Sample Details:</b>	SAMPLE ID:	Hole No	XC201-CPRC01
	SOCO2020080416	Sample Depth (m BGL)	3.20 - 3.70
		Sample Type and No	B15
		Specimen Ref

Sieving		Sedimentation	
Particle Size mm	% Passing	Particle Size mm	% Passing
125	100	0.0203	14
90	100	0.0060	9
75	100	0.0020	7
63	100		
50	100		
37.5	100		
28	94		
20	89		
14	84		
10	81		
6.3	76		
5.0	73		
3.35	69		
2.00	60		
1.18	51		
0.600	41	Particle density, Mg/m <sup>3</sup>	
0.425	37	2.65 assumed	
0.300	33	Dry mass of sample, kg	
0.212	29	2.7	
0.150	26		
0.063	21

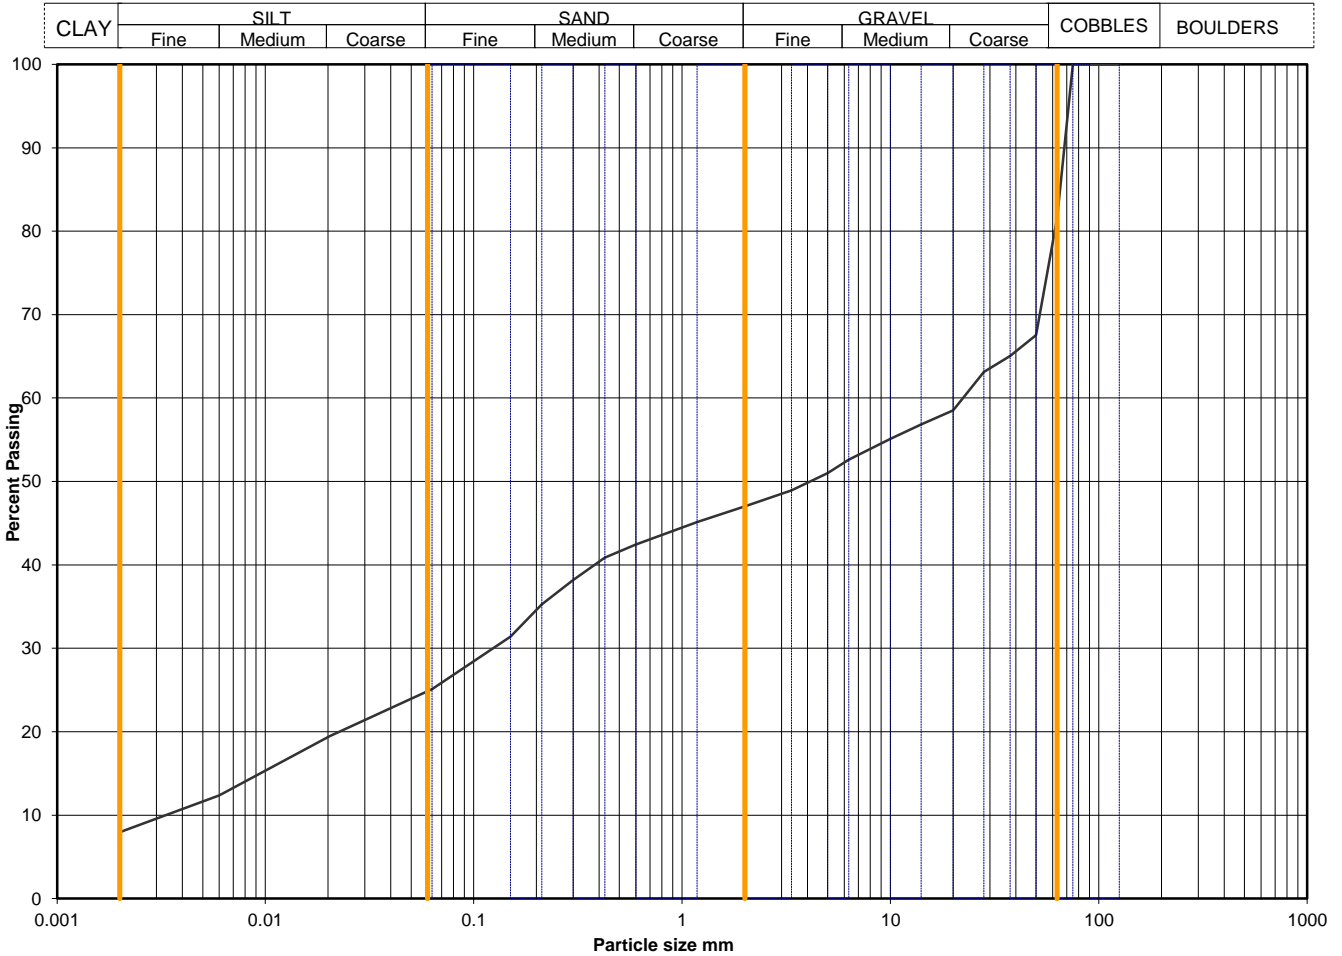
<b>Sample Details:</b>	SAMPLE ID:	Hole No	XC201-CPRC01A
	SOCO2020080417	Sample Depth (m BGL)	1.20 - 2.00
		Sample Type and No	B6
		Specimen Ref

Sieving		Sedimentation	
Particle Size mm	% Passing	Particle Size mm	% Passing
125	100	0.0203	19
90	100	0.0060	12
75	100	0.0020	8
63	82		
50	68		
37.5	65		
28	63		
20	59		
14	57		
10	55		
6.3	53		
5.0	51		
3.35	49		
2.00	47		
1.18	45		
0.600	42	Particle density, Mg/m <sup>3</sup>	
0.425	41	2.65	assumed
0.300	38	Dry mass of sample, kg	
0.212	35	10.7	
0.150	31		
0.063	25

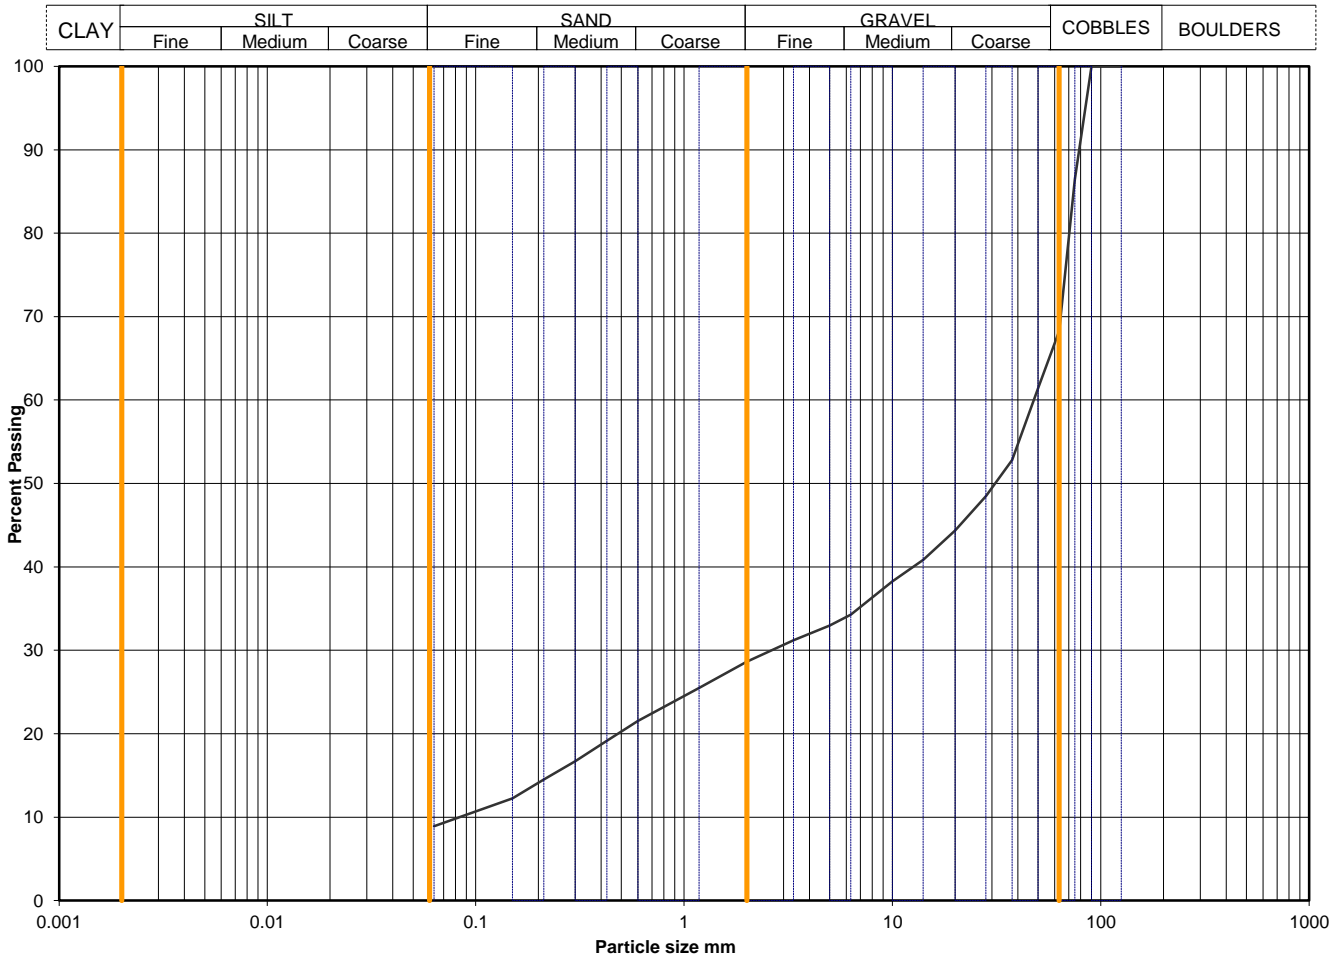
<b>Sample Details:</b>	SAMPLE ID:	Hole No	XC201-CPRC01A
	SOCO2020080420	Sample Depth (m BGL)	2.40 - 3.40
		Sample Type and No	B13
		Specimen Ref

Sieving		Sedimentation	
Particle Size mm	% Passing	Particle Size mm	% Passing
125	100		
90	100		
75	86		
63	68		
50	61		
37.5	53		
28	48		
20	44		
14	41		
10	38		
6.3	34		
5.0	33		
3.35	31		
2.00	29		
1.18	26		
0.600	22		
0.425	19		
0.300	17		
0.212	14		
0.150	12		
0.063	9		
		Dry mass of sample, kg	
		10.0

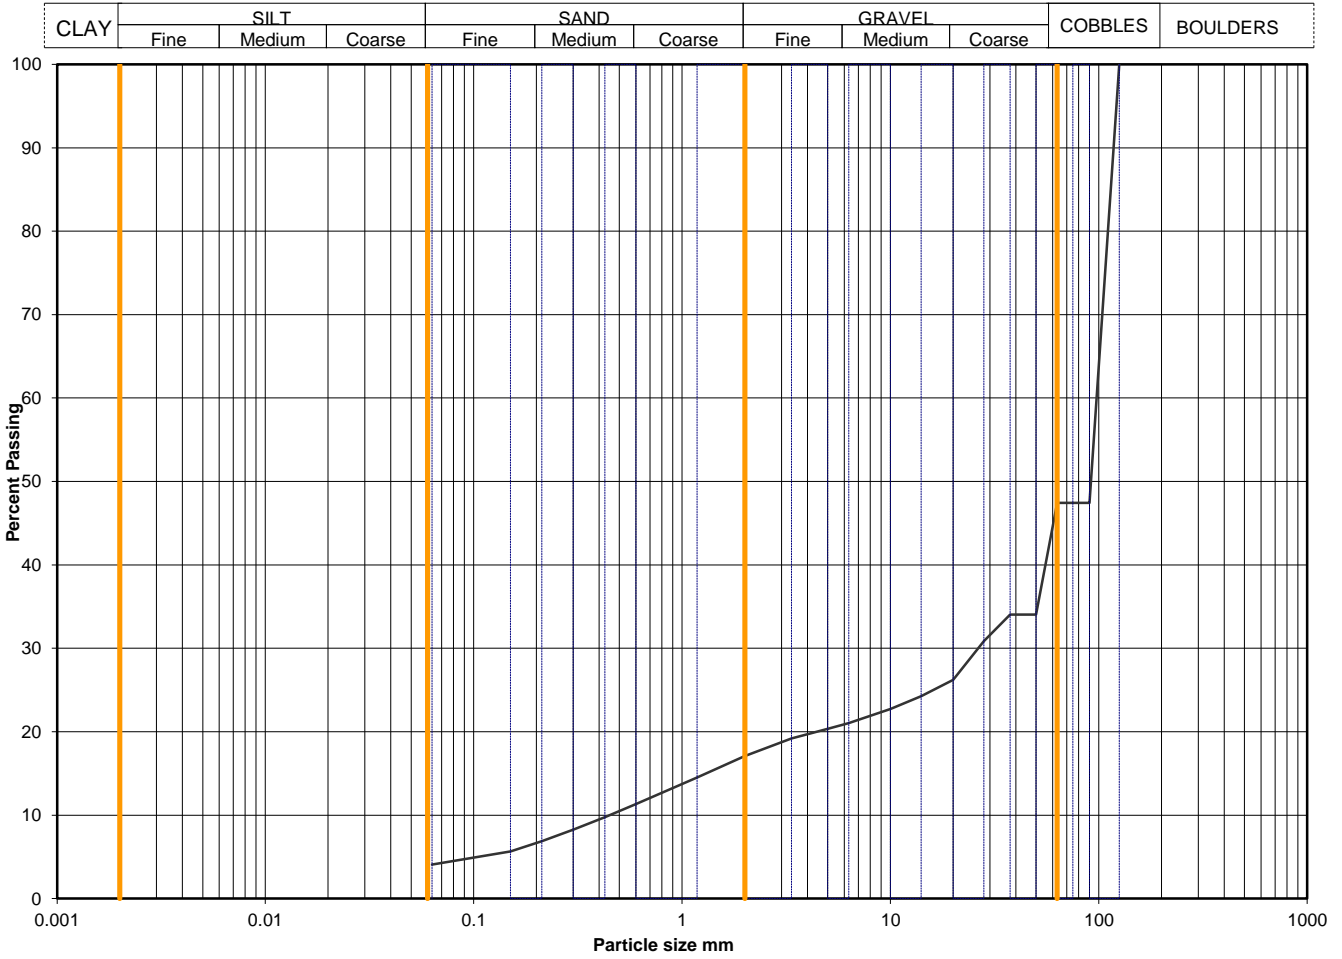
<b>Sample Details:</b>	SAMPLE ID:	Hole No	XC201-CPRC01A
	SOCO2020080422	Sample Depth (m BGL)	3.40 - 3.60
		Sample Type and No	B16
		Specimen Ref

Sieving		Sedimentation	
Particle Size mm	% Passing	Particle Size mm	% Passing
125	100		
90	47		
75	47		
63	47		
50	34		
37.5	34		
28	31		
20	26		
14	24		
10	23		
6.3	21		
5.0	20		
3.35	19		
2.00	17		
1.18	15		
0.600	11		
0.425	10		
0.300	8		
0.212	7		
0.150	6		
0.063	4		
		Dry mass of sample, kg	
		5.4

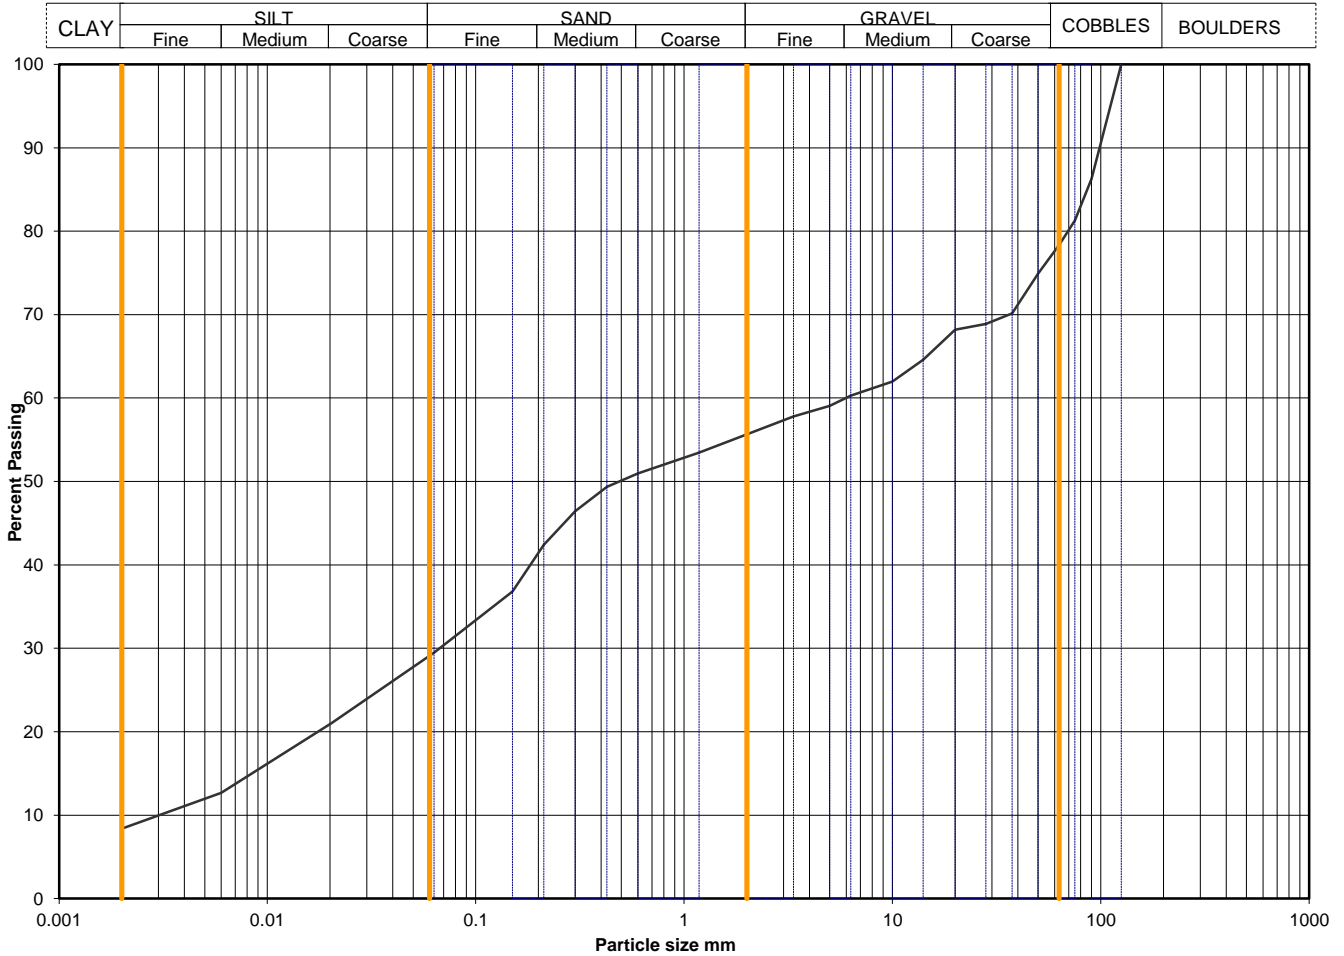
<b>Sample Details:</b>	SAMPLE ID:	Hole No	XC201-CPRC02
	SOCO2020080424	Sample Depth (m BGL)	0.20 - 1.20
		Sample Type and No	B2
		Specimen Ref

Sieving		Sedimentation	
Particle Size mm	% Passing	Particle Size mm	% Passing
125	100	0.0203	21
90	86	0.0060	13
75	81	0.0020	8
63	78		
50	75		
37.5	70		
28	69		
20	68		
14	65		
10	62		
6.3	60		
5.0	59		
3.35	58		
2.00	56		
1.18	53		
0.600	51	Particle density, Mg/m <sup>3</sup>	
0.425	49	2.65 assumed	
0.300	46	Dry mass of sample, kg	
0.212	42	15.4	
0.150	37		
0.063	29

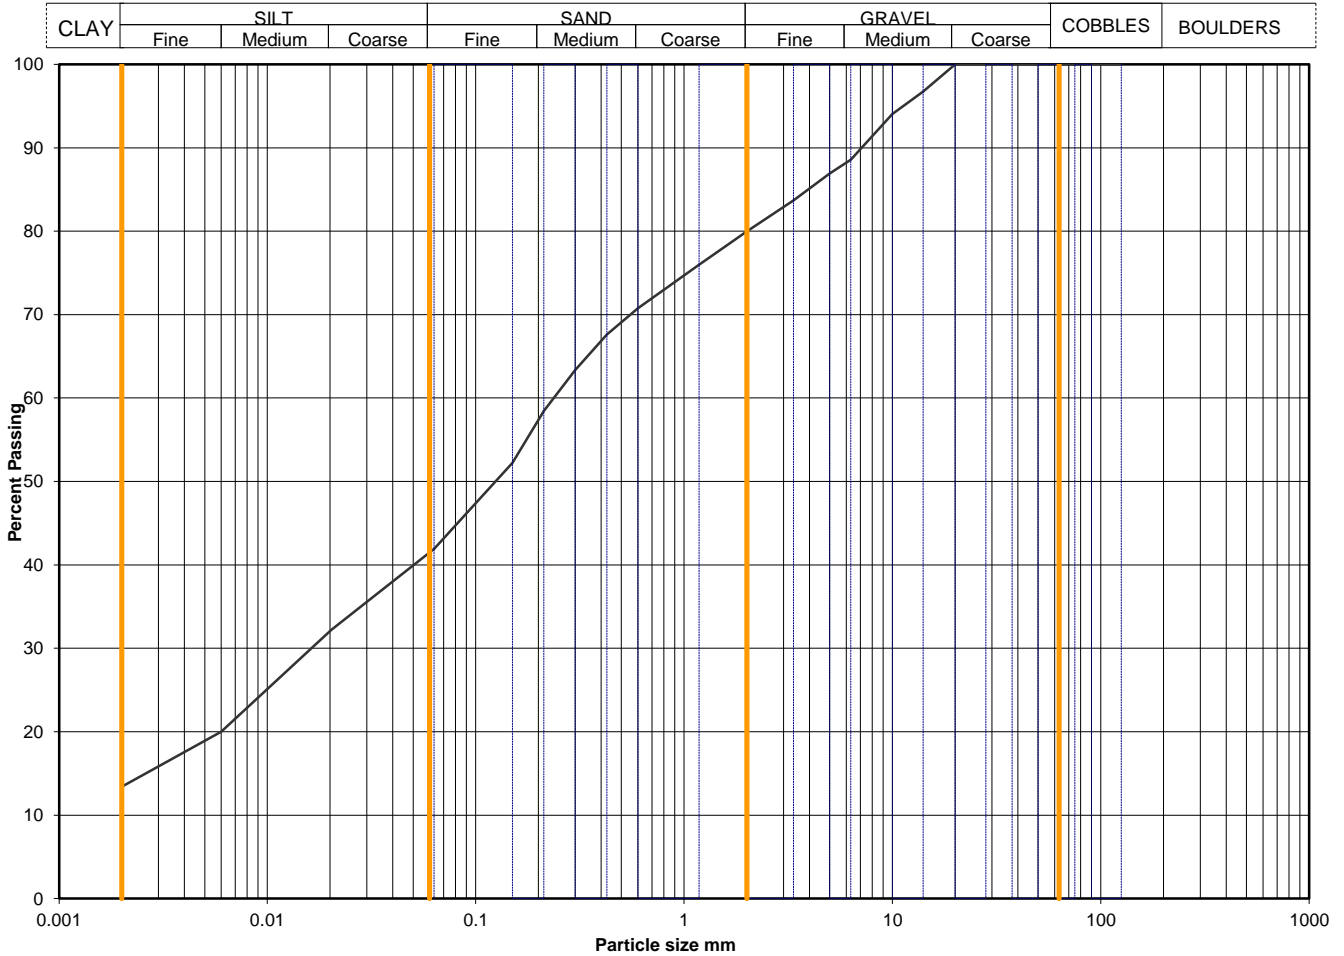
<b>Sample Details:</b>	SAMPLE ID:	Hole No	XC201-CPRC02
	SOCO2020080428	Sample Depth (m BGL)	2.50 - 2.80
		Sample Type and No	B10
		Specimen Ref

Sieving		Sedimentation	
Particle Size mm	% Passing	Particle Size mm	% Passing
125	100	0.0203	32
90	100	0.0060	20
75	100	0.0020	13
63	100		
50	100		
37.5	100		
28	100		
20	100		
14	97		
10	94		
6.3	89		
5.0	87		
3.35	84		
2.00	80		
1.18	76		
0.600	71	Particle density, Mg/m <sup>3</sup>	
0.425	68	2.65	assumed
0.300	63	Dry mass of sample, kg	
0.212	58	1.9	
0.150	52		
0.063	42

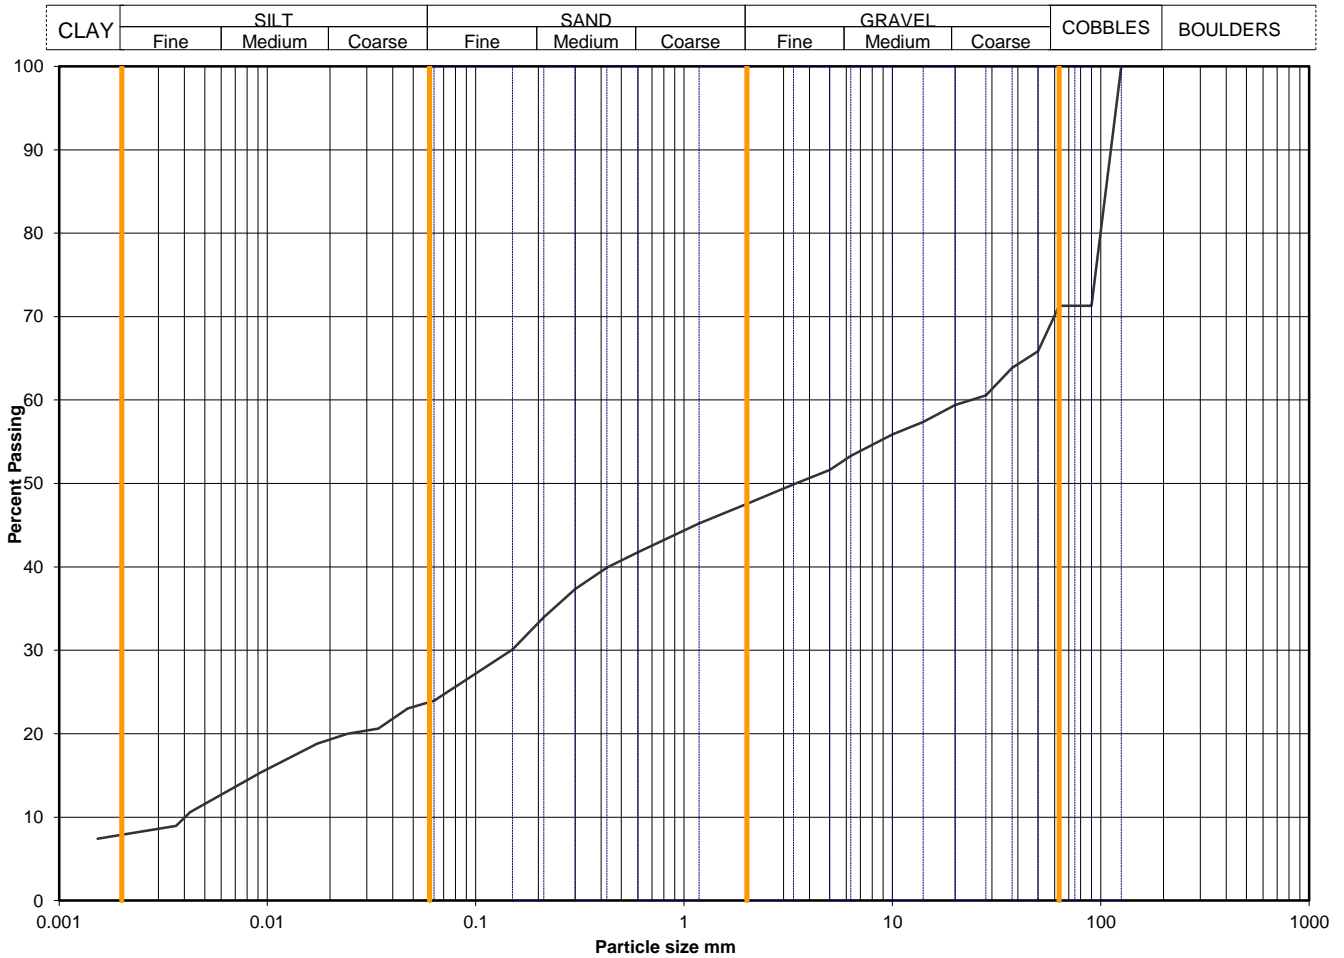
<b>Sample Details:</b>	SAMPLE ID:	Hole No	XC201-TP01
	SOCO202010025	Sample Depth (m BGL)	1.70 - 2.20
		Sample Type and No	B6
		Specimen Ref

Sieving		Sedimentation	
Particle Size mm	% Passing	Particle Size mm	% Passing
125	100	0.0630	24
90	71	0.0472	23
75	71	0.0341	21
63	71	0.0242	20
50	66	0.0173	19
37.5	64	0.0092	15
28	61	0.0043	11
20	59	0.0036	9
14	57	0.0015	7
10	56		
6.3	53		
5.0	52		
3.35	50		
2.00	48		
1.18	45		
0.600	42	Particle density, Mg/m <sup>3</sup>	
0.425	40	2.65	assumed
0.300	37	Dry mass of sample, kg	
0.212	34	6.6	
0.150	30		
0.063	24

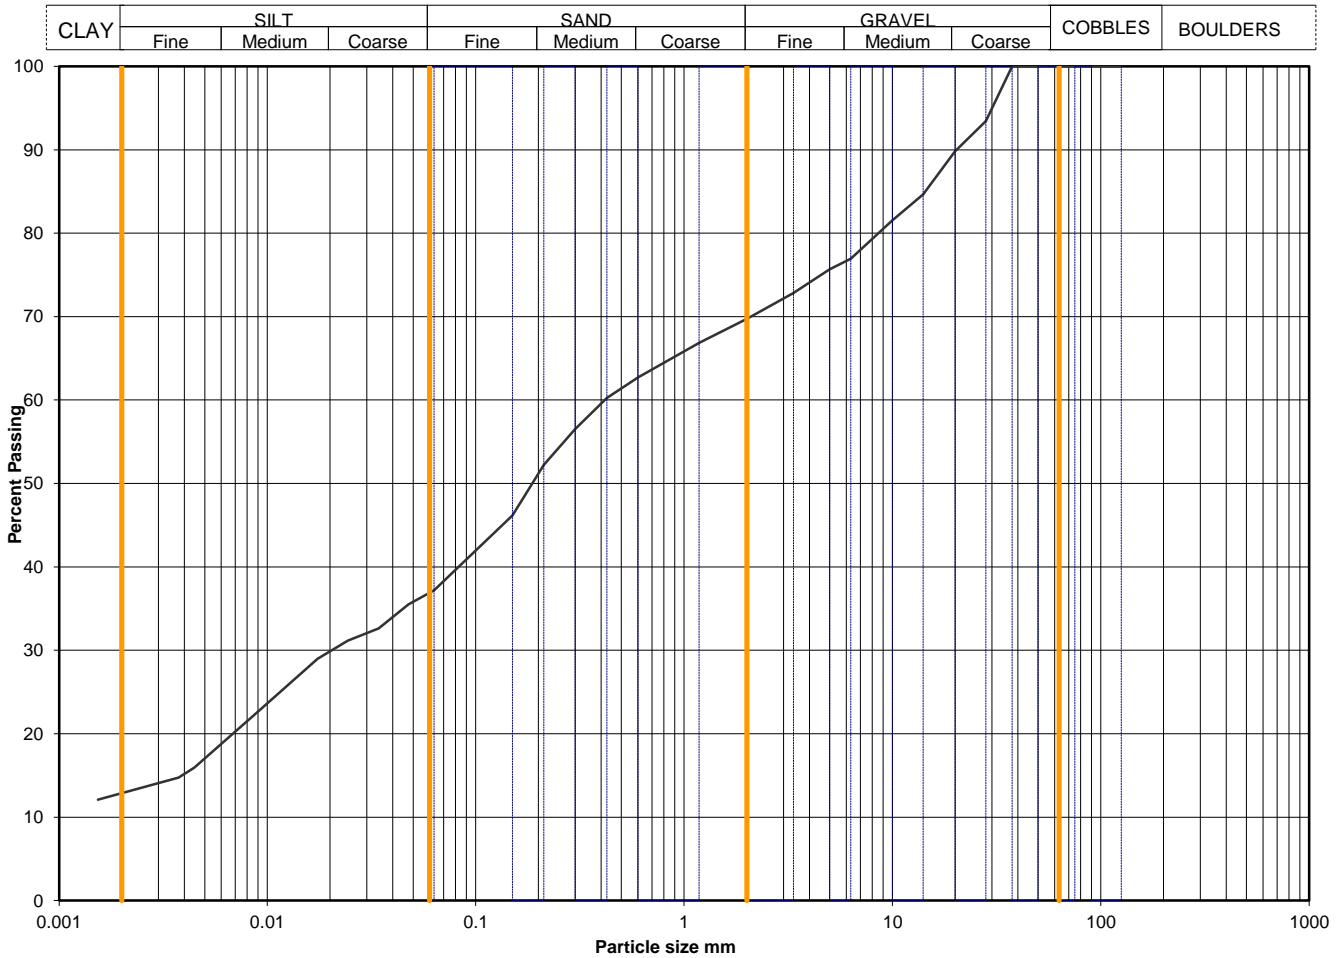
<b>Sample Details:</b>	SAMPLE ID:	Hole No	XC201-TP01
	SOCO2020100213	Sample Depth (m BGL)	2.70 - 3.20
		Sample Type and No	B10
		Specimen Ref

Sieving		Sedimentation	
Particle Size mm	% Passing	Particle Size mm	% Passing
125	100	0.0630	37
90	100	0.0475	36
75	100	0.0342	33
63	100	0.0243	31
50	100	0.0174	29
37.5	100	0.0093	23
28	93	0.0045	16
20	90	0.0037	15
14	85	0.0015	12
10	82		
6.3	77		
5.0	76		
3.35	73		
2.00	70		
1.18	67		
0.600	63		
0.425	60		
0.300	57		
0.212	52		
0.150	46		
0.063	37

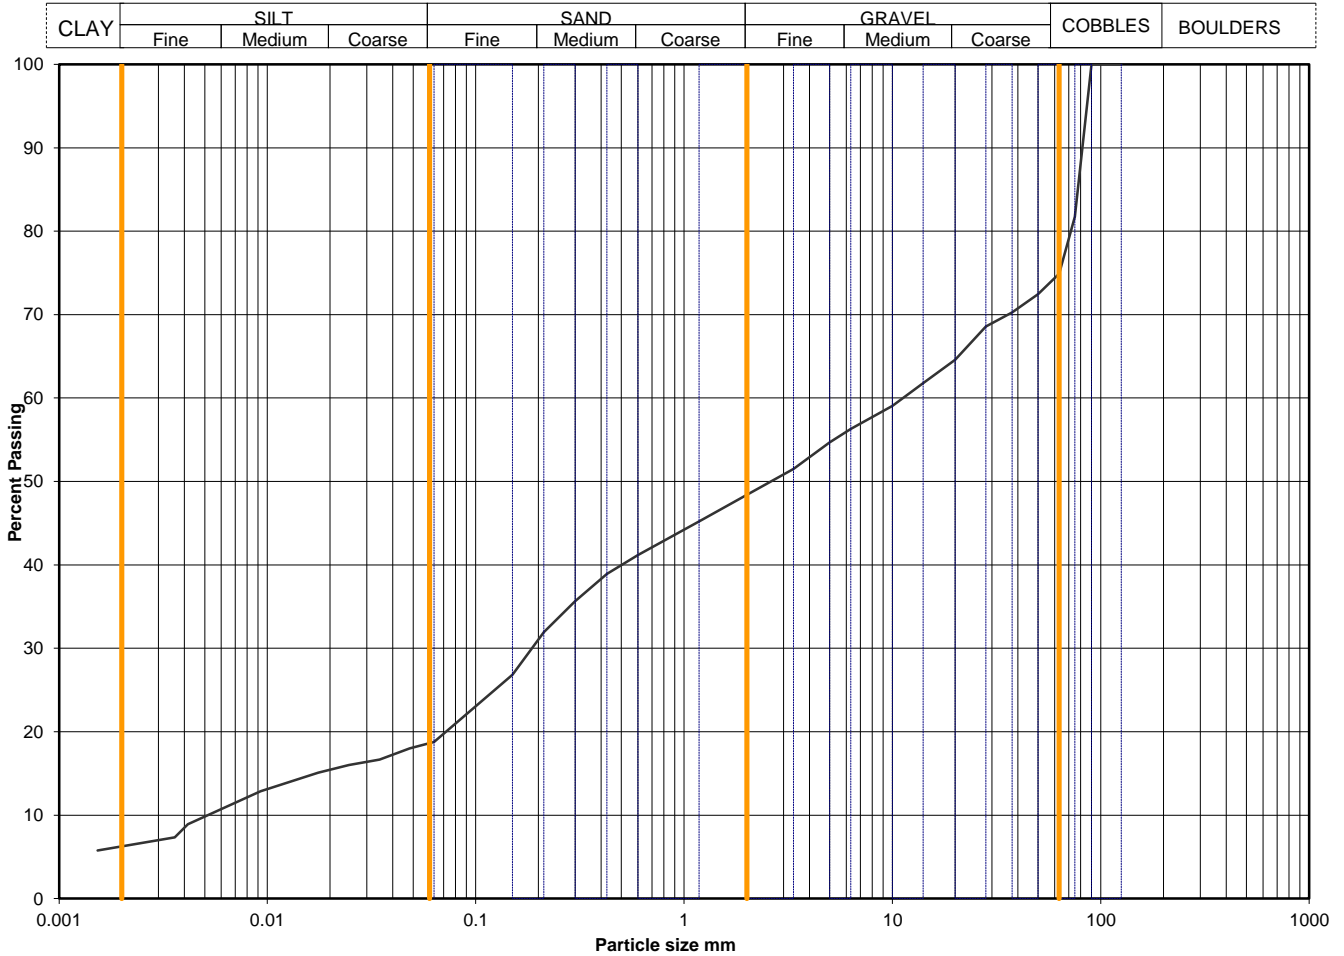
<b>Sample Details:</b>	SAMPLE ID:	Hole No	XC201-TP02
	SOCO2020100217	Sample Depth (m BGL)	1.50 - 2.00
		Sample Type and No	B6
		Specimen Ref

Sieving		Sedimentation	
Particle Size mm	% Passing	Particle Size mm	% Passing
125	100	0.0630	19
90	100	0.0482	18
75	82	0.0345	17
63	75	0.0246	16
50	72	0.0175	15
37.5	70	0.0093	13
28	69	0.0042	9
20	65	0.0036	7
14	62	0.0015	6
10	59		
6.3	56		
5.0	55		
3.35	52		
2.00	48		
1.18	45		
0.600	41		
0.425	39		
0.300	36		
0.212	32		
0.150	27		
0.063	19		
		Particle density, Mg/m <sup>3</sup>	
		2.65 assumed	
		Dry mass of sample, kg	
		13.7
