Iarnród Éireann  
Cork Line Level Crossings  
XC201 (19-135-1)

T.PIT4
	Trial Pit Photographs
Client:	Iarnród Éireann
Engineer:	Jacob's
Date:	July 2020

## **Appendix E**

## **Indirect CBR Test Data**

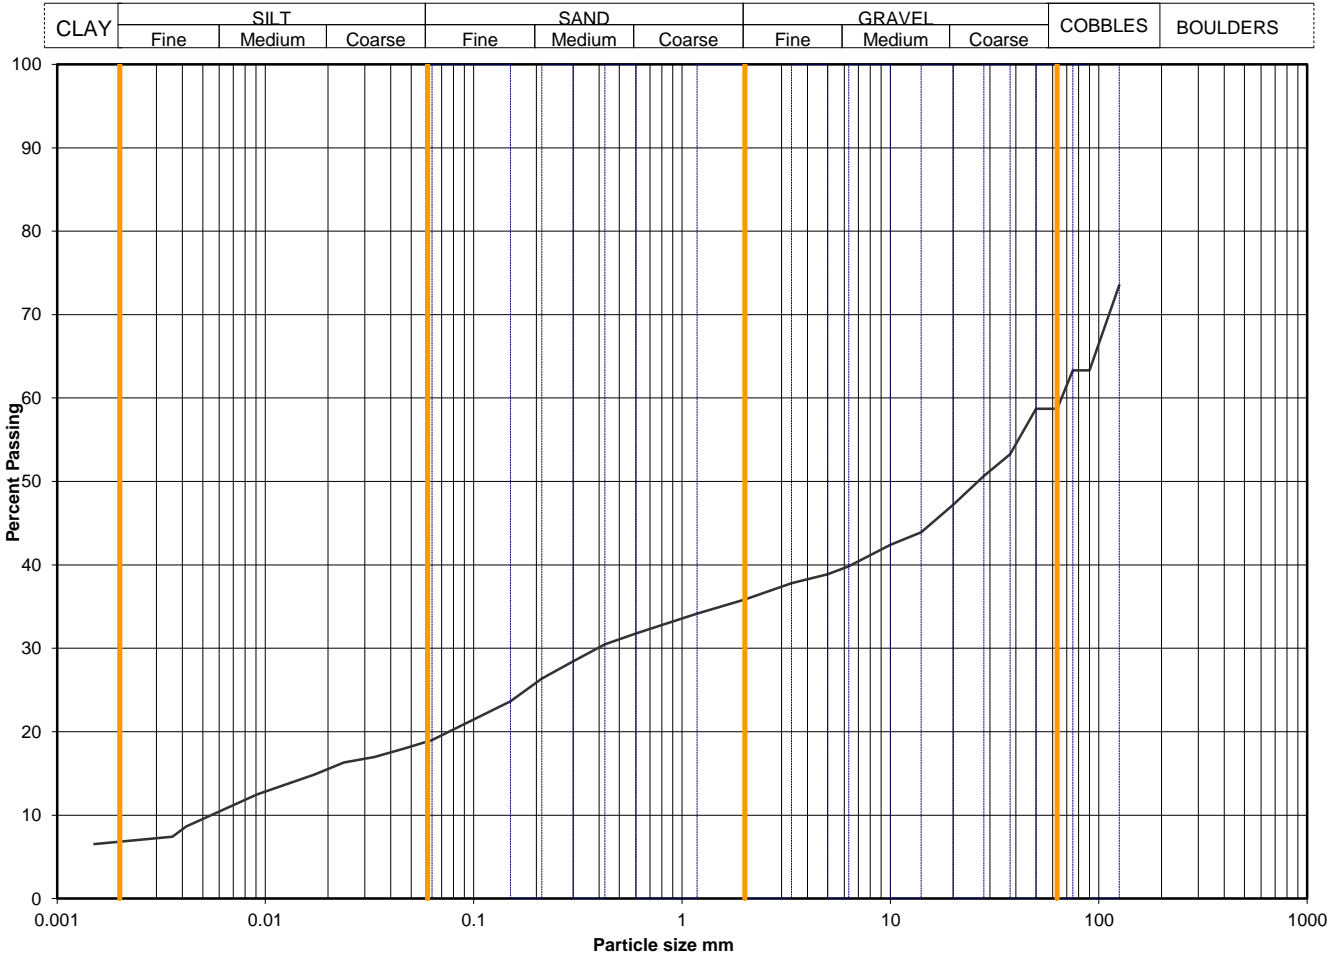
<b>Sample Details:</b>	SAMPLE ID:	Hole No	XC201-TP03
	SOCO2020100225	Sample Depth (m BGL)	2.20 - 2.70
		Sample Type and No	B8
		Specimen Ref

Sieving		Sedimentation	
Particle Size mm	% Passing	Particle Size mm	% Passing
125	74	0.0630	19
90	63	0.0466	18
75	63	0.0334	17
63	59	0.0238	16
50	59	0.0171	15
37.5	53	0.0091	12
28	51	0.0042	9
20	47	0.0036	7
14	44	0.0015	7
10	42		
6.3	40		
5.0	39		
3.35	38		
2.00	36		
1.18	34		
0.600	32	Particle density, Mg/m <sup>3</sup>	
0.425	30	2.65 assumed	
0.300	28	Dry mass of sample, kg	
0.212	26	13.2	
0.150	24		
0.063	19

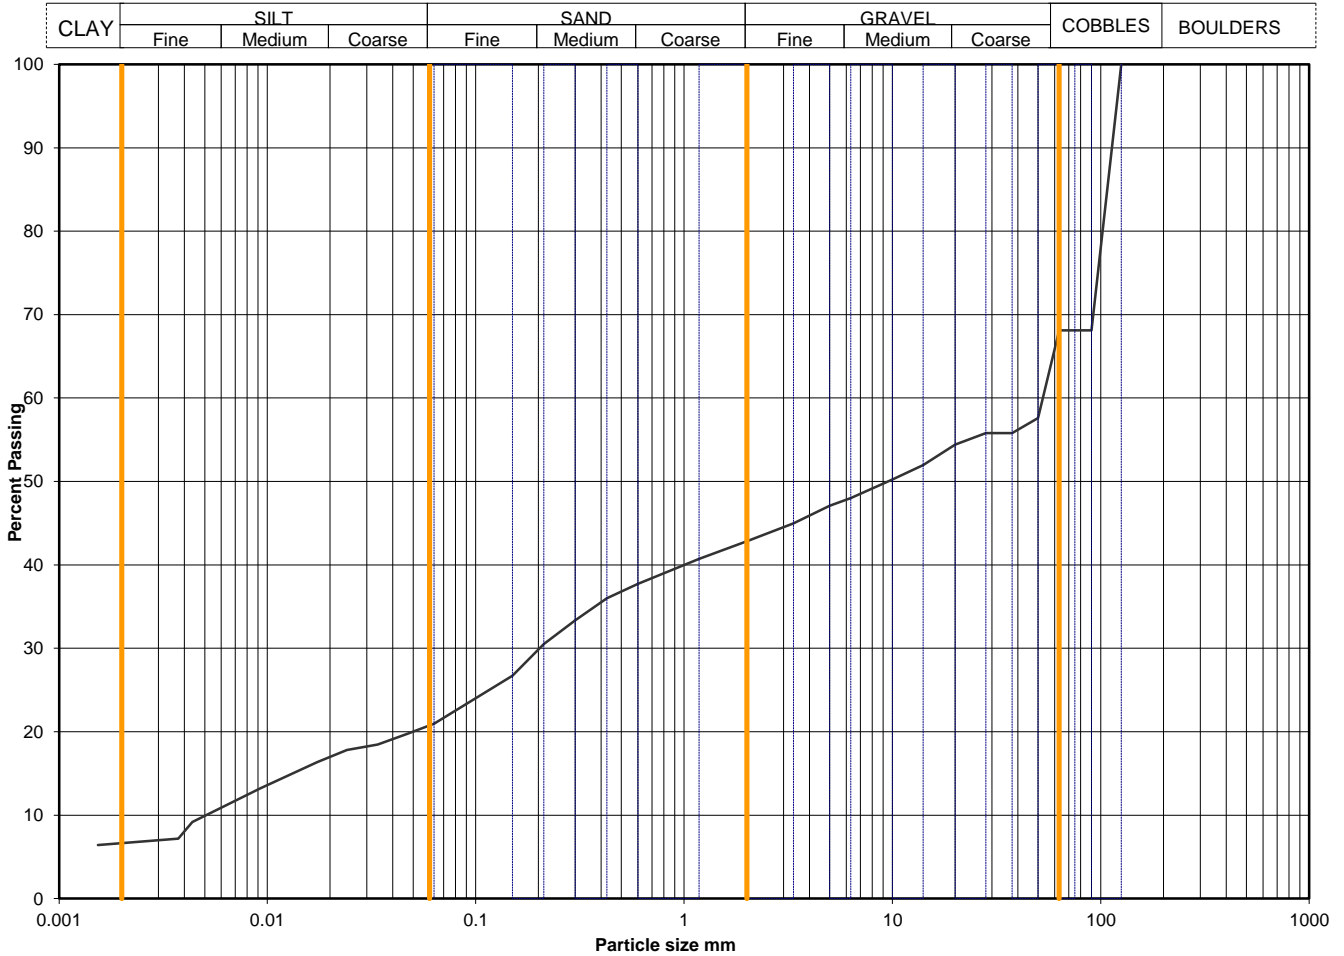
<b>Sample Details:</b>	SAMPLE ID:	Hole No	XC201-TP04
	SOCO2020100231	Sample Depth (m BGL)	1.30 - 1.80
		Sample Type and No	B6
		Specimen Ref

Sieving		Sedimentation	
Particle Size mm	% Passing	Particle Size mm	% Passing
125	100	0.0630	21
90	68	0.0472	20
75	68	0.0339	18
63	68	0.0241	18
50	58	0.0173	16
37.5	56	0.0092	13
28	56	0.0044	9
20	54	0.0037	7
14	52	0.0015	6
10	50		
6.3	48		
5.0	47		
3.35	45		
2.00	43		
1.18	41		
0.600	38	Particle density, Mg/m <sup>3</sup>	
0.425	36	2.65 assumed	
0.300	33	Dry mass of sample, kg	
0.212	30	6.1	
0.150	27		
0.063	21

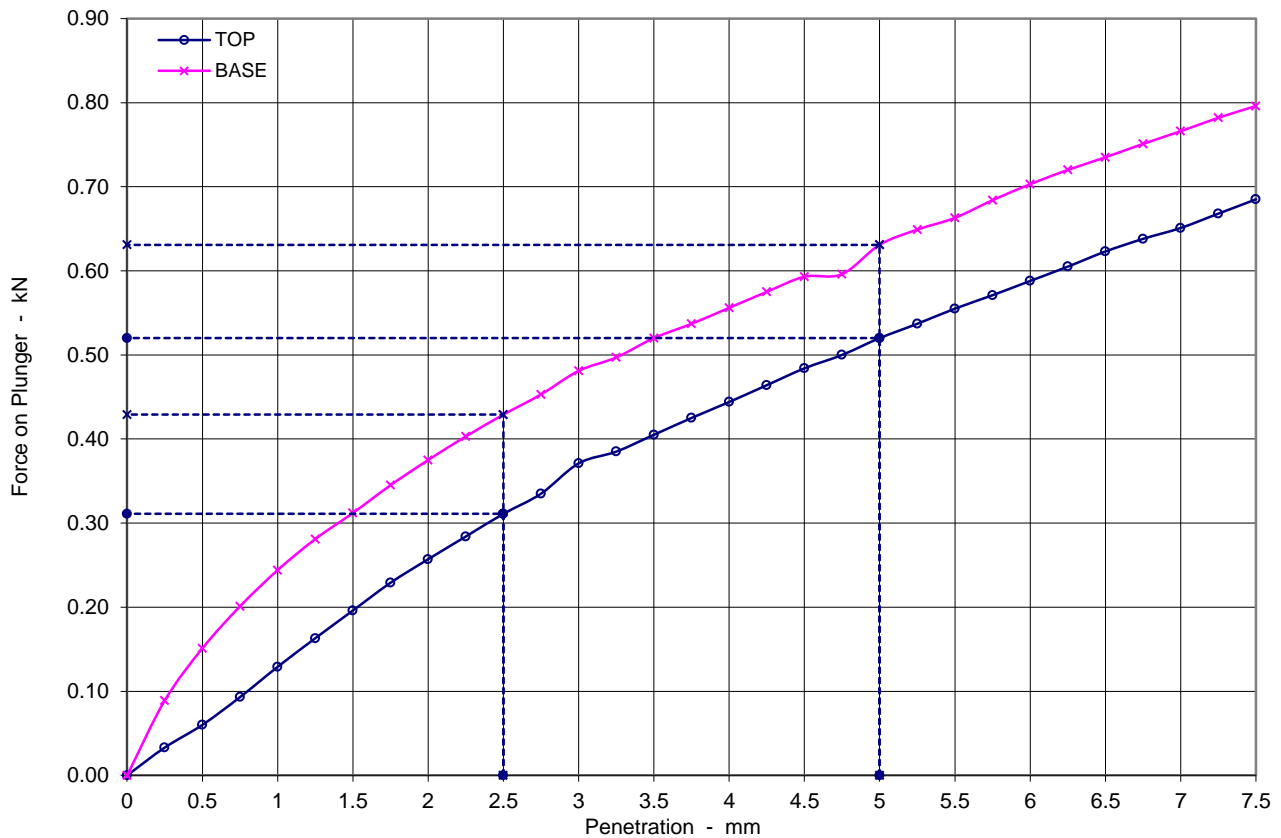
Sample Details:	SAMPLE ID:	Hole No	XC201-TP01
	SOCO202010024	Sample Depth (m)	0.50 - 1.00
		Sample Type and No	D1
		Specimen Ref	1

Soil description	Brown slightly sandy gravelly CLAY.
------------------	-------------------------------------

Test Conditions	
Sample Retained on 20 mm sieve	% 17

Sample Conditions	
Initial Moisture Content	% 12.0
Bulk Density	Mg/m <sup>3</sup> 1.97
Dry Density	Mg/m <sup>3</sup> 1.77
Moisture Content - TOP	% 11.0
Moisture Content - BASE	% 12.0

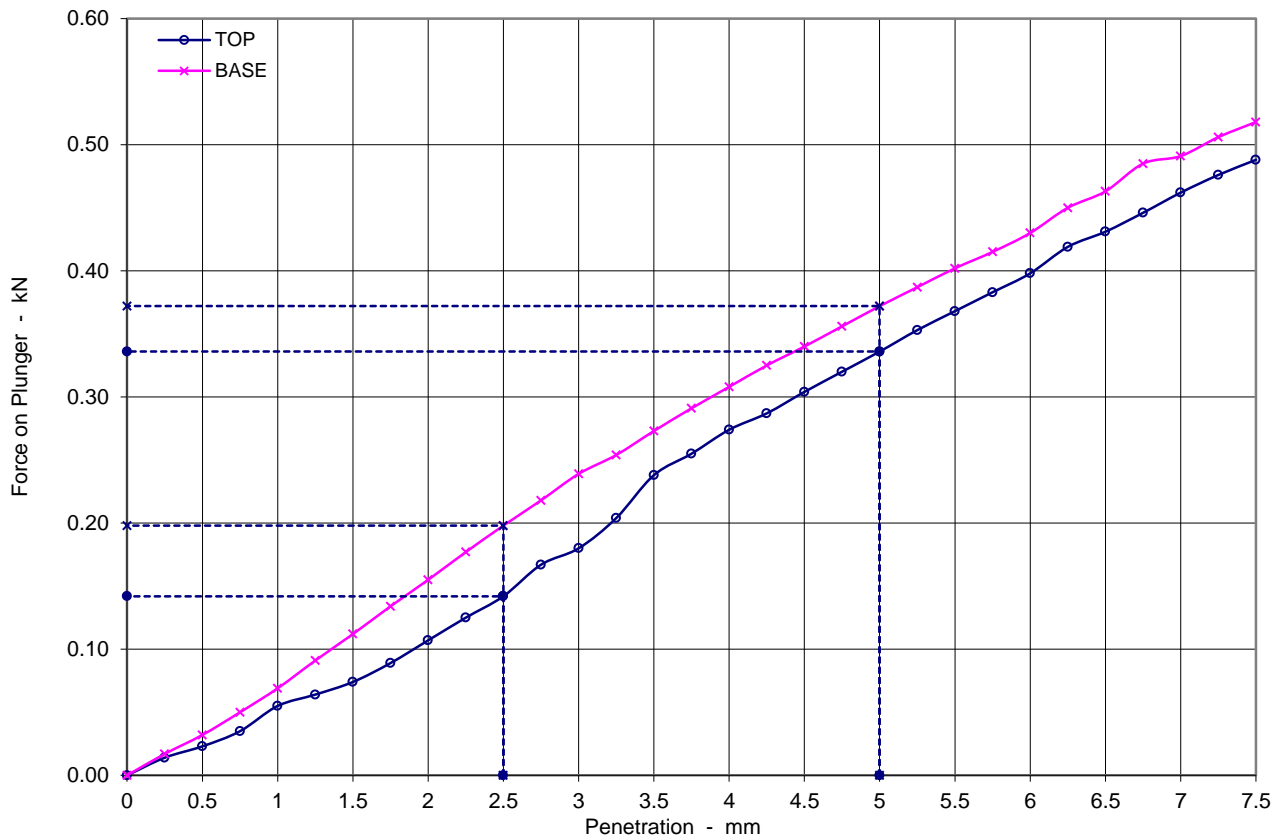
Sample Details:	SAMPLE ID:	Hole No	XC201-TP04
	SOCO2020100233	Sample Depth (m)	2.00 - 2.50
		Sample Type and No	B8
		Specimen Ref	1

Soil description | Brown slightly sandy slightly gravelly CLAY.

Test Conditions		
Sample Retained on 20 mm sieve	%	0

Sample Conditions		
Initial Moisture Content	%	10.0
Bulk Density	Mg/m <sup>3</sup>	2.12
Dry Density	Mg/m <sup>3</sup>	1.92
Moisture Content - TOP	%	10.0
Moisture Content - BASE	%	10.0
