10.0 LANDSCAPE AND VISUAL

This Remedial Environmental Impact Assessment Report (rEIAR) has been prepared to accompany a substitute consent application for an existing quarry at Windmillhill, Rathcoole, Co. Dublin. The remedial Landscape and Visual Impact Assessment (LVIA) was prepared by Cunnane Stratton Reynolds.

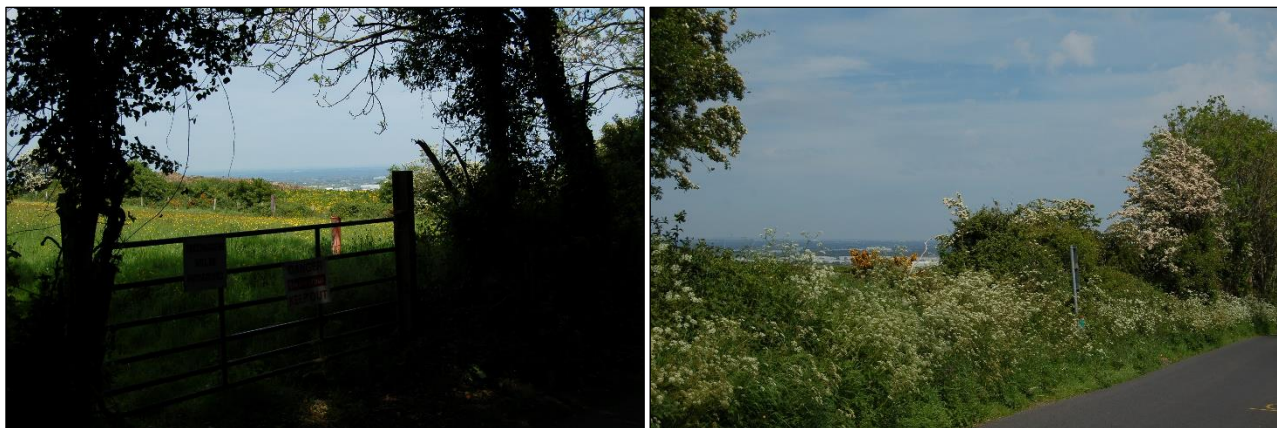
Figure 10.3: Views west of mapped Scenic View on Windmill Road

from minor gaps within the roadside vegetation, to the west of the mapped scenic view location. These views are as illustrated below in Figure 10.3 below and it is also evident that these are not in the direction of the site and therefore not affected.

To the south, vegetation frequently prevents visibility, however some gaps in the hedgerow further along the road to the northeast reveal glimpses of the undulating rural landscape with Saggart Hill and a patchwork of small fields and some tree clumps, are evident.

The existing quarry development is not visible from this location as shown above.

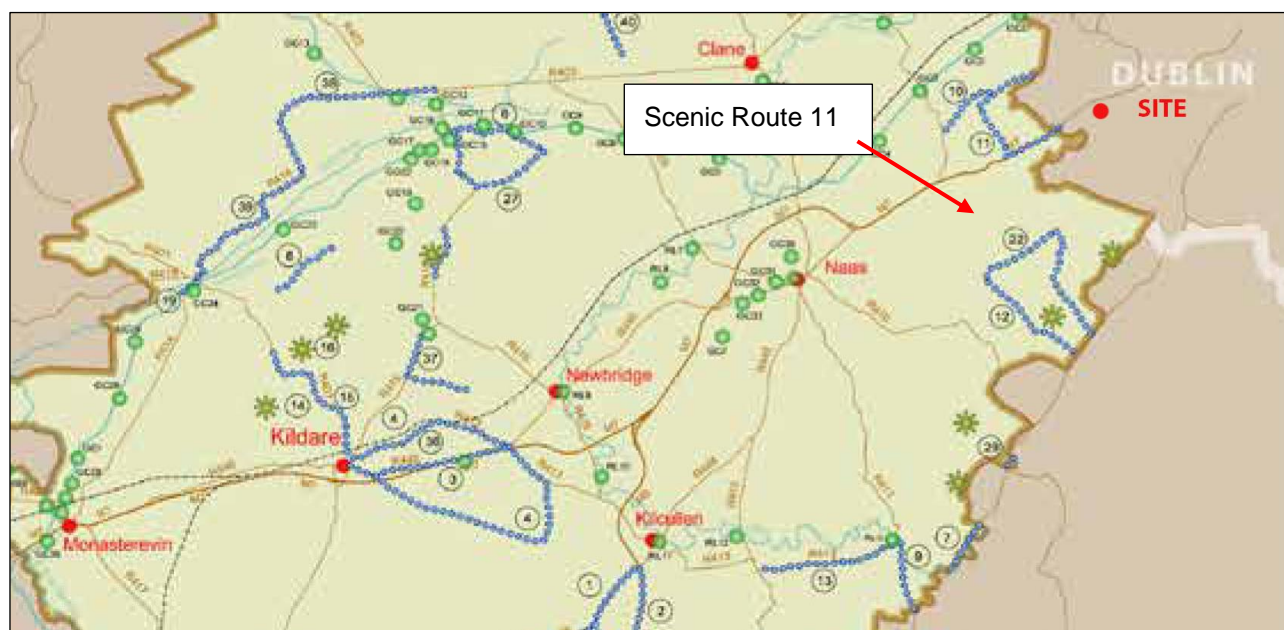
Figure 10.4: Scenic Routes and Viewpoints. Source: Kildare County Council

The visual assessment considers the effects of the Development upon the nearest Scenic route - No. 11. Scenic Routes 10 and 22 are focussed to the west, and north-west, and therefore away from the site. The canal views are not likely to have visibility and are not considered further.

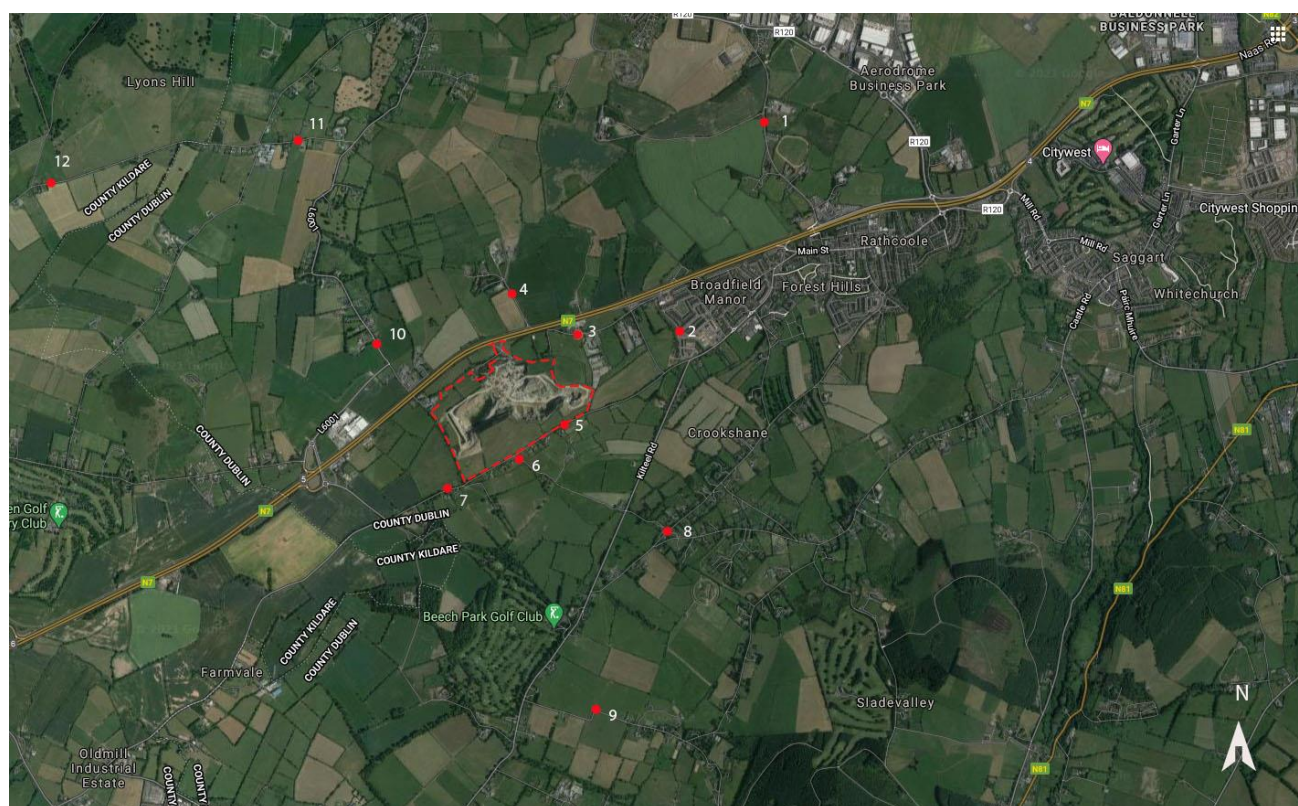
**Figure 10.9: Viewpoint Locations 1-12, Image Source: Google Maps 2021.Viewpoint Assessment**

The viewpoints are described below, under the headings 'Existing view', 'Visual Receptor Sensitivity', Magnitude of Change' (which has occurred) and the 'Significance of Effect'.

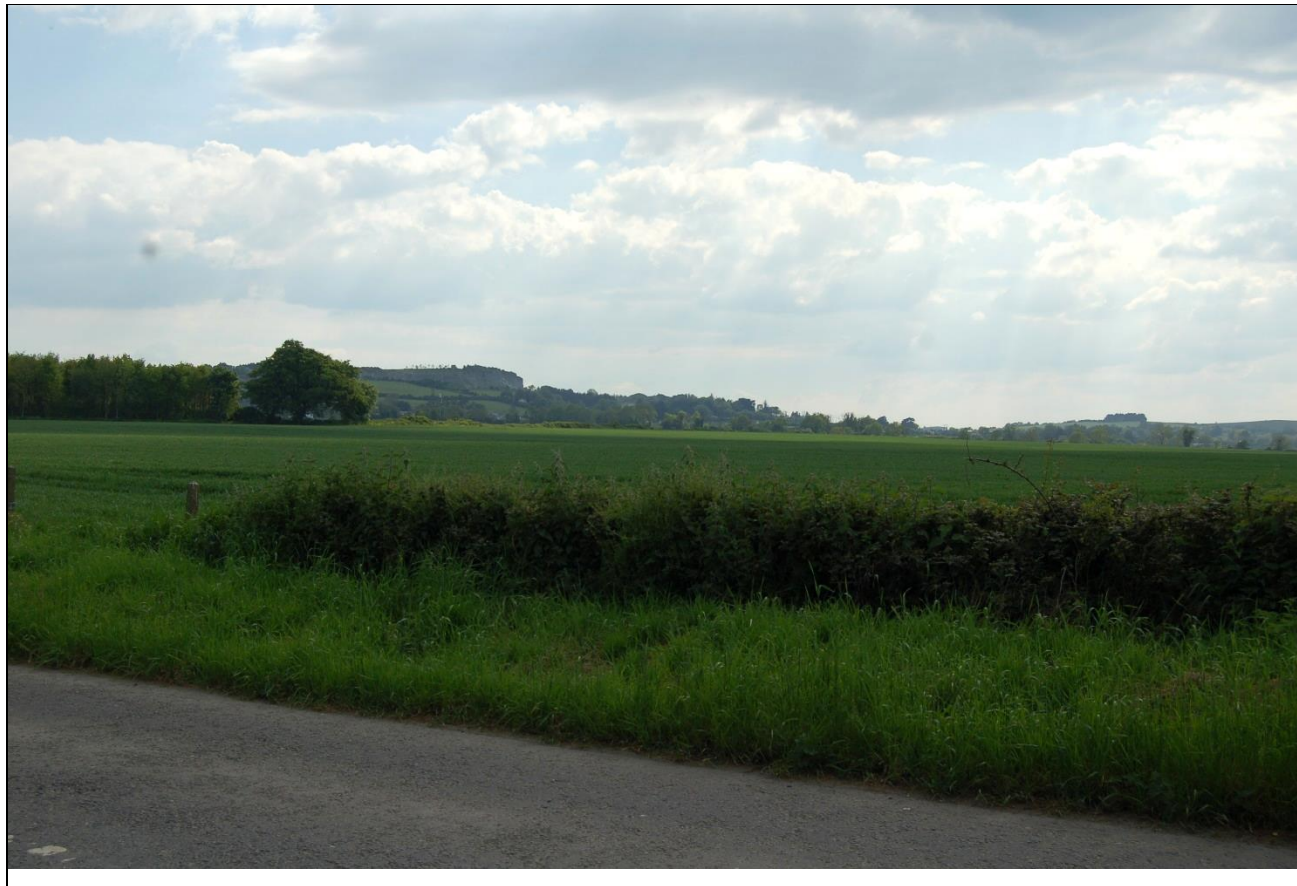
Figure 10.10: Viewpoint 1

The significance of the visual effect is **Moderate-Significant**. The quality of the effect is considered adverse, long term. An element of professional judgement was applied to the guideline Matrix outlined in Table 10.3.

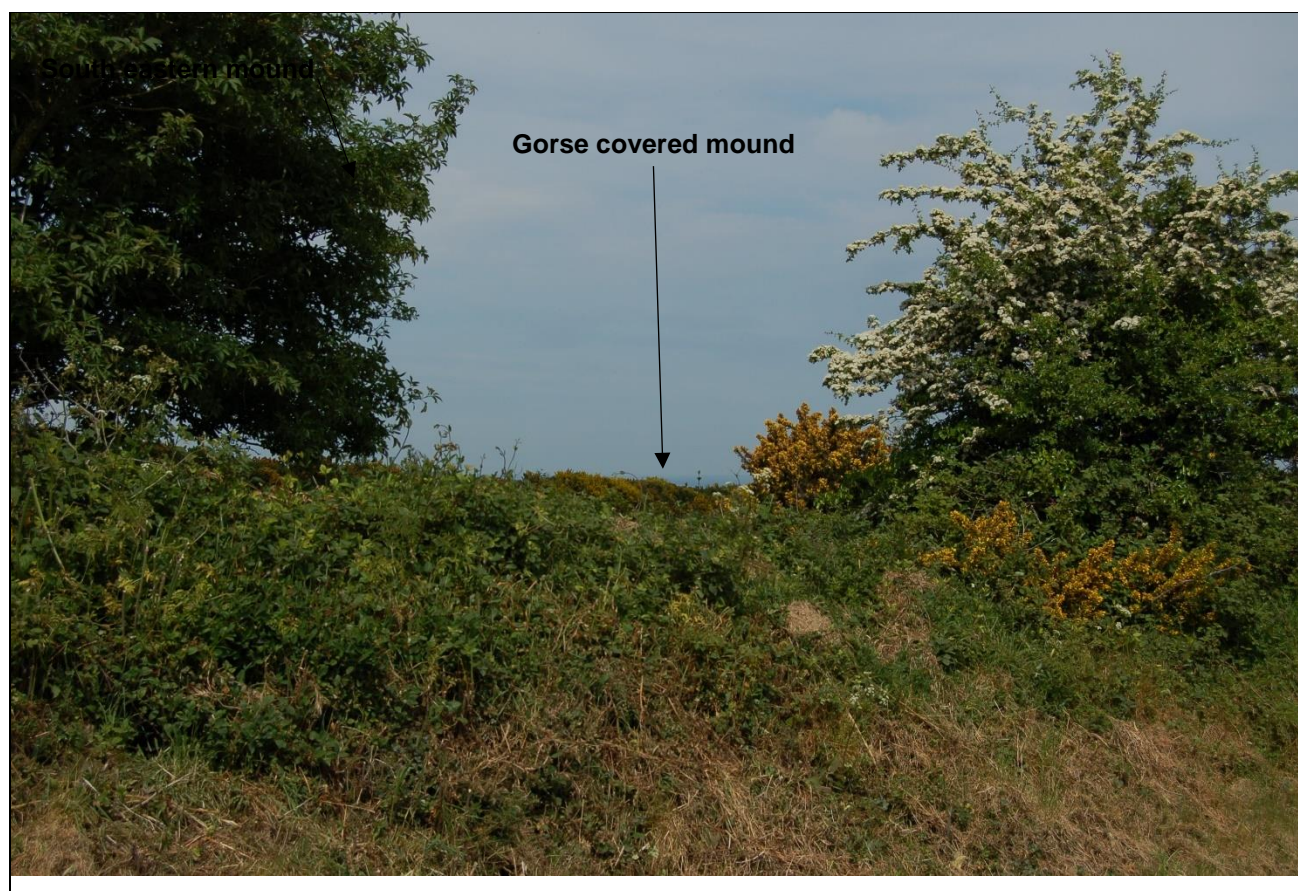
Figure 10.14: Viewpoint 5 Existing View

The visual effect is considered **Not Significant**. The quality of the effect is considered neutral.

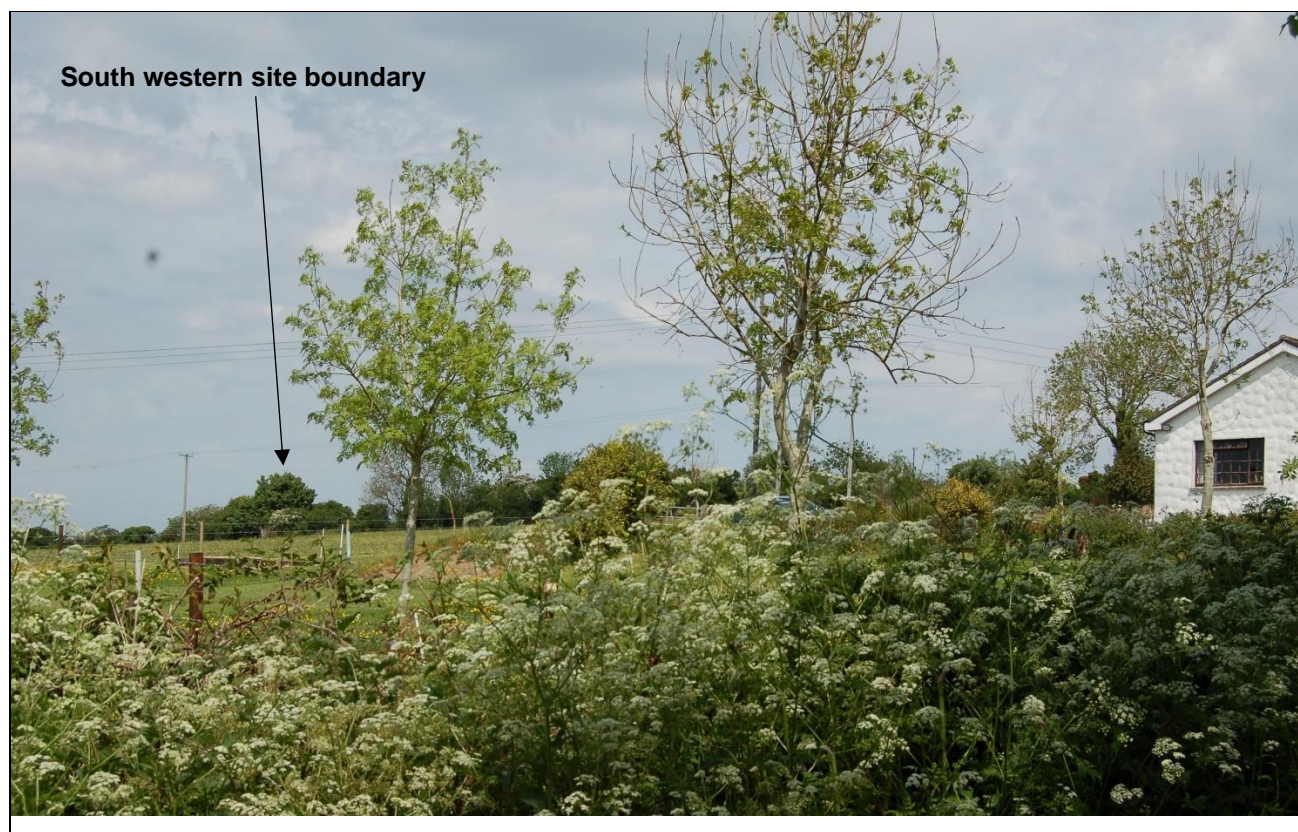
Figure 10.16: Viewpoint 7 Existing View

Viewpoint 7 –Group of houses along Windmill Road to the southwest of quarry

This view looks across the undulating agricultural lands, beyond the foreground dwellings and vegetation, towards the ridgeline of Windmill Hill. The windmill remains are evident in the view. The landscape is a rolling rural landscape, with clumps of trees and some dwellings evident. The quarry itself is not visible, however some of the (now vegetated) overburden mounds appear evident to either side of the hill, as indicated in Figure 10.17 above, however, it should be noted that these appear distant.

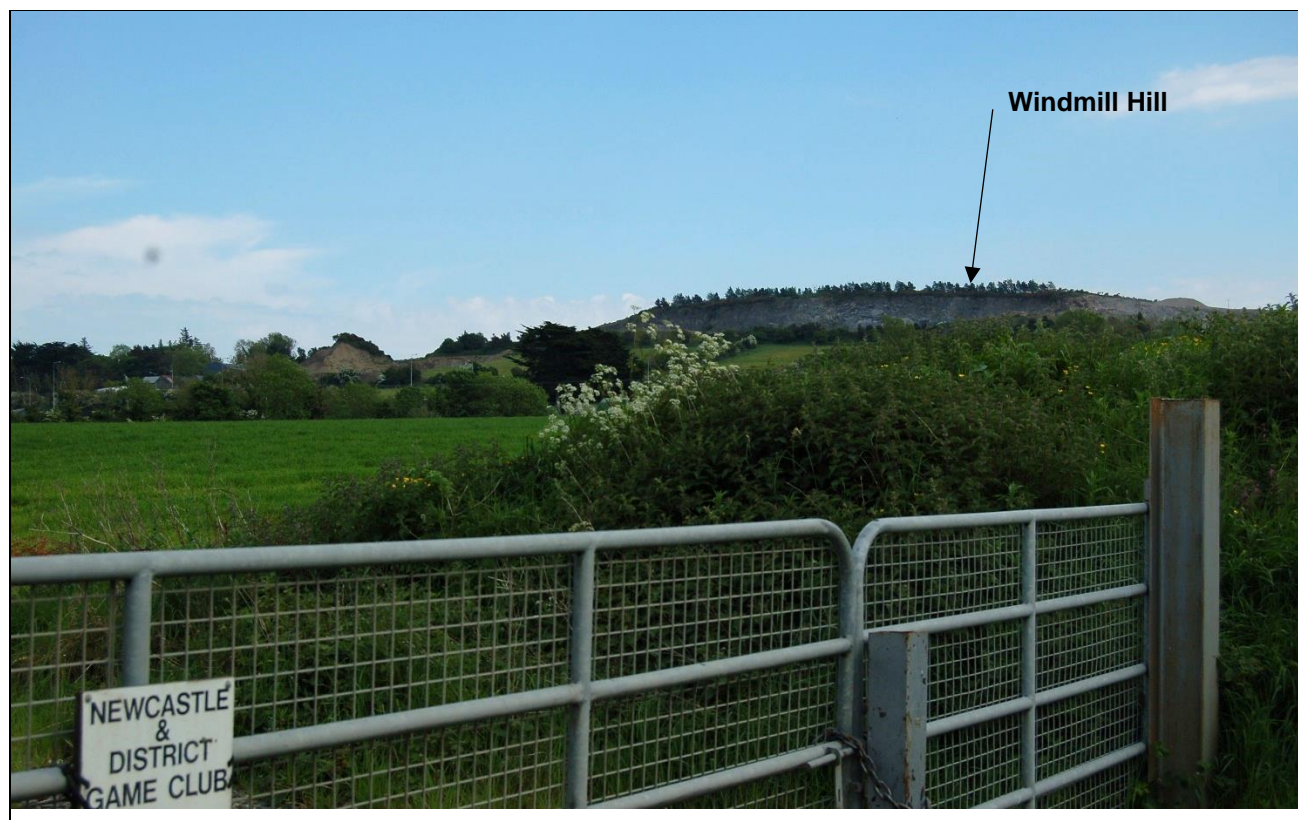
Figure 10.19: Viewpoint 10 Existing View

The significance of the visual effect is considered to be **Moderate to Significant**. The quality of the effect is considered adverse, long term.
