### INLAND FISHERIES IRELAND OBSERVATION

**Re: Section 37E Application to An Bord Pleanála for a Wind Farm Development & Associated Works, at Glenard and other townlands, County Donegal.**

# **Guidelines on Protection of Fisheries During Construction Works in and Adjacent to Waters**

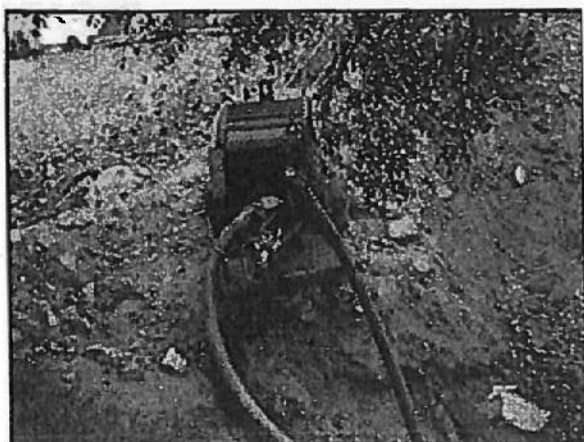
*Drip tray is undersized, dangerously positioned and leaking oil. Unacceptable practice.*

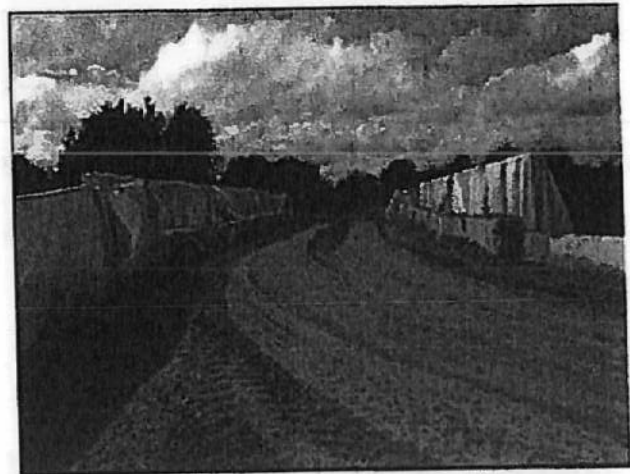
*A crossing structure over a designated salmonid water. Note: terram covered fencing, reinforced concrete traffic barriers and fall back from the watercourse.*

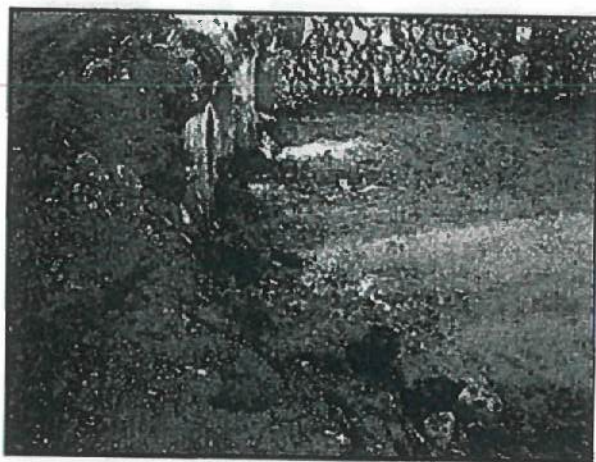
*The inevitable result from the crossing shown above. Continuous silt discharges. Unacceptable practice.*

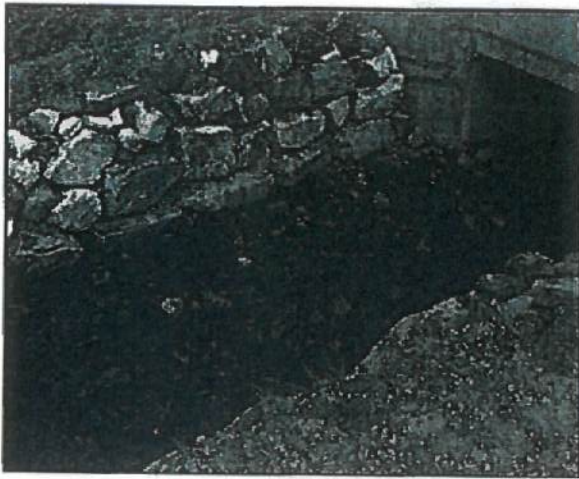
*An embedded box culvert sized to match existing stream profile.*

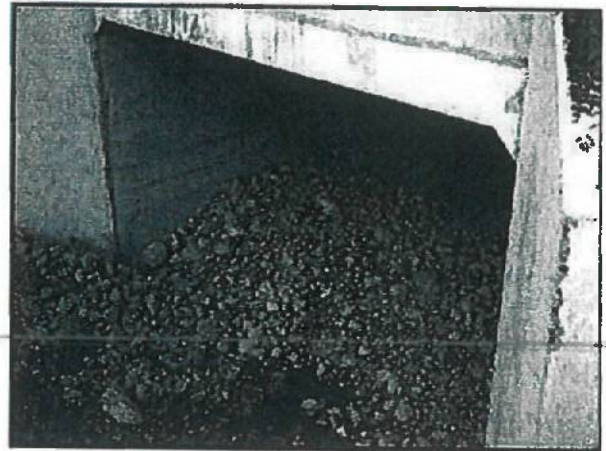
*Off-line culvert at construction stage back filled with gravel. The size range and depth of fill required will be site specific.*

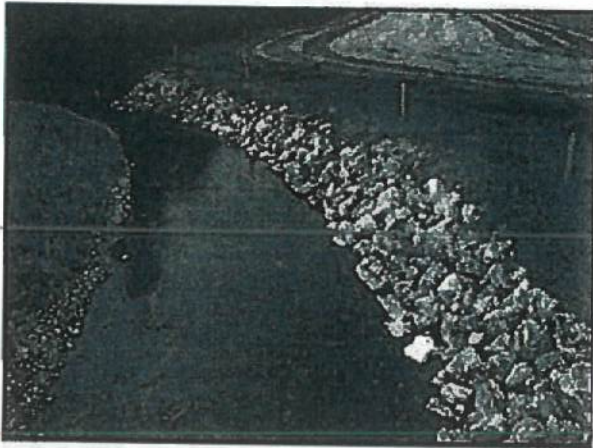
*The boulders in these bank protection works are not large enough, not sunken below stream bed level and likely to be undercut and dislodged in a storm event.*

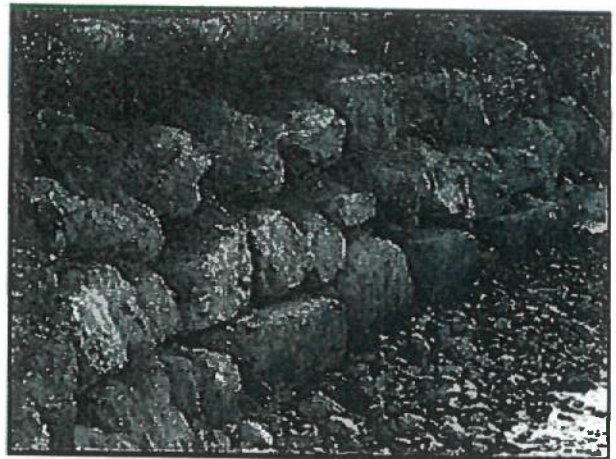
*Revegetation of rock armour facilitated by the placing of locally sourced topsoil (to ensure no importation of non local grasses and shrubs) between each layer or course of boulders at installation time.*

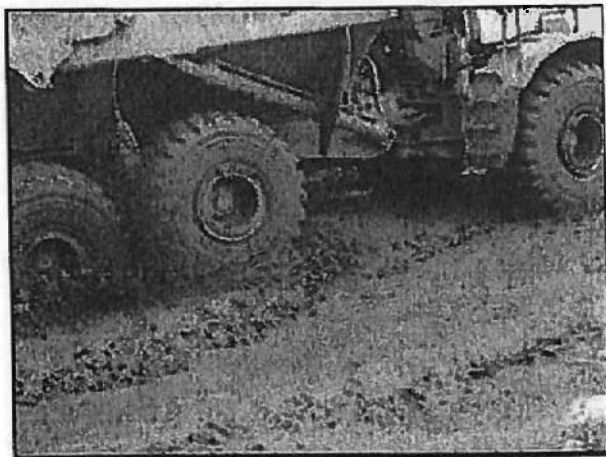
*Construction sites require careful management. Is this the optimal haul route in terms of impact minimisation?*

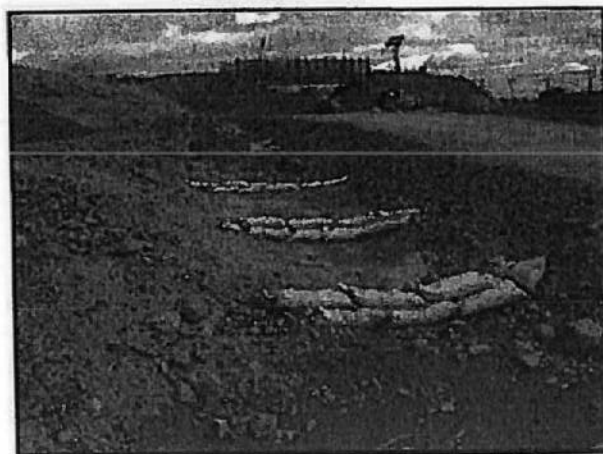
*Silt discharge minimisation by providing retention areas to reduce discharge velocity and allow settlement during rainfall events.*

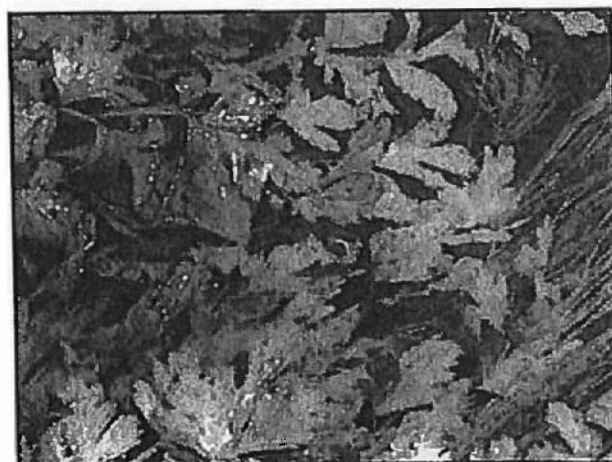
*The practical impact of poor silt control.*

7.2 Discharge of silt-laden waters to fisheries streams is of particular concern. Silt can clog fish spawning beds and juvenile fish species are particularly sensitive. Plant and macroinvertebrate communities can literally be blanketed over, and this can lead to loss or degradation of valuable habitat. It is important to incorporate best practices into construction methods to minimise discharges of silt/suspended solids to waters.

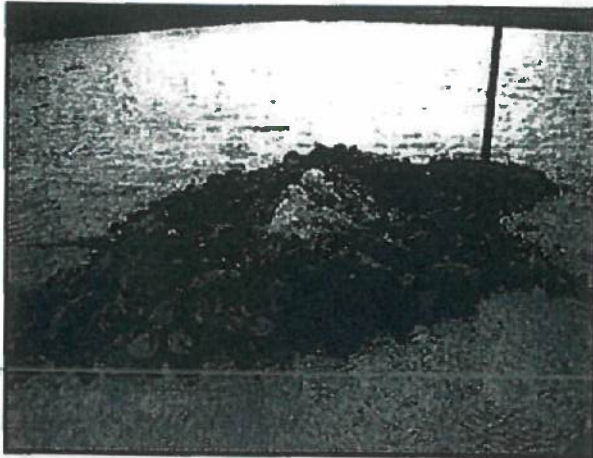
*Silt control pond. The blue hose conveying pumped silt laden waters has its outlet securely anchored within the stone aggregate thereby dissipating energy, minimising disturbance, and preventing pond contents being disturbed and re-suspended.*

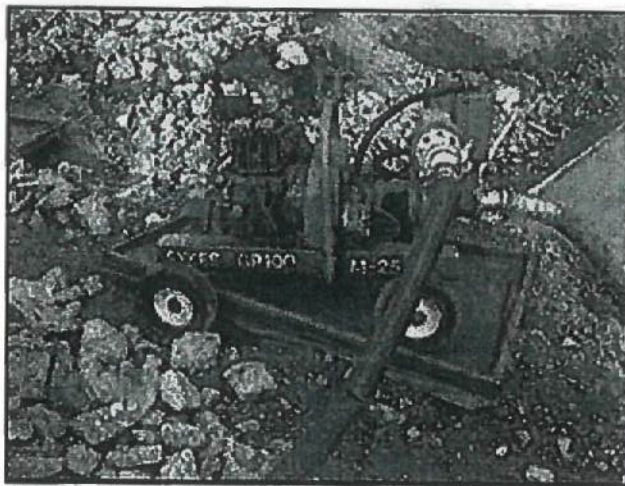
*Poor work practice. The drip tray is undersized, constructed of too light a material, and accordingly overly flexible, easily damaged, and unlikely to retain oil residues.*

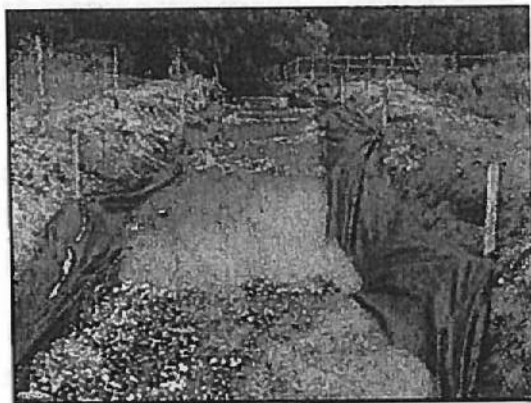
*Terram lined (to prevent erosion) silt control pond outlet channel showing gravel acting as filter medium for silt removal.*

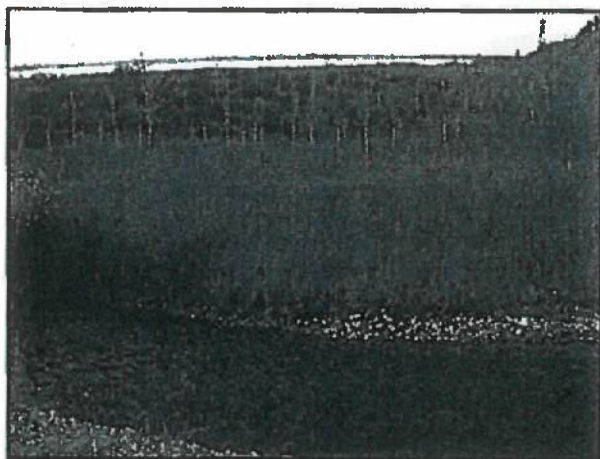
*Well vegetated newly established river channel, with broadleaves planted to within 5 meters of the overflow channel. The root structures aid bankside stability.*

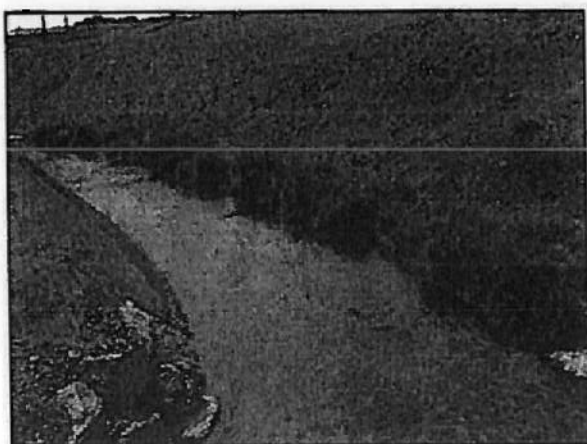
*Newly created channel. The riparian grasses on the right bank have been transferred from the previous course of the now redundant original channel. The root structures stabilise the bank area while the grasses provide a degree of cover and shade and provide habitat for aquatic insects which form part of the food for fish.*

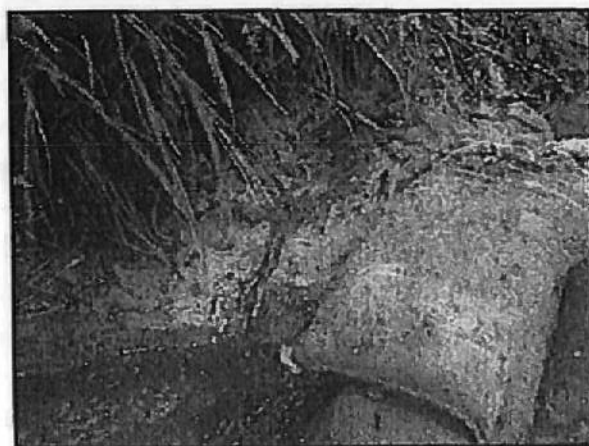
*Grout loss to waters is normally stopped by placing dry cement over the leak, with sand bags on top to restrict grout flow until the leak solidifies. (This photograph was taken after water flow was re-established following solidification of the grout.)*

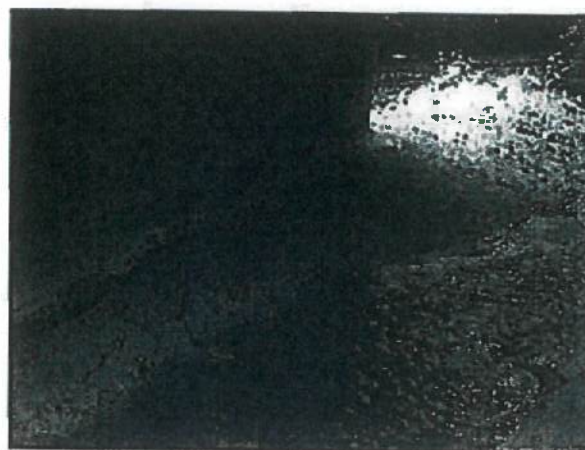
*Gunite rebound on a stream bed where no precautions were taken to prevent its entry to waters. Rebound having a pH >11.5 would have entered the actively flowing stream with dire environmental consequences.*
