ARCHITECTURAL HERITAGE
IMPACT ASSESSMENT
SANTRY LODGE
OLD BALLYMUN ROAD

RECORD OF PROTECTED STRUCTURES
REFERENCE 953 FCC

FOR JACOBS IDOM ON BEHALF OF
TRANSPORT INFRASTRUCTURE IRELAND

METROLINK

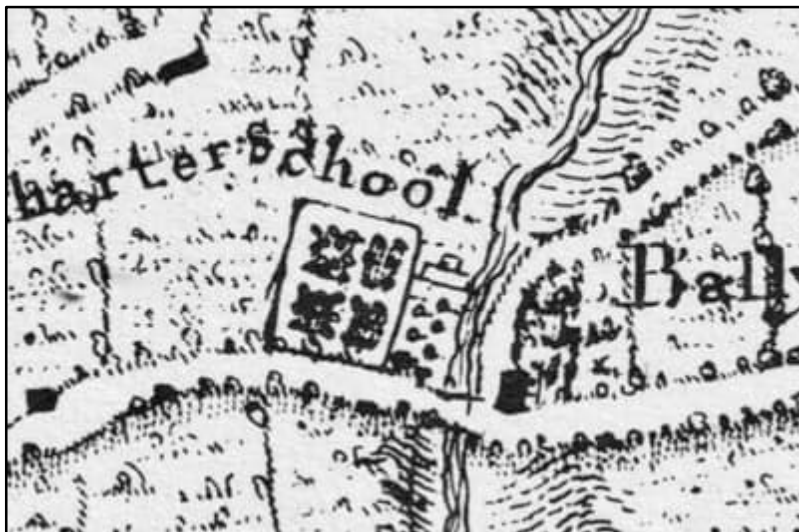
Figure 2: Detail of Rocque's map of County Dublin, 1760

The nature of the school site and the extent of the buildings in the early years is impossible to determine with any accuracy. The first visual clue appears some sixteen years after the school was founded when the school was depicted on John Rocque's *Actual Survey of the County of Dublin*, published in 1760, which shows west at the top (Figure 2). The map is at a very small scale and was not based on the kind of detailed survey that was undertaken by the Ordnance Survey in the following century. The two main landscape features are the Santry River and Ballymun Road, providing the context. While buildings were normally shown in black on this map, nothing of that kind is shown on Rocque at the charter school. However, set back from the road and close to the river there is a rectangular shape with a smaller rectangle to the rear, suggesting the presence of a building orientated north-south and with a return at the rear. This appears to be approached by an avenue lined by trees, while to the south is a substantial garden, denoted as a rectangular area divided by intersecting pathways into four quadrants.

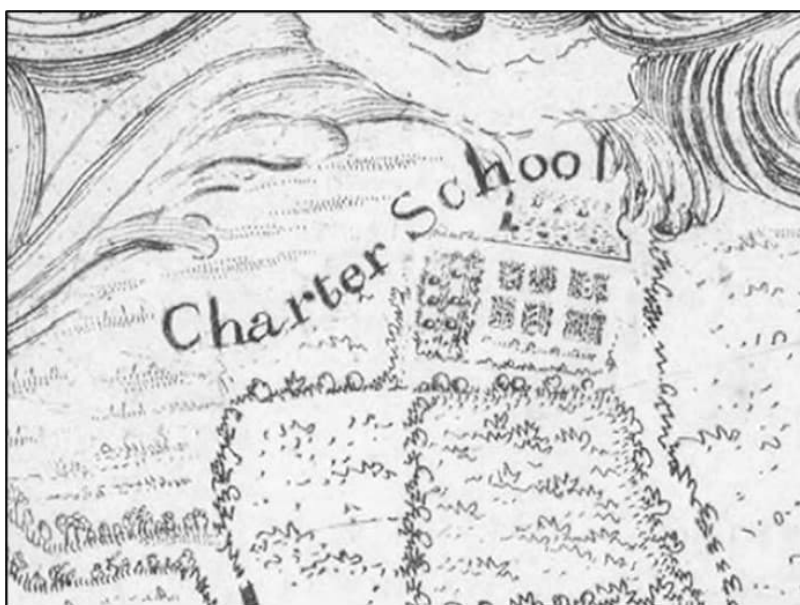
Figure 3: Detail of Rocque's map of 1757

John Rocque had produced a map of Dublin Bay three years earlier and this showed the Santry Charter School at the northern extremity of the map, partly bleeding into the cartouche (Figure 3). This map is at a slightly larger scale but is no clearer. It shows the

garden divided into six areas rather than four and with another garden area to the west. To the north of the gardens is a faint trace of an L-shaped building with another, smaller, building to the north. This conflicts with the information on the 1760 map.

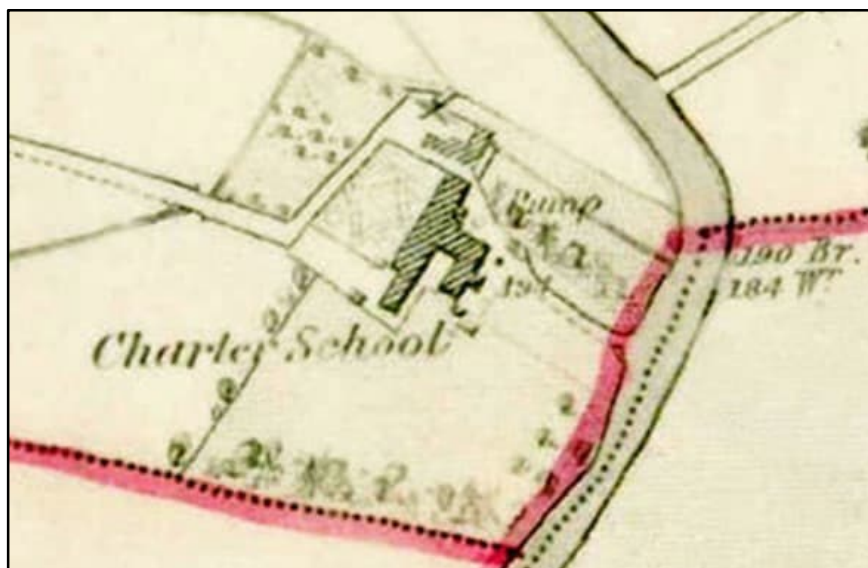
Figure 5: Detail of Ordnance Survey map of 1843

The first-edition Ordnance Survey six-inch map of County Dublin was published in 1843 and the extract reproduced above shows Santry Lodge as it was then (Figure 5). This shows a range of buildings with a great deal more complex ground plan than had been depicted on Rocque's or Taylor's maps. Some idea of what was in those buildings is available from the survey carried out by the Valuation Office in 1845, shortly after the map was published. This assumed that the plan form of the school was separated into a number of rectangles, though without a diagram to indicate the location of each of these rectangles the picture is not entirely clear. For sake of clarity, the table below includes columns indicating the equivalent measurements in metres.

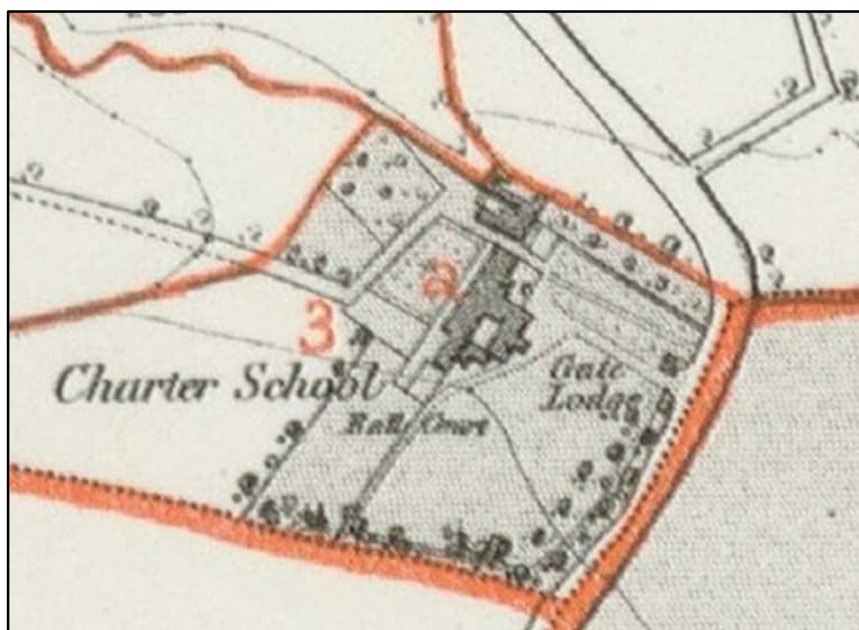
Figure 7: Detail of Ordnance Survey map of 1871

This map shows that an extension had been added to the buildings in between the front section and the rear section, at the southern end and that a ball court had been provided to the south of the buildings. The outbuildings to the north of the school had also been extended with a new range to the north of the original outbuildings. A gate lodge had also been built since the time of the 1843 map.

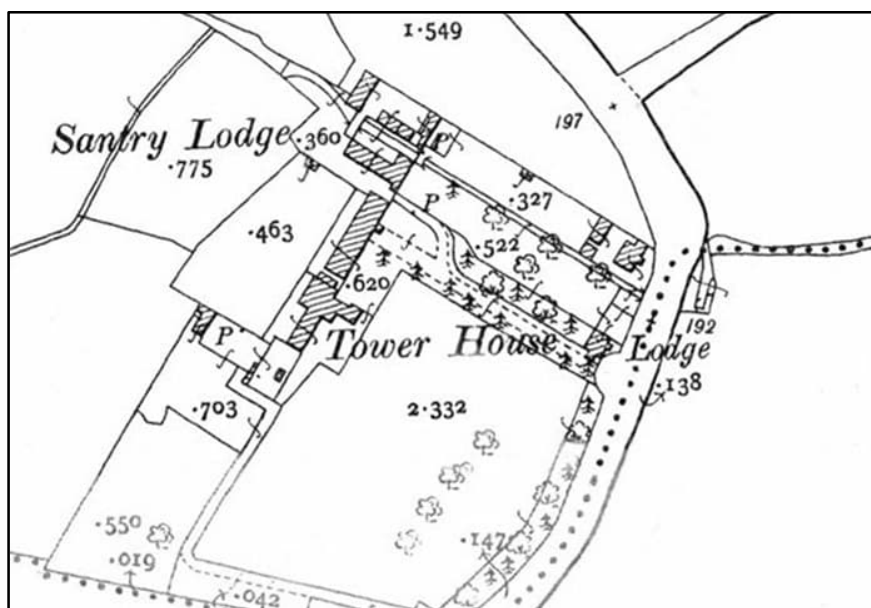
Figure 9: Detail of Ordnance Survey map of 1909

The map shows that there is a gap between Tower House and the remnant of the school building, which was now renamed Santry Lodge. This gap had always been there but had not shown up on the six-inch maps as the scale was too small.

The map also shows that a new house was built on the road frontage at the north-eastern corner of the grounds of Santry Lodge. A new driveway had been laid out to serve Tower House, running south-south-west from the house before turning eastward to Ballymun Road. A gate lodge had also been built to serve Tower House, though that is just outside the frame of this map extract. Three pumps are shown on the map, one in the original position near the pathway leading to the outbuildings, another to the east of the outbuildings and the third to the west of the southern end of Tower House.

The dates assigned to maps in Fingal’s report are not all accurate. The Ordnance Survey map of circa 1900 actually dates from 1907, which confirms that the map post-dates the closure of the school and conversion to houses by a number of years. This dating has no significant implications for the conclusions in Fingal’s report, but is noted here to ensure clarity.

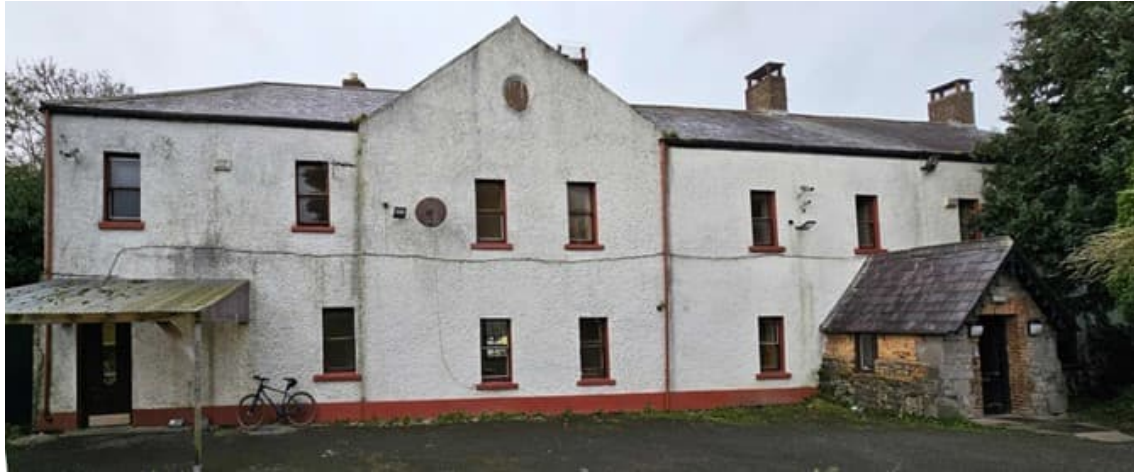
Plate 1: Front elevation of Santry Lodge

Santry Lodge is a two-storey, eight-bay building faced with roughcast render over a smooth-rendered plinth. The roof is slated and is gabled at the northern end, hipped at the southern end. A gable rises from the façade in the third and fourth bays from the southern end; this is in the plane of the façade to the north and forward of the façade to the south by about 100mm. There are four chimneys. The windows in the front elevation are single-pane timber sashes with curled horns. A gabled porch projects from the third bay from the northern end and is described below.

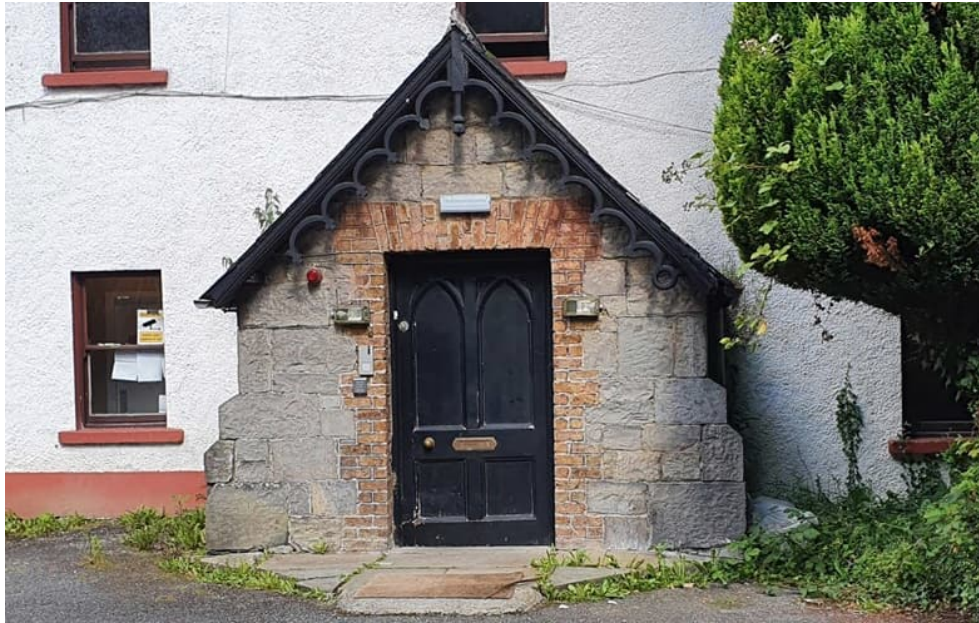
Plate 3: Front view of porch

The porch is faced with roughly dressed squared blocks of calp limestone. The door is four-panelled with pointed segmental tracery in the upper panels. The doorway is of buff-coloured brick with traces of red ochre staining and is pointed with wiggling. The roof is slated, with ceramic ridge tiles having roll mouldings. The porch is gabled to the front with curled bargeboards. At the sides the porch has high plinths of rubble limestone that step in to a second plinth of mixed brick and limestone rubble, some of the brick being buff-coloured, while a few bricks are red and of poorer quality. Above this second plinth the masonry is of buff-coloured brick with flush pointing. The two steps above the plinths are flanchued with Roman cement.

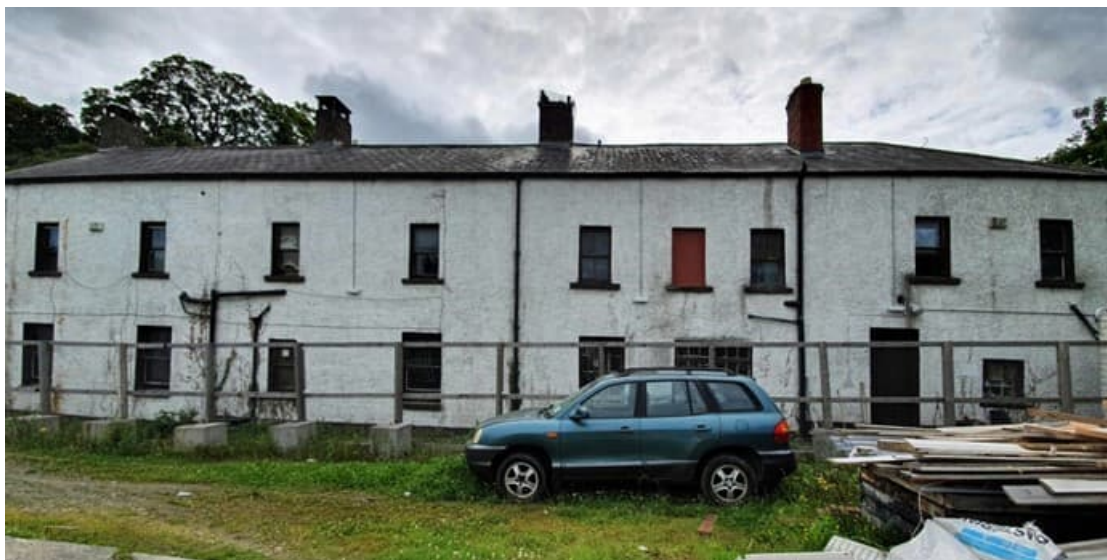
Plate 5: Rear elevation of Santry Lodge

The rear elevation is nine-bay and two-storey, grouped with two bays between each chimneystack, except that the second group from the south has three bays with a blind window in the centre. As with the front elevation, the rear of the building is roughcast rendered and painted. Six of the windows on the upper floor are single-pane timber sliding sashes with curled horns, while the other two, being the third and fifth from the south, flanking the blind window, are two-over-two sashes with quadrant horns. At ground-floor level there is one doorway in the rear elevation and seven windows. One of the windows is a two-over-two timber sliding sash and another is a six-over-six sash, both with quadrant horns. One is a late twentieth century small-paned timber casement, while the rest of the windows are single-pane sashes with curled horns. The rainwater goods are of uPVC.

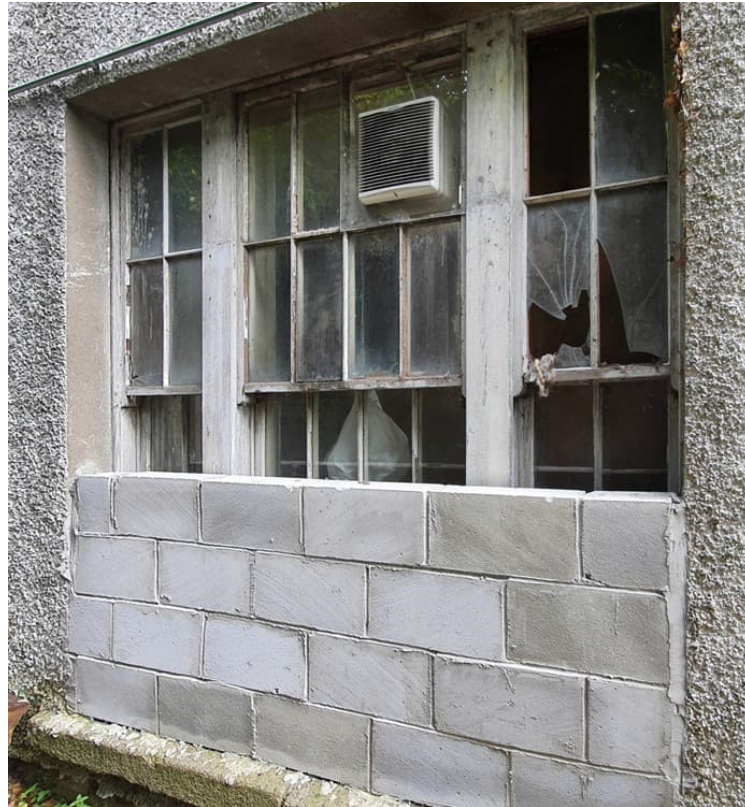
Plate 7: Wyatt window at southern end

The northern end of the building is a plain gable surmounted by a chimneystack. A small boiler house is built against the gable and its flue climbs the wall. At the southern end of the building the roof is hipped and there is a substantial Wyatt window with a central eight-over-eight sash flanked by four-over-four sashes. All three sashes have quadrant horns. The window has a stone sill.

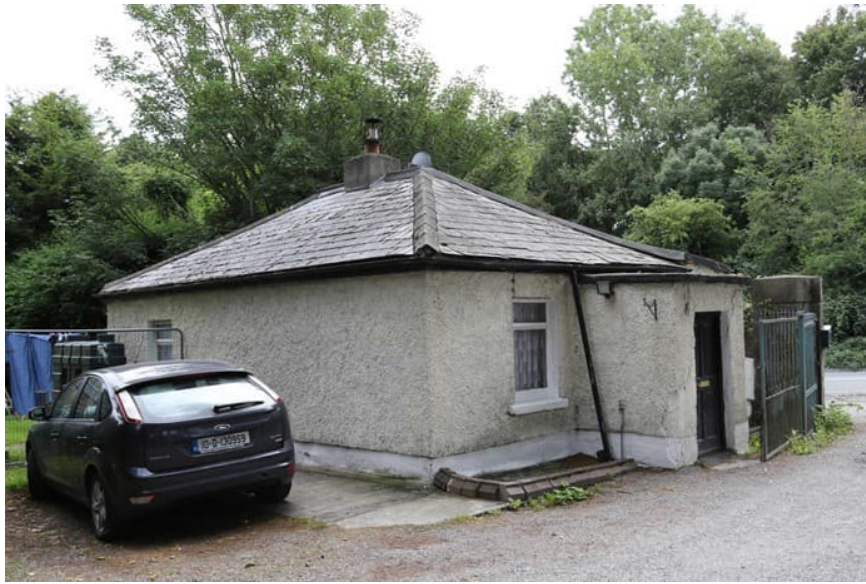
Plate 9: Gate lodge

The gate lodge at Santry Lodge is single-storey and originally two-bay, with a later addition on the eastern side bearing a single window. The original plan form is a simple rectangle, slightly deeper than broad and with a hipped slated roof with ceramic ridge and hip tiles. The façade is roughcast rendered. A flat-roofed porch projects to the front. The windows are replacement uPVC.

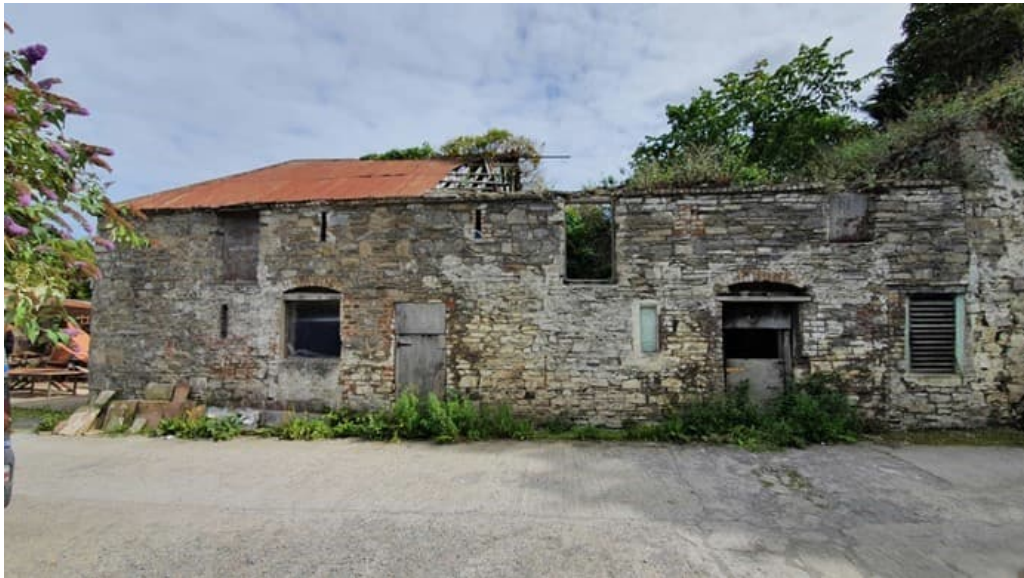
Plate 11: Southern elevation of outbuildings

The outbuildings associated with the charter school are to the north of Santry Lodge and consist of a range of stone-built structures aligned on the northern margin of the laneway leading past the northern end of Santry Lodge into the lands at the rear. The western section of these buildings, seen in the photograph above, are two-storey, the upper floor being partly within the roof space. The structure at the eastern end is concealed beneath a heavy growth of ivy but is taller than the rest of the buildings and appears to be full two-storey. To the east of these buildings is an area enclosed by hoardings and not accessible to examine any buildings in that area. Most of the openings have brick surrounds, with a mixture of brick, much of it of early nineteenth century date. The easternmost building has an elliptical-arched carriage entrance.

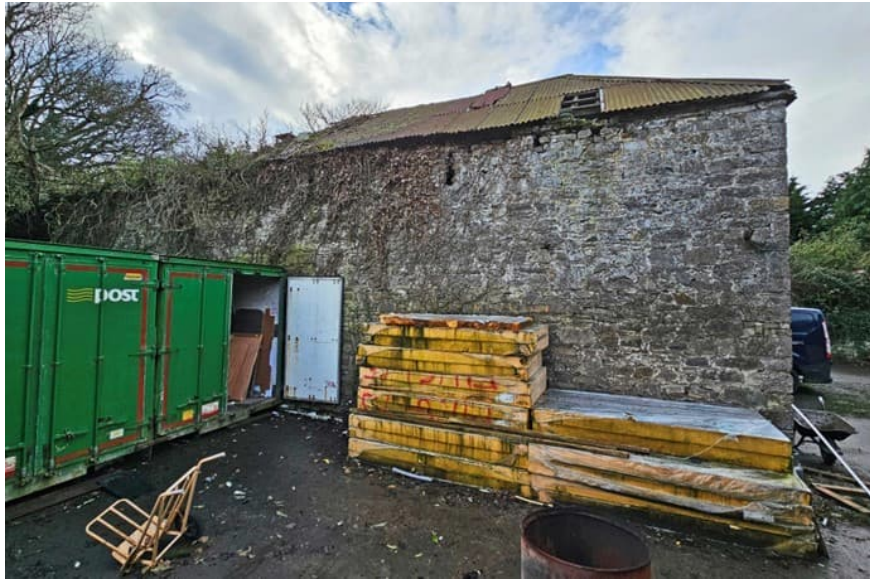
Plate 13: Northern elevation of outbuildings

Part of the northern side of the outbuildings at the eastern end is concealed behind a heavy growth of vegetation. The visible section, towards the western end, has no windows or other openings. At the western end of the outbuildings there is a large opening at ground-floor level and a window above. These buildings are semi ruinous, with the roof collapsed or absent in many places.

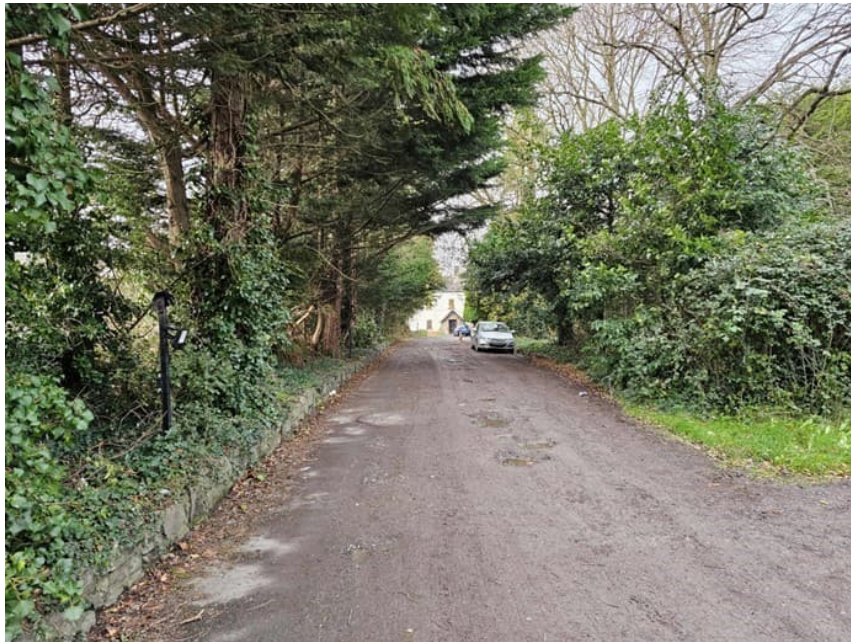
Plate 15: View towards Santry Lodge along the avenue

Santry Lodge is approached from the road by a straight avenue about 95 metres long leading from the gateway to the building. The driveway is lined with Cupressus trees on the southern side, with a mix of other vegetation, while on the northern side there is a mix of laurel and deciduous trees. On the southern side there is a low kerb of rubble stone.

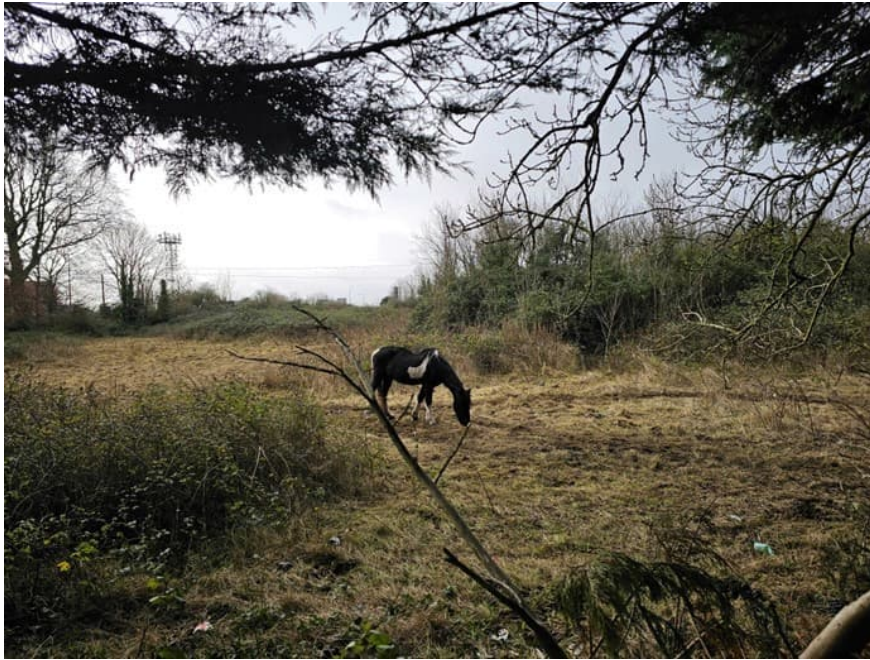
Plate 17: View to south from avenue

The land attached to Santry Lodge to the front of the building includes the avenue and land immediately to the north of the avenue and a small area immediately to the front of the building. Land to the south of the building and to the south of the avenue is in separate ownership, being the land associated with Tower House. Apart from the land immediately adjacent to the road frontage, as described below, the rest of the land is overgrown and is devoid of significant trees or other landscape features.

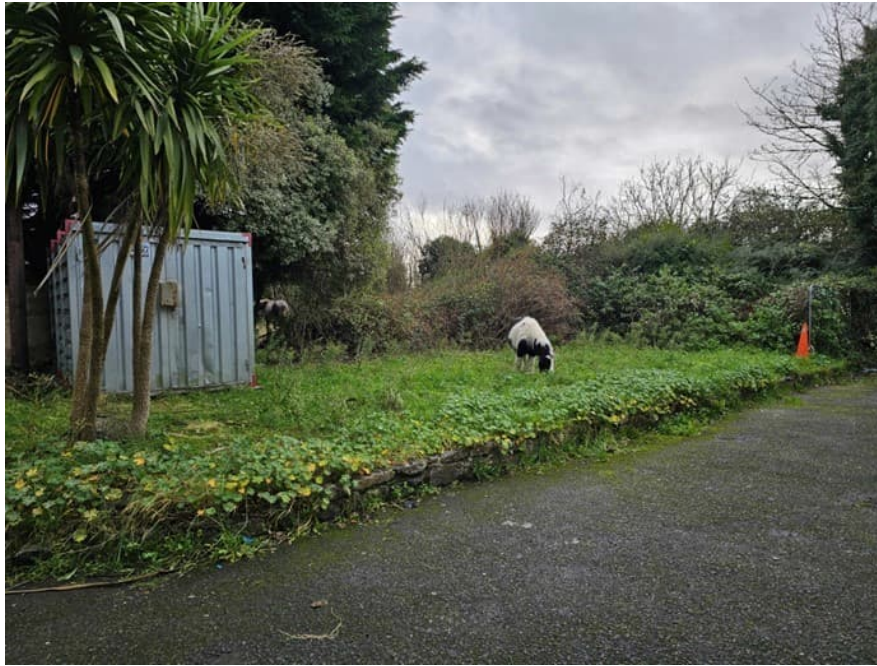
Plate 19: Land immediately to the front of Santry Lodge

Immediately to the front of the house at Santry Lodge is an area paved with asphalt, beyond which is a small grassed area. This is the limit of the land ownership at Santry Lodge and a dense barrier of brambles separates the rest of the land to the front of the house from the field beyond, which is part of the land that was the grounds of the now-demolished Tower House. The photograph below shows that bramble thicket, beyond which the field is largely overgrown with clumps of brambles and with areas of self-seeded trees.

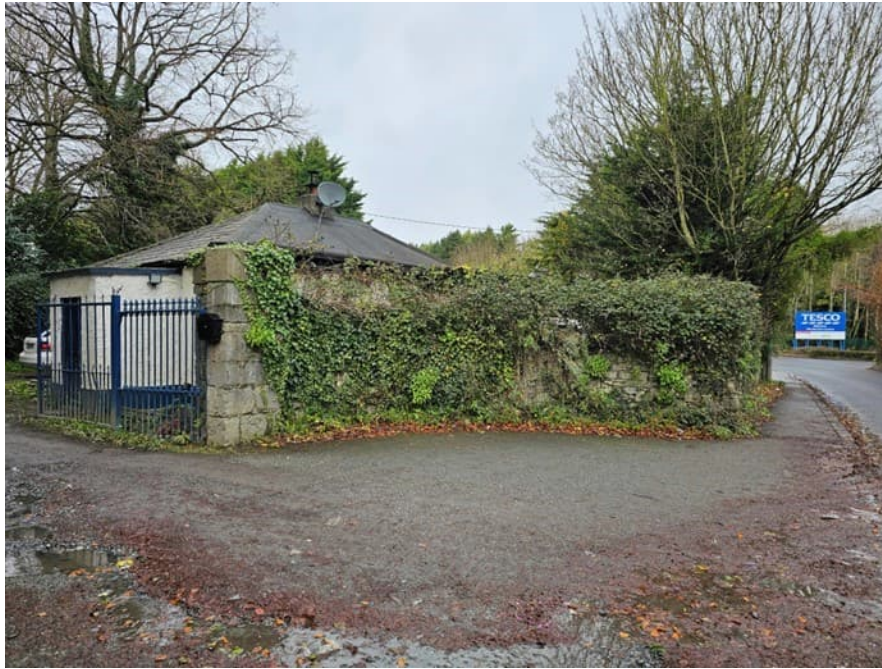
Plate 21: Northern wing wall at gateway

The entrance to Santry Lodge is via a gateway recessed from the road, with two curved wing walls. The gate piers are of roughly dressed calp limestone blocks capped with concrete and recessed on the sides facing the avenue to receive the open gates. The wing walls are largely concealed beneath ivy but are of rubble limestone. The gateway has been widened, with a new steel section added to the northern gate. The original northern gate is of wrought iron with cast-iron bosses and spearheads. The southern gate is of later twentieth century steel.

The gateway and front boundary wall of Santry Lodge are also now protected as being in the curtilage of a protected structure. The impact on the gateway and wall would now be assessed as profound. The mitigation proposed in the EIAR was to relocate the wall and gateway on the revised front boundary of Santry Lodge, on the eastern side of the proposed road that would run through the grounds of the house. As has been noted above, this mitigation would still be appropriate and will be implemented in accordance with method statements to be prepared by the PCA and carried out in consultation with Fingal County Council.

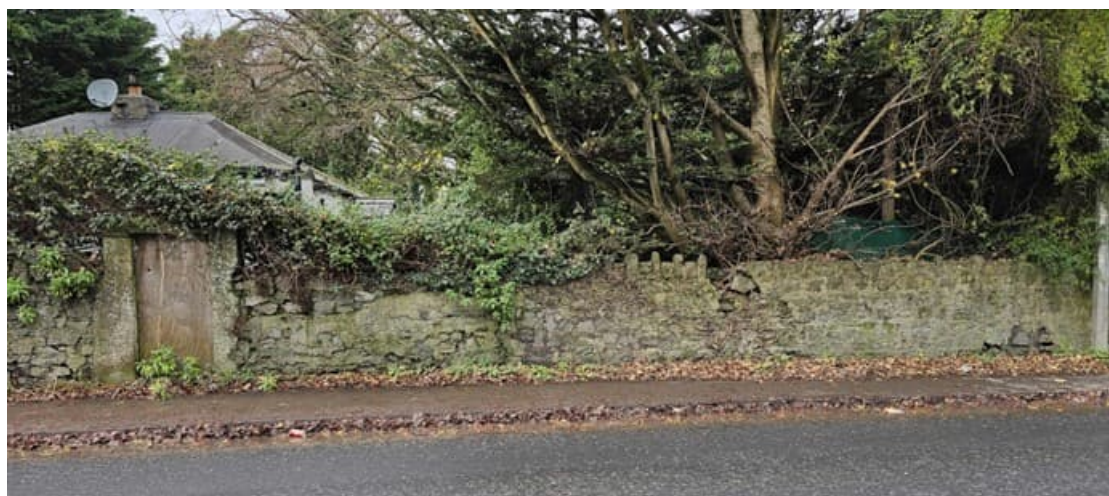
Plate 23: Wall on road frontage to the north of the gateway

It was noted in the historical background above that the grounds of Santry Charter School were enclosed by a wall. Part of this wall still survives along the frontage of Old Ballymun Road, but part of it in very poor condition. To the north of the gateway to Santry Lodge the wall is more or less intact, though apparently partly rebuilt. A pedestrian gateway has been formed through the wall, flanked by mass concrete. The rest of the wall is almost intact, with alternating horizontal and vertical stones as capping along the southern section and a different arrangement in the northern section, suggesting some reconstruction. To the south of the gateway, in the area seen in the photograph below, much of the wall has collapsed. In this section there are some larch trees just inside the wall.

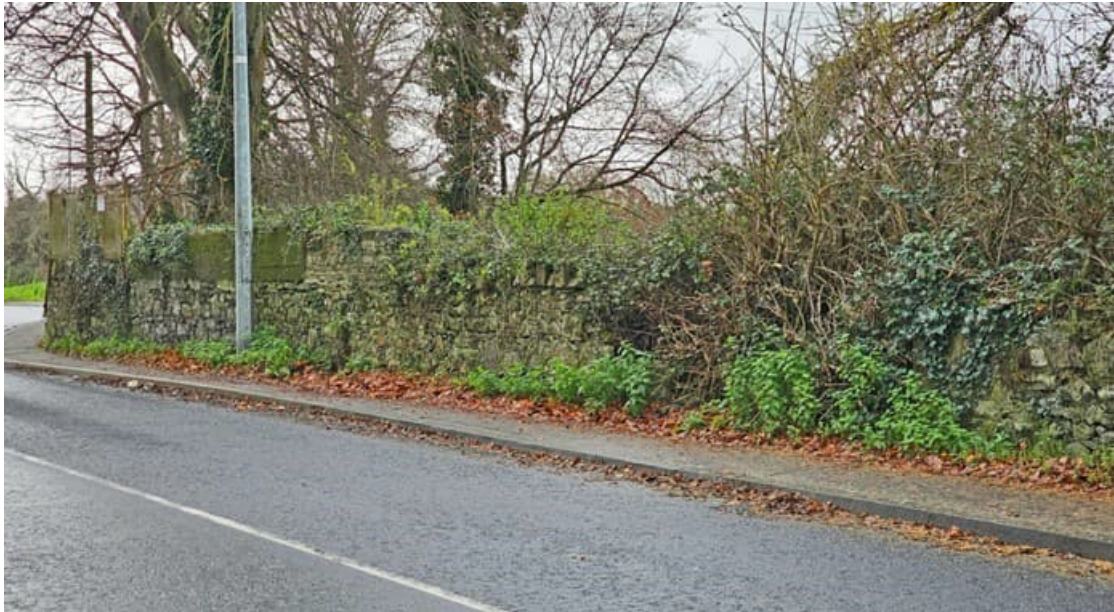
Plate 25: Central section of front boundary wall

In the central section, the front boundary wall is mainly intact, with a section collapsed to the right in the photograph above, while another section, to the rear of the lamp post, has been repaired with mass concrete. In the southern section, approaching the gate lodge to Tower House, parts of the wall have collapsed and are closed with palisade fencing. Other parts are intact and stand with vertical stone used as capping. Within this area there are some beech trees and some ash just inside the front wall.

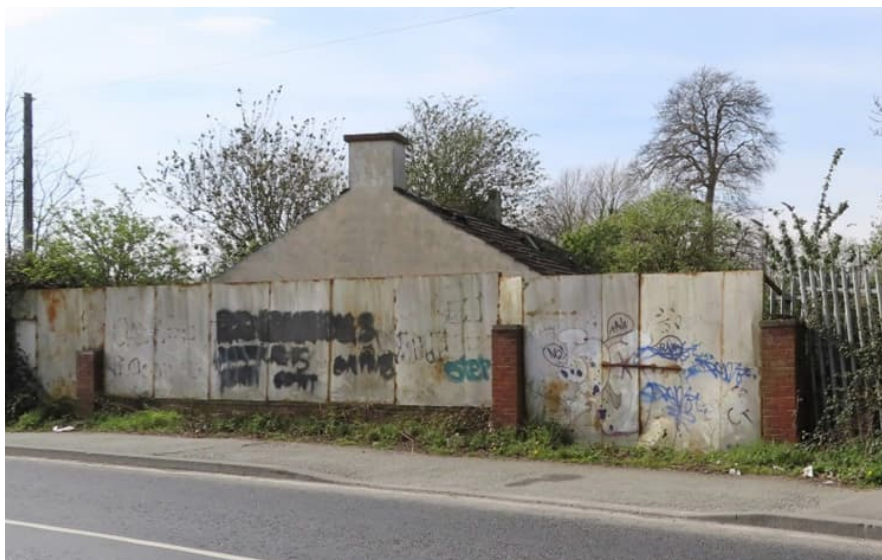
Plate 27: Southern lodge and gateway

The southern of the two gate lodges was built at the end of the nineteenth century as the gate lodge for Tower House. It is currently vacant and derelict. The lodge is single-storey and set at right angles to Old Ballymun Road. The road frontage at this point is marked by a low brick wall with brick pillars. The former gateway is flanked by brick pillars and the wall and piers are capped by mass concrete copings. The brickwork is of a relatively late date.

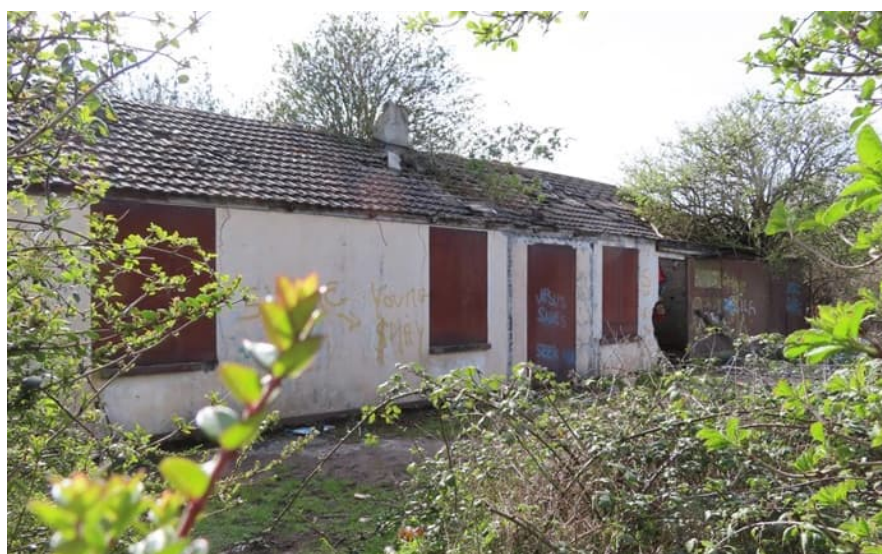
Plate 28: Front façade of southern lodge

The house faces north onto the former driveway to Tower House. The original lodge was small, with a central doorway flanked by windows, and this is seen to right of centre in the photograph above. A later addition to the east is seen at left in the photograph, while to the north is a later garage. The house is cement rendered and painted and the roof has a covering of profiled concrete tiles, though many of the tiles are missing. The windows are boarded up with steel plates. The window sills are of precast concrete.
