## TECHNICAL NOTE

**Re:** Project Metrolink - Refined Phase IIa Building Damage Assessment for Arthur Cox Building at 13-14 Earlsfort Terrace

**Ref:** 22-232A-TN01

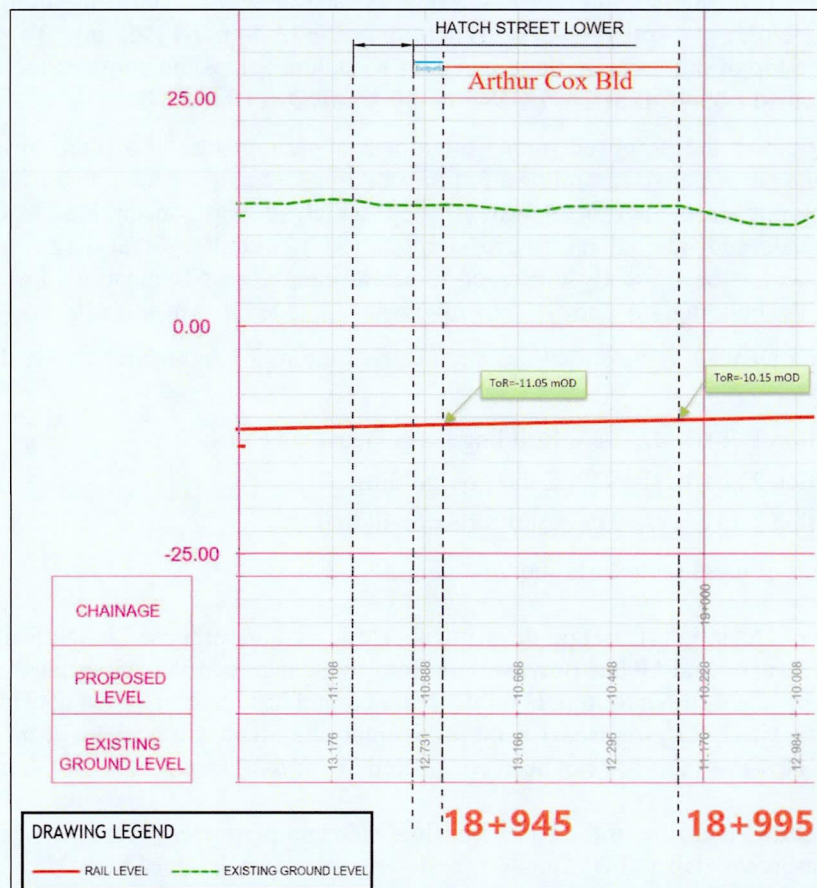
Figure 3-2 Design tunnel profile (top of rail level) from RO Long-Section Drawings

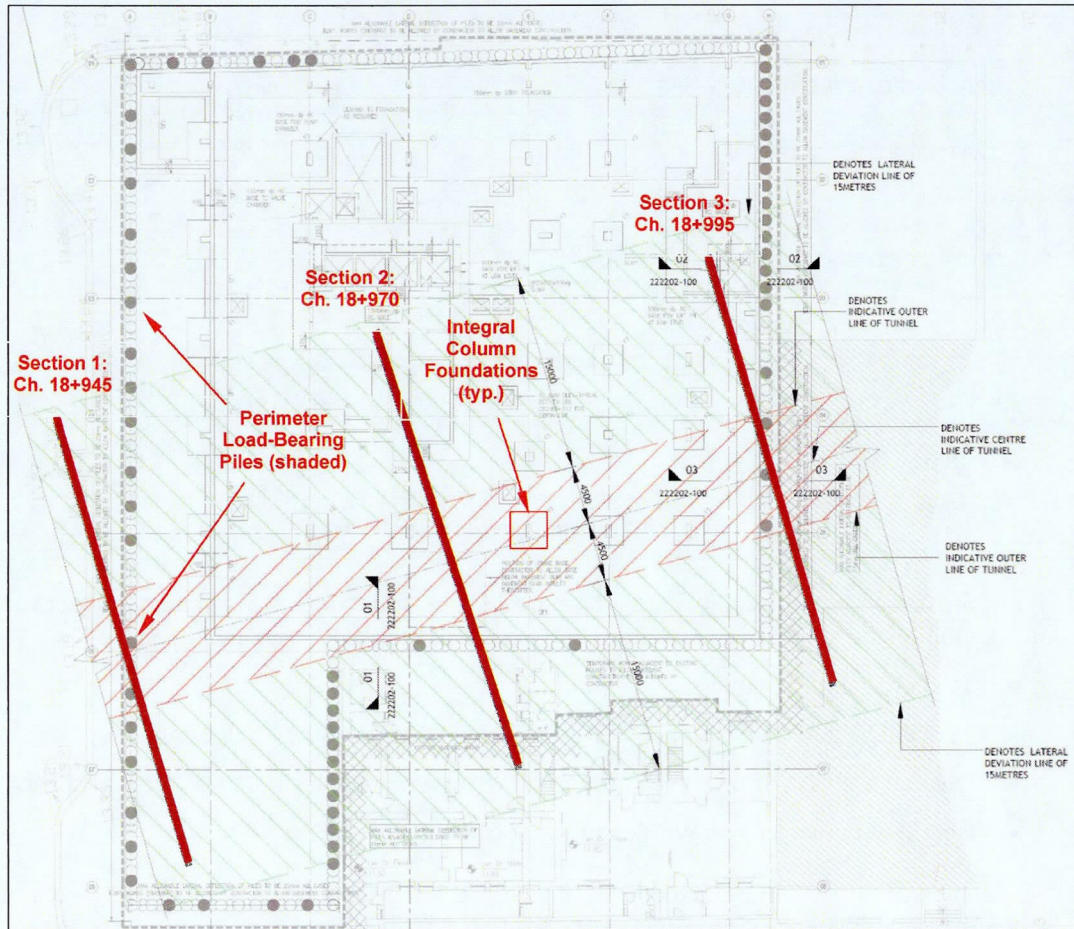
Figure 3-3 Tunnel alignment superimposed on plan of the basement and perimeter secant pile wall.

Figure 3-3 shows the proposed tunnel alignment superimposed on a plan drawing of the basement and perimeter secant pile wall of the building. The figure identifies where there are load-bearing piles in the perimeter wall (shaded) which support concentrated loads from the building façade and internal reinforced concrete (RC) structure. It also shows where the basement slab has been locally thickened to create integral pad foundations for the internal columns of the building. A copy of the drawings is included in Appendix A.

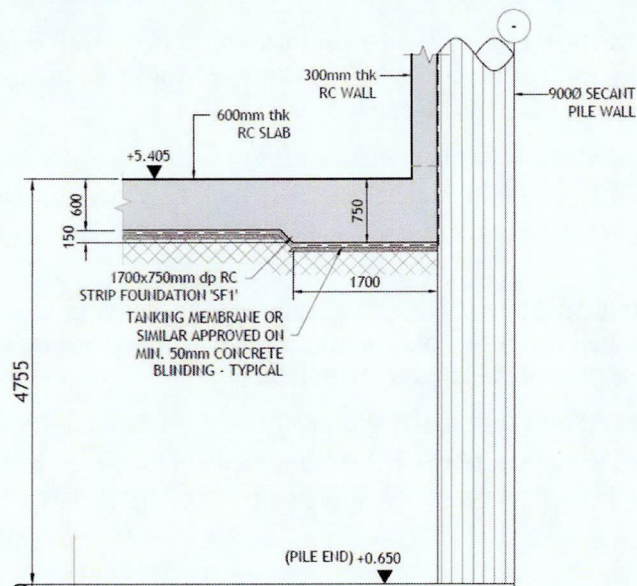
Figure 3-4 Profile of basement floor slab and 900mm diameter perimeter secant pile wall on Hatch St.

Figure 3-4 shows a profile of the basement floor slab and perimeter secant pile wall on Hatch St. The basement slab is 600mm thick and subgrade level is at **+4.80mOD**. The slab is locally 150mm thicker at the integral pad foundations for the internal columns and basement wall. Toe level for the secant piles on this side of the building is **+0.65mOD**.

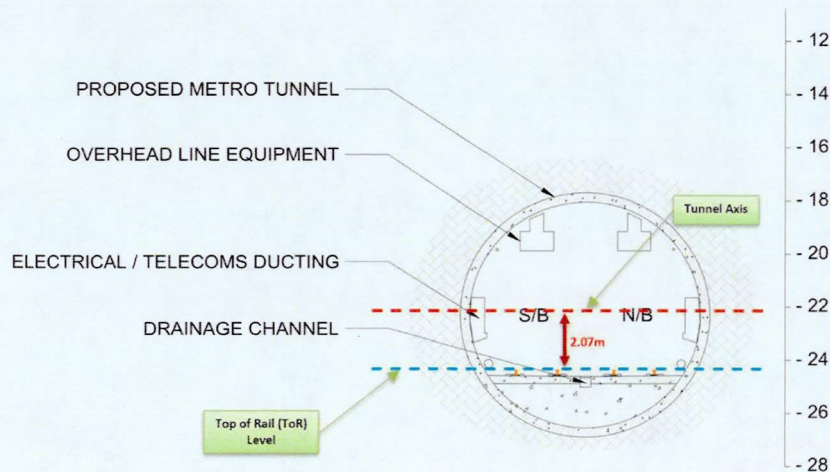
*Figure 3-5 – Typical profile of the tunnel*

Figure 3-5 shows a typical profile of the tunnel. The following is a summary of relevant information on the tunnel geometry from Section 2.1 of the BDR (copy in Appendix A):

The calculation of tunnelling settlements for the Building Damage Assessment is based on the **9.53m** outer diameter of the TBM cutter head.

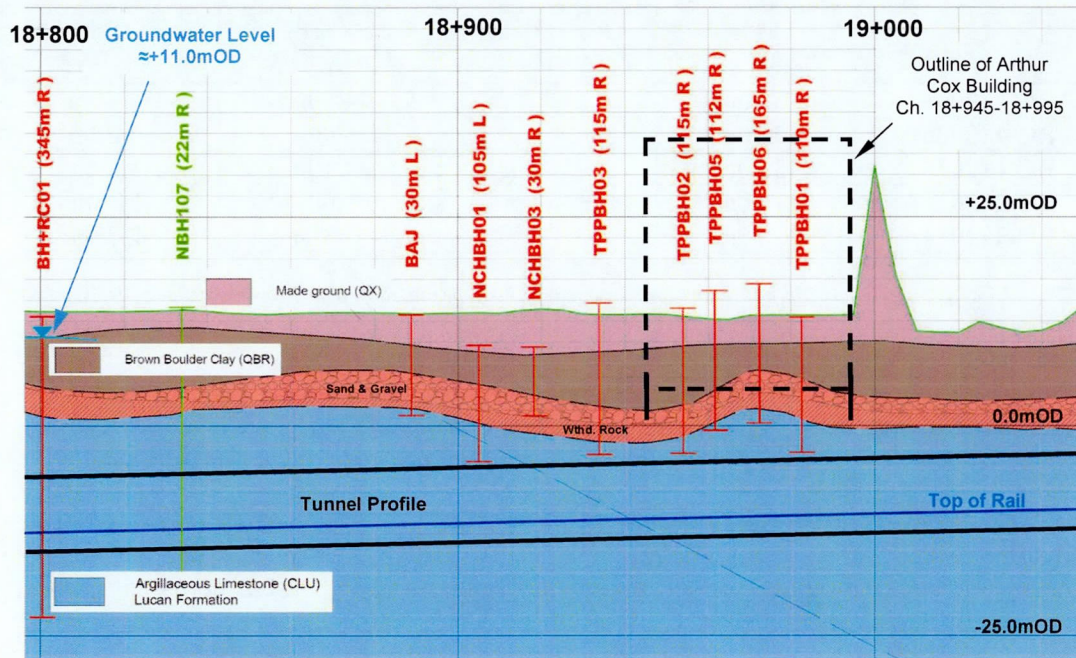
Figure 4-2 Geological Cross-Section [Sheet 26 of 28 from Appendix A20.9 to Chapter 20 of the EIAR]

- The tunnel profile is shown to be in the Limestone bedrock under the building.
- Based on the interpreted geological section in Figure 4-2 Jacobs/IDOM have assumed the following ground loss parameters for the Building Damage Assessment along section of the tunnel under the Arthur Cox Building:

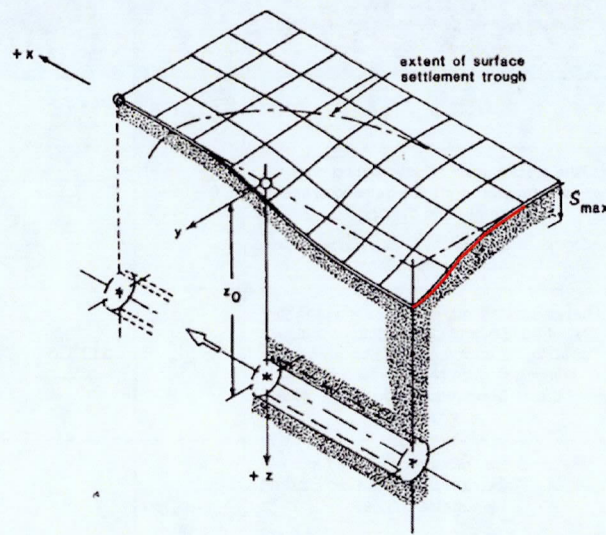
Figure 5-1 Profile of settlements over an advancing tunnel (Mair et al, 1996)

As described in Section 4.2.2 of the BDR, the shape of the settlement trough above the tunnel has been assumed to follow a Gaussian distribution curve centred over the centreline of the tunnel, as illustrated in Figure 5-1 and Figure 5-2.

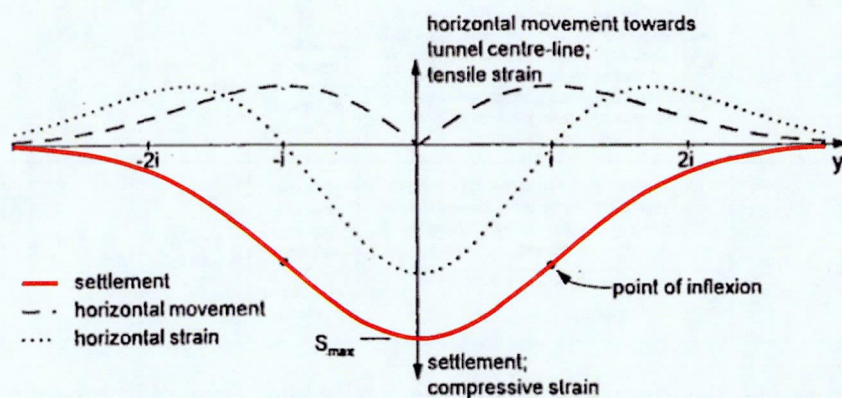
Figure 5-2 Profile of vertical and horizontal movements over the tunnel centreline and the corresponding horizontal strains (Figure 4-3 of the BDR in Appendix 5.17 of the EIAR)

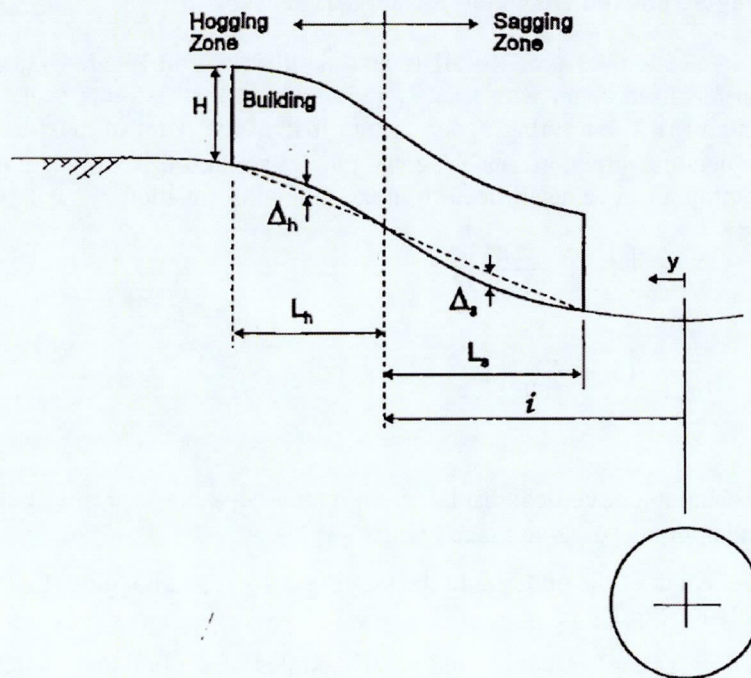
Figure 5-3 – Theoretical profile of building deformation (Figure 4-5 in the BDR)

As described in Section 4.3.4 of the BDR, to assess the potential building damage it is assumed that the building behaves as an ideal beam of height  $H$  that deforms to the profile of the ground movements at the foundation level (i.e. at the tip of the secant pile wall or at basement subgrade level). This creates sagging and hogging zones of building movements, as illustrated in Figure 5-3, which are analysed separately to determine the maximum limiting tensile strain on the building.

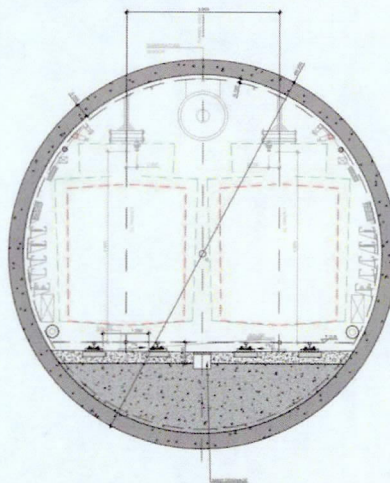
Figure 2-1: TBM Tunnel Geometry

The tunnel lining itself has been assessed for all relevant ground loading conditions, manufacturing loads (demoulding, storage, and transportation) and segment installation during ring-build. The main characteristics of the segments are:

- Typology: Universal ring.
- Thickness: 35 cm.
- Concrete class: C40/50
- Reinforcement: Steel bars class C + steel fibres (Model Code FRC 4e)
- Fire protection: Polypropylene fibres
