SLANE BYPASS & PUBLIC REALM ENHANCEMENT SCHEME

Additional Information Response Document

December 2024

ABP-318573-23

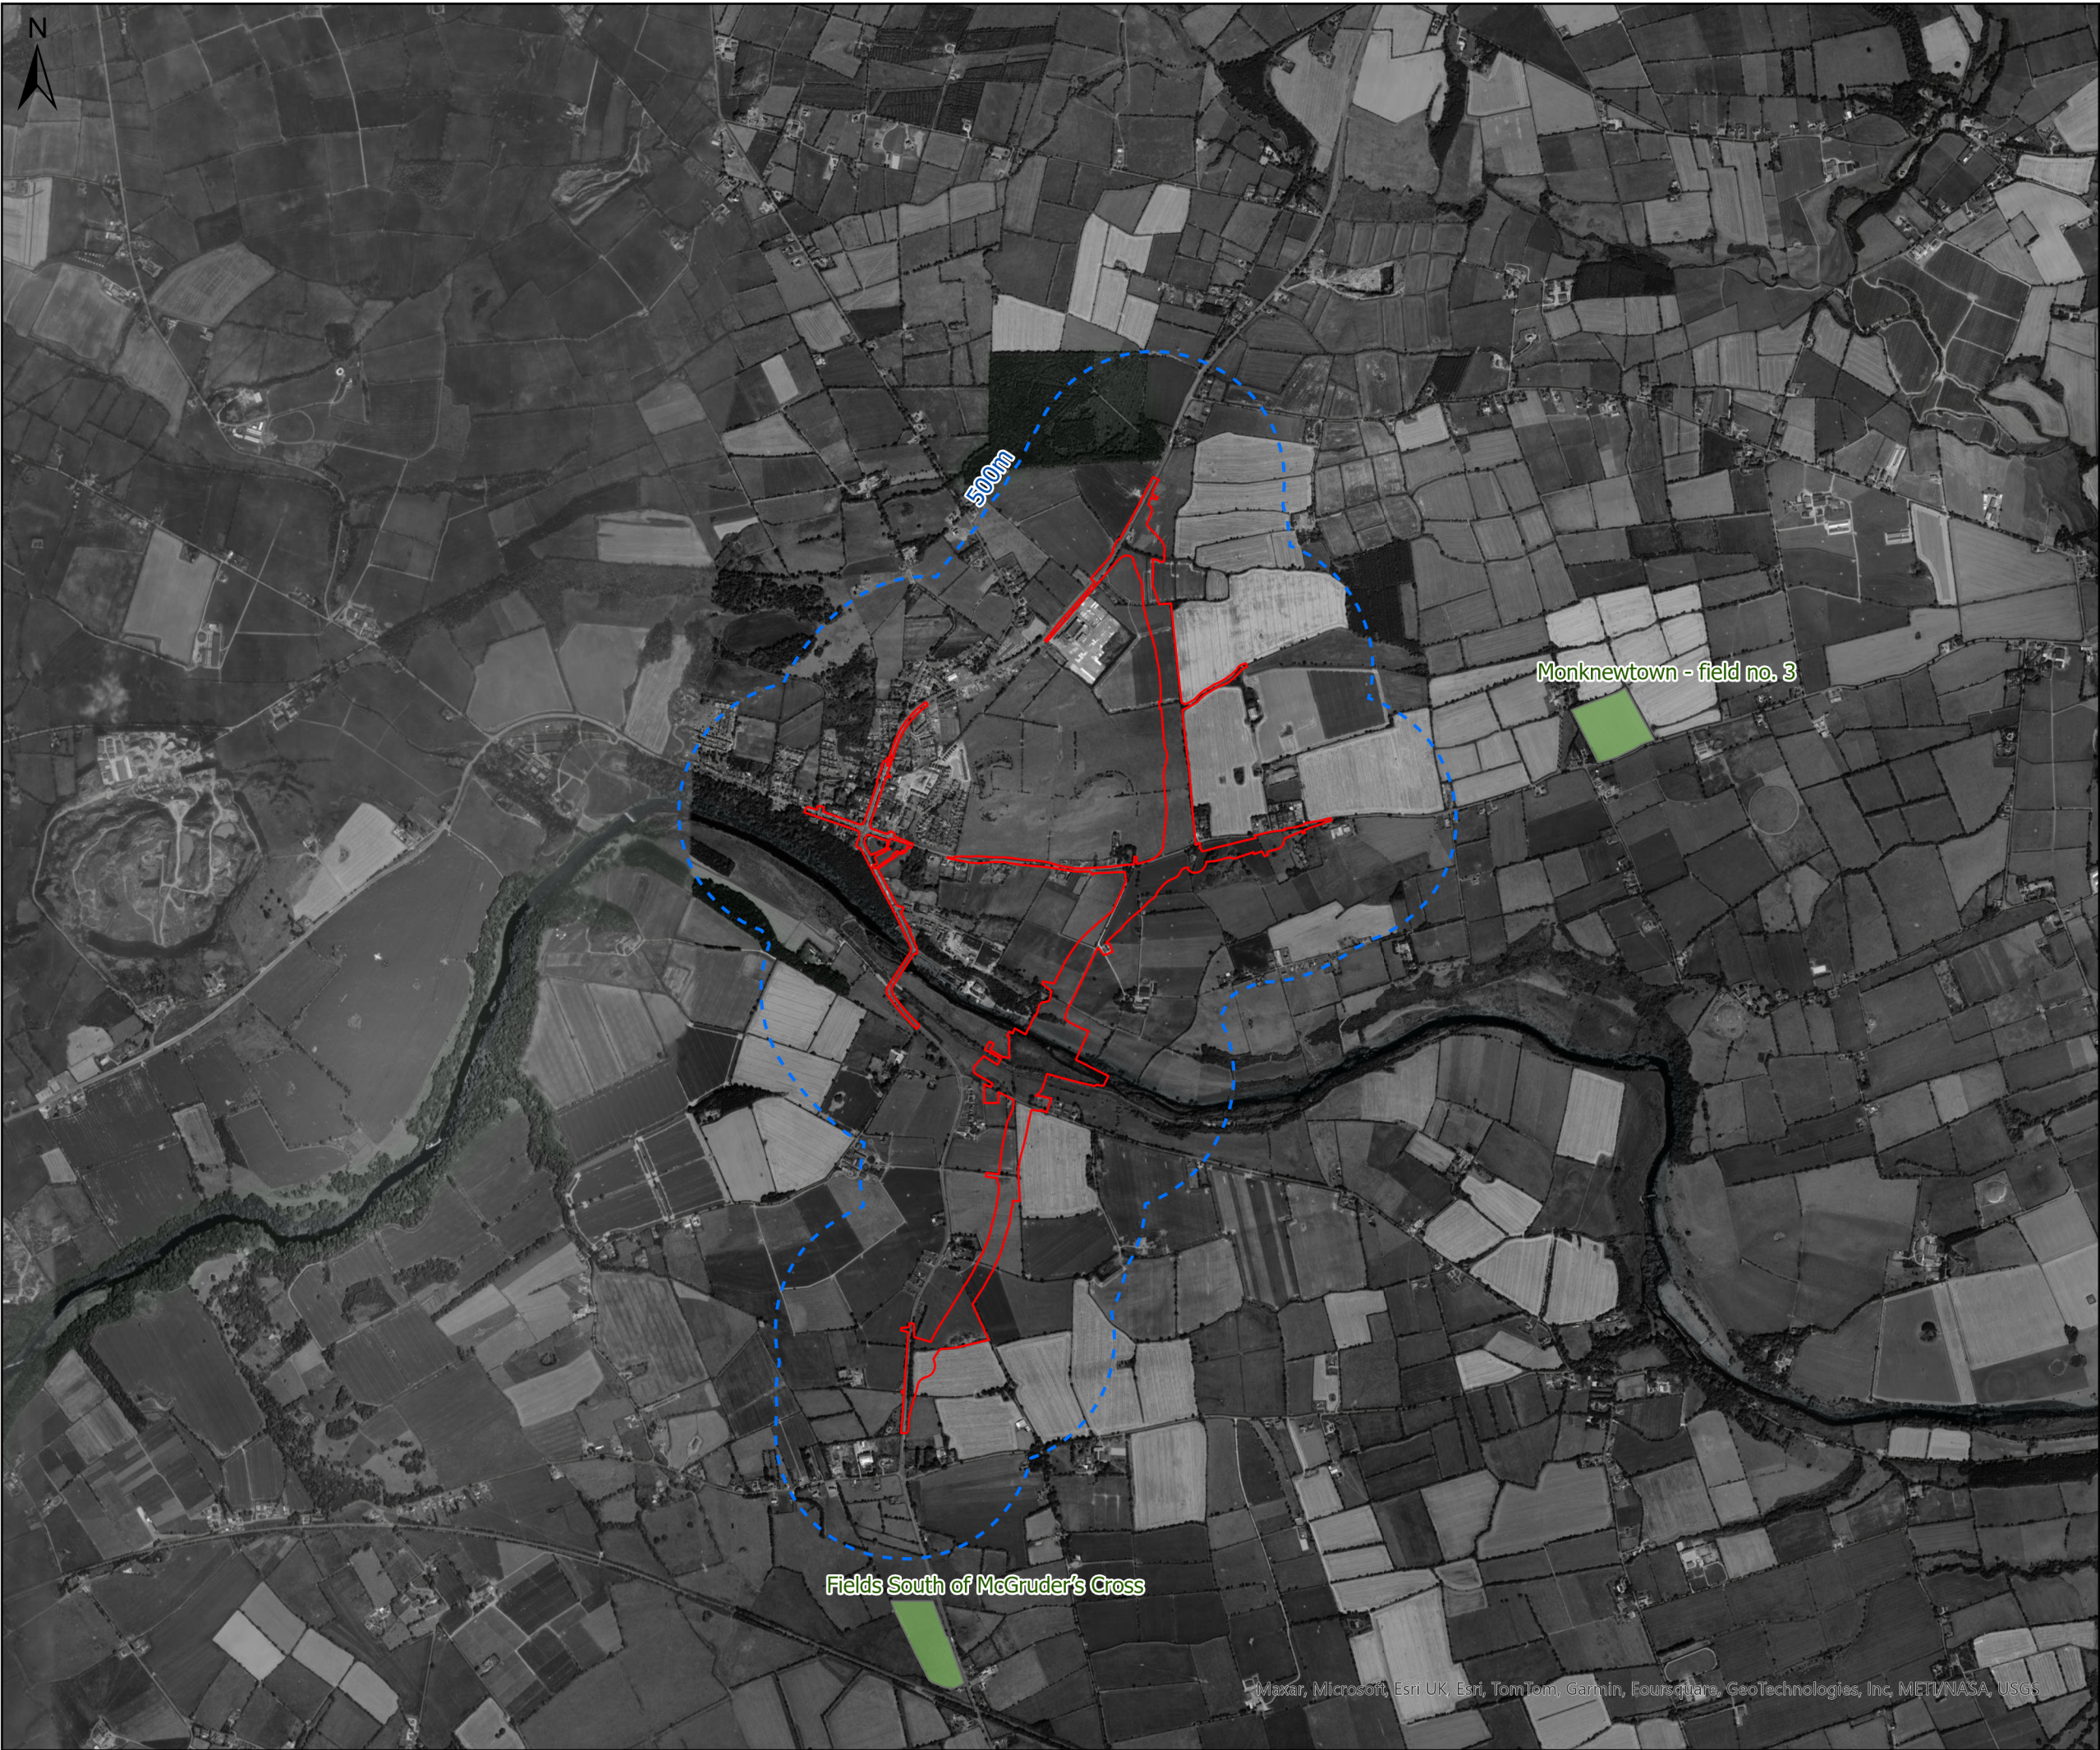
Figure 4.4:
Golden plover records from the winter farmland bird surveys and the overwintering wildfowl surveys

Of the three sightings, none were recorded within either the footprint of the Proposed Scheme or within the 500m disturbance buffer of that footprint, see **Figure 4.4**.

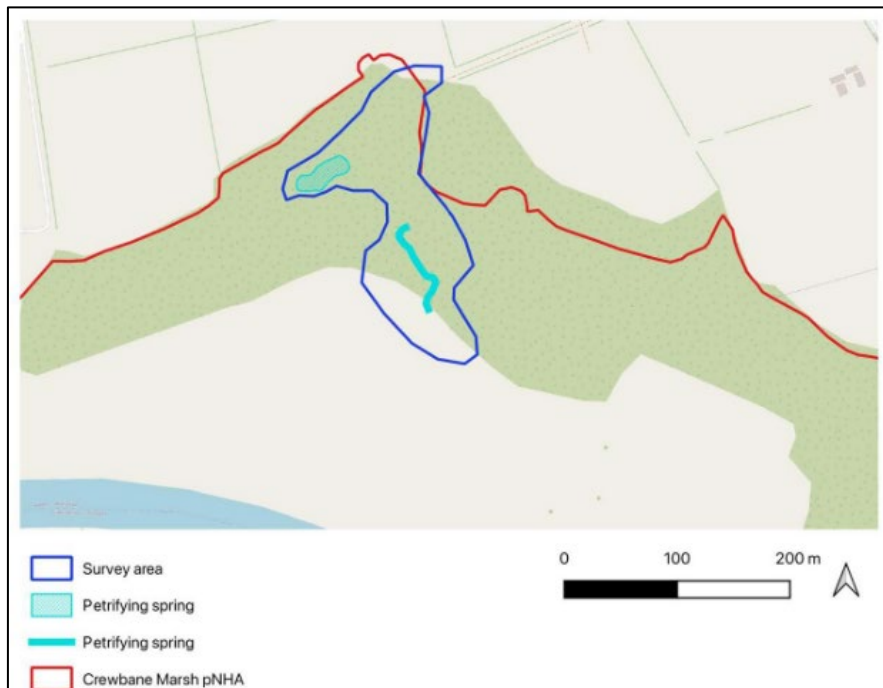
Figure 1.18: Ecology Survey Area in Crewbane Marsh pNHA

- In Crewbane Marsh pNHA there is an area of petrifying spring vegetation at the top of the slope (**Figure 1.18**). This has multiple springheads with paludal tufa. However, it is highly poached and trampled by animals. Below this, to the south-east, there is a petrifying spring/stream with strong cascade tufa

formation and good flow. The pH in the stream was 7.79 (within described range, as per Denyer *et al.*, 2023). The stream discharges into the floodplain below. The spring is very overgrown, but positive indicator species are present in open areas as listed below.

- At least six positive indicator species for Annex I priority petrifying spring habitat (Denyer *et al.*, 2023) were present in the petrifying spring areas in the survey area: common stonewort (*Chara vulgaris*), long-stalked yellow-sedge (*Carex lepidocarpa*), carnation sedge (*Carex panicea*), red fescue (*Festuca rubra*), curled hook-moss (*Palustriella commutata*), butterwort (*Pinguicula vulgaris*).
- Both petrifying spring areas are examples of the Annex I priority habitat “*petrifying springs with tufa formation*” but are in poor condition due to vegetation succession to a grass dominated sward on the slope and animal trampling in the open area at the top of the slope.

A site survey was carried out by RPS and Denyer Ecology on 5 November 2024 to assess whether there were any examples of the Annex I priority habitat “petrifying springs with tufa formation” or “alkaline fen” present within the pNHA and downgradient of the Proposed Scheme. The survey identified two (2 No.) areas of petrifying tufa springs within the pNHA. It concluded that these petrifying springs were examples of Annex I priority habitats; “petrifying springs with tufa formation” which “are in poor condition due to vegetation succession on the slope and animal trampling in the open area at the top of the slope”. Locations of the confirmed petrifying springs are detailed in **Figure 1.18** and also in the attached Denyer Ecology report¹⁰.

During the additional ecological site assessment, previously unmapped alkaline fen was noted at the top of the slope, outside of the zone of influence of the Proposed Scheme (see **Figure 1.18**), within the Crewbane Marsh pNHA/River Boyne and River Blackwater SAC. This location may align with the brief description of “Crewbane Complex” containing “seepage from higher ground to the north”, as described by Goodwillie (1992). No other location of alkaline fen habitat was noted from the additional ecological site assessment.

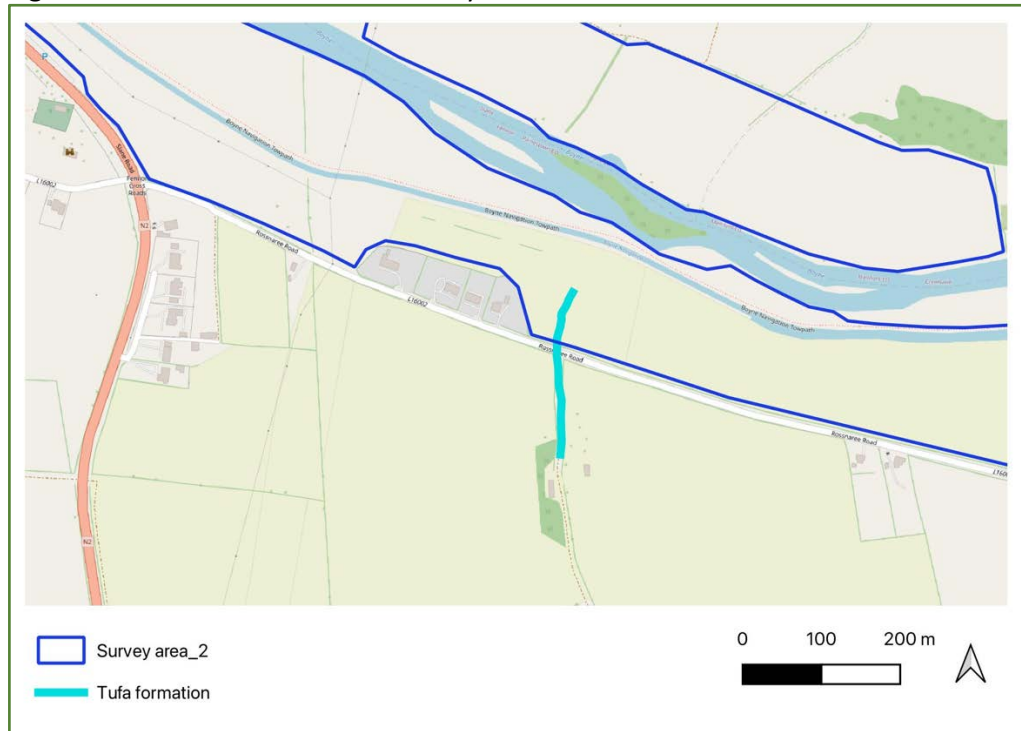
Figure 3. Tufa formation in main survey area

Within the main survey area, tufa was recorded in one location (Figure 3). This is a dry stream bed where there is cascade tufa formation on rocks within the stream bed (Photographs 1 and 2). The presence of bare soil and the aquatic moss *Rhynchostegium riparioides* suggests that there is occasional flow in this stream. However, most of the vascular plant and bryophyte species recorded in the stream bed were non-wetland (terrestrial) species. Only one positive indicator species for Annex I priority petrifying spring habitat (Denyer et al., 2023) was recorded (*Didymodon tophaceus*). The stream was followed upstream where there is a culvert under the road (Photograph 3). This was also dry and had old cascade tufa formation present. To the south of the road, the stream channel remained dry until c. 115m upstream from the road culvert. Here a pond has been created to the east of the track into which most of the stream flow is diverted. Above the diversion the stream has good flow and a pH of 7.9, suggesting a strong groundwater influence. Tufa was present in the channel in this location and the petrifying spring positive indicator species *Pellia endiviifolia* was present in small amounts.

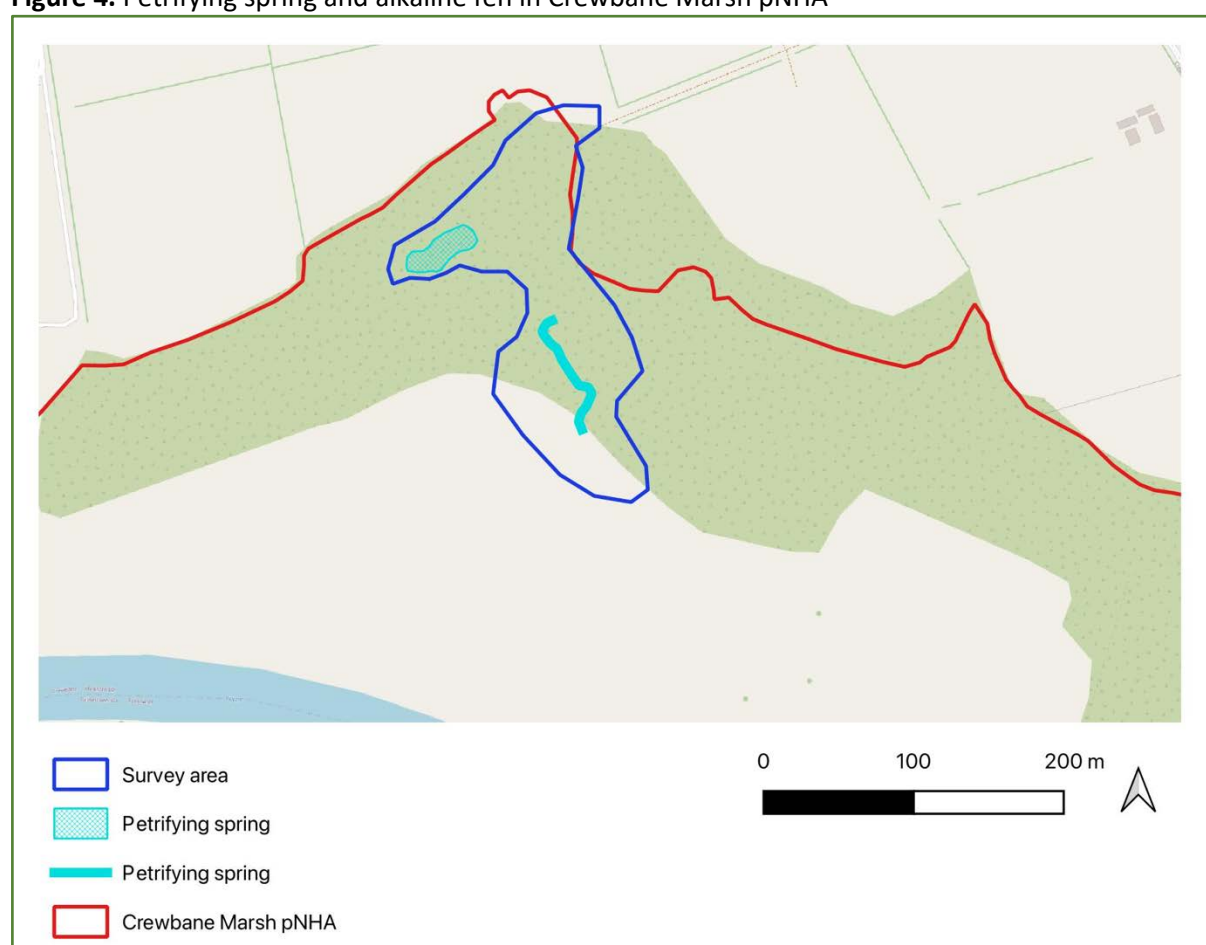
Figure 4. Petrifying spring and alkaline fen in Crewbane Marsh pNHA

In Crewbane Marsh pNHA there is an area of petrifying spring vegetation at the top of the slope (Figure 4). This has multiple springheads with paludal tufa (e.g. Photograph 4). However, it is highly poached and trampled by animals. Below this, to the south-east, there is a petrifying spring/ stream with strong cascade tufa formation (e.g. Photograph 5) and good flow. The pH in the stream was 7.79. The stream discharges into the floodplain below. The is very overgrown, but positive indicator species are present in open areas.

Both petrifying spring areas are examples of the **Annex I priority habitat 'petrifying springs with tufa formation'**, but are in poor condition due to vegetation succession on the slope and animal trampling in the open area at the top of the slope.

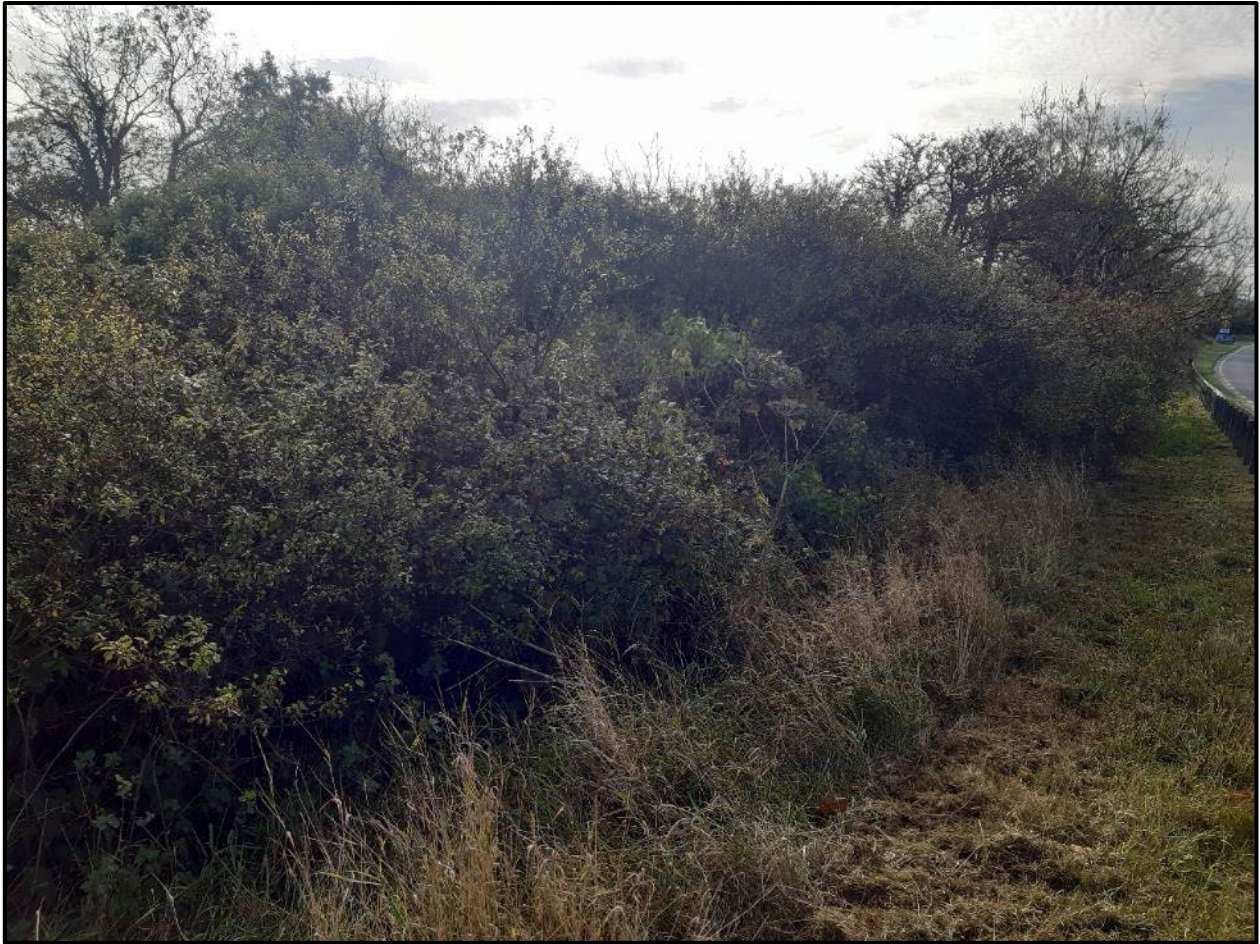
Plate 2 Boundary 2

This hedgerow scored 22 when assessed using the HAS.

The total length of this boundary within the land acquisition boundary is 23m. The entirety of this length lies within the scheme alignment/works boundary.

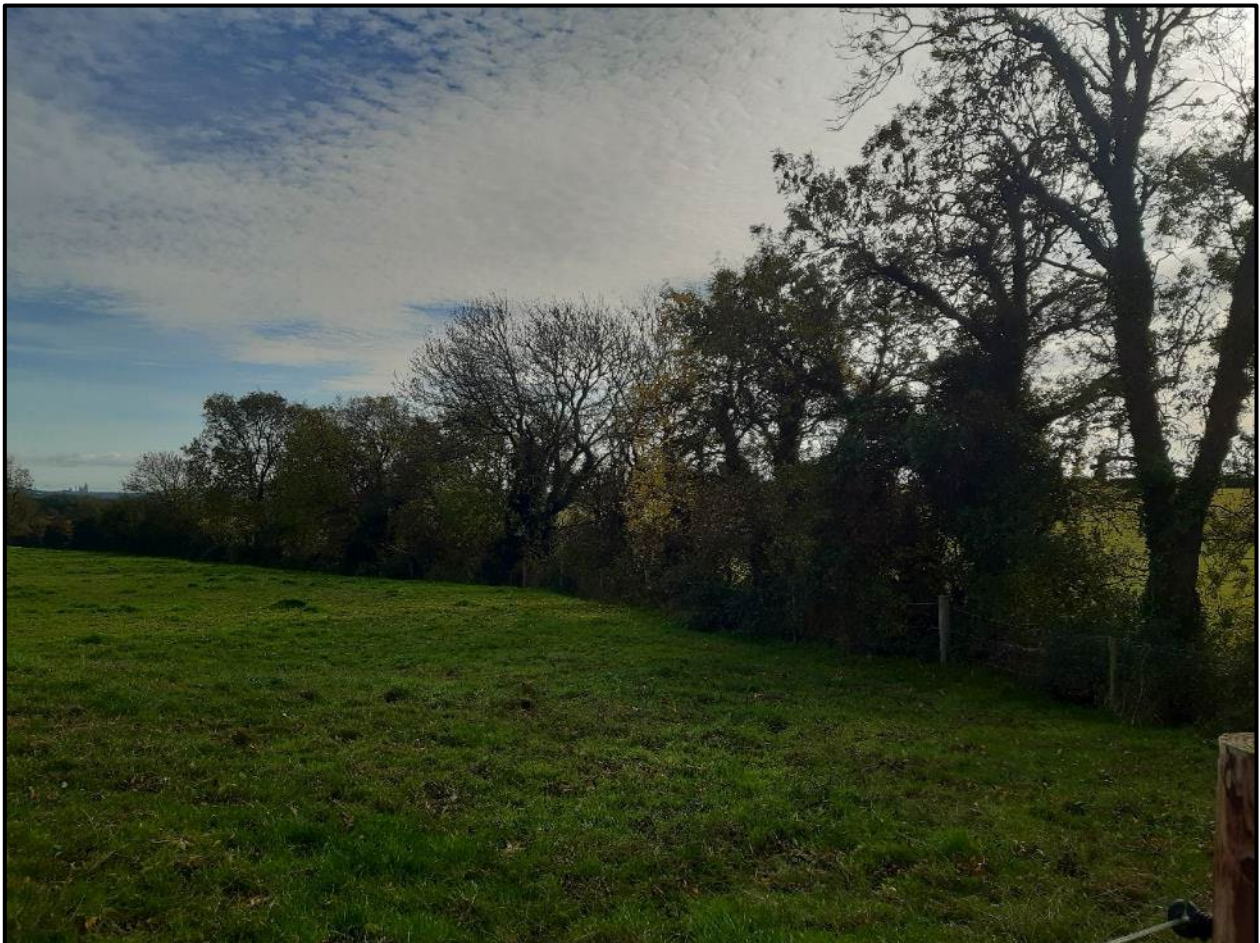
Plate 3 Boundary 3

This treeline scored 31 when assessed using the HAS.

The total length of this boundary within the land acquisition boundary is 174.7m. 136.2m of this length lies within the scheme alignment/works boundary.

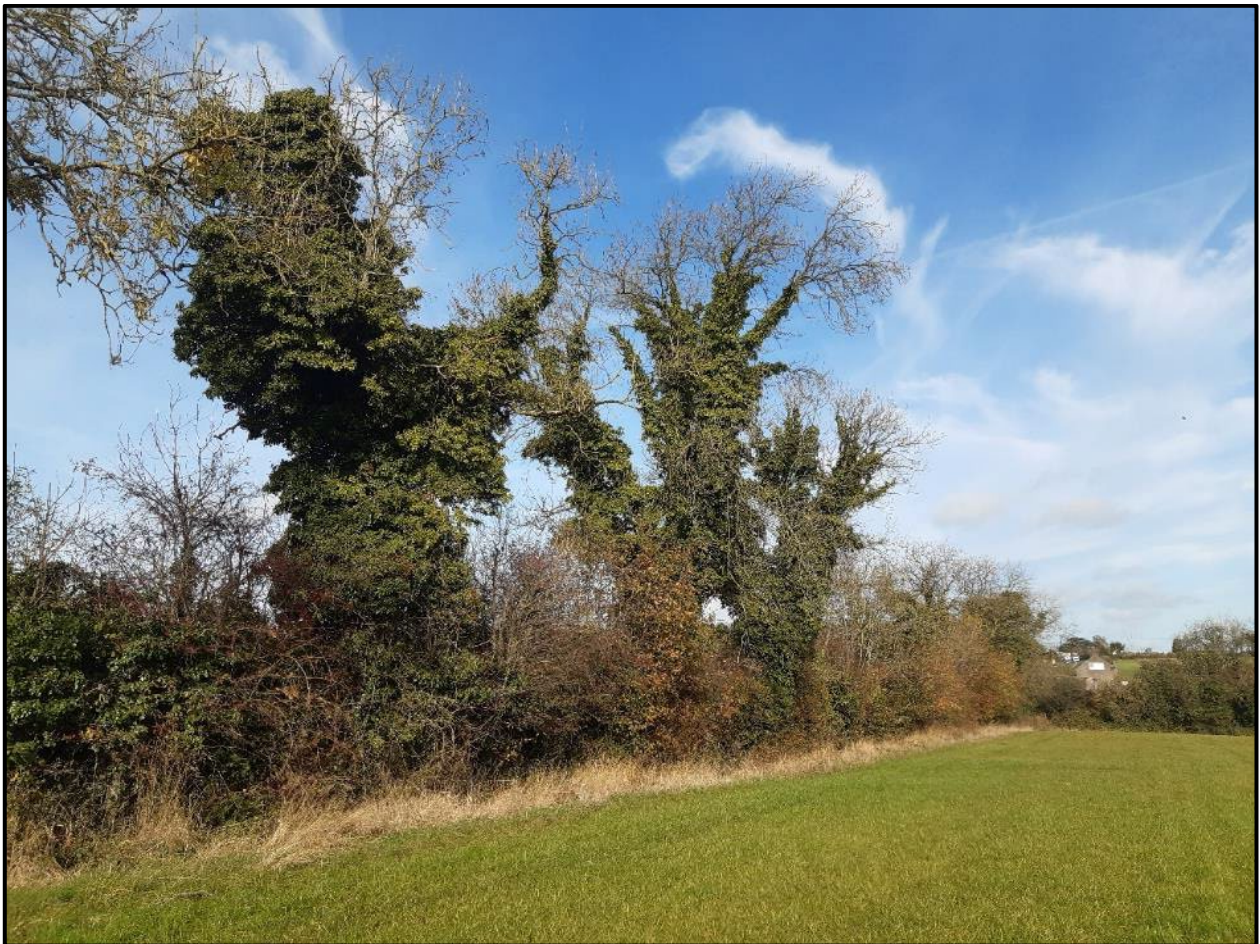
Plate 4 Boundary 4

This boundary scored 29 when assessed using the HAS.

The total length of this boundary within the land acquisition boundary is 111.9m. 69.1m of this length lies within the scheme alignment/works boundary.

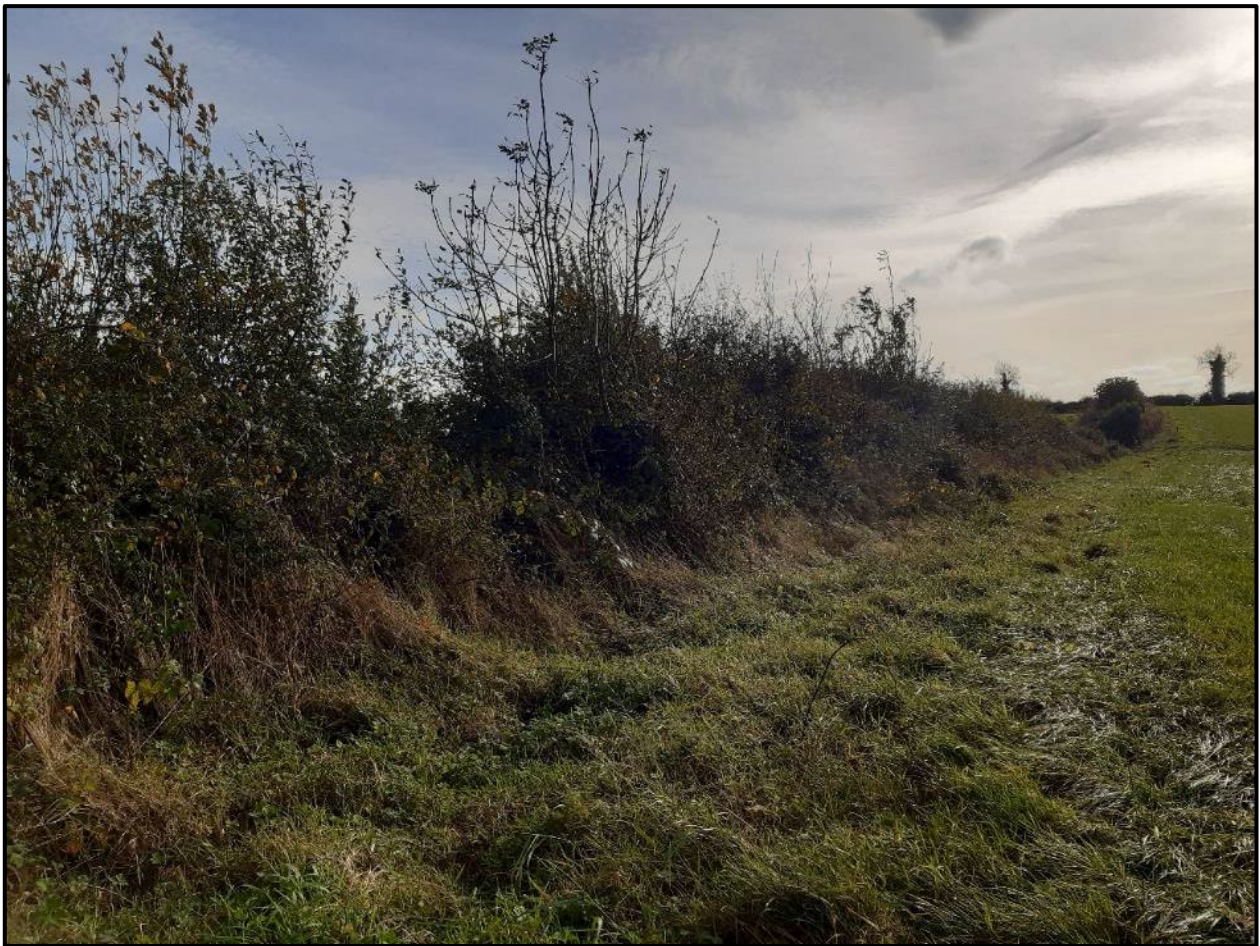
Plate 5 Boundary 5

Boundary 5 was classified as a hedgerow. It was an internal farm boundary and was also present on 1st edition OSI maps. It was relatively species rich containing 10 favourable tree, shrub and woody climber species listed in Appendix D of the HAS booklet. These species consisted of abundant ivy with frequent rose, occasional blackthorn, ash, gorse, elder, holly, guelder-rose (*Viburnum opulus*) and hawthorn and rare goat willow (*Salix caprea*). Abundant brambles were also present. Ground flora included creeping bent (*Agrostis stolonifera*), Yorkshire fog (*Holcus lanatus*), nettles, herb-robert, couch grass, bush vetch, creeping buttercup, horsetail (*Equisetum* sp.) and greater bird's-foot trefoil (*Lotus pedunculatus*). This hedgerow was built upon a bank of approximately 0.5m high with an adjacent dry drain of up to approximately 2m deep in parts. This hedgerow has been cut A-shape to approximately 2m high previously and was approximately 5m wide. The basal porosity of this hedgerow was dense with the exception of a small section towards the southern extent. It was also a continuous hedgerow with no gaps. There was abundant ivy visible on the bank/floor of the hedgerow and the margins contained frequent couch grass and occasional nettles.

This boundary scored 31 when assessed using the HAS.

The total length of this boundary within land acquisition boundary is 193.3m. The entirety of this length lies within the scheme alignment/works boundary.

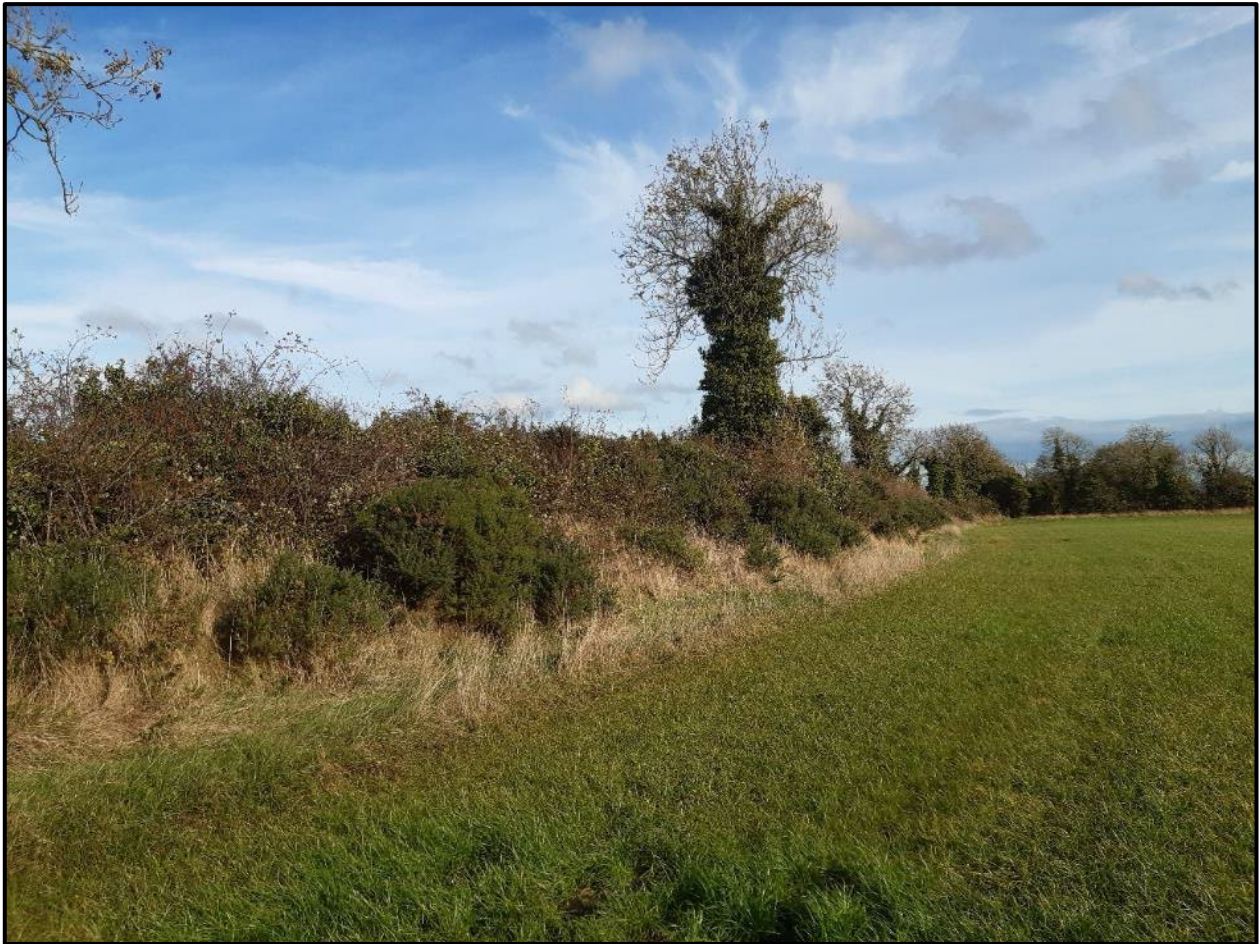
Plate 6 Boundary 6

This boundary scored 33 when assessed using the HAS.

The total length of this boundary within the land acquisition boundary is 107.1m. 48.5m of this length lies within the scheme alignment/works boundary.

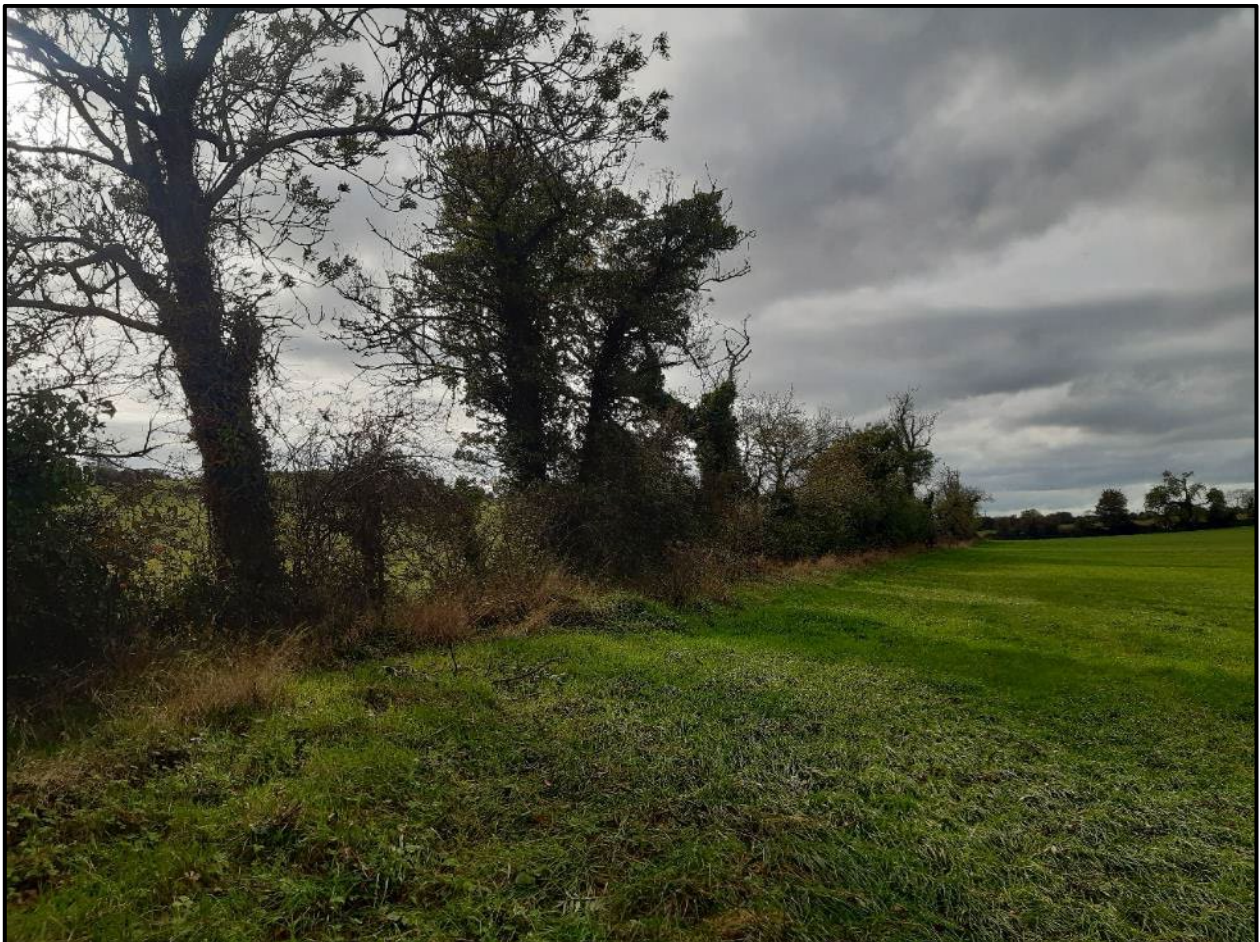
Plate 7 Boundary 8

This boundary scored 28 when assessed using the HAS.

The total length of this boundary within the land acquisition boundary is 85.9m. 56.1m of this length lies within the scheme alignment/works boundary.

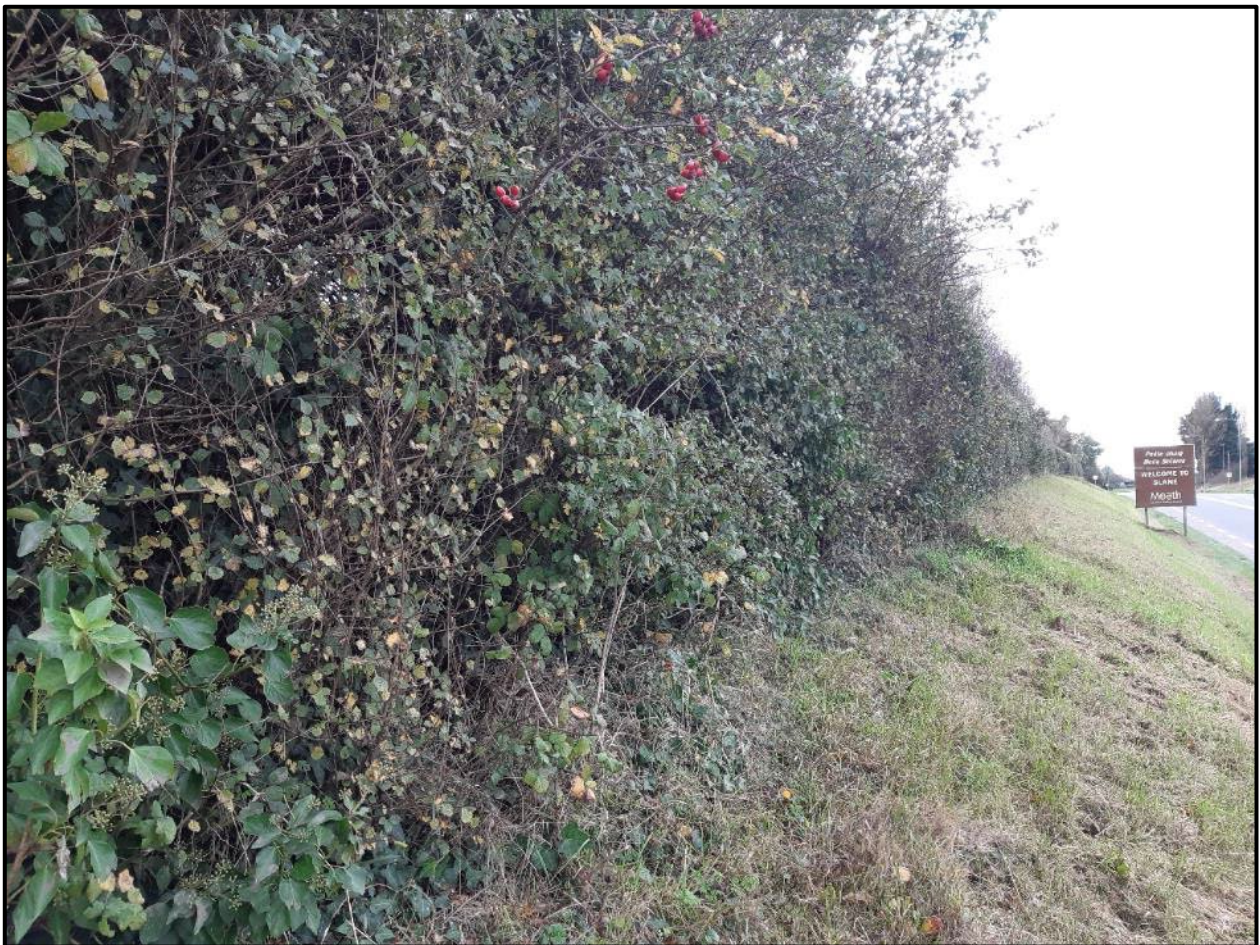
Plate 8 Boundary 9

This boundary scored 28 when assessed using the HAS.

The total length of this boundary within the land acquisition boundary is 220.9m. 1.8m of this length lies within the scheme alignment/works boundary.

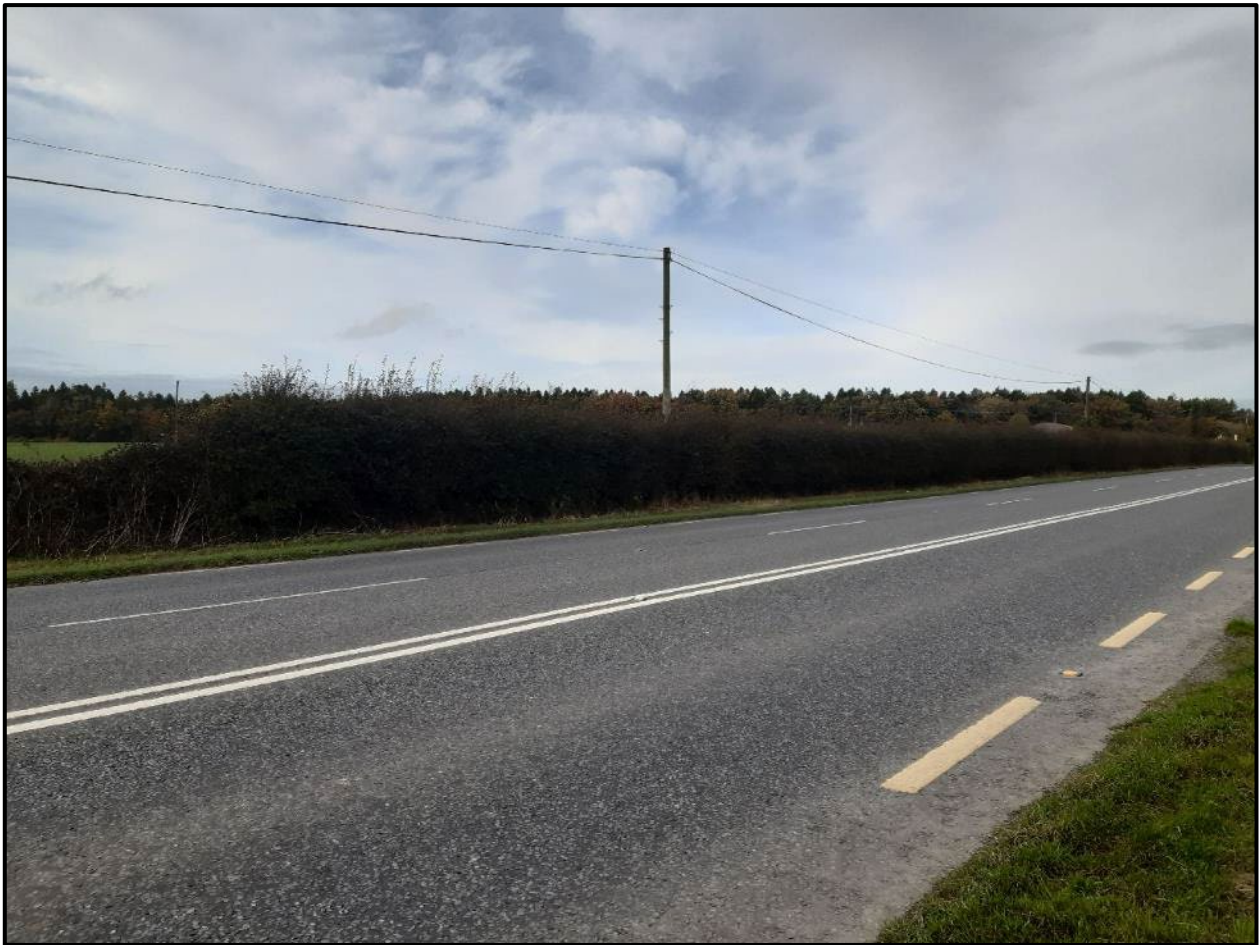
Plate 9 Boundary 14

This boundary scored 16 when assessed using the HAS.

The total length of this boundary within the land acquisition boundary is 168.4m. 10.2m of this length lies within the scheme alignment/works boundary.

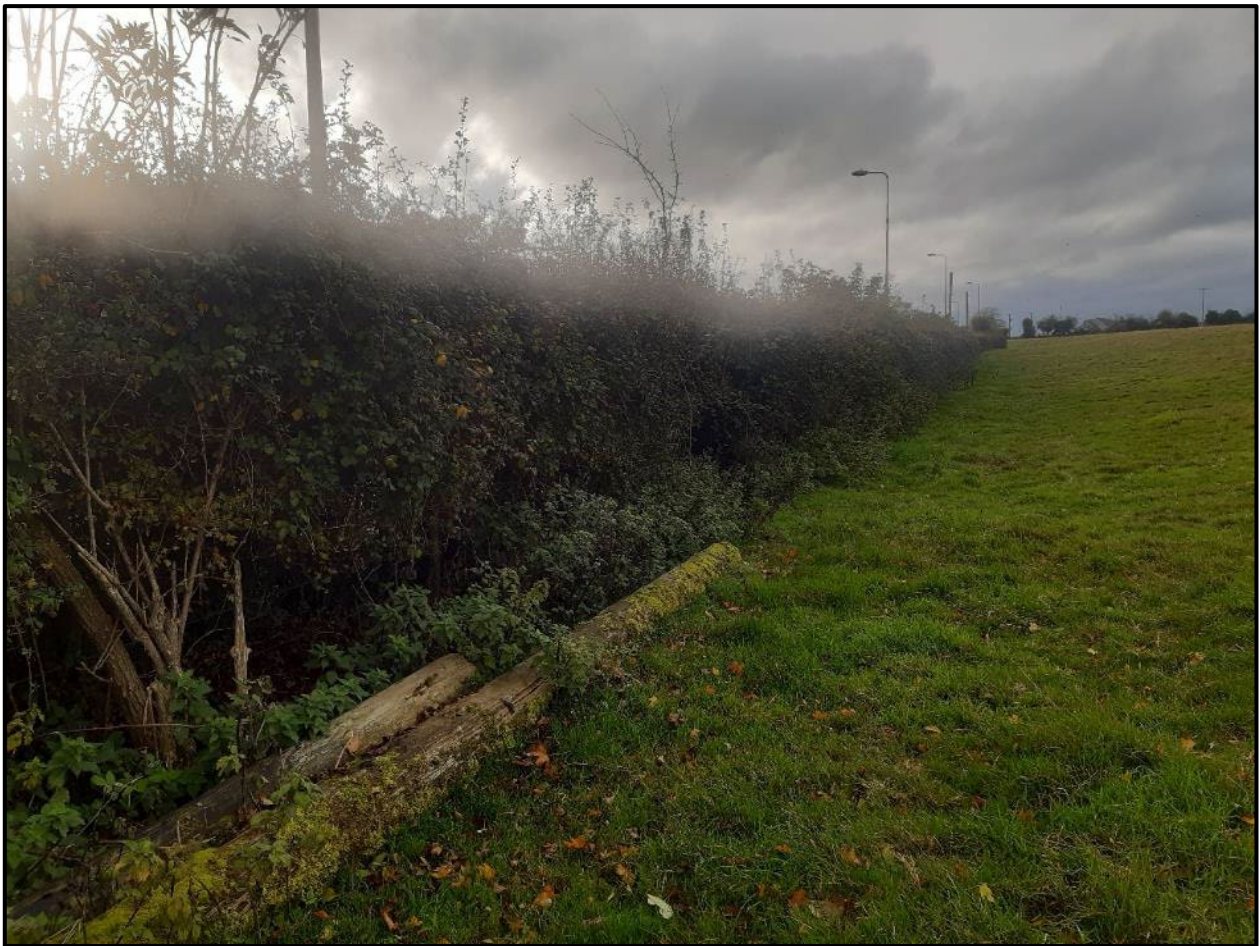
Plate 10 Boundary 15

This boundary scored 28 when assessed using the HAS.

The total length of this boundary within the land acquisition boundary is 360.8m. 259.7m of this length lies within the scheme alignment/works boundary.

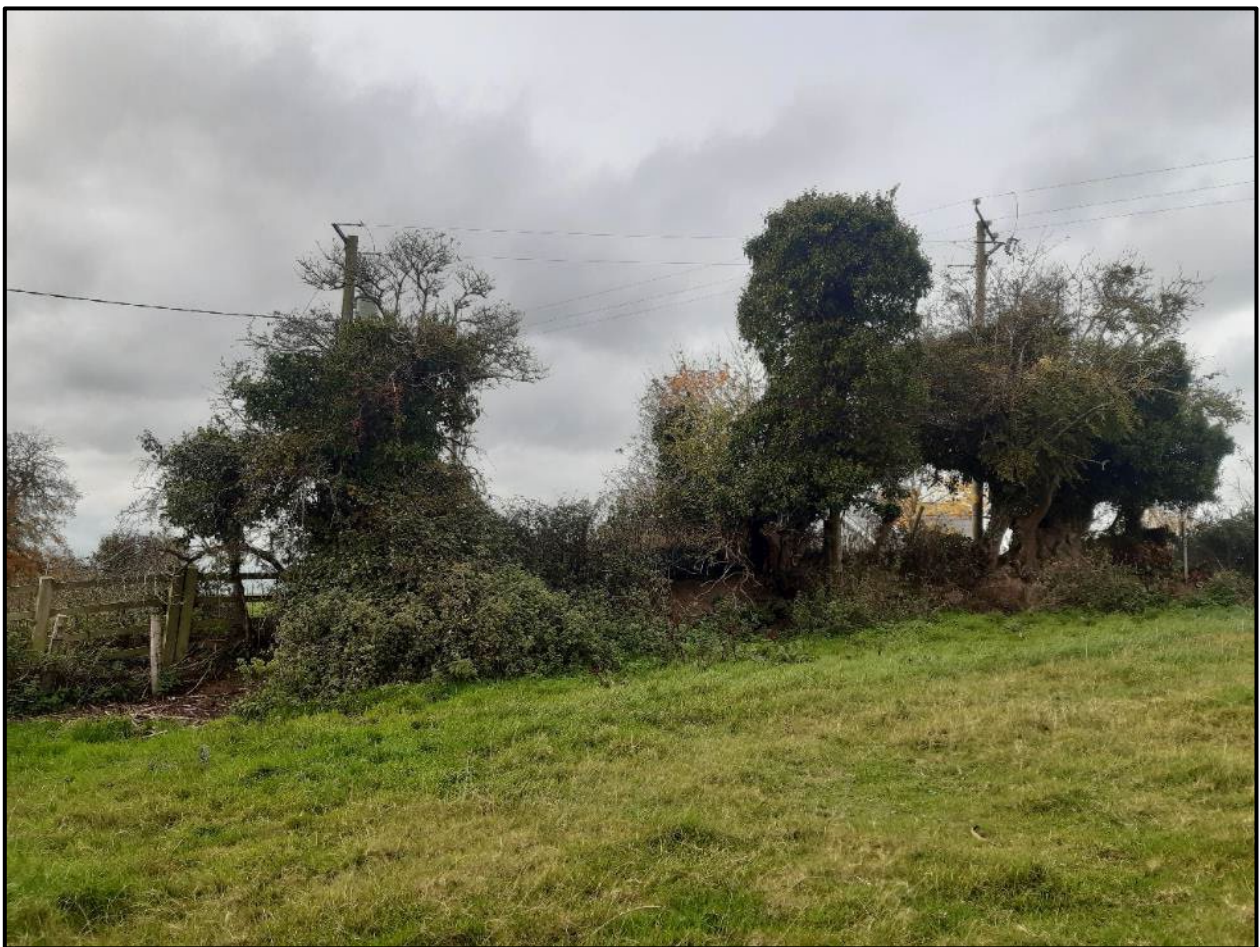
Plate 11 Boundary 16

This boundary scored 16 when assessed using the HAS.

The total length of this boundary within the land acquisition boundary is 8.5m. 2.5m of this length lies within the scheme alignment/works boundary.

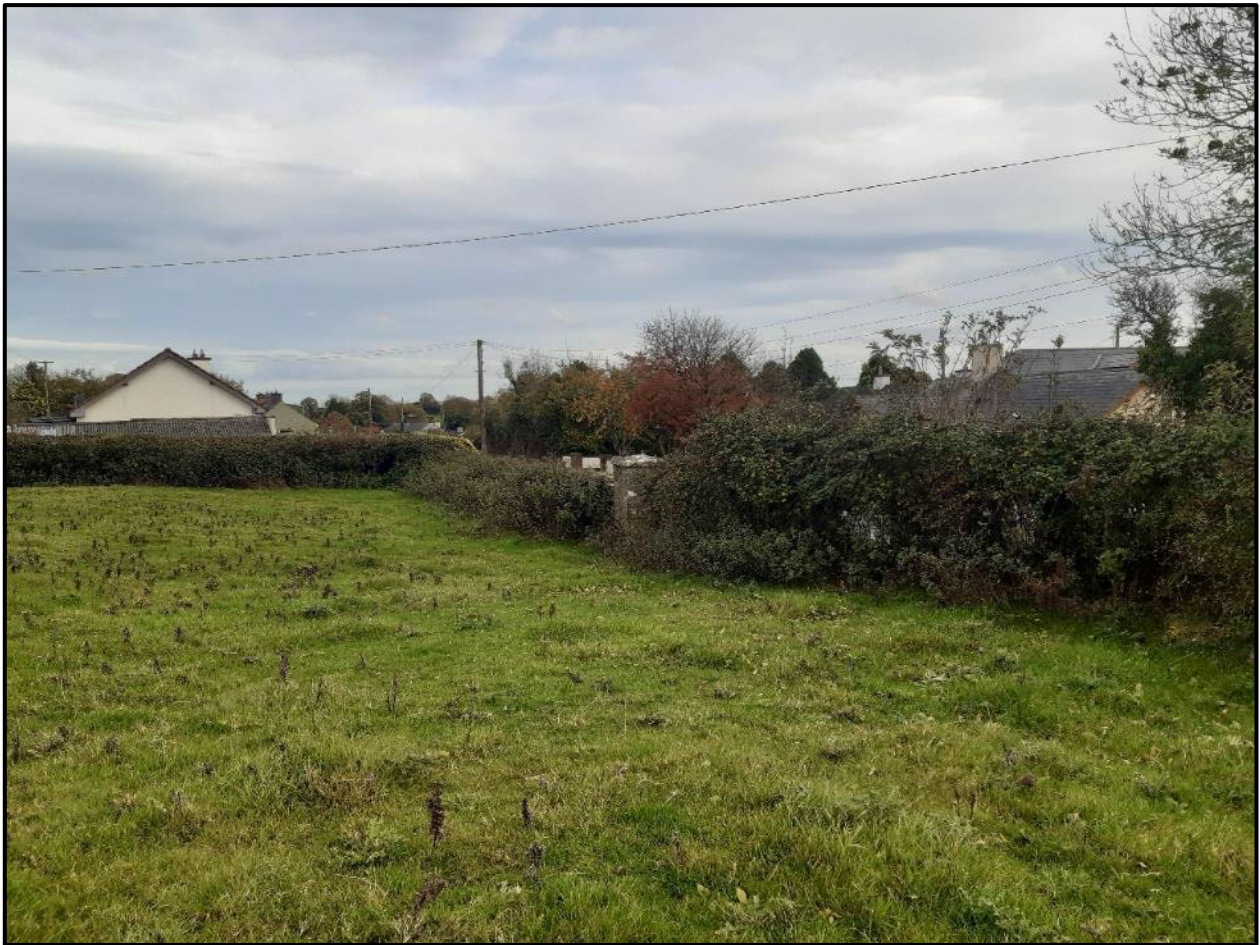
Plate 12 Boundary 18

This boundary scored 27 when assessed using the HAS.

The total length of this boundary within the land acquisition boundary is 44.6m. 15m of this length lies within the scheme alignment/works boundary.

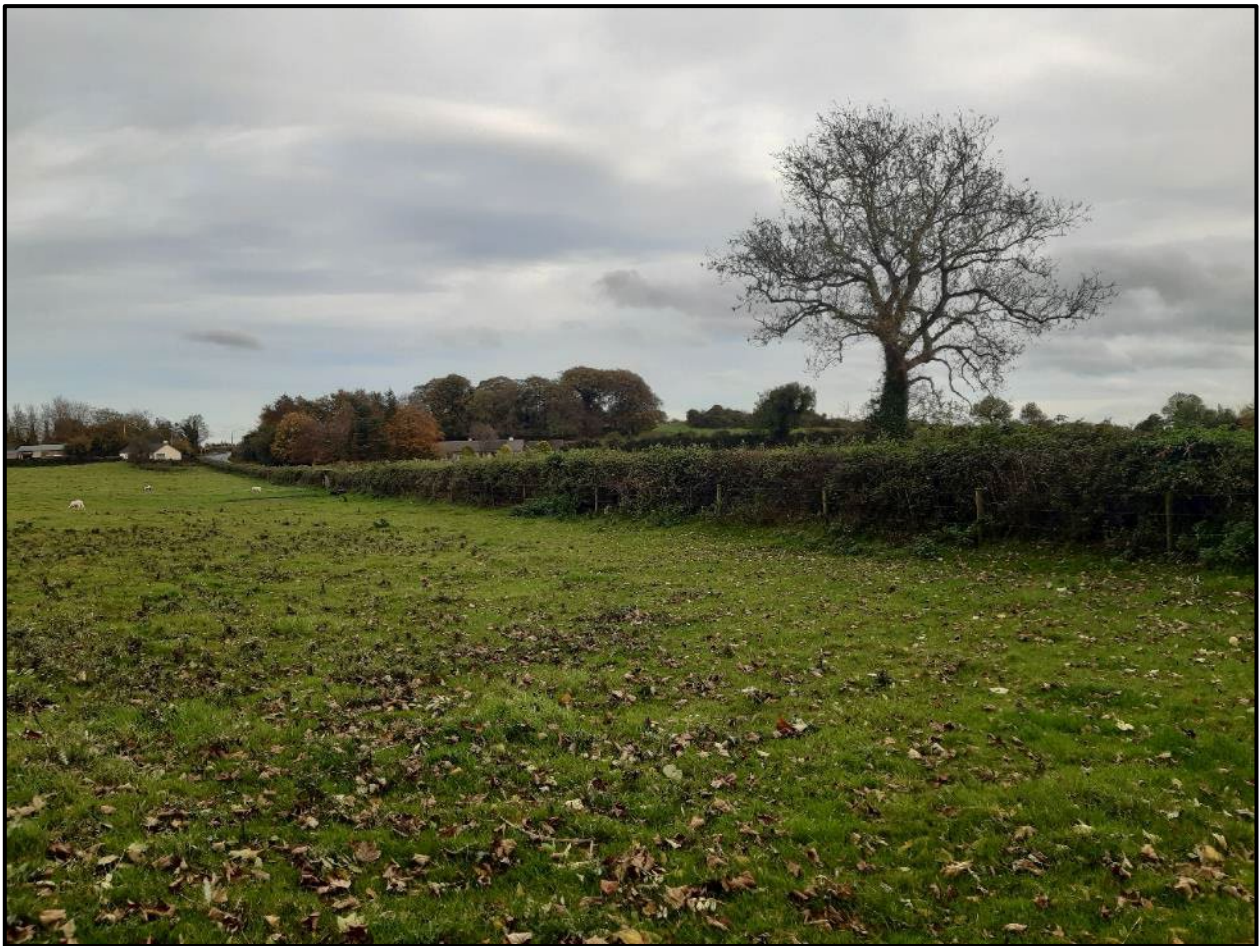
Plate 13 Boundary 20

This boundary scored 25 when assessed using the HAS.

The total length of this boundary within the land acquisition boundary is 220.2m. 86.6m of this length lies within the scheme alignment/works boundary.
