SLANE BYPASS & PUBLIC REALM ENHANCEMENT SCHEME

Additional Information Response Document

December 2024

ABP-318573-23

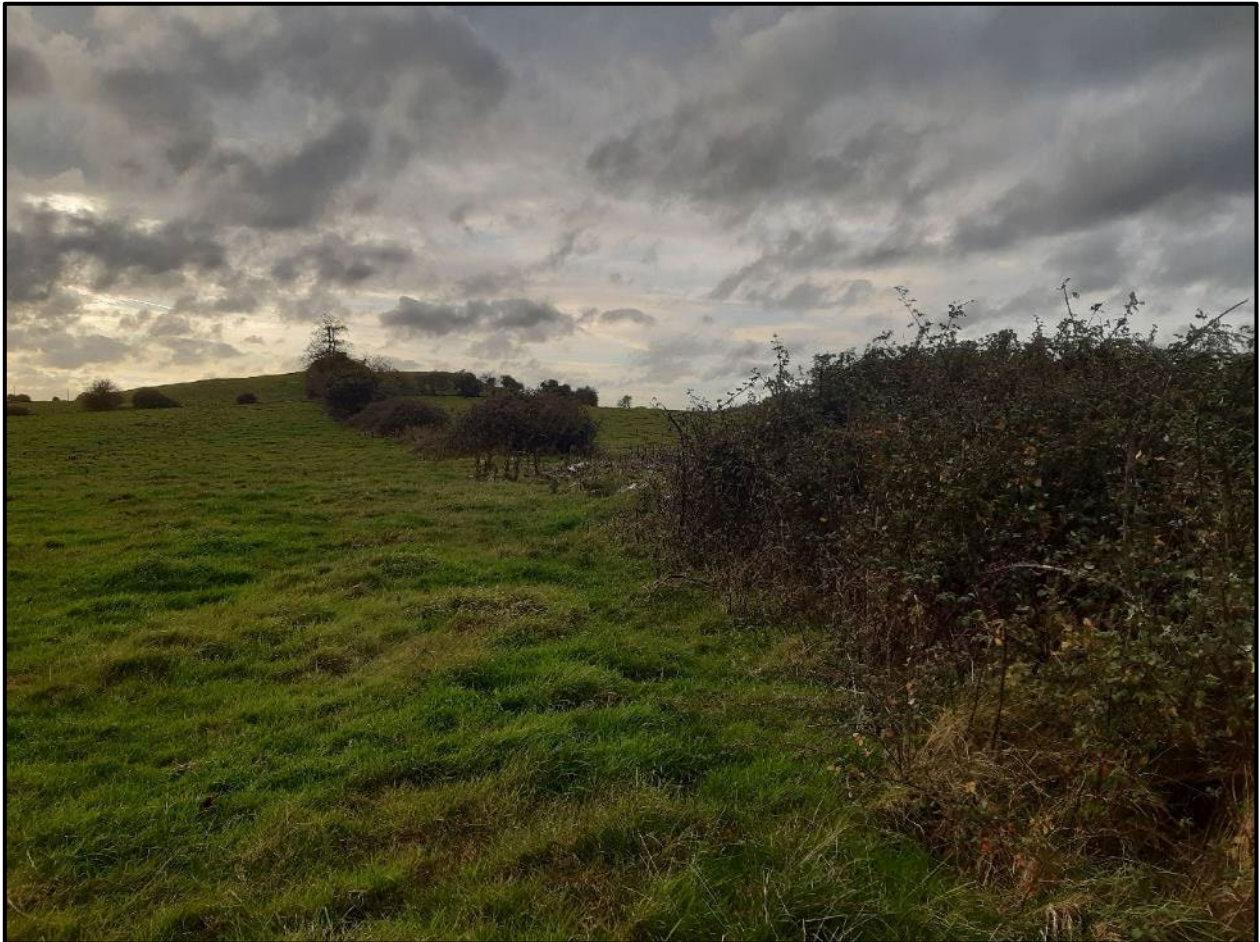
Plate 14 Boundary 22

This boundary scored 20 when assessed using the HAS.

The total length of this boundary within the land acquisition boundary is 96m. 54.8.6m of this length lies within the scheme alignment/works boundary. However, at least 50% of this length is a gap.

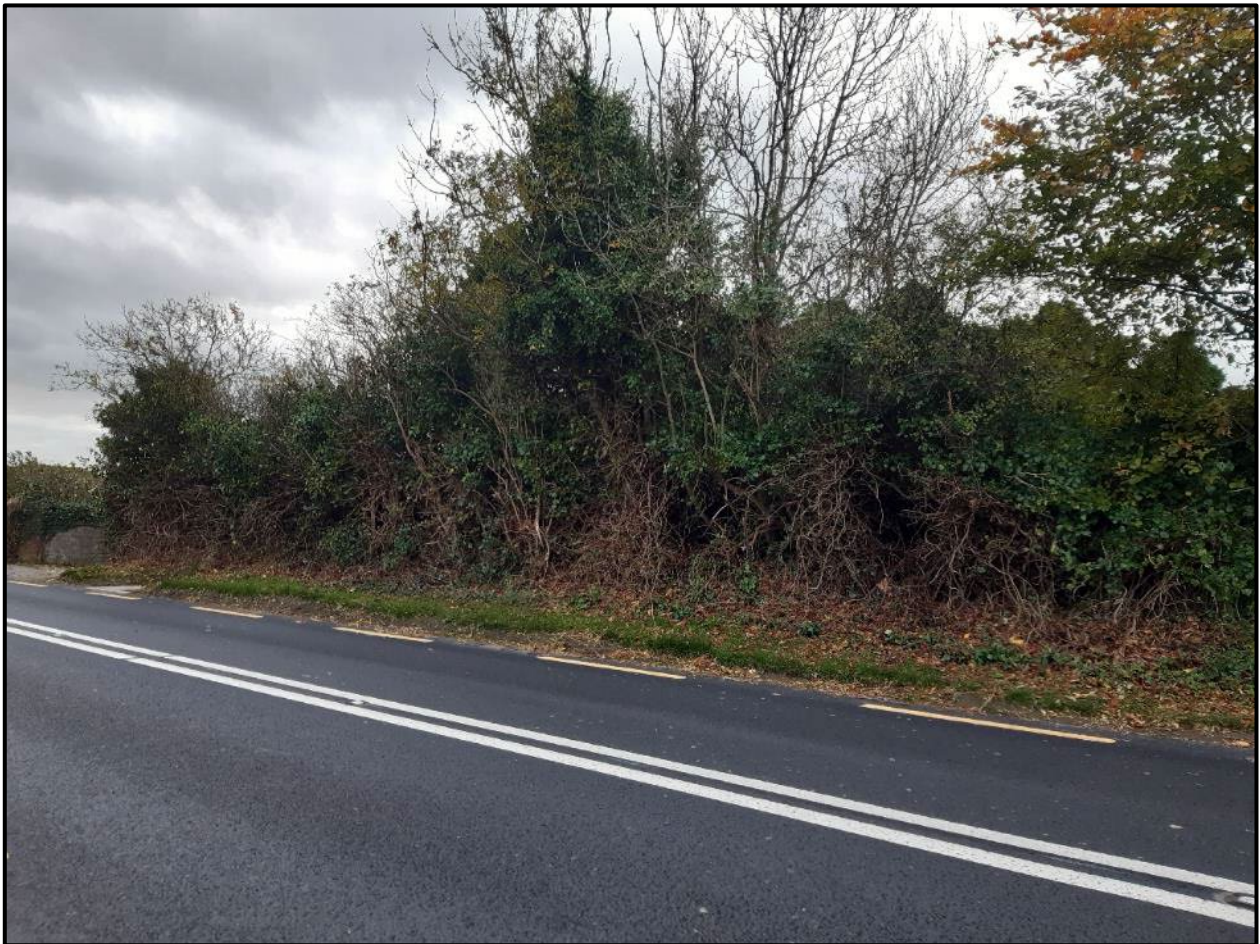
Plate 15 Boundary 24

This boundary scored 27 when assessed using the HAS.

The total length of this boundary within the land acquisition boundary 17.3m. The entirety of this length lies within the scheme alignment/works boundary.

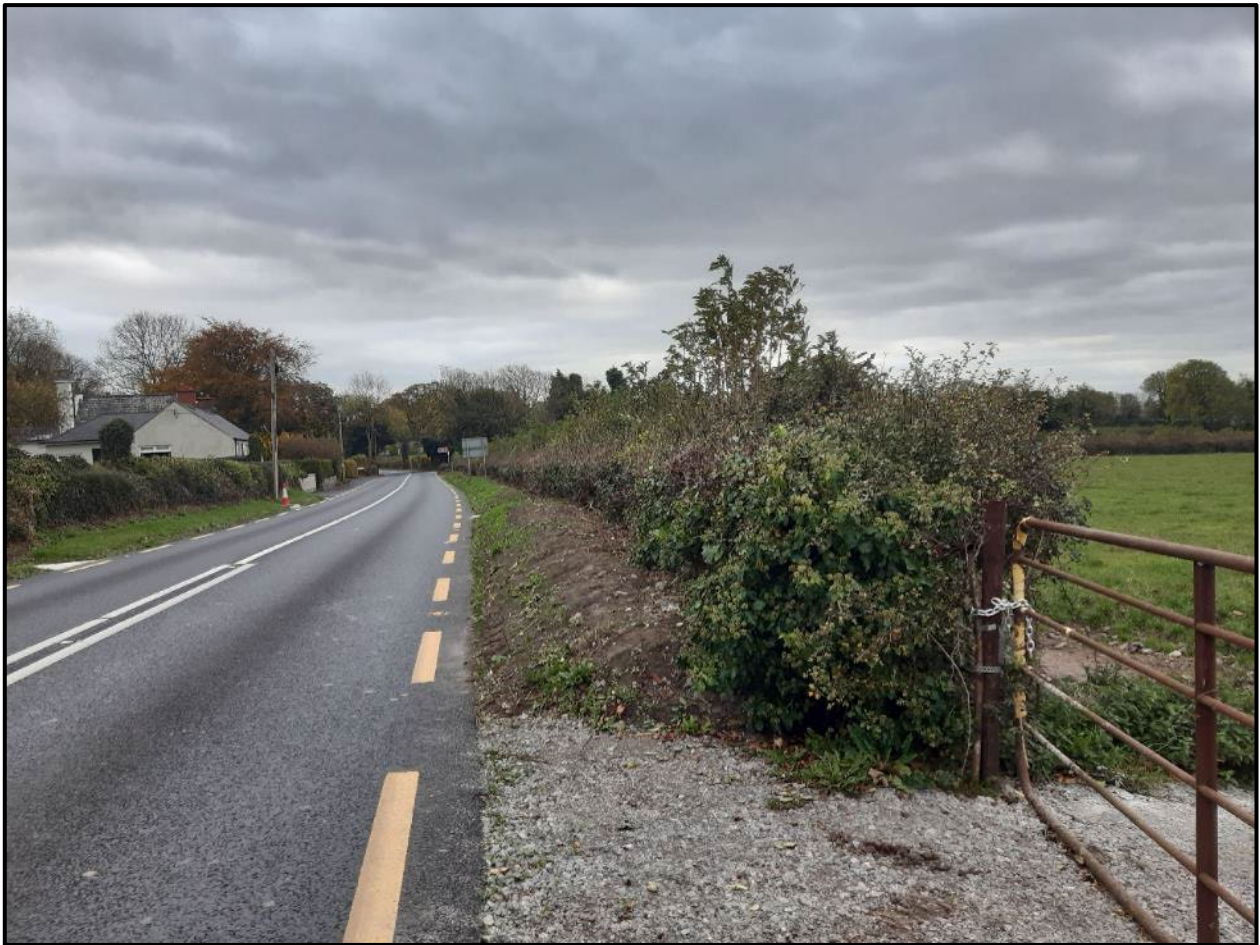
Plate 16 Boundary 27

This boundary scored 21 when assessed using the HAS.

The total length of this boundary within the land acquisition boundary is 109.7m. The entirety of this length lies within the scheme alignment/works boundary.

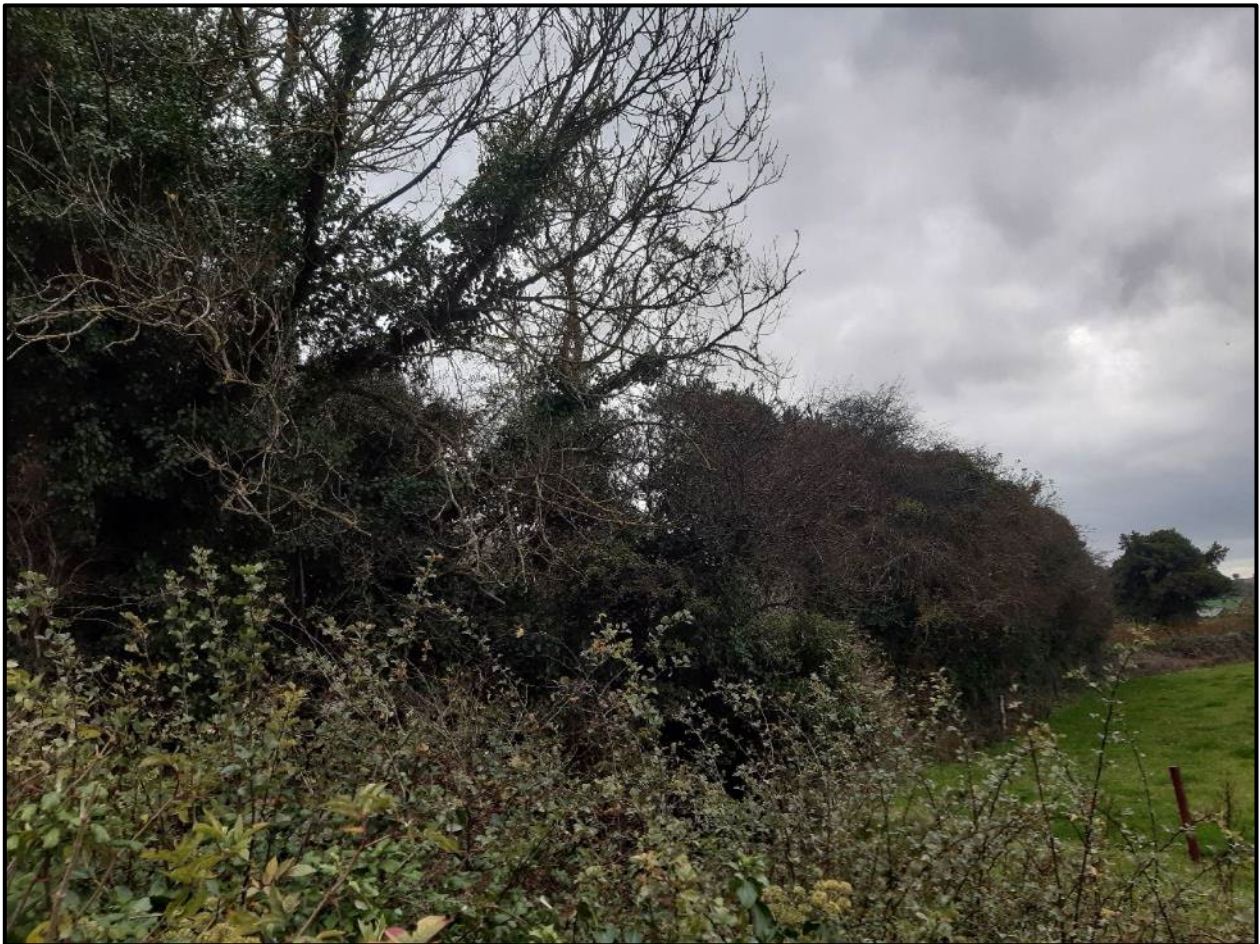
Plate 17 Boundary 28

This boundary scored 29 when assessed using the HAS.

The total length of this boundary within the land acquisition boundary is 11.9m. 9.9m of this length lies within the scheme alignment/works boundary.

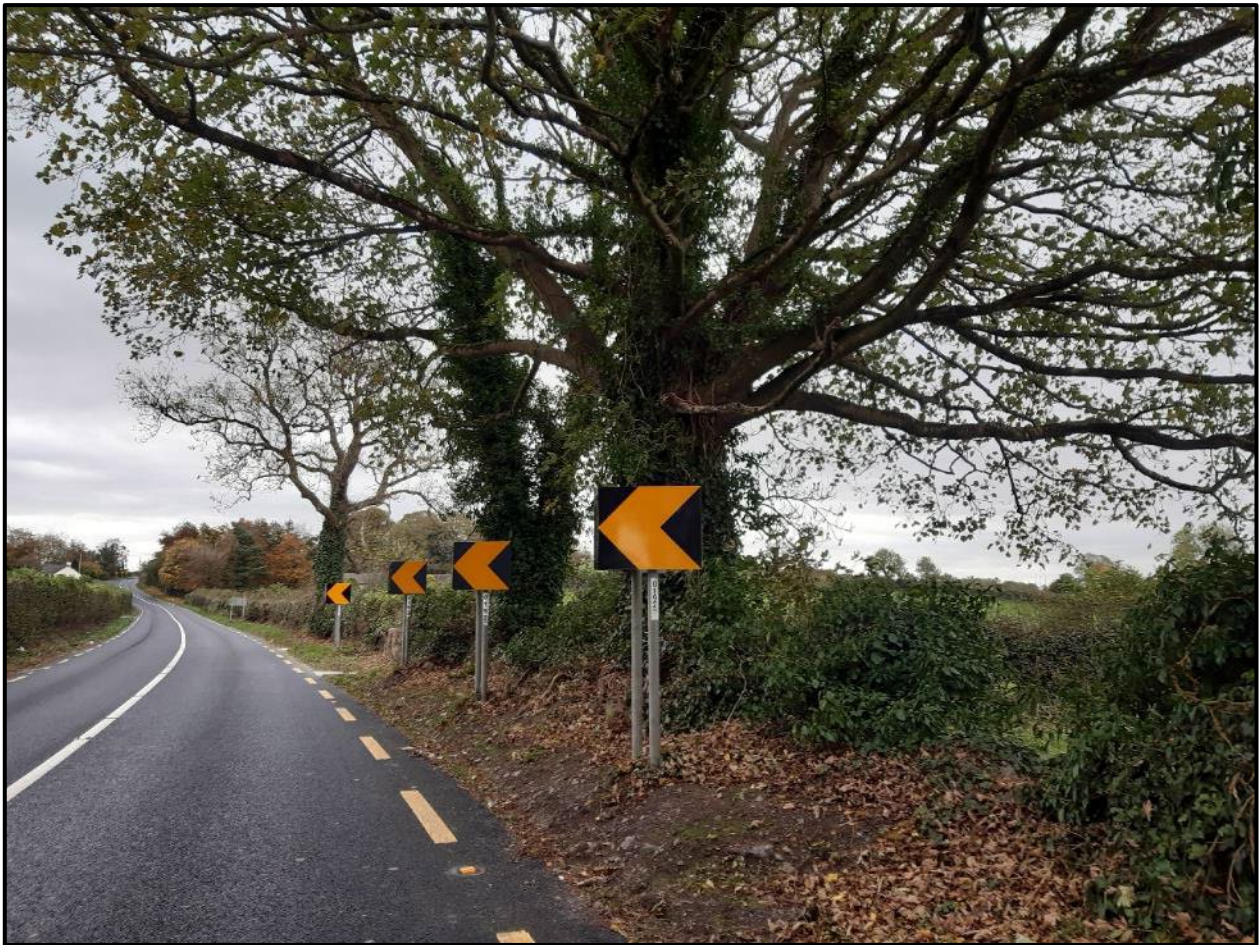
Plate 18 Boundary 30

This boundary scored 21 when assessed using the HAS.

The total length of this boundary within the land acquisition boundary is 24.3m. The entirety of this length lies within the scheme alignment/works boundary.

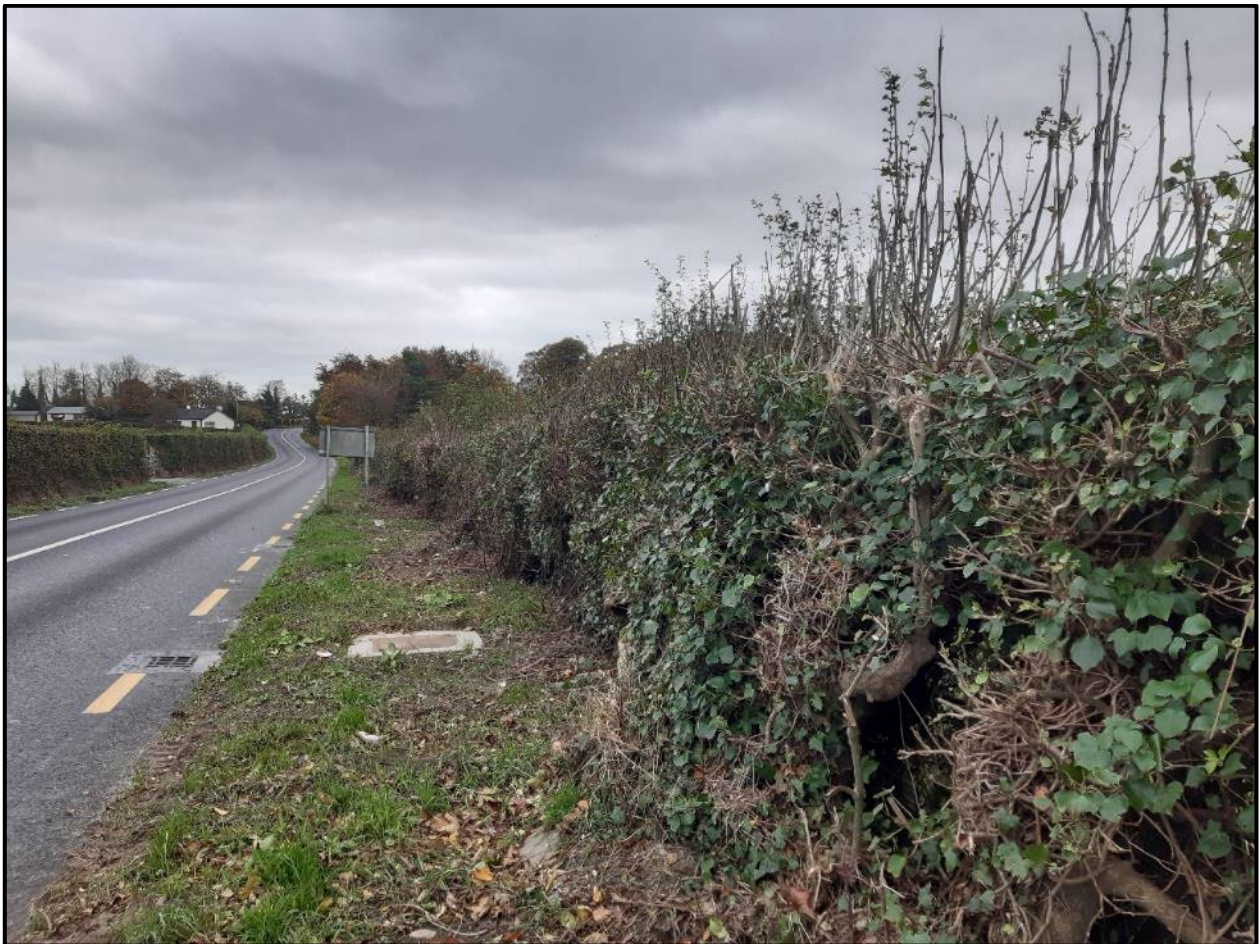
Plate 19 Boundary 31

This boundary scored 25 when assessed using the HAS.

The total length of this boundary within the land acquisition boundary is 182.7m. 128.8m of this length lies within the scheme alignment/works boundary.

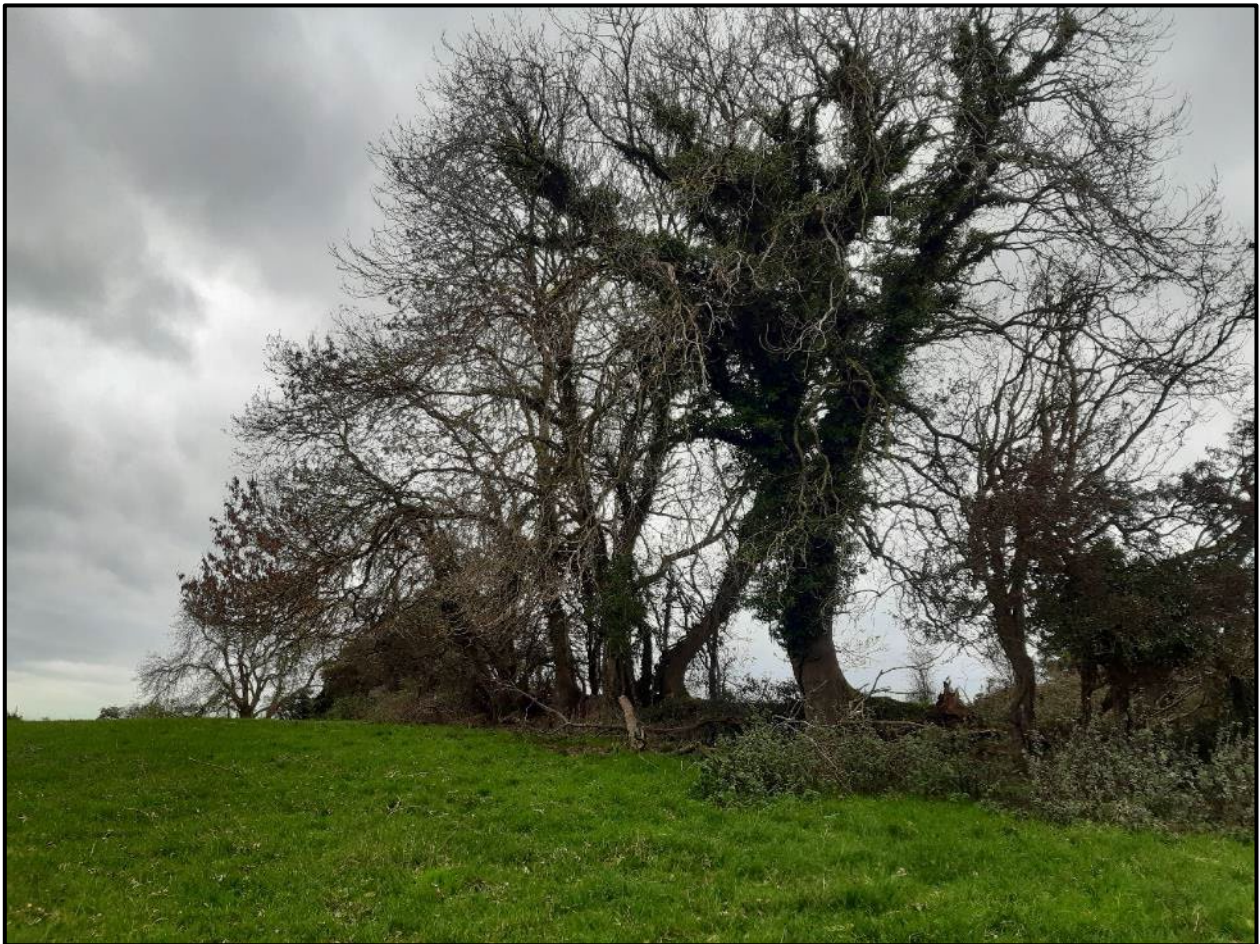
Plate 20 Boundary 32

Boundary 32 was classified as a treeline. It was an internal field boundary and was not present on 1st edition OSI maps. It contained 3 favourable tree, shrub and woody climber species listed in Appendix D of the HAS booklet. These species were occasional ivy, ash and hawthorn. Occasional brambles were also present. Ground flora included cock's-foot (*Dactylis glomerata*), nettles, wood avens and cow parsley. This treeline was located on a bank of approximately 1-1.25m height and 3m width. This bank was heavily degraded. As a treeline, this boundary was >4m high and it was 1-2m wide. Due to the lack of scrubby vegetation between the trees, this boundary was classified as derelict and open. It was also considered to be 5-10% gappy with no individual gap >5m wide.

This boundary scored 13 when assessed using the HAS.

The total length of this boundary within the land acquisition boundary is 11.3m. 6.1m of this length lies within the scheme alignment/works boundary.

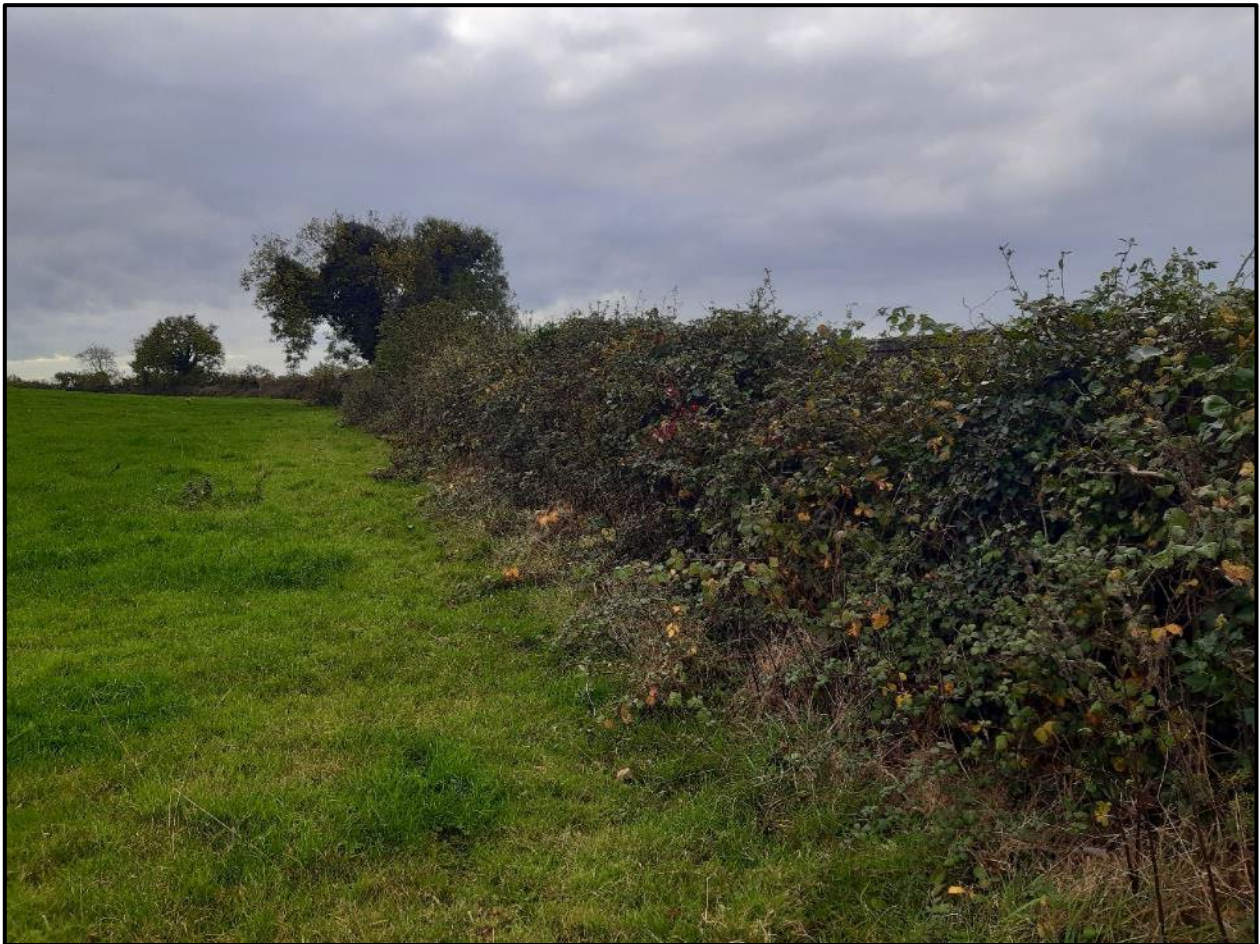
Plate 21 Boundary 34

Boundary 34 was classified as a hedgerow. It was a farm boundary, which was also present on 1st edition OSI maps and is also a townland boundary. Additionally, it was a non-linear boundary. It contained 5 favourable tree, shrub and woody climber species listed in Appendix D of the HAS booklet. These species consisted of abundant ivy with occasional elder, ash and hawthorn and rare rose. Occasional sycamore and rare beech, both unfavourable tree species listed in Appendix D of the HAS booklet, were also observed in addition to frequent brambles. Ground flora was dominated by nutrient rich species such as cleavers and nettles with noxious weeds such as docks and creeping thistle. Other herbaceous species included cow parsley, creeping buttercup, bush vetch, cock's-foot and hogweed.

This hedgerow was located on a bank of <0.5m height. There was also a slope down from the hedgerow to the adjacent residential property. The hedgerow has been boxed to approximately 2m high and 1.5m wide. There is a single mature ash tree towards the southern extent of the hedgerow. This hedgerow was continuous with no gaps, however, the northern quarter to a third of the hedgerow is primarily composed of dominant nettles with brambles and ivy. The basal porosity was considered to be semi-opaque for the majority of the hedgerow. The bank had minor signs of degradation. Sheep-wire has been attached to the hedgerow.

This boundary scored 34 when assessed using the HAS.

The total length of this boundary within the land acquisition boundary is 101.7m. 90.3m of this length lies within the scheme alignment/works boundary.

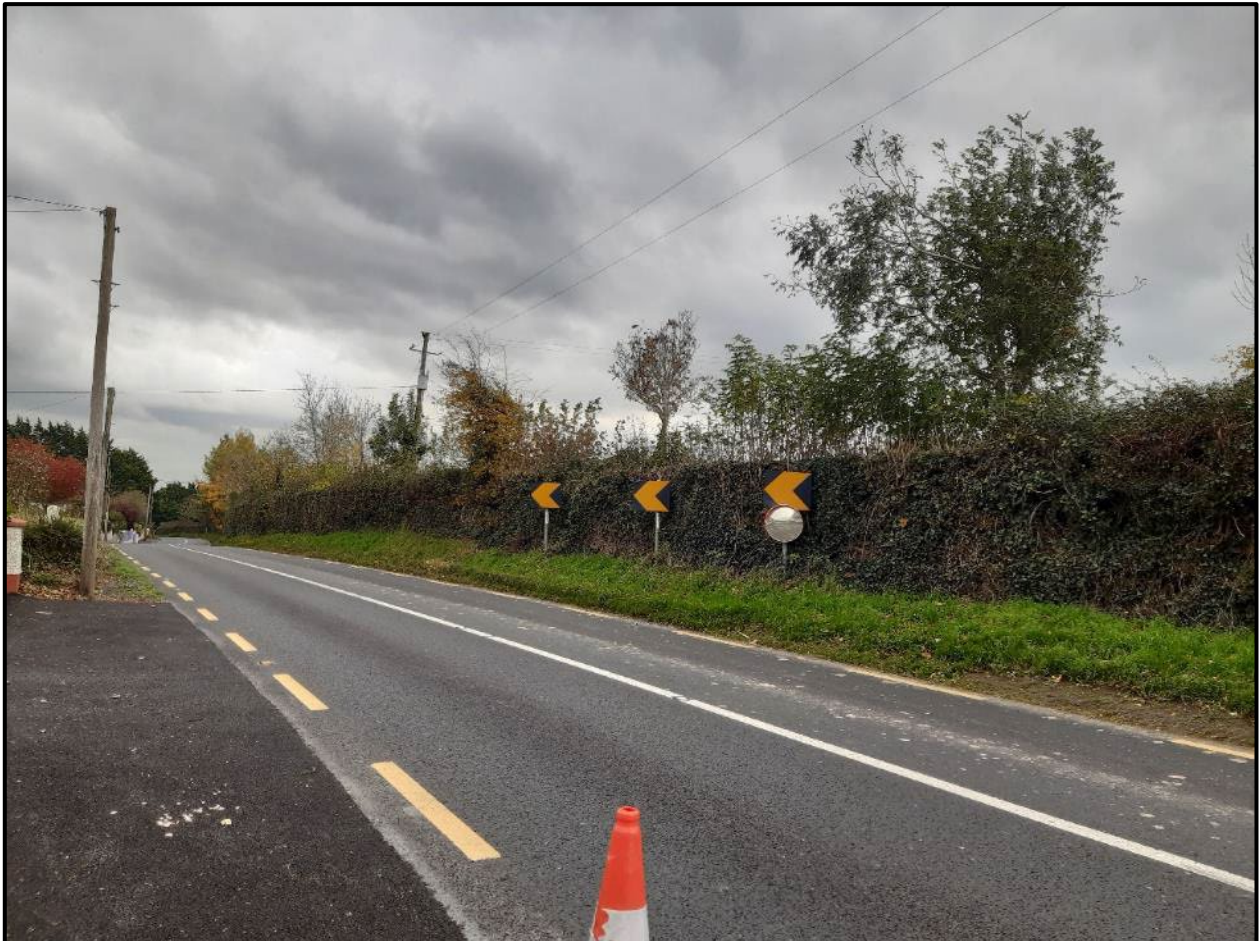
Plate 22 Boundary 35

Boundary 35 was classified as a hedgerow. It was a roadside boundary which was also present on 1st edition OSI maps. It contained 5 favourable tree, shrub and woody climber species listed in Appendix D of the HAS booklet. These species consisted of abundant ivy and hawthorn with occasional elder and damson with rare hazel (*Corylus avellana*). Occasional sycamore and rare fuchsia (*Fuchsia magellanica*), and garden privet (*Ligustrum ovalifolium*), each of which are unfavourable tree or shrub species listed in Appendix D of the HAS booklet were also observed within the hedgerow in addition to frequent brambles. Ground flora was dominated by nutrient rich and rank species such as cleavers and false oat grass.

This hedgerow was located on a bank of approximately 1.25m height. The hedgerow has been boxed to approximately 3m high and 2.5m wide. There was immature garden trees on the southern side of the hedgerow. A gap of approximately 7m was observed within the taller scrubby hedgerow vegetation which had been planted with fuchsia, hazel and garden privet slips. Overall, the basal porosity was considered to be dense for the majority of the hedgerow. The bank had minor signs of degradation.

This boundary scored 28 when assessed using the HAS.

The total length of this boundary within the land acquisition boundary is 258.2m. 138.1m of this length lies within the scheme alignment/works boundary.

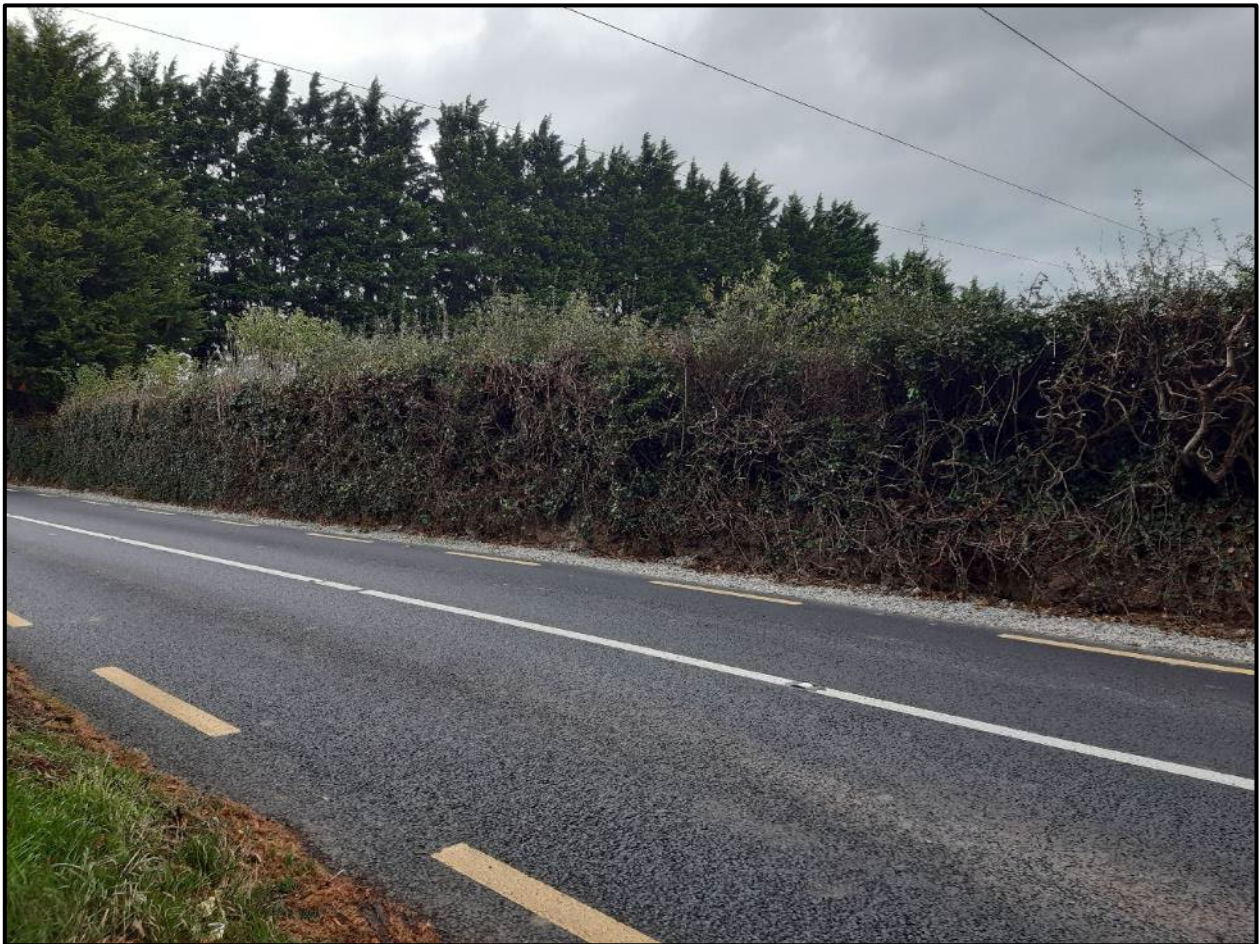
Plate 23 Boundary 36

This boundary scored 31 when assessed using the HAS.

The total length of this boundary within the land acquisition boundary is 48.6m. 17.3m of this length lies within the scheme alignment/works boundary.

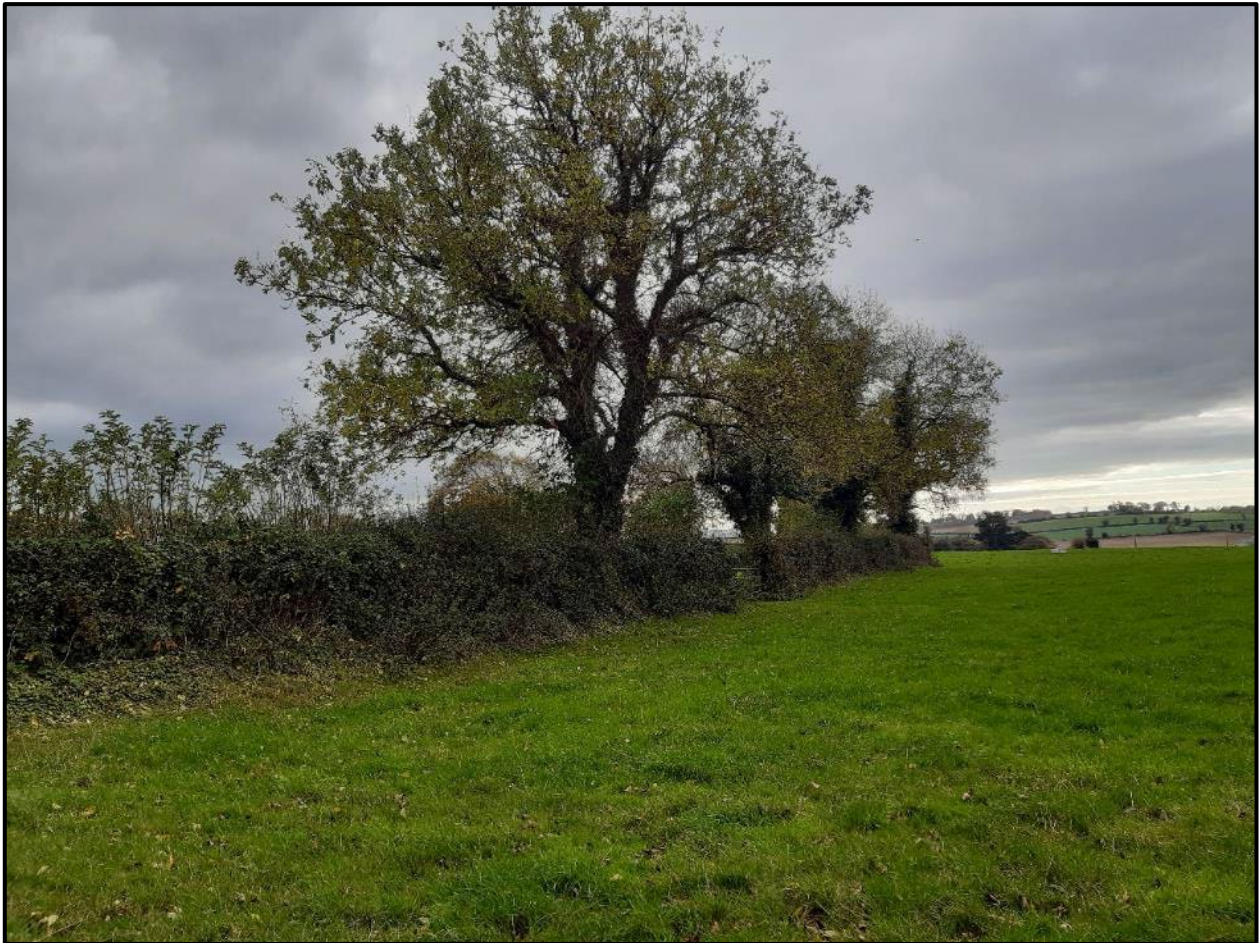
Plate 24 Boundary 38

This hedgerow was located on a bank of approximately 1m high and 2.5m wide. The hedgerow is boxed to approximately 2m high and 1.5m wide with occasional mature trees. A dry drain was observed towards the southern extent of the hedgerow. This drain was approximately 1.5m deep and 1.5m wide. This hedgerow was continuous with no gaps and the basal porosity was considered to be semi-opaque. There were minor signs of degradation of the bank.

This boundary scored 27 when assessed using the HAS.

The total length of this boundary within the land acquisition boundary is 177.6m. 133.1m of this length lies within the scheme alignment/works boundary.

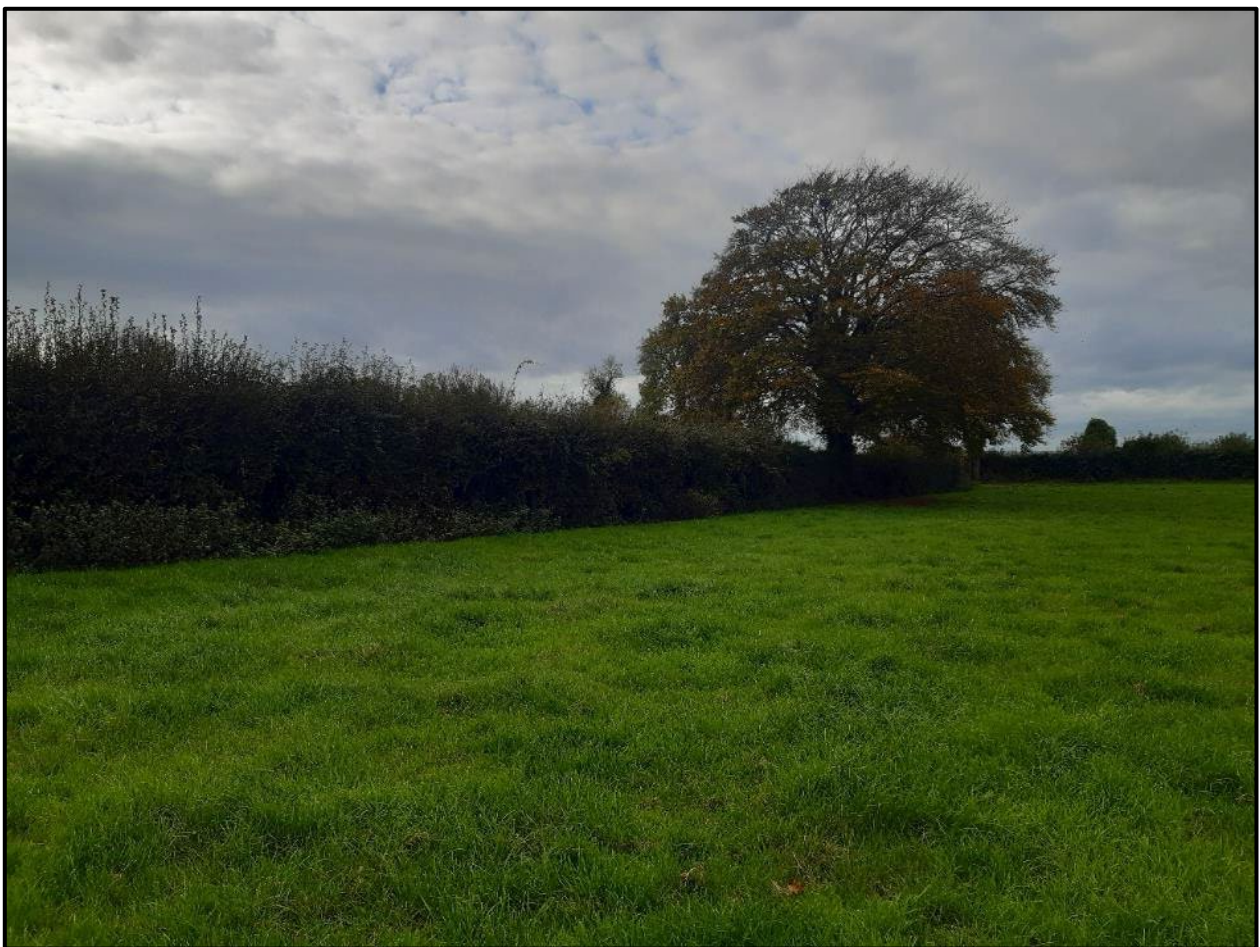
Plate 25 Boundary 39

This boundary scored 25 when assessed using the HAS.

The total length of this boundary within the land acquisition boundary is 61.3m. 42.7m of this length lies within the scheme alignment/works boundary.

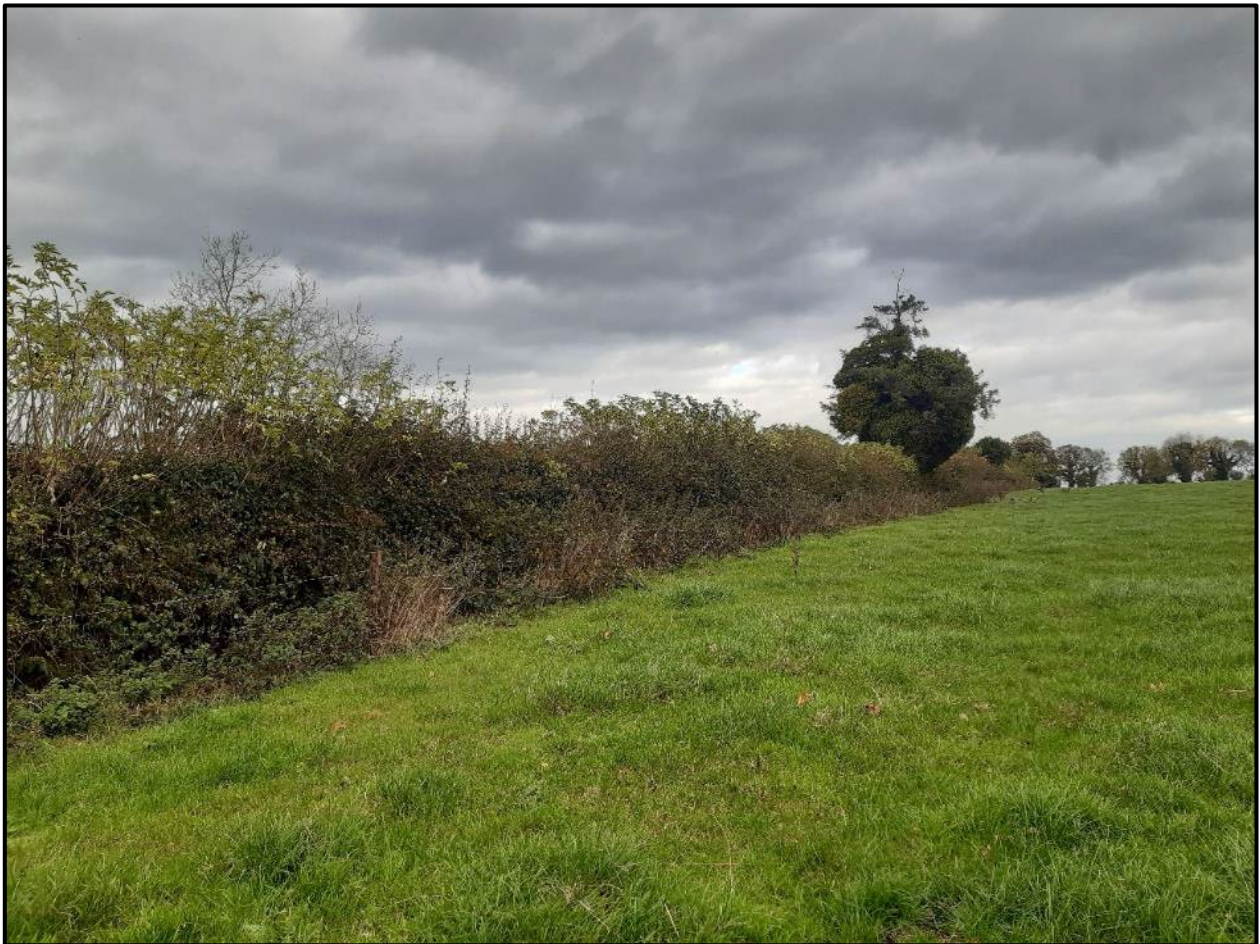
Plate 26 Boundary 40

Boundary 40 was classified as a hedgerow. It was an internal farm boundary which was also present on 1st edition OSI maps. It contained 9 favourable tree, shrub and woody climber species listed in Appendix D of the HAS booklet. These species consisted of abundant ivy and hawthorn with occasional blackthorn, rose and elder with rare holly, wych elm, crab apple and ash. Occasional sycamore and rare conifers were also present, both species that are unfavourable tree species listed in Appendix D of the HAS booklet. Frequent brambles were also observed. Ground flora included abundant nutrient rich species such as nettles and cleavers in conjunction to noxious weeds such as spear thistle, creeping thistle and ragwort. Other ground flora species present included lord's and ladies (*Arum maculatum*), soft shield fern, dandelion, hogweed, knapweed (*Centaurea nigra*), cow parsley, herb-robert, hart's tongue fern and meadow vetchling. This hedgerow was located on a bank of approximately 1-1.5m high. There was also a shallow (<0.5m deep and 0.75m wide), dry, vegetated drain present on the field side of this boundary. The hedgerow is boxed to approximately 1.5m high and 3-4m wide with rare mature trees. This hedgerow was continuous with no gaps and the basal porosity was considered to be semi-opaque. There were minor signs of degradation of the bank.

This boundary scored 32 when assessed using the HAS.

The total length of this boundary within the land acquisition boundary is 264.4m. 125.6m of this length lies within the scheme alignment/works boundary.

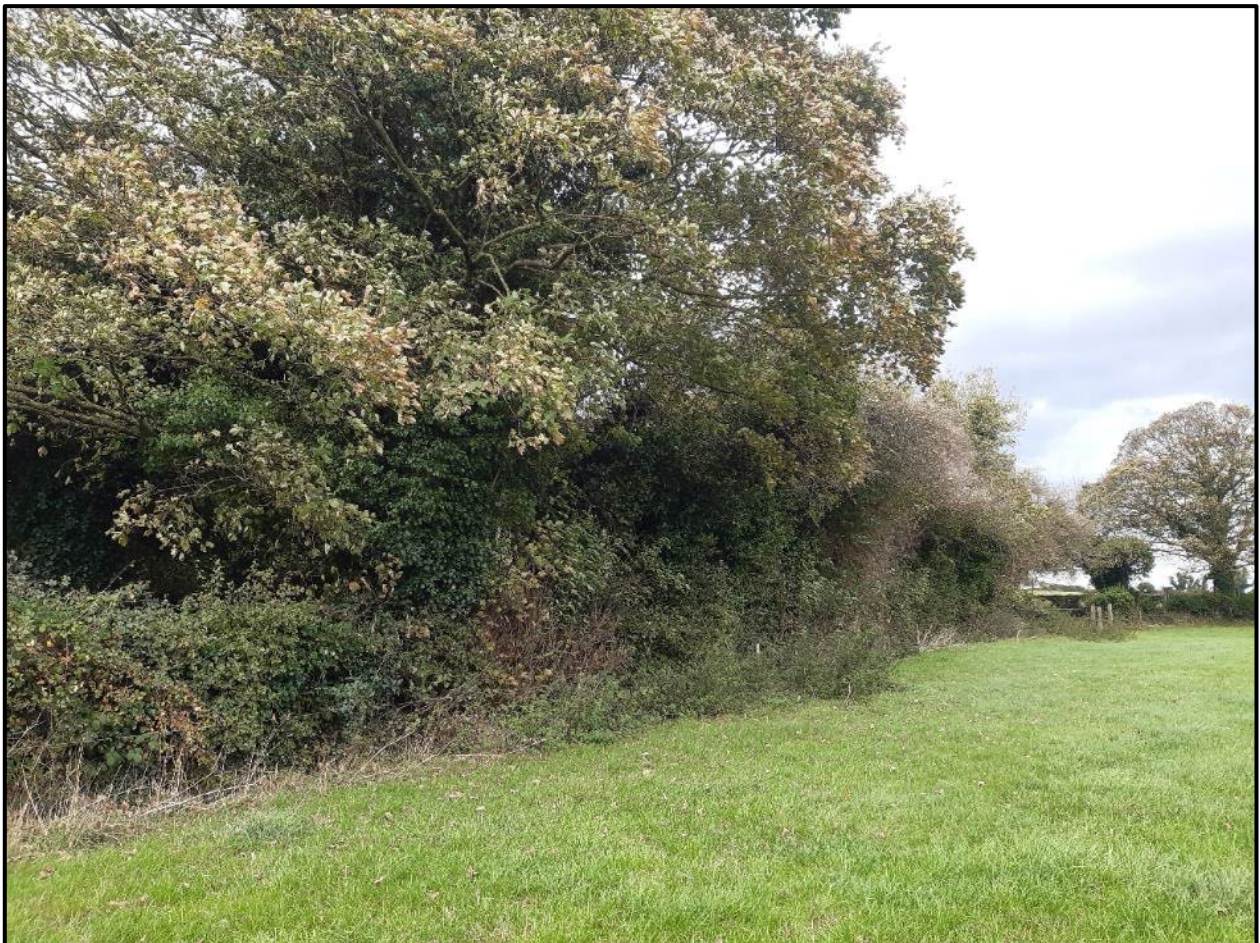
Plate 27 Boundary 41

This boundary scored 33 when assessed using the HAS.

The total length of this boundary within the land acquisition boundary is 61.2m. 12.7m of this length lies within the scheme alignment/works boundary.

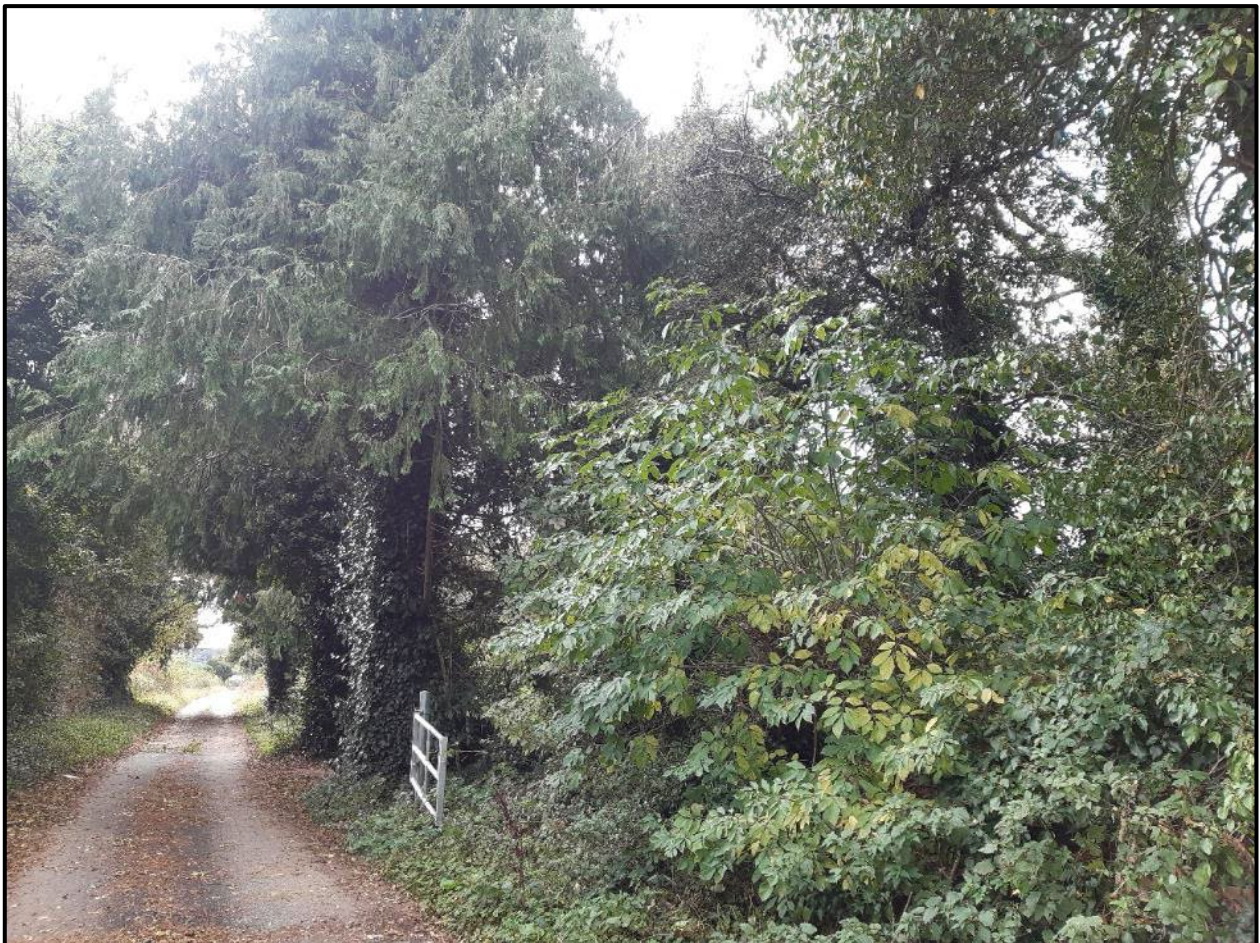
Plate 28 Boundary 42

Boundary 42 was classified as a treeline. It was an internal farm boundary which was also present on 1st edition OSI maps. It contained 4 favourable tree, shrub and woody climber species listed in Appendix D of the HAS booklet. These species consisted of abundant ivy with occasional elder and rare ash and hawthorn. Frequent Wilson's honeysuckle, occasional conifers and rare sycamore were also present, all species that are unfavourable tree species listed in Appendix D of the HAS booklet. Occasional brambles were also observed. Ground flora included abundant nutrient rich species such as nettles in conjunction to noxious weeds such as docks. Other species included nipplewort, wood avens, false oat grass, hedge woundwort, false brome, cow parsley, hogweed and creeping buttercup. This treeline was located on a bank less than 0.5m high. There was no management of the trees, however, the lower scrubby vegetation had been previously boxed to approximately 1.5m high. This treeline was >3m wide and was 5-10% gappy. No individual gap was >5m wide. The basal porosity was considered to be semi-translucent. There were minor signs of degradation of the bank.

This boundary scored 21 when assessed using the HAS.

The total length of this boundary within the land acquisition boundary is 54.5m. 10.9m of this length lies within the scheme alignment/works boundary.

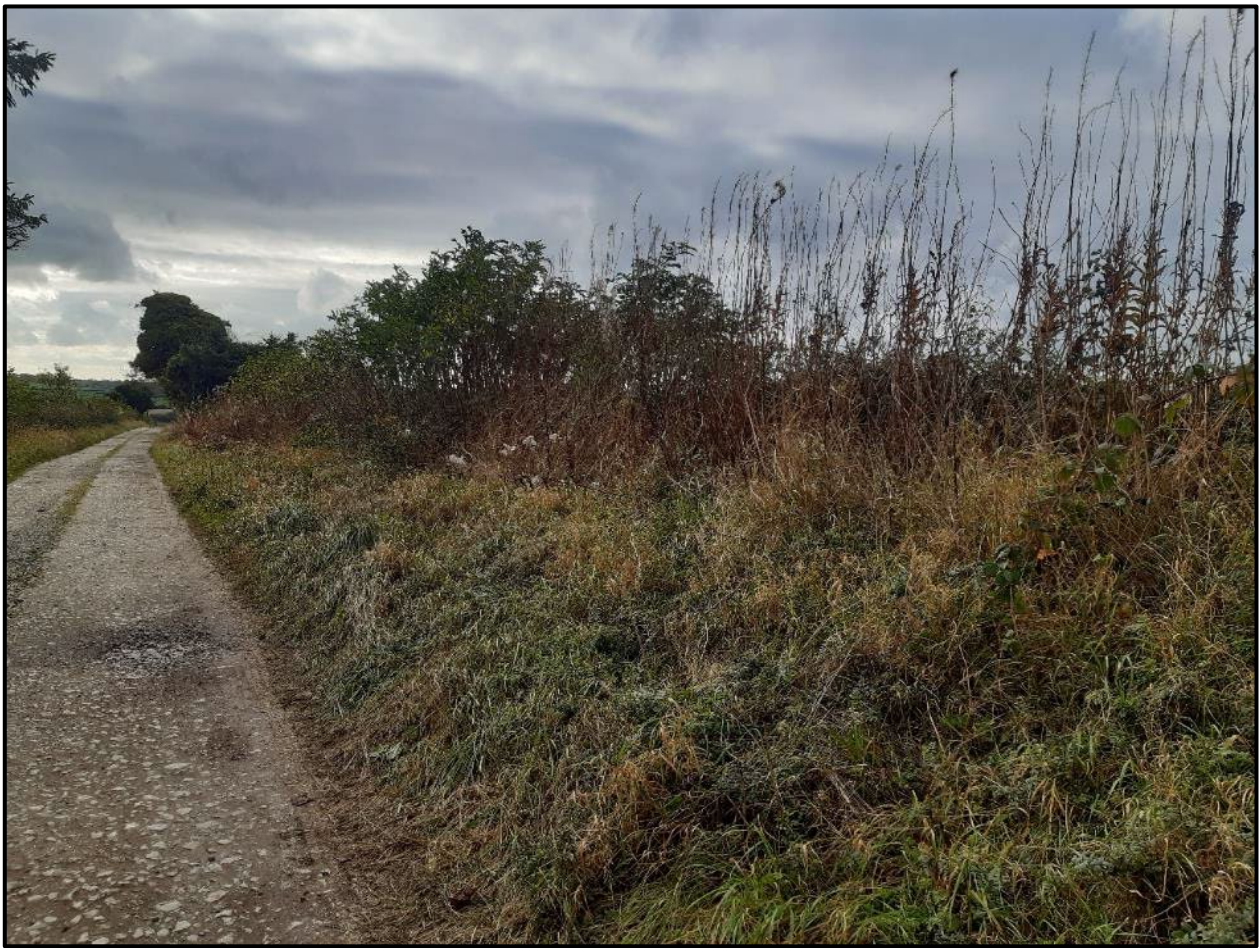
Plate 29 Boundary 43

Boundary 43 was classified as a hedgerow. It was a farm boundary which was also present on 1st edition OSI maps. It contained 5 favourable tree, shrub and woody climber species listed in Appendix D of the HAS booklet. These species consisted of abundant ivy with frequent ash, hawthorn and elder and occasional rose. Rare conifer, species that are unfavourable tree species listed in Appendix D of the HAS booklet were also observed in addition to frequent brambles. Ground flora included cock's-foot, rosebay willowherb (*Chamaenerion angustifolium*), false oat grass, cow parsley, meadow vetchling, knapweed, nettles, creeping buttercup, hogweed, broadleaved plantain (*Plantago major*), bush vetch, ribwort plantain (*Plantago lanceolata*), dandelion, nipplewort and wood avens. This hedgerow was located on a bank of approximately 1.25m high and 3-4m wide. The woody vegetation had been boxed to approximately 1.5m high with a number of mature trees. Overall width was >3m. This treeline was continuous with no gaps. The basal porosity was considered to be semi-opaque. There were signs of minor degradation of the bank.

This boundary scored 28 when assessed using the HAS.

The total length of this boundary within the land acquisition boundary is 209.7m. 131.9m of this length lies within the scheme alignment/works boundary.
