SLANE BYPASS & PUBLIC REALM ENHANCEMENT SCHEME

Additional Information Response Document

December 2024

ABP-318573-23

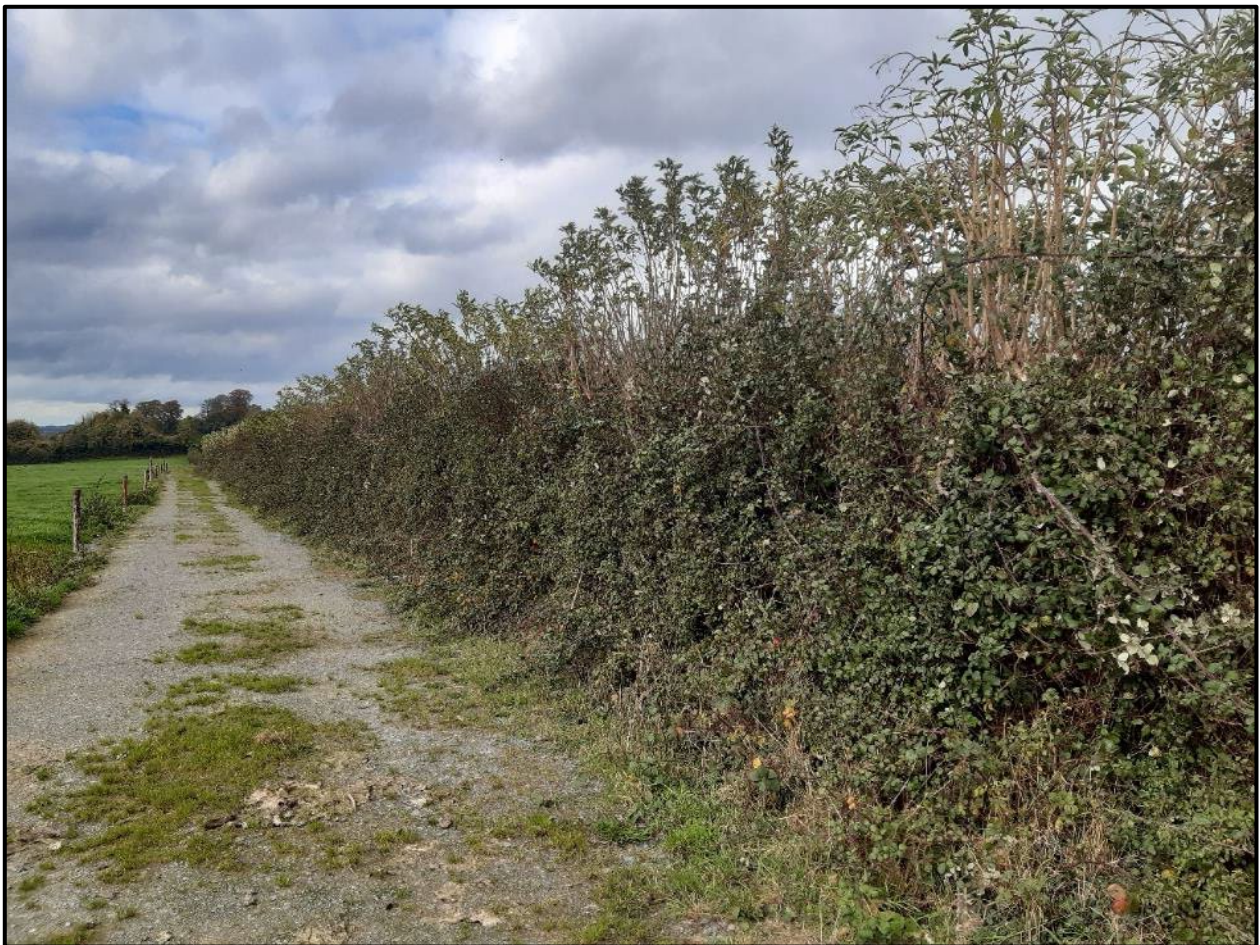
Plate 30 Boundary 44

Boundary 44 was classified as a hedgerow. It was an internal farm boundary which was also present on 1st edition OSI maps. It contained 5 favourable tree, shrub and woody climber species listed in Appendix D of the HAS booklet. These species consisted of abundant ivy with frequent blackthorn and elder, occasional hawthorn and rare rose. Frequent brambles were also present. Ground flora included nutrient rich species such as cleavers and nettles in conjunction with noxious weeds such as spear thistle and ragwort. Other species observed included upright hedge parsley (*Torilis japonica*), creeping buttercup, false brome, bush vetch, cow parsley, cock's-foot, herb-robert, dandelion and nipplewort. This hedgerow was located on a bank of approximately 1m high. The woody vegetation had been boxed to approximately 2-2.5m high and 3m wide. This hedgerow was continuous with no gaps and the basal porosity was considered to be dense. There were signs of minor degradation of the bank.

This boundary scored 27 when assessed using the HAS.

The total length of this boundary within the land acquisition boundary is 68.6m. 57.4m of this length lies within the scheme alignment/works boundary.

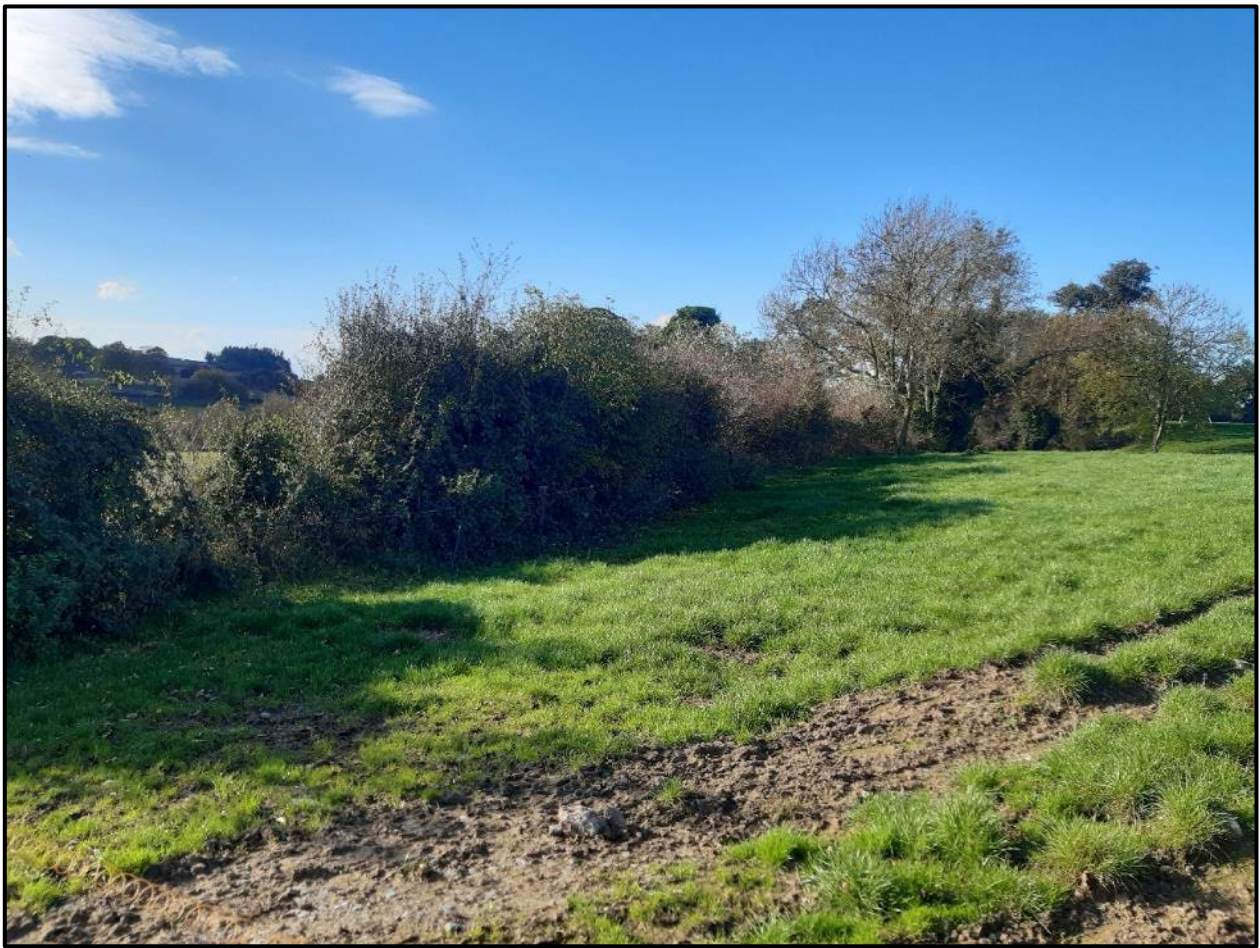
Plate 31 Boundary 46

Boundary 46 was classified as a hedgerow. It was an internal farm boundary, it was present on 1st edition OSI maps and also linked to woodland on 1st edition OSI maps. It contained 5 favourable tree, shrub and woody climber species listed in Appendix D of the HAS booklet. These species consisted of abundant ivy with frequent elder and occasional ash, rose and hawthorn. Frequent brambles were also present. Ground flora included abundant nutrient rich species such as cleavers and nettles in conjunction with noxious weeds such as ragwort. Other species observed included creeping buttercup, bush vetch and cow parsley. This hedgerow was located on a bank of approximately 0.5m high. There is also a drop on the southern side of the hedgerow. There was no obvious recent management of the hedgerow, however, it seems like the sides were cut previously. The hedgerow was approximately 3m tall and 2m wide. This hedgerow was continuous with no gaps and the basal porosity was considered to be semi-translucent. Less than 20% of the bank was degraded.

This boundary scored 36 when assessed using the HAS.

The total length of this boundary within the land acquisition boundary is 78.5m. 57.5m of this length lies within the scheme alignment/works boundary.

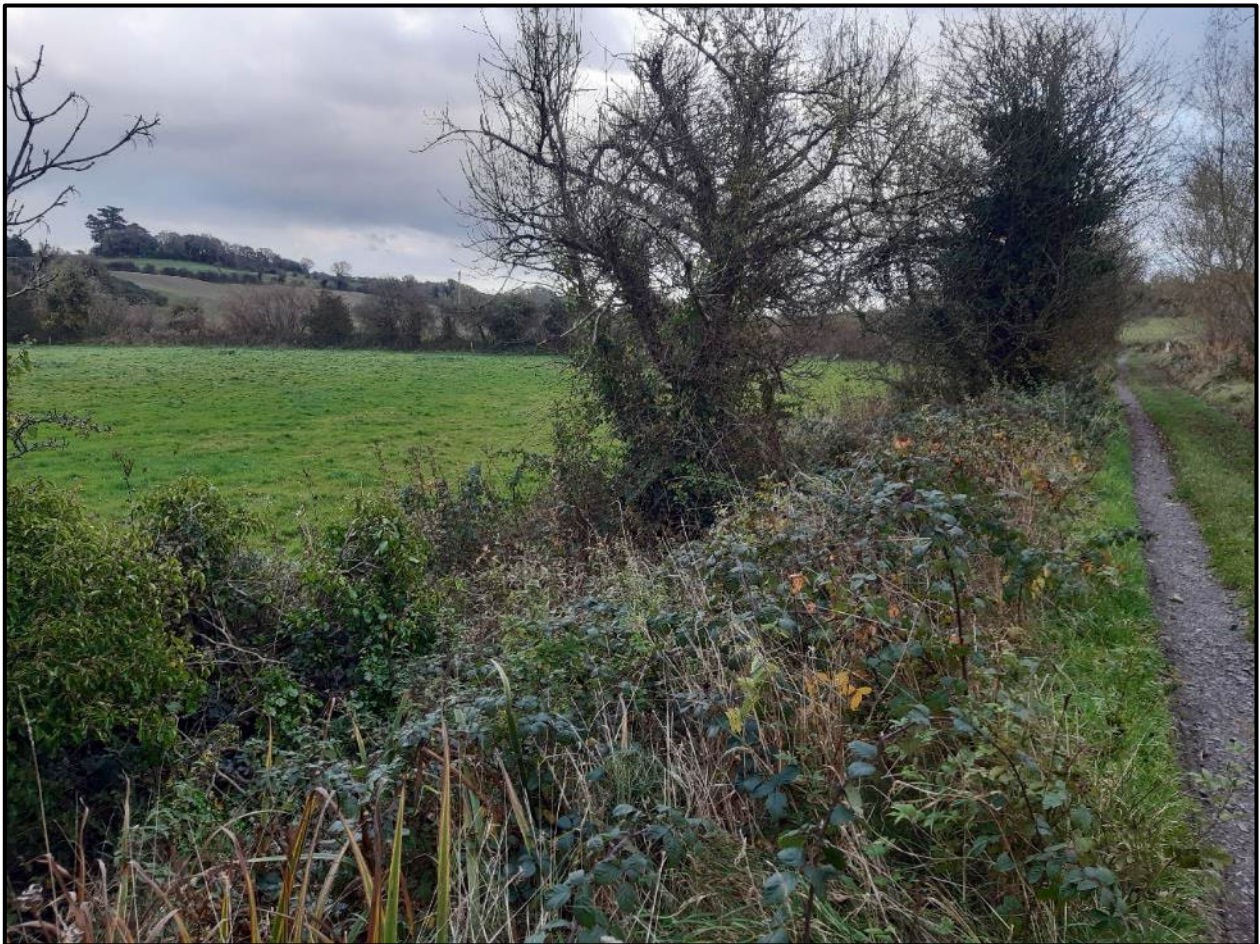
Plate 32 Boundary 51

Boundary 51 was classified as a treeline. It was a canal boundary and also present on 1st edition OSI maps. It contained 5 favourable tree, shrub and woody climber species listed in Appendix D of the HAS booklet. These species consisted of abundant ivy with frequent hawthorn and occasional elder, ash and grey willow. The ash trees had signs of dieback. Occasional crack willow (*Salix fragilis*) and sycamore and rare snowberry, all species that are listed as unfavourable in Appendix D of the HAS booklet were also observed in addition to abundant brambles. Ground flora included nutrient rich species such as cleavers and nettles in conjunction with cock's-foot, ribwort plantain, knapweed, flag iris (*Iris pseudacorus*), creeping buttercup, meadowsweet (*Filipendula ulmaria*), horsetail, dandelion, soft shield fern, bush vetch, cow parsley and rosebay willowherb. This hedgerow was located on a bank of low bank of <0.5m high. This hedgerow was located on the northern side of the canal towpath. A wet drain of approximately 1.5m wide was located to the north of this hedgerow. There was a slope of approximately 3m down to this drain from the hedgerow. Another drain was located on the southern side of the towpath. There was no obvious recent management of the hedgerow, however, it seems like the sides were cut previously. The hedgerow was approximately 3m tall and 2.5m wide. The western section of this hedgerow primarily consisted of a few trees with brambles and nettles on the bank while the eastern section contained more scrubby species and was more dense. This hedgerow contained >10% gaps and the basal porosity was considered to be semi-translucent. Minor bank degradation was observed along with sheep-wire and barbwire attached to the hedgerow.

This boundary scored 27 when assessed using the HAS.

The total length of this boundary within the land acquisition boundary is 195.6m. 182.6m of this length lies within the scheme alignment/works boundary.

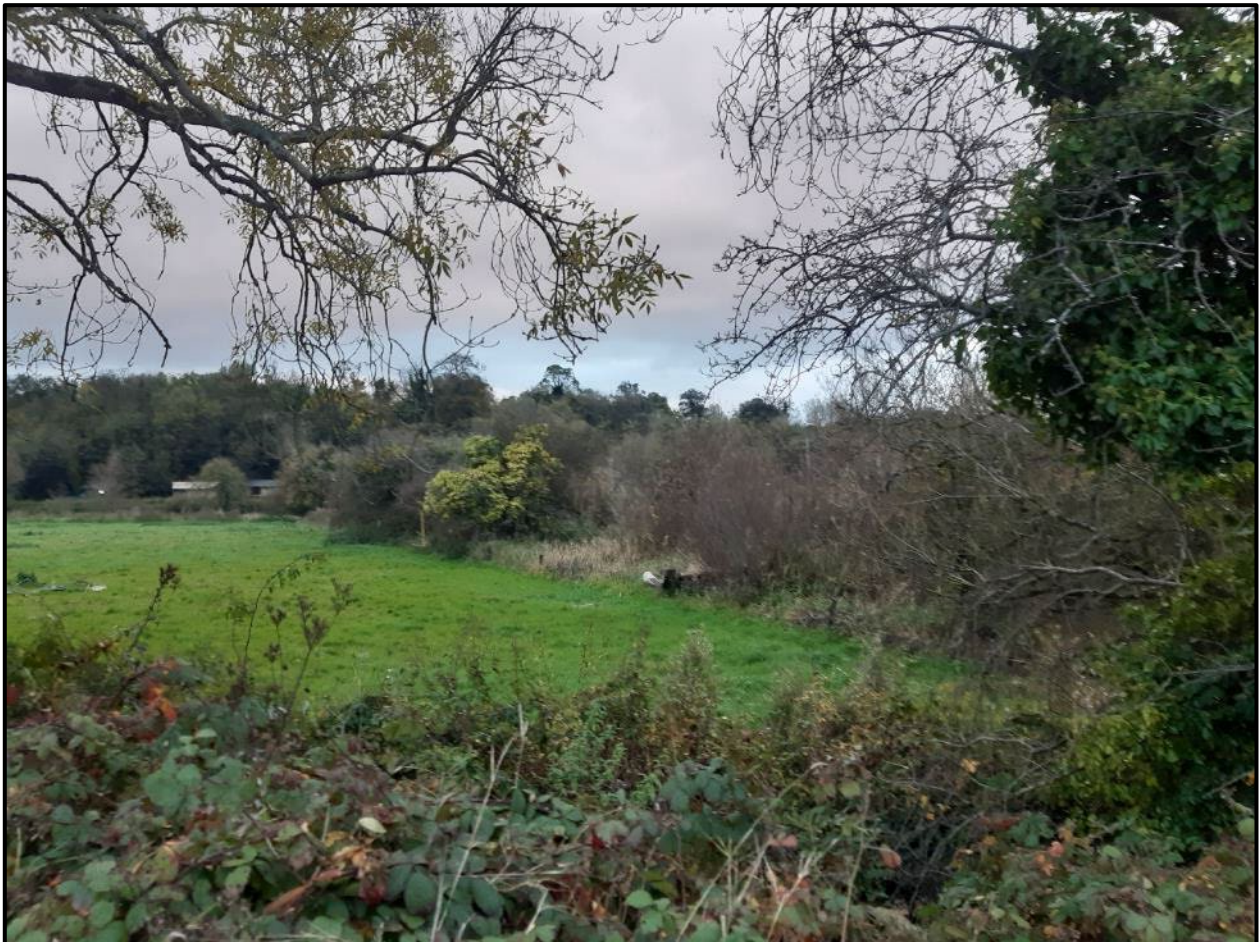
Plate 33 Boundary 52

This boundary scored 34 when assessed using the HAS.

The total length of this boundary within the land acquisition boundary is 122.9m. 19.1m of this length lies within the scheme alignment/works boundary.

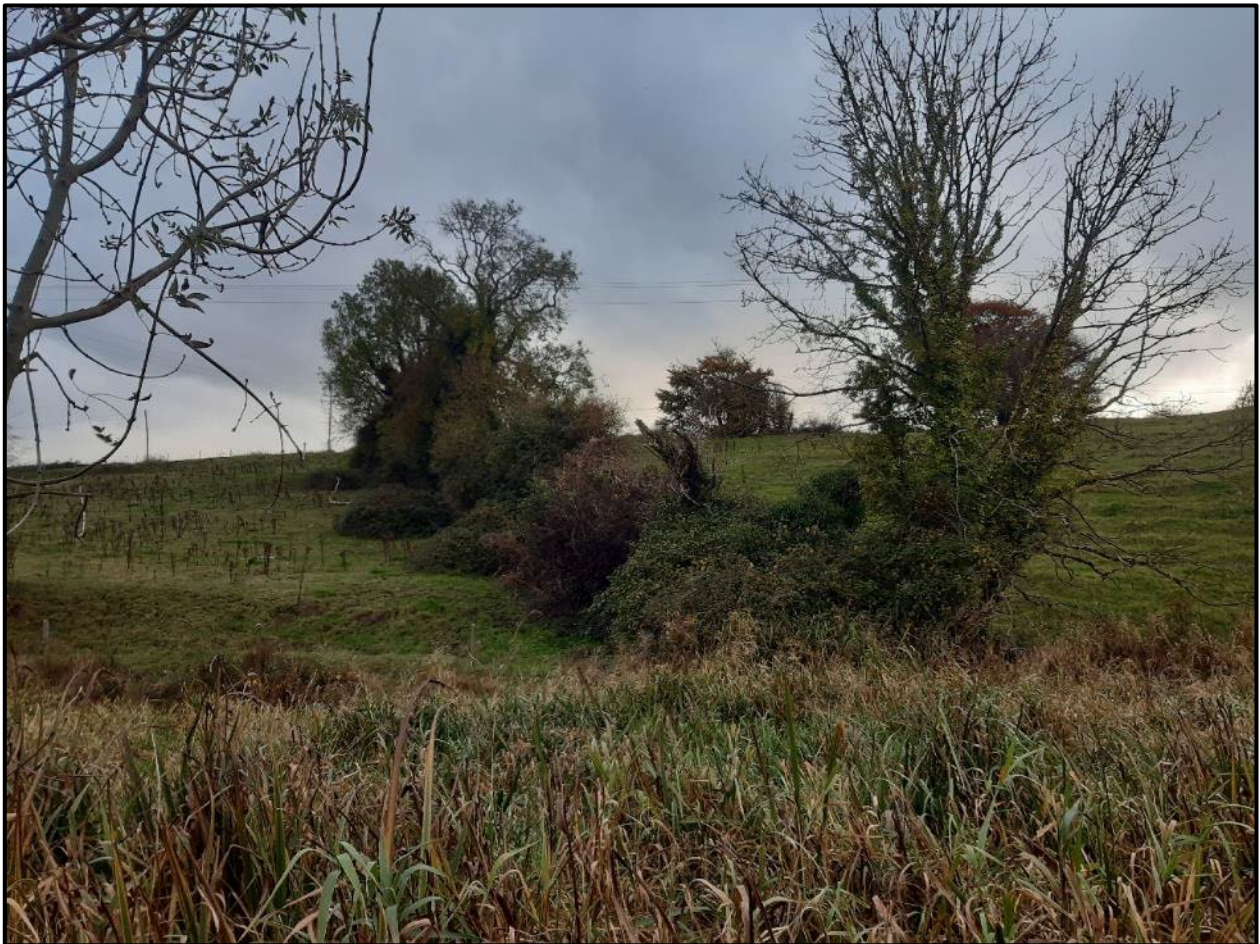
Plate 34 Boundary 53

Boundary 53 was classified as a treeline. It was a farm boundary and also present on 1st edition OSI maps. It contained 5 favourable tree, shrub and woody climber species listed in Appendix D of the HAS booklet. These species consisted of frequent ivy and hawthorn with occasional ash, elder and rare rose. The ash trees had signs of dieback. Abundant brambles were also present. Ground flora included abundant nettles, a nutrient rich species. Other ground flora species observed included cock's-foot, chickweed (*Stellaria media*), bush vetch, hedge woundwort, red clover (*Trifolium pratense*), herb-robert, cow parsley, creeping buttercup, common sorrel (*Rumex acetosa*), wood avens, dandelion, ribwort plantain, yarrow, nipplewort and crested dog's tail (*Cynosurus cristatus*). This treeline is located between two fields. There is a drop of approximately 1.5m between western and eastern fields with the eastern field lower than the western field. This treeline is located in the western field. The drop between fields has stone placed up against the bank. There were no obvious signs of management of the treeline on the day of the survey and it varied in width from 1m to 6-7m throughout its length. This hedgerow contained 5-10% gaps with no one gap being >5m long. Basal porosity was considered to be semi-opaque. Less than 20% of the stone-faced bank had signs of degradation. Barbwire was observed attached to the hedgerow.

This boundary scored 31 when assessed using the HAS.

The total length of this boundary within the land acquisition boundary is 87m. 46.9m of this length lies within the scheme alignment/works boundary.

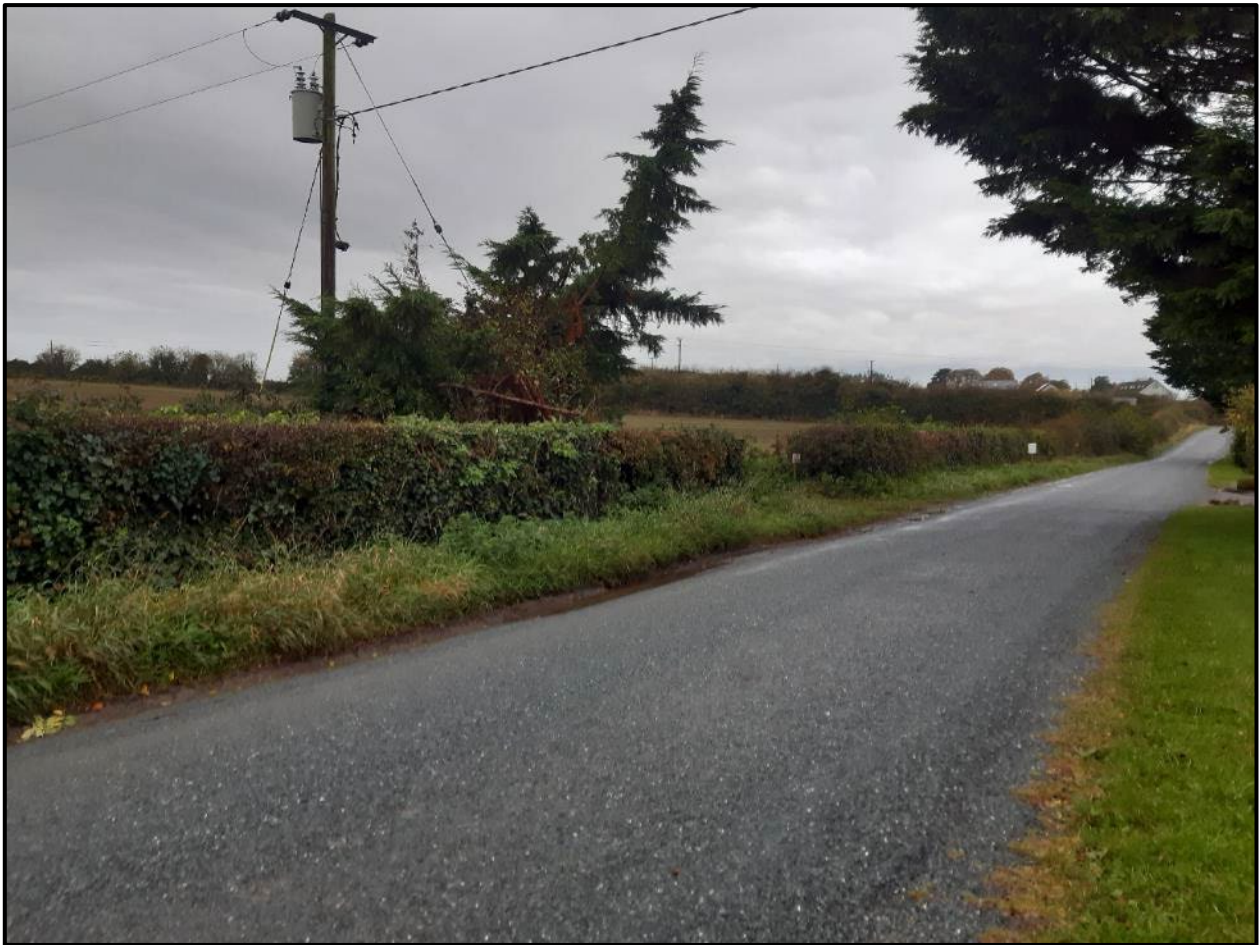
Plate 35 Boundary 54

Boundary 54 was classified as a hedgerow. It was a roadside boundary and also present on 1st edition OSI maps. It contained 3 favourable tree, shrub and woody climber species listed in Appendix D of the HAS booklet. These species consisted of abundant, frequent hawthorn and occasional elder. Rare conifers, species that are listed as unfavourable in Appendix D of the HAS booklet were also observed in addition to frequent brambles. Ground flora included frequent nettles and cleaver, both nutrient rich species, in addition to rank grass such as couch grass, false oat grass, cock's-foot. Other ground flora species present included cow parsley and creeping buttercup. This hedgerow was located on a bank less than 0.5m high. The hedgerow itself was boxed to approximately 2m wide and 1.25m high. It was continuous with no gaps and basal porosity was considered to be semi-opaque. There were signs of minor degradation of the bank.

This boundary scored 21 when assessed using the HAS.

The total length of this boundary within the land acquisition boundary is 101.7m. 67.9m of this length lies within the scheme alignment/works boundary.

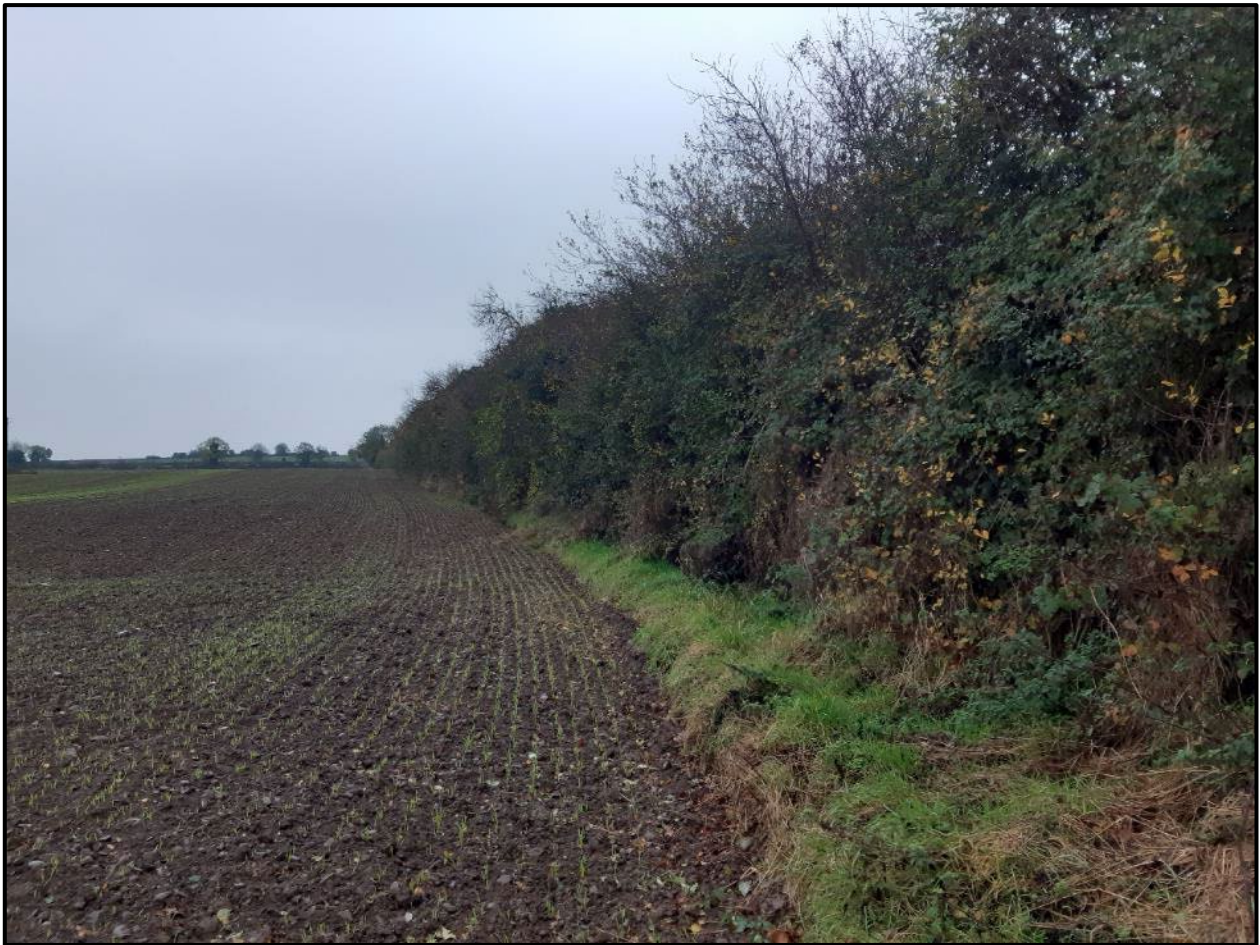
Plate 36 Boundary 55

This boundary scored 27 when assessed using the HAS.

The total length of this boundary within the land acquisition boundary is 111.8m. 82.7m of this length lies within the scheme alignment/works boundary.

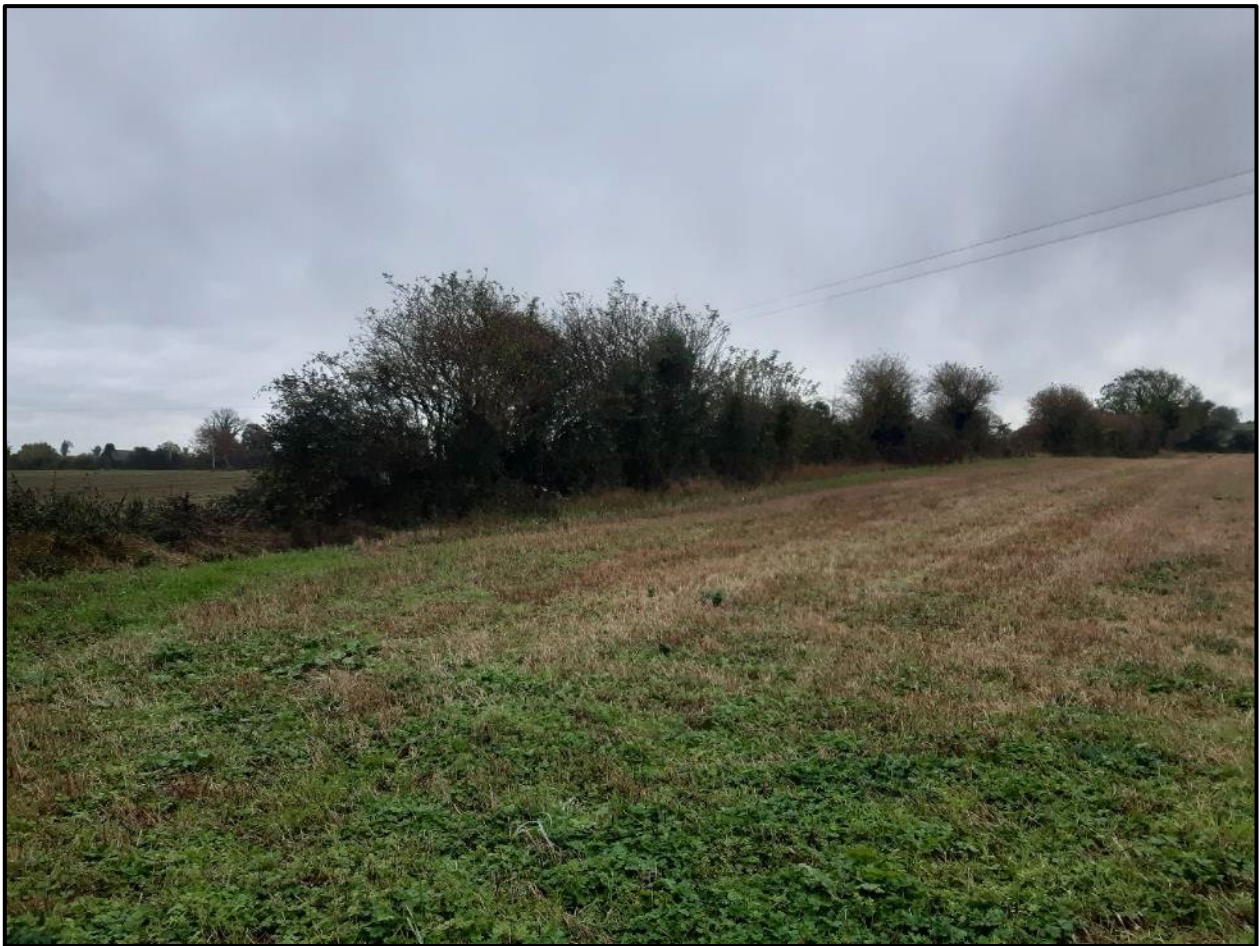
Plate 37 Boundary 56

This boundary scored 29 when assessed using the HAS.

The total length of this boundary within the land acquisition boundary is 165m. 134.1m of this length lies within the scheme alignment/works boundary.

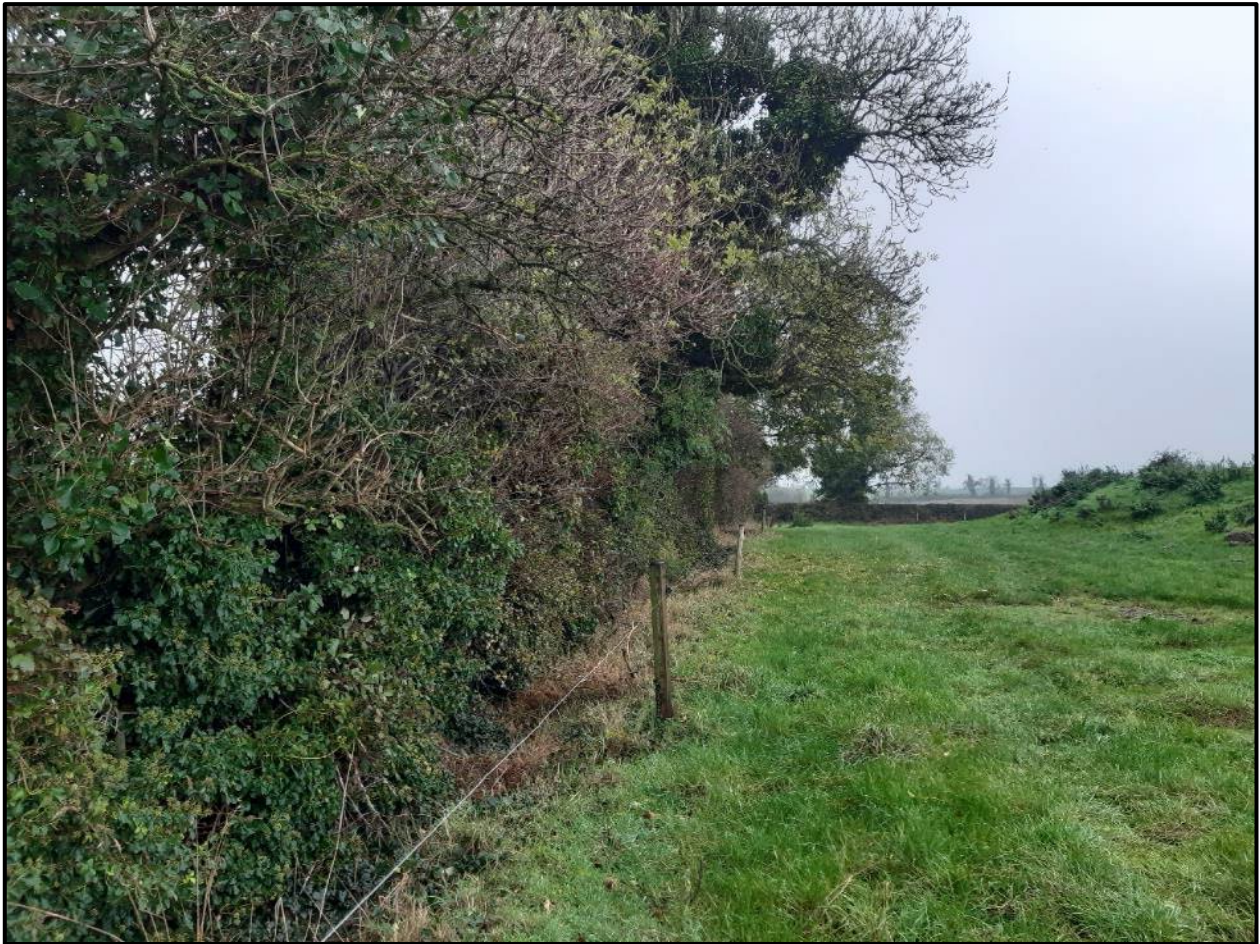
Plate 38 Boundary 58

This boundary scored 30 when assessed using the HAS.

The total length of this boundary within the land acquisition boundary is 80.1m. 54.4m of this length lies within the scheme alignment/works boundary.

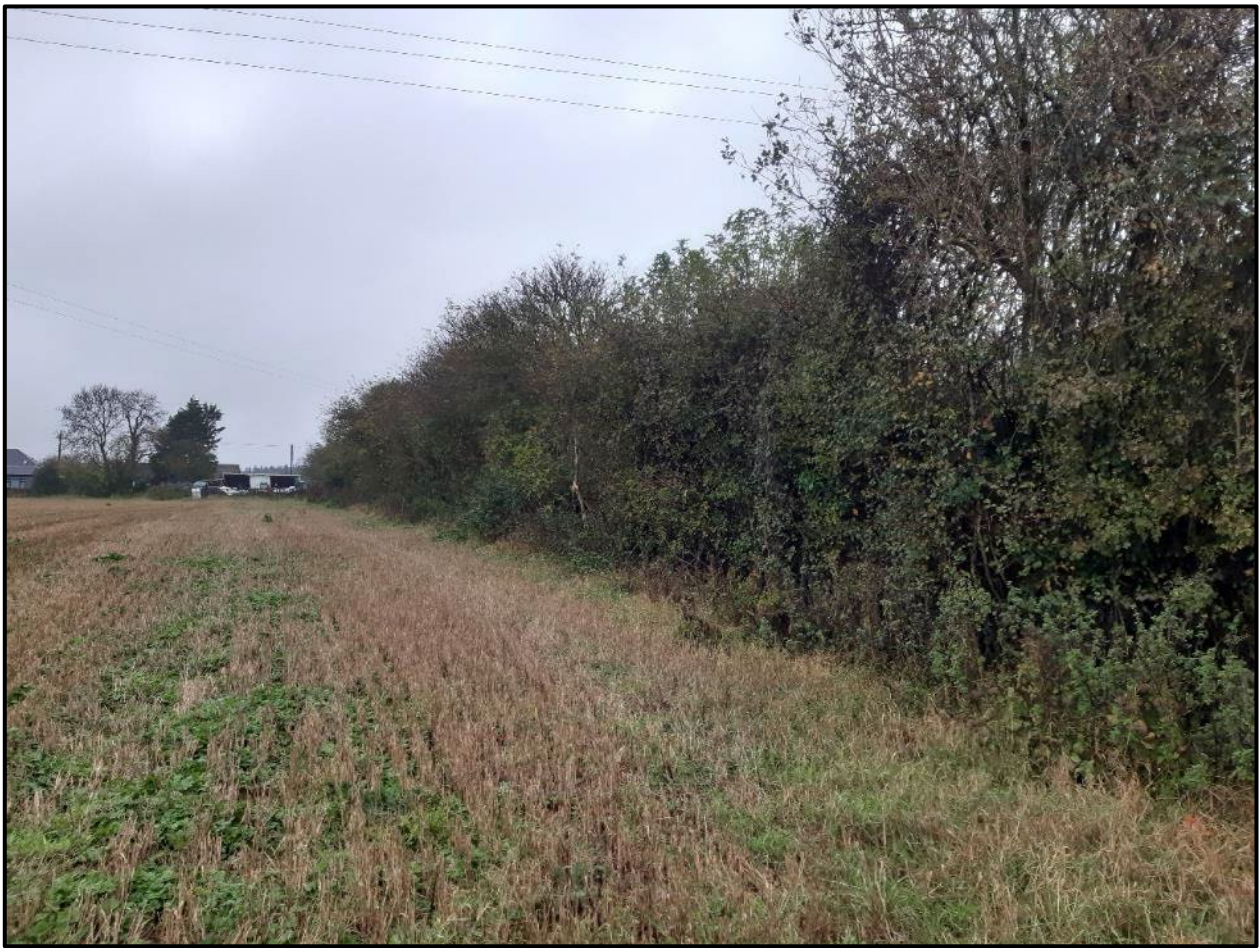
Plate 39 Boundary 59

This boundary scored 31 when assessed using the HAS.

The total length of this boundary within the land acquisition boundary is 39.2m. 32.2m of this length lies within the scheme alignment/works boundary.

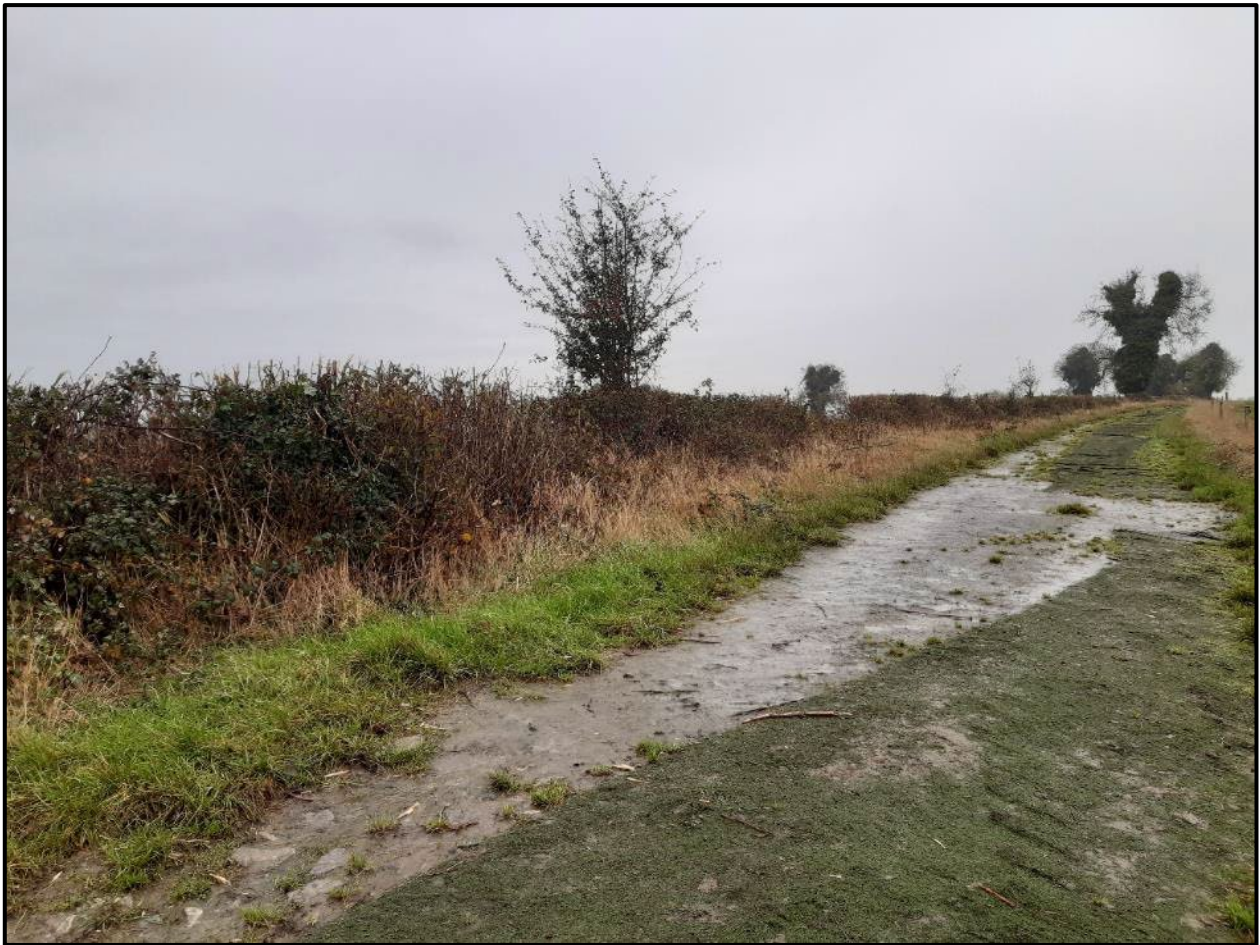
Plate 40 Boundary 60

Boundary 60 was classified as a hedgerow. It was an internal farm boundary, was also present on 1st edition OSI maps and it is a townland boundary. It contained 4 favourable tree, shrub and woody climber species listed in Appendix D of the HAS booklet. These species consisted of frequent hawthorn and elder with occasional ivy and rare gorse. Frequent brambles were also present. Ground flora had signs of nutrient enrichment as occasional nettles were observed. Other ground flora species included cow parsley and false oat grass. This hedgerow was located on a slope of approximately 1.5m high with the field to the north on a lower level than the hedgerow. The hedgerow had been recently boxed (with rare hawthorn trees) to approximately 1.25m high and 1m wide. It had between 5-10% gaps and no one gap >5m long. Basal porosity was considered to be semi-translucent. There were signs of minor degradation of the bank/slope.

This boundary scored 22 when assessed using the HAS.

The total length of this boundary within the land acquisition boundary is 69.1m. 55.4m of this length lies within the scheme alignment/works boundary.

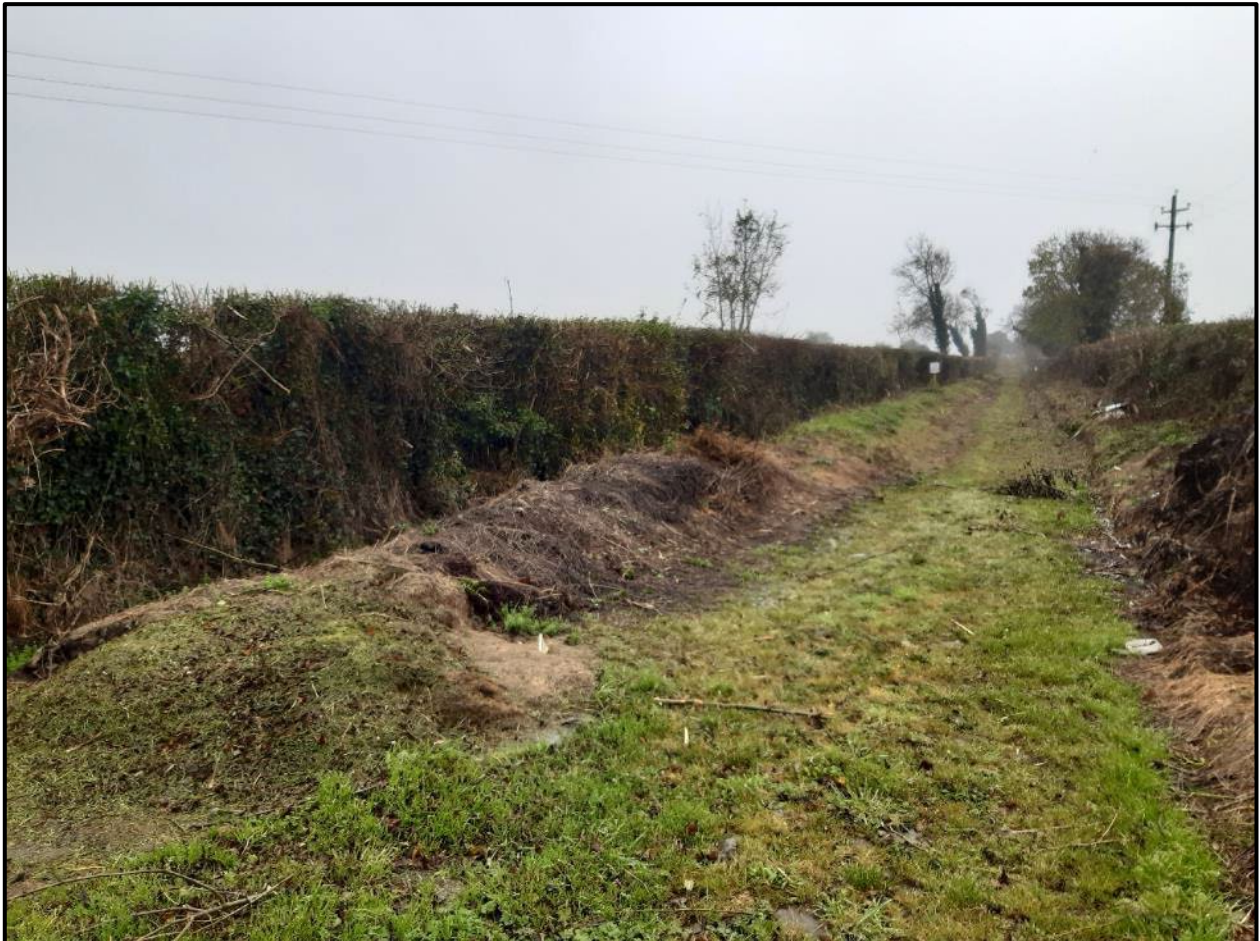
Plate 41 Boundary 61

This boundary scored 29 when assessed using the HAS.

The total length of this boundary within the land acquisition boundary is 80.1m. 64.9m of this length lies within the scheme alignment/works boundary.

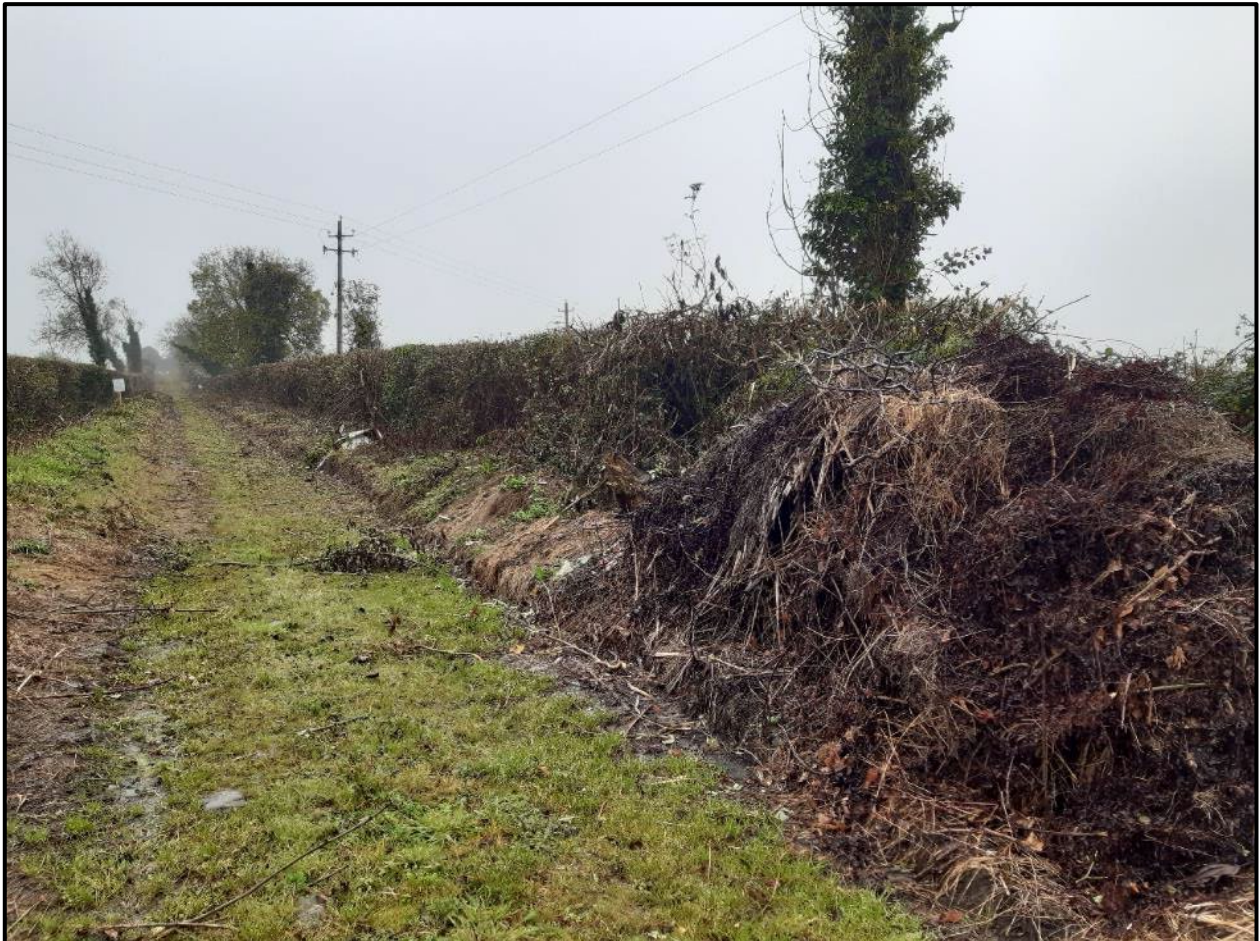
Plate 42 Boundary 62

This boundary scored 29 when assessed using the HAS.

The total length of this boundary within the land acquisition boundary is 79.2m. 64.1m of this length lies within the scheme alignment/works boundary.

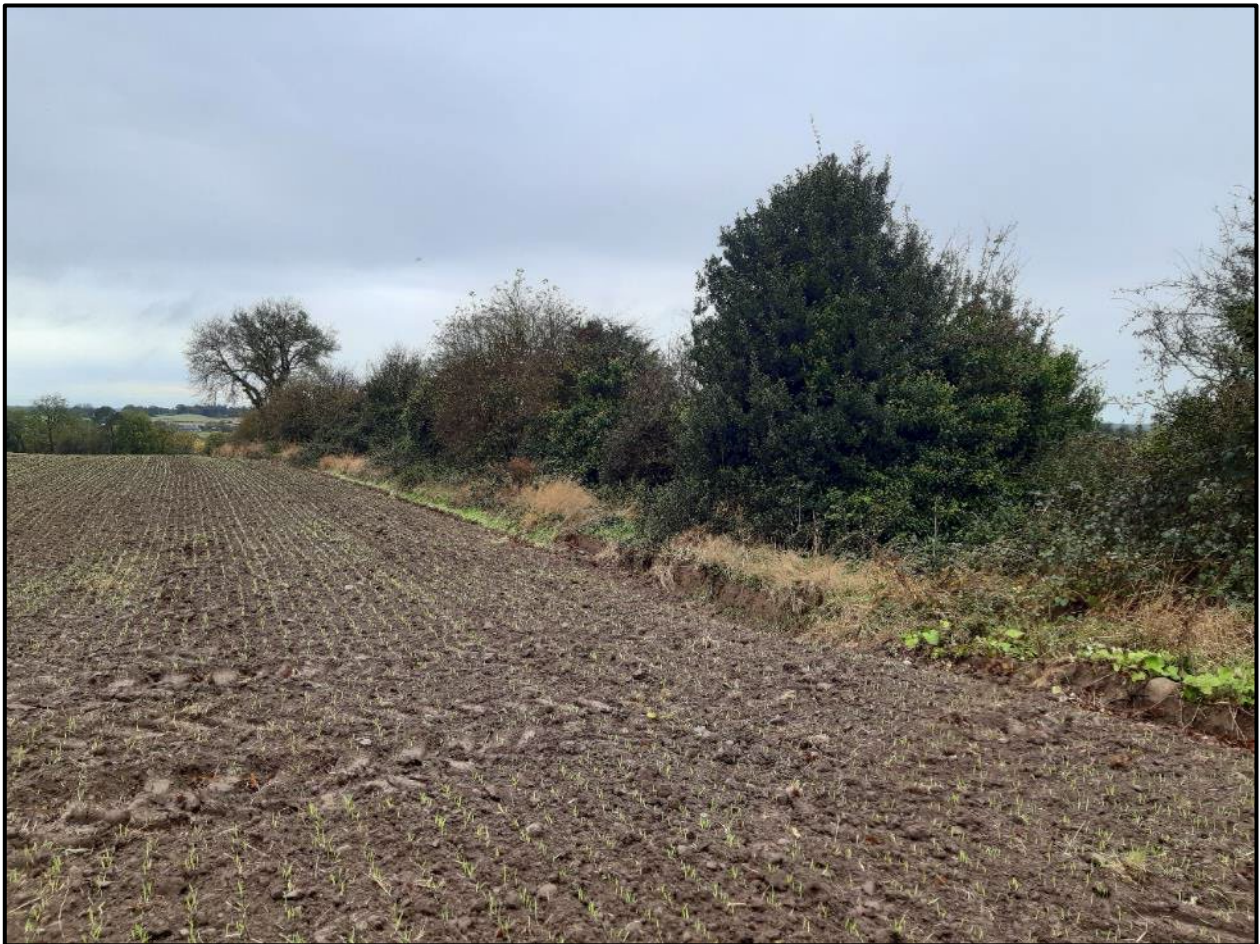
Plate 43 Boundary 63

This boundary scored 33 when assessed using the HAS.

The total length of this boundary within the land acquisition boundary is 120.8m. 80m of this length lies within the scheme alignment/works boundary.

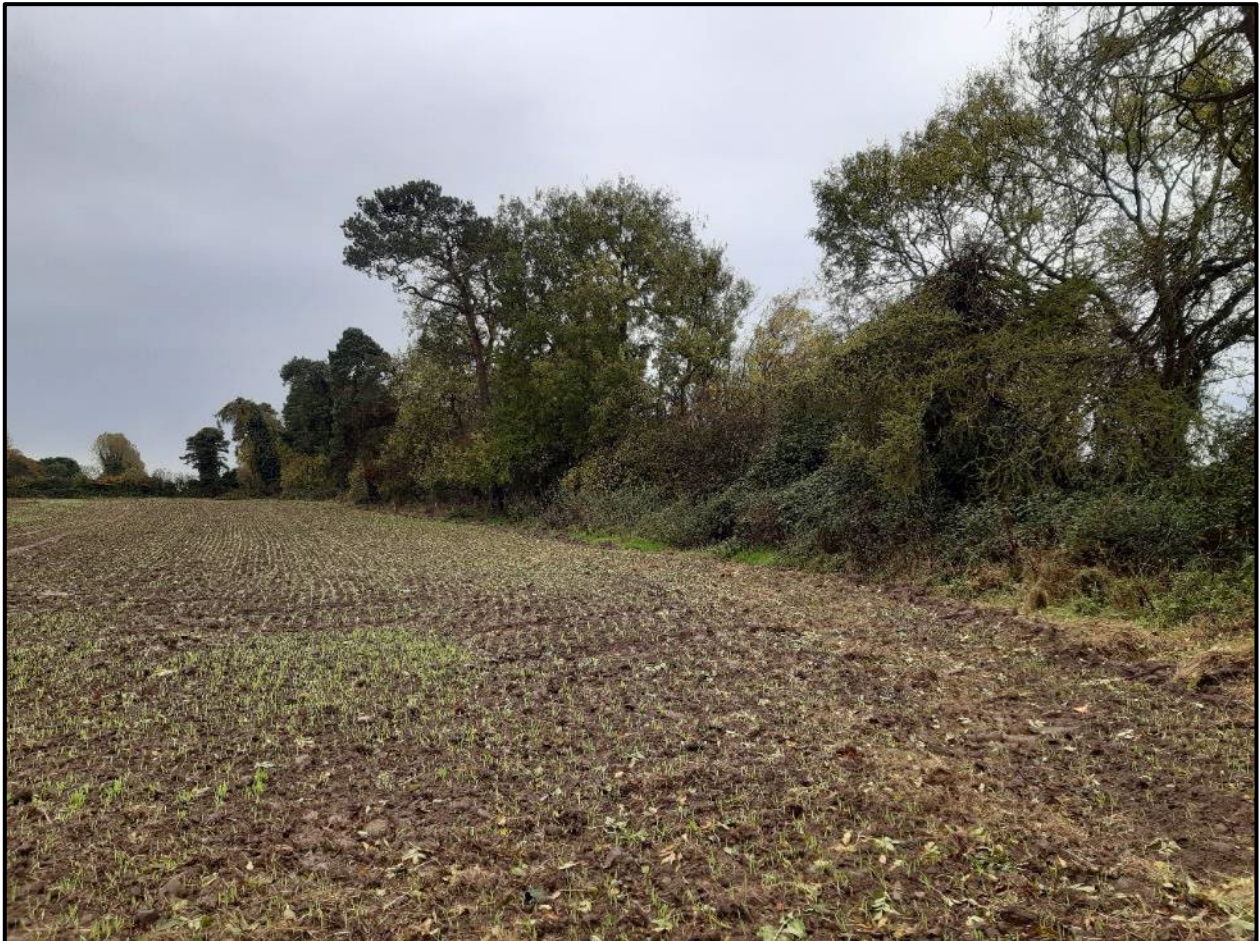
Plate 44 Boundary 64

This boundary scored 37 when assessed using the HAS.

The total length of this boundary within the land acquisition boundary is 176.5m. 112m of this length lies within the scheme alignment/works boundary.

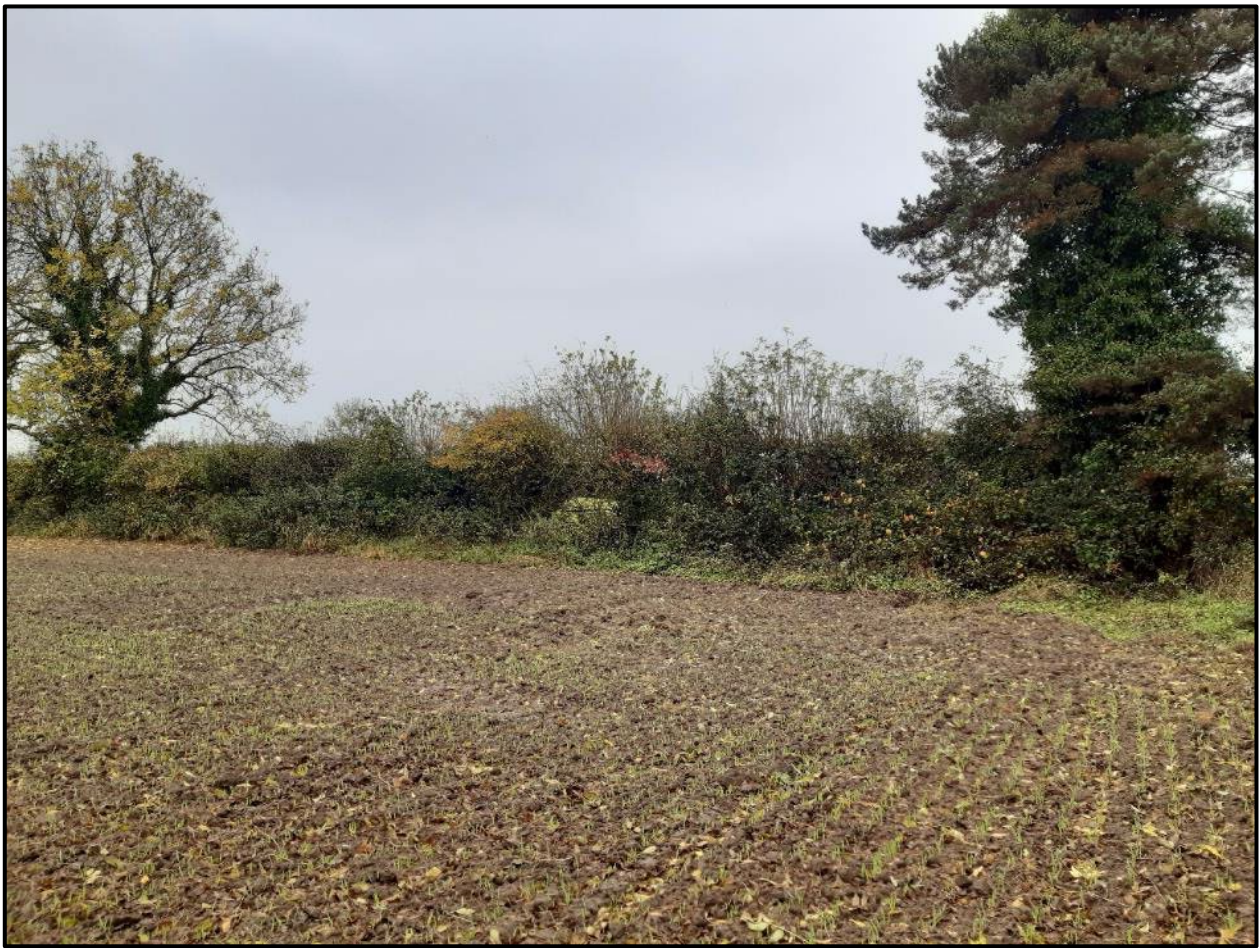
Plate 45 Boundary 65

Boundary 65 was classified as a hedgerow. It was a farm boundary, was present on 1st edition OSI maps and is also a townland boundary. It contained 3 favourable tree, shrub and woody climber species listed in Appendix D of the HAS booklet. These species consisted of abundant ivy with occasional elder and hawthorn. Frequent brambles were also present. Rare conifers, species that are listed as unfavourable in Appendix D of the HAS booklet were also observed within this hedgerow. Ground flora was very nutrient rich and included species such as nettles and cleavers, in addition to rank grass such as false oat grass. Other ground flora species present included herb-robert, false brome and creeping buttercup. This hedgerow was located on a low bank <0.5m high. There was no recent management of this hedgerow however, the lower vegetation had been previously cut A-shape to approximately 2.5m high and >3m wide. There was abundant ivy throughout the hedgerow. The hedgerow was continuous with no gaps. Basal porosity was considered to be semi-translucent. There were signs of minor degradation of the bank.

This boundary scored 30 when assessed using the HAS.

The total length of this boundary within the land acquisition boundary is 21.8m. 14.6m of this length lies within the scheme alignment/works boundary.
