SLANE BYPASS & PUBLIC REALM ENHANCEMENT SCHEME

Additional Information Response Document

December 2024

ABP-318573-23

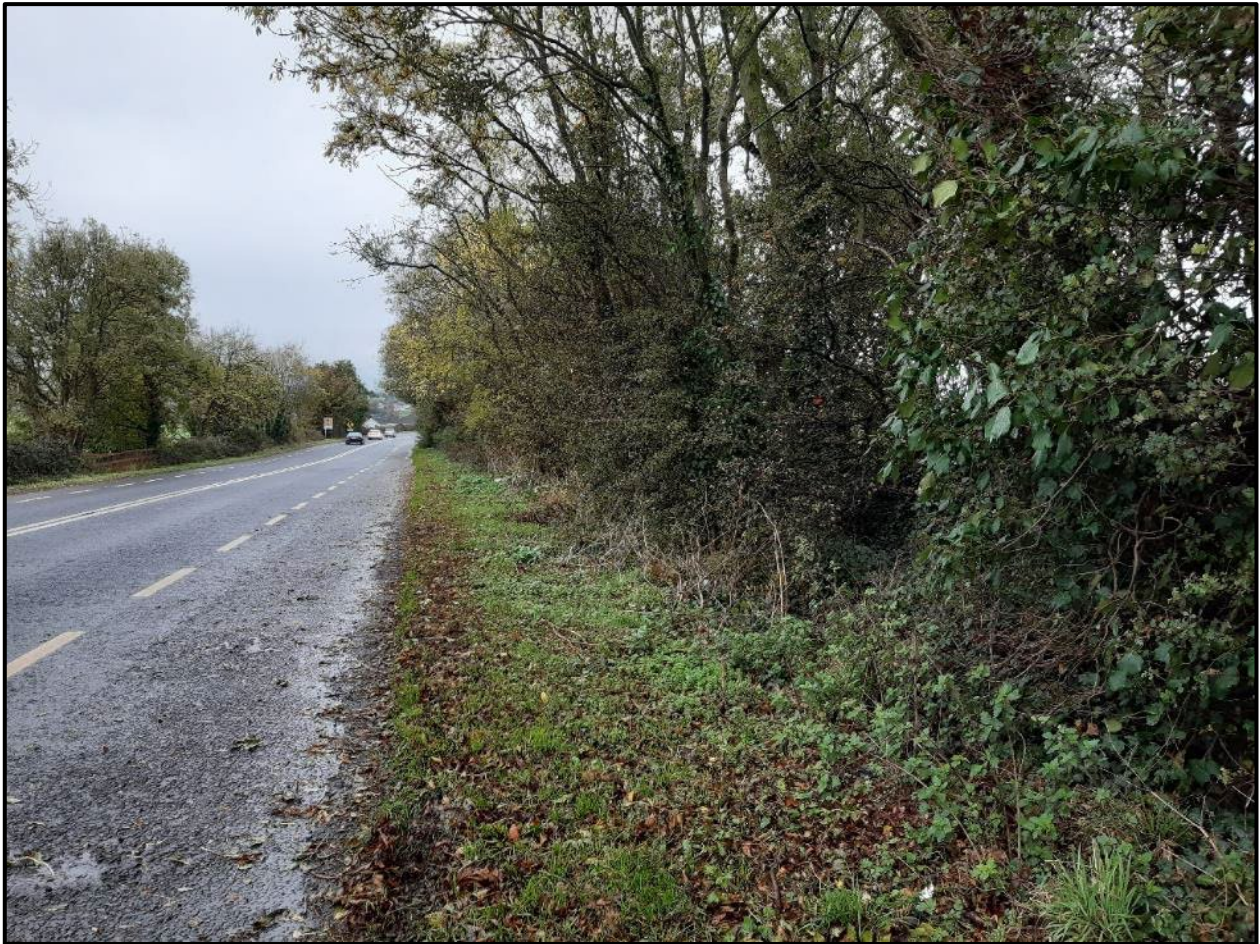
Plate 46 Boundary 66

This boundary scored 37 when assessed using the HAS.

The total length of this boundary within the land acquisition boundary is 55.3m. 48.2m of this length lies within the scheme alignment/works boundary.

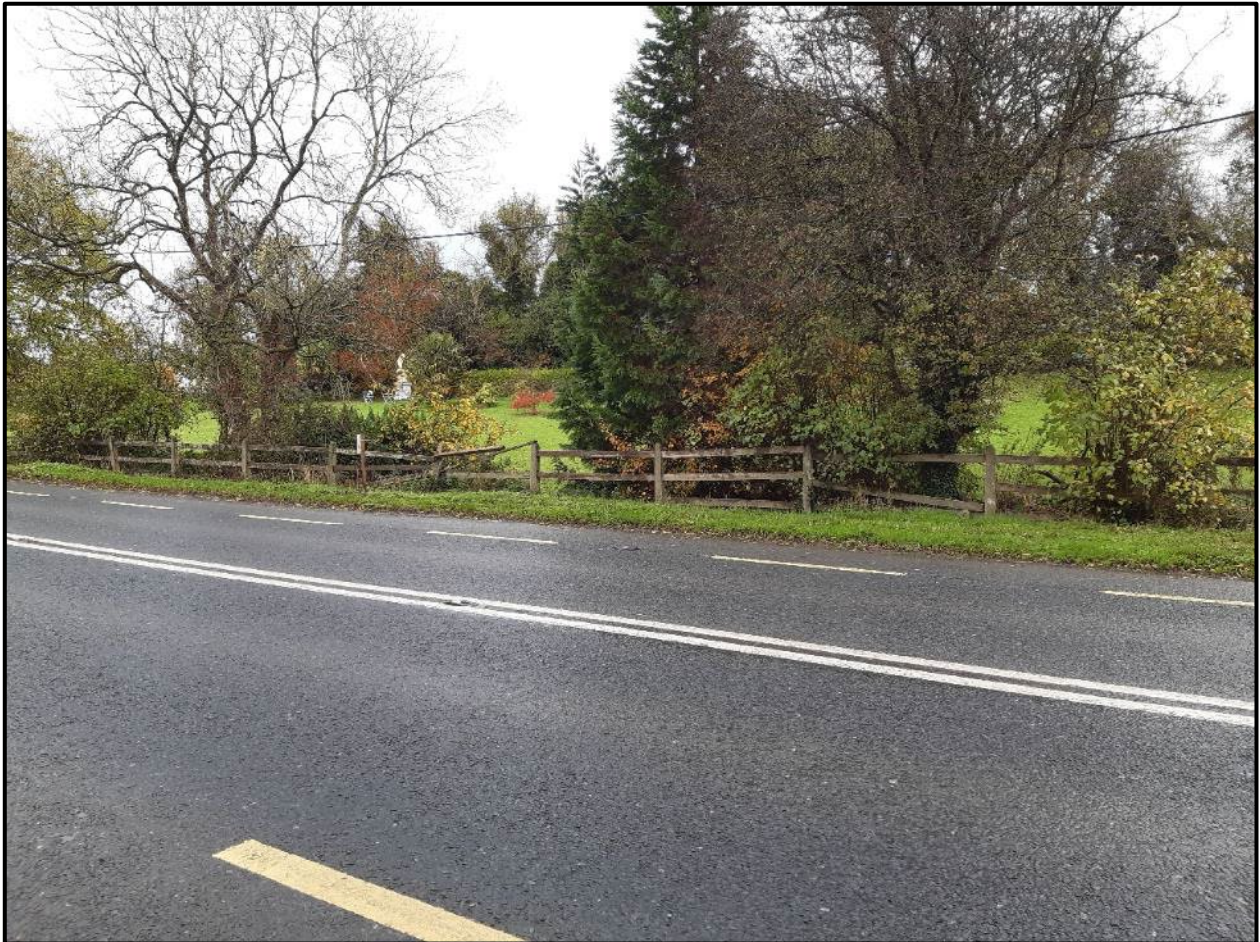
Plate 47 Boundary 67

This boundary scored 12 when assessed using the HAS.

The total length of this boundary within the land acquisition boundary is 47.8m. 29m of this length lies within the scheme alignment/works boundary.

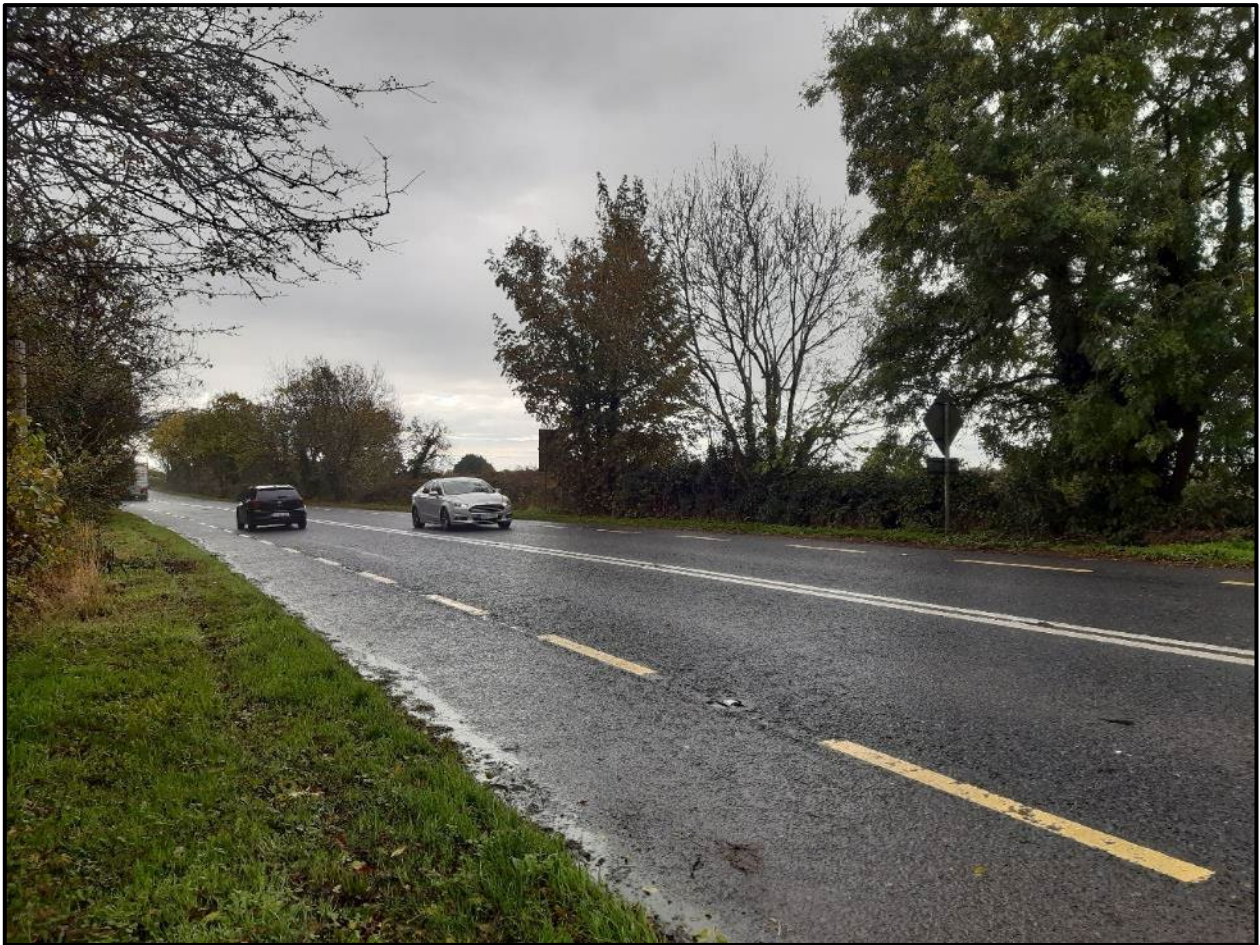
Plate 48 Boundary 68

Boundary 68 was classified as a treeline. It was a roadside boundary and also present on 1st edition OSI maps. It contained 3 favourable tree, shrub and woody climber species listed in Appendix D of the HAS booklet. These species consisted of frequent ivy with occasional ash and elder. The ash had signs of ash die back. Abundant brambles were also present. Rare sycamore, a species that is listed as unfavourable in Appendix D of the HAS booklet were also observed within this treeline. Ground flora included cow parsley, bush vetch and cleavers. This hedgerow was located around a timber fence and there is a slope of approximately 2m height down from the roadside to the adjacent field. This treeline has had its sides cut previously. It contained between 5 and 10% gaps with no individual gap >5m in length. Basal porosity was considered to be semi-translucent. There were signs of minor degradation of the slope.

This boundary scored 22 when assessed using the HAS.

The total length of this boundary within the land acquisition boundary is 19.6m. 15.7m of this length lies within the scheme alignment/works boundary.

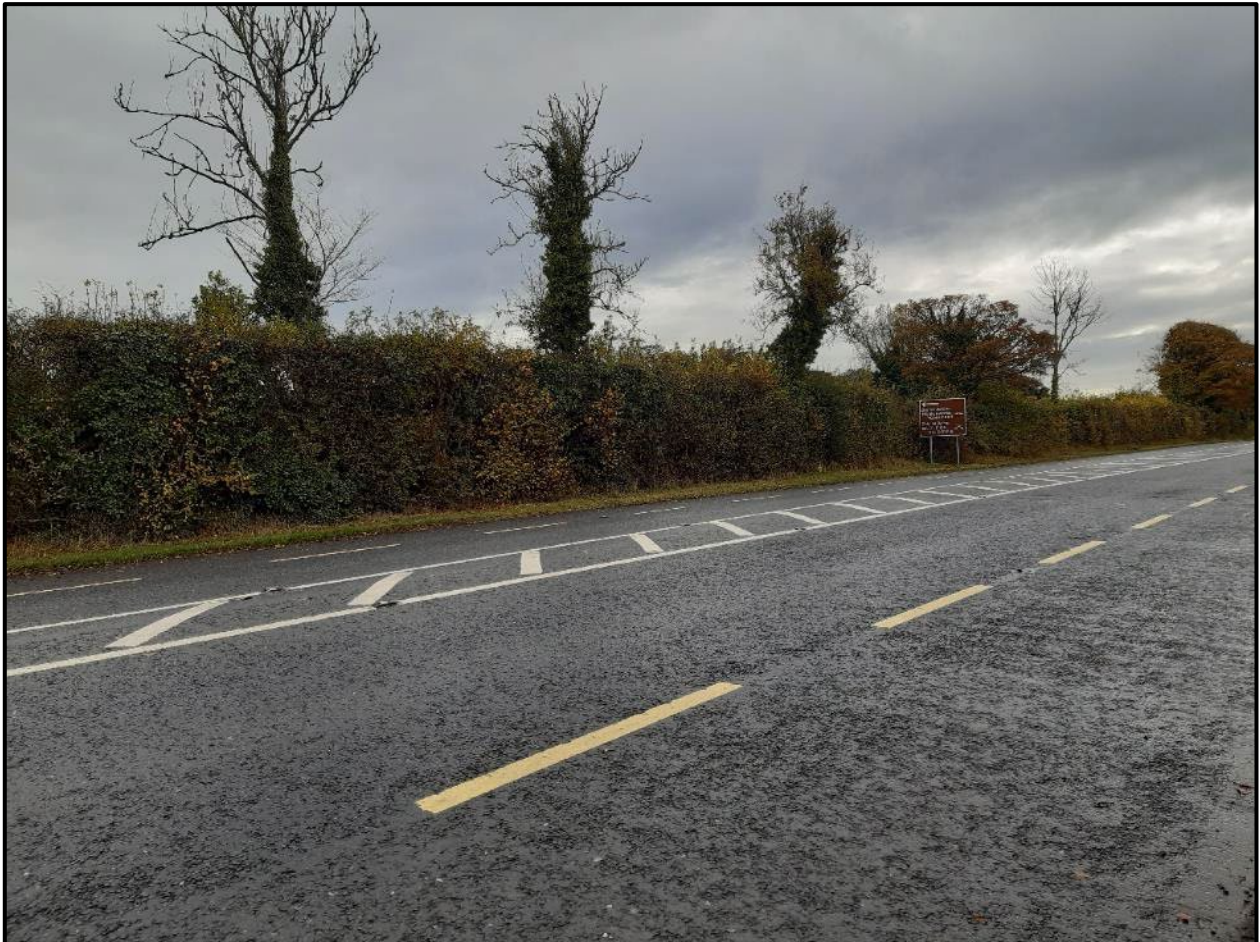
Plate 49 Boundary 71

Boundary 71 was classified as a treeline. It was a roadside boundary and also present on 1st edition OSI maps. It contained 6 favourable tree, shrub and woody climber species listed in Appendix D of the HAS booklet. These species consisted of abundant ivy with frequent elm, hawthorn and blackthorn with occasional rose and ash. The ash had signs of ash die or were dead. Frequent brambles were also present. Occasional sycamore, a species that is listed as unfavourable in Appendix D of the HAS booklet were also observed within this treeline. Ground flora included cow parsley, ribwort plantain, hart's-tongue fern, soft shield fern, bush vetch, black medic (*Medicago lupulina*), germander speedwell and false brome. This treeline was located on a bank of approximately 1m high. The lower vegetation within this treeline was boxed to approximately 3m high and 2-3m wide. A drain was observed on the eastern side of the hedgerow which was approximately 1.5m wide and 1.5m deep. The hedgerow was continuous with no gaps. Basal porosity was considered to be dense. There were signs of minor degradation of the bank.

This boundary scored 32 when assessed using the HAS.

The total length of this boundary within the land acquisition boundary is 143.4m. 97.8m of this length lies within the scheme alignment/works boundary.
