Peat Stability Risk Assessment (PSRA) for Carrig Renewables Wind Farm

Client	MKO
Document Ref.	22063-R-001-02-PSRA
Project Title	Carrig Renewables Wind Farm
Date	14/09/2023

Project Title:	Carrig Renewables Wind Farm
Report Title:	Peat Stability Risk Assessment (PSRA) for Carrig Renewables Wind Farm
Document Reference:	22063-R-001-02-PSRA

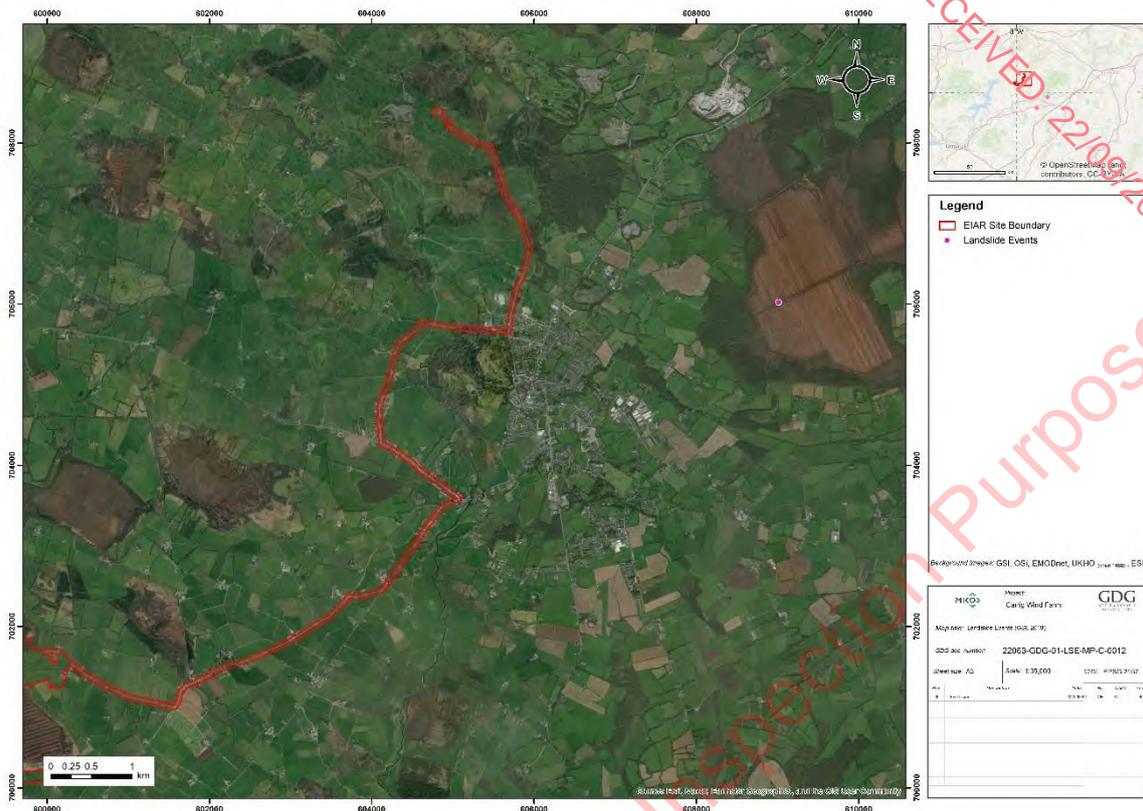
Figure 1-1: Closest recorded landslide to the site boundary (GSI, 2022).

According to the GSI landslide inventory (GSI, 2022), the closest landslide is located around 10 km northeast of the closest turbine (T02) and around 9.7km from the site boundary. The area of the peat slide was not recorded, but it is recorded to have occurred around 1900 and resulted in “an old road (being) swallowed in the bog”. Little other information is available, but this location appears to be a relatively flat, deep raised peat bog, and therefore the failure mechanism was likely a bog burst. Figure 1-1 shows the landslide event closest to the site boundary. The locations of the past landslide events identified in the GSI landslide archive are shown in Figure G- 1 in Appendix G.

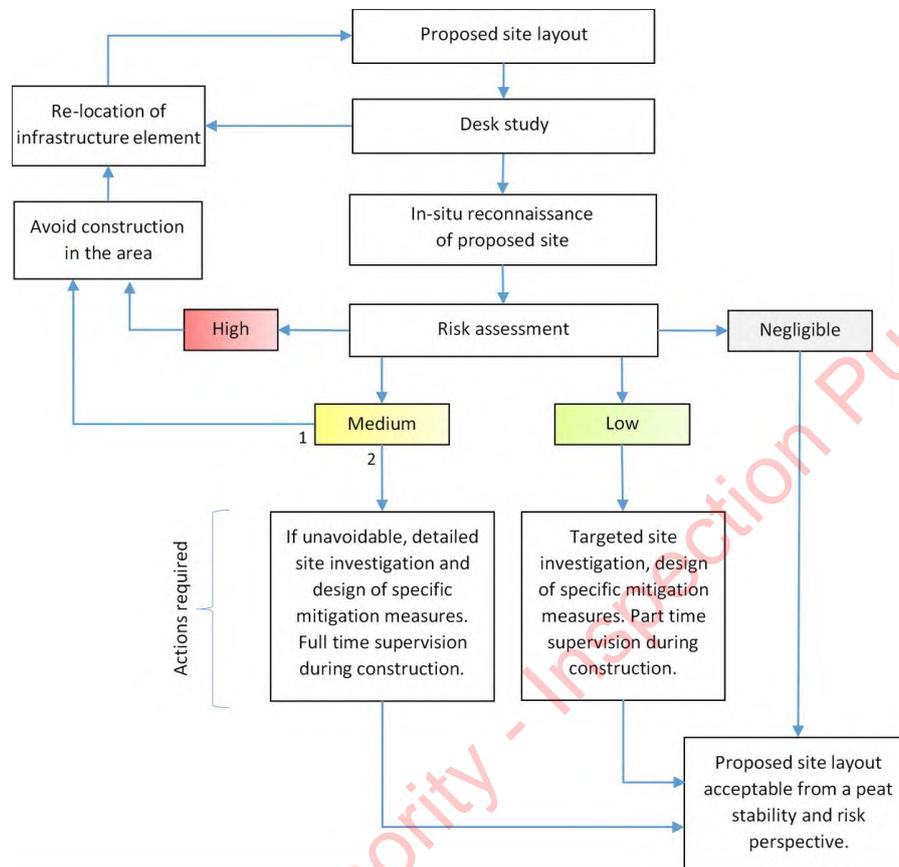
Figure 1-2: Workflow of the PSRA methodology for the acceptability of the proposed site layout (Scottish Executive, 2017).

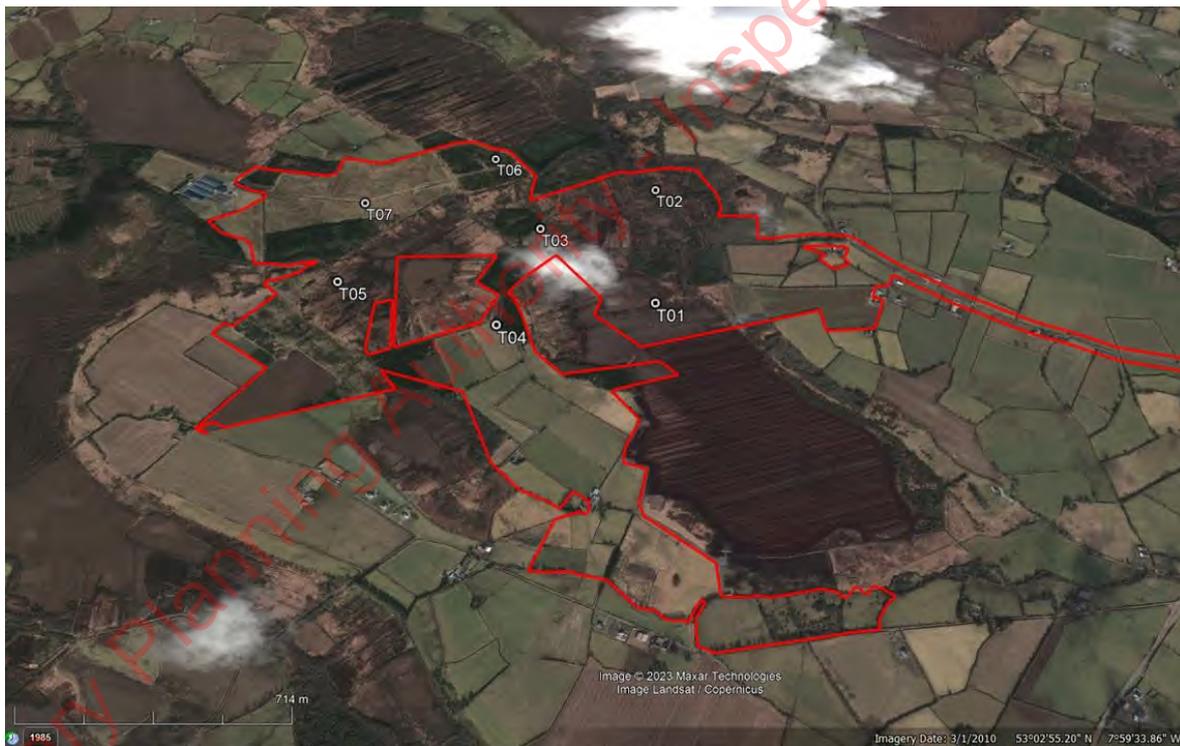
Figure 2-1: Multitemporal Satellite Imagery (Google Earth, 2010). White dots indicate the proposed WTG layout.

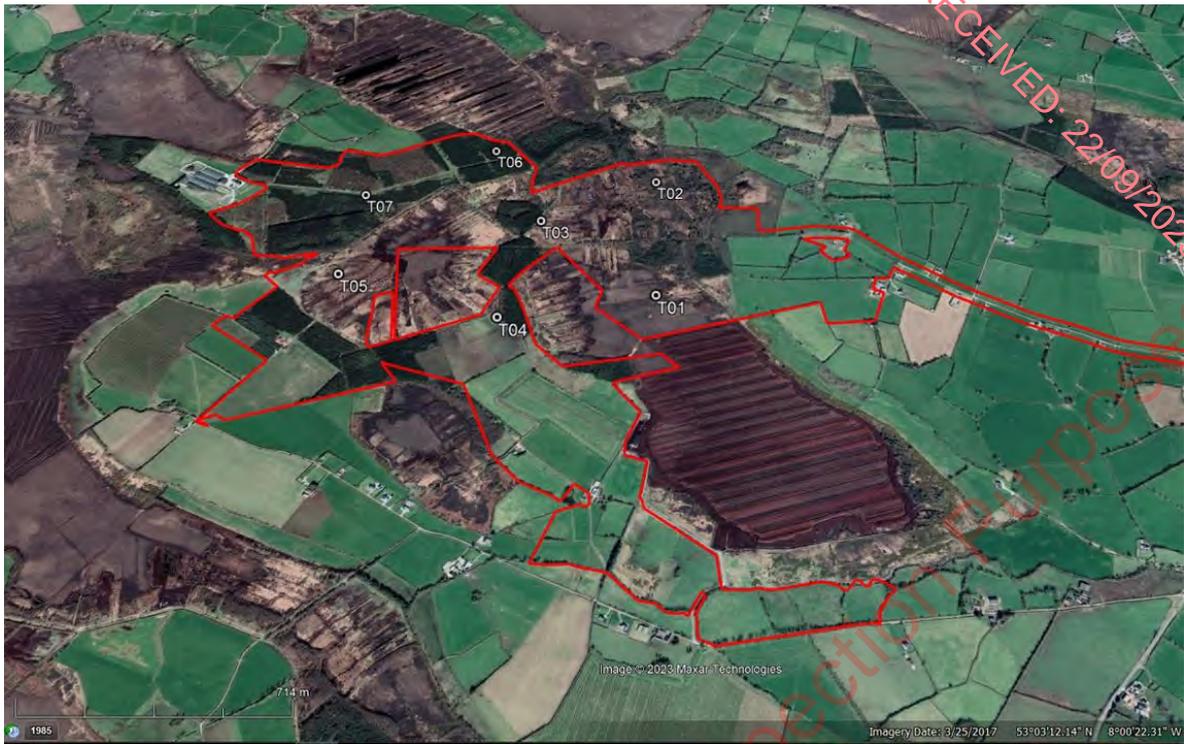
Figure 2-2: Multitemporal Satellite Imagery (Google Earth, 2017). White dots indicate the proposed WTG layout.

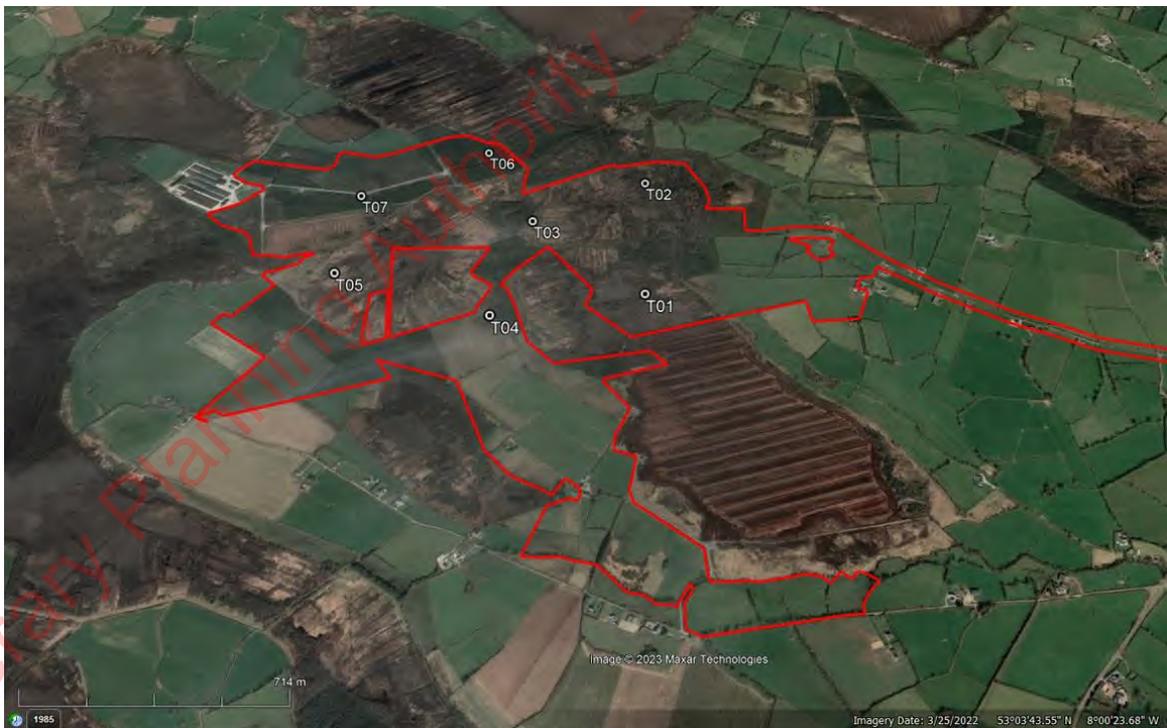
Figure 2-3: Multitemporal Satellite Imagery (Google Earth, 2022). White dots indicate the proposed WTG layout.

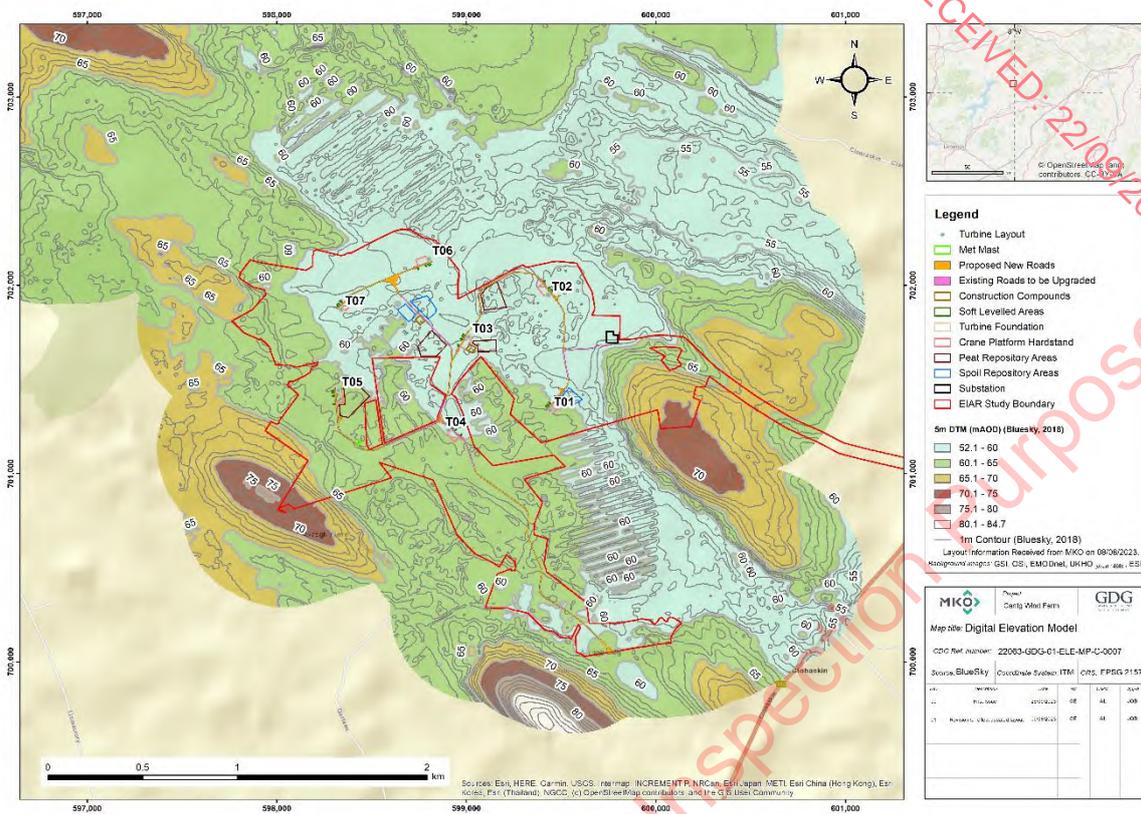
Figure 2-4: Digital Elevation Model for the proposed development, showing the low lying, generally flat topography (Bluesky, 2018).

The topography of the site is largely low-lying and flat, with low NW-SE oriented ridges mapped by the GSI as drumlins located around the site boundary. The peat bogs on site occupy low-lying, generally flat depressions between the drumlins. The topography of the site can be described as flat to undulating raised bog plain. The elevation varies between 52 m to 85 mOD (meters above ordnance datum). A topographically low area of <60mOD is identified to the west of T02, which remains persistently waterlogged, based on site observations and aerial imagery.

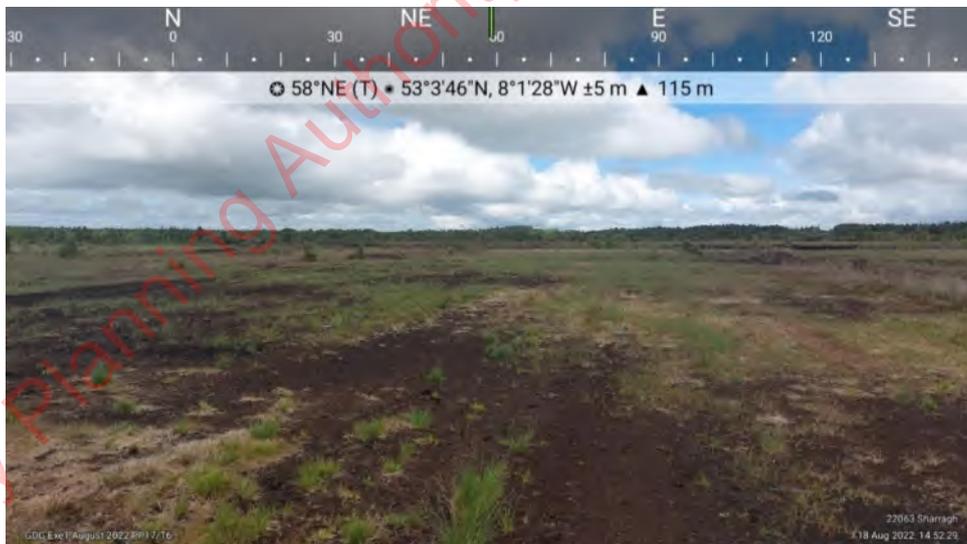
Figure 3-1: Harvested peat close to T05.

GDG conducted a site reconnaissance as part of the assessment. This comprised four site visits (July 2022, August 2022, November 2022 and March 2023) to record geomorphological features concerning the Proposed Development, peat depths and peat strength. An indication of the site conditions (harvested peat, peat bogs, wetlands and forestry) with flat topography are shown in Figure 3-1 and Figure 3-2.

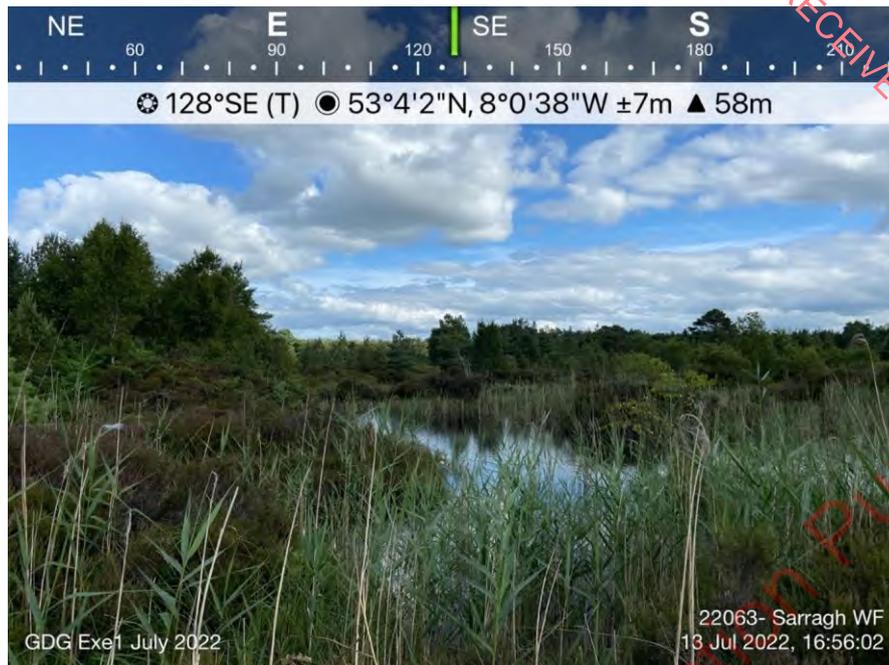
Figure 3-2: Waterlogged cut-over peat bog 200m to the west of T02.

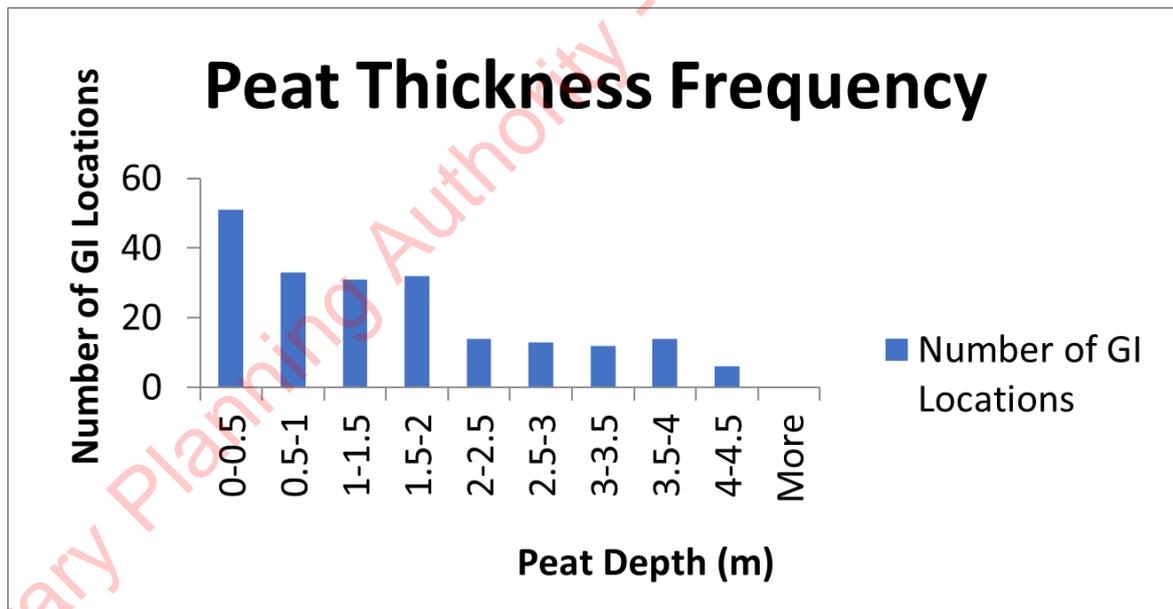
Figure 3-3: Histogram of peat thickness results across the site.

Peat thickness encountered by intrusive investigations across the site varies from 0m to a maximum of 4.5m, with an average of 1.68m recorded. The frequency of different peat thicknesses are shown in Figure 3-3. In total, 40.8% of recorded peat thicknesses were under 1m, and 78.2% were under 2m. Laterally extensive regions of >2m in depth were encountered, particularly in the vicinity of T01, T02, T06, northeast of T03, and between T05 and the proposed construction compound. The depths encountered are considered moderate to deep in places: with probes identifying peat thicknesses of up to 4.5m.

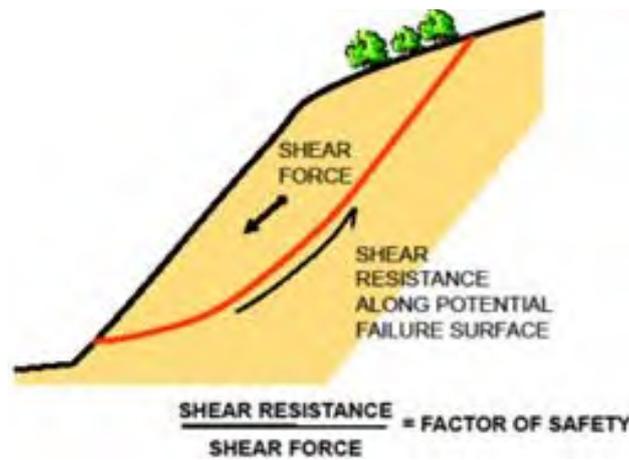
Figure 4-1: Balance of forces in a slope (Scottish Executive, 2017).

The factor of safety is a measure of the stability of a slope. For any slope, the degree of stability depends on the balance between the landslide driving forces (weight of the slope) and its inherent shear strength, illustrated in Figure 4-1.

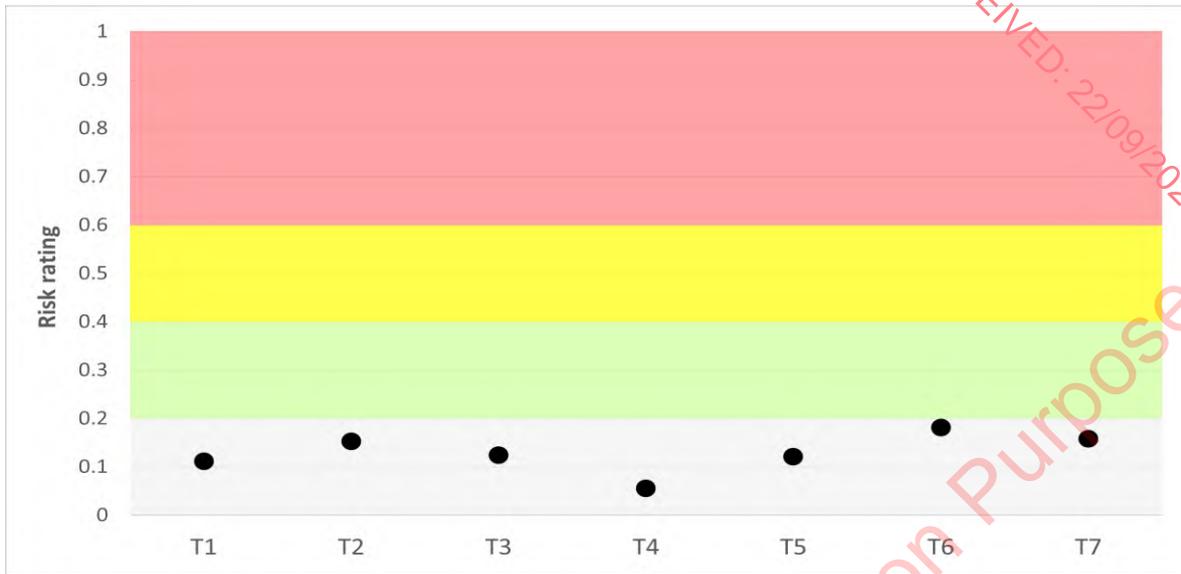
Figure 5-1: Risk ratings at the proposed turbine locations.

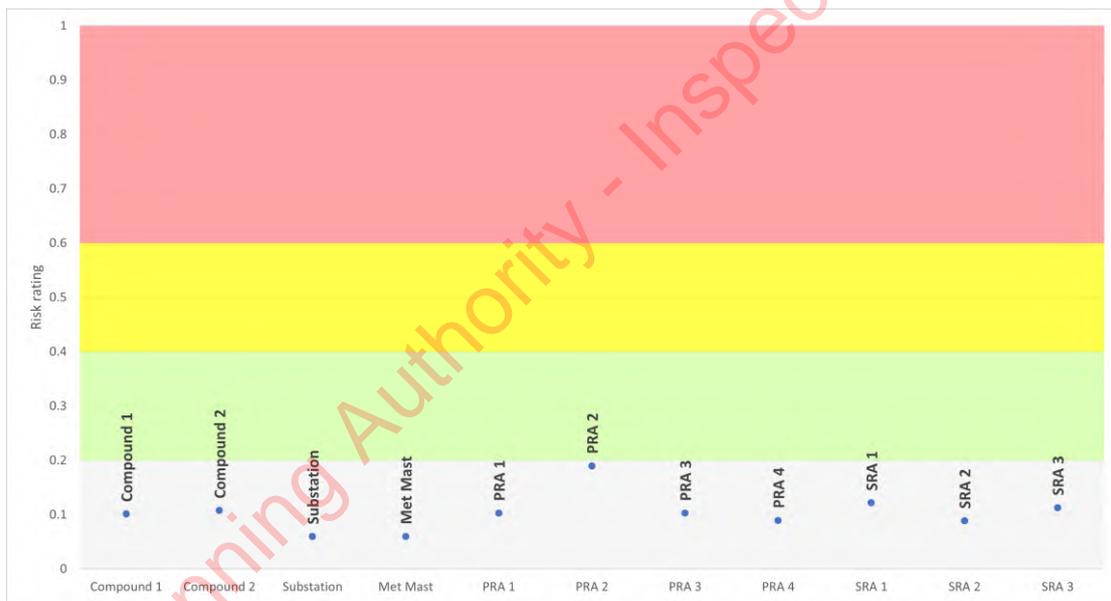
Figure 5-2: Risk ratings at the proposed infrastructure element sites.

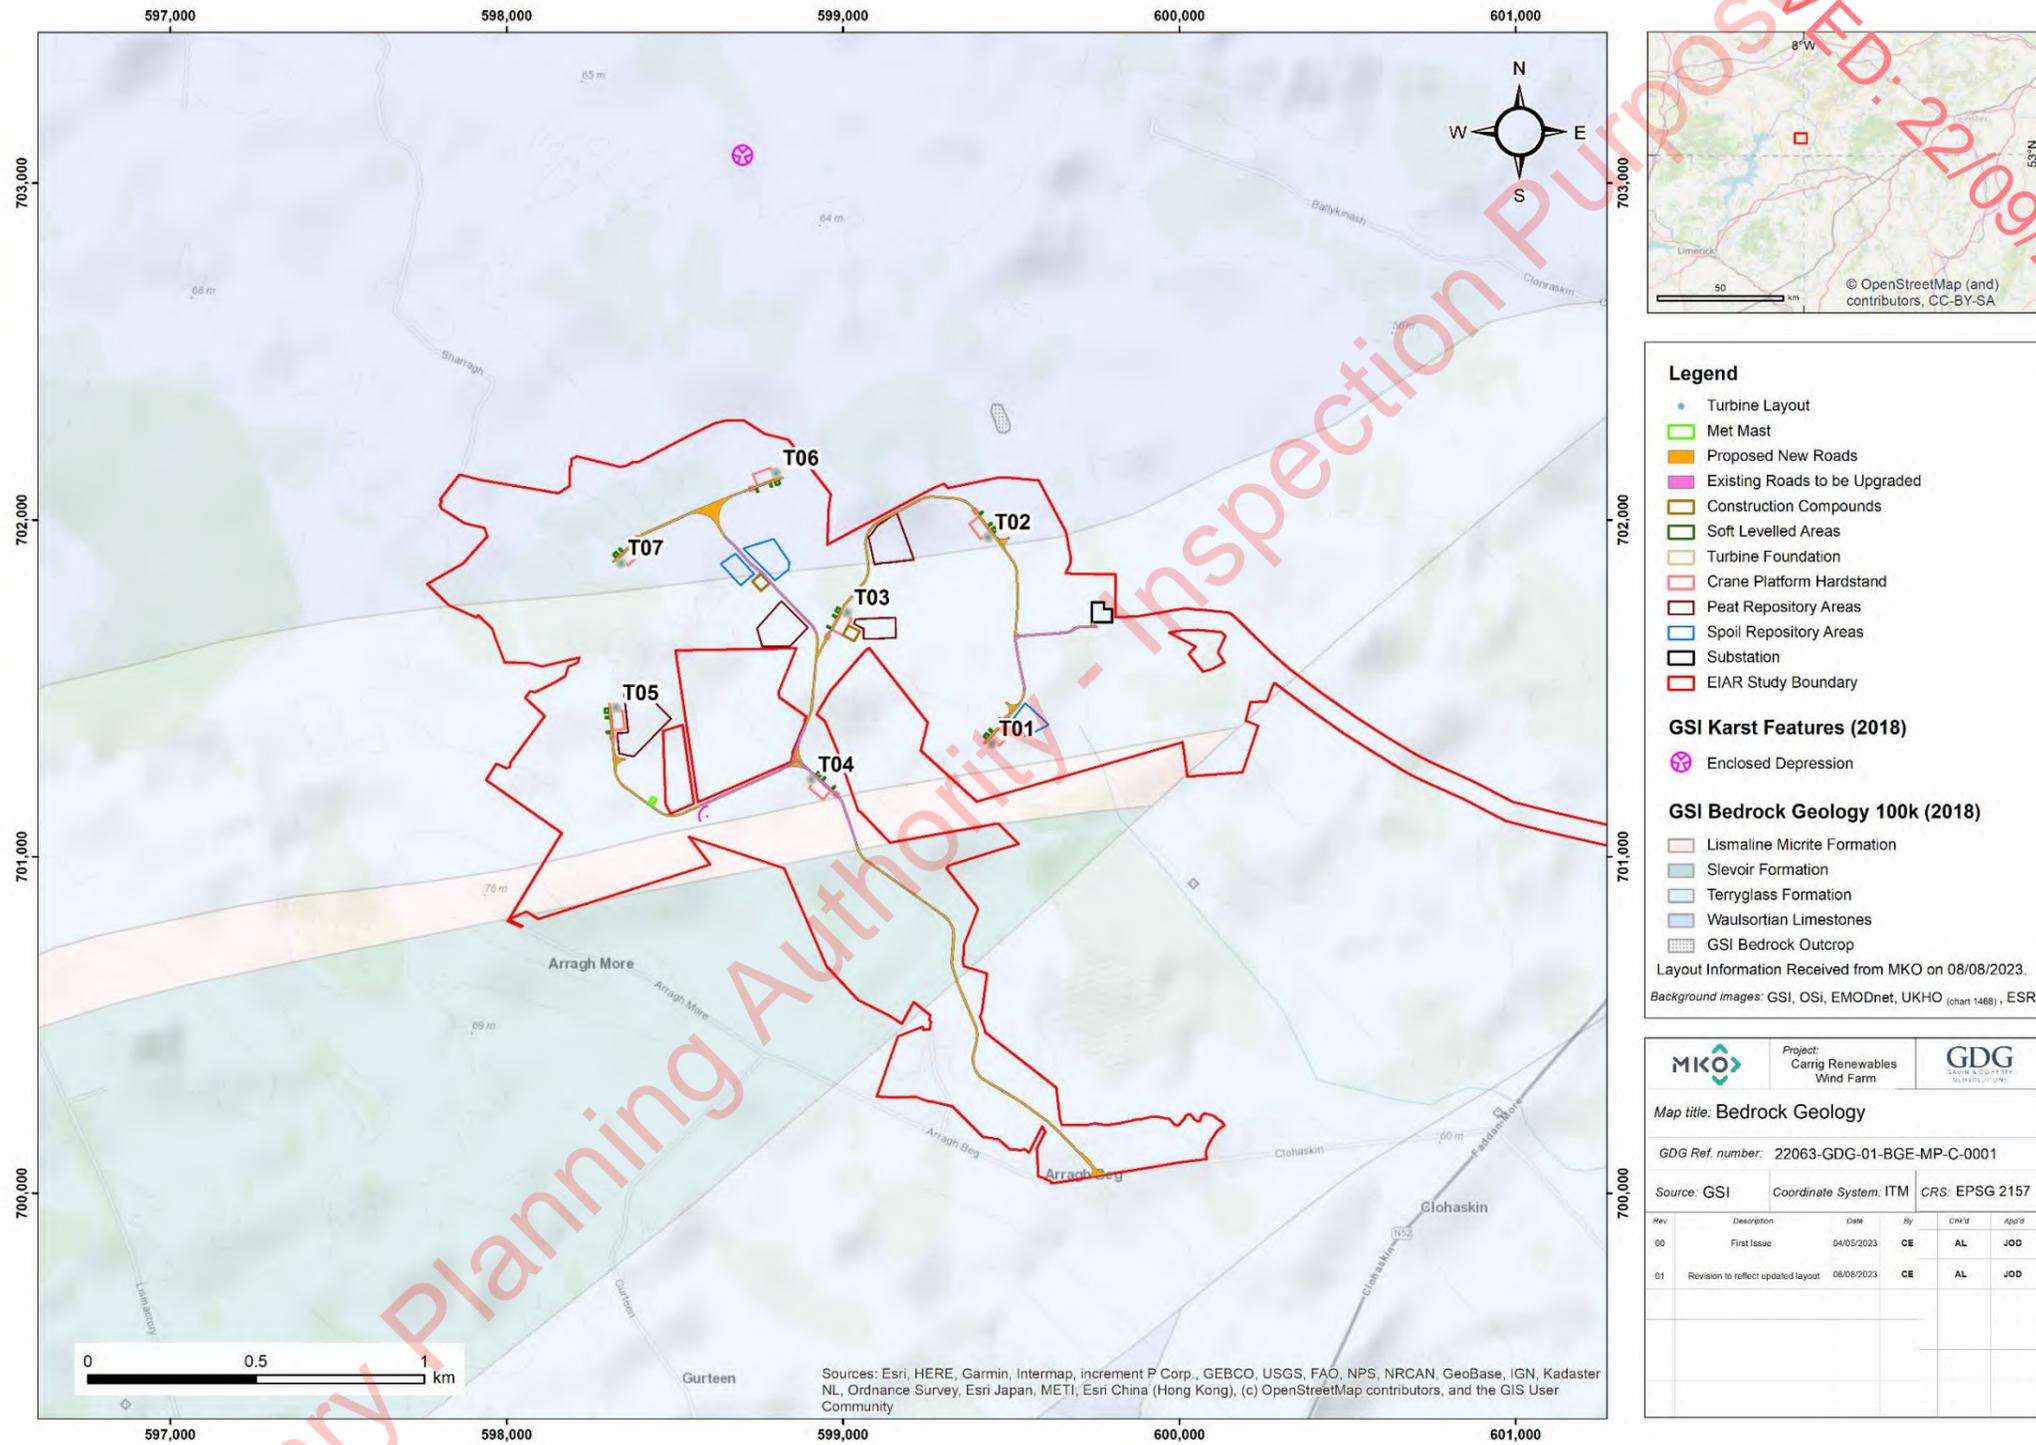
Figure B- 1: Bedrock geology 100k (GSI).

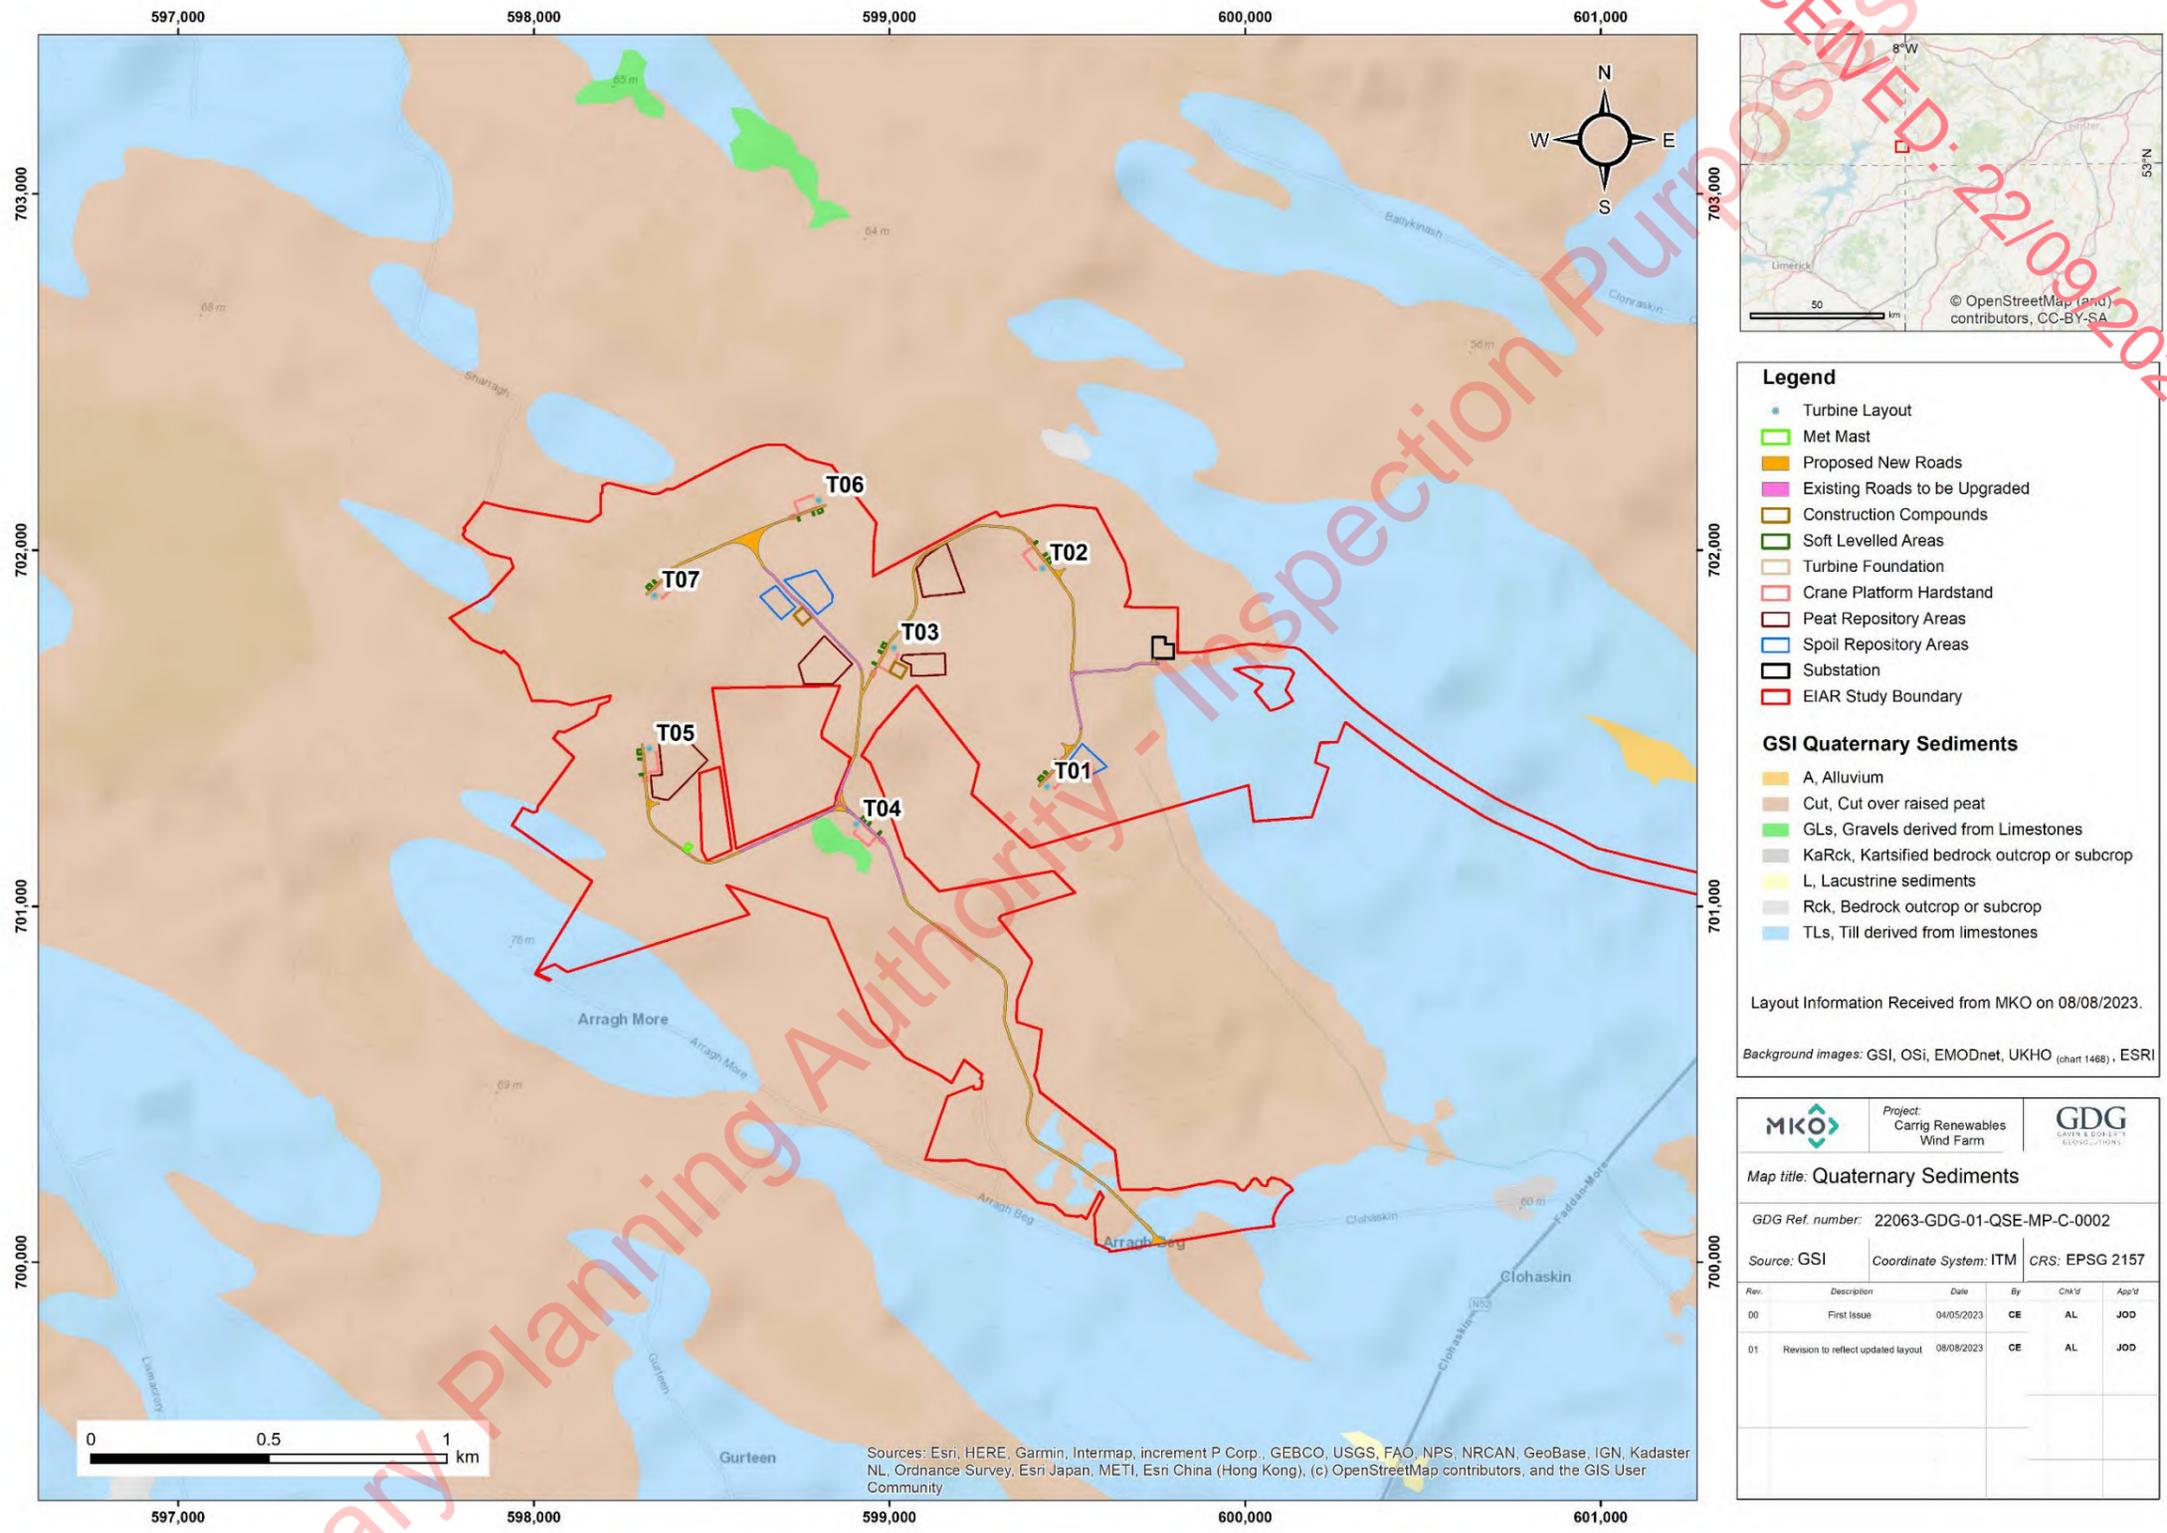
Figure B- 2: Quaternary sediments (GSI).

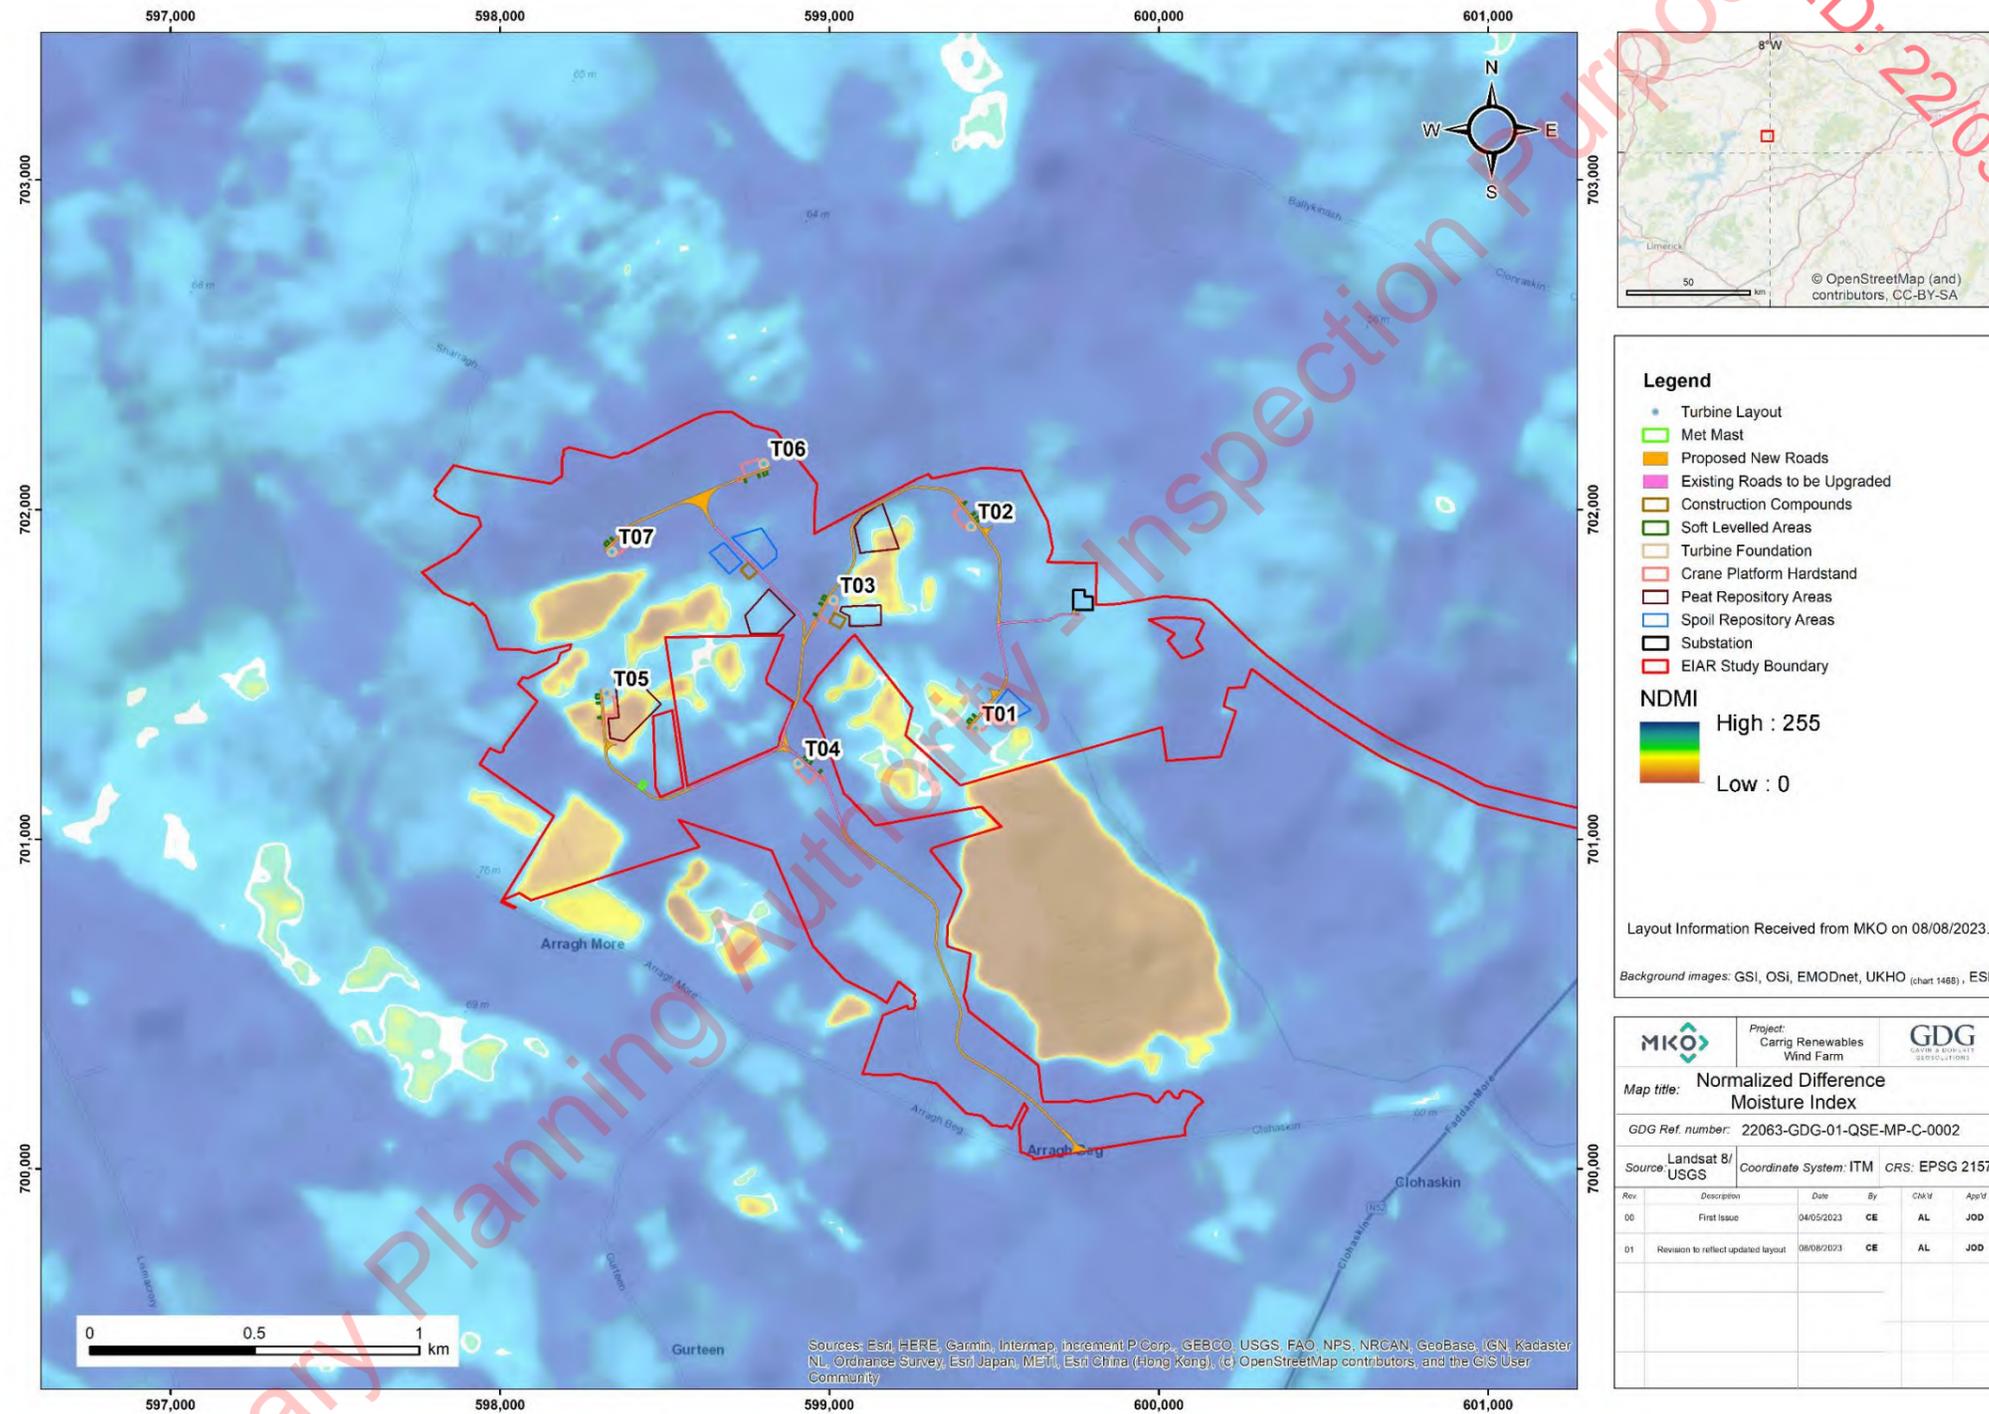
Figure D- 1: Moisture Index developed from Landsat 8 and the USGS.

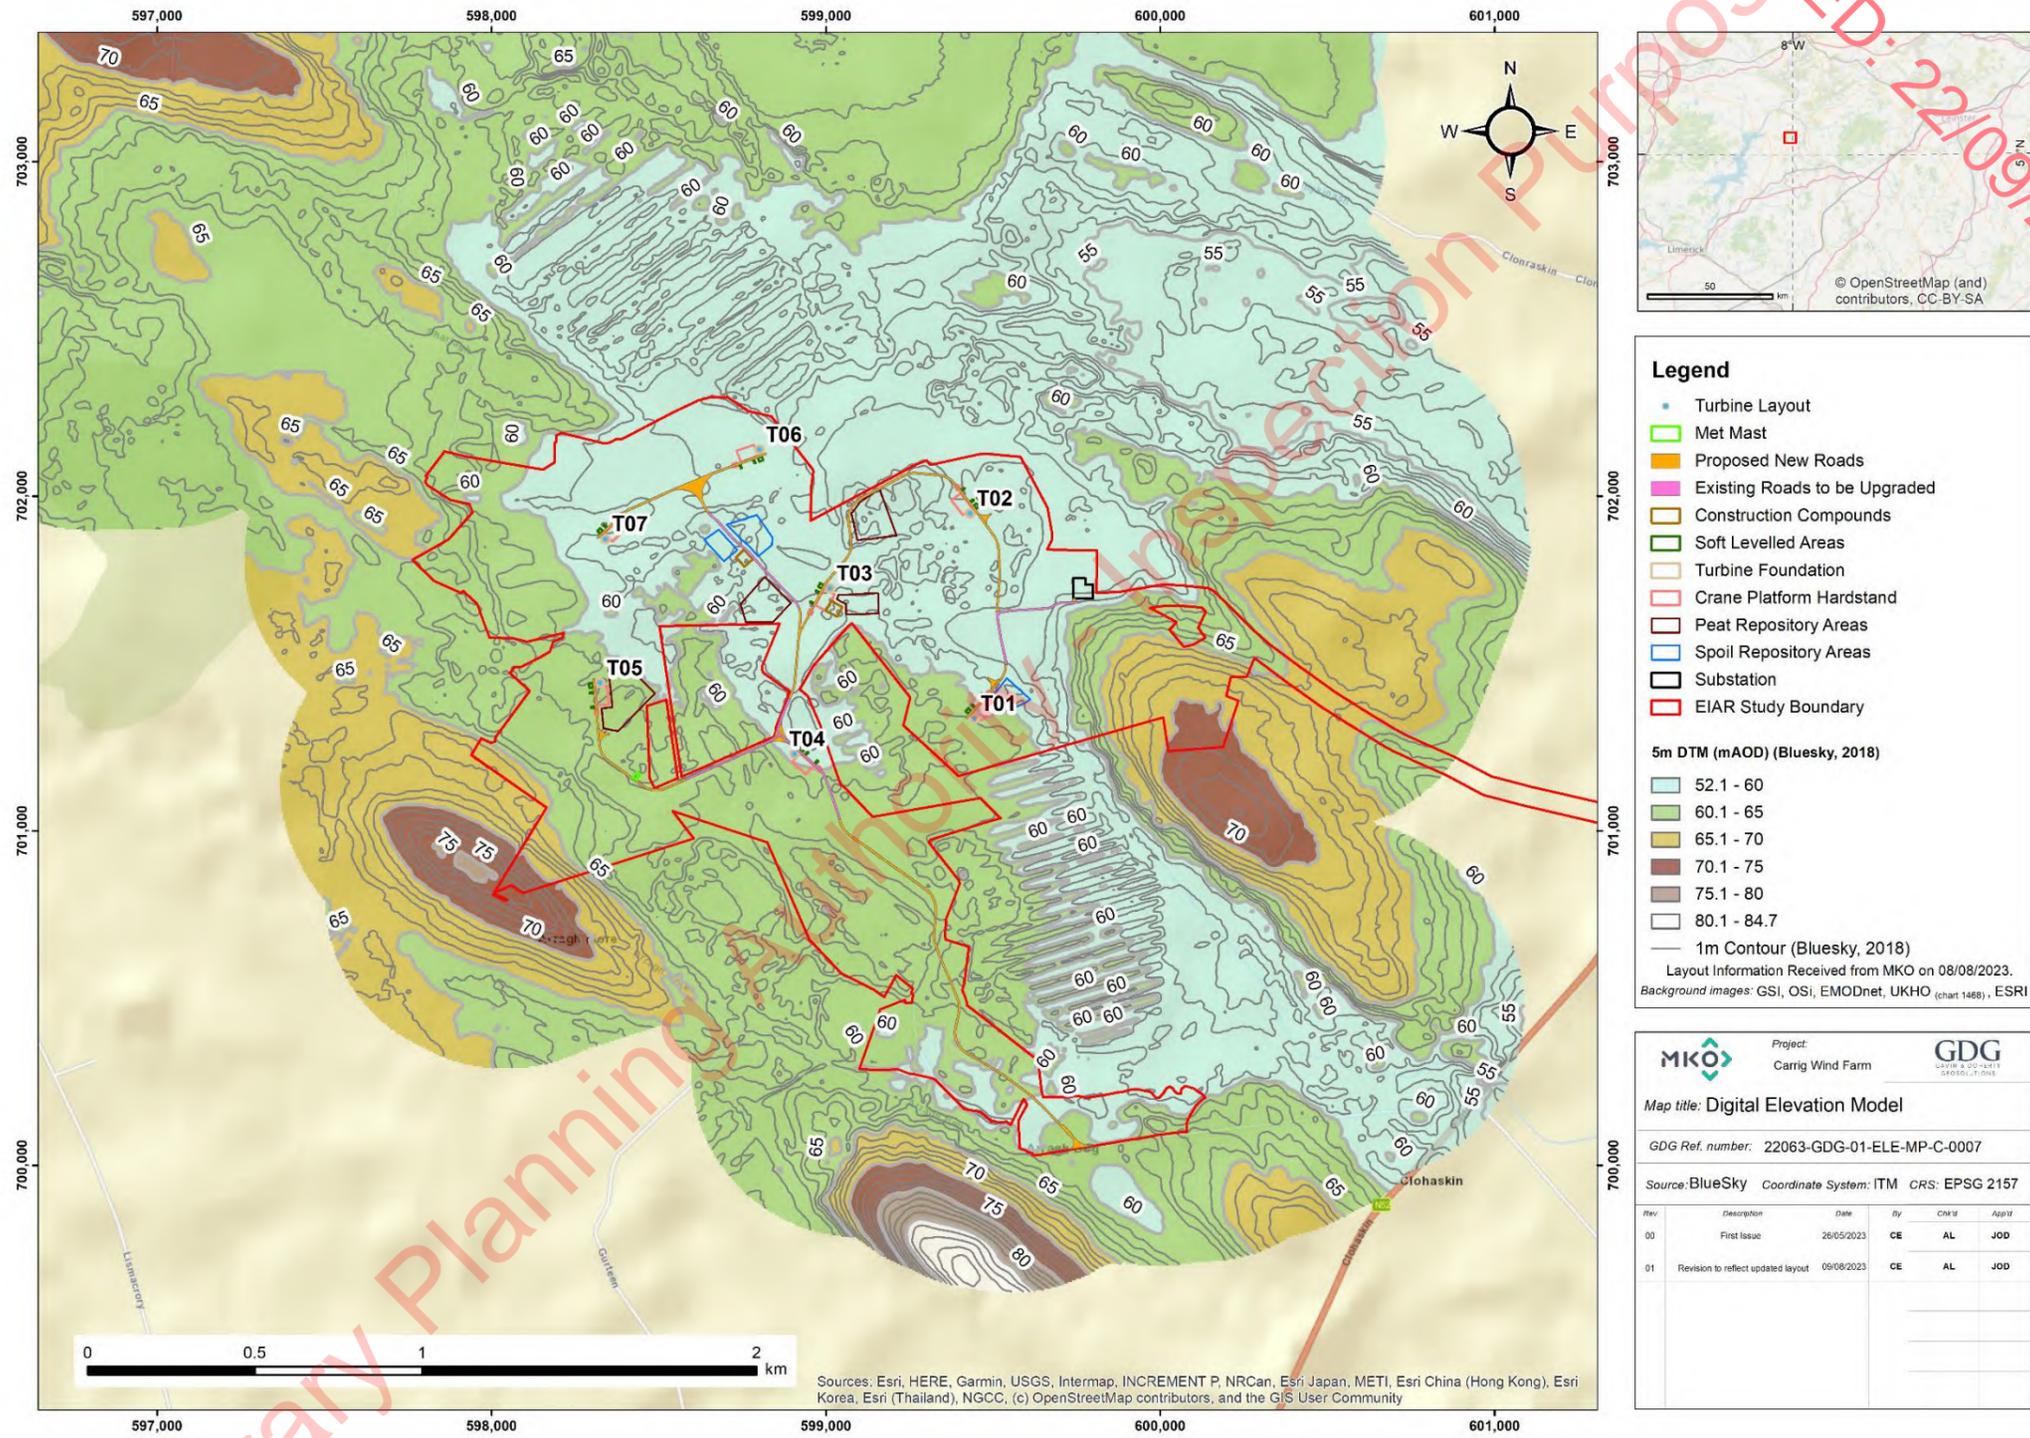
Figure F- 1: 5-meter Digital Elevation Model and 1m Contours sourced from BlueSky (2018).
