Peat Stability Risk Assessment (PSRA) for Carrig Renewables Wind Farm

Client	MKO
Document Ref.	22063-R-001-02-PSRA
Project Title	Carrig Renewables Wind Farm
Date	14/09/2023

Project Title:	Carrig Renewables Wind Farm
Report Title:	Peat Stability Risk Assessment (PSRA) for Carrig Renewables Wind Farm
Document Reference:	22063-R-001-02-PSRA

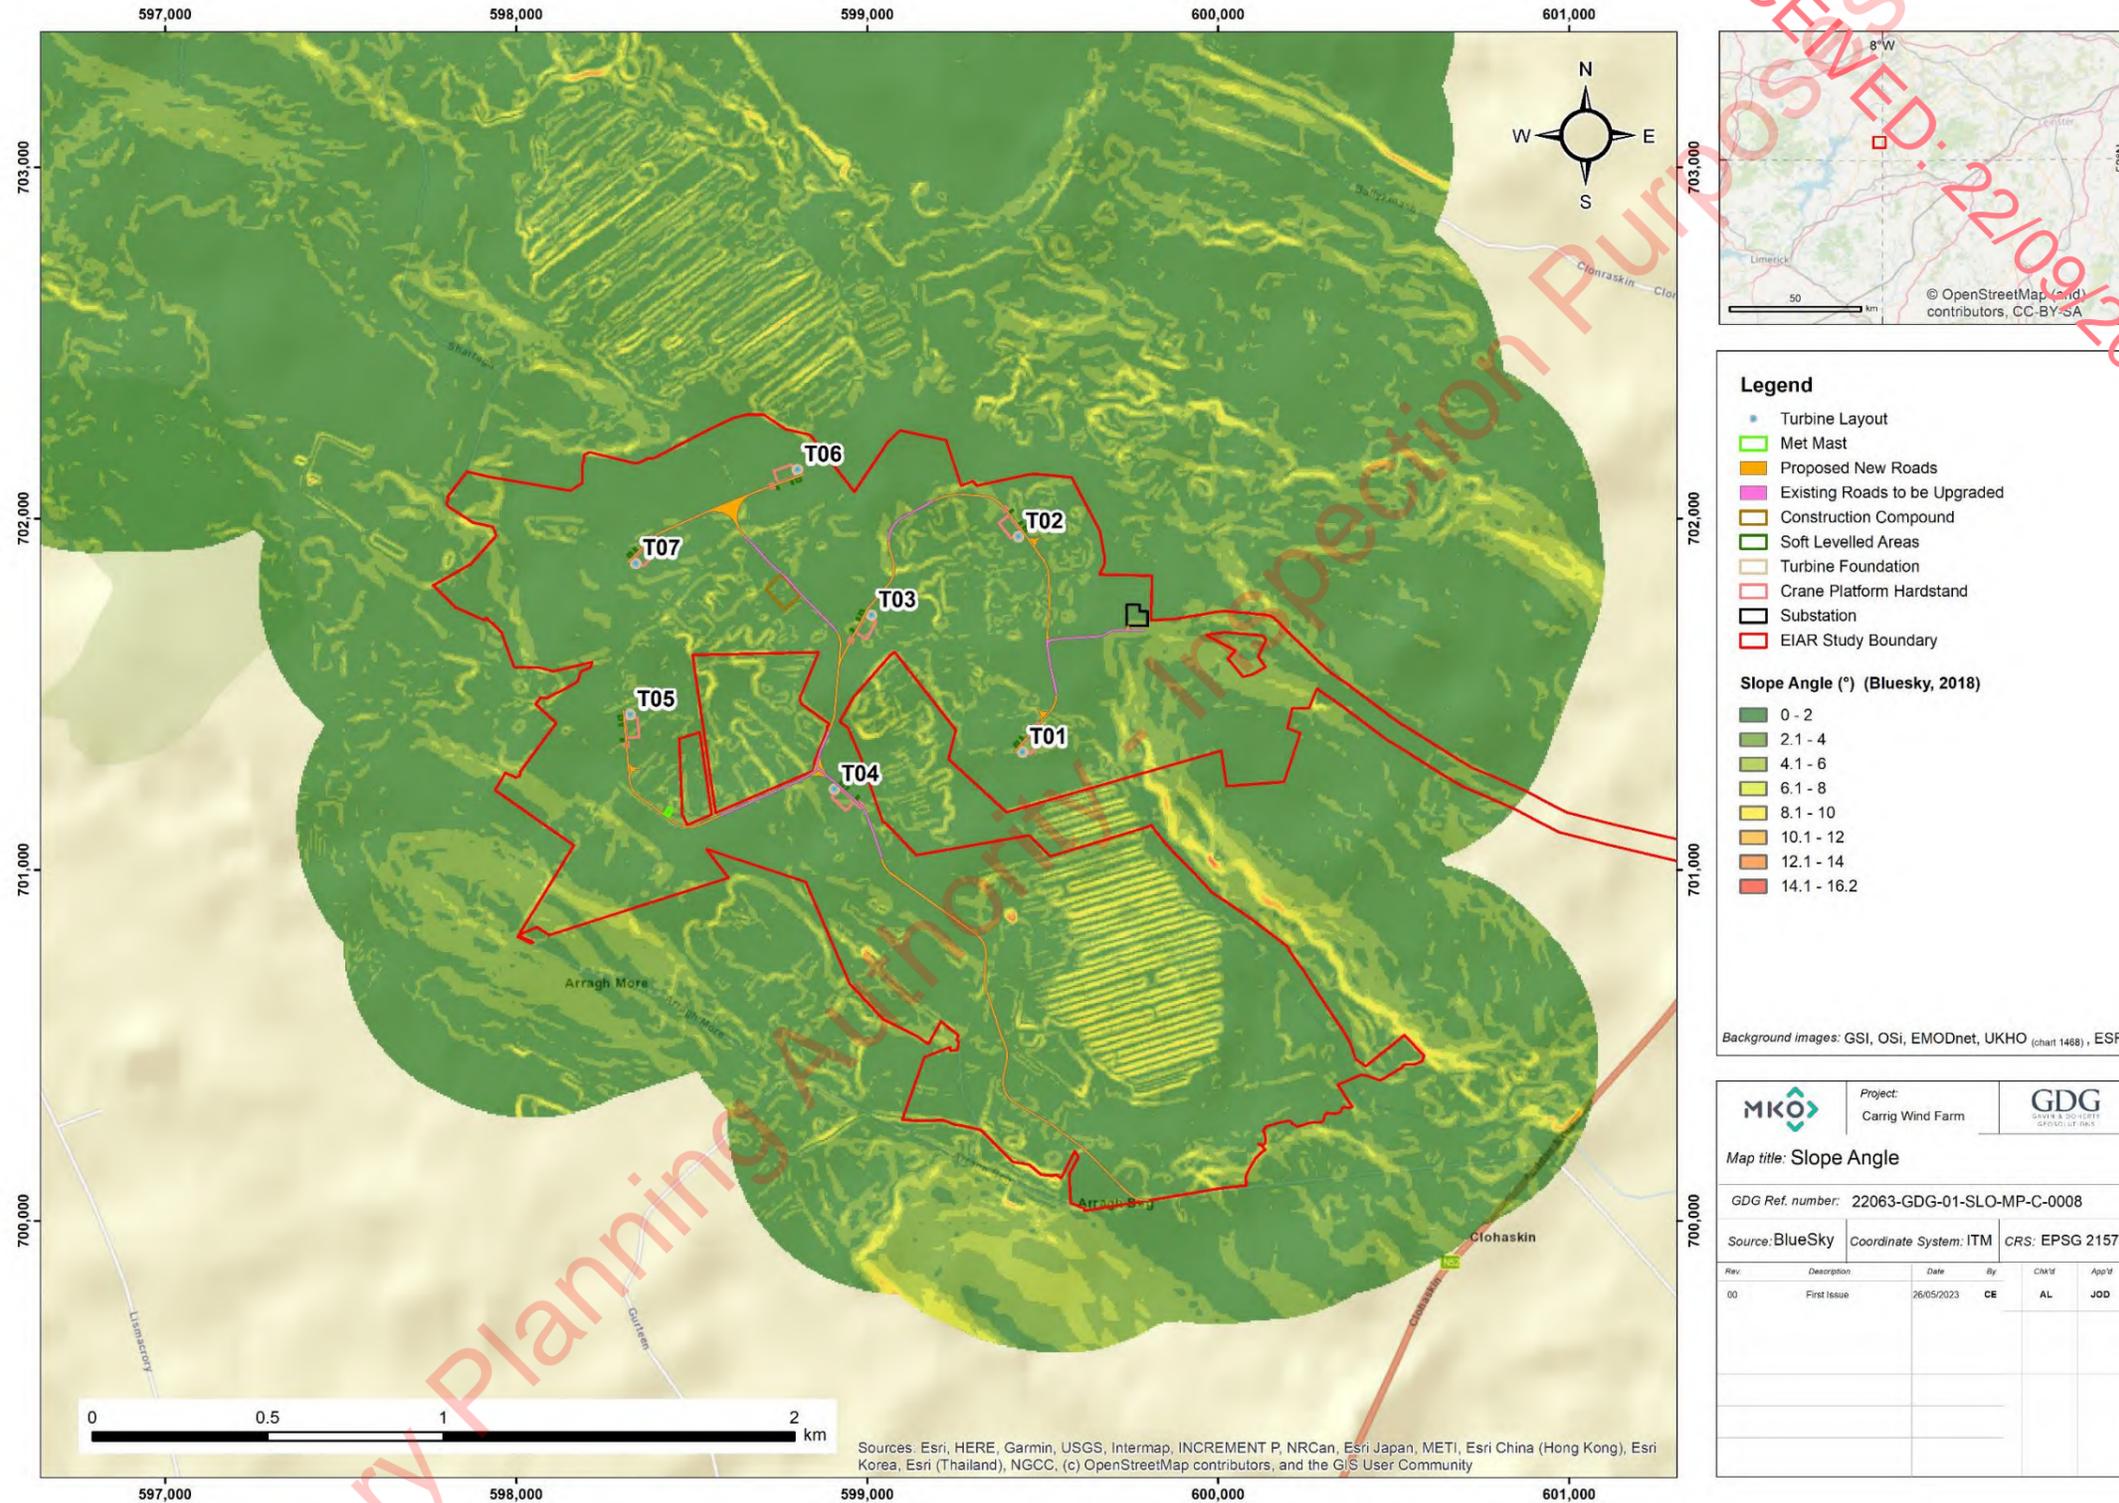
Figure F- 2: Slope Angle (°) sourced from BlueSky (2018).

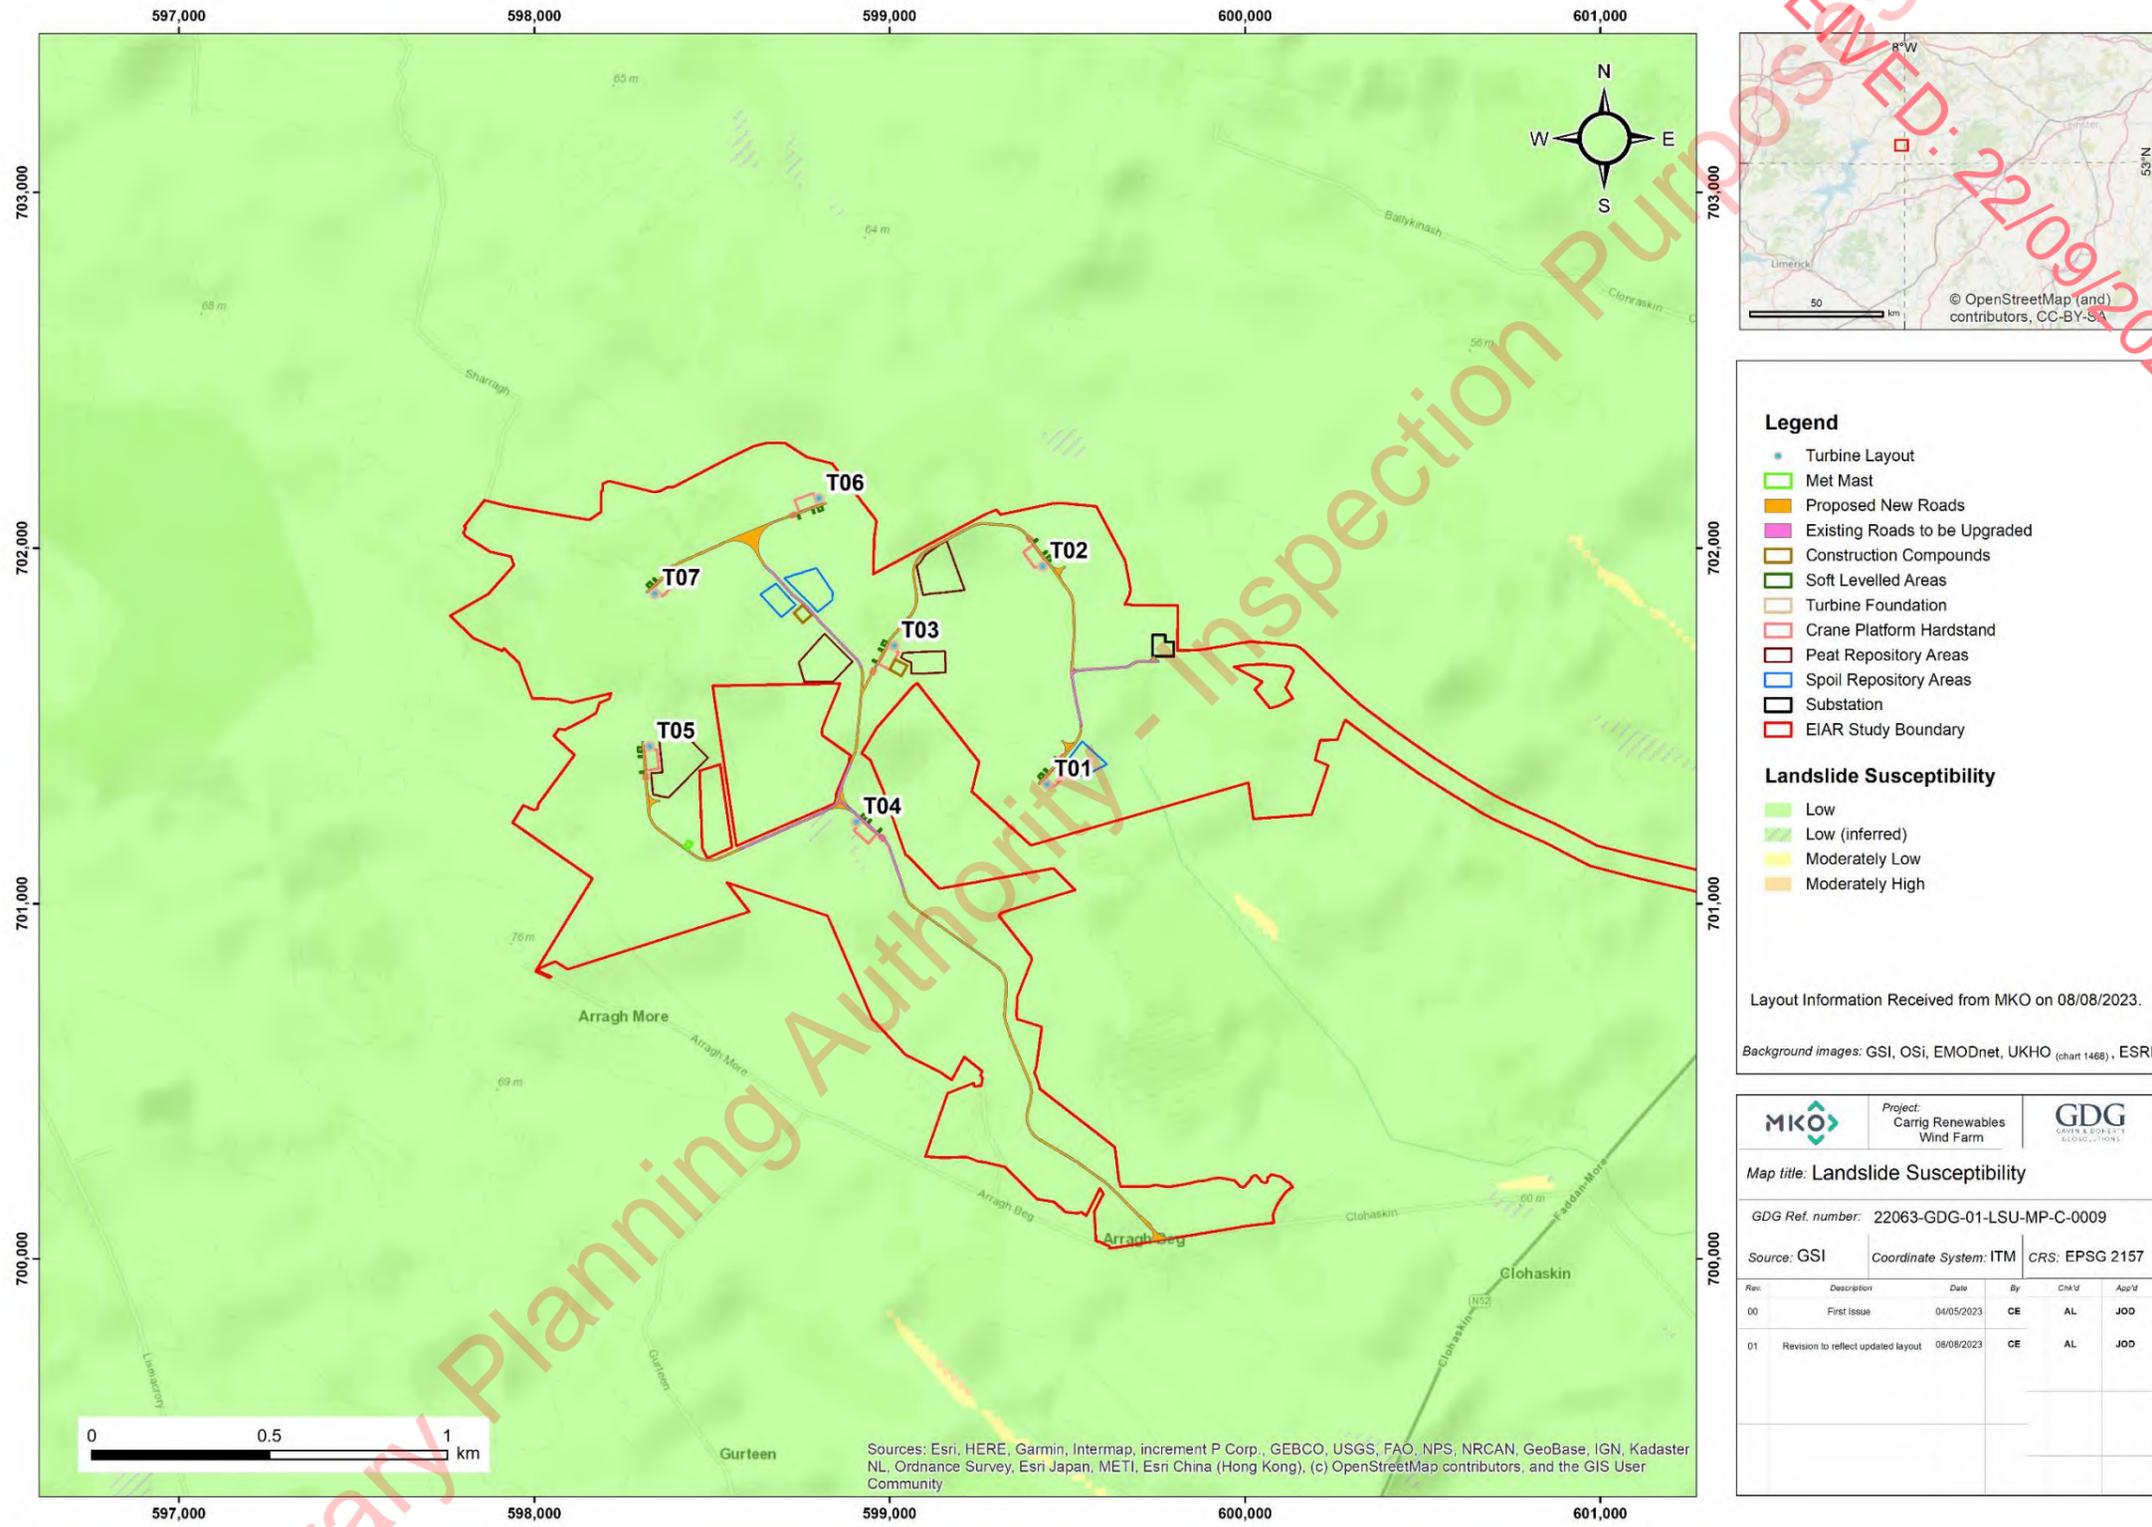
Figure G- 2: Landslide Susceptibility (GSI).

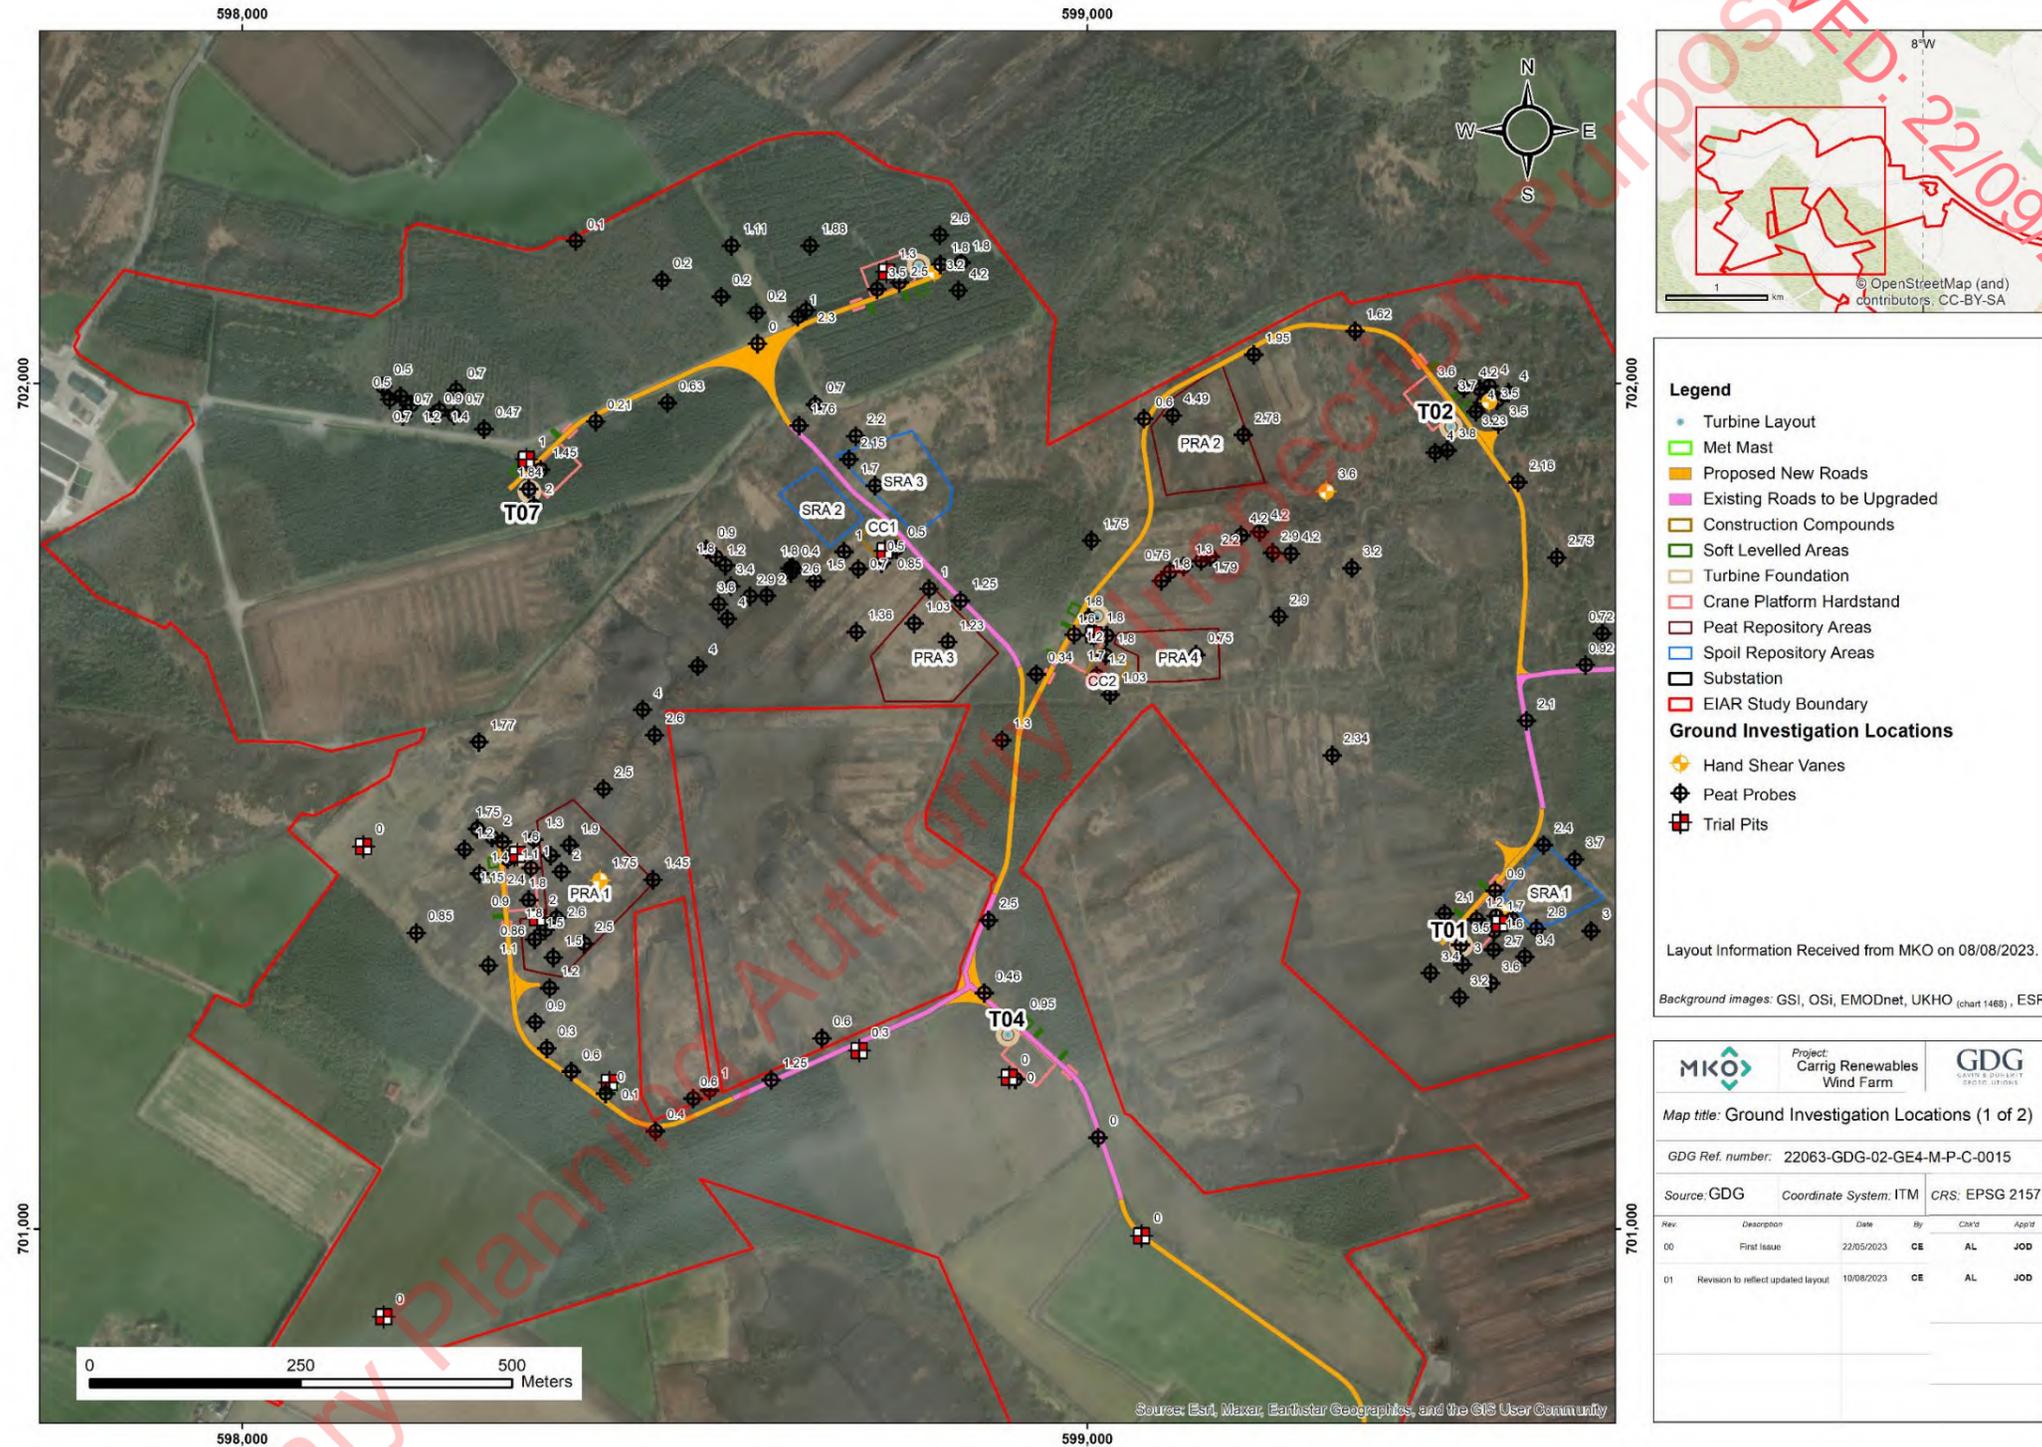
Figure J- 1: Geo-investigation map (1 of 2).

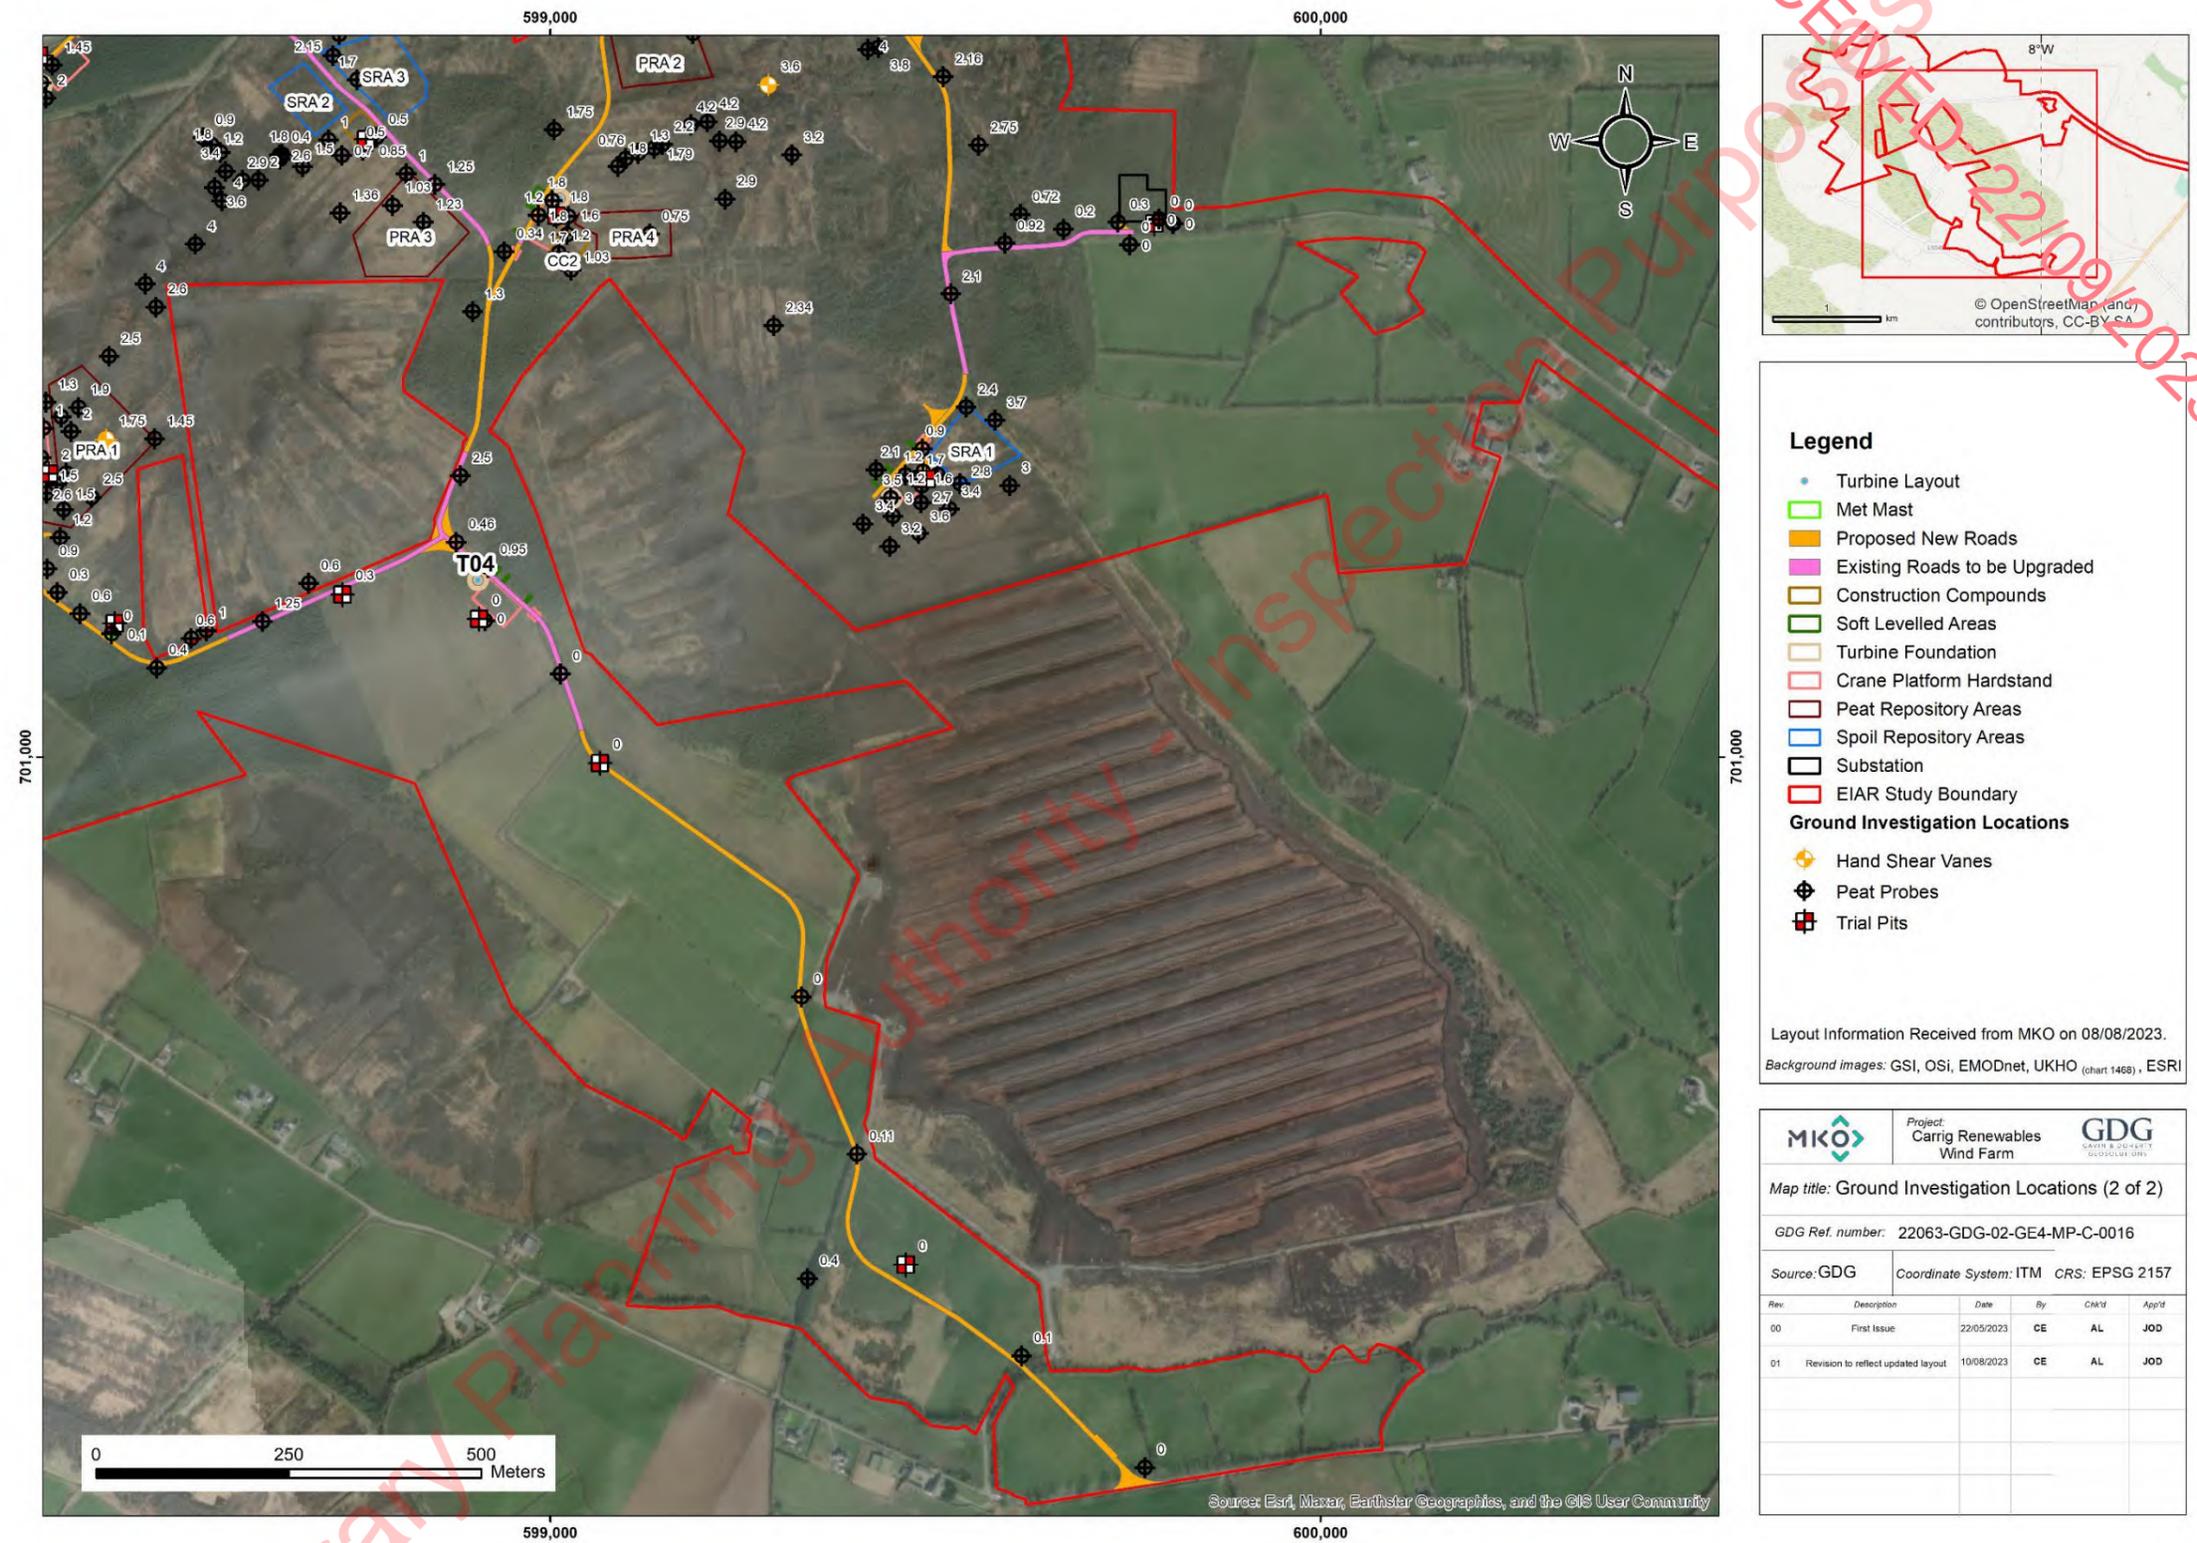
Figure J- 2: Geo-investigation map (2 of 2)

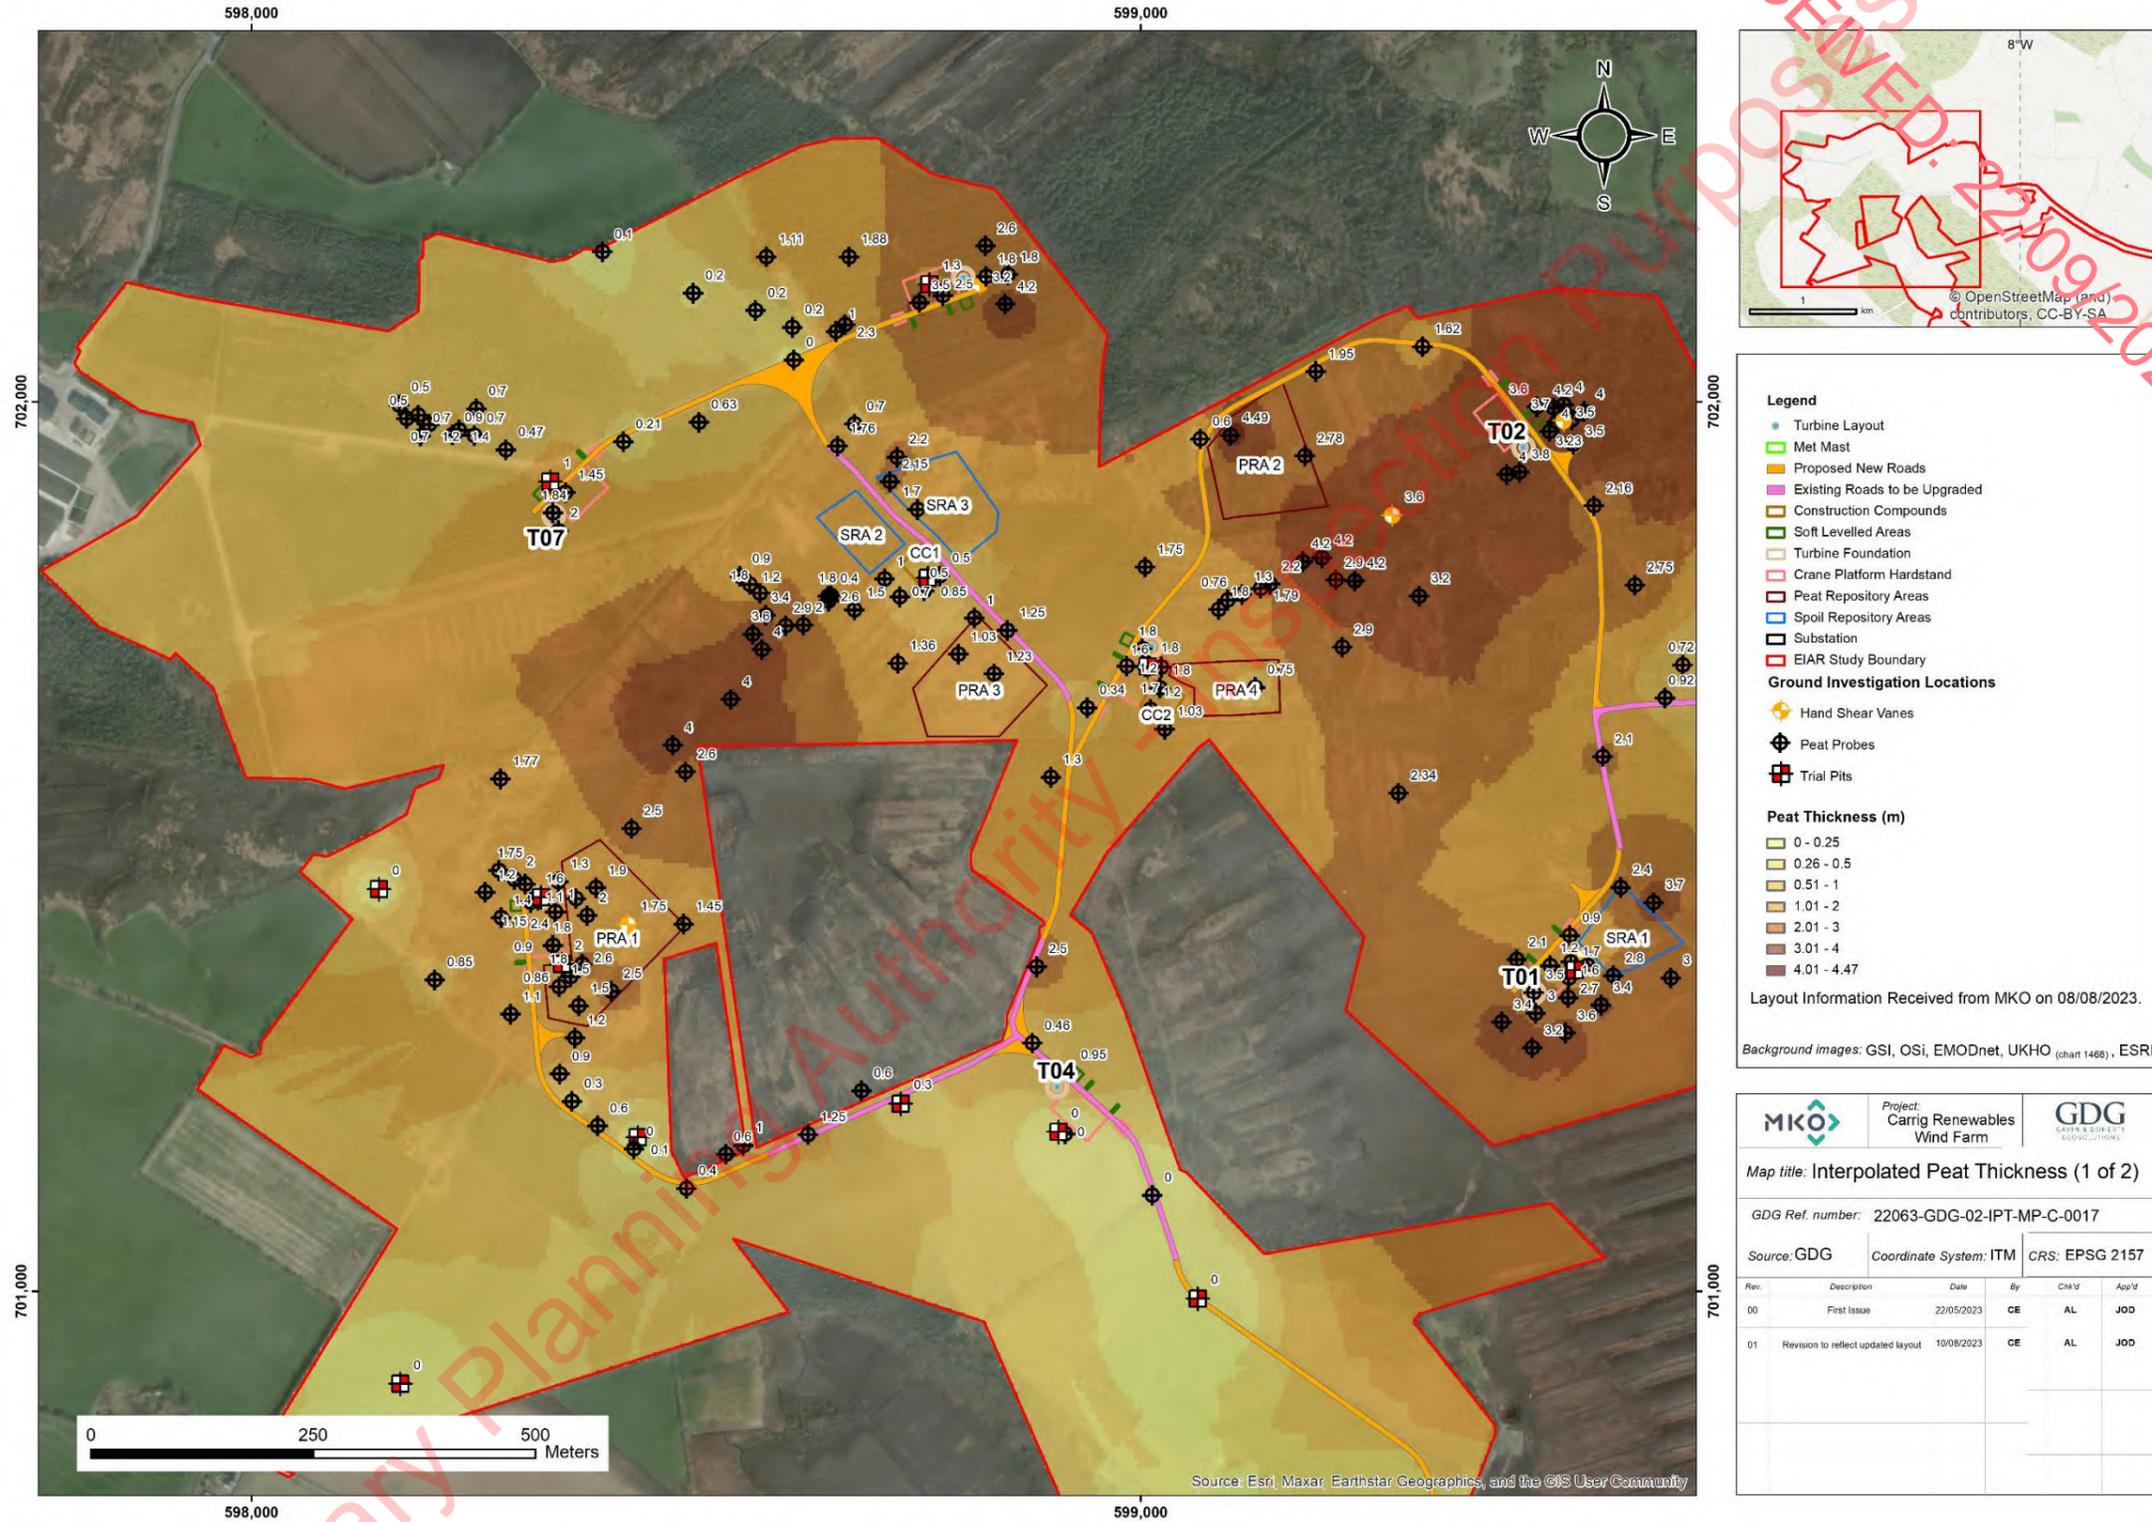
Figure J- 3: Interpolated peat depth map (1 of 2).

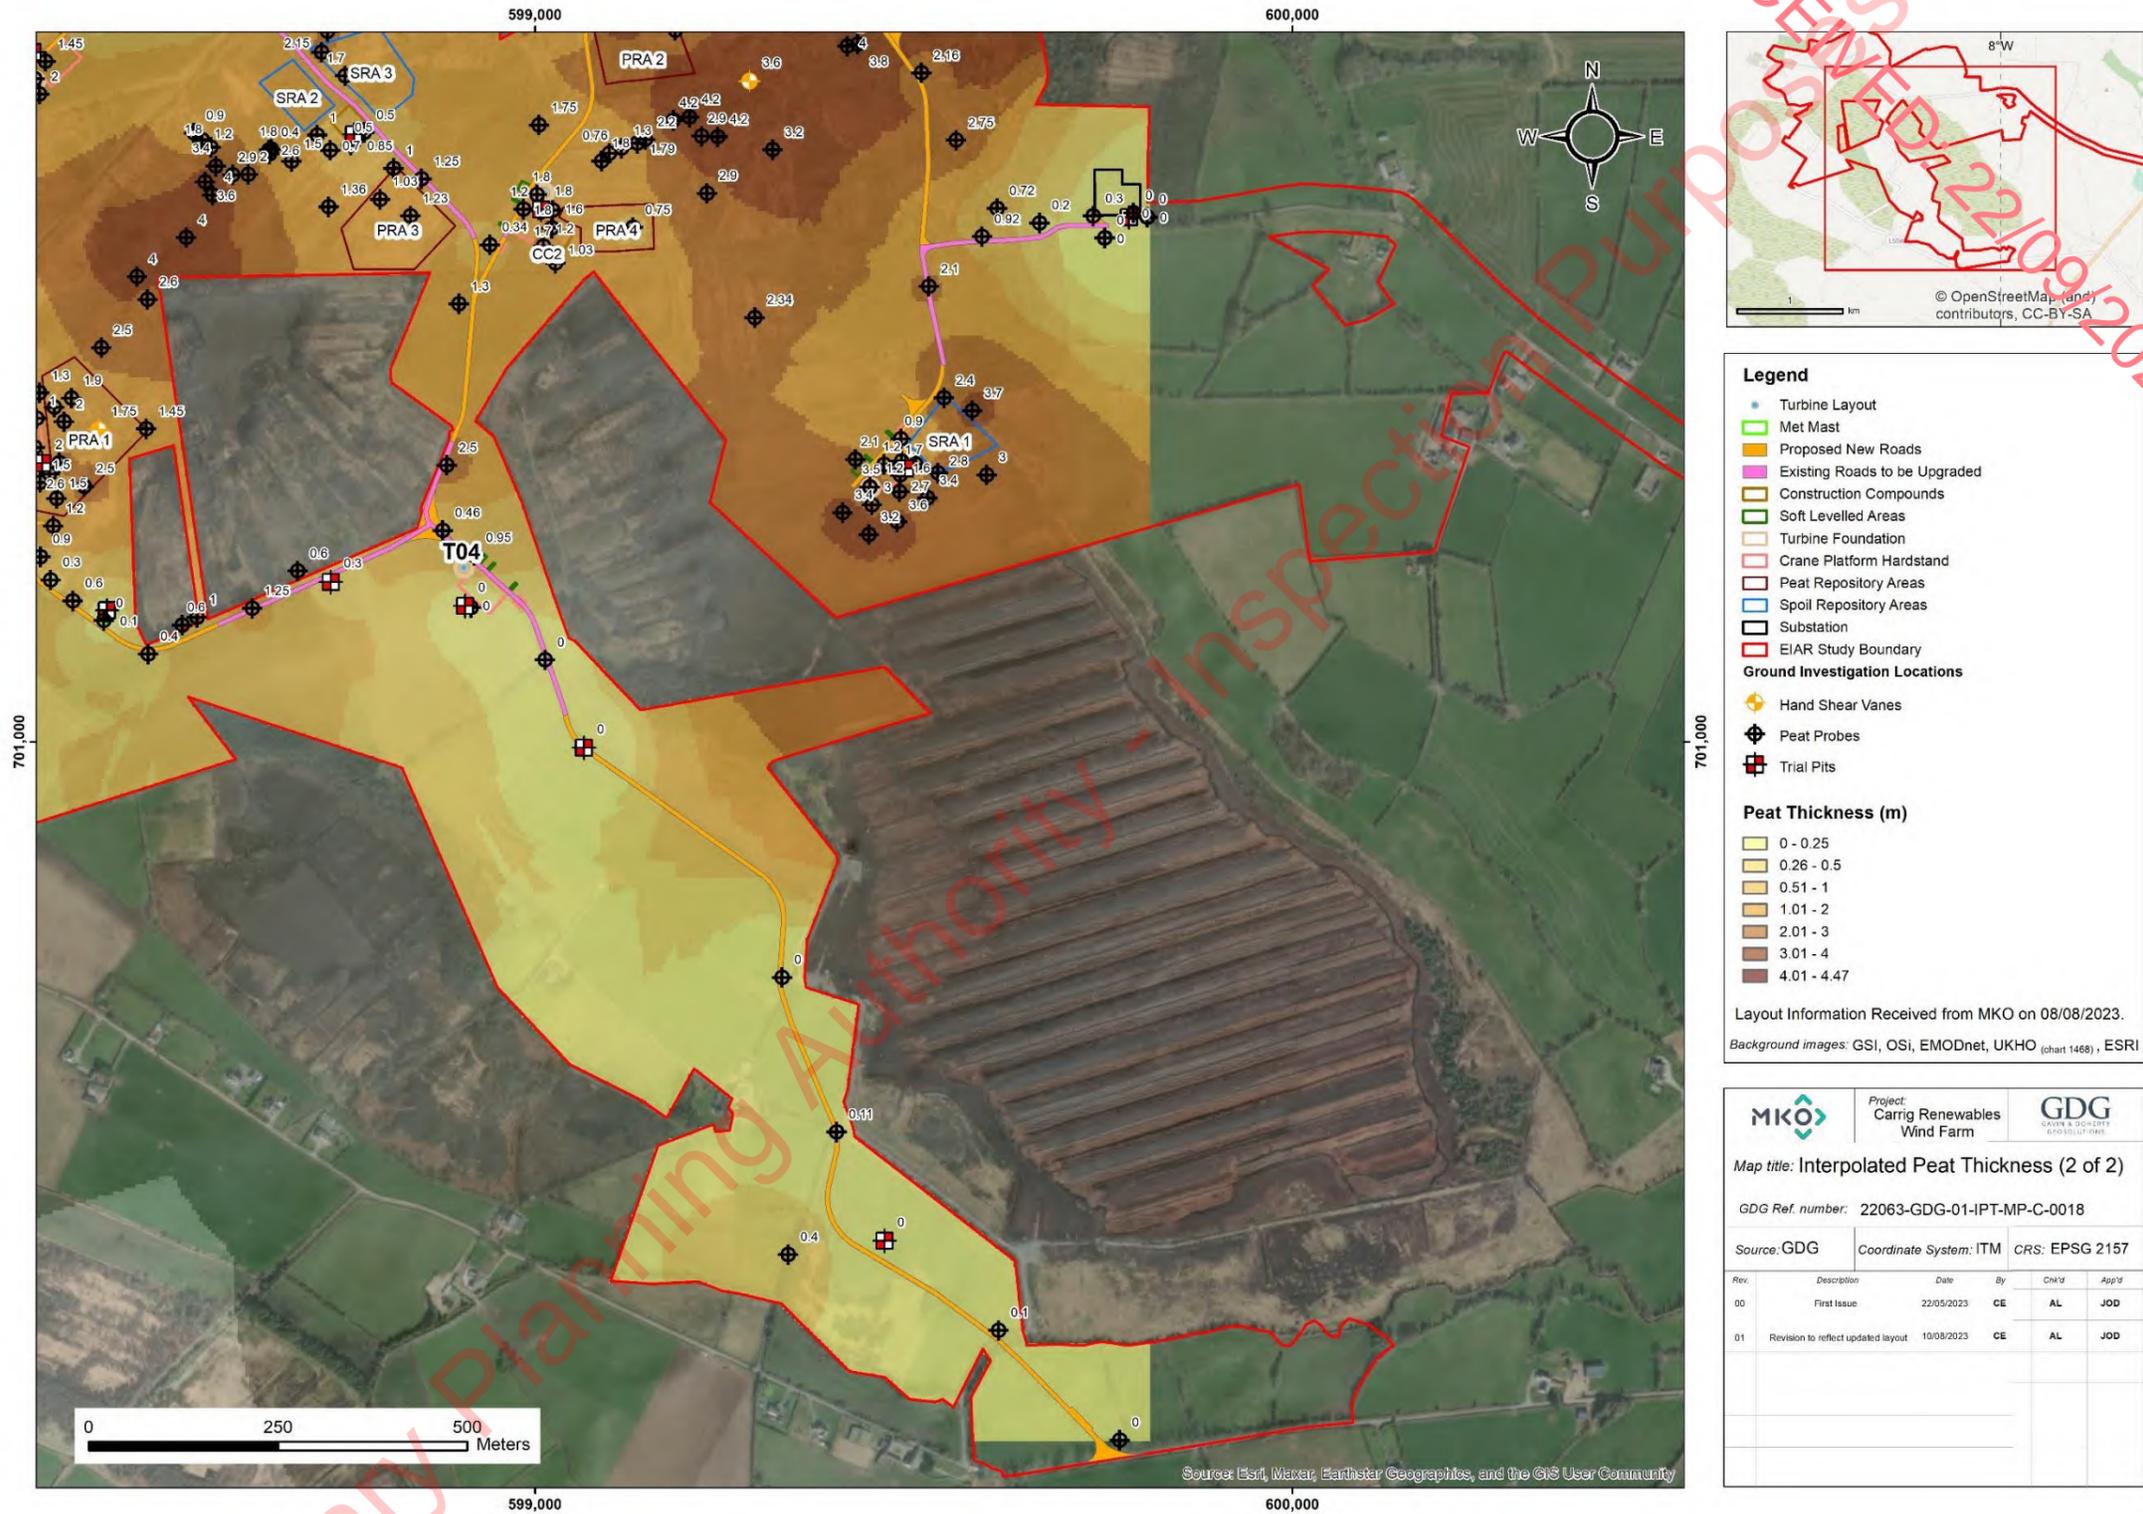
Figure J- 4: Interpolated peat depth map (2 of 2).

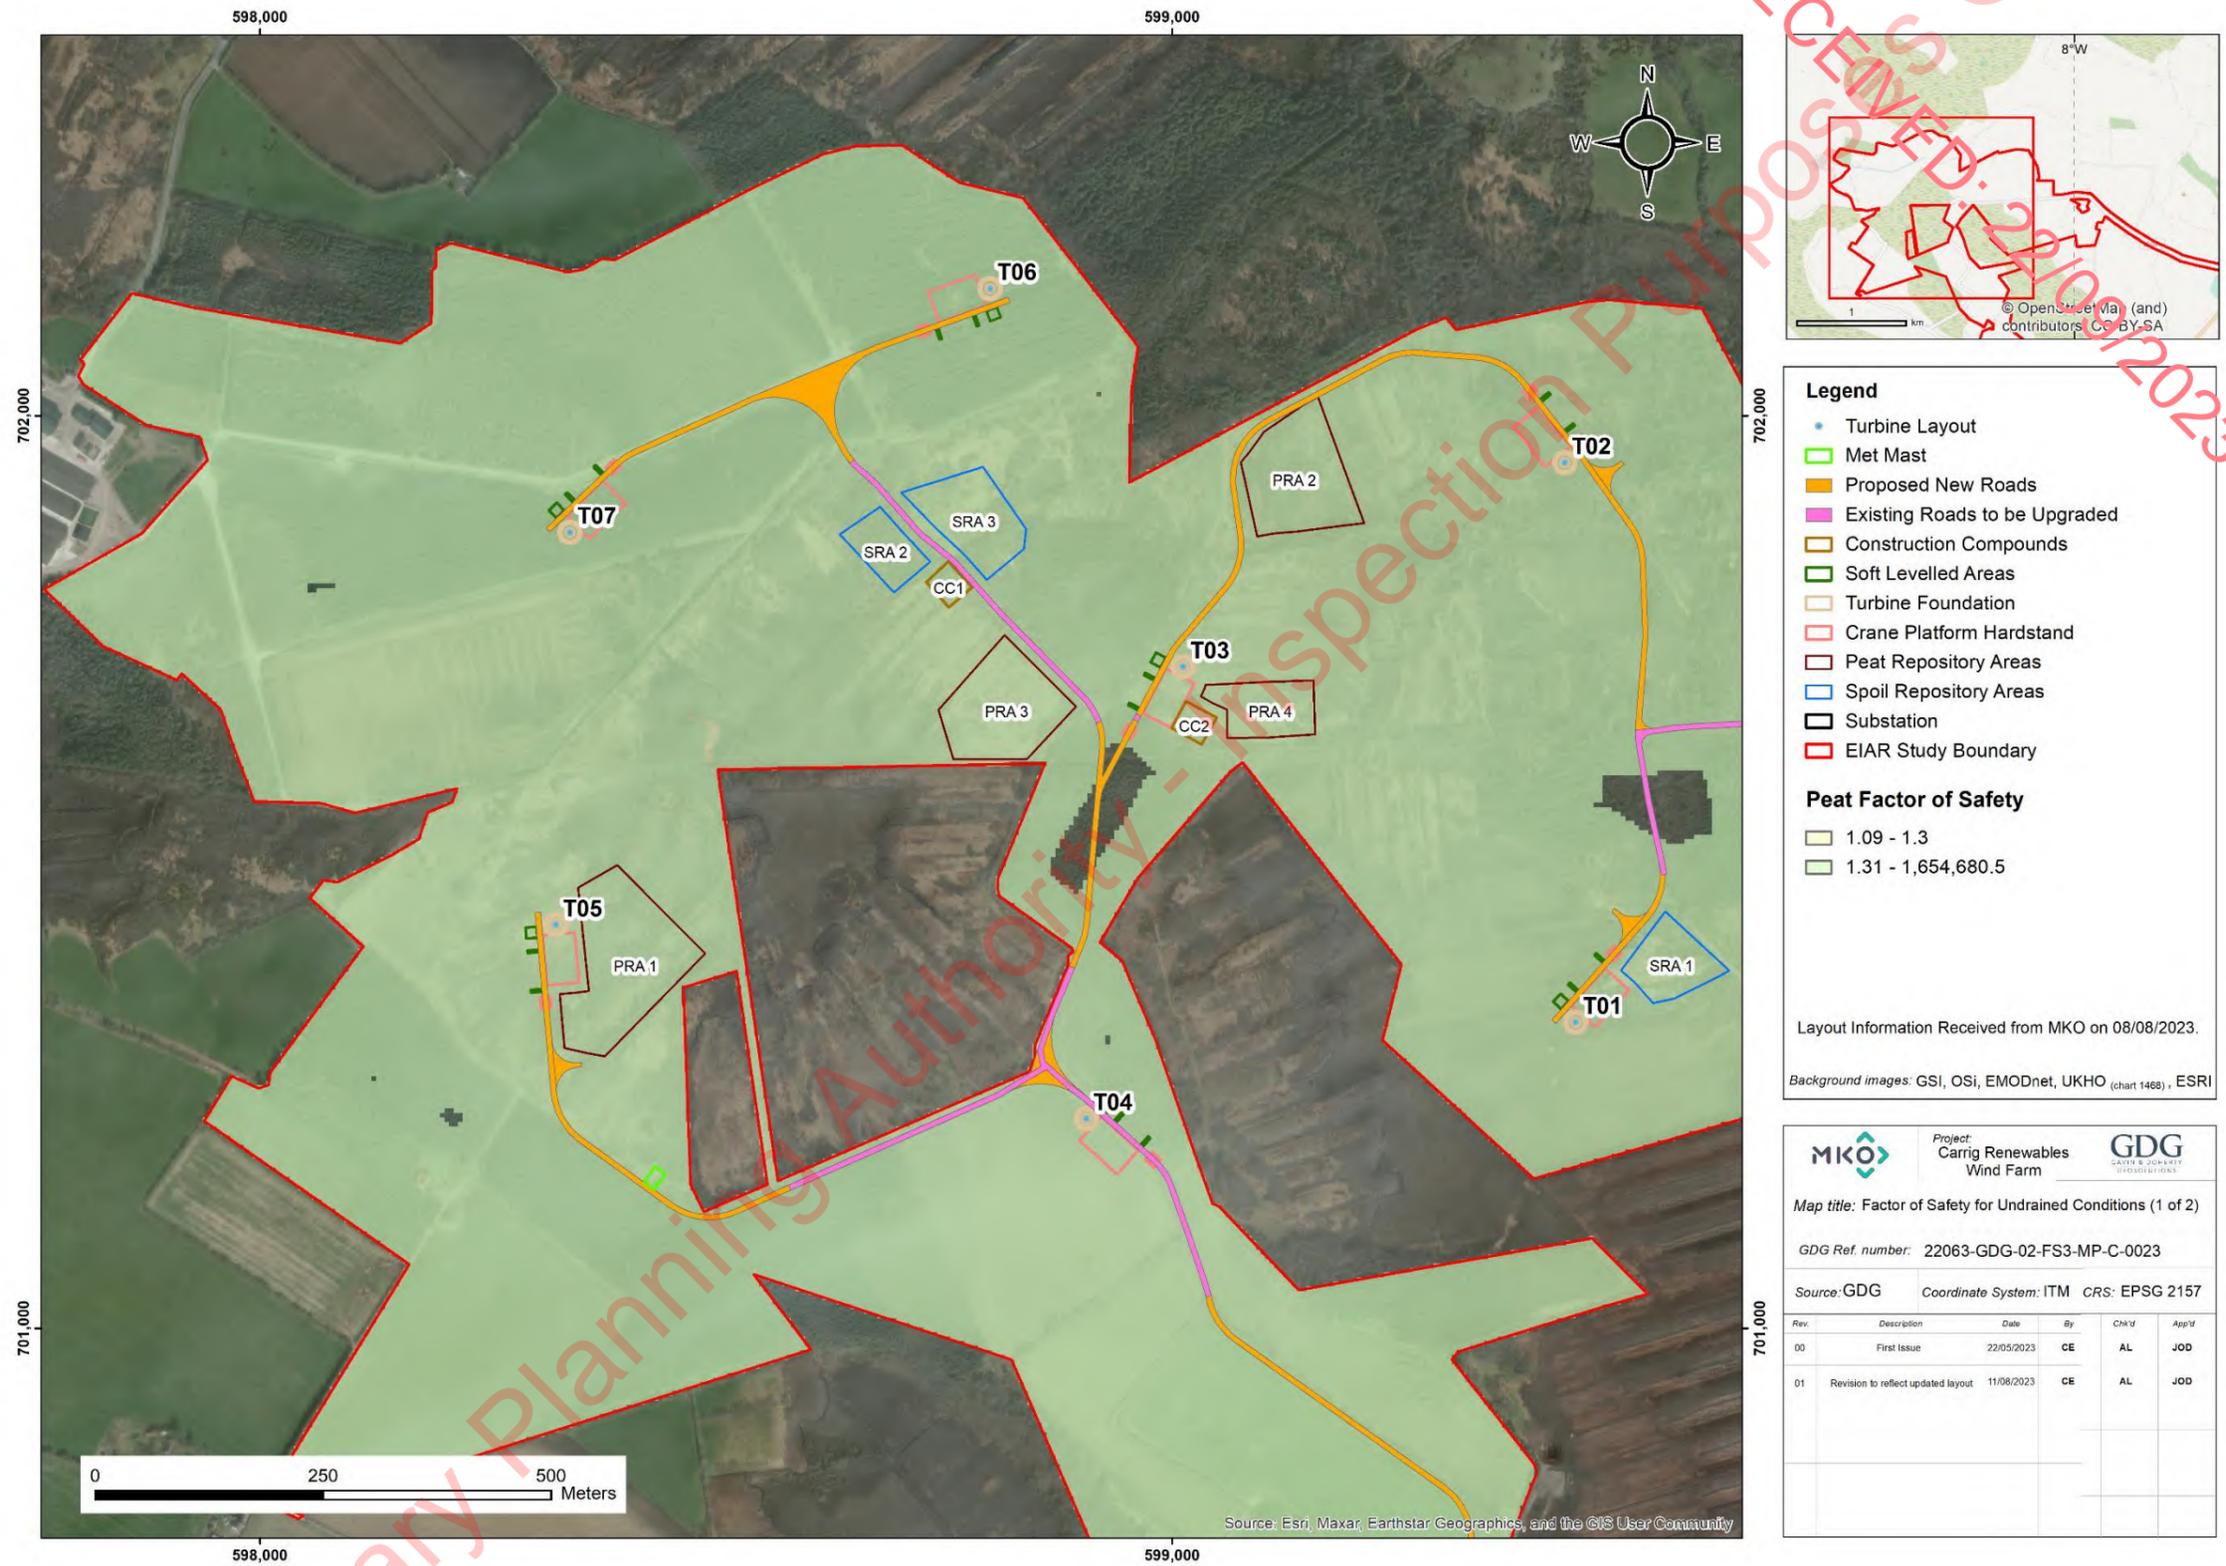
Figure K- 1: FoS for undrained conditions (1 of 2).
