Peat Stability Risk Assessment (PSRA) for Carrig Renewables Wind Farm

Client	MKO
Document Ref.	22063-R-001-02-PSRA
Project Title	Carrig Renewables Wind Farm
Date	14/09/2023

Project Title:	Carrig Renewables Wind Farm
Report Title:	Peat Stability Risk Assessment (PSRA) for Carrig Renewables Wind Farm
Document Reference:	22063-R-001-02-PSRA

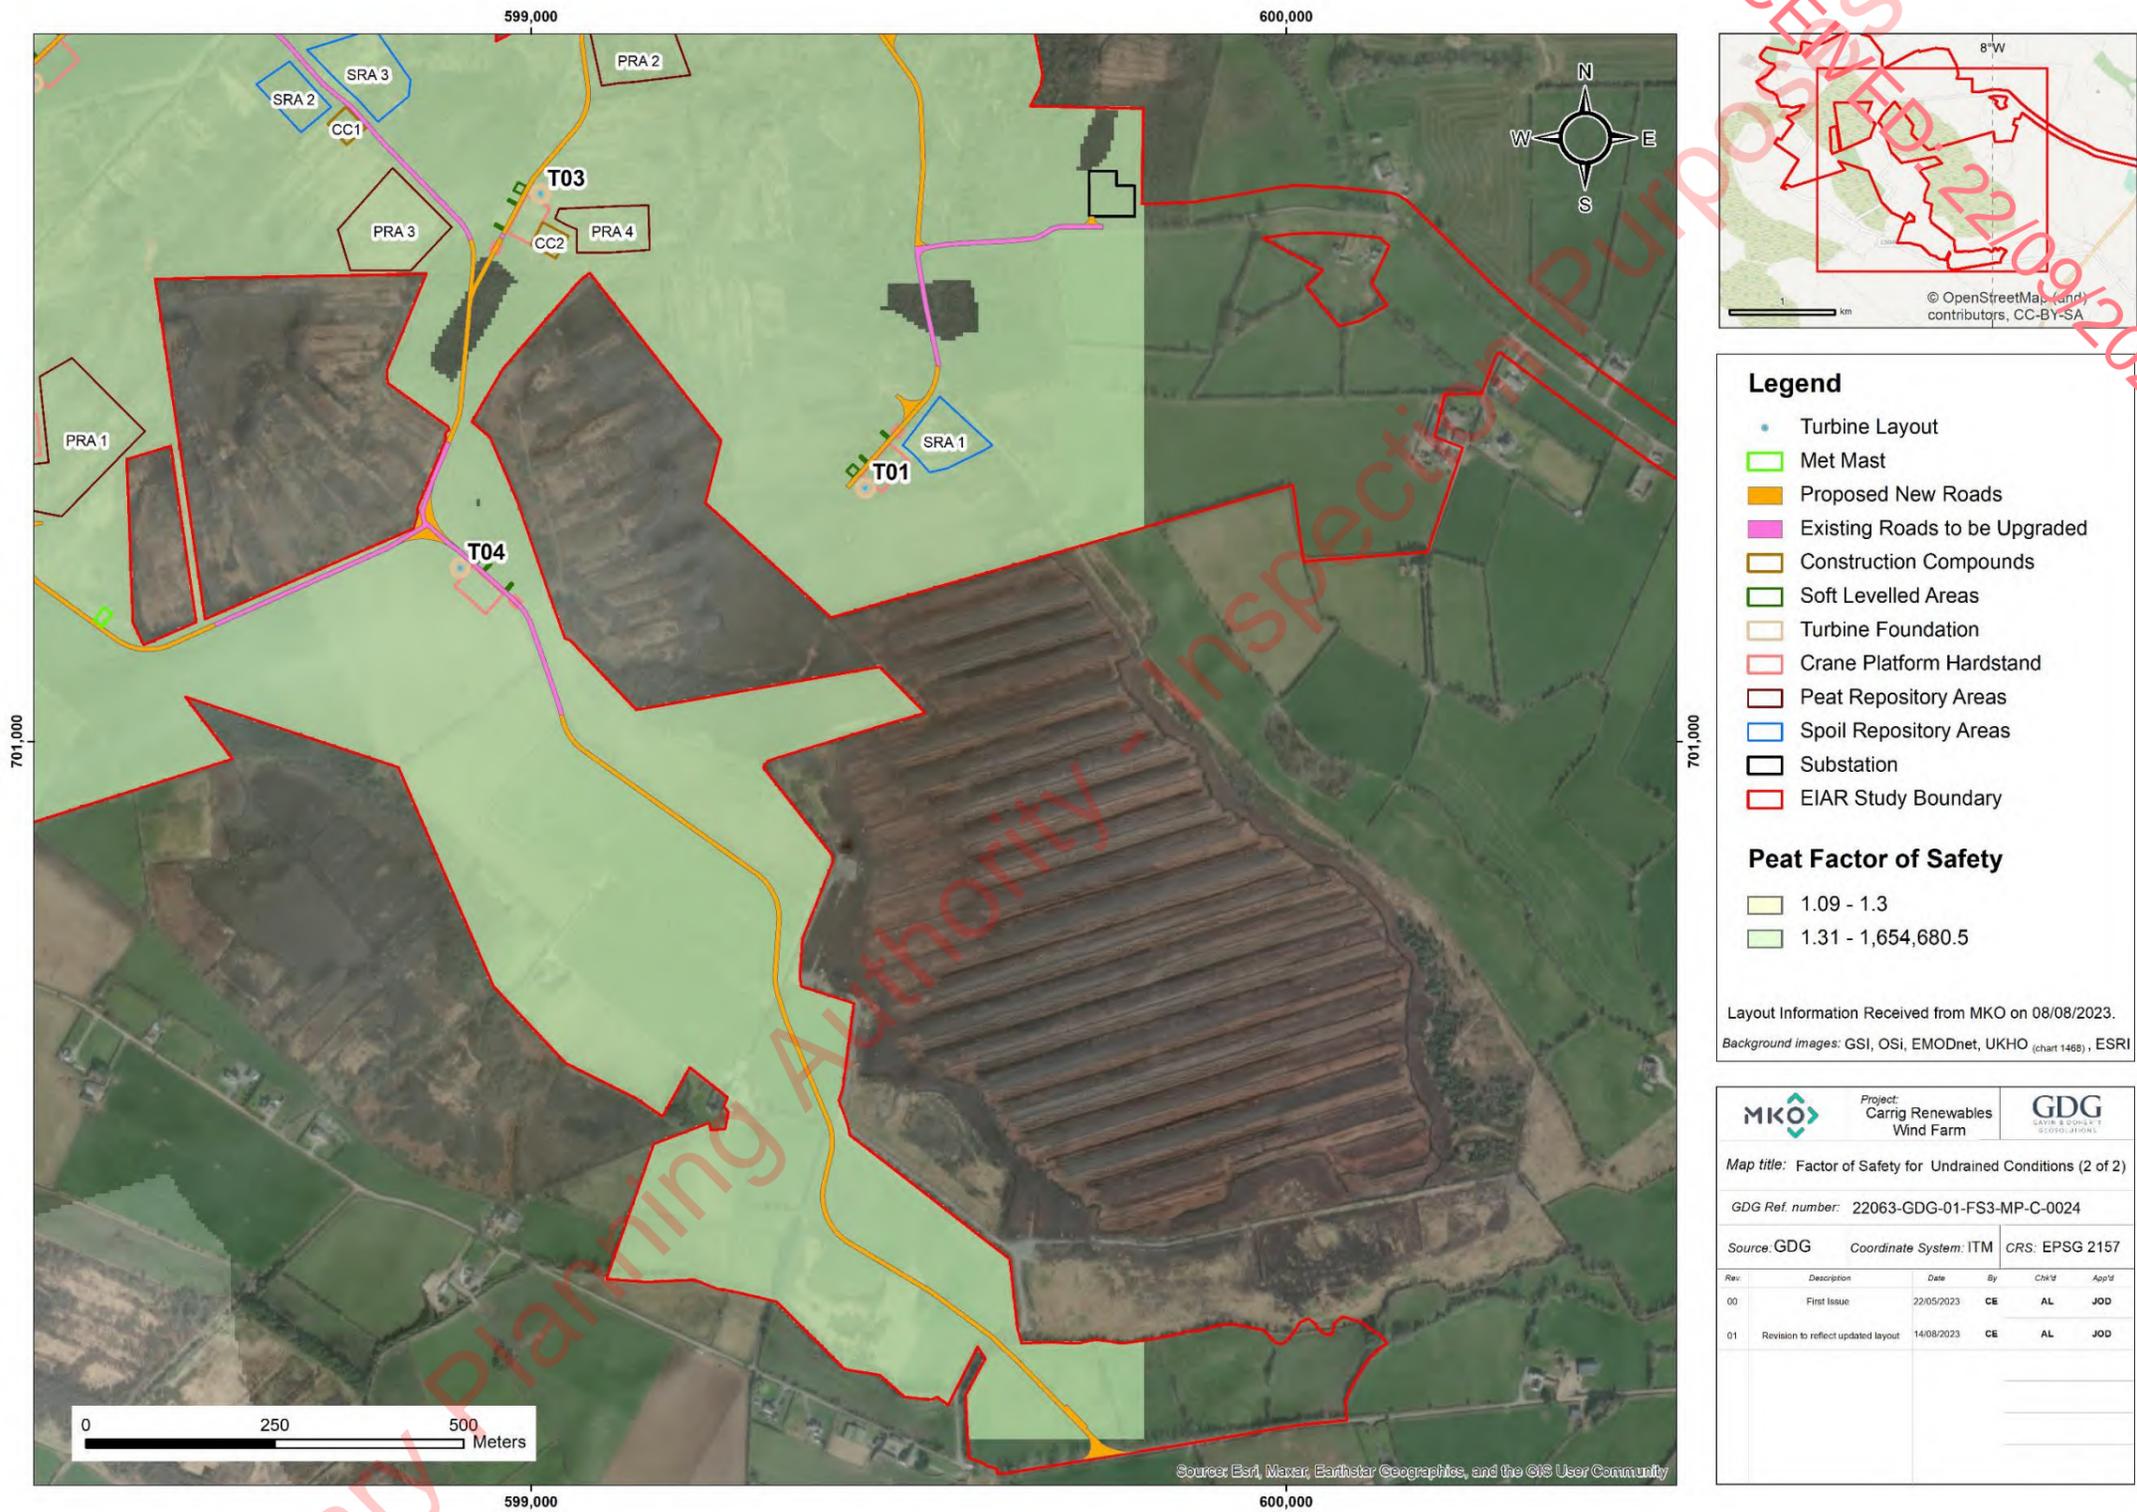
Figure K- 2: FoS for undrained conditions (2 of 2).

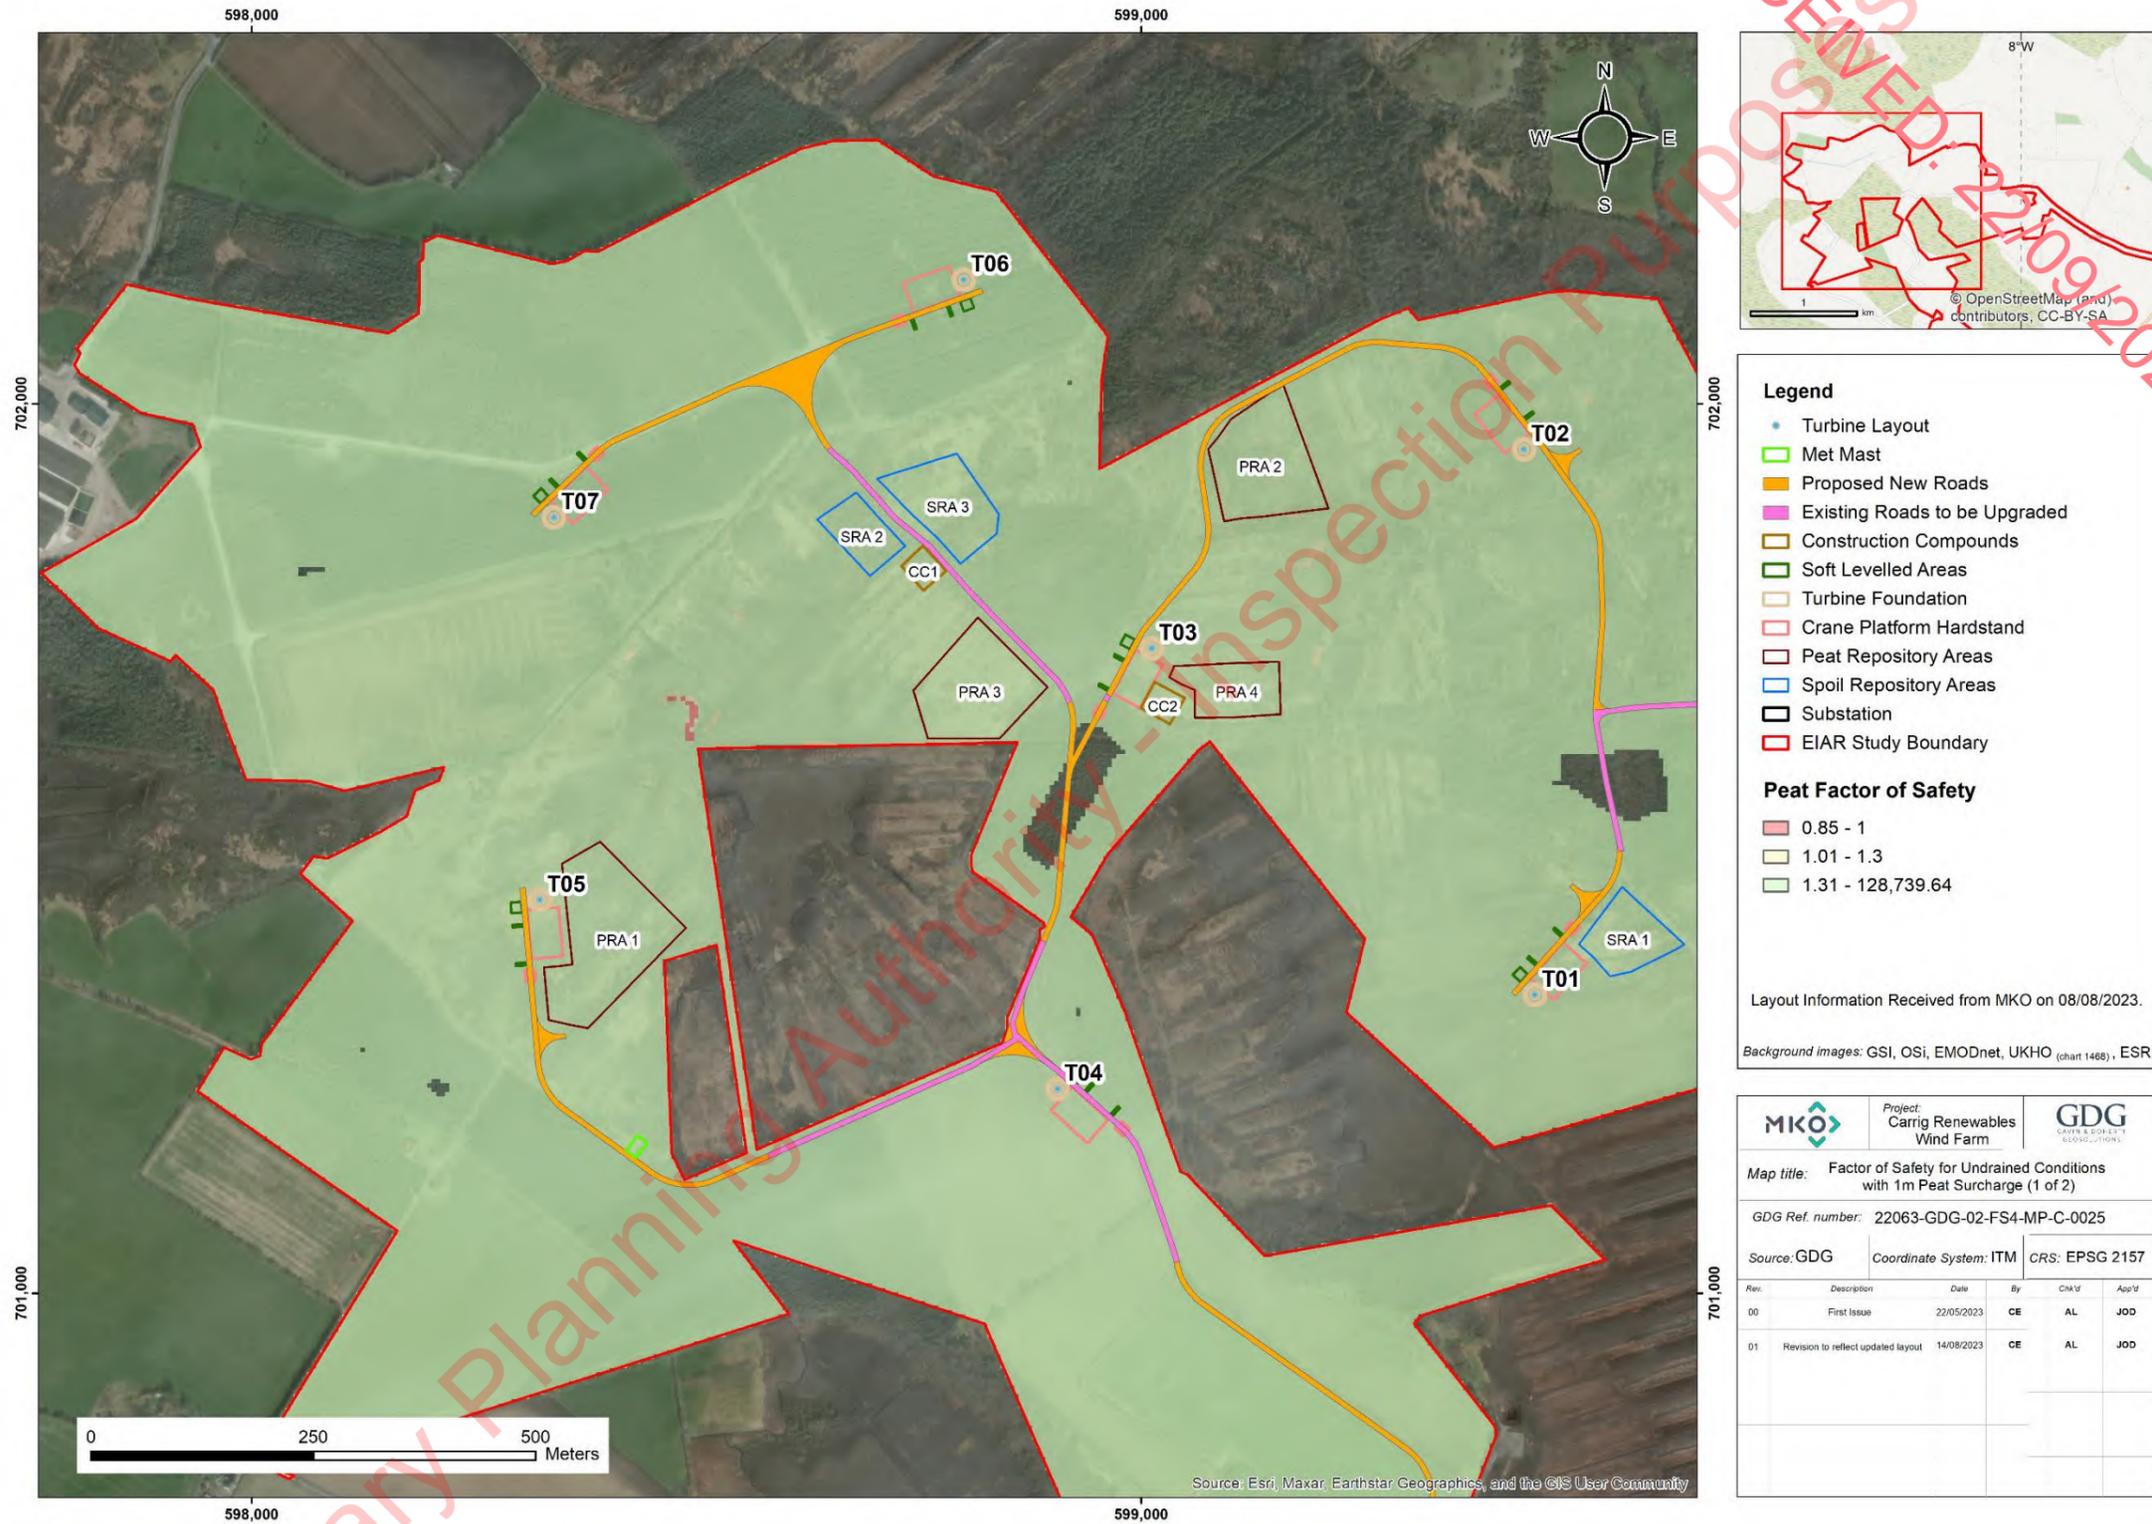
Figure K- 3: FoS for undrained conditions and surcharge of 1 m (i.e. 10 kPa) (1 of 2).

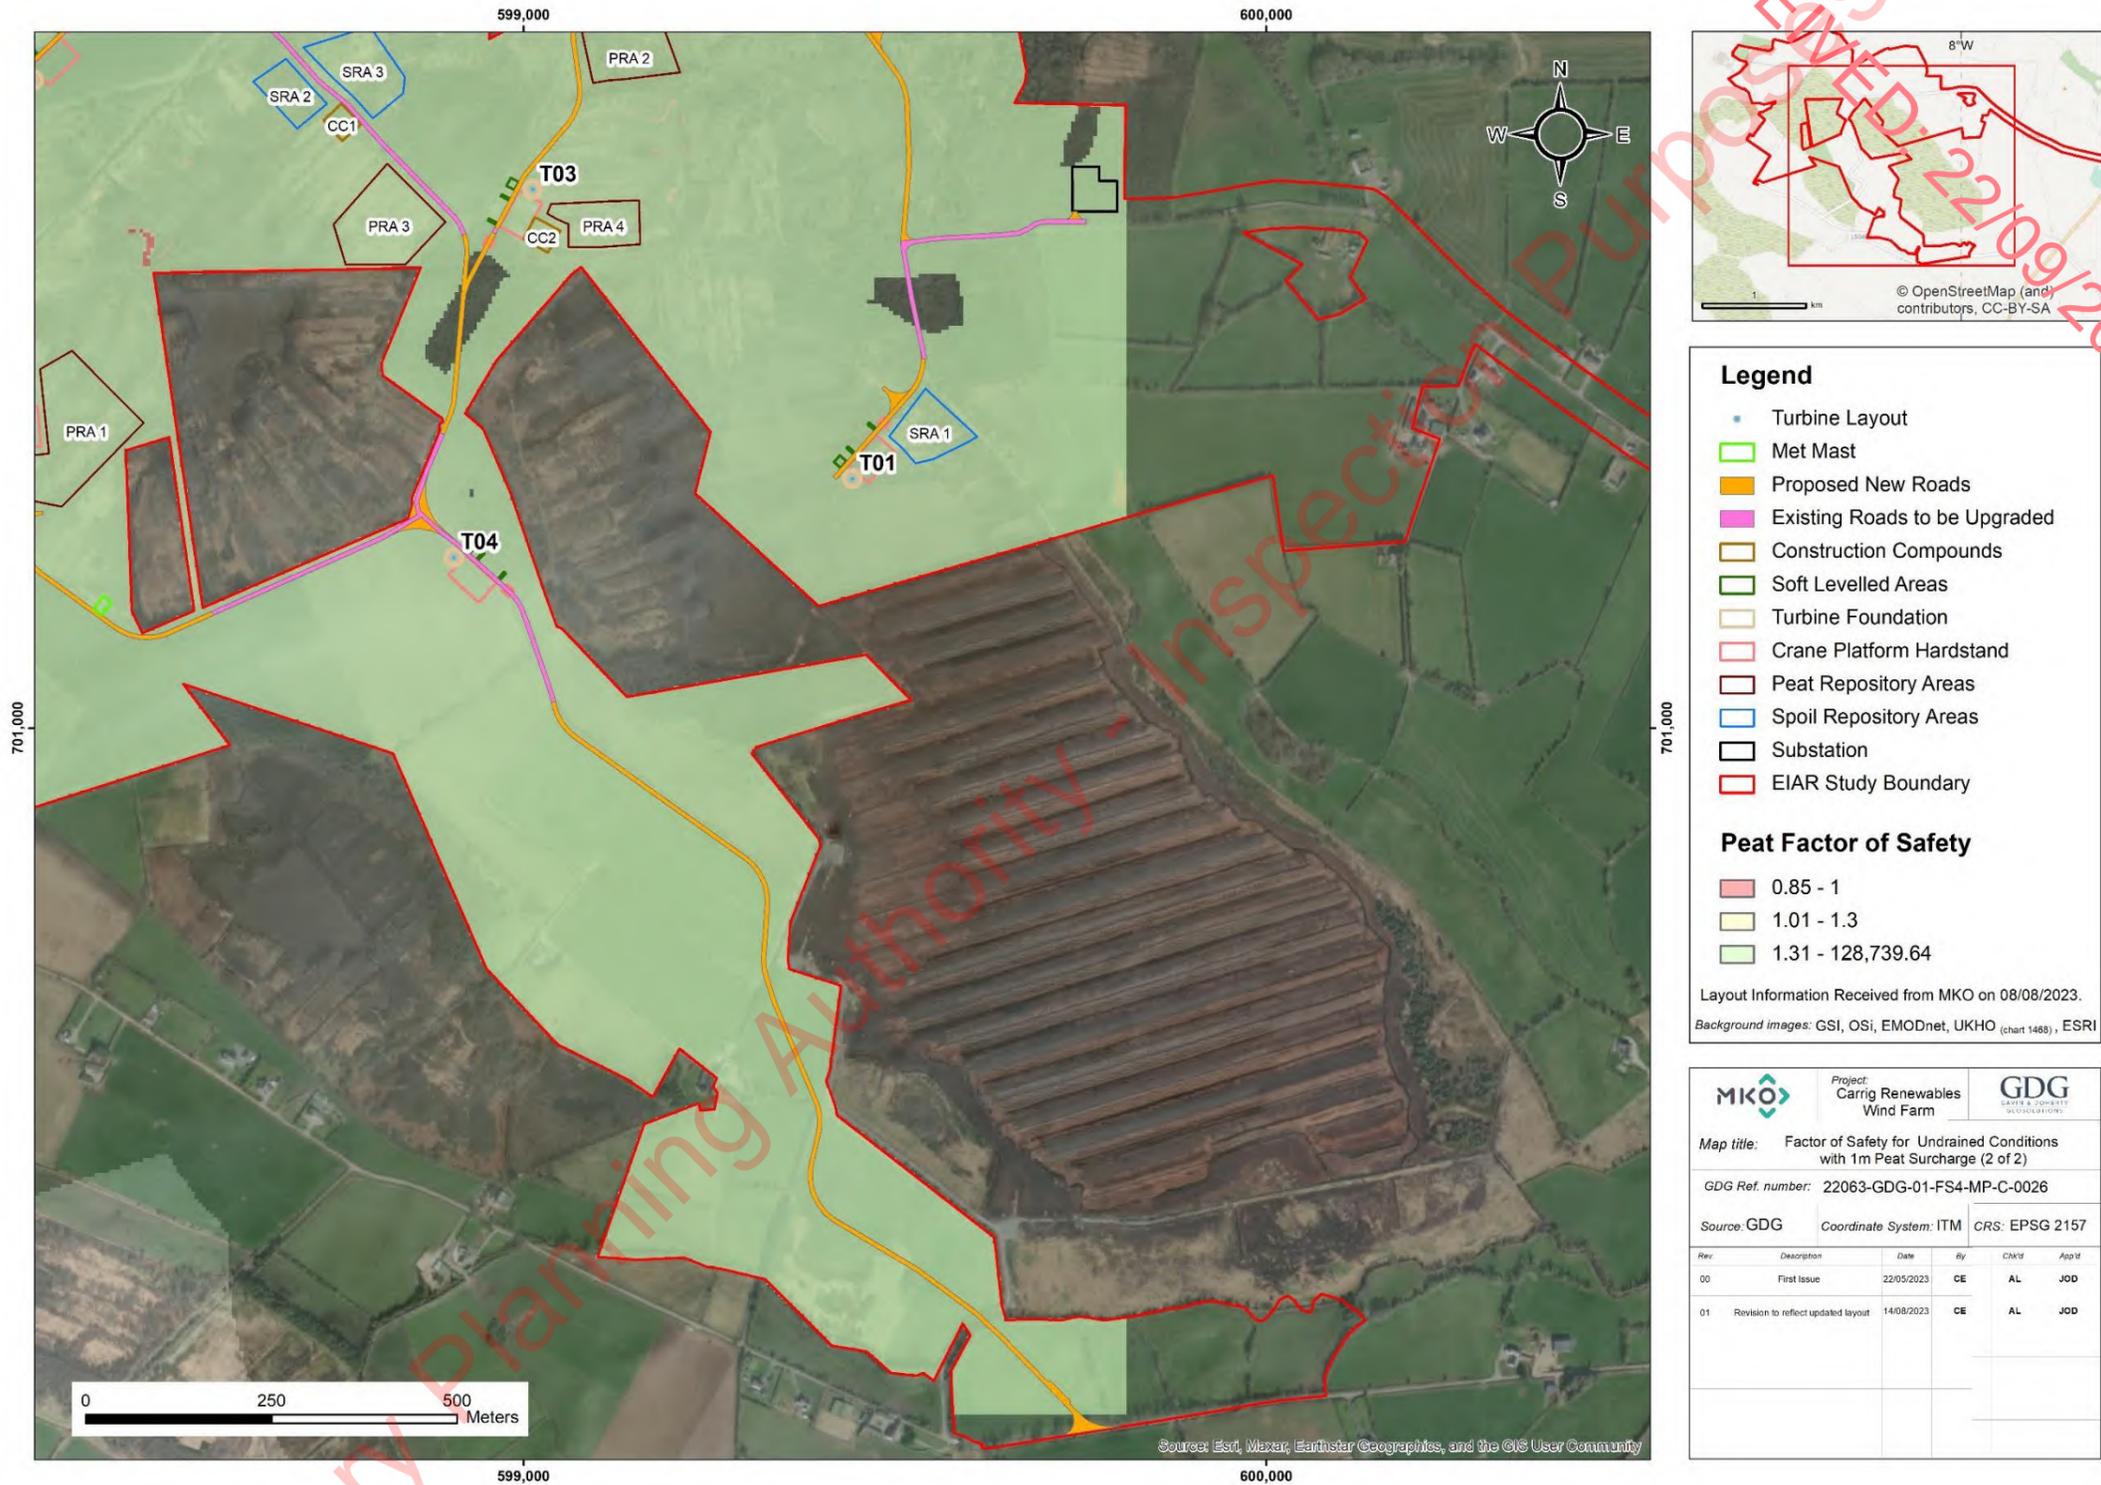
Figure K- 4: FoS for undrained conditions and surcharge of 1 m (i.e. 10 kPa) (2 of 2)

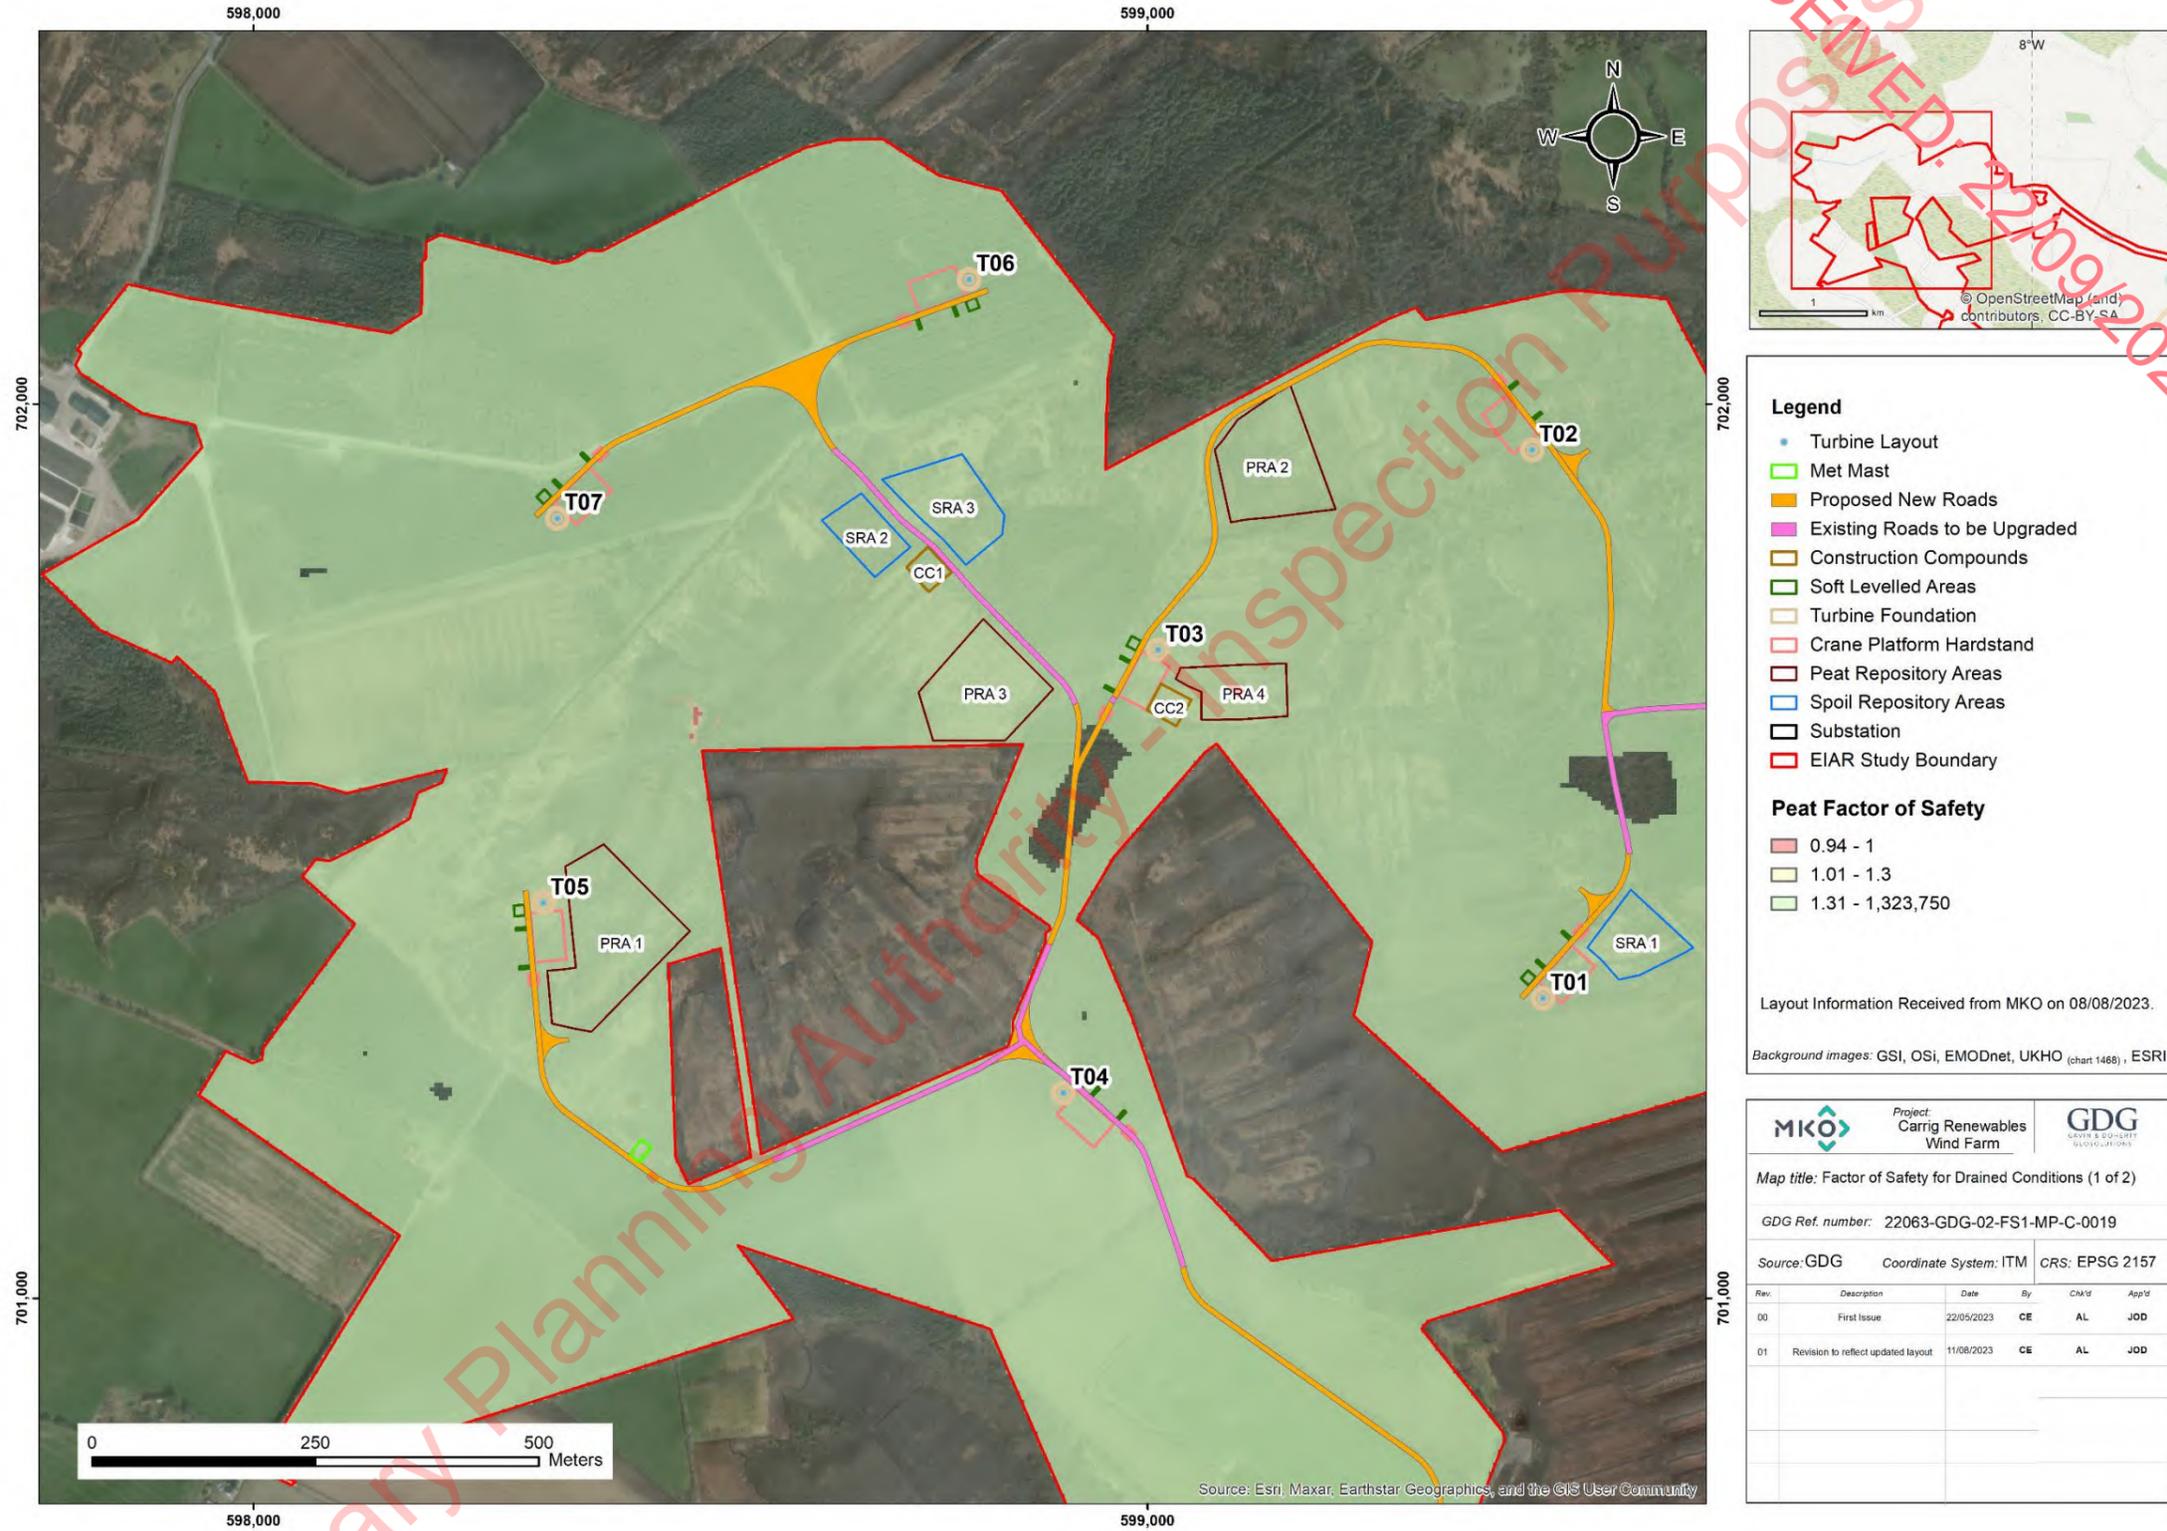
Figure K- 5: FoS for drained conditions (1 of 2).

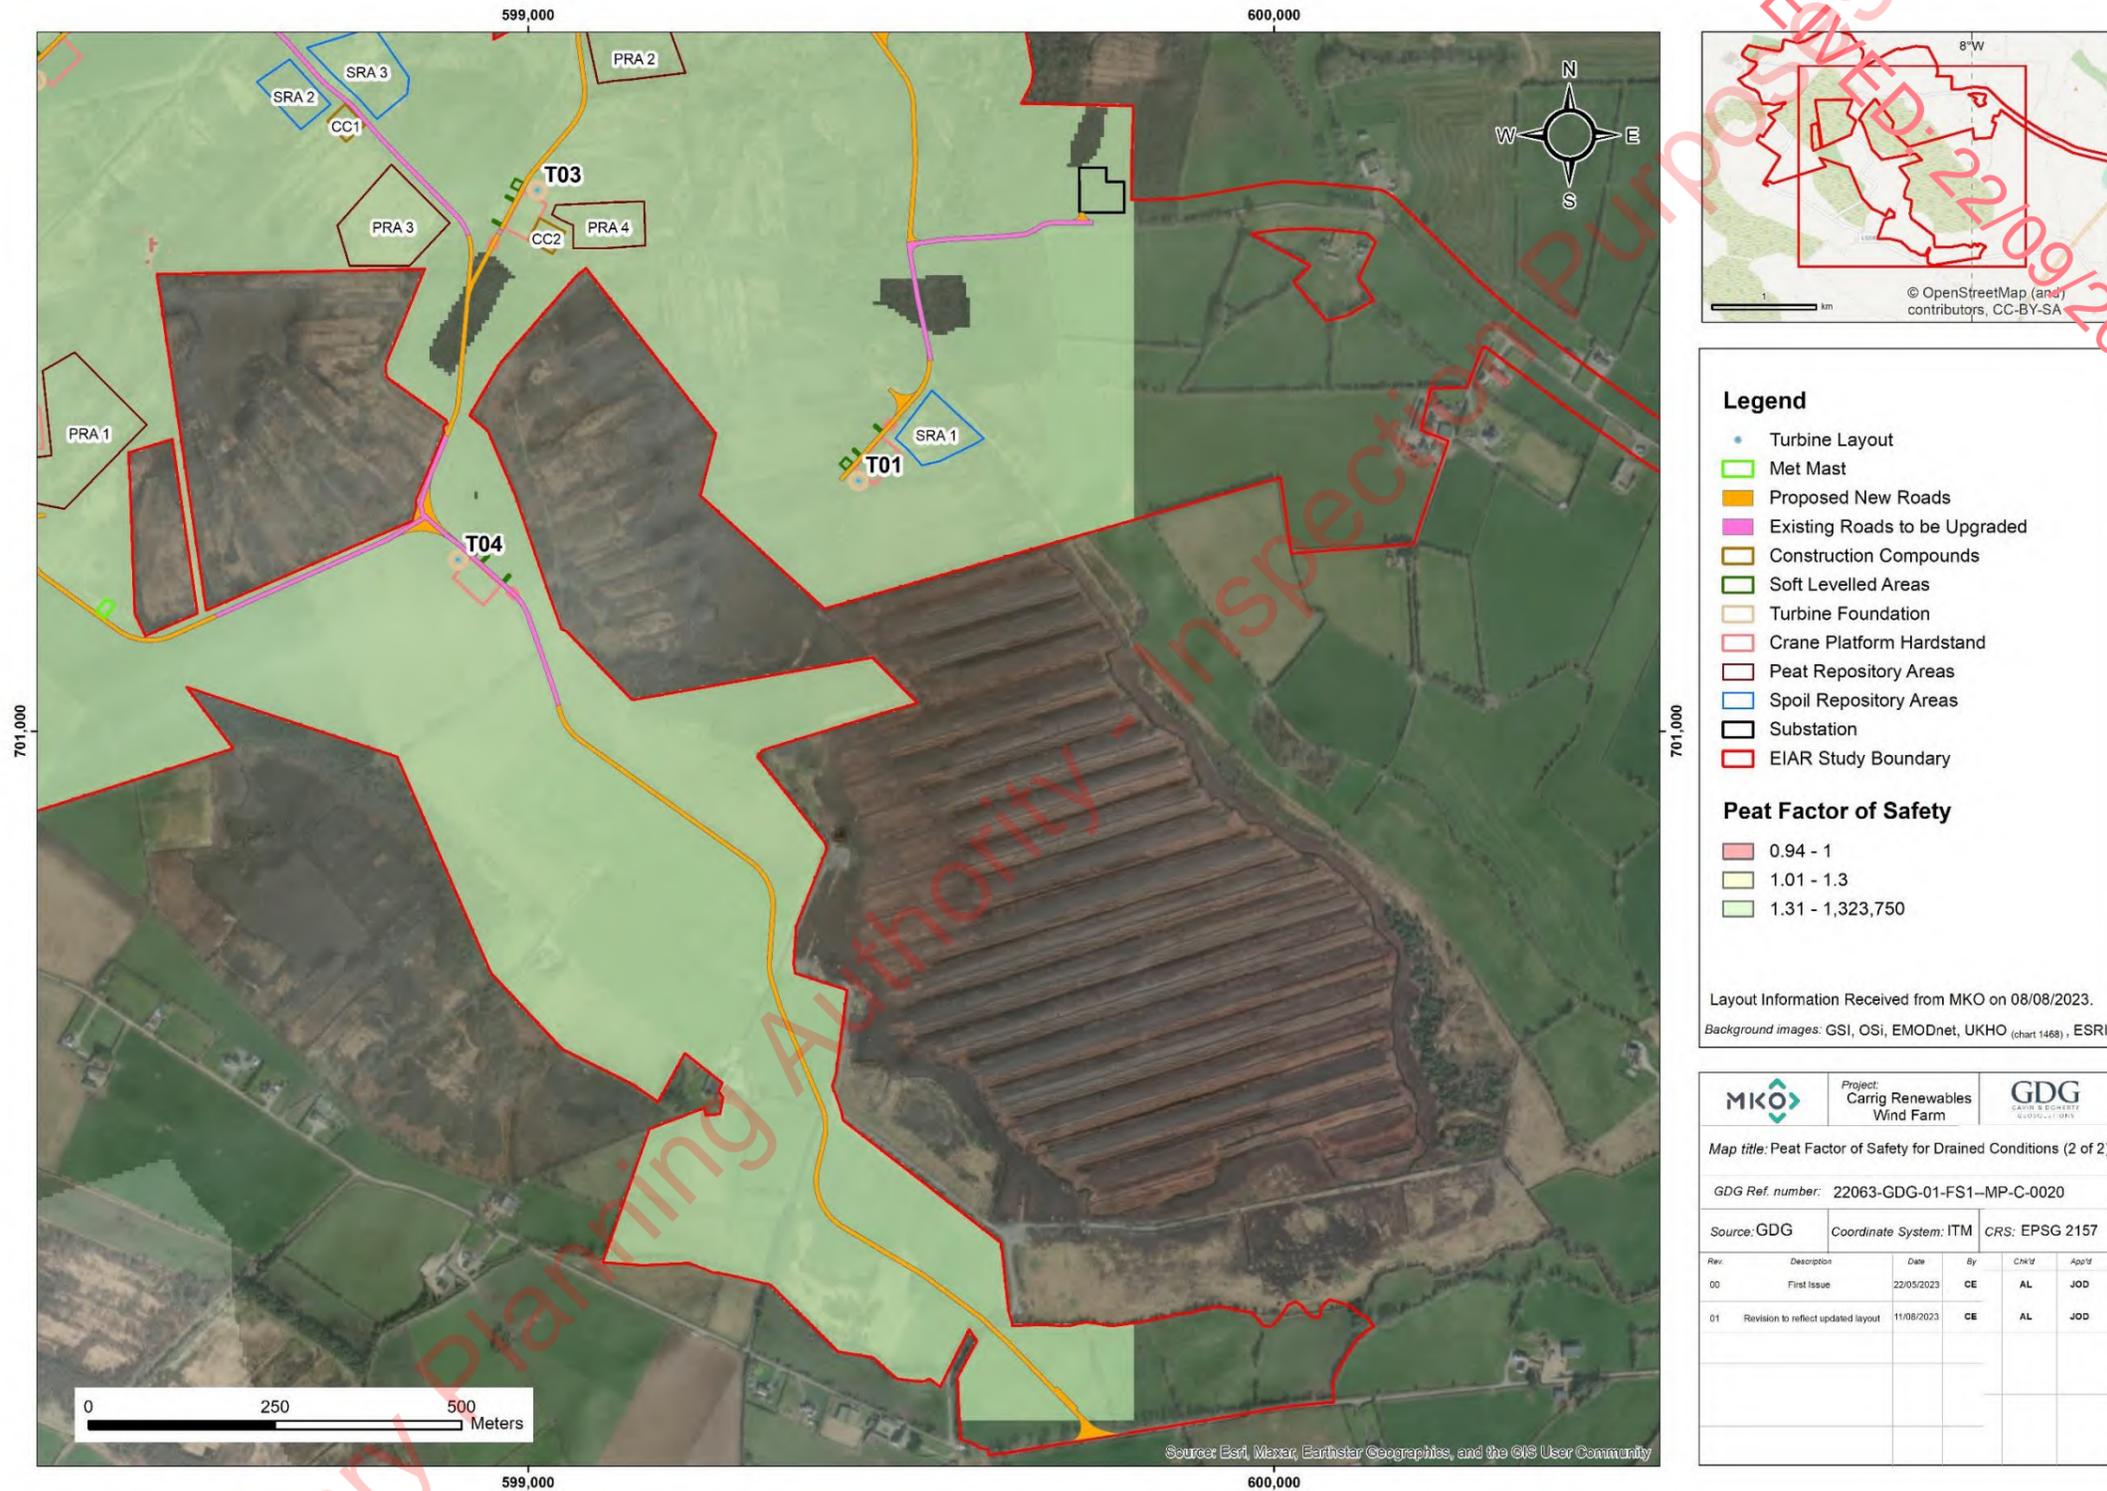
Figure K- 6: FoS for drained conditions (2 of 2).

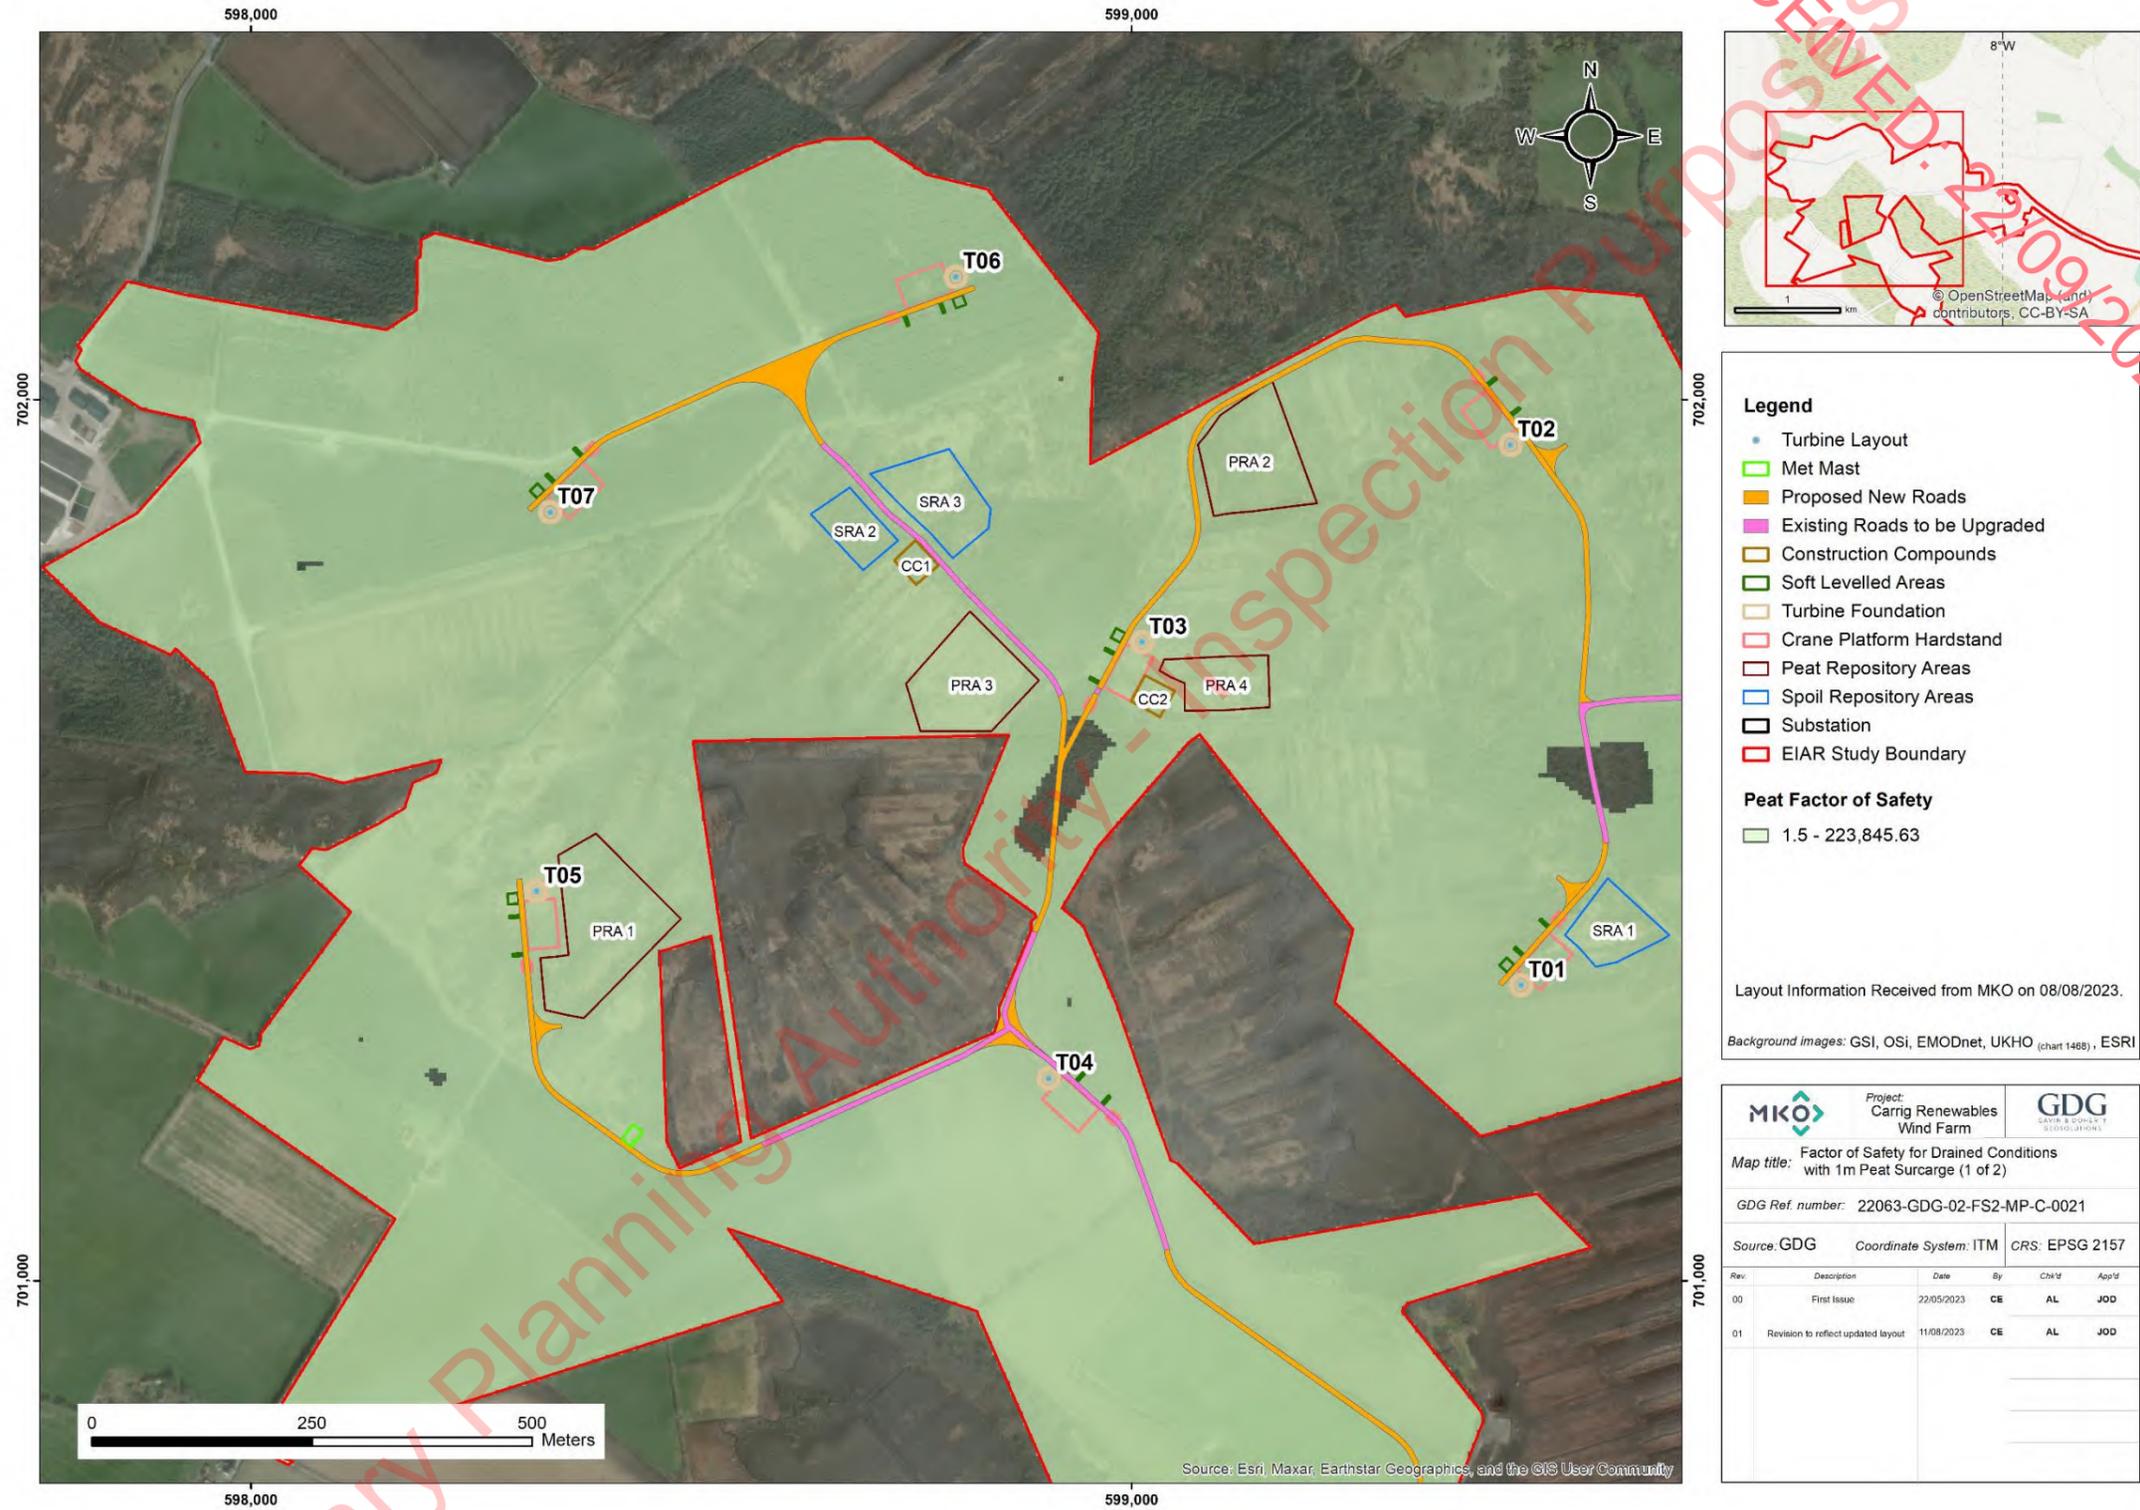
Figure K- 7: FoS for drained conditions and surcharge of 1 m (i.e. 10 kPa) (1 of 2).

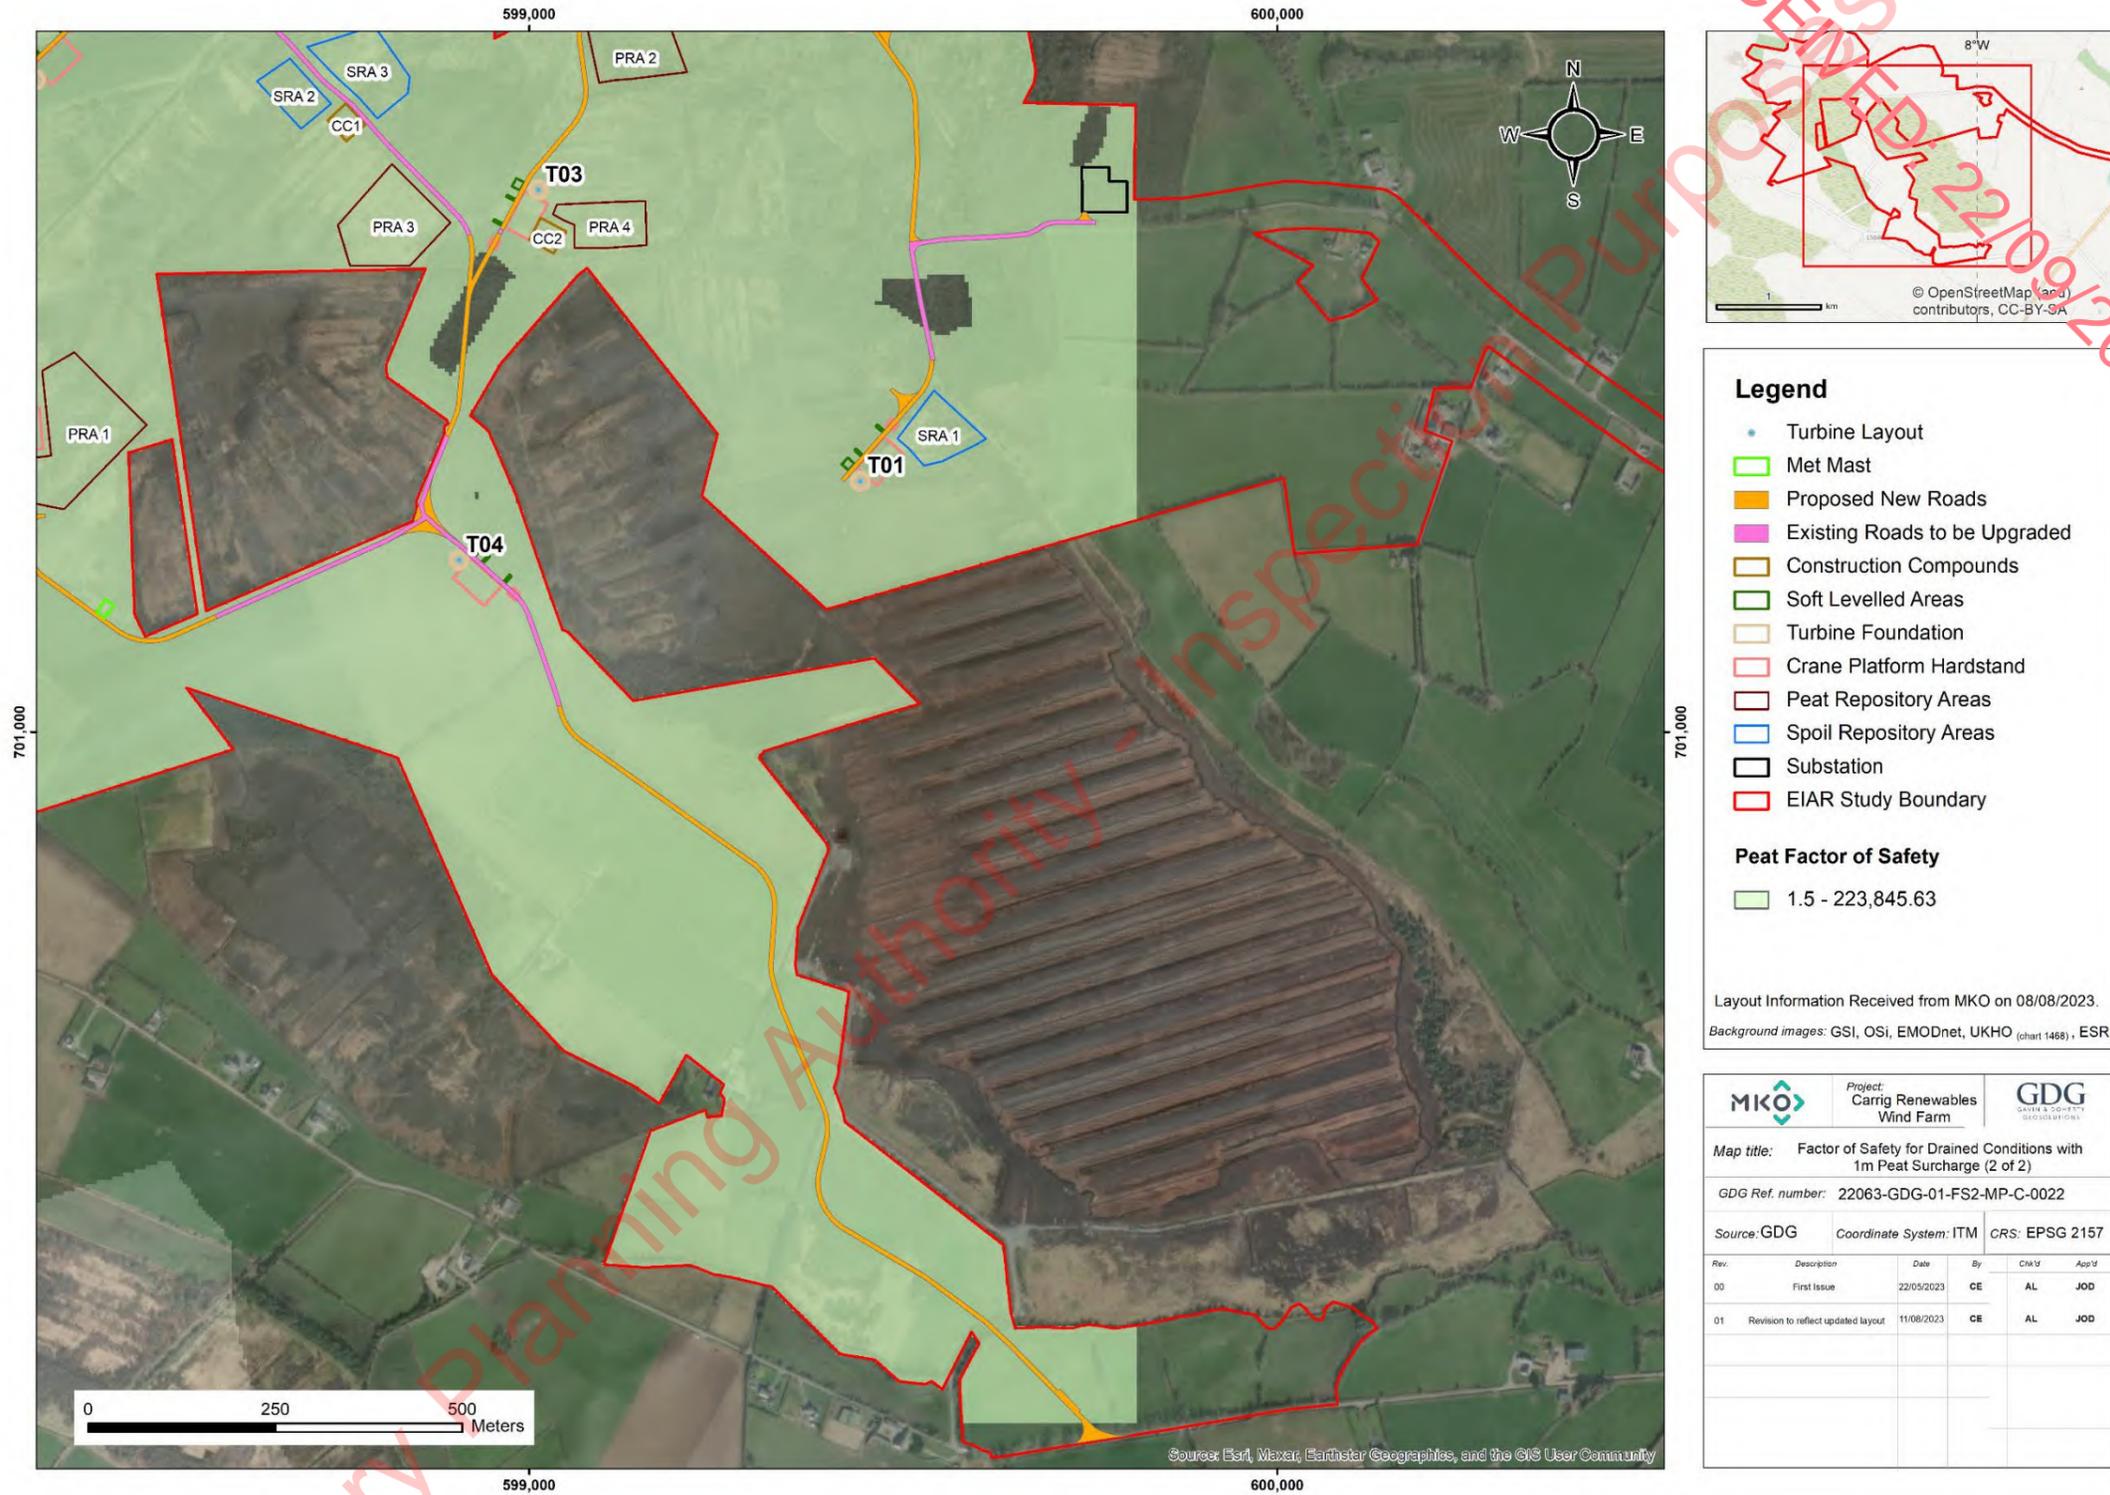
Figure K- 8: FoS for drained conditions and surcharge of 1 m (i.e. 10 kPa) (2 of 2).
