Peat Stability Risk Assessment (PSRA) for Carrig Renewables Wind Farm

Client	MKO
Document Ref.	22063-R-001-02-PSRA
Project Title	Carrig Renewables Wind Farm
Date	14/09/2023

Project Title:	Carrig Renewables Wind Farm
Report Title:	Peat Stability Risk Assessment (PSRA) for Carrig Renewables Wind Farm
Document Reference:	22063-R-001-02-PSRA

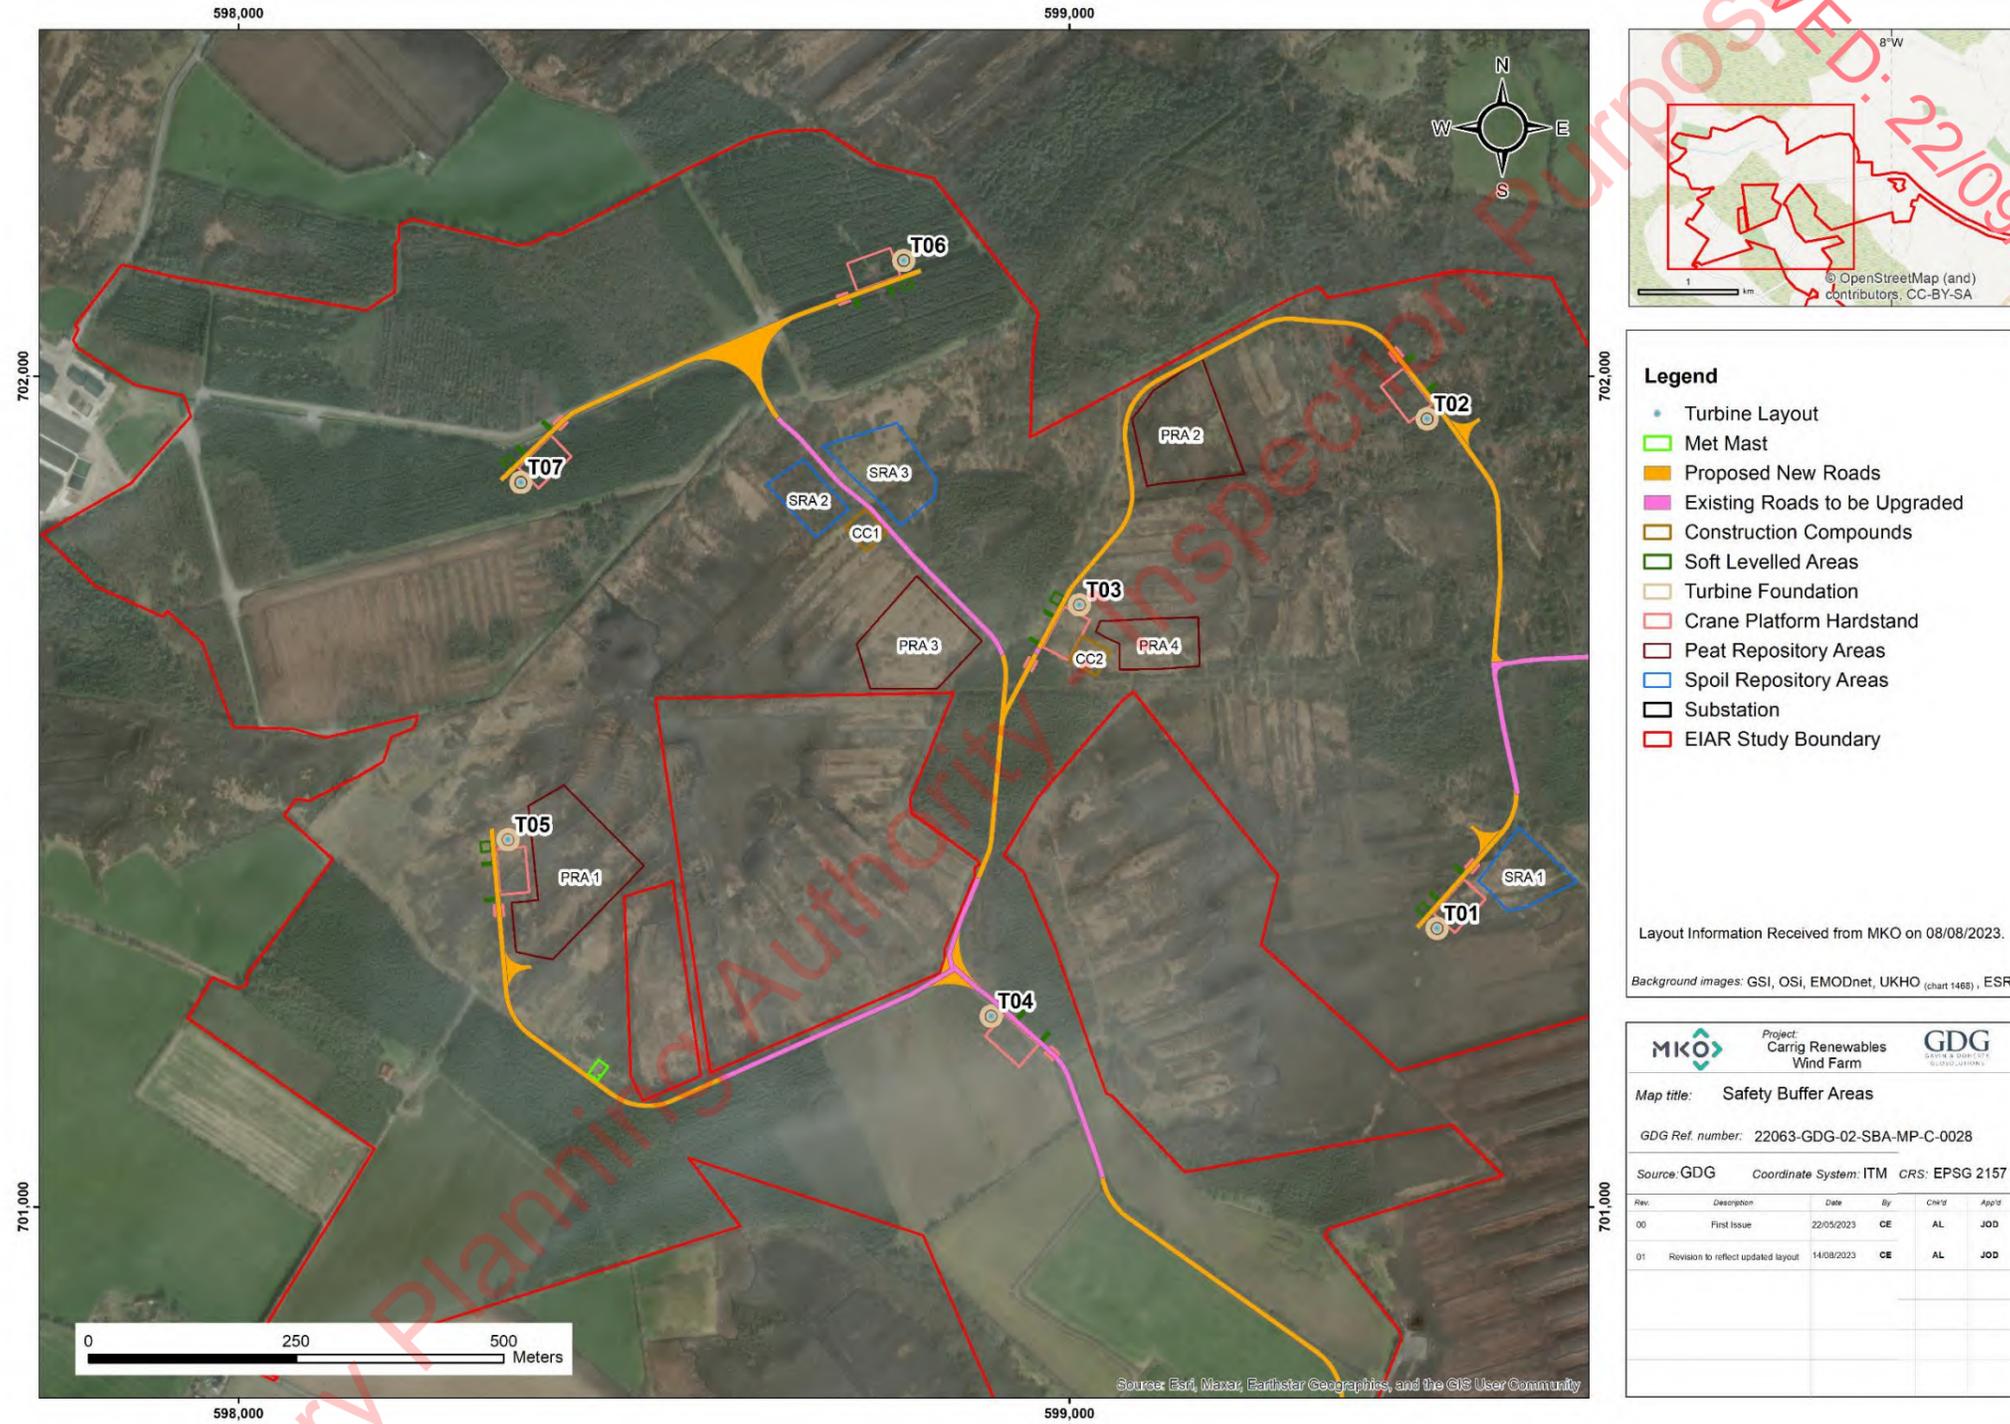
Figure L- 1 : Safety buffers (1 of 2).

The site was found to have both acceptable factors of safety and levels of risk against peat instability at all infrastructure locations. Twenty-three small areas, referred to as safety buffers (see Appendix L), have been highlighted and will have restricted construction activities; they should not be used for

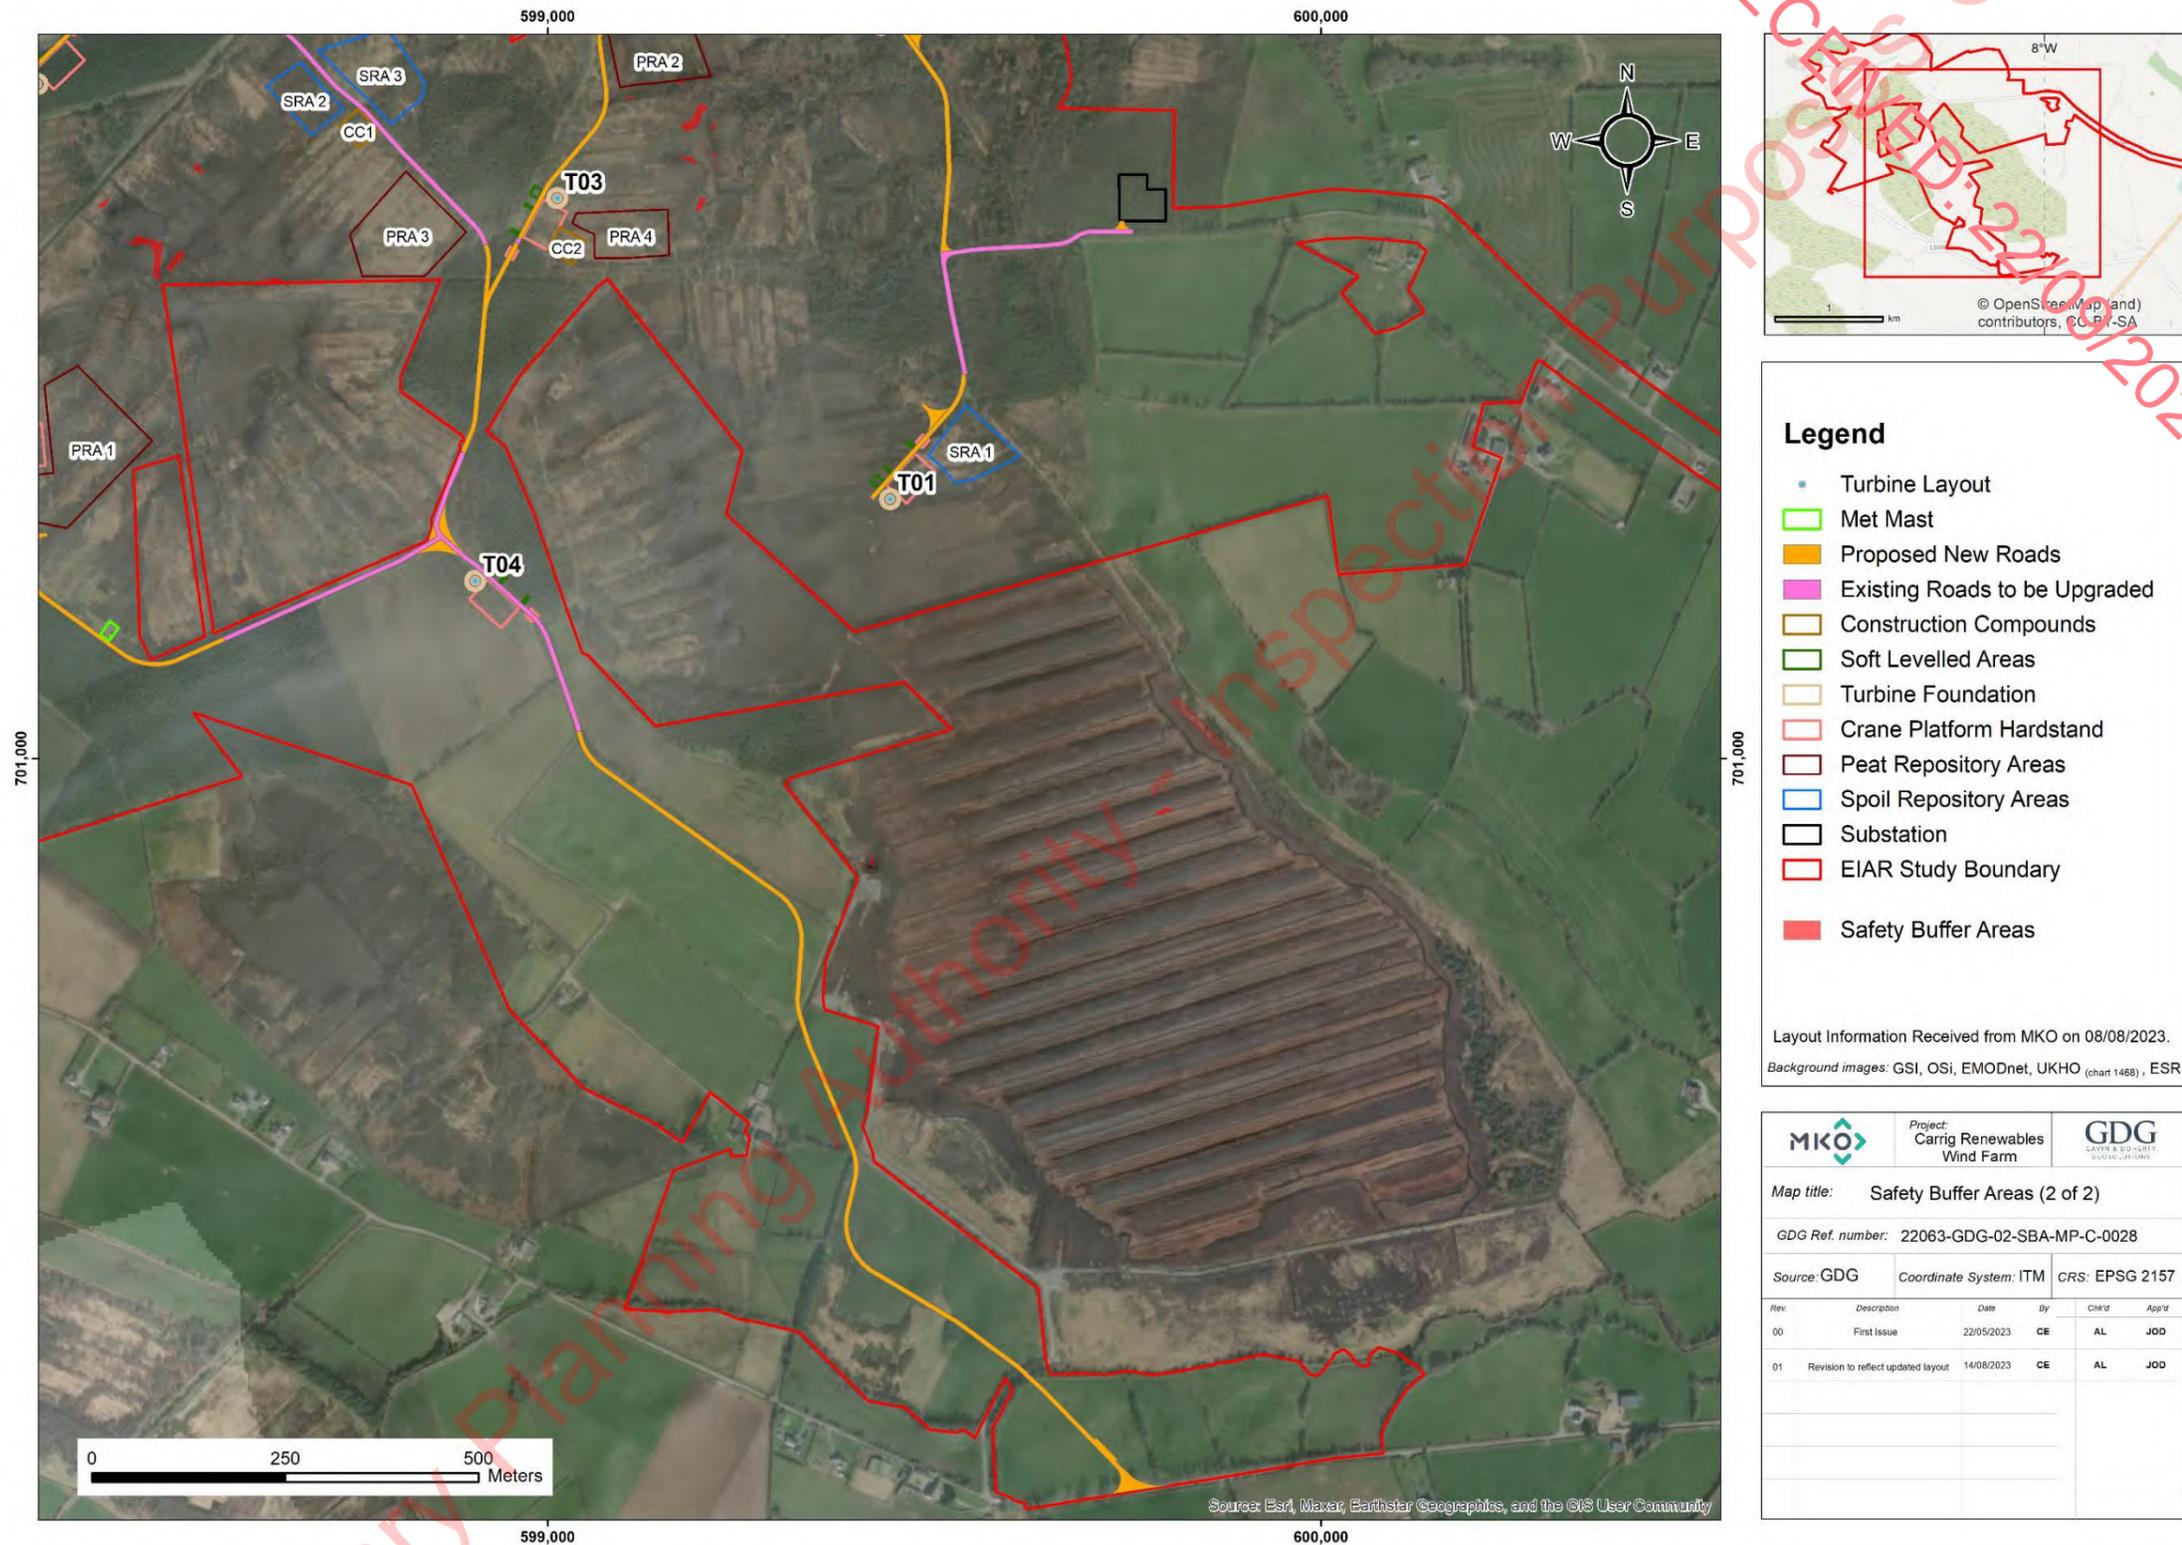
Figure L- 2: Safety buffers (2 of 2).
