# Further Information Response (ABP-318793-24 P. Ref. 23/169)

**Proposed Quarry Extension at Mullymagowan Townland, Stradone, Co. Cavan**

## **P&S Civil Works Ltd.**

### **SLR Environmental Consulting (Ireland) Ltd**

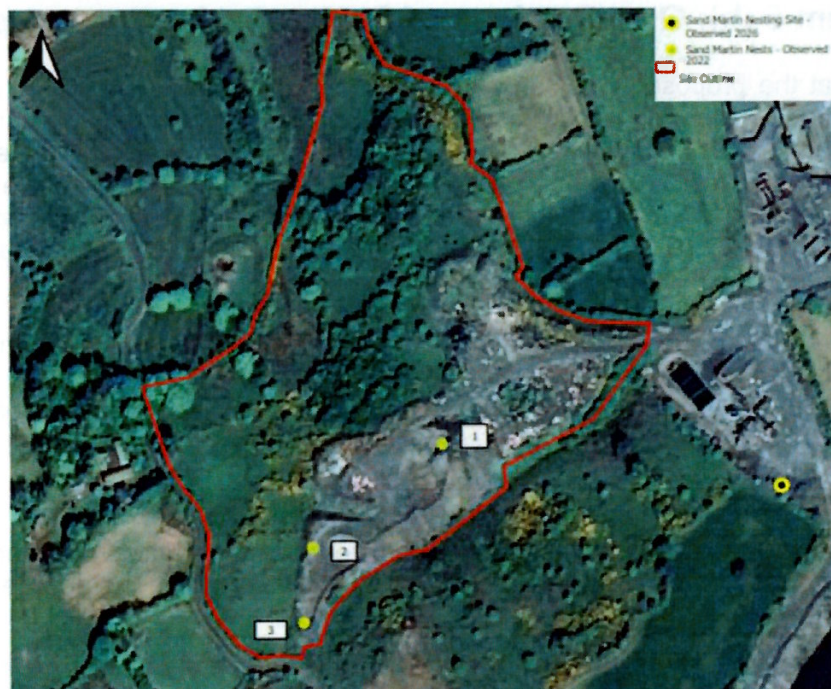
**Figure 1 Active Sand Martin Nesting Location 2026**

**Figure 1** below shows the location of the active sand martin nesting location in the large stockpile in the south-east corner of the application site. This stockpile is located at 53.943694, -7.199377.

Should any stockpiles with signs of sand martin nesting be observed within the proposed application site, the Applicant undertakes not to remove these during the bird breeding season, 1st March to 31st August. If removed outside this period, an alternative sand pile will be created in an undisturbed area of the application site in time for the summer return of sand martin colonies. The Applicant has further committed to placing of sand piles along the western boundary of the currently inactive (flooded) quarry site, that can remain untouched and outside of the operational extension area.

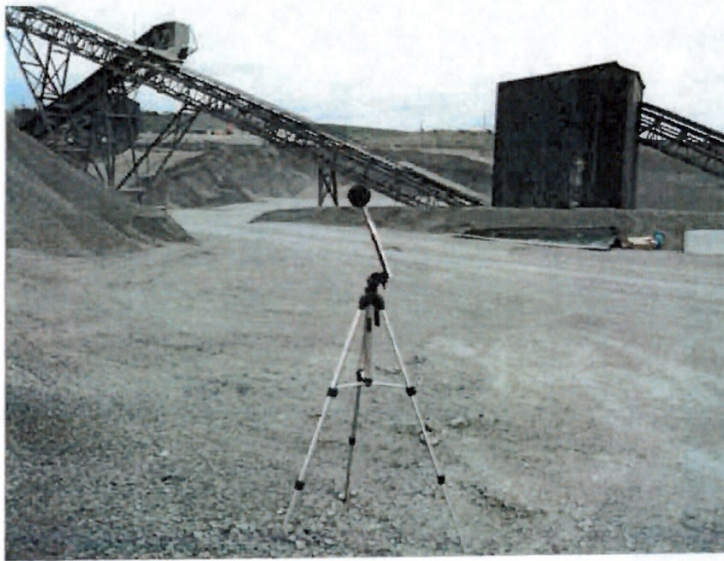
**Noise monitoring equipment at N 1 (looking towards the operation)**

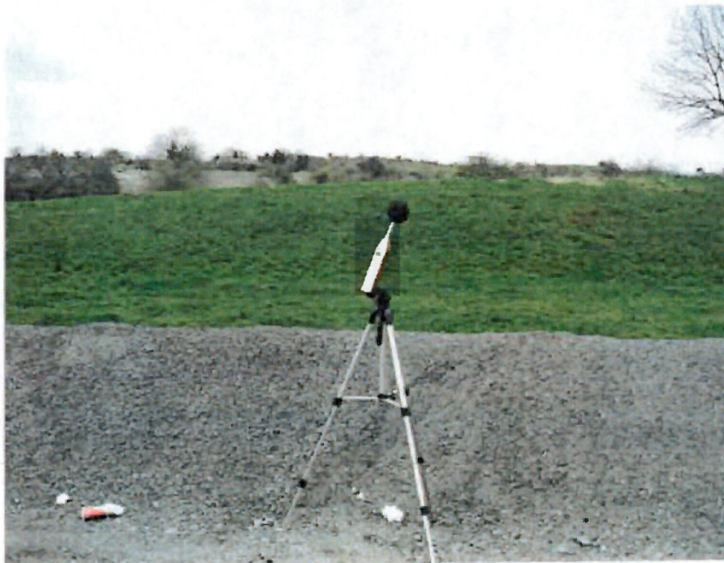
**Noise monitoring equipment at N1 (looking away from the operation (boundary))**

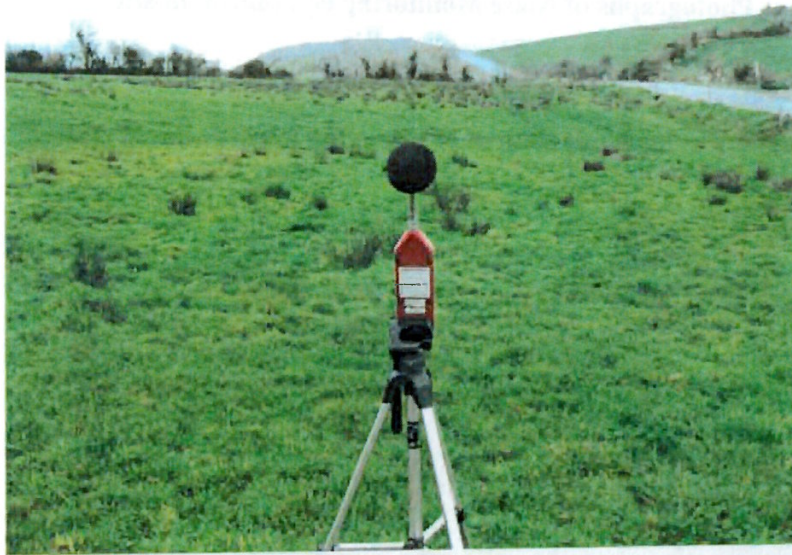
**Noise monitoring equipment at N3 (looking towards the operation)**

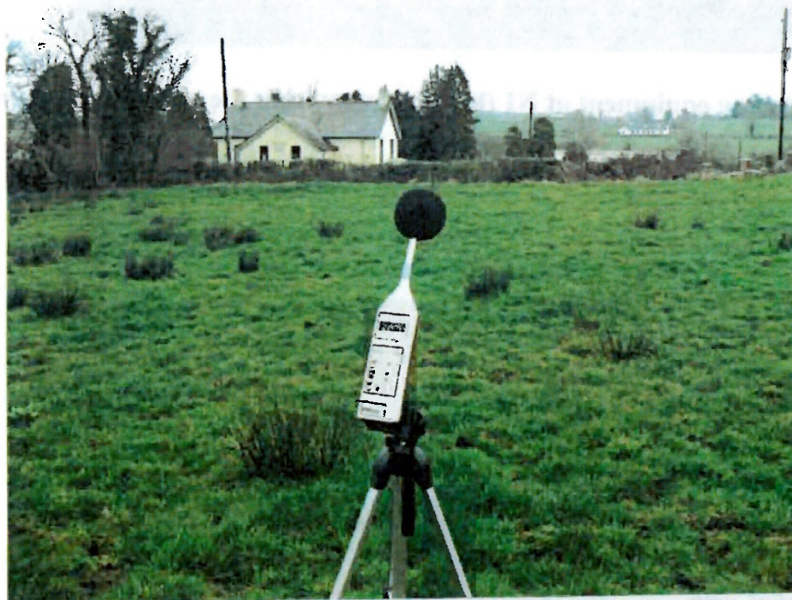
**Noise monitoring equipment at N3 ( looking away from the operation (boundary))**

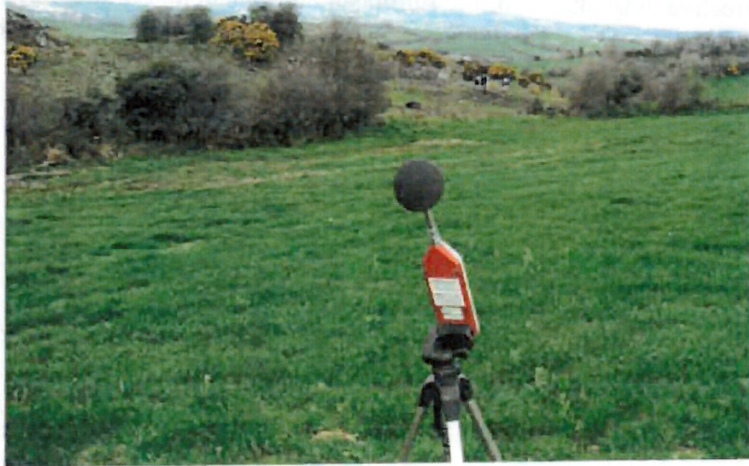
**Noise monitoring equipment at N5 (looking towards the operation)**

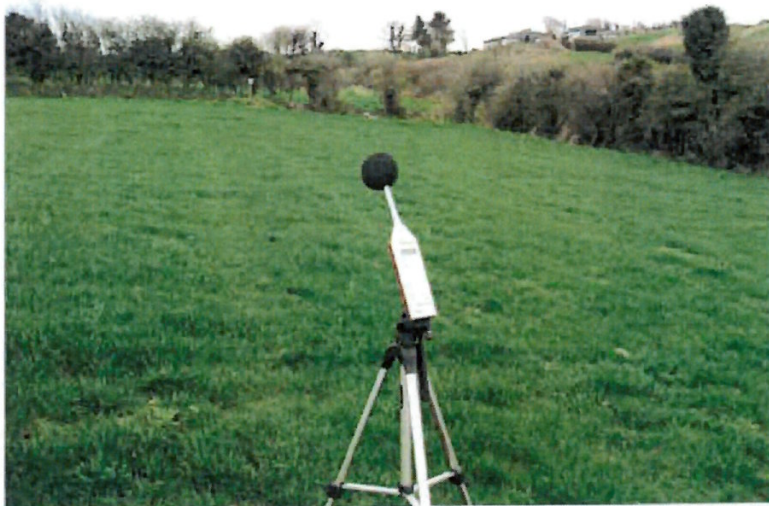
**Noise monitoring equipment at N5 (looking away from the operation)**

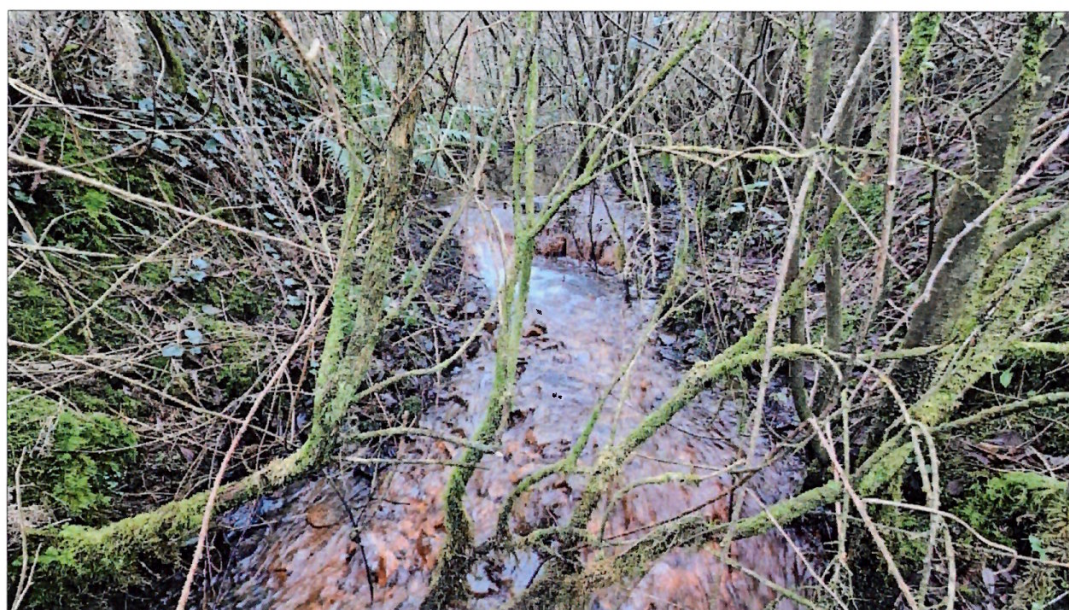
Site 1 was an upstream control site on the Corraneary Stream c. 300m upstream of the proposed quarry outfall. The stream was a U-shaped upland eroding stream (FW1), 1-1.5m wide with water depth between 0.1-0.3m. The stream had a sinuous profile but had however been historically deepened with 1.5-2.5m high banks (Plate 3.1). The historical hydromorphological impacts (i.e. deepening) resulted in limited flow diversity and the predominance of slow flowing deeper glide. Consequentially, the stream had very localised riffle habitat. The bed supported localised angular cobble and gravels with moderate to heavy siltation (silt plumes underfoot with evident settlement on instream substrata due to the lower energy at the survey). The bed was also moderately compacted and covered with an Iron oxidising bacterial film (Plate 3.2). The stream was too shaded to support macrophytes and none were recorded. The splash zones and wet banks of the riparian areas supported occasional fox-tail feathermoss (*Thamnobryum alopercum*). The riparian areas supported dense growth of willow (*Salix cinerea* sp. *oleifolia*), gorse (*Ulex europaeus*), hawthorn (*Crataegus monoygna*) and localised bramble (*Rubus fruticosus*). The bordering land uses were of semi-improved grassland (GA1) and the exposed bare ground of the quarry (ED2).

**Plate 3.1** Survey site 1 on the upper reaches of the Corraneary Stream

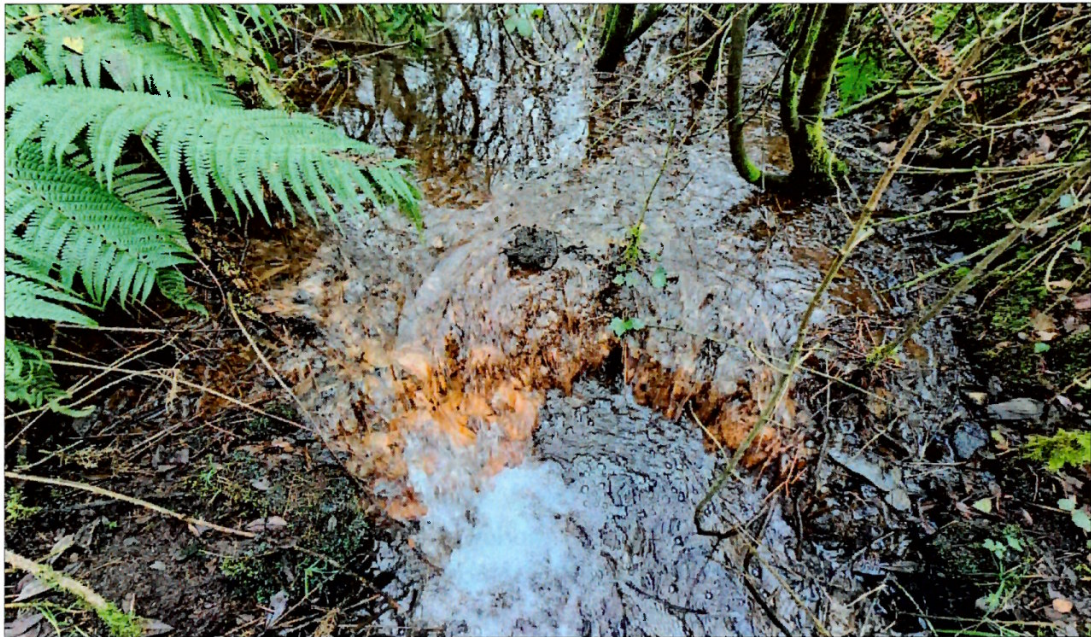
**Plate 3.2** Survey site 1 on the upper reaches of the Corraneary Stream showing deposition of iron-oxidising bacterial film on the bed

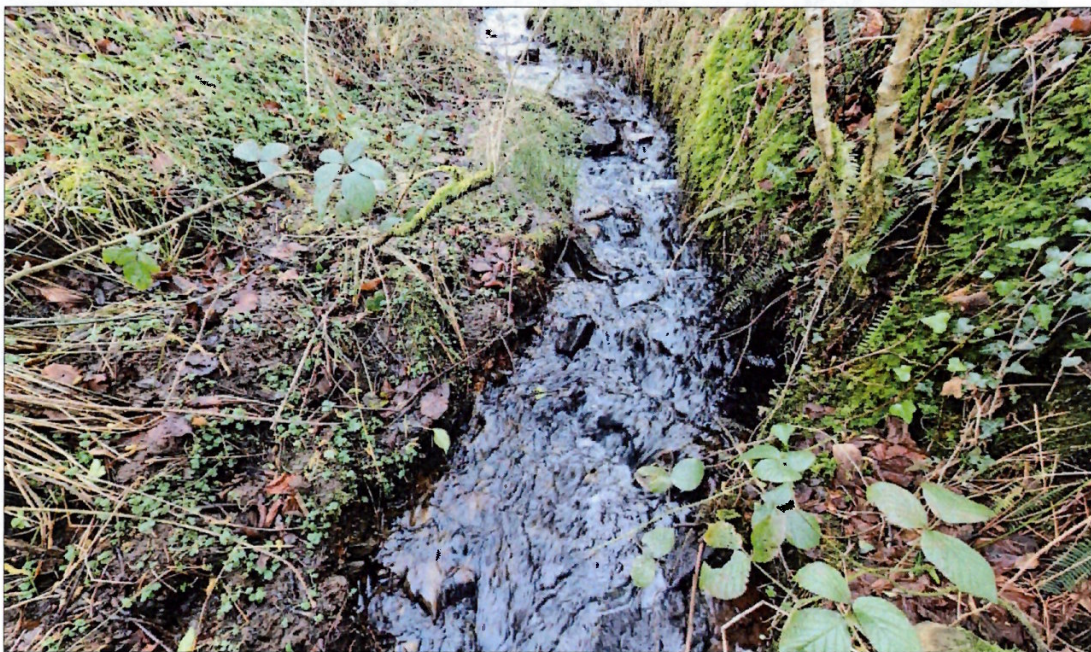
Site 2 was situated on the Corraneary Stream at the proposed discharge location. The stream at site 2 was a 1m wide upland eroding stream (FW2) with water depth 0.1-0.2m and 0.5-1m high banks (**Plate 3.3**). The survey areas was situated immediately upstream of a small drainage ditch confluence emanating from improved grassland along the east bank. The stream had a sinuous channel form with a flow profile of mixed riffle and shallow glide with very localised shallow pool. Given its high energy the stream supported no macrophytes. As with upstream areas, the splash zones of the riparian areas supported occasional fox-tail feathermoss. The bed supported mixed small boulder, cobble and angular coarse gravels with no filamentous algae cover. The bed was moderately compacted and silted with silt plumes underfoot. The riparian areas supported mature ash (*Fraxinus excelsior*), hazel (*Corylus avellana*), hawthorn, gorse, common ivy (*Hedera helix*) and bramble. The damp lower river banks supported abundant opposite-leaved golden saxifrage (*Chrysosplenium oppositifolium*). The bordering land use was of semi-improved grassland (GA1).

**Plate 3.3** Survey site 2 on the Corraneary Stream adjoining the proposed discharge location

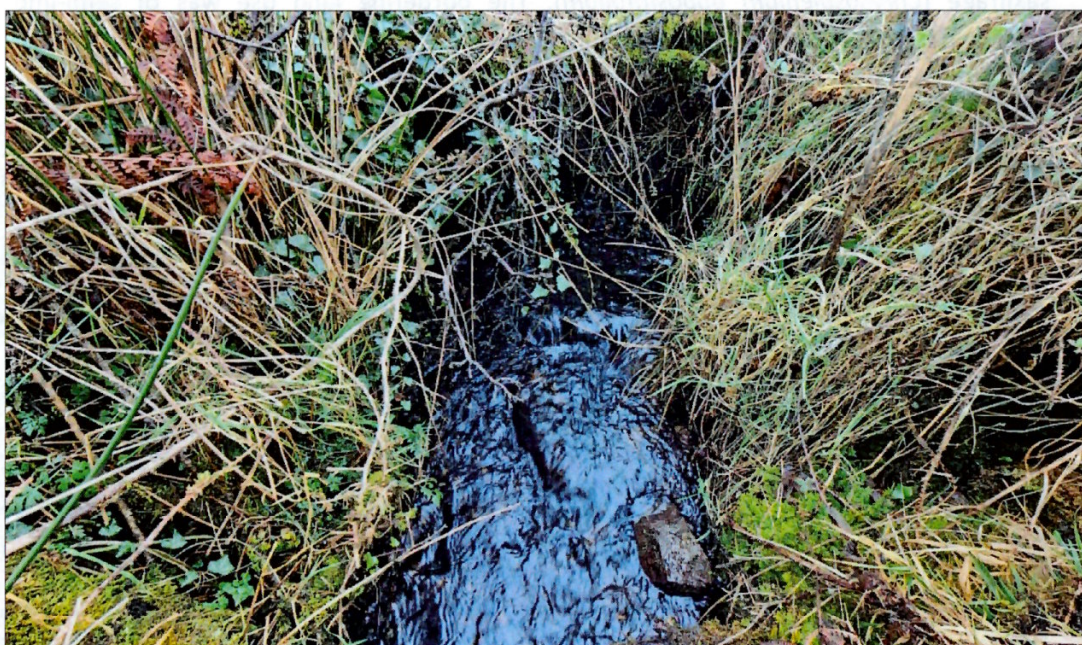
Site 3 was situated c. 50m downstream of the proposed quarry discharge on the Corraneary Stream. The stream was representative of a 1m wide upland eroding stream (FW2) of lower energy than upstream. The stream had water depth 0.1-0.2m with 1-1.5m high banks. The stream had been historically straightened along the adjoining field boundaries. The stream however, had swift flowing water dominated by riffle with glide. As with upstream it supported no macrophytes due to the high energy. The stream supported drab brook-moss (*Hygrohypnum luridum*) on large woody debris instream and locally shining hookeria (*Hookeria lucens*). The bed supported cobble with mixed angular coarse, medium and fine gravels with no filamentous algae cover. The bed was moderately silted with silt plumes underfoot with moderate compaction. The riparian areas supported mature beech (*Fagus sylvatica*), hawthorn, blackthorn (*Prunus spinosa*), grey willow and bramble. The bordering land use was of semi-improved grassland (GA1).

**Plate 3.4** Survey site 3 on the Corraneary Stream downstream of the proposed quarry discharge location

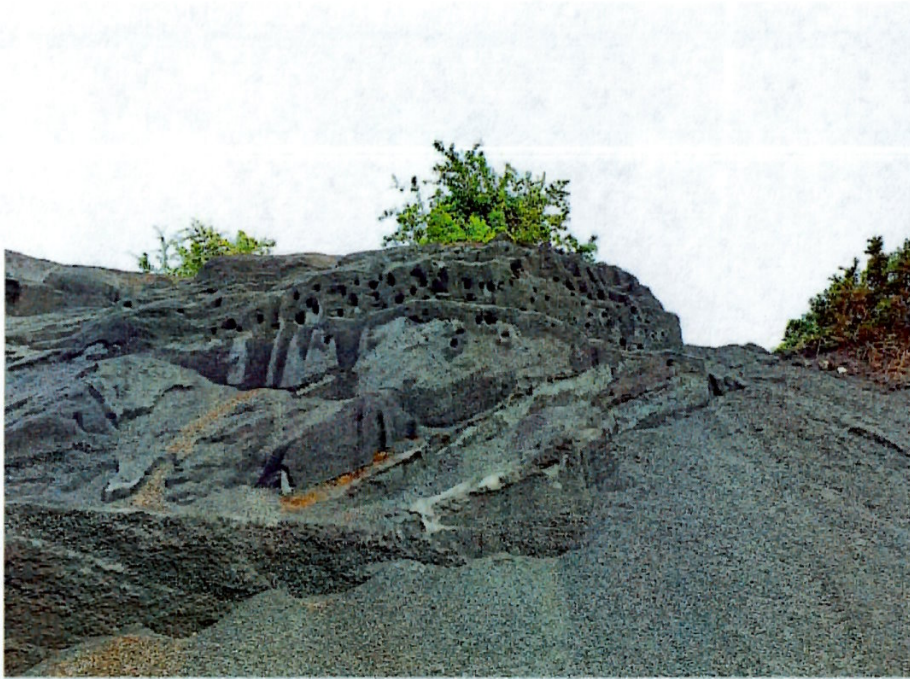
Plate 10: Example of old Sand Martin nests on Site – Photographed at Point #3 on Figure 5-3

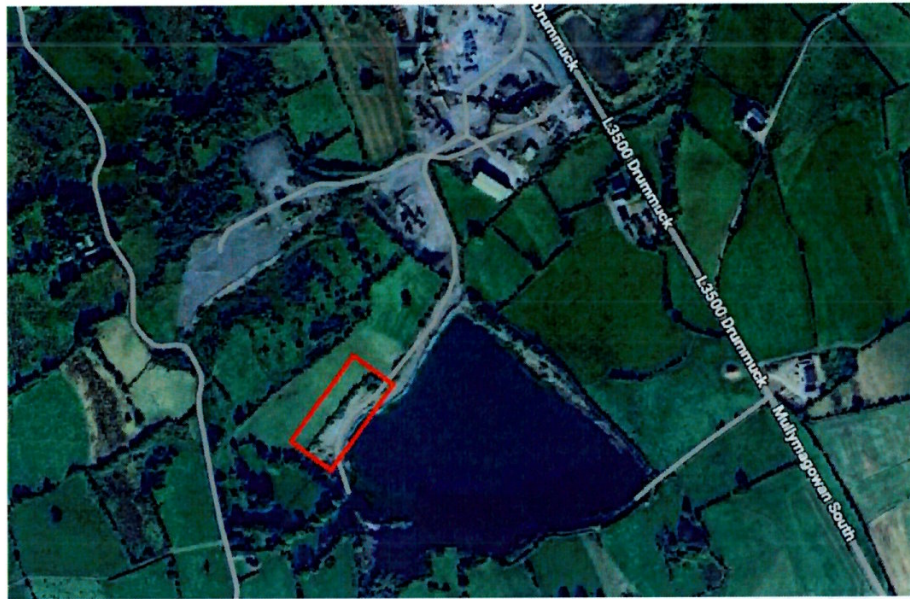
- **Sand Martins** (Amber Listed on the BoCCI list. Sand Martins use sand faces to make nests onsite. Sand Martin Nests are visibly present on bare stockpiles near the aggregate washing plant and north of the existing quarry void there are potential nesting areas. To ensure sand martins are protected onsite the following control measures will be implemented:
  - Existing established sand martin nests in stockpiles near the aggregate washing plant and quarry void will be fenced off and protected to prevent disturbance.
  - Additional habitat for further nesting can be provided in the area indicated in Figure 3 below.

Figure 3 showing the area at western corner of site to be developed to accommodate sand martin nests.
