## Coastal Erosion Study

# Ringaskiddy Resource Recovery Centre

## Environmental Impact Statement

Issue 3 | 28 August 2026

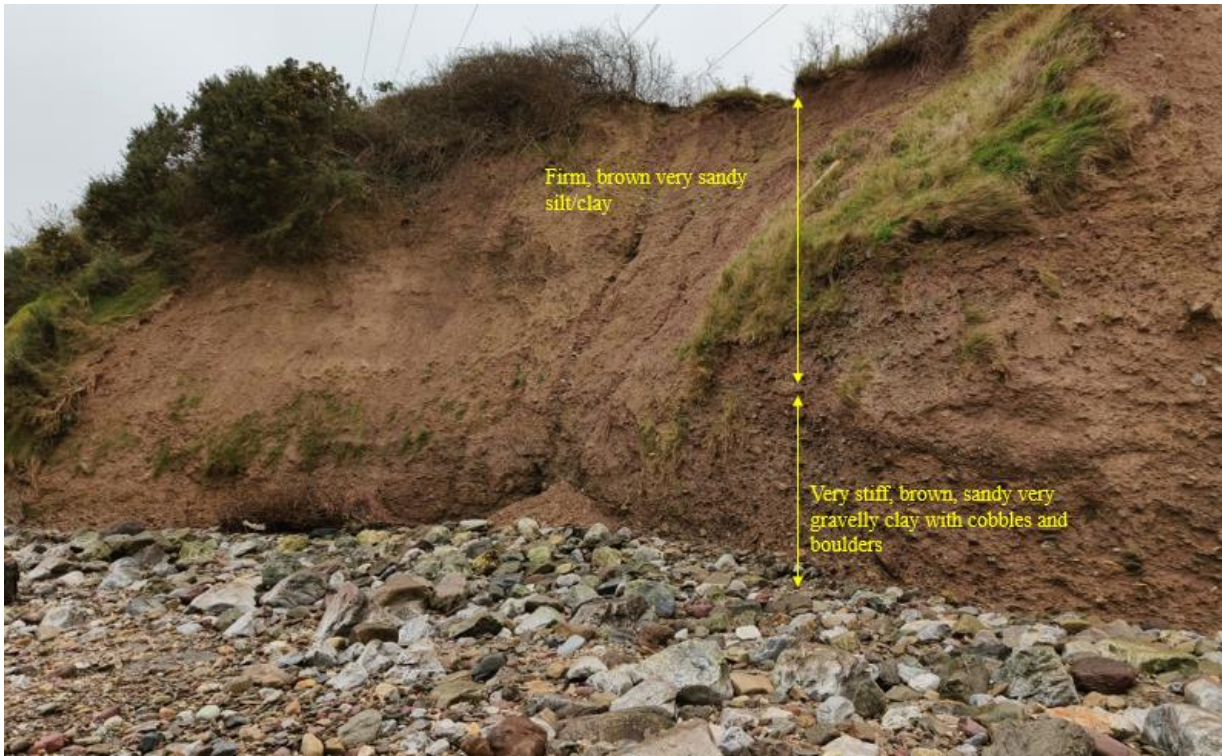
During the site walkover the cliff face was noted as having fresh unvegetated slumps and landslide features along the extent of the proposed development coastal boundary. Upon inspection of these features, it appeared that the slumped material and the material in the slope scarps is silty and sandy in consistency. The slump and landslide features become more substantial as the height of the cliff rises towards the southern boundary. A stiff/hard brown sandy very gravelly clay with cobbles and boulders was visible in areas at the toe of the slope where it was not covered by slumped material. The overlying material comprises of firm brown, very sandy silt/clay.

**Figure 5 Representative cross section of the stratigraphic profile of the eastern coastal cliff boundary**

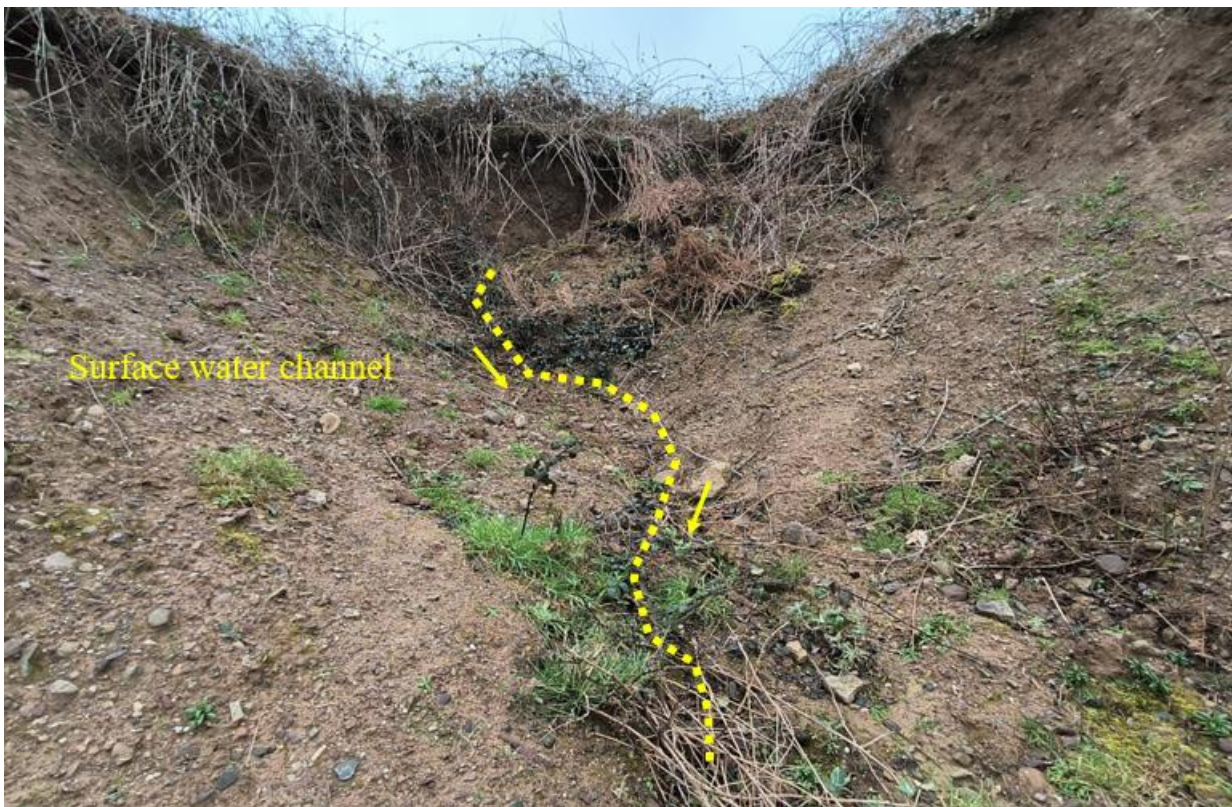
Erosion at the toe of the cliff face was noted and notching evident as outlined in **Figure 6**. There is evidence of overland water flow down the cliff face and is likely to contribute to slope failure. Surface water from the top of the cliff was recorded flowing through a landslide scarp and in other areas surface water channels are evident on the cliff face. Groundwater seepages were noted at the toe of the cliff slope.

**Figure 6 Surface water channel in a landslide scarp**

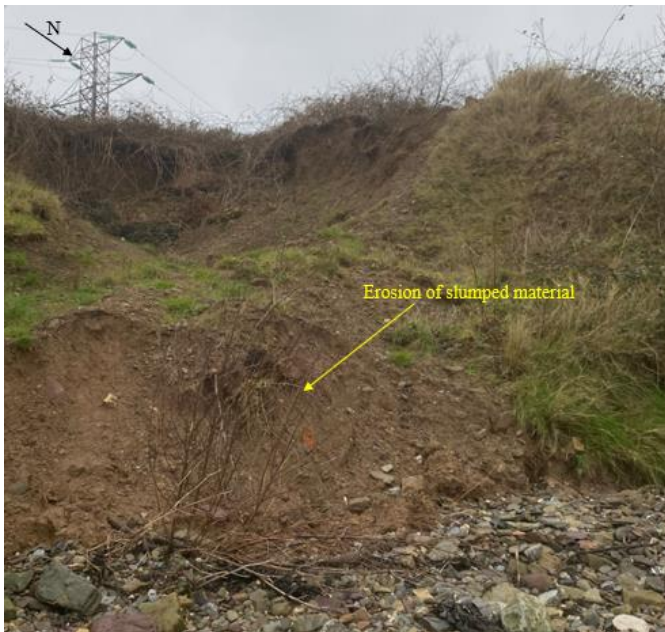
A larger landslide was recorded at the southern boundary of the site, which is the same failure that was recorded in 2016 between Section F and G. This landslide occurs at a 10m high cliff section and has a bowl like morphology with steepened side slopes. The landslide presents as a global slip of material. A surface water channel runs through the failure and the slumped material at the toe has been eroded.

**Figure 7 Landslide between Section F and G**

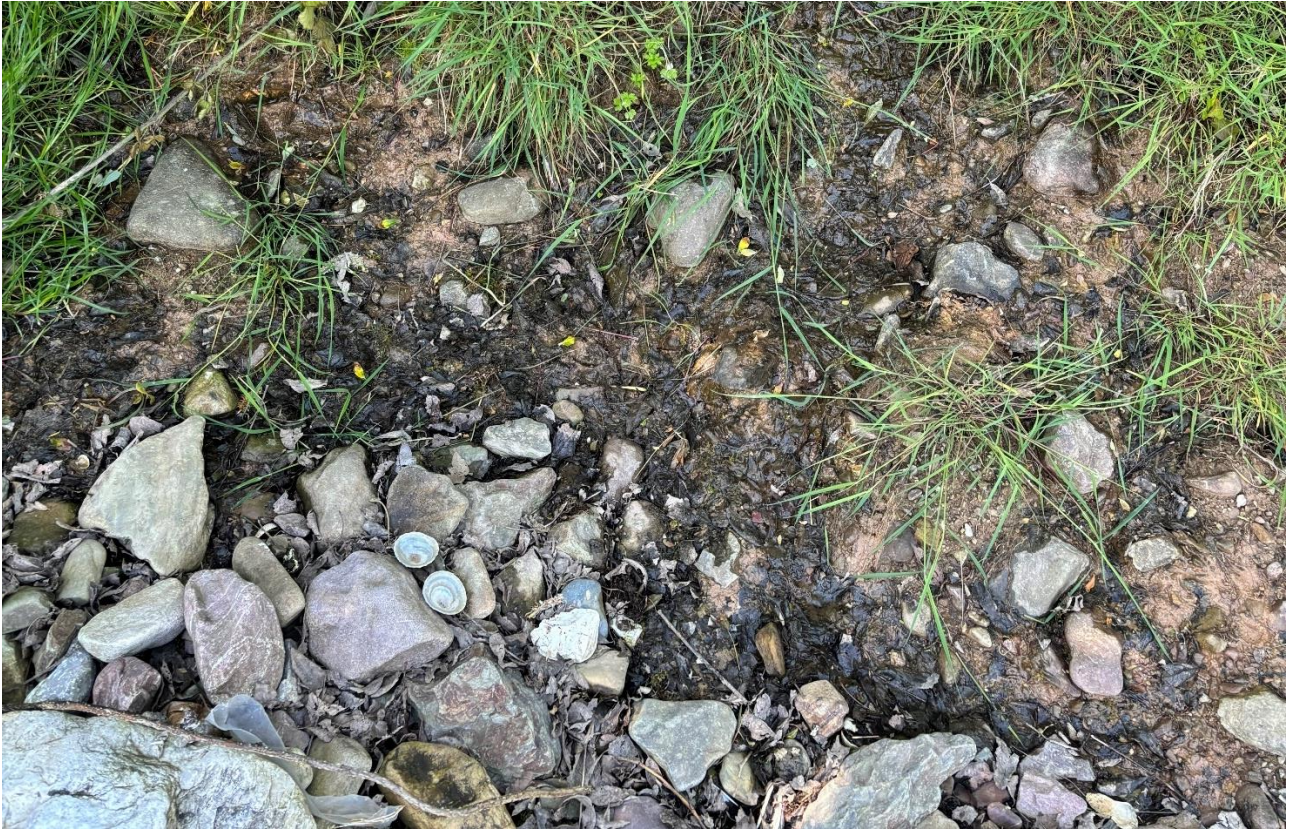
Despite the dry weather, the cliff toe appeared saturated at a number of locations along much of the beach, and a number of groundwater seepage springs were observed (see **Figure 8** as one example from the site visit report), indicating ongoing subsurface hydrological activity independent of the lack of rainfall.

**Figure 8 View of the seepage at the cliff toe mid-way between cross-sections E and F**

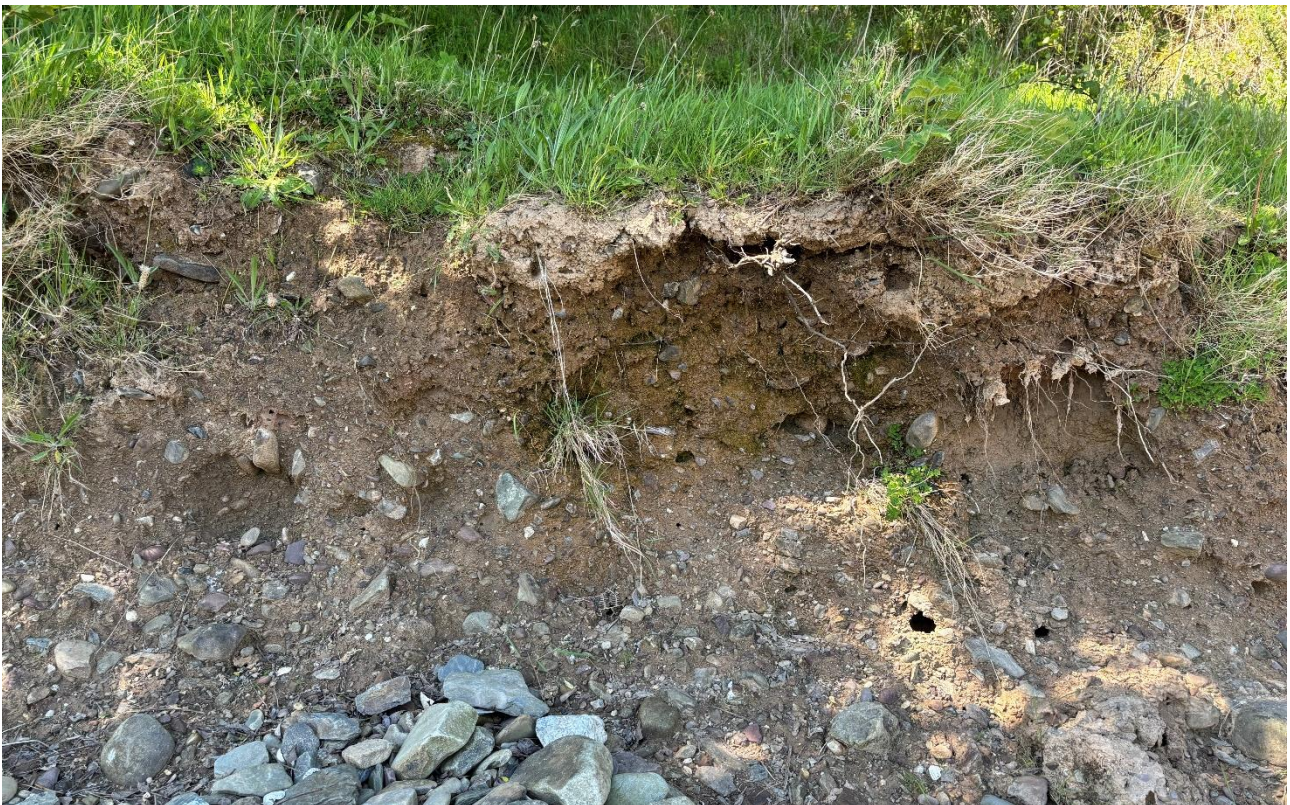
Several minor cliff failures were also observed, along with evidence of toe notching (see **Figure 9** as one example from the site visit report). Combined with the absence of vegetation at the cliff base, this suggests that the toe is periodically reached and influenced by tides and waves.

**Figure 9 View of cliff toe notching at cross-section D**

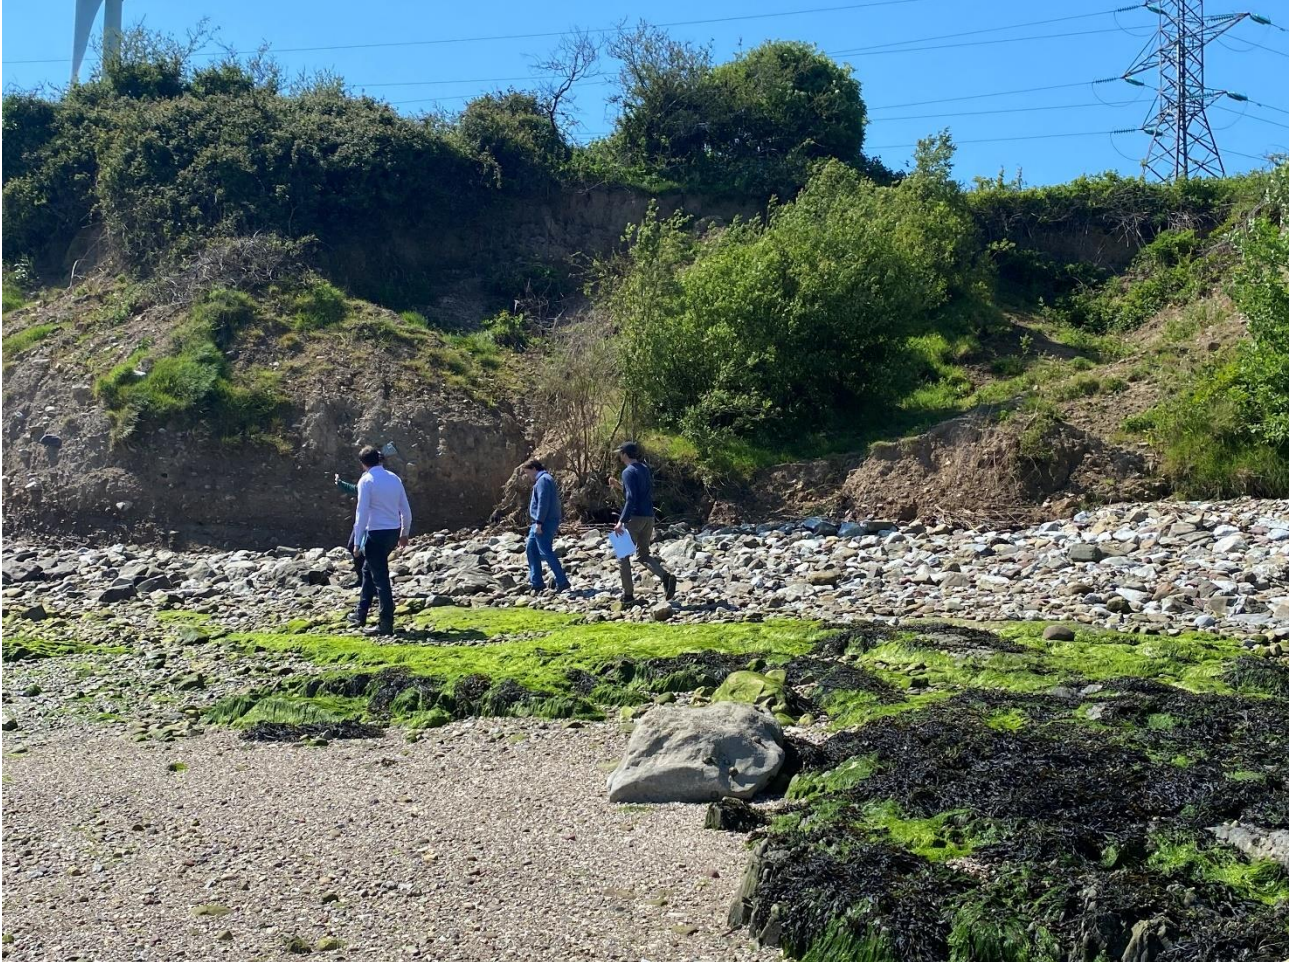
The significant cliff failure identified in the 2016 site walkover (refer to **Section 2.3.1**) and the topographic survey assessment (refer to **Section 2.2**), can be seen in **Figure 10**. Exposures of the underlying mudstone/sandstone bedrock (as identified in the GI for the area) were noted along the beach in this section.

**Figure 10 View of the cliff face between Sections F and G**

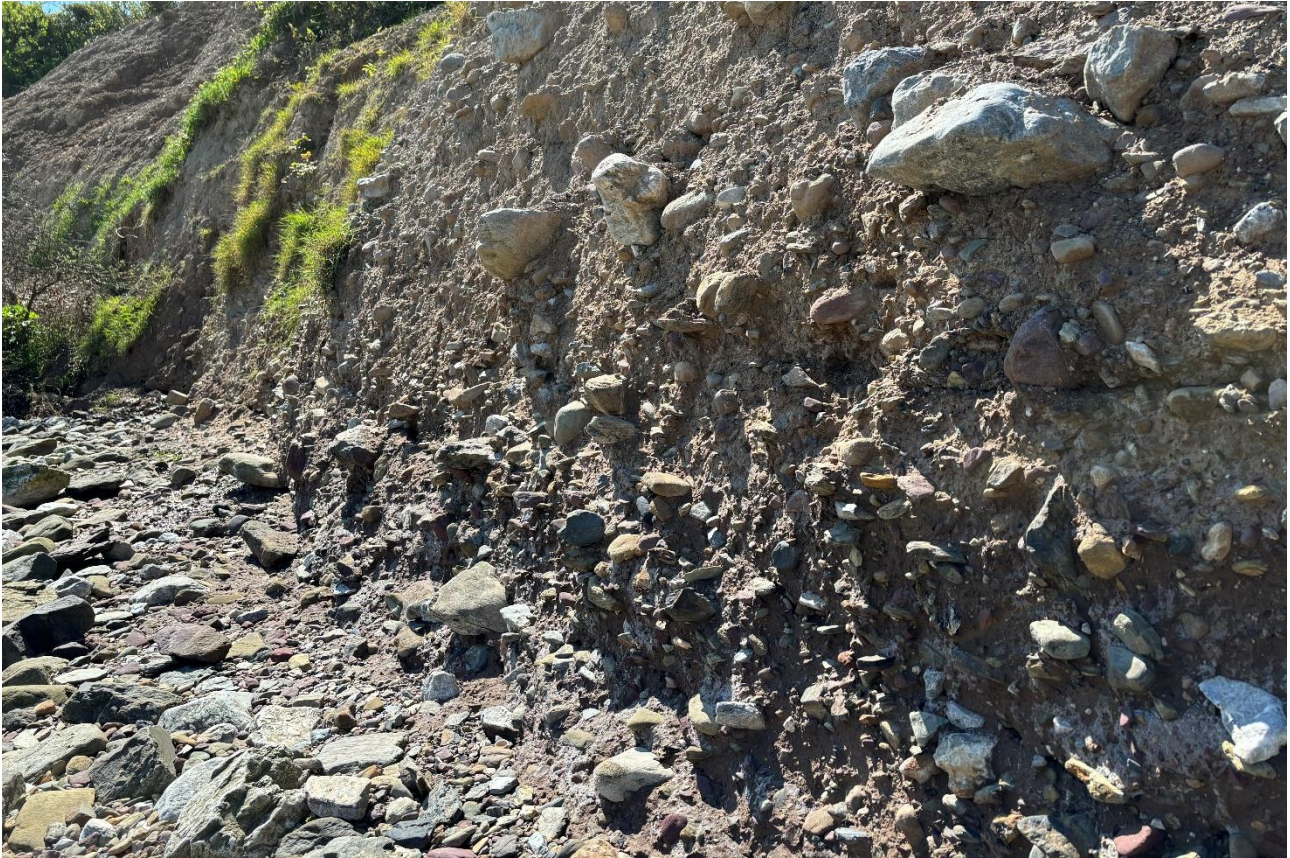
Just south of cross-section G, a distinct material change in the cliff face is observed. A very stiff/hard sandy very gravelly clay with many cobbles and occasional boulders extending approximately 1m above beach level was observed along the cliff toe, sloping gently downwards from south to north. This layer is an over consolidated glacial till and is significantly stiffer and more granular than the overlying strata (see **Figure 11**).

**Figure 11 View of the cliff face south of cross-section G**

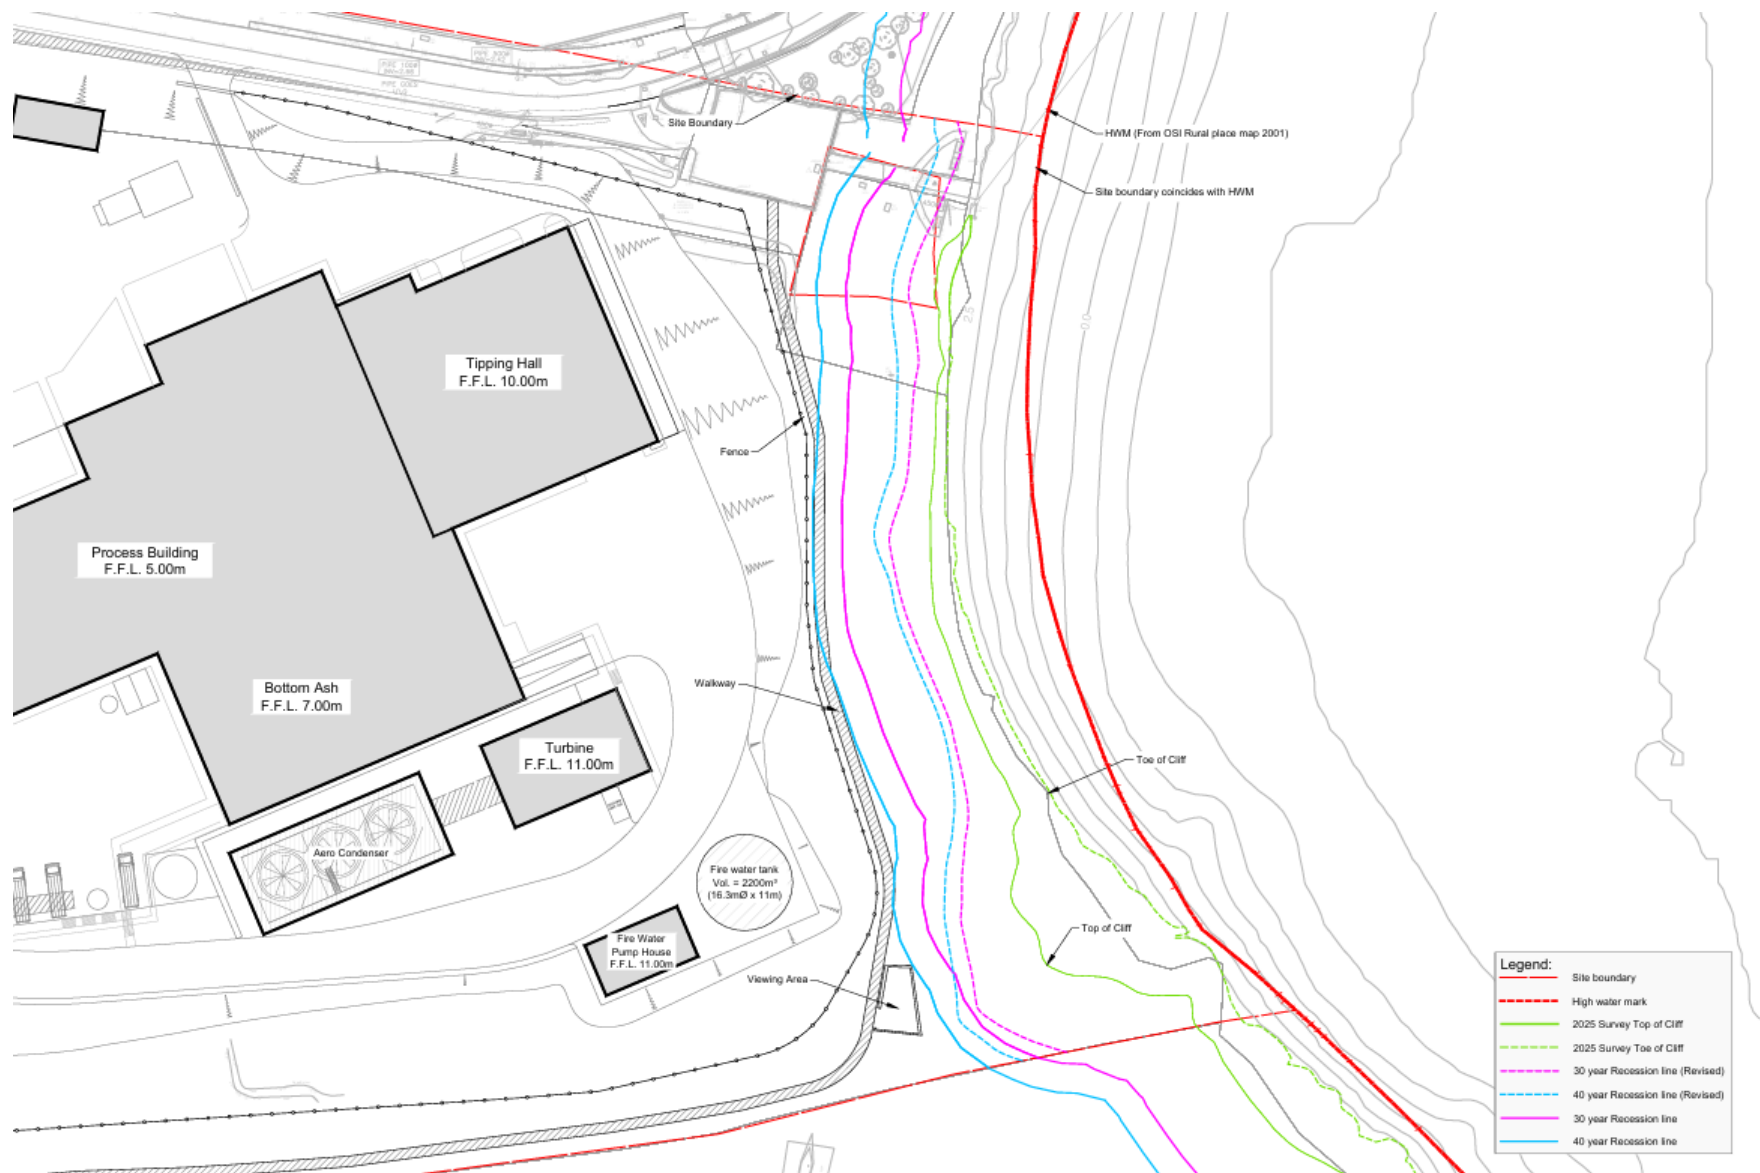
However, the study found that there could be a risk of an effect on a small section of the proposed development after 40 years which would be confined only to the amenity walkway and viewing platform which are located outside of the proposed security fence line.

Figure 13 Projected Cliff Top Retreat Lines (including updated Assessment, see Appendix I) Based on the 2025 Topographic Baseline for 30-Year (2055) and 40-Year (2065) Timeframes

Arup investigated a number of coastal protection options that could be applied to the Indaver site. Arup has recommended that the Indaver coastal boundary is monitored on an annual basis and the placement of approximately 1,150m<sup>3</sup> of sacrificial material (shingle of appropriate size and rounded shape with high density and resistance to abrasion) above the foreshore on Gobby beach along the eastern boundary of the Indaver site. This will be a 'soft' solution which will potentially reduce erosion rates by limiting the exposure of the toe of the cliff face to wave action.

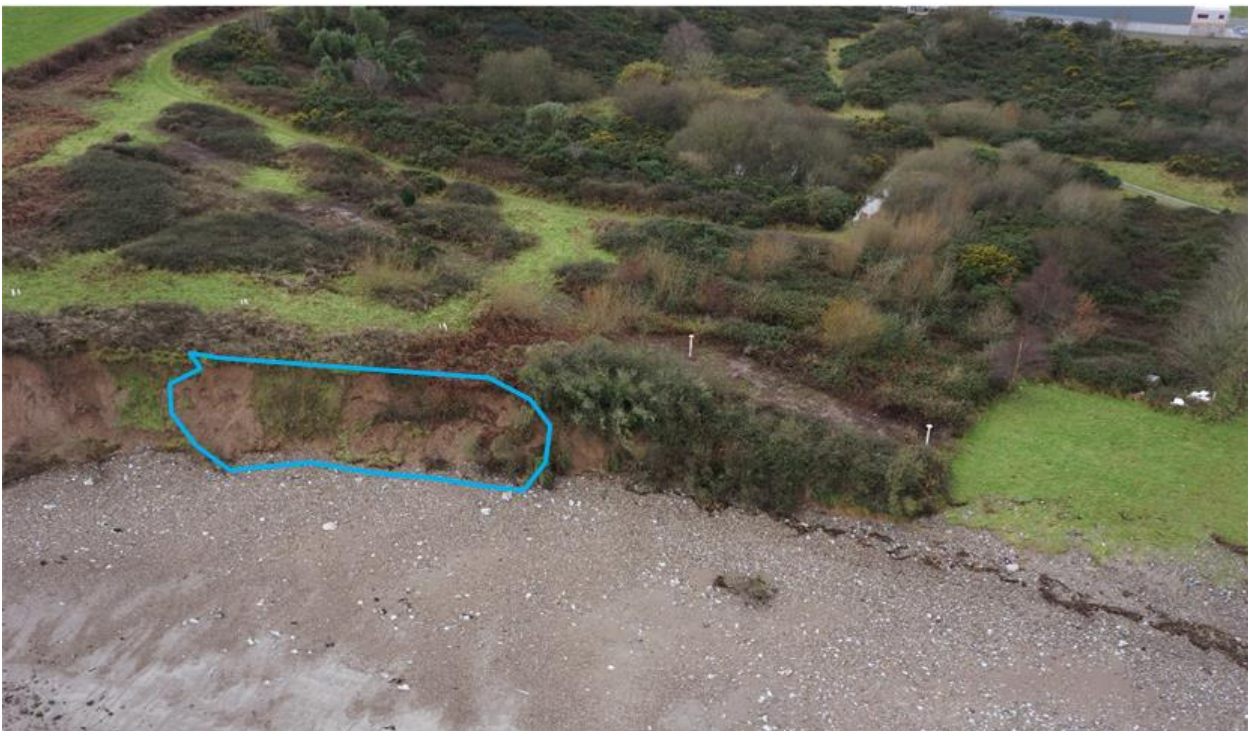
In January 2016 Indaver commissioned a drone survey of the coast adjacent to the proposed development site. **Figure 1** and **Figure 3** below show two areas where significant slope failures occurred. The first area shown in **Figure 1** (circled in blue) is approx. 20m long and cliff height is roughly 2 to 3m. This area is located approximately 50m south of the car park. The second area shown in **Figure 3** (circled in blue) is a further 20m south and is approximately 40m in length and cliff height is roughly 7 to 9m.

**Figure 1 Drone photography showing first area of slope failure and minimal damage to the beach north of this location**

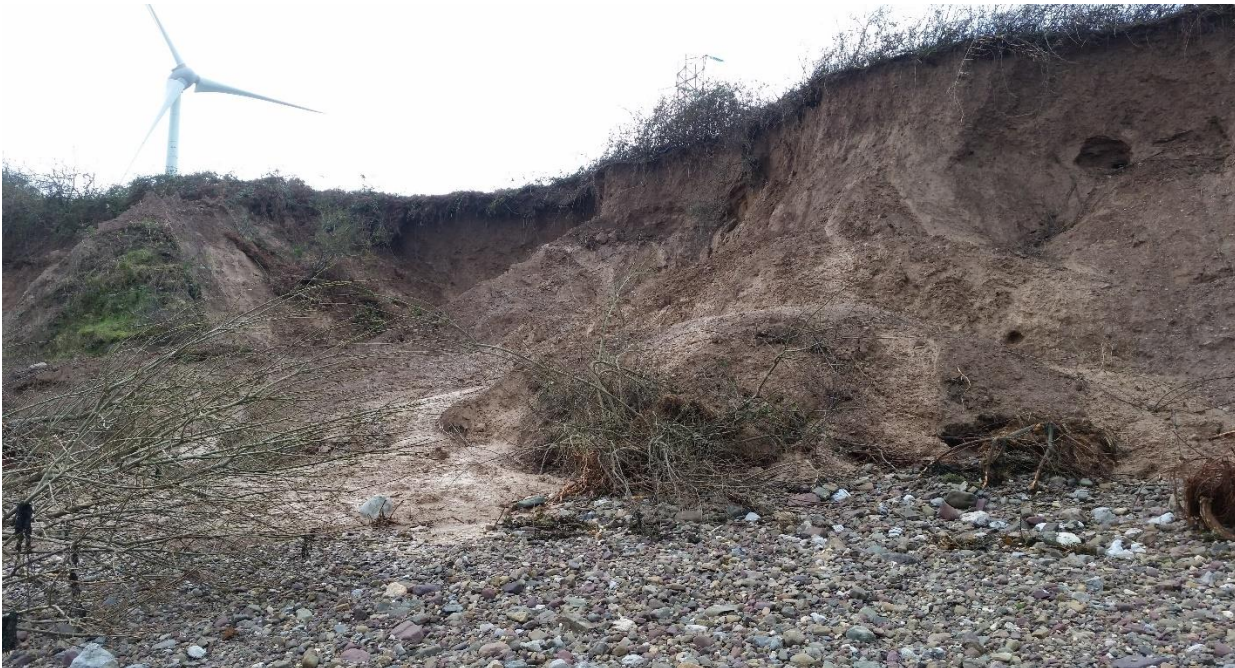
**Figure 8** Second area of slope failure further 20m south

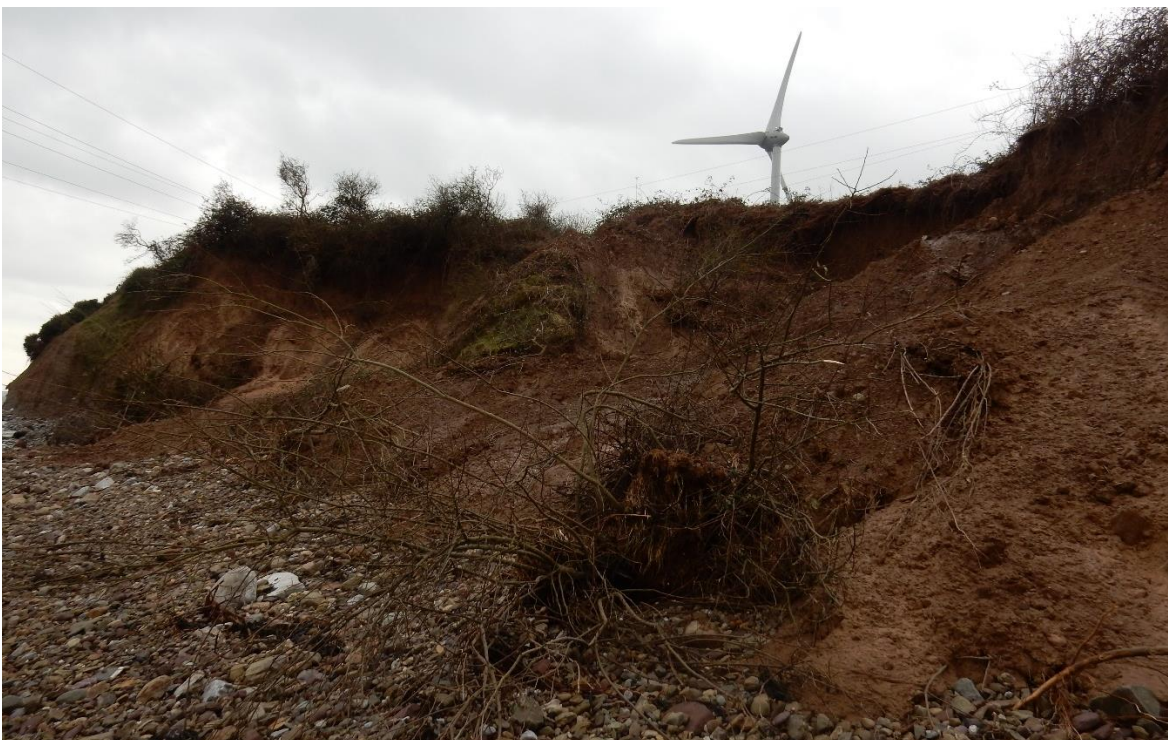
The evidence observed on site shows that the recent slope failures are due to the effects of the excessive rainfall over the month of December. While sea erosion is a contributing factor to erosion along this section of coast, the recent slips were triggered by water pressure and flow within the cliff material causing instability and slip failure.

**Figure 15 Area of collapse showing flatter slope**

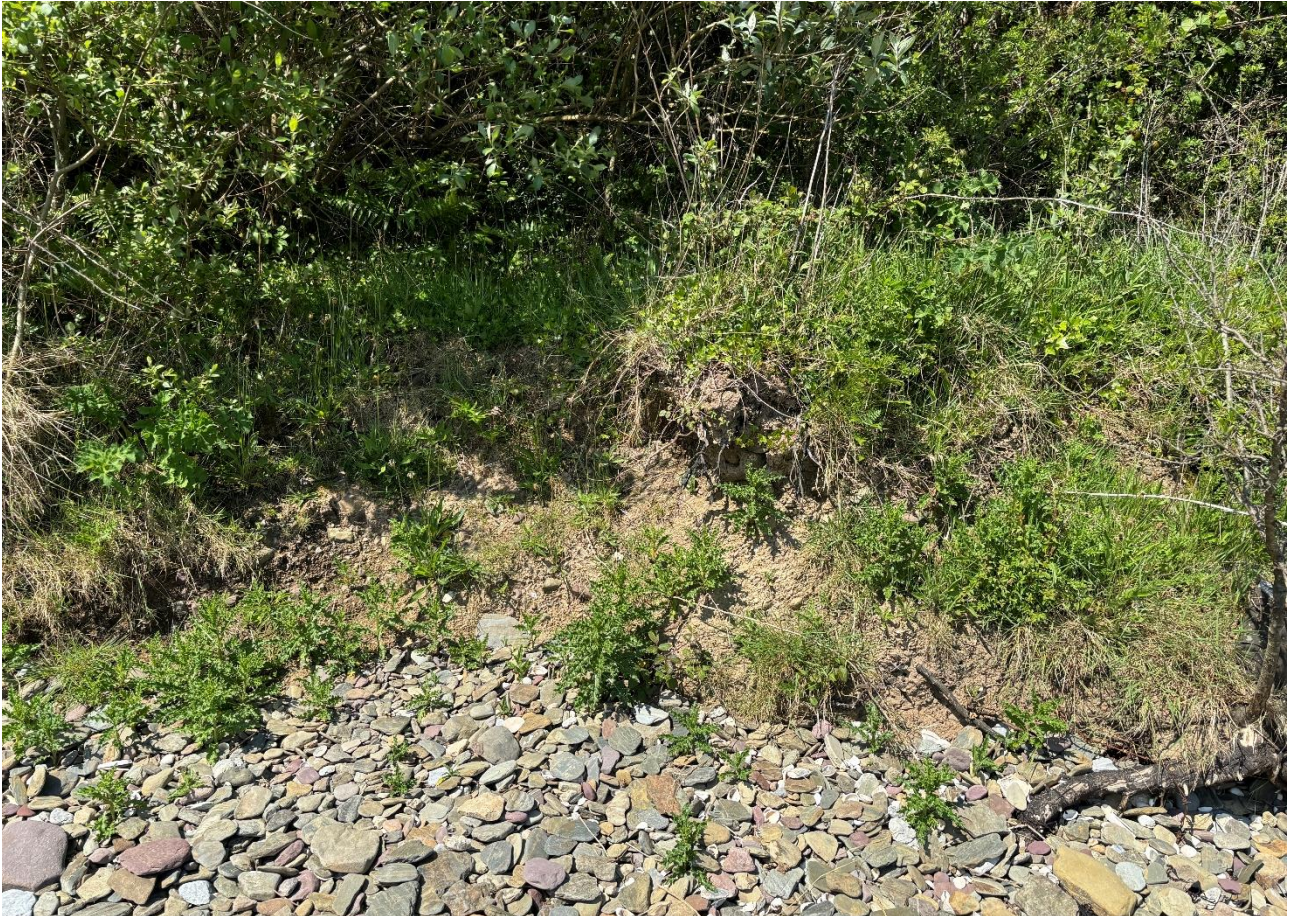
**Figure 7 View of the cliff toe at cross-section C**

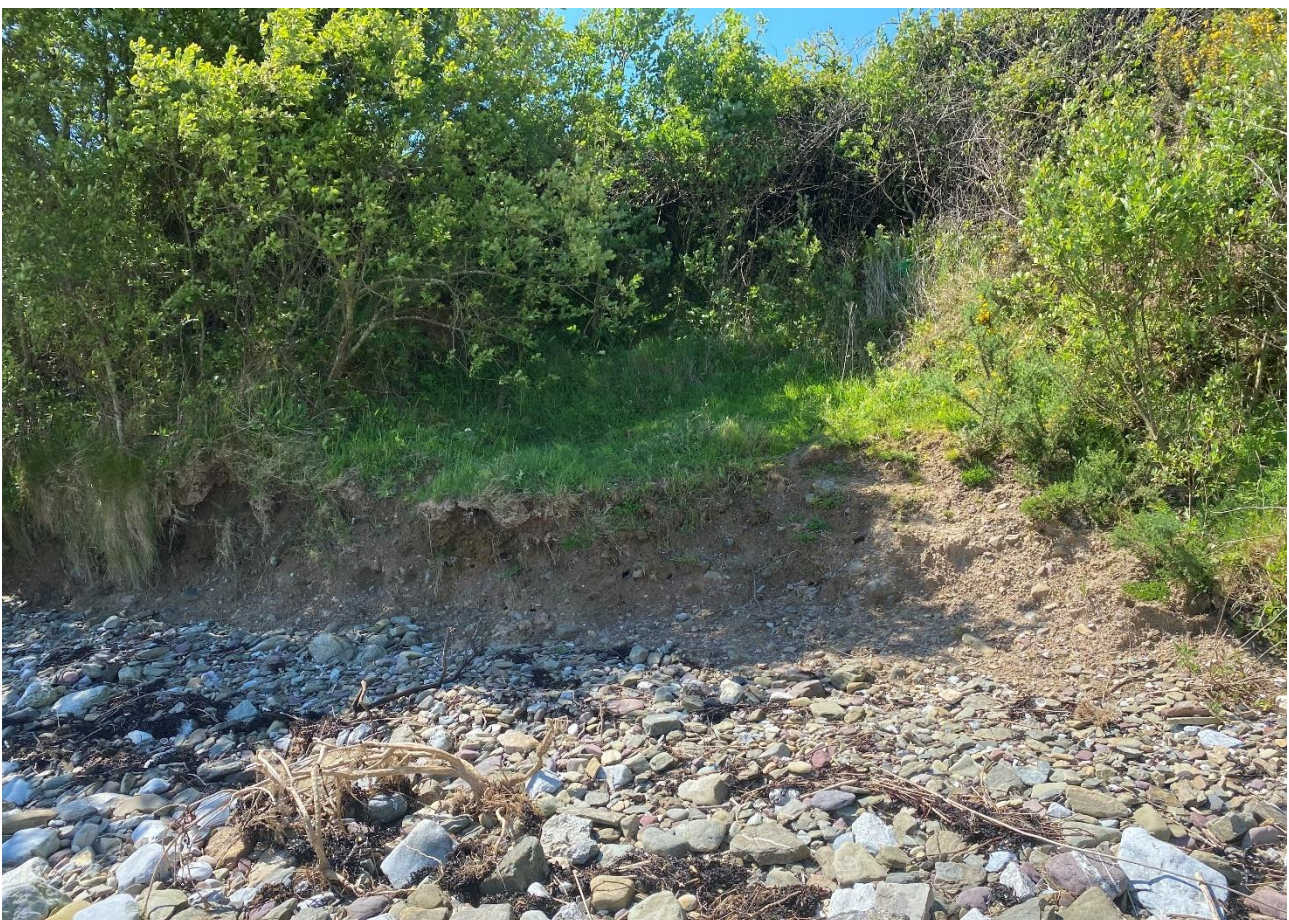
**Figure 8 View of the cliff face at cross-section D**

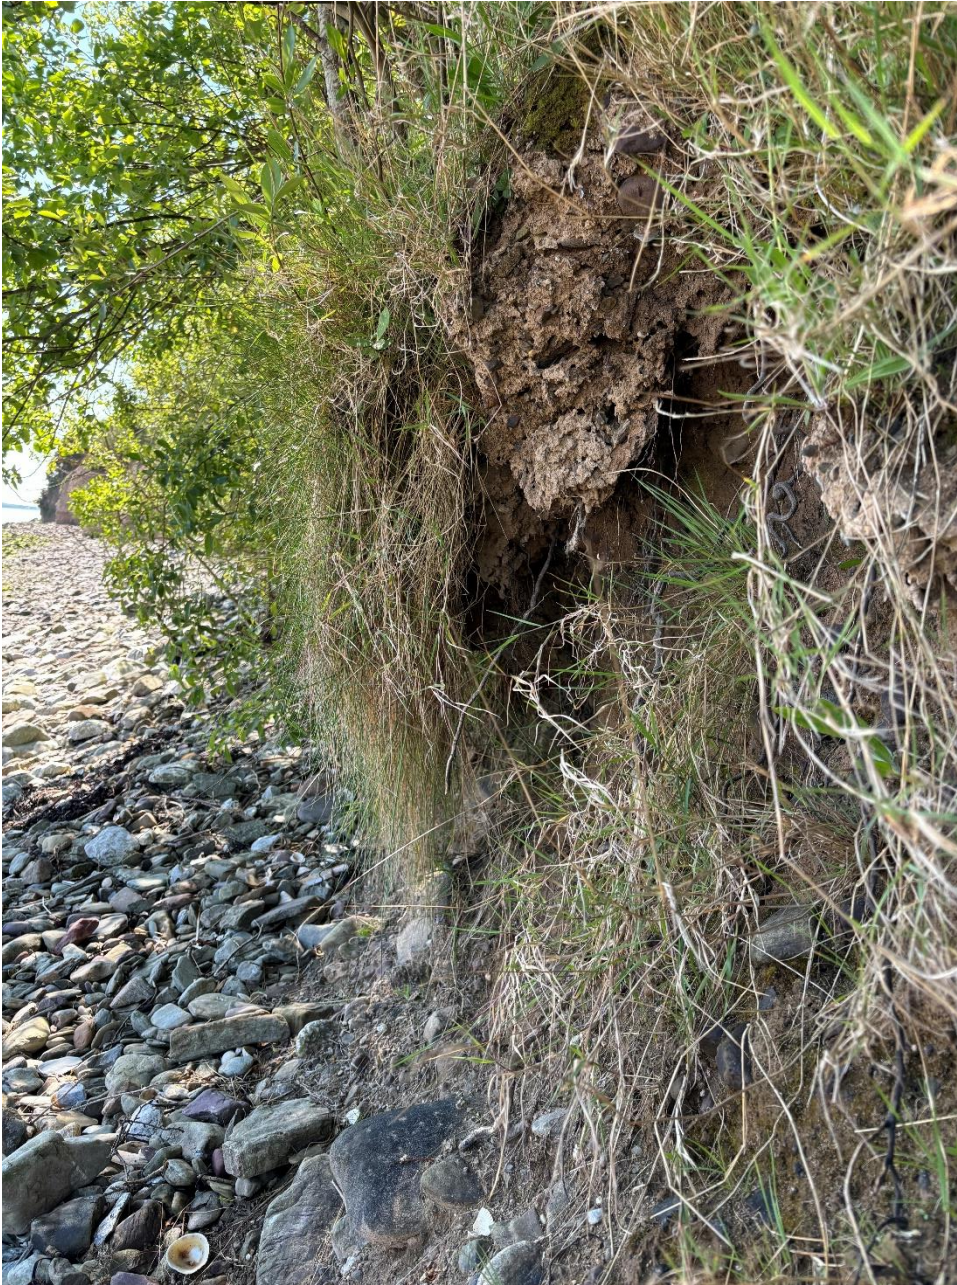
**Figure 11 View of cliff toe notching just south of cross-section D**

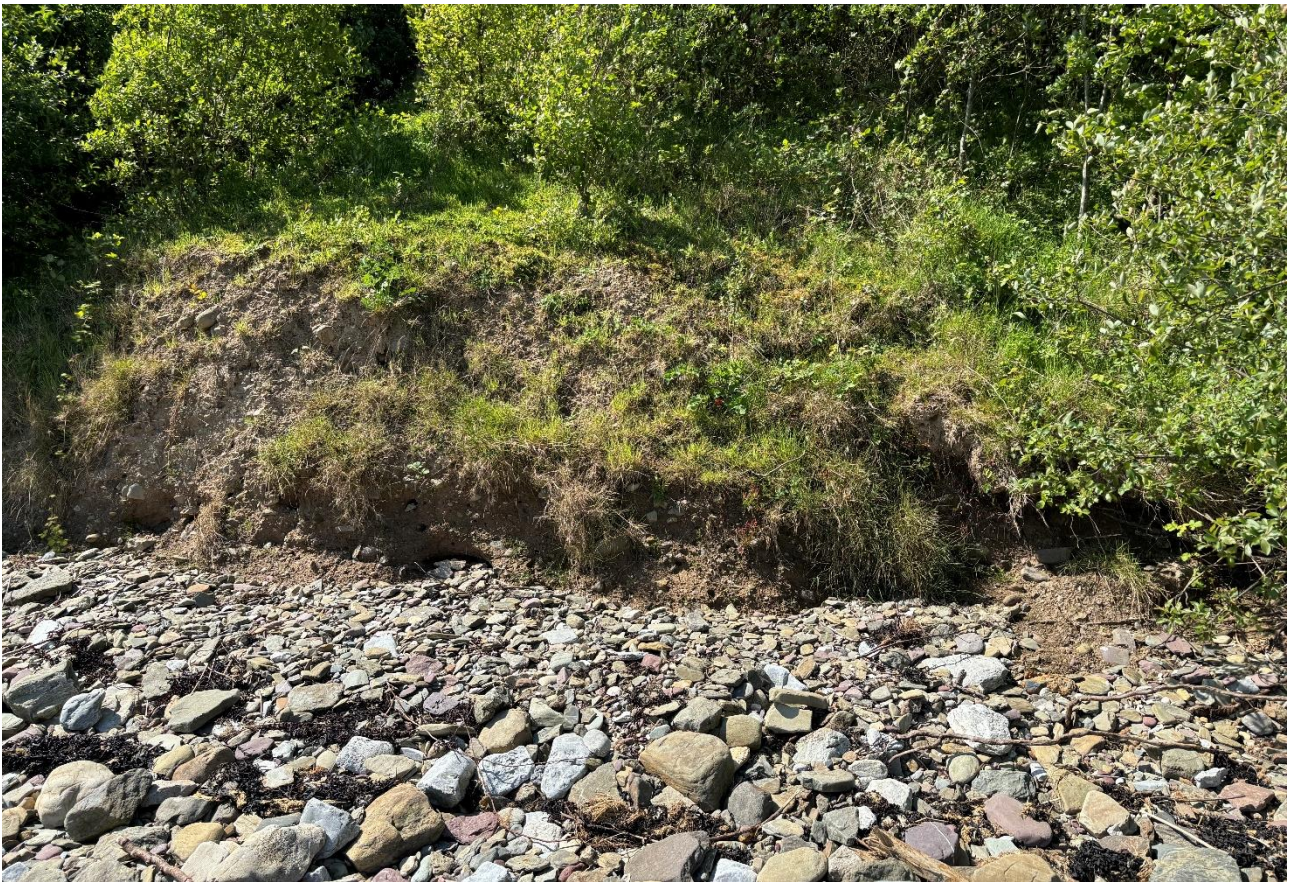
**Figure 14 View of the cliff face mid-way between cross-sections E and F**

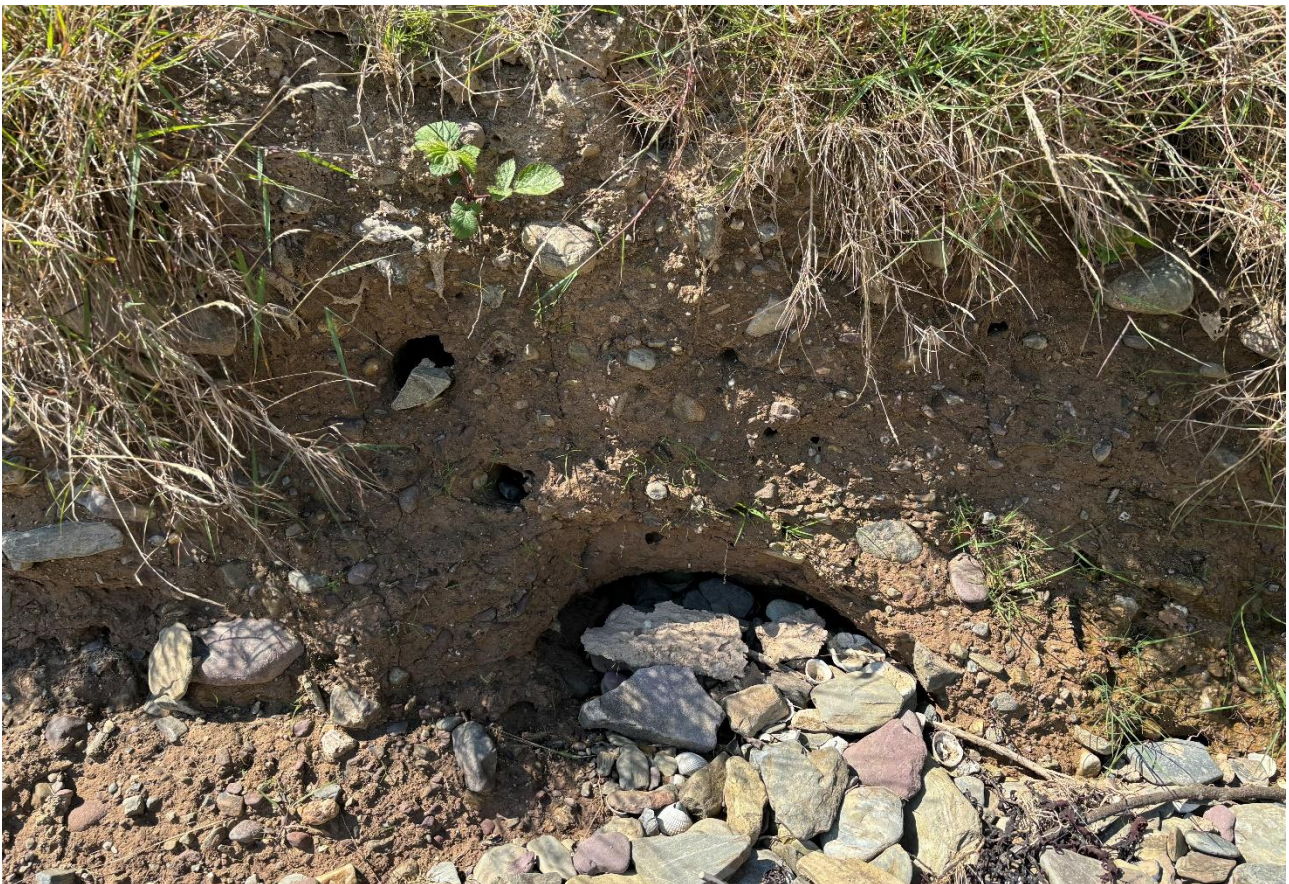
**Figure 16 View of the cliff toe mid-way between cross-sections E and F**

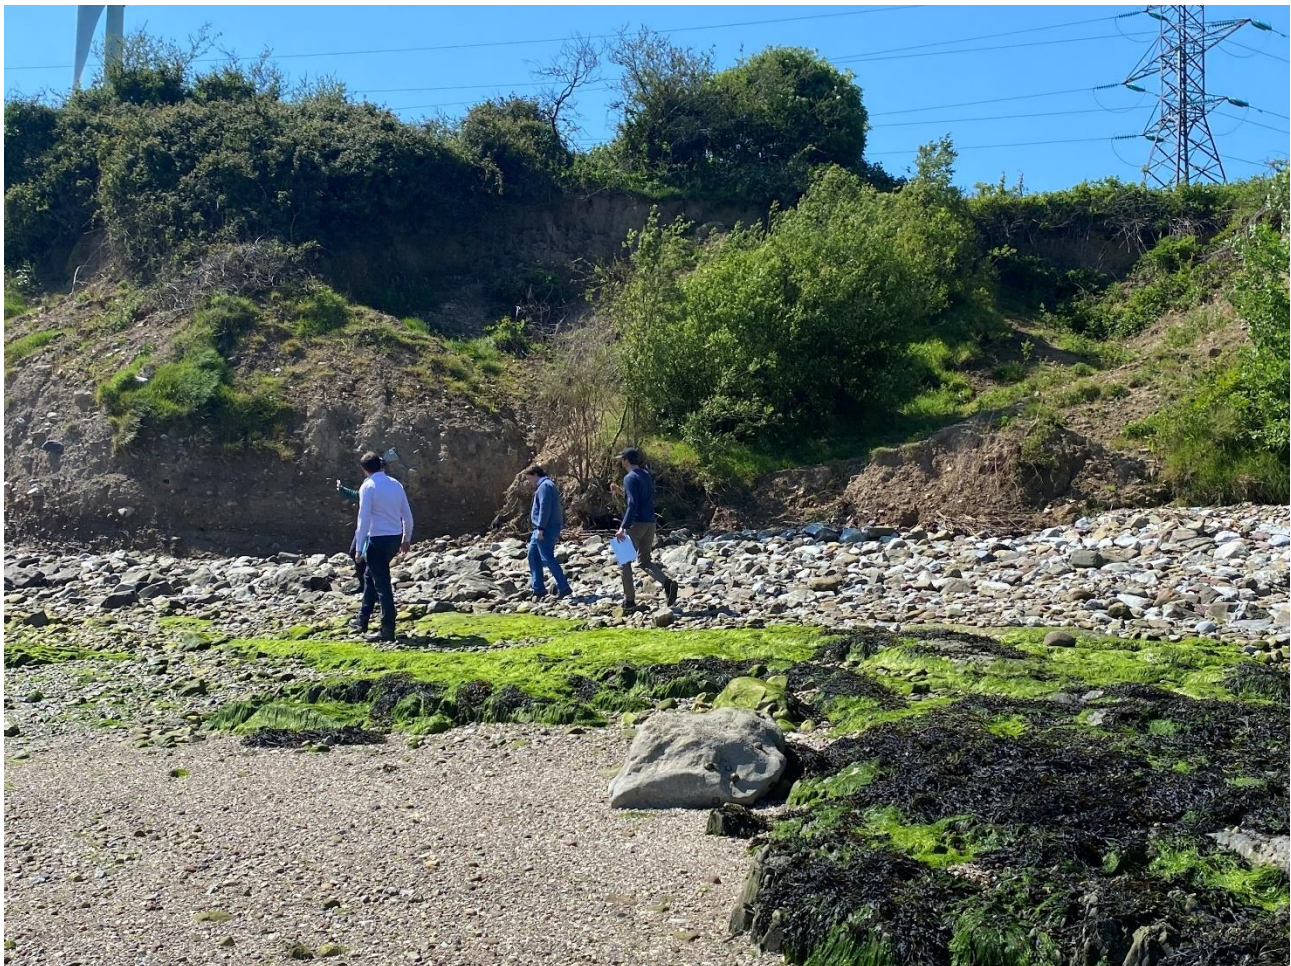
Exposures of the underlying mudstone layer (as identified in the GI for the area) were noted along the beach in this section (see **Figure 19** and **Figure 28**).

**Figure 19 View of the central and southern channels at sections F and G**

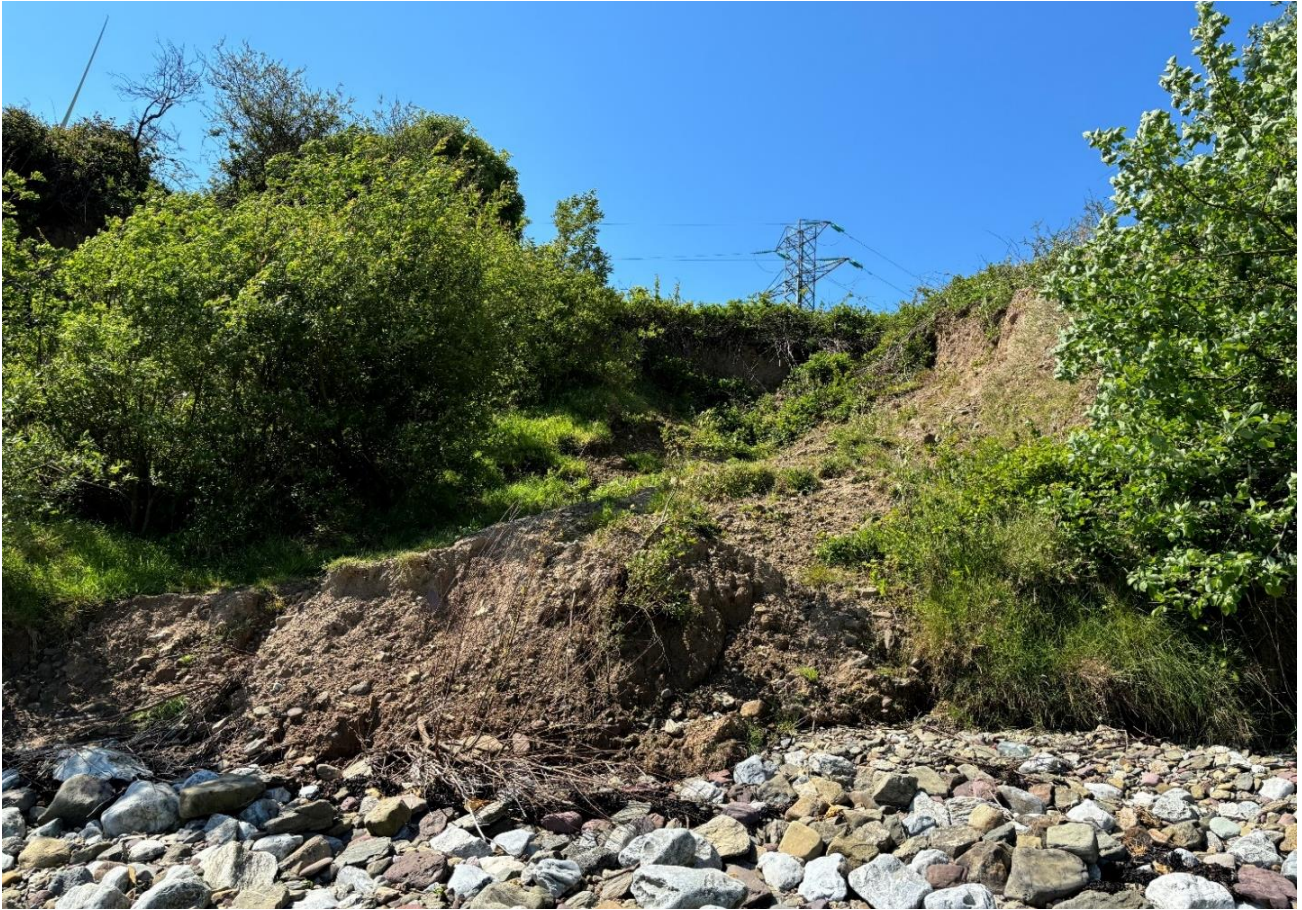
**Figure 20 View of the central channel at cross-section G from the beach**

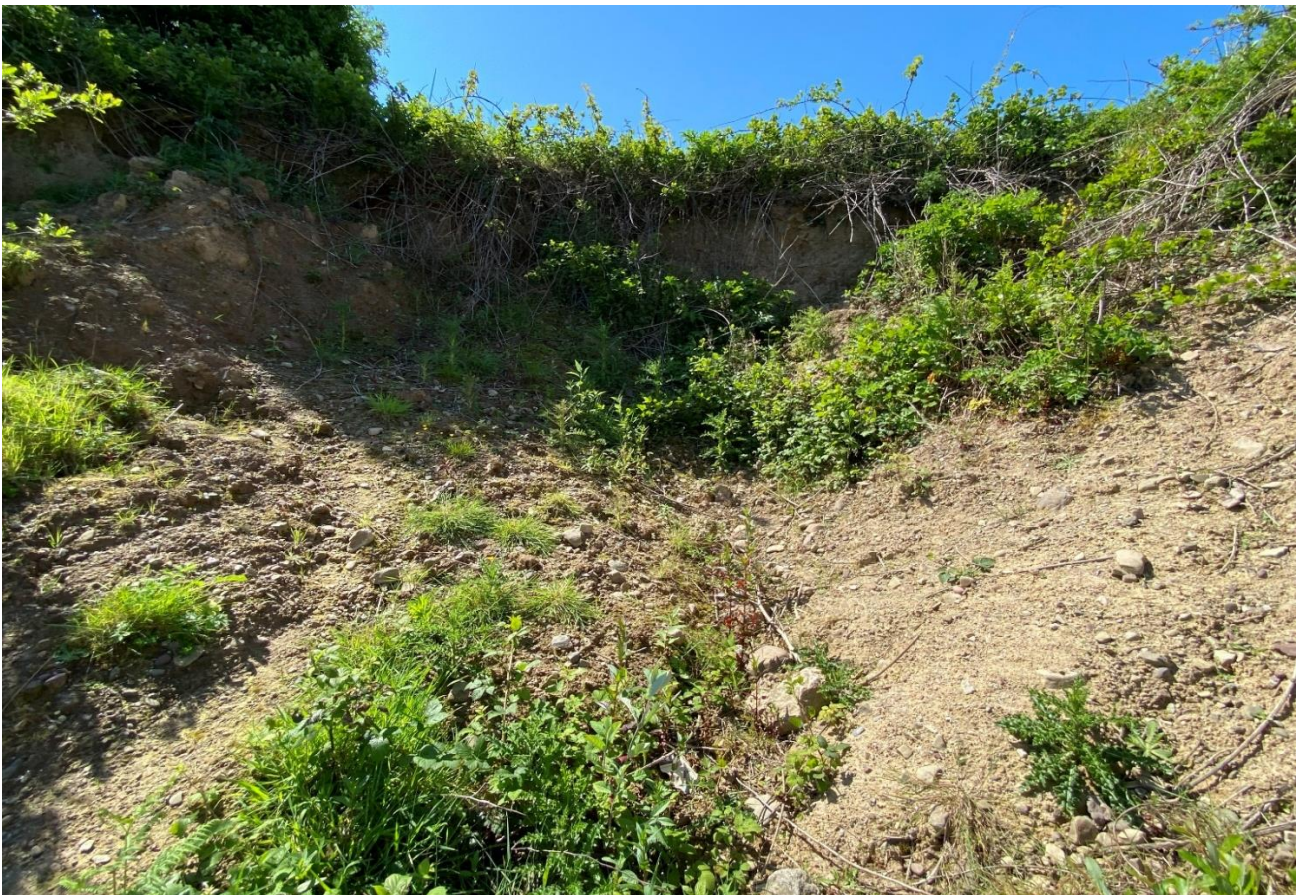
**Figure 21 View of upper slope of central valley at Section G**
