## Coastal Erosion Study

# Ringaskiddy Resource Recovery Centre

## Environmental Impact Statement

Issue 3 | 28 August 2026

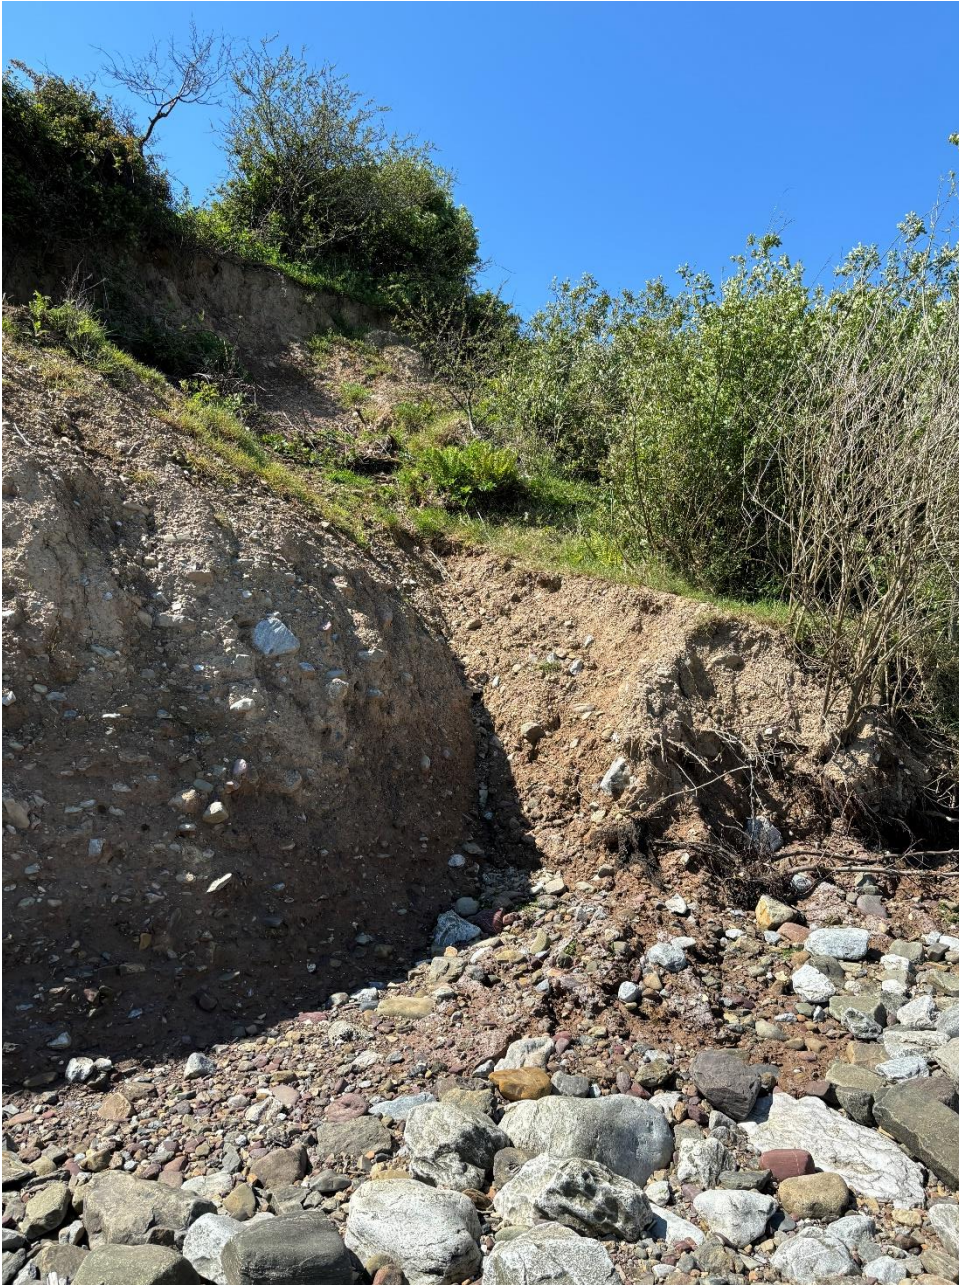
**Figure 22 View of the lower section of cliff face at cross-section G**

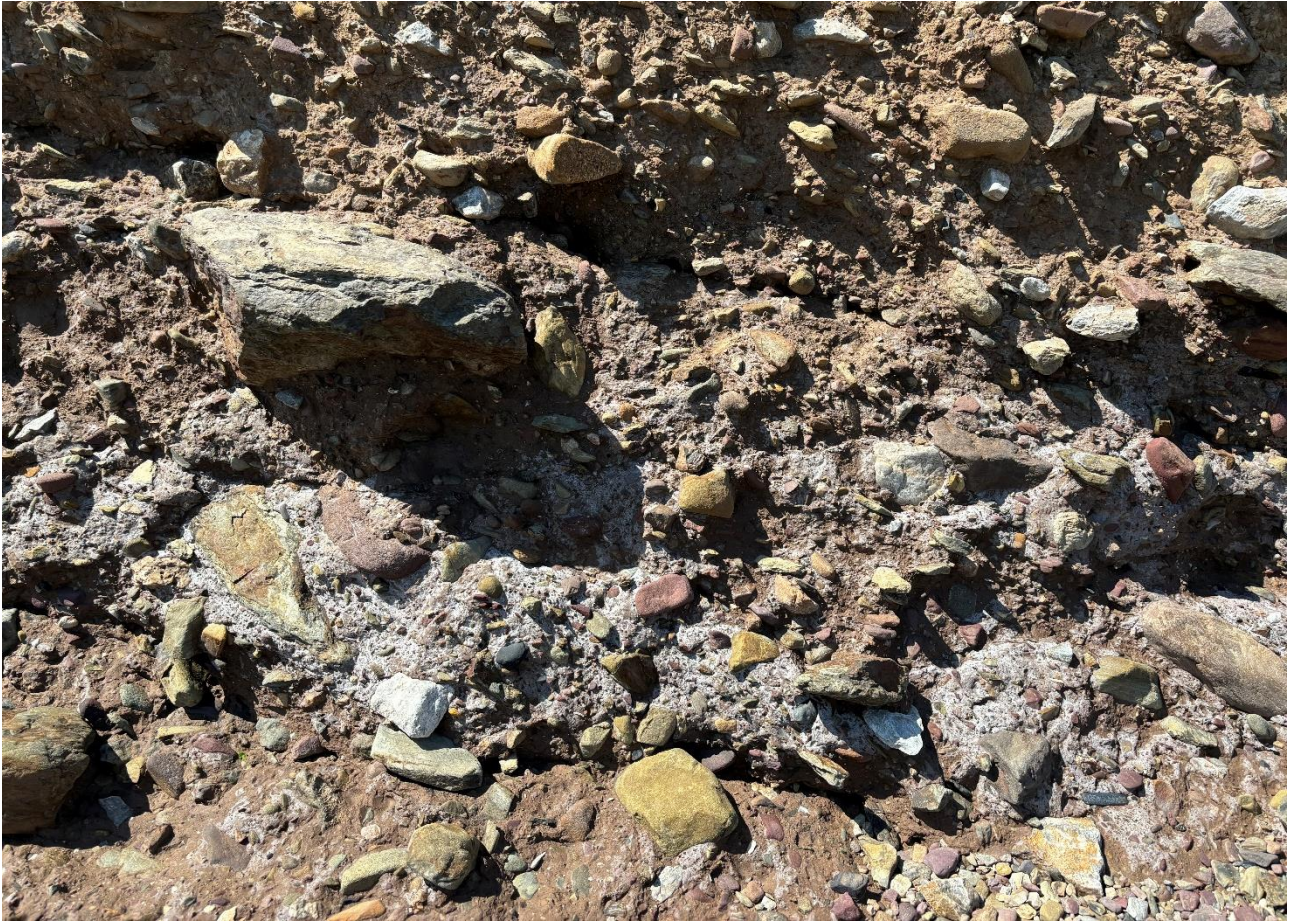
**Figure 27 View of the cliff toe south of cross-section G**

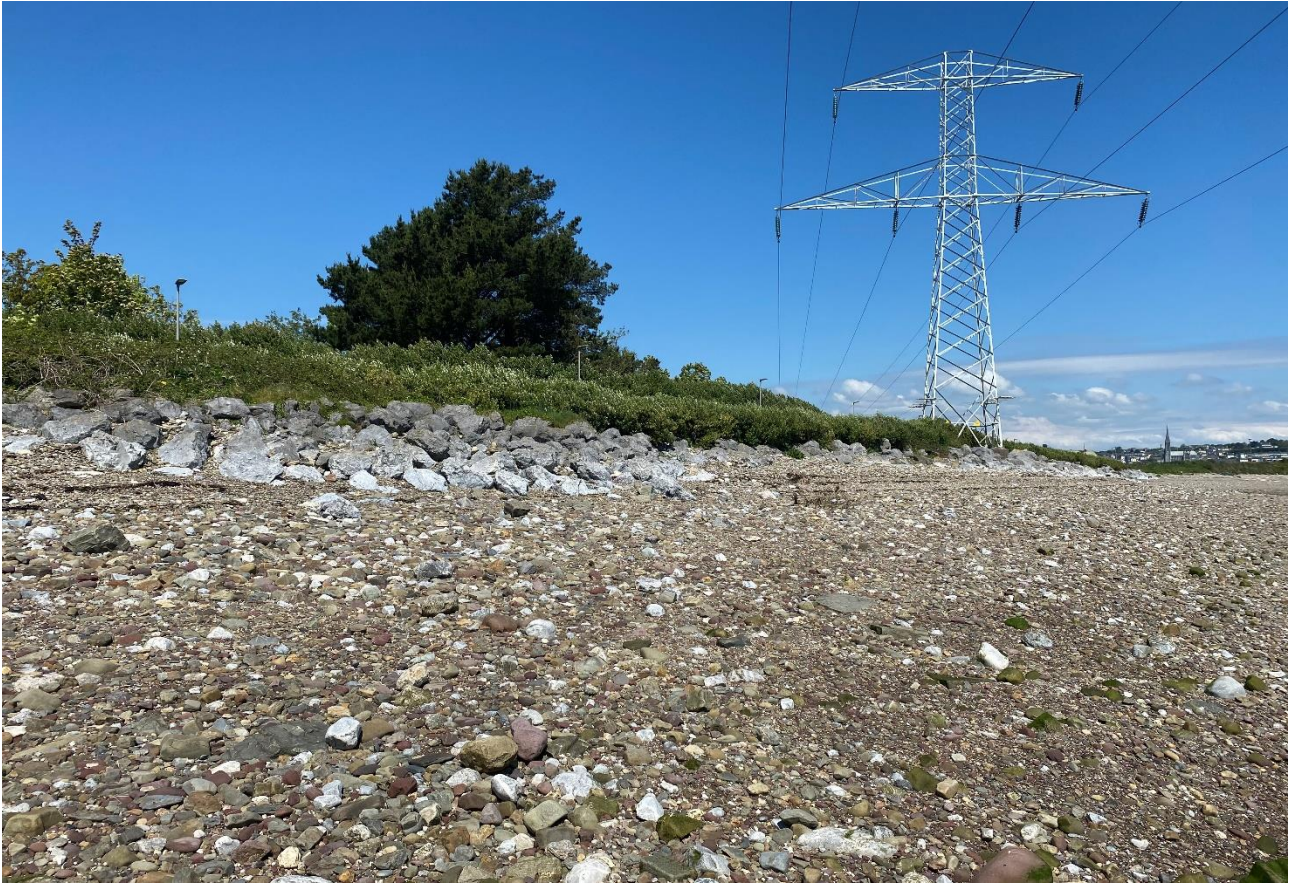
**Figure 33 View of the rock revetment along the bank north of the site**

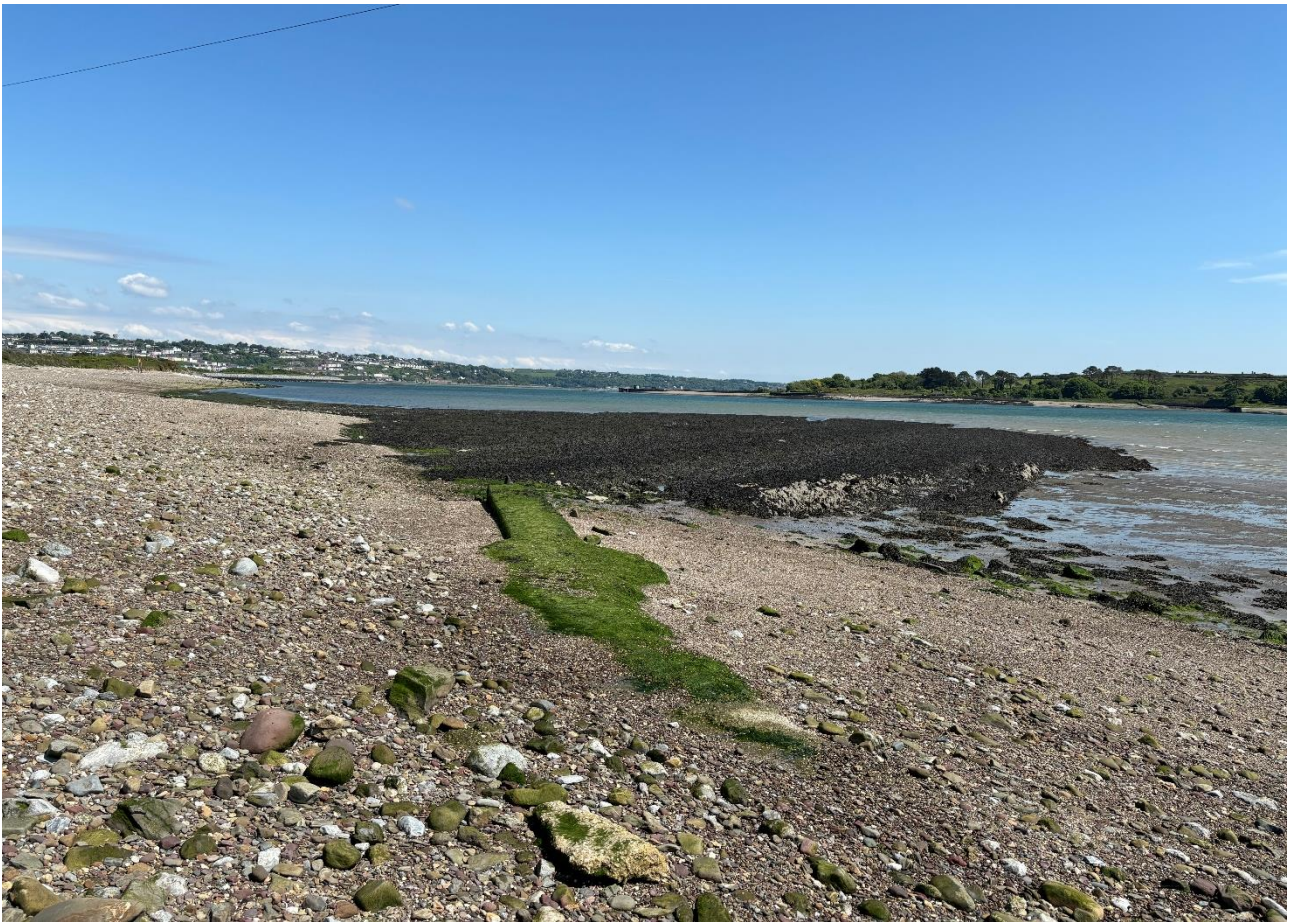
**Figure 34 Drainage network outfall**
