## Public Consultation No.2

### Annex 3.2 I: Drogheda Station Canopies Report

As part of the DART+ Coastal project, the Northern Line between Malahide and Drogheda is to be electrified with 1.5kV DC overhead line electrification. A study has been undertaken to determine the impact of electrification on station canopies. The study has identified that only the station canopy at Drogheda MacBride Station on Platform 1 will be affected and, as such, is the only canopy covered in this report. It is important to note that Drogheda (MacBride) Station is a protected structure which includes its canopies on the platforms.

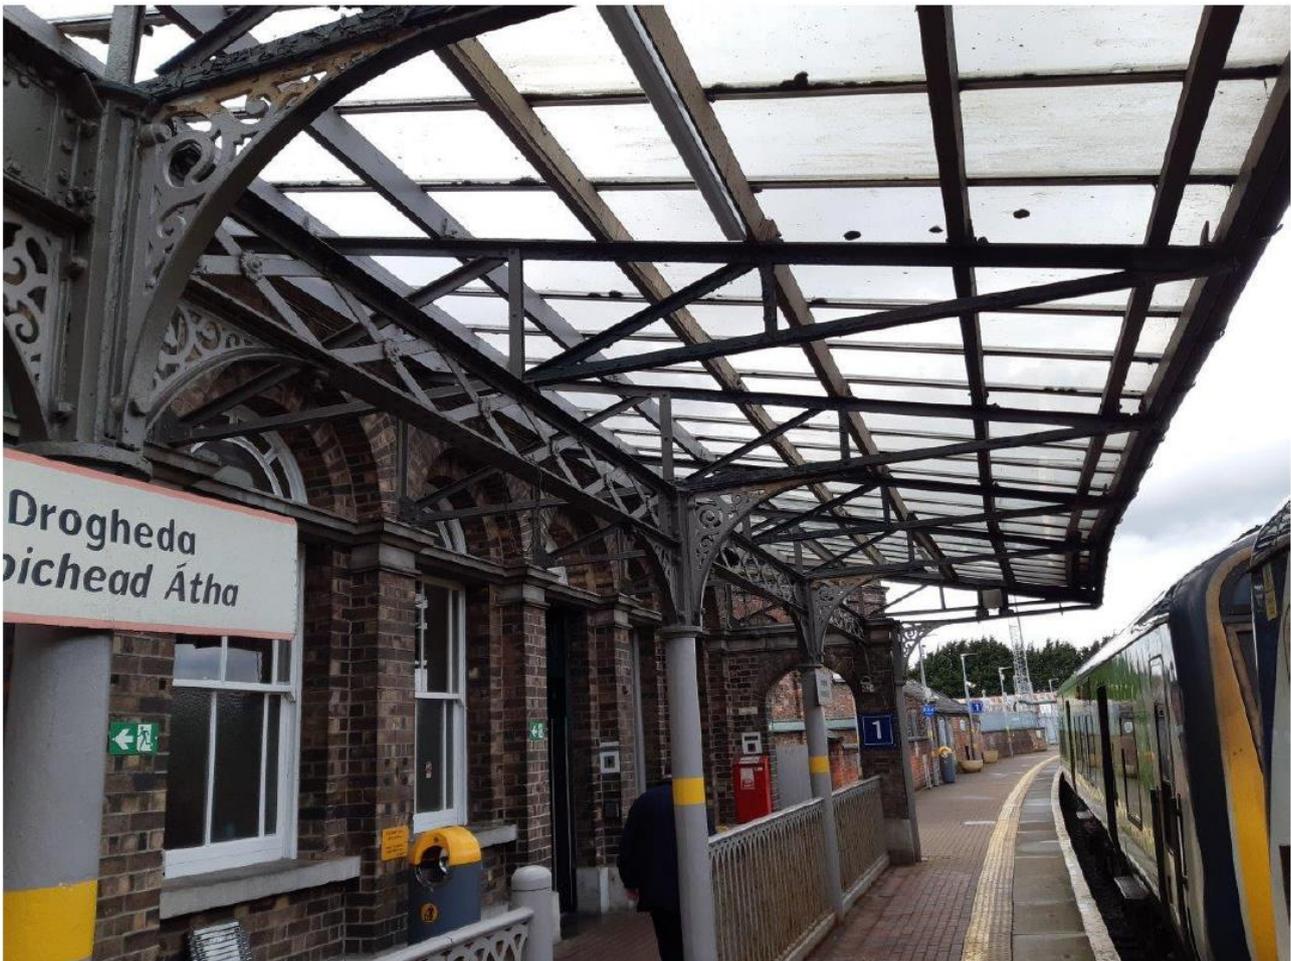
Figure 2-1: Drogheda Platform 1 Canopy

The canopy at Drogheda Station Platform 1 is situated along the length of track which is to be electrified. This is a historic structure and was constructed in 1853 without cognisance of necessary clearances for OHLE.

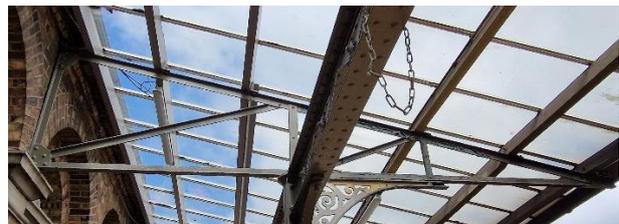
Figure 5-7: Typical Truss (nts)

All trusses are made from steel (and/or possibly wrought or cast iron) members connected together with rivets – see Figure 5-7 below. The top and bottom chord (TC and BC respectively) are T-sections continuous from the wall to the tip where the chords meet. Where the two chords meet, rivets connect the webs of the two chords: this connection induces a slight eccentricity or skewing of the top/bottom chord. Where the truss connects to the wall the web of the t-section has been cut and the flange has been bent up and fixed to the wall with a single anchor or bolts. The bottom chord seems to be bearing on a corbel; no anchors or bolts have been observed. There are 3 vertical members in the truss (refer to Figure 5-6). The first vertical (V1) is a T-section against the wall. V1 is connected to the TC and BC by a gusset plate either side of the web and two rivets in each web. Vertical 2 (V2) is directly above the column and consists of two flat bars, each connected to either side of the web of the TC and BC. One of the flat bars have been bent away from the truss in order to rivet it to the lattice truss. There is also a single rivet connecting the two flat bars midspan. Vertical 3 (V3) is similar to V2 - just shorter. There are 2 diagonals (D1 and D2) within the truss, both of which have T-sections. D1 is connected to the gusset plate at V1 and BC with a rivet, and the opposite end the web of D1 is connected to the web of TC. Diagonal 2 (D2) is between V2 and V3 and the web of D2 is connected to the webs of Tc and BC respectively with 1 rivet each side.

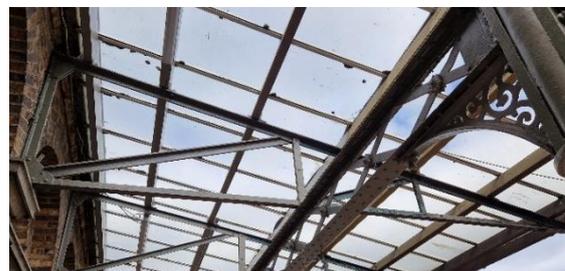
**Figure 5-8: Intermediate Truss (nts)**

The intermediate trusses (T3 and T5) are similar to the typical truss described above, but with some slight differences. The TC flange of the intermediate truss appears to be wider than that of the typical truss. The intermediate trusses are not supported by a column - rather the lattice truss spanning between the columns. The gusset plates between V1 and BC also differ from the typical truss. The angle of D1 is thus slightly different from the typical truss. Where the chords meet at the end the number of rivets at the connection differ from the typical truss.

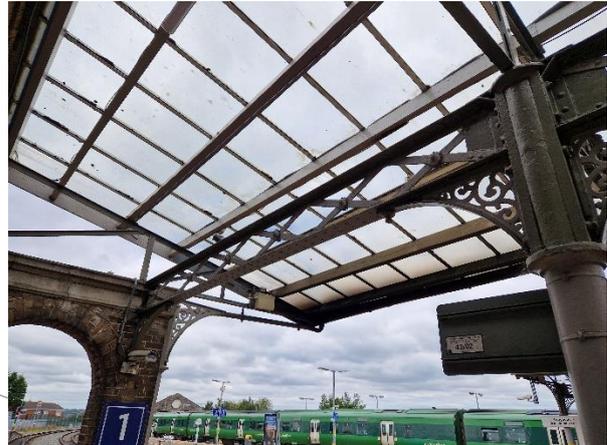
**Figure 5-9: Lattice Truss (nts)**

The lattice trusses span between the columns. The top and bottom chord consist of horizontal flat bars connected to two back-to-back unequal angles. The cross bracing between the top and bottom chords consists of flat bars. They are slotted in between the back-to-back angles and connected with 1 rivet at each end. There is also a rivet connecting the 2 cross bracing members where they intersect. The lattice trusses typically only have their self-weight as vertical load, apart from lattice trusses L24 and L46 that support the intermediate trusses.

The lattice truss provides lateral stability to the top of the columns by mobilizing a frame action. However, the typical and intermediate trusses are not restrained laterally or stabilised by the lattice truss. For the typical and intermediate trusses, the single bolt/anchor in the wall provides some lateral stability to the top chord of the trusses. However, it seems that the majority of the lateral stability of the trusses is provided by the roofing acting as a membrane. The current lateral stability system of the canopy does not appear to be able to provide the strength and stiffness necessary for such systems, which is typical of structures from that era.

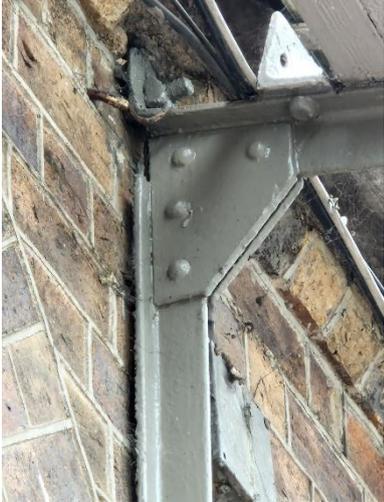
<p>Truss is pulling away from the wall. Connection appears to be bending open. Anchor bolt head appears to be rusted.</p>	<p>All typical trusses</p>

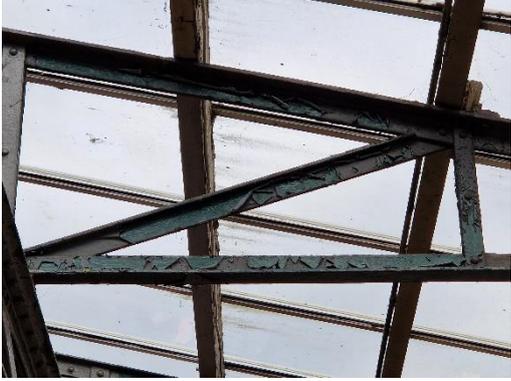
<p>Paint is peeling from the steel. Assuming this is rust protection the steel will be susceptible to rust in future.</p>	<p>All typical trusses</p>

The following details are based on the assumption that approach-2 is used. For the modification to take place and the truss to be cut back, the relevant purlins and roof covering will need to be removed as well. The trusses will need to be propped while the modification takes place. While the remedial work takes place it is proposed that additional remedial works be done to the trusses. To solve the concern of lateral stability, it is recommended that a V-brace be installed at 2 trusses. The V-brace will be connected to the truss at the 2<sup>nd</sup> vertical (V2) near the top chord and again at the lattice truss. Along with the V-brace a stiff angle will need to be installed at purlin level to connect all the trusses to the ones that have been laterally restrained with the V-brace, see Figure 5-14 below. Any other damage, misalignment, and corrosion needs to be repaired. The trusses will also need to be painted to replace the rust protection that is currently peeling from the steel.

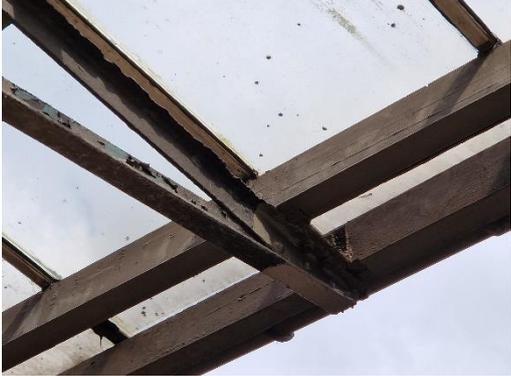
<p>Flange of the top chord has been corroded away.</p>	<p>T6</p>

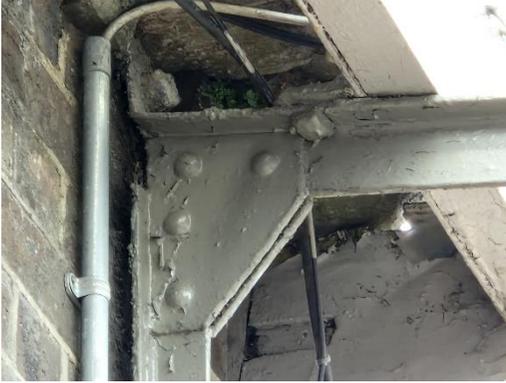
<p>Truss is pulling away from the wall. Connection appears to be bending open.</p>
T1

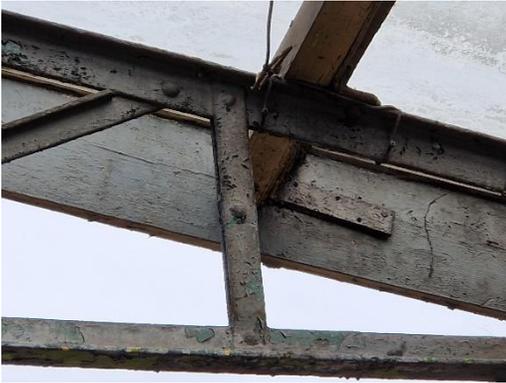
<p>Paint is peeling from the steel. Assuming this is rust protection the steel will be susceptible to rust in future.</p>

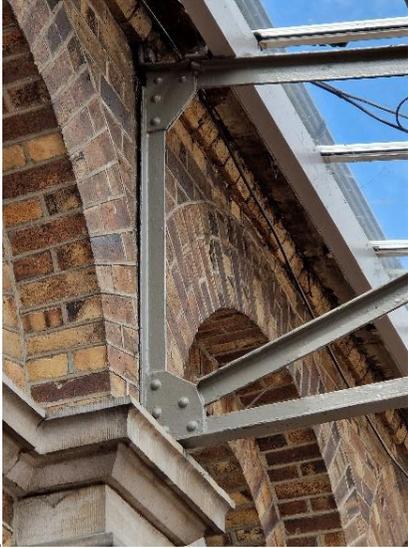
<p>Truss is pulling away from the wall.</p>

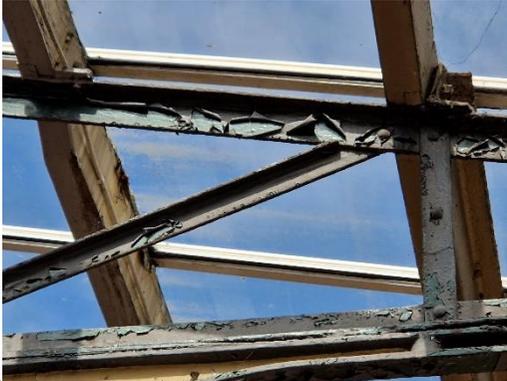
<p>Paint is peeling from the steel. Assuming this is rust protection the steel will be susceptible to rust in future.</p>

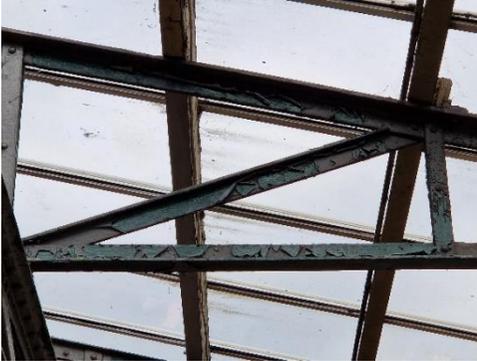
<p>Paint is peeling from the steel. Assuming this is rust protection the steel will be susceptible to rust in future.</p>
T3

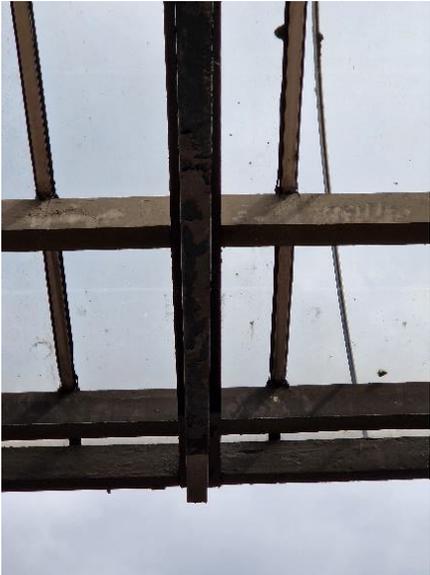
<p>Due to the webs being connected there is a slight eccentricity between the centre lines of the top and bottom chord.</p>

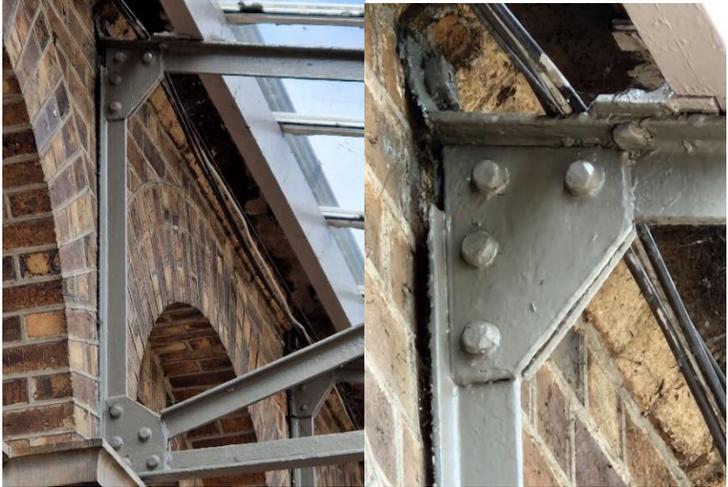
<p>Truss is pulling away from the wall. Connection appears to be bending open.</p>

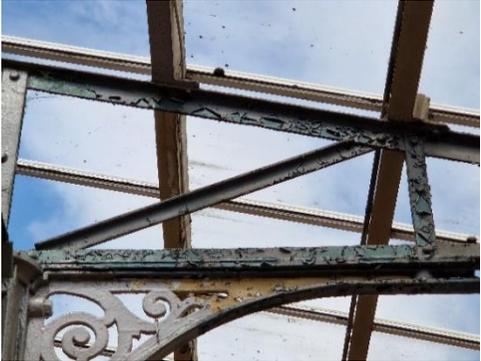
<p>Paint is peeling from the steel. Assuming this is rust protection the steel will be susceptible to rust in future.</p>

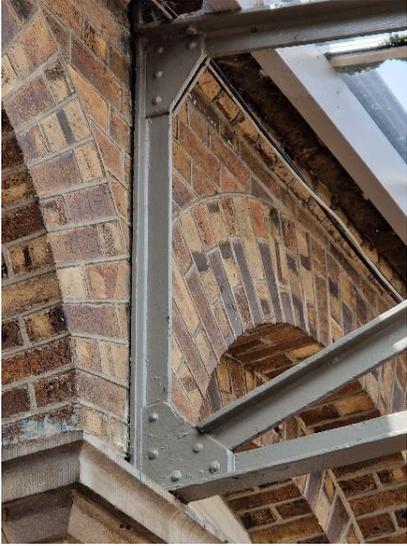
<p>Truss is pulling away from the wall.</p>

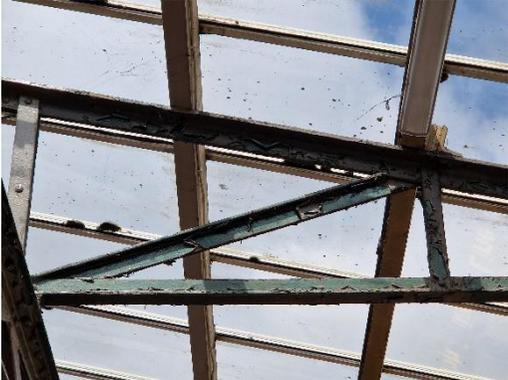
<p>Paint is peeling from the steel. Assuming this is rust protection the steel will be susceptible to rust in future.</p>

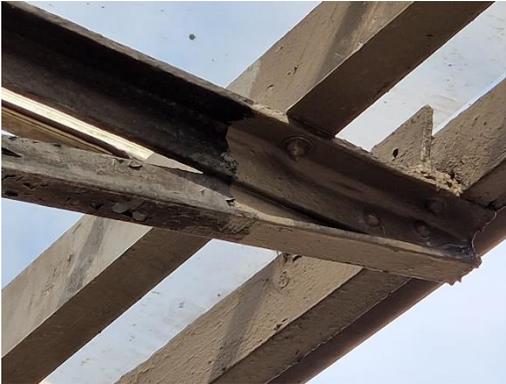
<p>Last purlin at the end is not fixed to the bracket provided.</p>

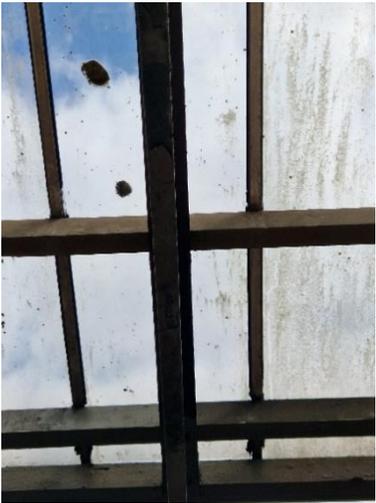
<p>Due to the webs being connected there is a slight eccentricity between the centre lines of the top and bottom chord.</p>

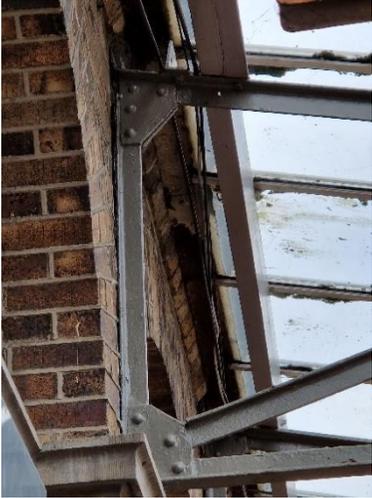
<p>Truss is pulling away from the wall. Connection appears to be bending open.</p>

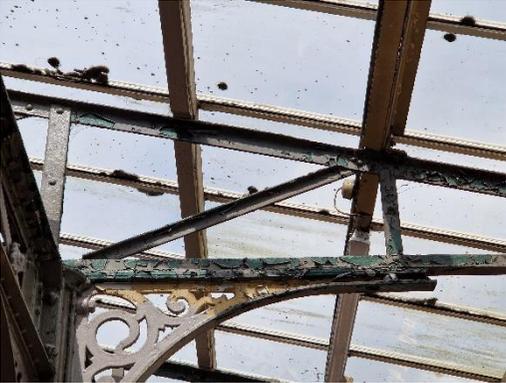
<p>Paint is peeling from the steel. Assuming this is rust protection the steel will be susceptible to rust in future.</p>

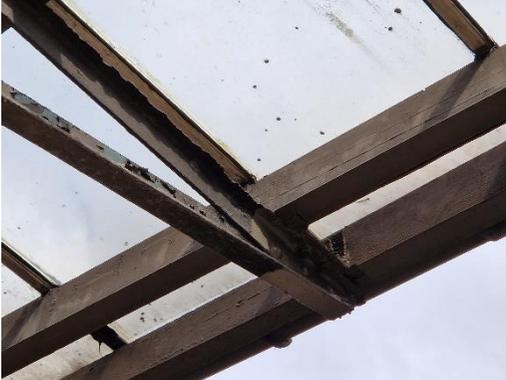
<p>Flange of the top chord has corroded away.</p>
<p>T7</p>

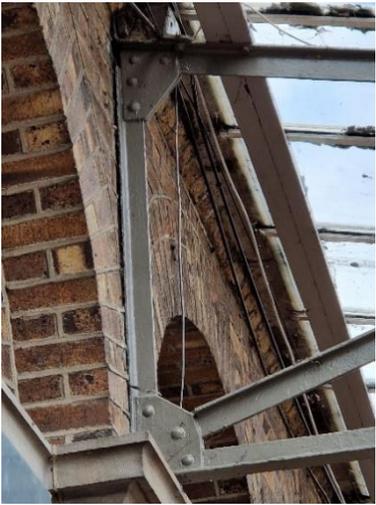
<p>Truss is pulling away from the wall.</p>

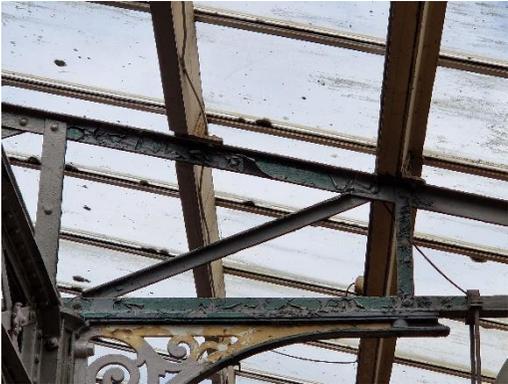
<p>Paint is peeling from the steel. Assuming this is rust protection the steel will be susceptible to rust in future.</p>
T8

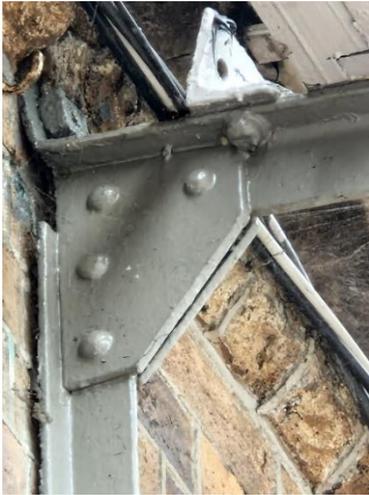
<p>Truss is pulling away from the wall. Connection appears to be bending open.</p>

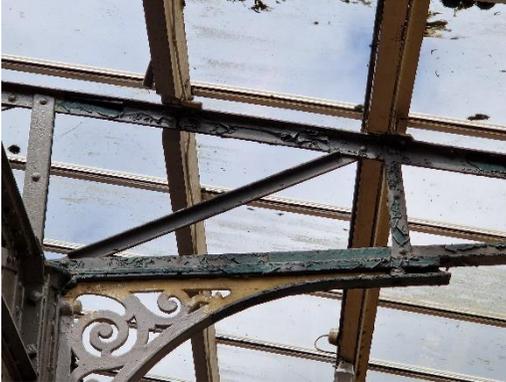
<p>Paint is peeling from the steel. Assuming this is rust protection the steel will be susceptible to rust in future.</p>
T9

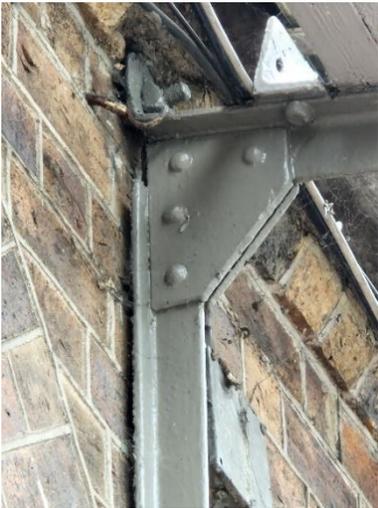
<p>Truss is pulling away from the wall. Connection appears to be bending open</p>

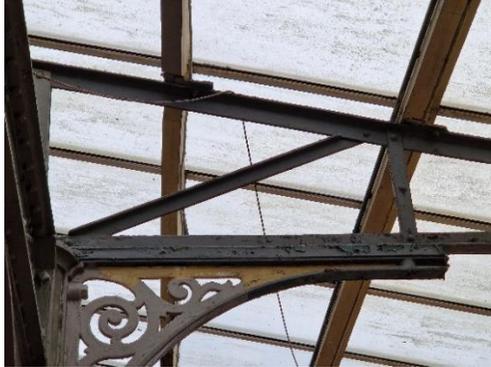
<p>Paint is peeling from the steel. Assuming this is rust protection the steel will be susceptible to rust in future.</p>

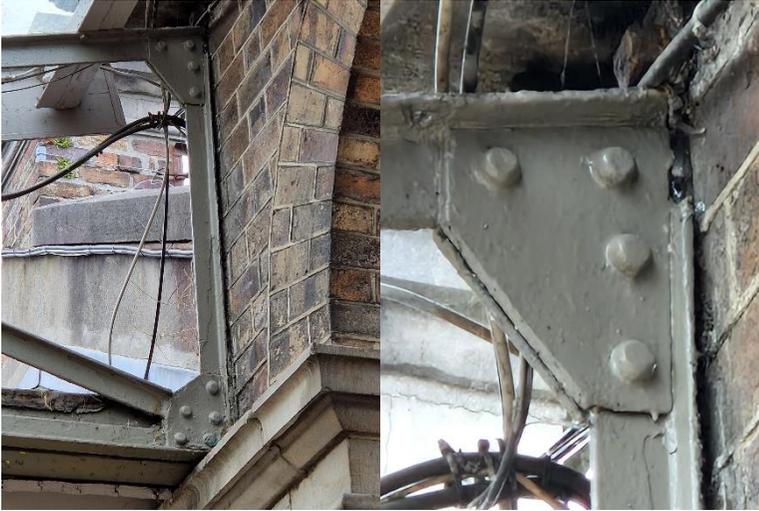
Truss is pulling away from the wall. Connection appears to be bending open. Anchor bolt head appears to be rusted.

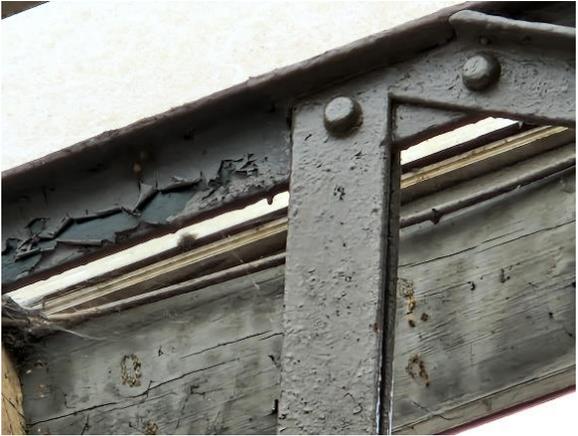
<p>Paint is starting to peel from the steel. Assuming this is rust protection the steel will be susceptible to rust in future.</p>

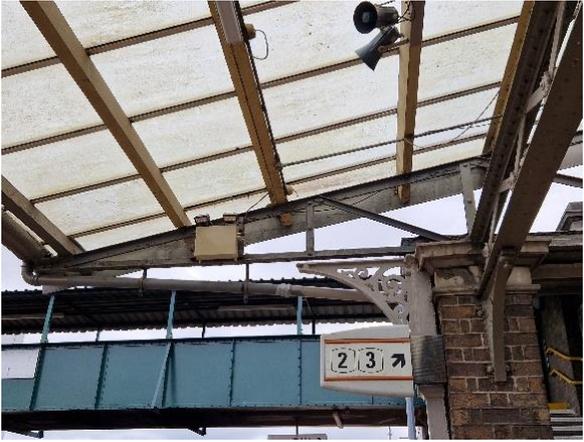
<p>Corbel at the top of the column is badly cracked.</p>

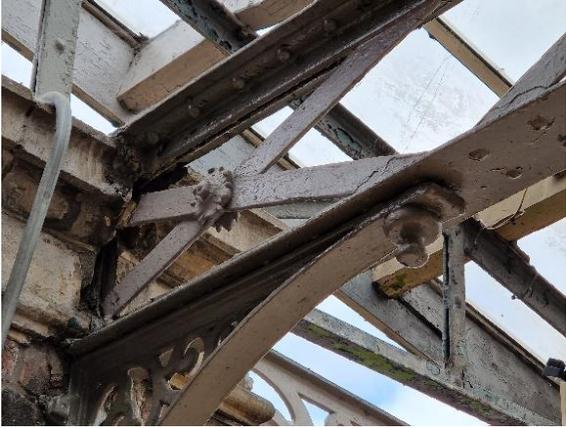
<p>Lattice girder shows weathering where it joins to the column.</p>
