APPROPRIATE ASSESMENT

This document relates to the Appropriate Assessment process undertaken for proposed bridge repairs on Galbally Bridge, Mandeville Park, Moorabbey, Co. Tipperary

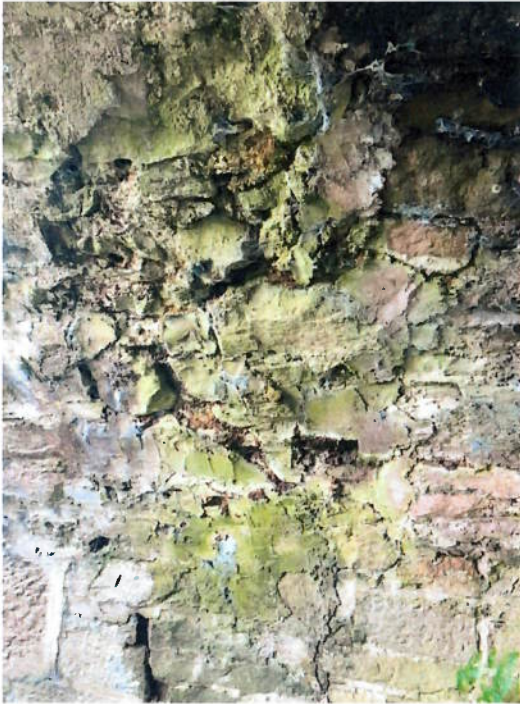
Figure 2. Cracks, holes and deteriorating stone and mortar on the underside of one of the arches.

The bridge piers, abutments and the undersides of all four arches, have radial and vertical cracks present. Some cracks have associated stone and/or mortar loss (See Figure 2, Figure 3 and Figure 4). The parapets have various location of small holes and dislodged mortar. Both upstream and downstream abutments have vegetation growing on them including one 2.5m tree growing on top of one cutwater (Figure 5). Further deterioration to the bridge structure, will eventually result in a structure failure where it will be both unusable and unsafe to the general public and users.

- In order to repair the bridge cracks, holes and dislodged mortar within the arch barrels stainless steel stitching will be inserted through the voussoirs in the arch and connected to the intrados, after a high strength cement/grout mix will be used. It will be sprayed under high pressure into the cracks. All other cracks will then be pointed.
- The piers foundations will be underpinned and grouted.
- All spandrel and parapet walls will be repointed.
- Tie bars will be inserted into each arch, there will be two in each arch, their positions can be seen above in figure 5.
- Vegetation removal on each elevation
- The riverbed will be strengthened with stonework and rock armour

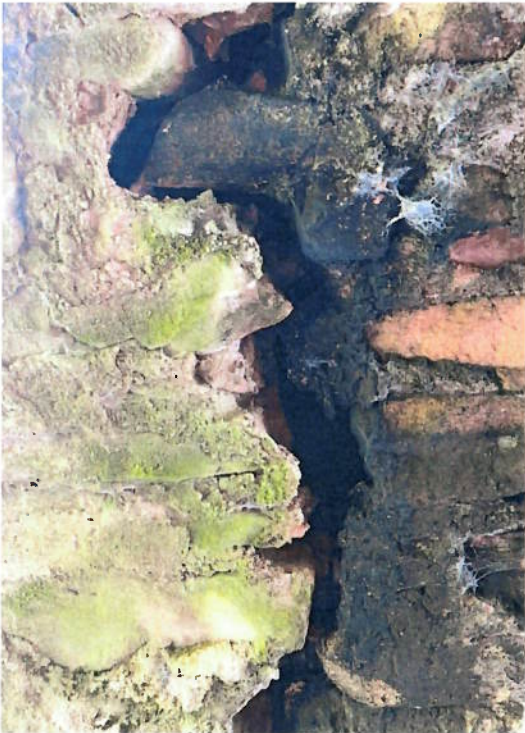
Figure 3. A large crack present on the underside of one of the arches.

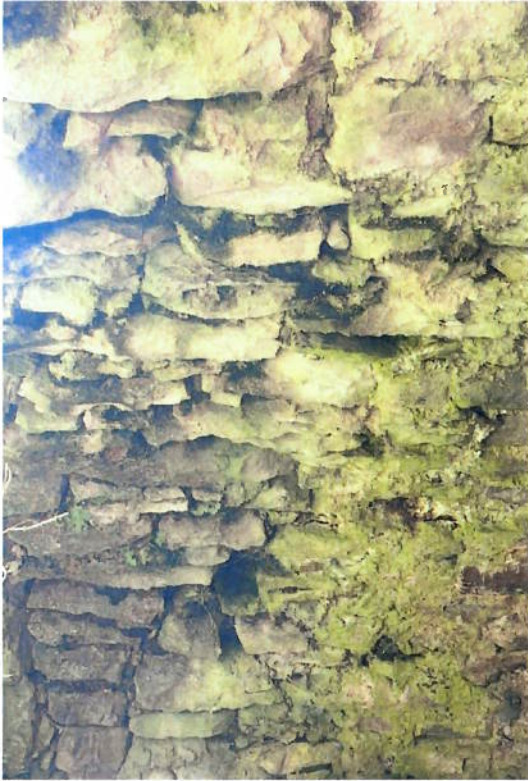
Figure 4. Cracks, holes and dislodged mortar on the underside of one of the arches.

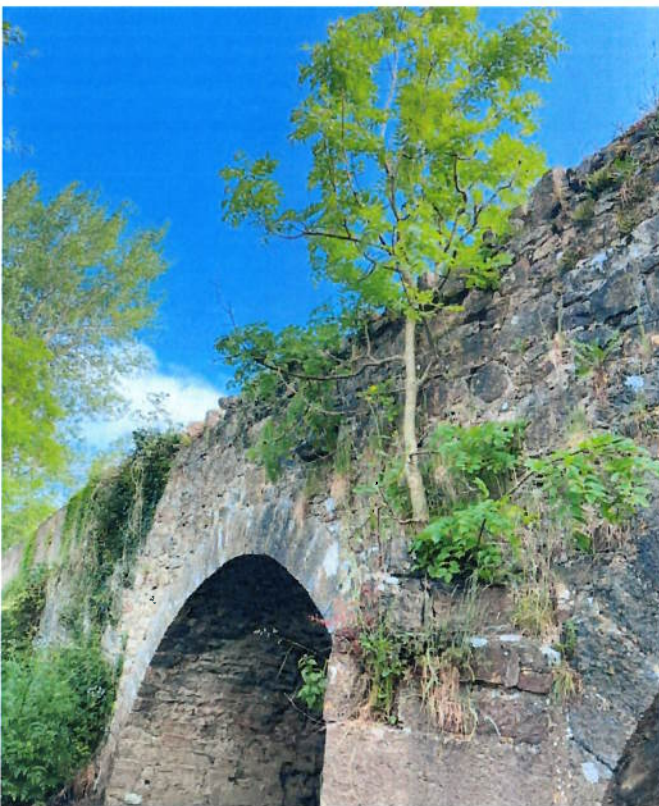
Figure 5. Vegetation present on the upstream bridge abutment and cutwater.
