N59 OUGHTERARD FOOTBRIDGE

Document title: Natura Impact Statement

Document reference: 0088798DG0046

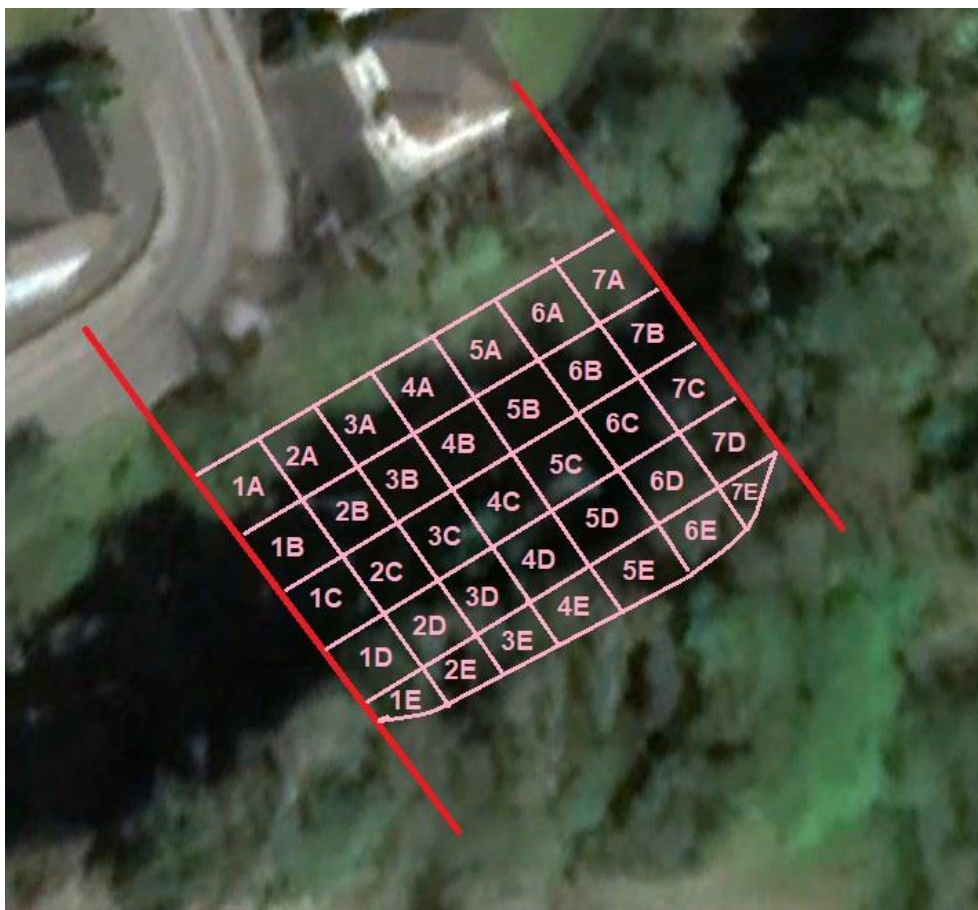
Figure 4-2 - Grid surveyed which covers the proposed footbridge location (see Figure 2.2 for bridge location).

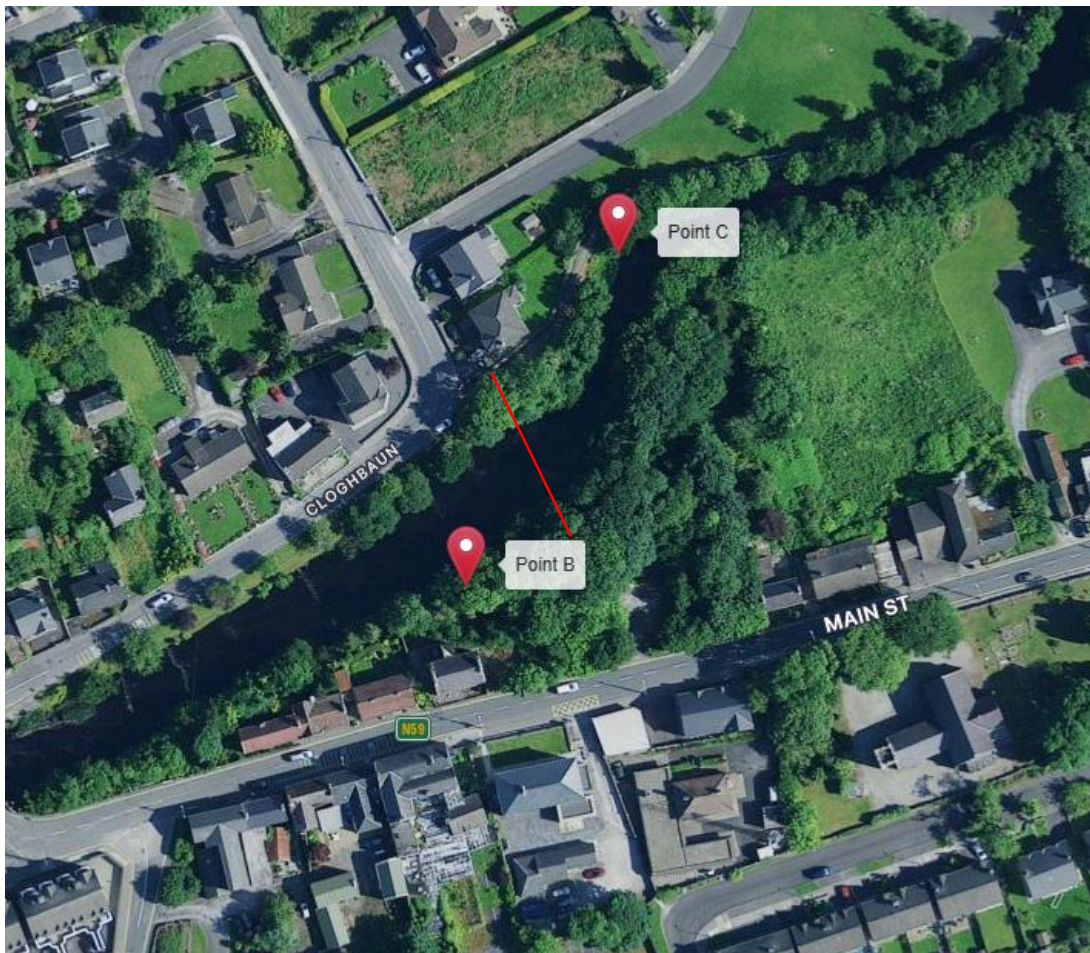
Figure 4 – showing locations of static detectors deployed on banks of Owenriff River and proposed location of new pedestrian bridge
