# Cuan Na Loinge Road Protection Scheme

Stage 1 Road Safety Audit

Langan Consulting Engineers

June 2025

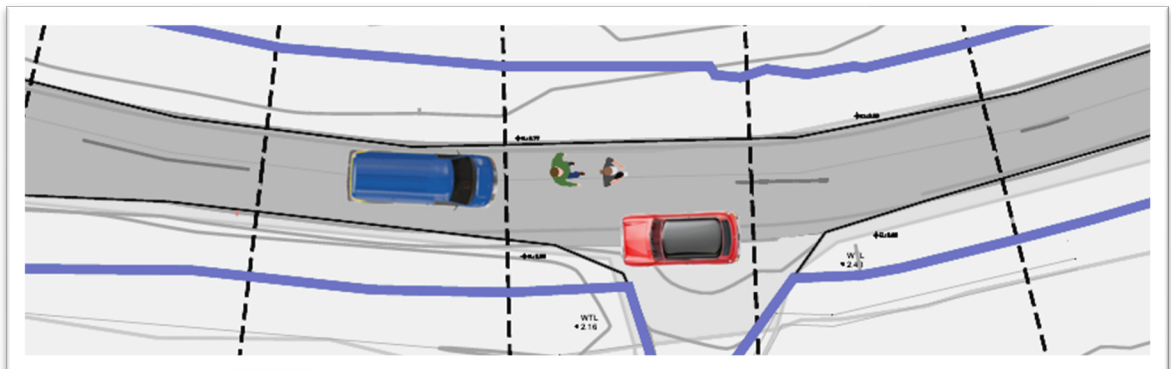
**Figure 2.1 – Pedestrians Stepping into Road Space Where the Pavement Narrows**

**Location:** All Sections of Scheme Road & Roadside

The varying widths of road pavement, flood protection walls, and verge space pose risks to pedestrians who might unexpectedly step in front of approaching vehicles.

An appropriate horizontal alignment should be established for the road to offer a continuous and consistent pedestrian refuge area, allowing walkers to step aside safely when vehicles approach.

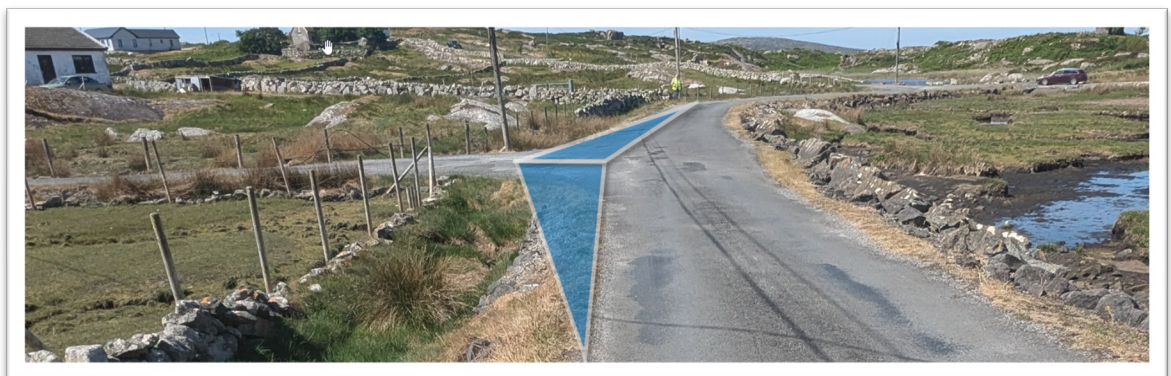
**Figure 2.2 – Example Side Road B – Junction Sight Lines Which Should Be Maintained**

**Location:** Flood Protection Walls Proposed Near Side Road A & Side Road B

The flood protection walls could serve to reduce sight lines for drivers approaching side road A and side road B junctions, increasing the risk of a side impact type collisions.

Check sight lines at junctions in both vertical and horizontal planes and adjust the position of the flood protection walls as needed.

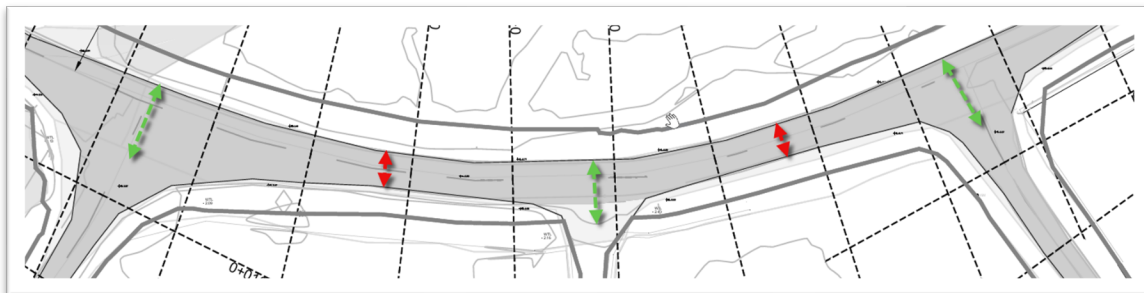
**Figure 2.3 – Variance in Pavement Cross Section Likely to Create Confusion & Conflict**

**Location:** All Sections of Scheme Road & Roadside

Flood protection walls may reduce visibility between opposing drivers on roads with varying pavement widths. The walls are likely to limit safe passing opportunities, causing risky reversing manoeuvres, conflicts, and driver frustration.

A suitable horizontal alignment should be developed for the road which provides for locations where two opposing vehicles can pass each other, connected by a consistent and predictable traffic lane.
