**Re:** Gort Town Centre Public Realm Enhancement Project, Gort, Co. Galway  
In the townlands of Gort, Co. Galway

## **Stage 1 Road Safety Audit**

**Gort Town Centre Public Realm Scheme**

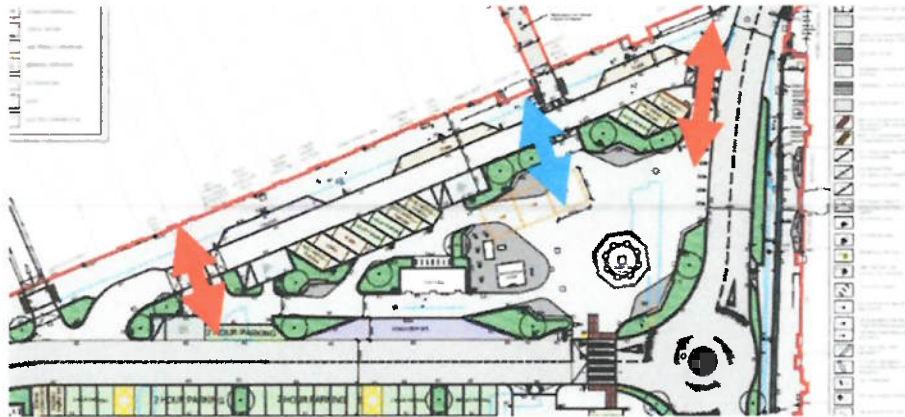
**Problem:** There is a large car park proposed for Lowry's Lane. The likely desire line for pedestrians from this car park is to walk along Lowry's Lane into Market Street and across to the town core. The pedestrian crossings of Market Street are to both ends, which requires a diversion off the likely desire line. Pedestrians are likely to cross Market Street as a continuation of, or close to, Lowry's Lane.

**Hazard:** No assistance for sight impaired pedestrians attempting to cross the road in this location is given. The sight impaired pedestrian may errantly enter the carriageway, into the path of oncoming traffic.

**Recommendation:** The Design Team should provide an uncontrolled crossing closer to the likely pedestrian desire line.

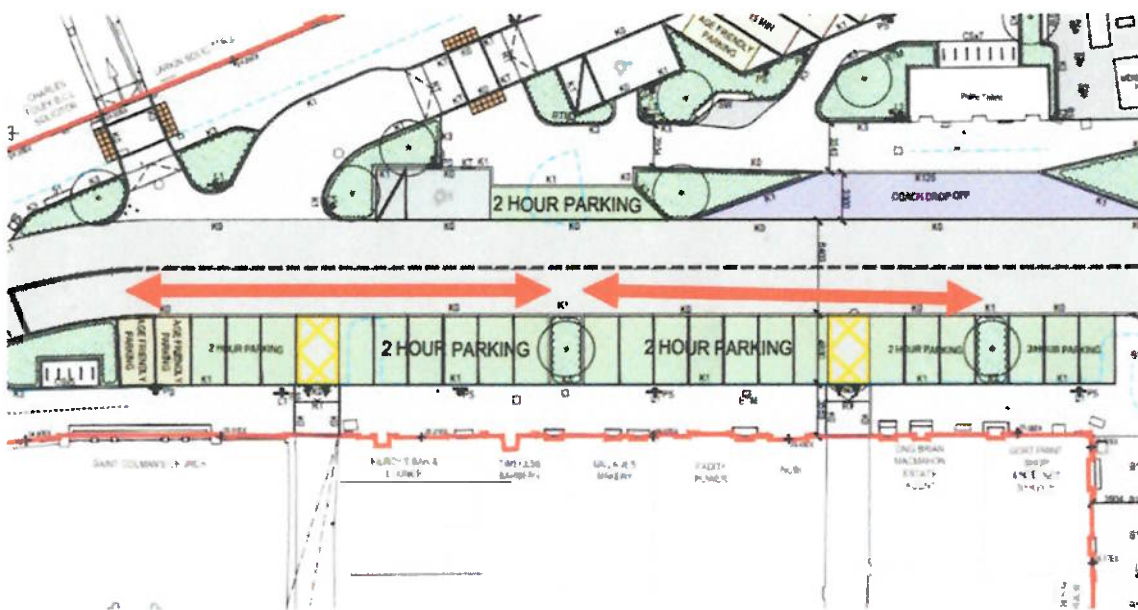
**Problem:** There is a long run of perpendicular car parking proposed on the Market Street main square. When these spaces are unoccupied the street will appear very wide. Wide and straight streets have a poor record of high vehicle speeds.

**Hazard:** Motorists may impact with other road users, possibly cyclists, at high-speed resulting in serious injuries.

**Recommendation:** Provide additional breaks in the parking that contain vertical features, in an attempt to control vehicle speeds.

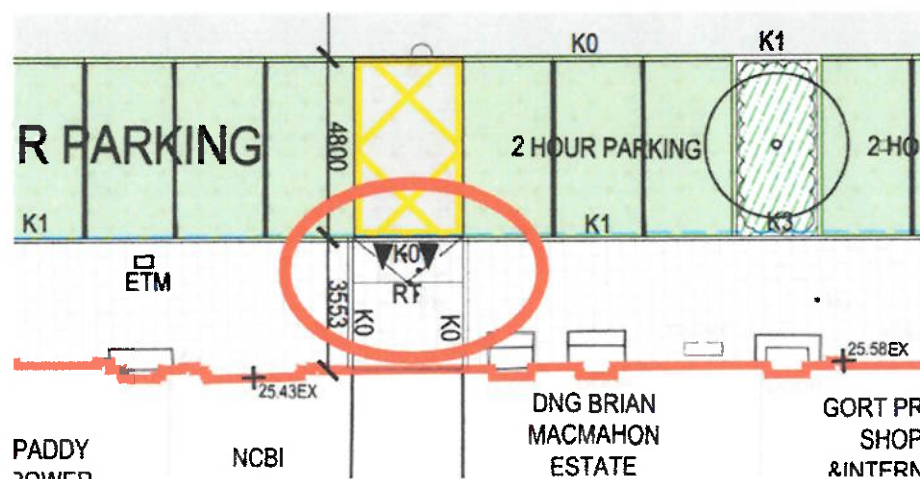
**Problem:** There are a number of locations where vehicles are permitted to cross the footpath in order to access driveways and back lands. At these locations a flush kerb is indicated to the rear of the car parking bay adjacent to a 100mm face kerb. It appears there is a ramp up from the car park level to the footpath level incorporated into the footpath. There are two problems with this arrangement.

**Hazard:**

1. Pedestrians walking along the line of the footpath may trip on the side of the ramp.
2. Sight impaired users may errantly depart the footpath where there is zero kerb face and walk within the car parking bays / carriageway.

**Recommendation:** Omit any trip hazards within the footpath and also retain a minimum 60mm kerb face between the footpath and the car parking bay / carriageway.

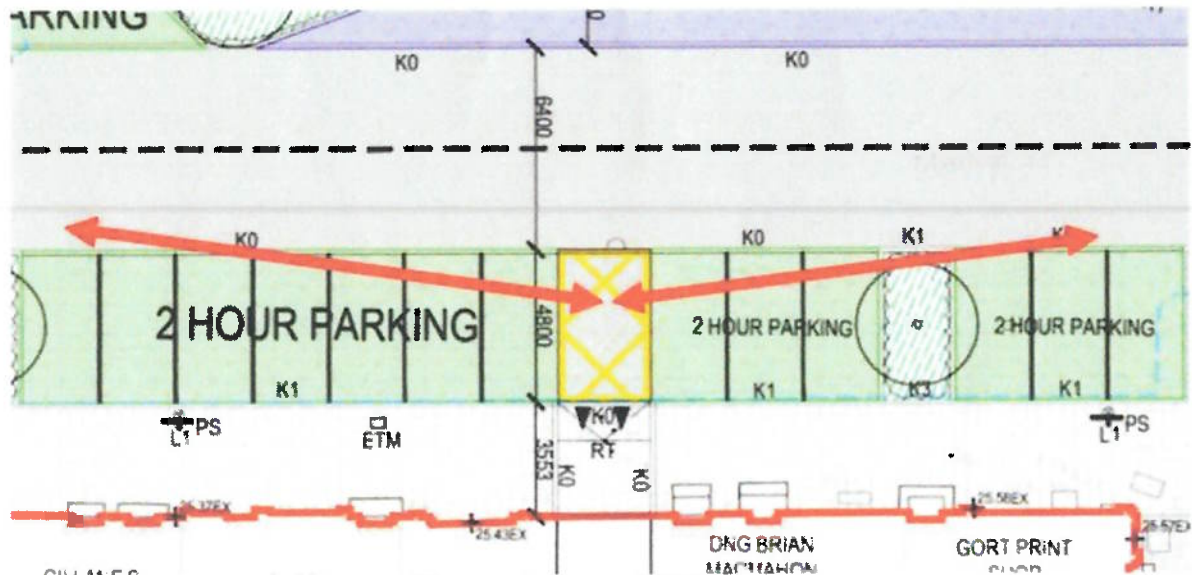
**Problem:** There are a number of locations where vehicles are permitted to cross the footpath in order to access driveways and back lands in between roadside parking bays. Visibility may be restricted by high sided vehicles in the parking bay.

**Hazard:** Motorists may proceed into the path of oncoming traffic.

**Recommendation:** Ensure adequate visibility is provided for all users entering the public carriageway.

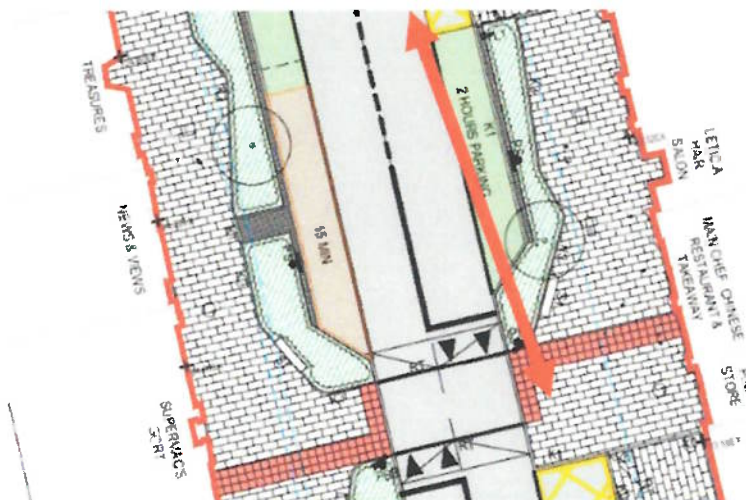
**Problem:** Visibility to pedestrians waiting to cross the road may be restricted by high sided vehicles parked in adjacent parking bays and/or high vegetation. This problem includes signal-controlled crossing locations, as pedestrians often cross the carriageway even when shown a red man at the light.

**Hazard:** Pedestrian may step out into the path of oncoming traffic.

**Recommendation:** the Design Team should ensure adequate visibility is provided. This should include pedestrians waiting to the rear of push chairs at the carriageway edge.

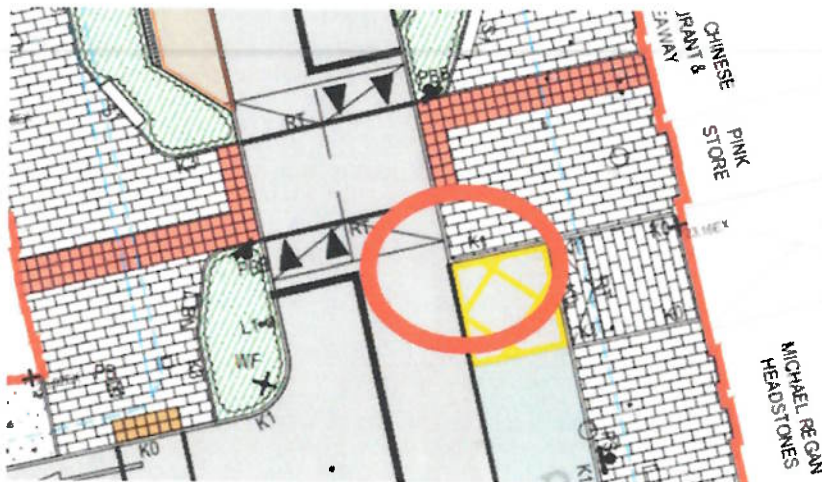
**Problem:** There are areas within the design that indicate a 100mm high kerb meeting at a 90 degree corner. Vehicles that attempt to turn at these locations are at risk of tyre damage on the kerb.

**Hazard:** Tyre damage caused at these locations may result in tyre failure elsewhere on high-speed roads.

**Recommendation:** The Design Team should design out areas of potential vehicle tyre damage.

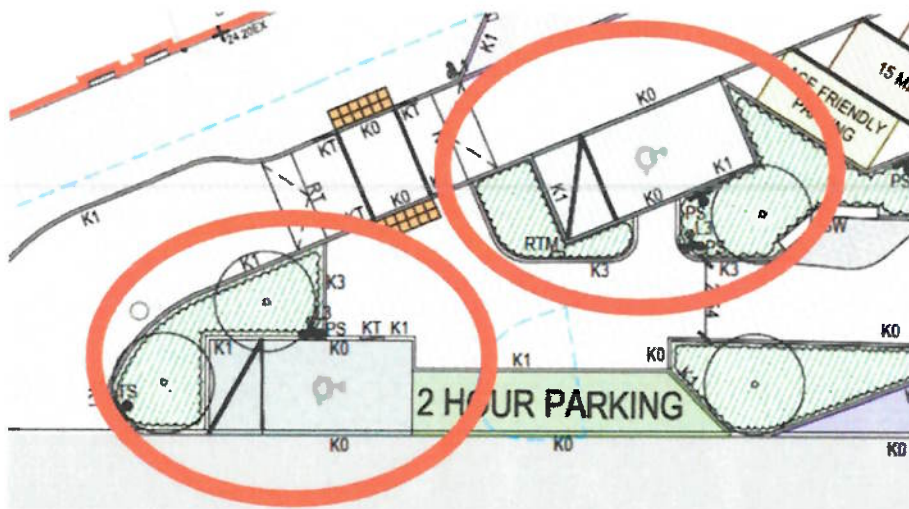
**Problem:** There are a number of disabled user parking bays located throughout the scheme. Some of these bays have landscaping located between the bay and the footpath. Users with differing disabilities use different methods of accessing / egressing their vehicles. This can include rear door access, rear side doors or front doors.

**Hazard:** Disabled users without direct access to the footpath may be required to travel on the carriageway prior to accessing the footpath. Impact from passing vehicles may result.

**Recommendation:** The Design Team should ensure direct access to the footpath can be achieved from all the vehicle passenger doors.

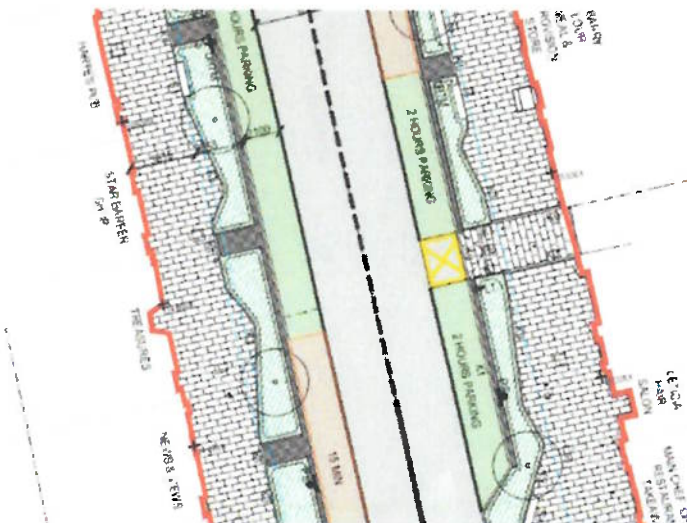
**Problem:** There are lengths of linear landscaping strips located adjacent to on-line parking bays. Although there are a number of paved links from the footpath at the rear of the landscaping through to the parking bay, these links will only be of use if the parked vehicle directly aligns with the paved link and even then, they will only be of use for the passenger adjacent to this link.

**Hazard:** Vehicle drivers and passengers are likely to walk within the carriageway until they can find a paved link through to the footpath. This may involve walking the full length of the parking bay on the carriageway. Impact from passing traffic may result.

**Recommendation:** The Design Team should omit the landscaping and provide direct connectivity to the footpath for all vehicle passengers.

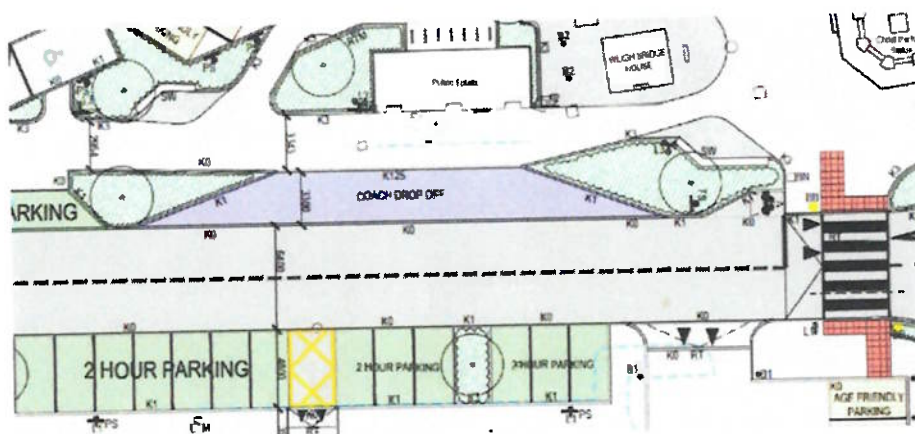
**Problem:** The coach drop-off bay is located on the northern side of Church Street. No information has been provided by the Design Team to the route of the coach. There is concern the coach may arrive from the M18/R458. If this is the case the coach will need to turn on or near to Church Street in order for the passenger door to be adjacent to the footpath, or passengers will alight into the carriageway. There is no obvious location for the coach to undertake a 'U' turn along Church Street.

**Hazard:** The coach may attempt to reverse into one of the side streets off Church Street. Impact with other road users may result. If passengers alight into the carriageway, impact from passing traffic may result.

**Recommendation:** The Design Team should ensure the coach arrives from Church Street west and does not need to undertake a 'U' turn in order to achieve a drop off or collection.

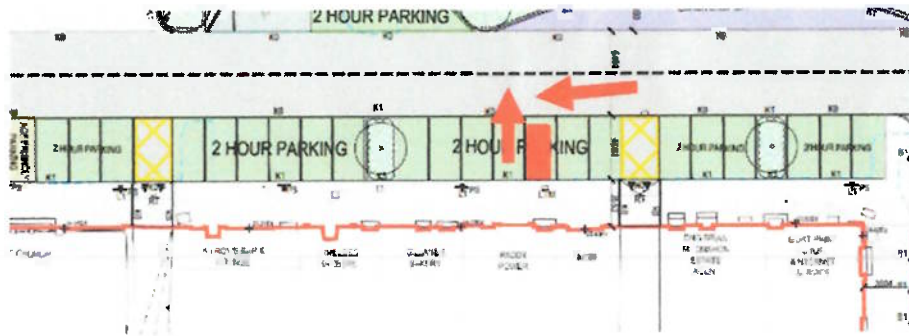
**Problem:** There is a long run of perpendicular parking bays on Church Street. Users attempting to exit these bays may have visibility to oncoming traffic restricted by adjacent parked high-sided vehicles.

**Hazard:** Exiting motorists may be struck by passing mainline traffic.

**Recommendation:** The Design Team should provide a buffer strip between the carriageway and parking bay, such that mainline traffic can observe a moving vehicle and slow/stop to permit this vehicle safe egress.

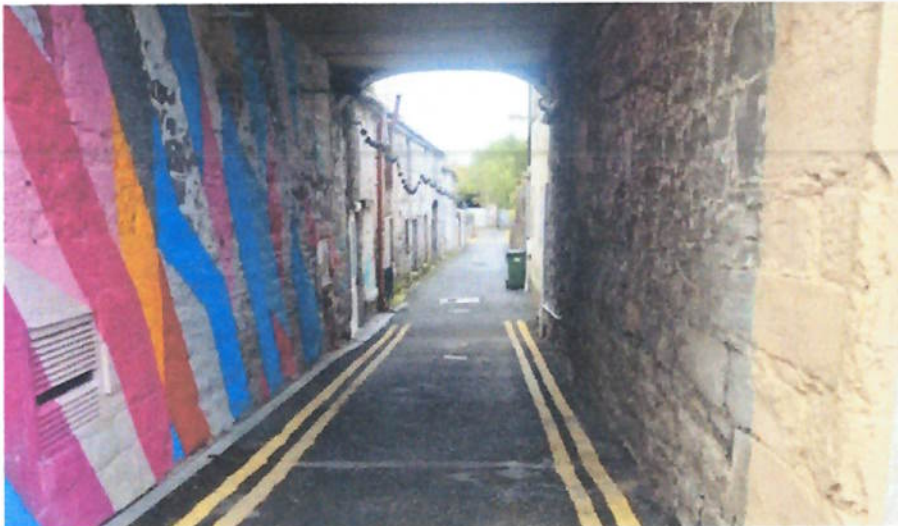
**Problem:** It appears from the drawings that pedestrian access to/from the car park is intended to be achieved via Lowry's Lane. This lane is very narrow and currently used by vehicles to access the rear of premises.

*Even for pedestrians =  
Absolutely the whole way down!  
Dangerous \*  
as there is  
No Room*

**Hazard:** Motor vehicles are unlikely to have sufficient room to pass wheelchair users. The motorist may decide to reverse back onto Market Street. Impact with pedestrians on Market Street may result.

**Recommendation:** Prohibit vehicular use of the lane.

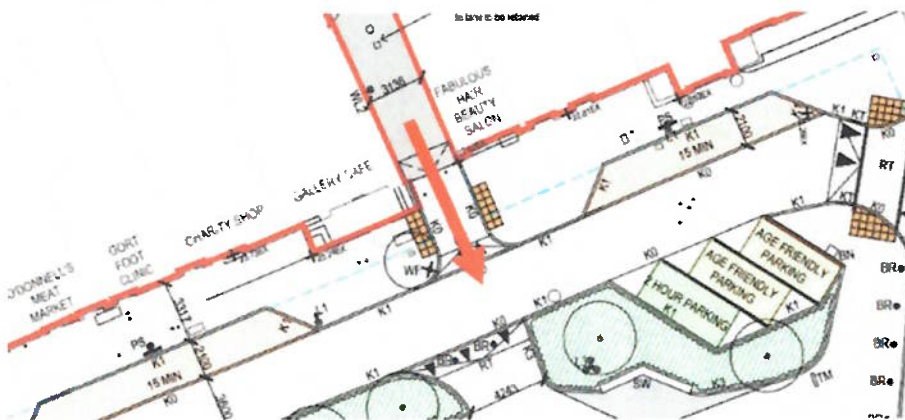
**Problem:** Pedestrians walking from Crowe Street car park to the town core are likely to walk along Lowry's Lane. Upon arrival at Market Street the pedestrian, possibly sight-impaired, is offered no warning they may be entering the Market Street carriageway.

**Hazard:** Motor vehicle impact with pedestrians on Market Street may result.

**Recommendation:** The Design Team should provide a pedestrian deterrent / hazard warning surface at the junction of Lowry's Lane / Market Street.

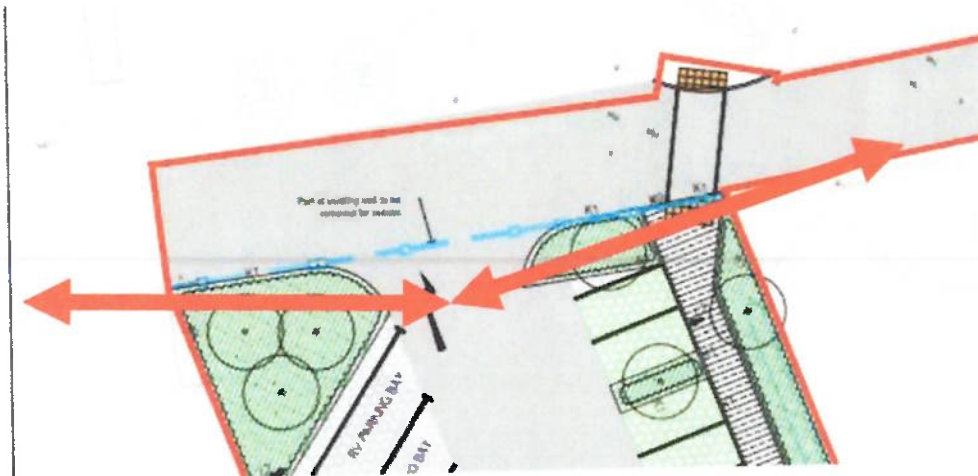
**Problem:** Visibility on exit from the car park may be restricted in either direction by boundary walls / vegetation.

**Hazard:** Car park users may exit into the path of oncoming traffic.

**Recommendation:** The Design Team should ensure suitable visibility is provided in both directions.

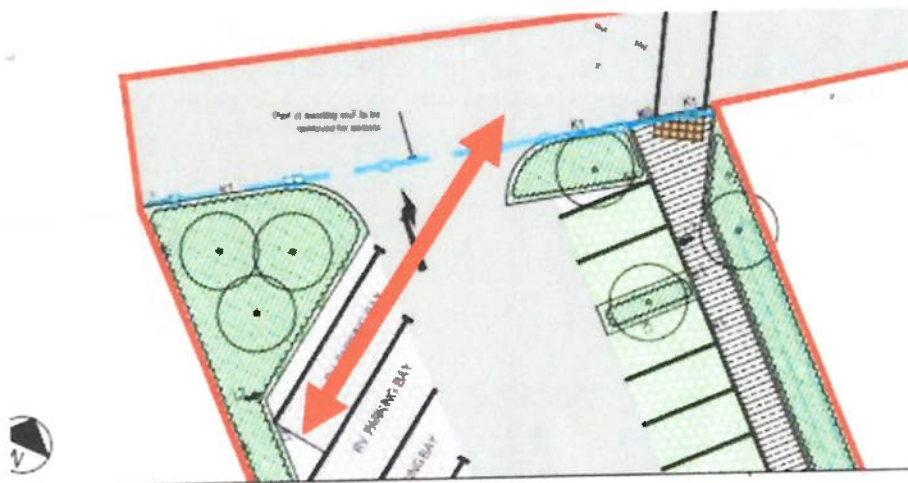
**Problem:** RV parking is indicated near the entrance to the car park. It is not clear how long vehicles are meant to enter / exit these spaces. It is likely the users will drive forward into the space and reverse back out of the car park junction in order to exit.

**Hazard:** Impact with vehicles entering the car park may result.

**Recommendation:** The RV spaces should be relocated where entry and exit to the car park can be achieved without need to reverse towards entering vehicles.

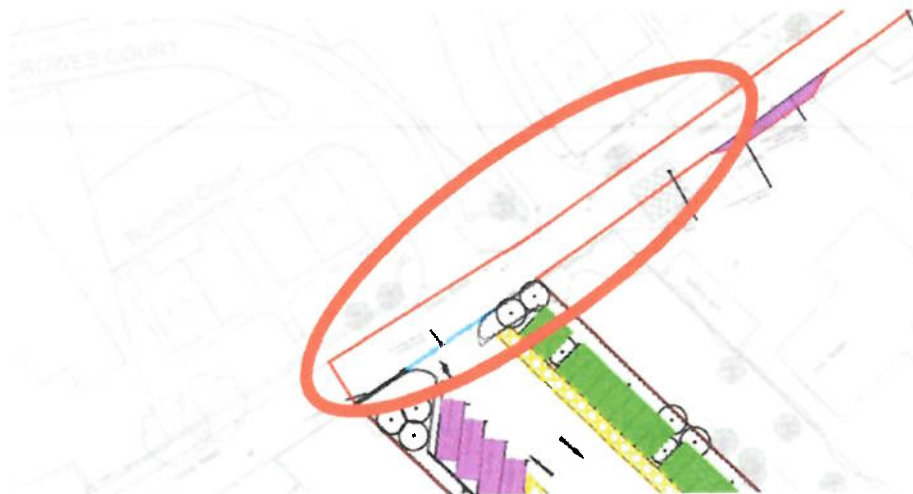
**Problem:** Sections of Crowe Street are intended to be widened, but this widening does not include the full length of the street. Sections remain narrow, where passage of two-way traffic may be difficult. Narrow sections include the carriageway at the housing development junctions opposite the proposed car park. Users existing the housing development and other junctions may be concentrating on vehicles approaching from their right only. The provision of the car park is likely to generate a substantial increase in traffic movements on Crowe Street.

**Hazard:** Head-on impact between users may result.

**Recommendation:** The Design Team should ensure adequate carriageway width is provided in areas where left turning movements onto Crowe Street may occur.

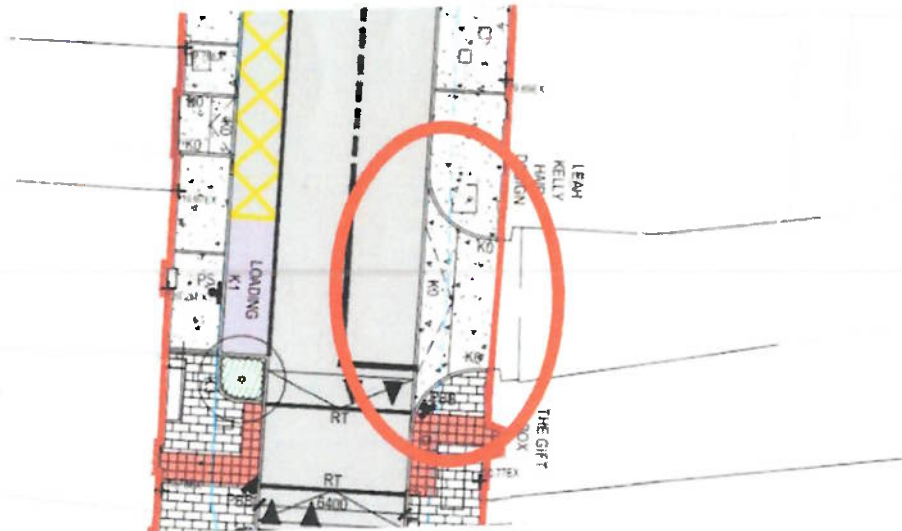
**Problem:** The paving plan indicates the kerb returning into the HGV access. Motorists may believe vehicles have priority at this junction, yet pedestrians are not advised to take care for vehicles here.

**Hazard:** Pedestrians, in particular sight-impaired pedestrians, may cross the mouth of the junction into the path of turning vehicles.

**Recommendation:** Due to the proximity of the tactile paving for the adjacent controlled crossing, tactile paving could be confusing if located for this entrance. The Design Team should remove the radius kerbs leading to the access lane and treat this area as a footpath crossover, where pedestrians have priority.

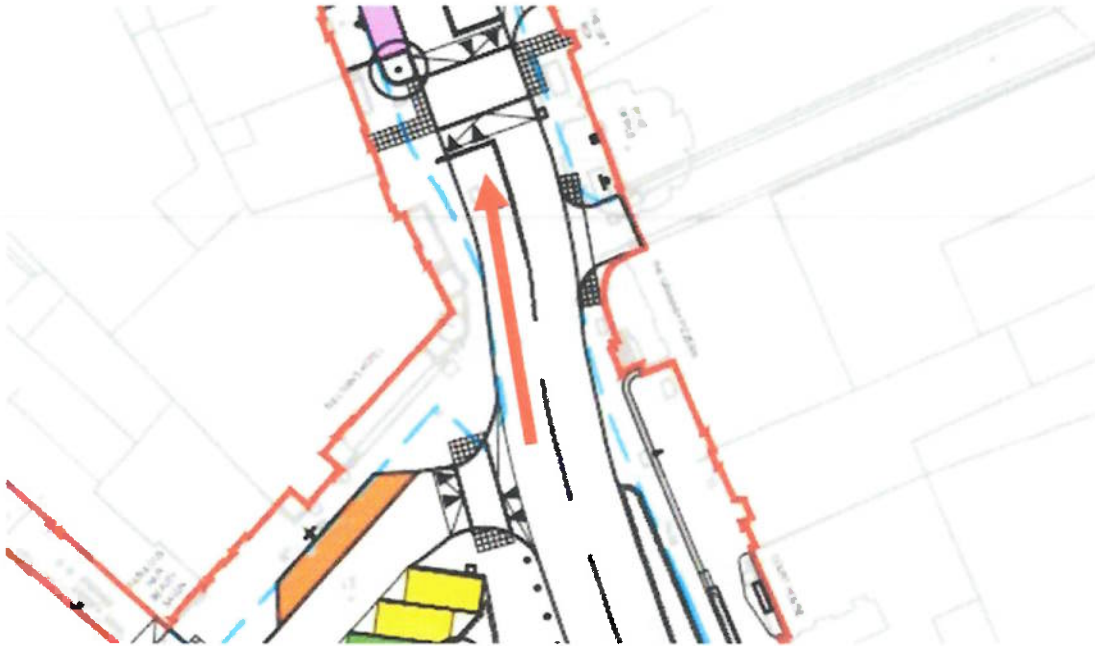
**Problem:** The controlled crossing located to the front of “The Gift Box / An Post” is located on a steep downhill section of carriageway. Vehicles approaching from the south may have their ability to stop compromised by the steep carriageway, particularly in wet or frosty conditions.

**Hazard:** Vehicles may overshoot the crossing, impacting with pedestrians.

**Recommendation:** The Design Team should provide enhanced friction material on the carriageway surface.

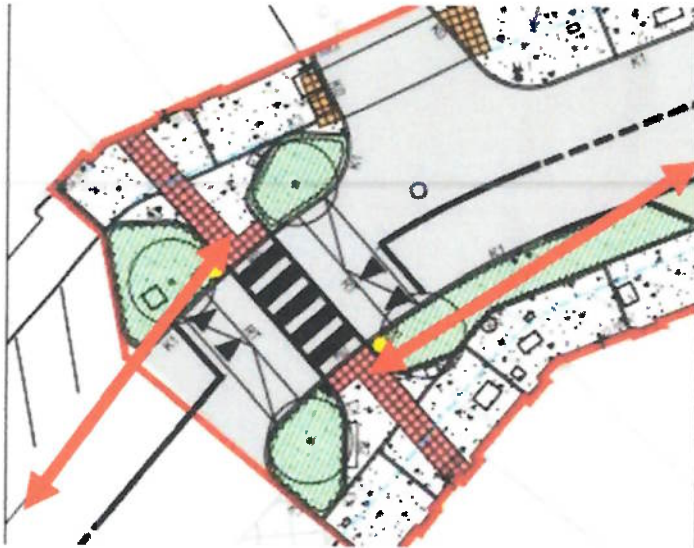
**Problem:** There is a zebra crossing proposed to the south of Garraghbeg Road junction. This zebra crossing is located on a bend with both landscaping and vehicles parking to both sides. Pedestrians waiting to cross the road may be shielded from view by either/or the landscaping or parked high sided vehicles.

**Hazard:** Pedestrians may commence their crossing into the path of unsighted vehicles.

**Recommendation:** The Design Team should ensure all visibility splays are clear of obstruction.

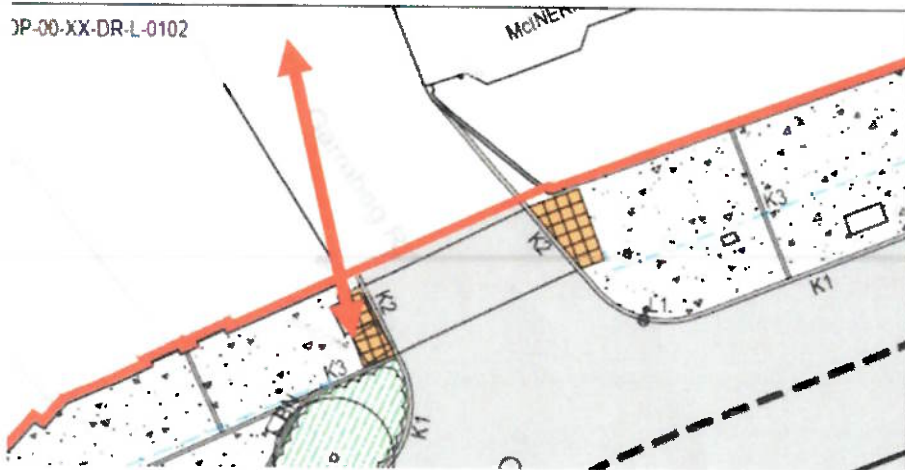
**Problem:** The tactile paving / pedestrian crossing on Gararghbeg Road is located such that pedestrians crossing from west to east will have very limited sight of vehicles approaching on Gararghbeg Road.

**Hazard:** Pedestrians may step into the carriageway into the path of oncoming vehicles.

**Recommendation:** Relocate the crossing closer to Church Street, where improved inter-visibility can be achieved.

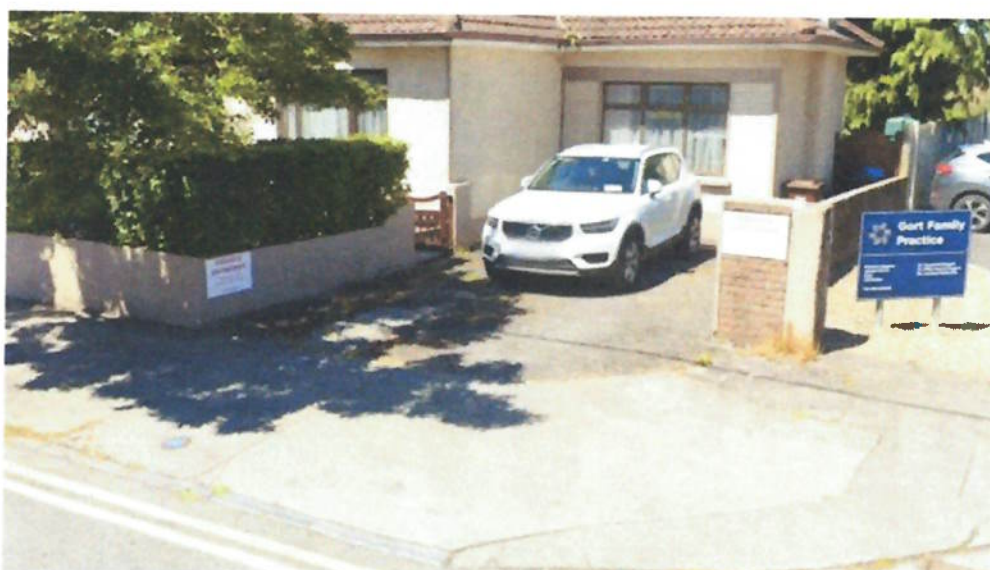
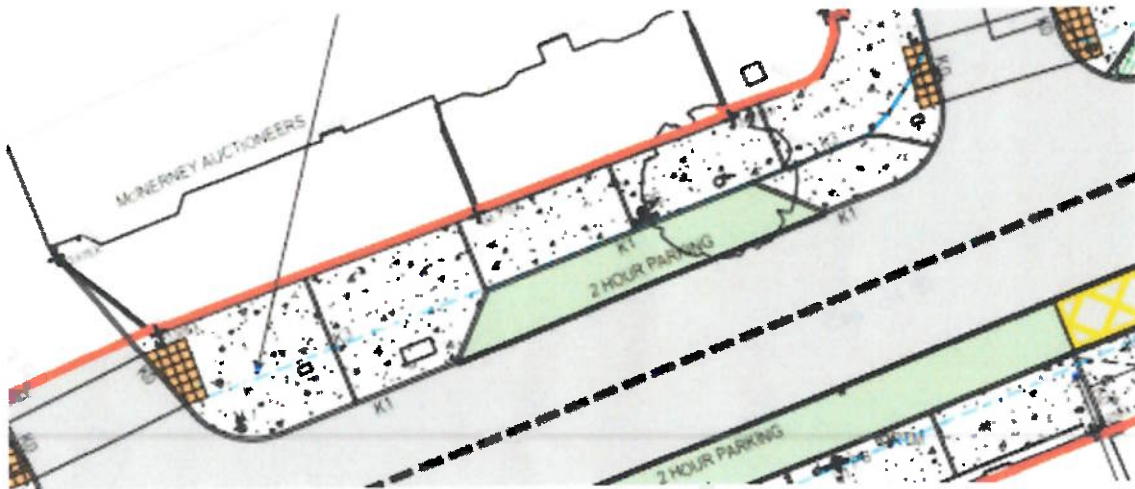
**Problem:** There is existing off-street parking located at McInerney Auctioneers and a dwelling house at the corner of the Gort Family Practice. The proposals include for the provision of a 100mm high kerb across both entrances and also a parking bay.

**Hazard:** Riders of powered two-wheeled vehicles may lose vehicle control when attempting to cross the kerb. Additionally high sided vehicles in the parking bay may restrict visibility on exit from the driveways.

**Recommendation:** The Design Team should provide suitable entrance to the parking areas, with suitable visibility splays.

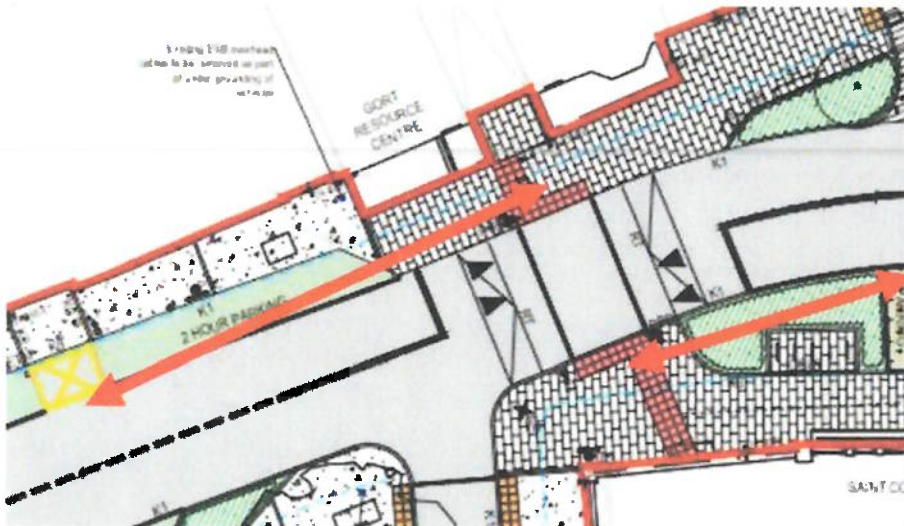
**Problem:** There is a parking bay located to both sides of the controlled crossing, also with landscaping to the east the crossing. High-sided vehicles within the parking bays or high vegetation may restrict driver visibility to the crossing signal heads and also visibility for motorists exiting Queens Street. Furthermore, pedestrians have a poor record at signal-controlled crossings of crossing when the red man is illuminated.

**Hazard:** Motorists may exit Queens Street into the path of oncoming traffic, Pedestrians may commence their crossing unsighted to oncoming motorists, or motorists may fail to stop when shown a red light.

**Recommendation:** The Design Team should ensure adequate visibility is provided.

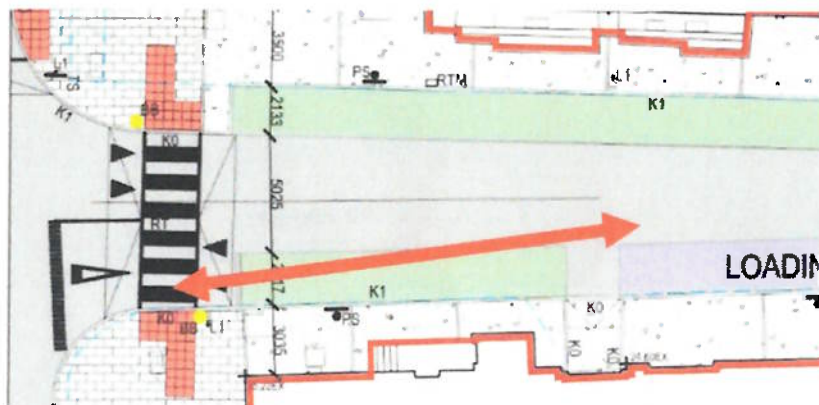
**Problem:** There is a parking bay located to the east of the controlled crossing. High sided vehicles within the parking bay may restrict driver visibility to the waiting or northbound crossing pedestrian.

**Hazard:** Pedestrians may commence their crossing unsighted to oncoming motorists.

**Recommendation:** The Design Team should reduce the carriageway width at the mouth of the junction such that the southern side of the crossing is visible to approaching motorists.

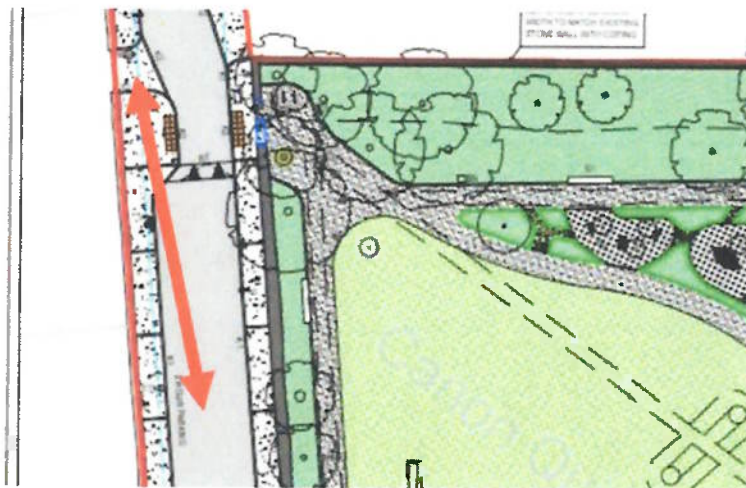
**Problem:** The proposed vehicle parking on Queens Street is to the west of the carriageway near the park. There is a dwelling house on the western side of the street. High-sided vehicles parked in the bay may restrict visibility for users exiting the dwelling driveway.

**Hazard:** Users may exit the driveway into the path of oncoming traffic.

**Recommendation:** The Design Team should ensure adequate driveway visibility is provided.

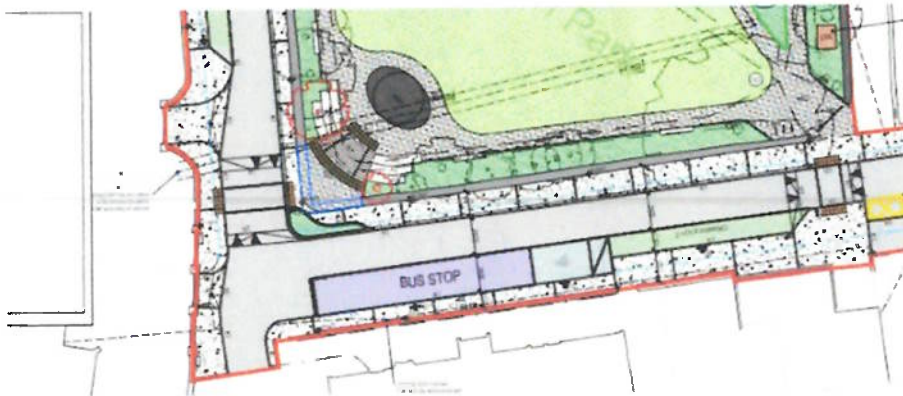
**Problem:** It appears the design is reducing the carriageway width on elements of Queens Street. There is a bus stop located on Queens Street. There is concern that the general reduction of carriageway width will result in difficulties for the bus to navigate along and around the tight bend in Queens Street. The bus may be required to reverse or over-run the footpath.

**Hazard:** The bus may impact with other vehicles or pedestrians.

**Recommendation:** The Design Team should ensure adequate carriageway space is provide for the bus to travel without the need to reverse or overhang the footpath.

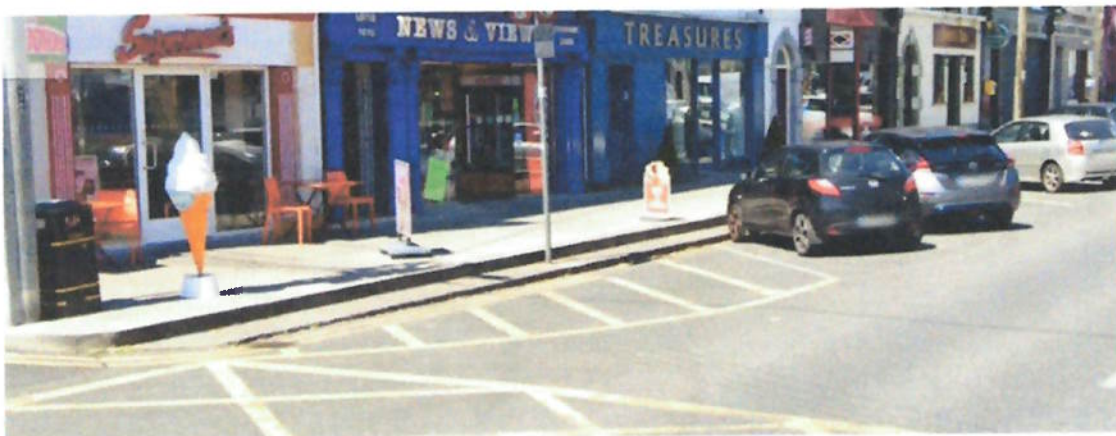
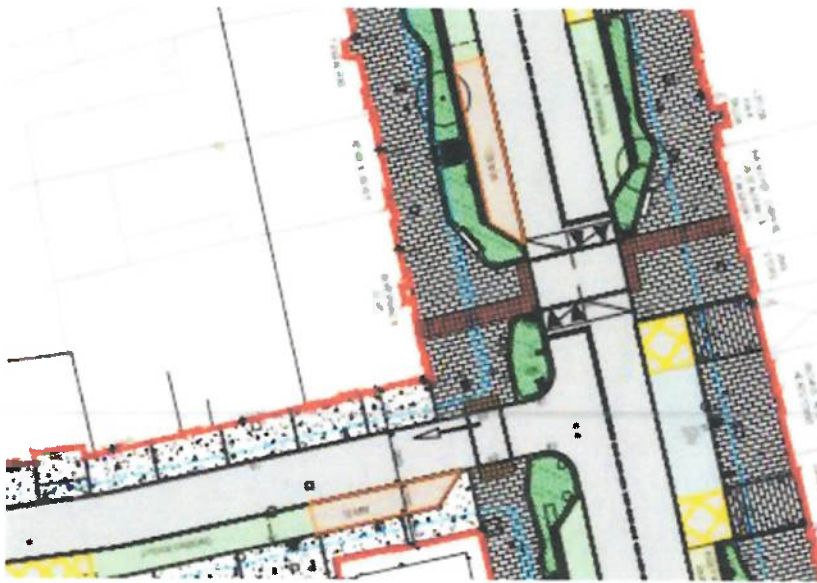
**Problem:** There is a pedestrian crossing proposed on Georges Street, outside of the Supermac's premises. Currently there is a double kerb in this location as the carriageway is substantially lower than the footpath. There is concern that the footpath to the crossing will be excessively steep.

**Hazard:** Mobility-impaired users may fall due to the gradient.

**Recommendation:** The Design Team should ensure all footpath gradients comply with current best practice.

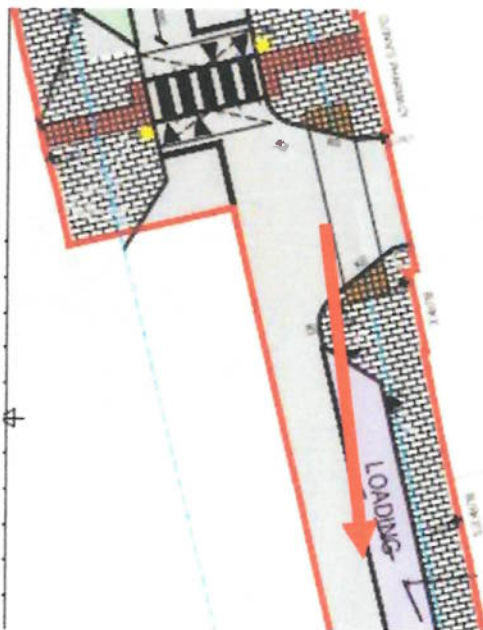
**Problem:** There is a loading bay located to the south of Station Road. Large vehicles parked in the bay may block visibility for exiting traffic.

**Hazard:** Users may exit Station Road into the path of oncoming traffic.

**Recommendation:** The Design Team should ensure suitable junction visibility is achieved.

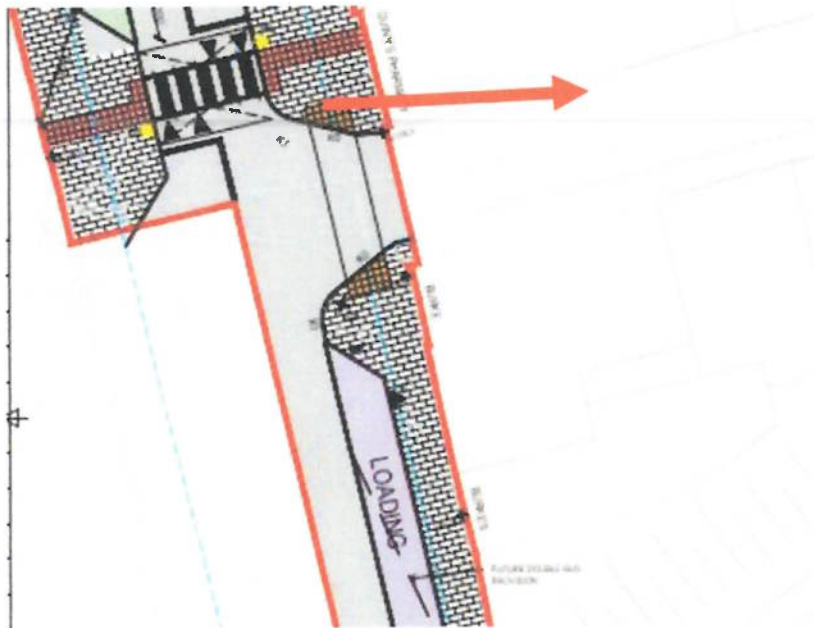
**Problem:** Pedestrians crossing north south of Station Road have their visibility to traffic exiting Station Road restricted by the building.

**Hazard:** Pedestrians may commence their road crossing and be subject to vehicle strikes.

**Recommendation:** The Design Team should relocate the tactile paving and dropped kerb closer to the Ennis Rd carriageway edge.

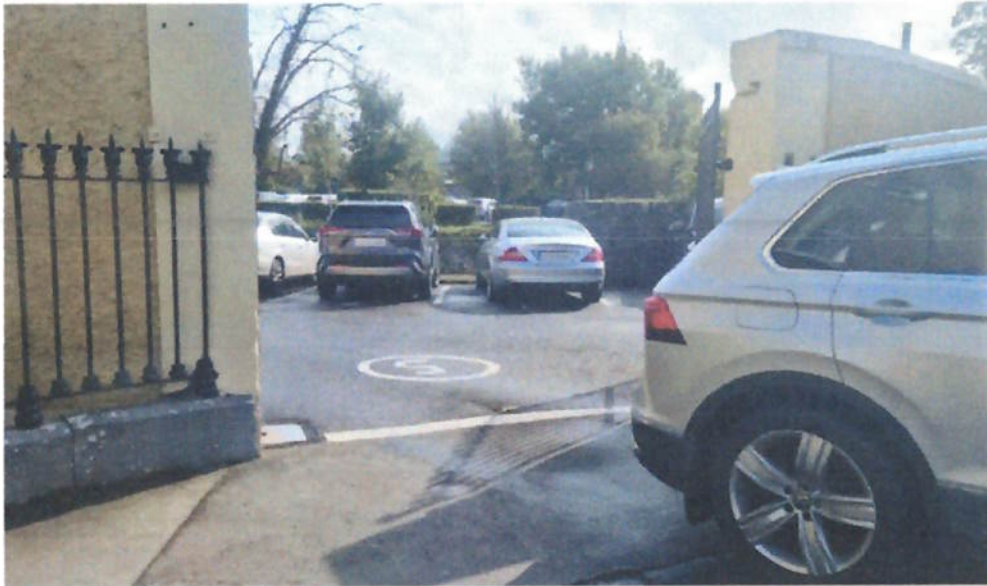
**Problem:** Motorists' visibility to pedestrians crossing the entrance to Gort Medical Centre is very restricted, both by boundary walls and the angle of the entrance. It was noted during the site visit this car park is very busy and has a high turnover rate.

**Hazard:** Pedestrian / vehicle collisions may result.

**Recommendation:** The team, in consultation with the medical centre, should undertake works to improve the existing car park access.

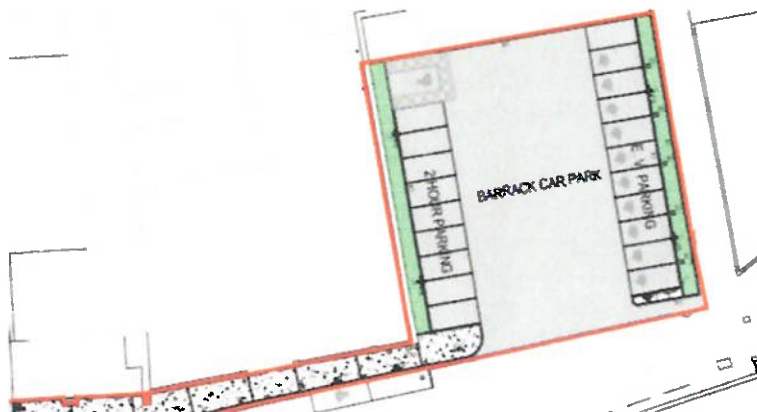
**Problem:** The car park has a large vacant space to the middle. We have been informed by the design team that this space is required for turning of HGVs. There is concern that overspill car parking will occur in this central space and this will prevent the HGV from turning here. The HGV may reverse back onto the regional Road.

**Hazard:** Impact with Regional Road traffic may occur.

**Recommendation:** The Design Team should provide suitable road markings and advisory signage in order to prevent vehicle parking within the turning area.

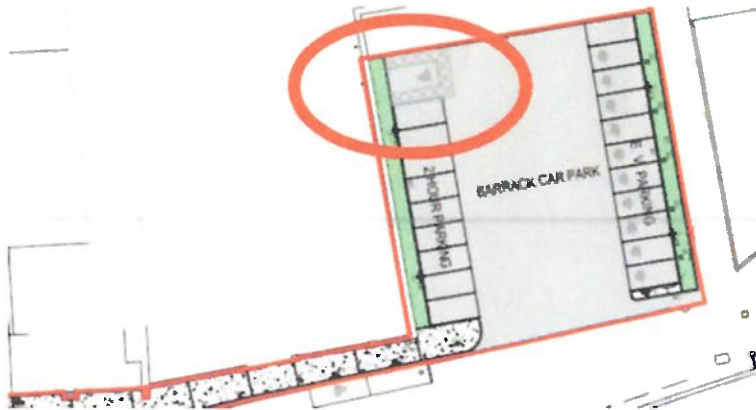
**Problem:** The disabled user parking space within the car park is not located adject to a segregated footpath. Disabled users will be required to walk through the trafficked area of the car park in order to access the footpath.

**Hazard:** Impact from passing or reversing vehicles may occur.

**Recommendation:** The Design Team should relocate the disabled user parking spaces, such that direct access to a segregated footpath can be achieved.
