CUNNANE STRATTON REYNOLDS

TREE SURVEY

Limerick City Greenway,
Limerick.

July 2024

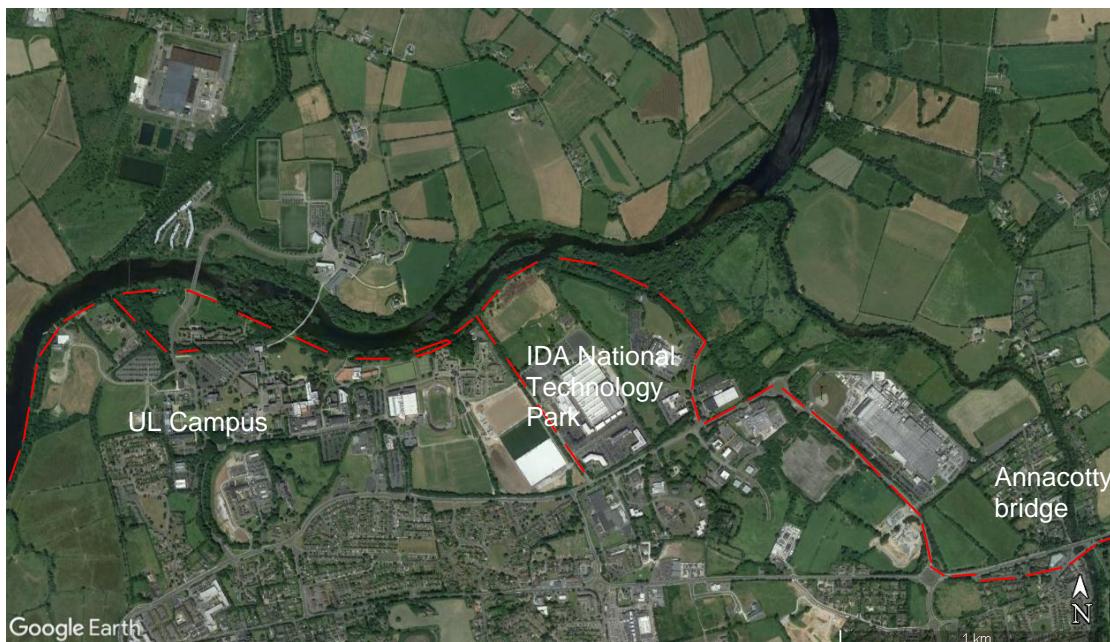
Figure 1: Low resolution satellite image of approximate tree survey area in red (courtesy of Google Earth).

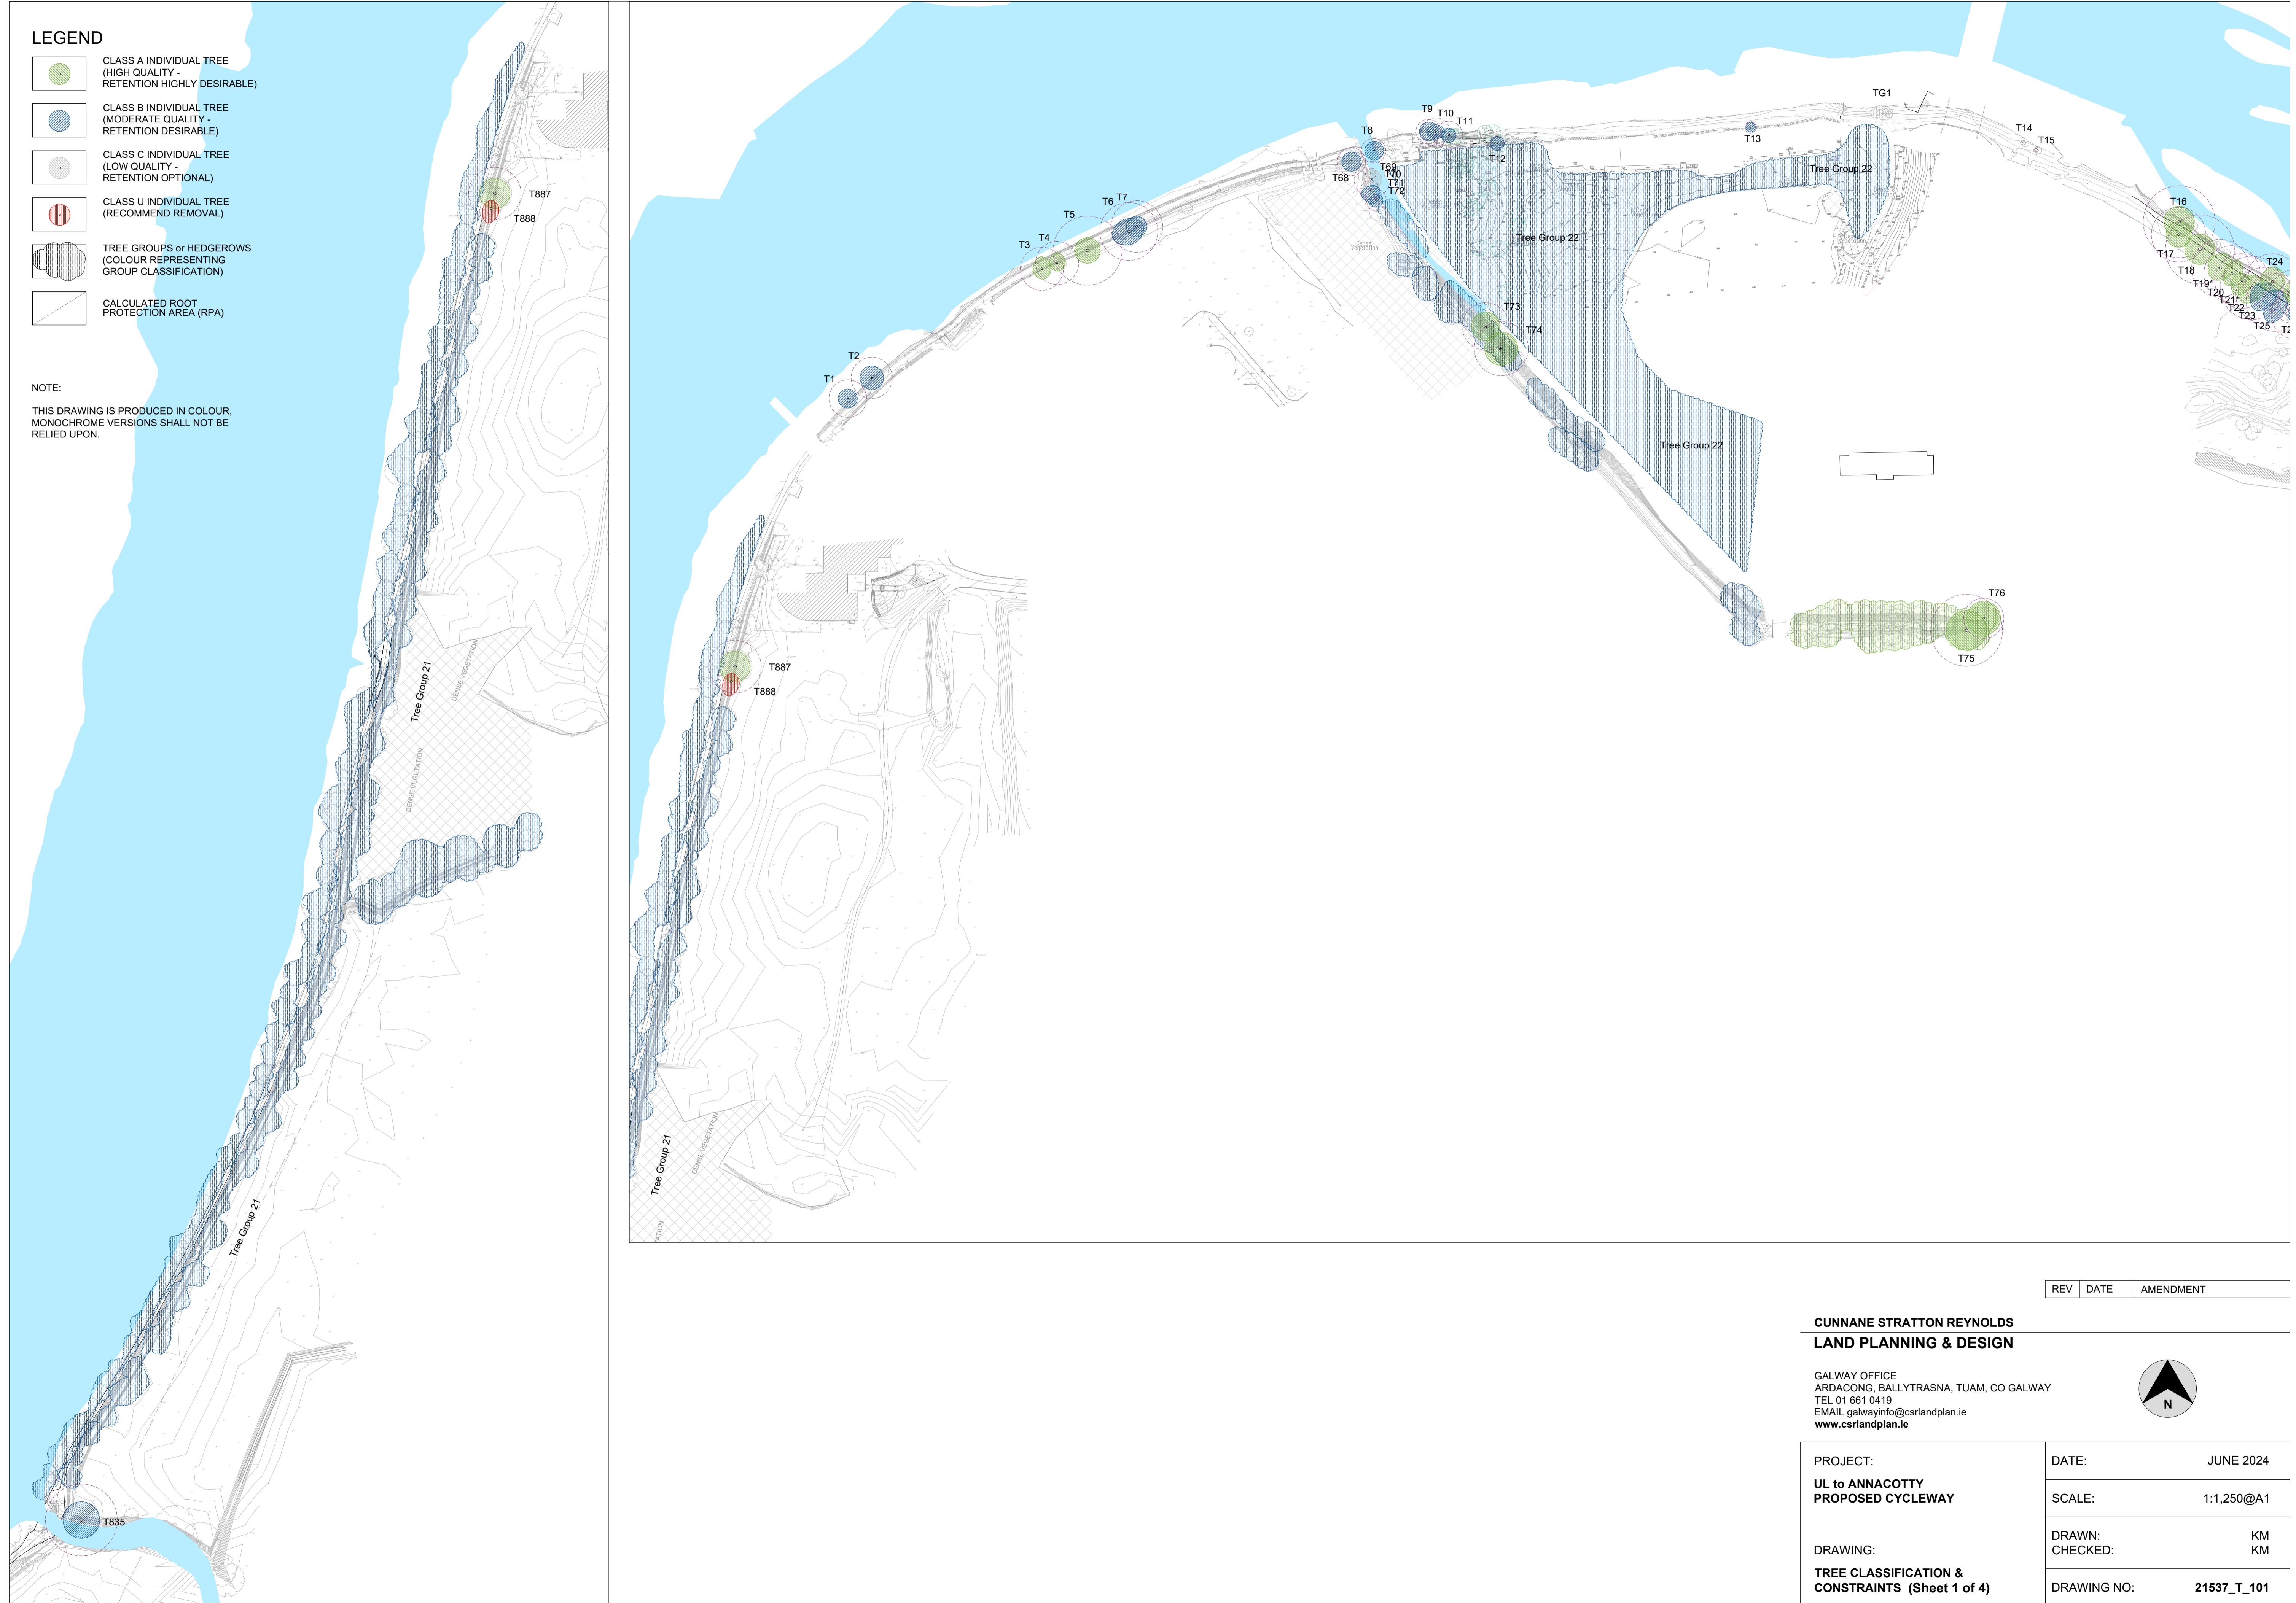
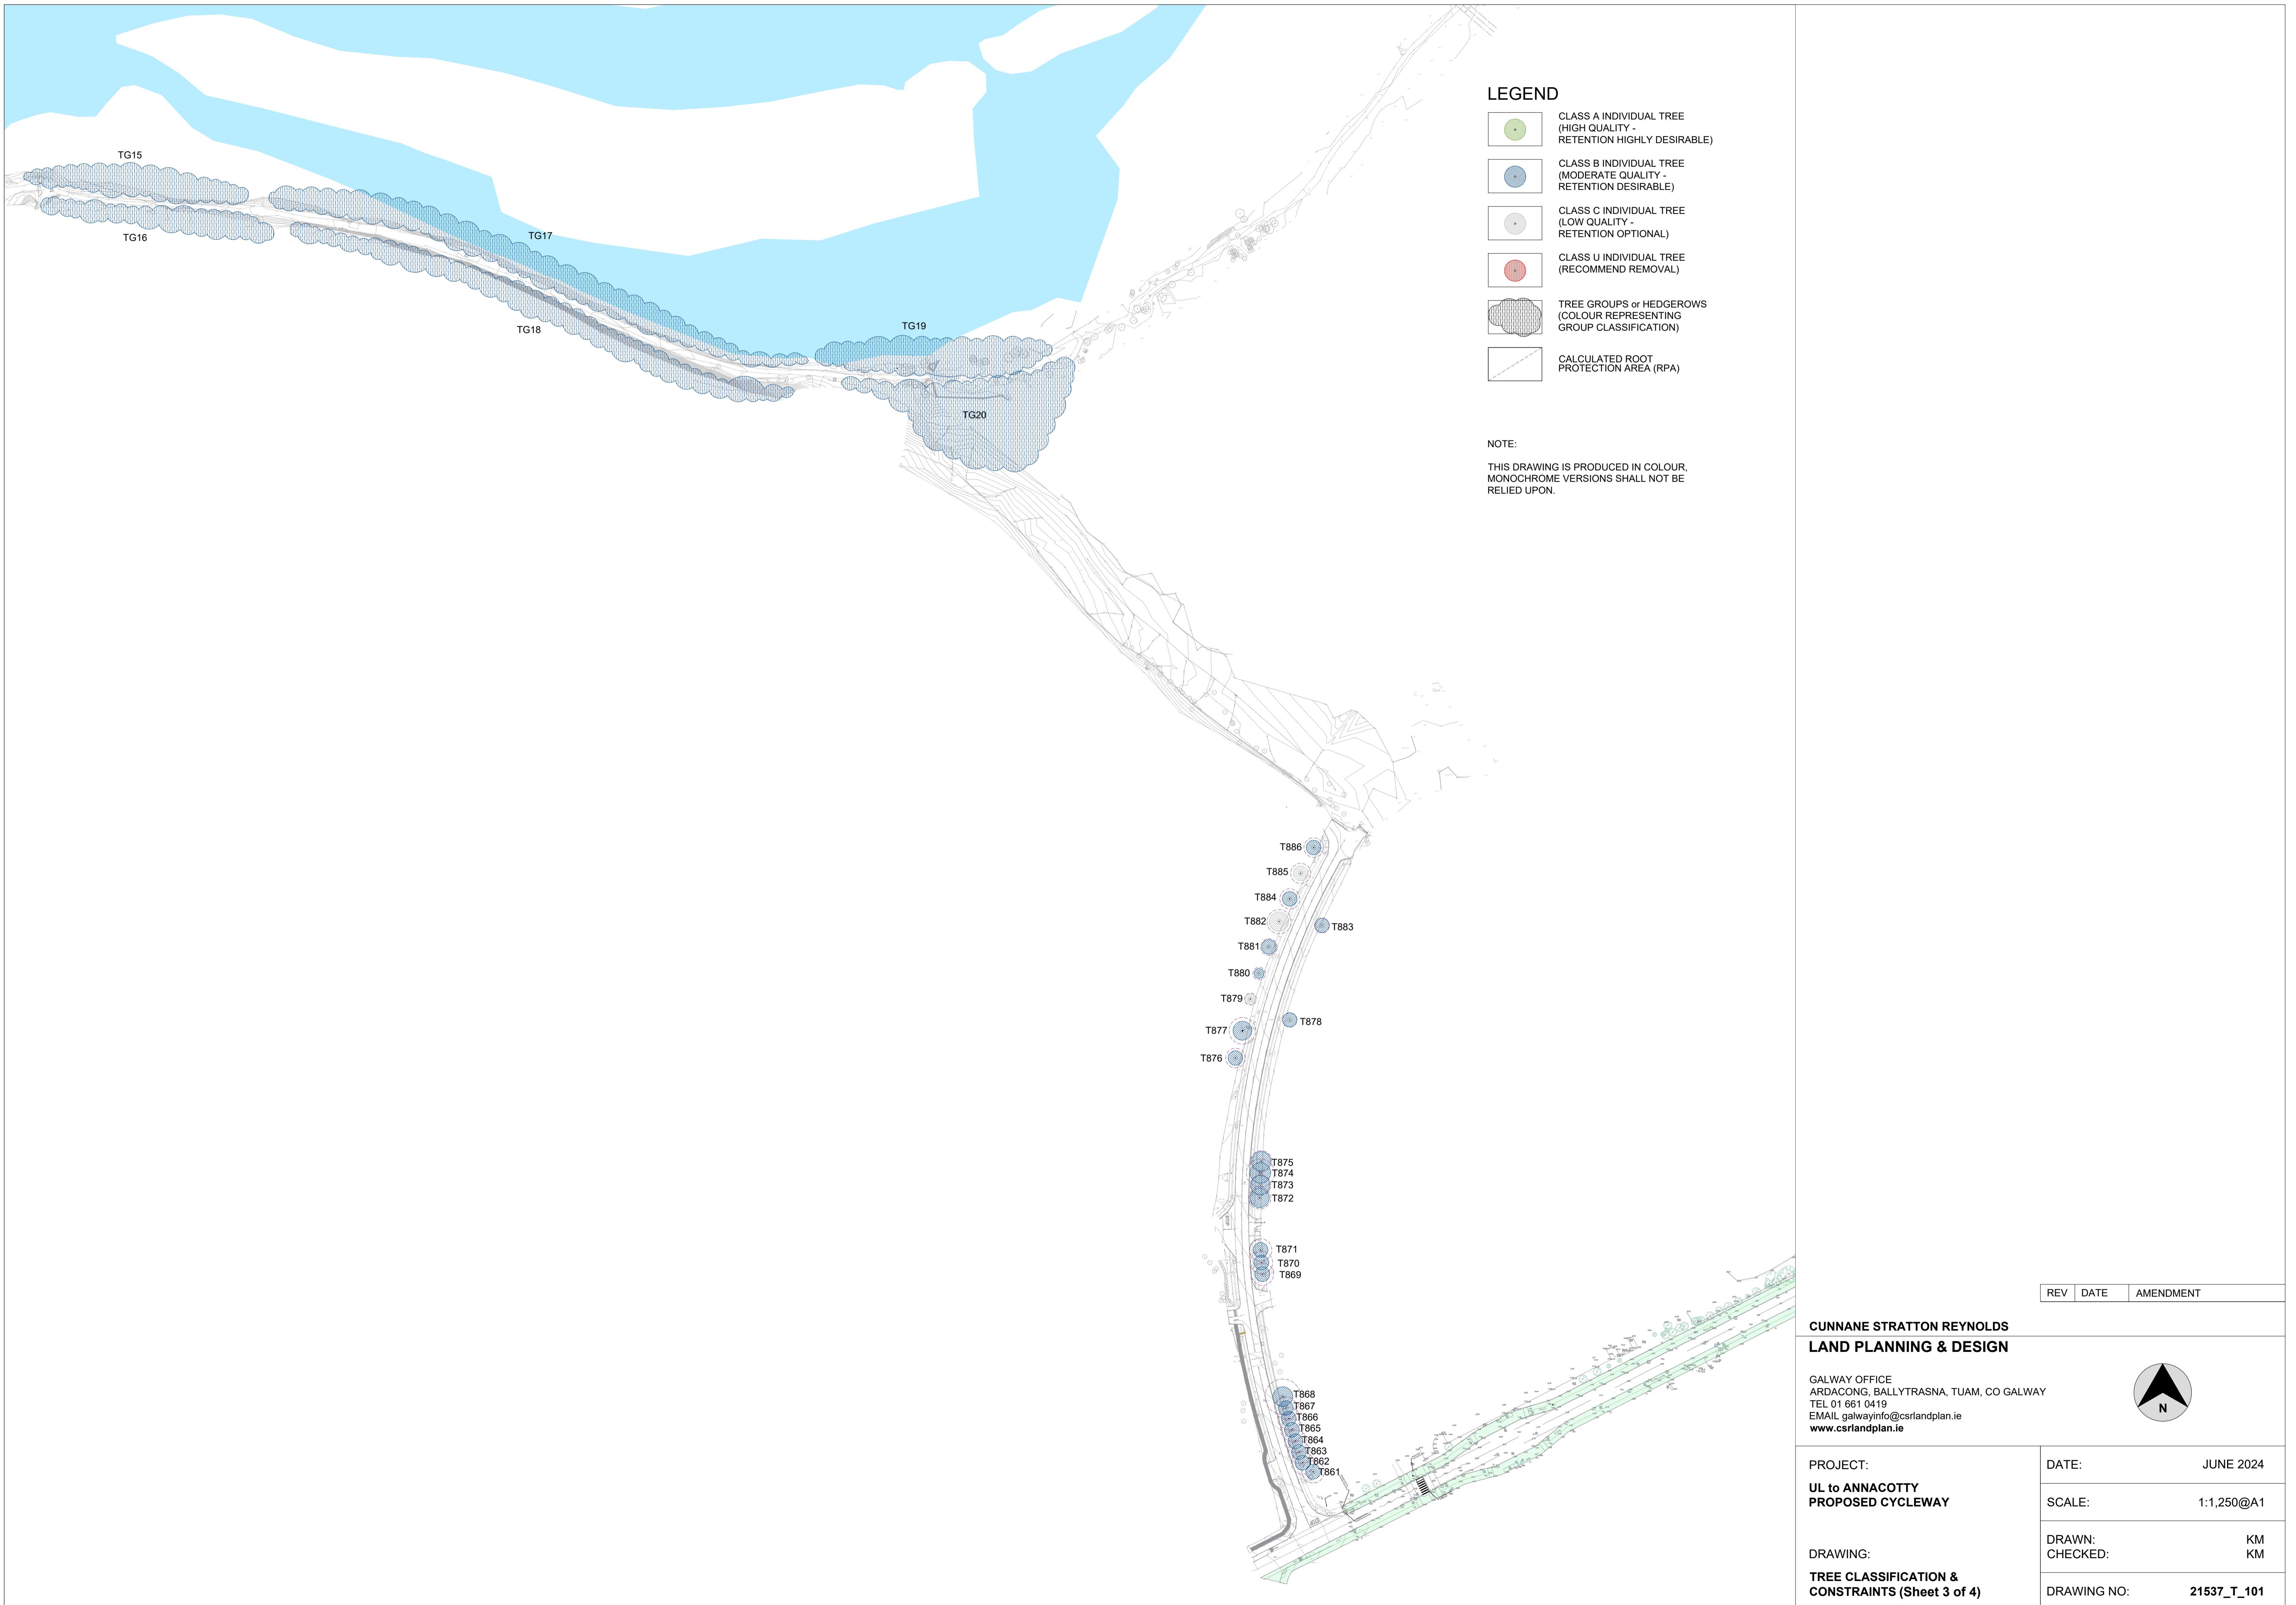
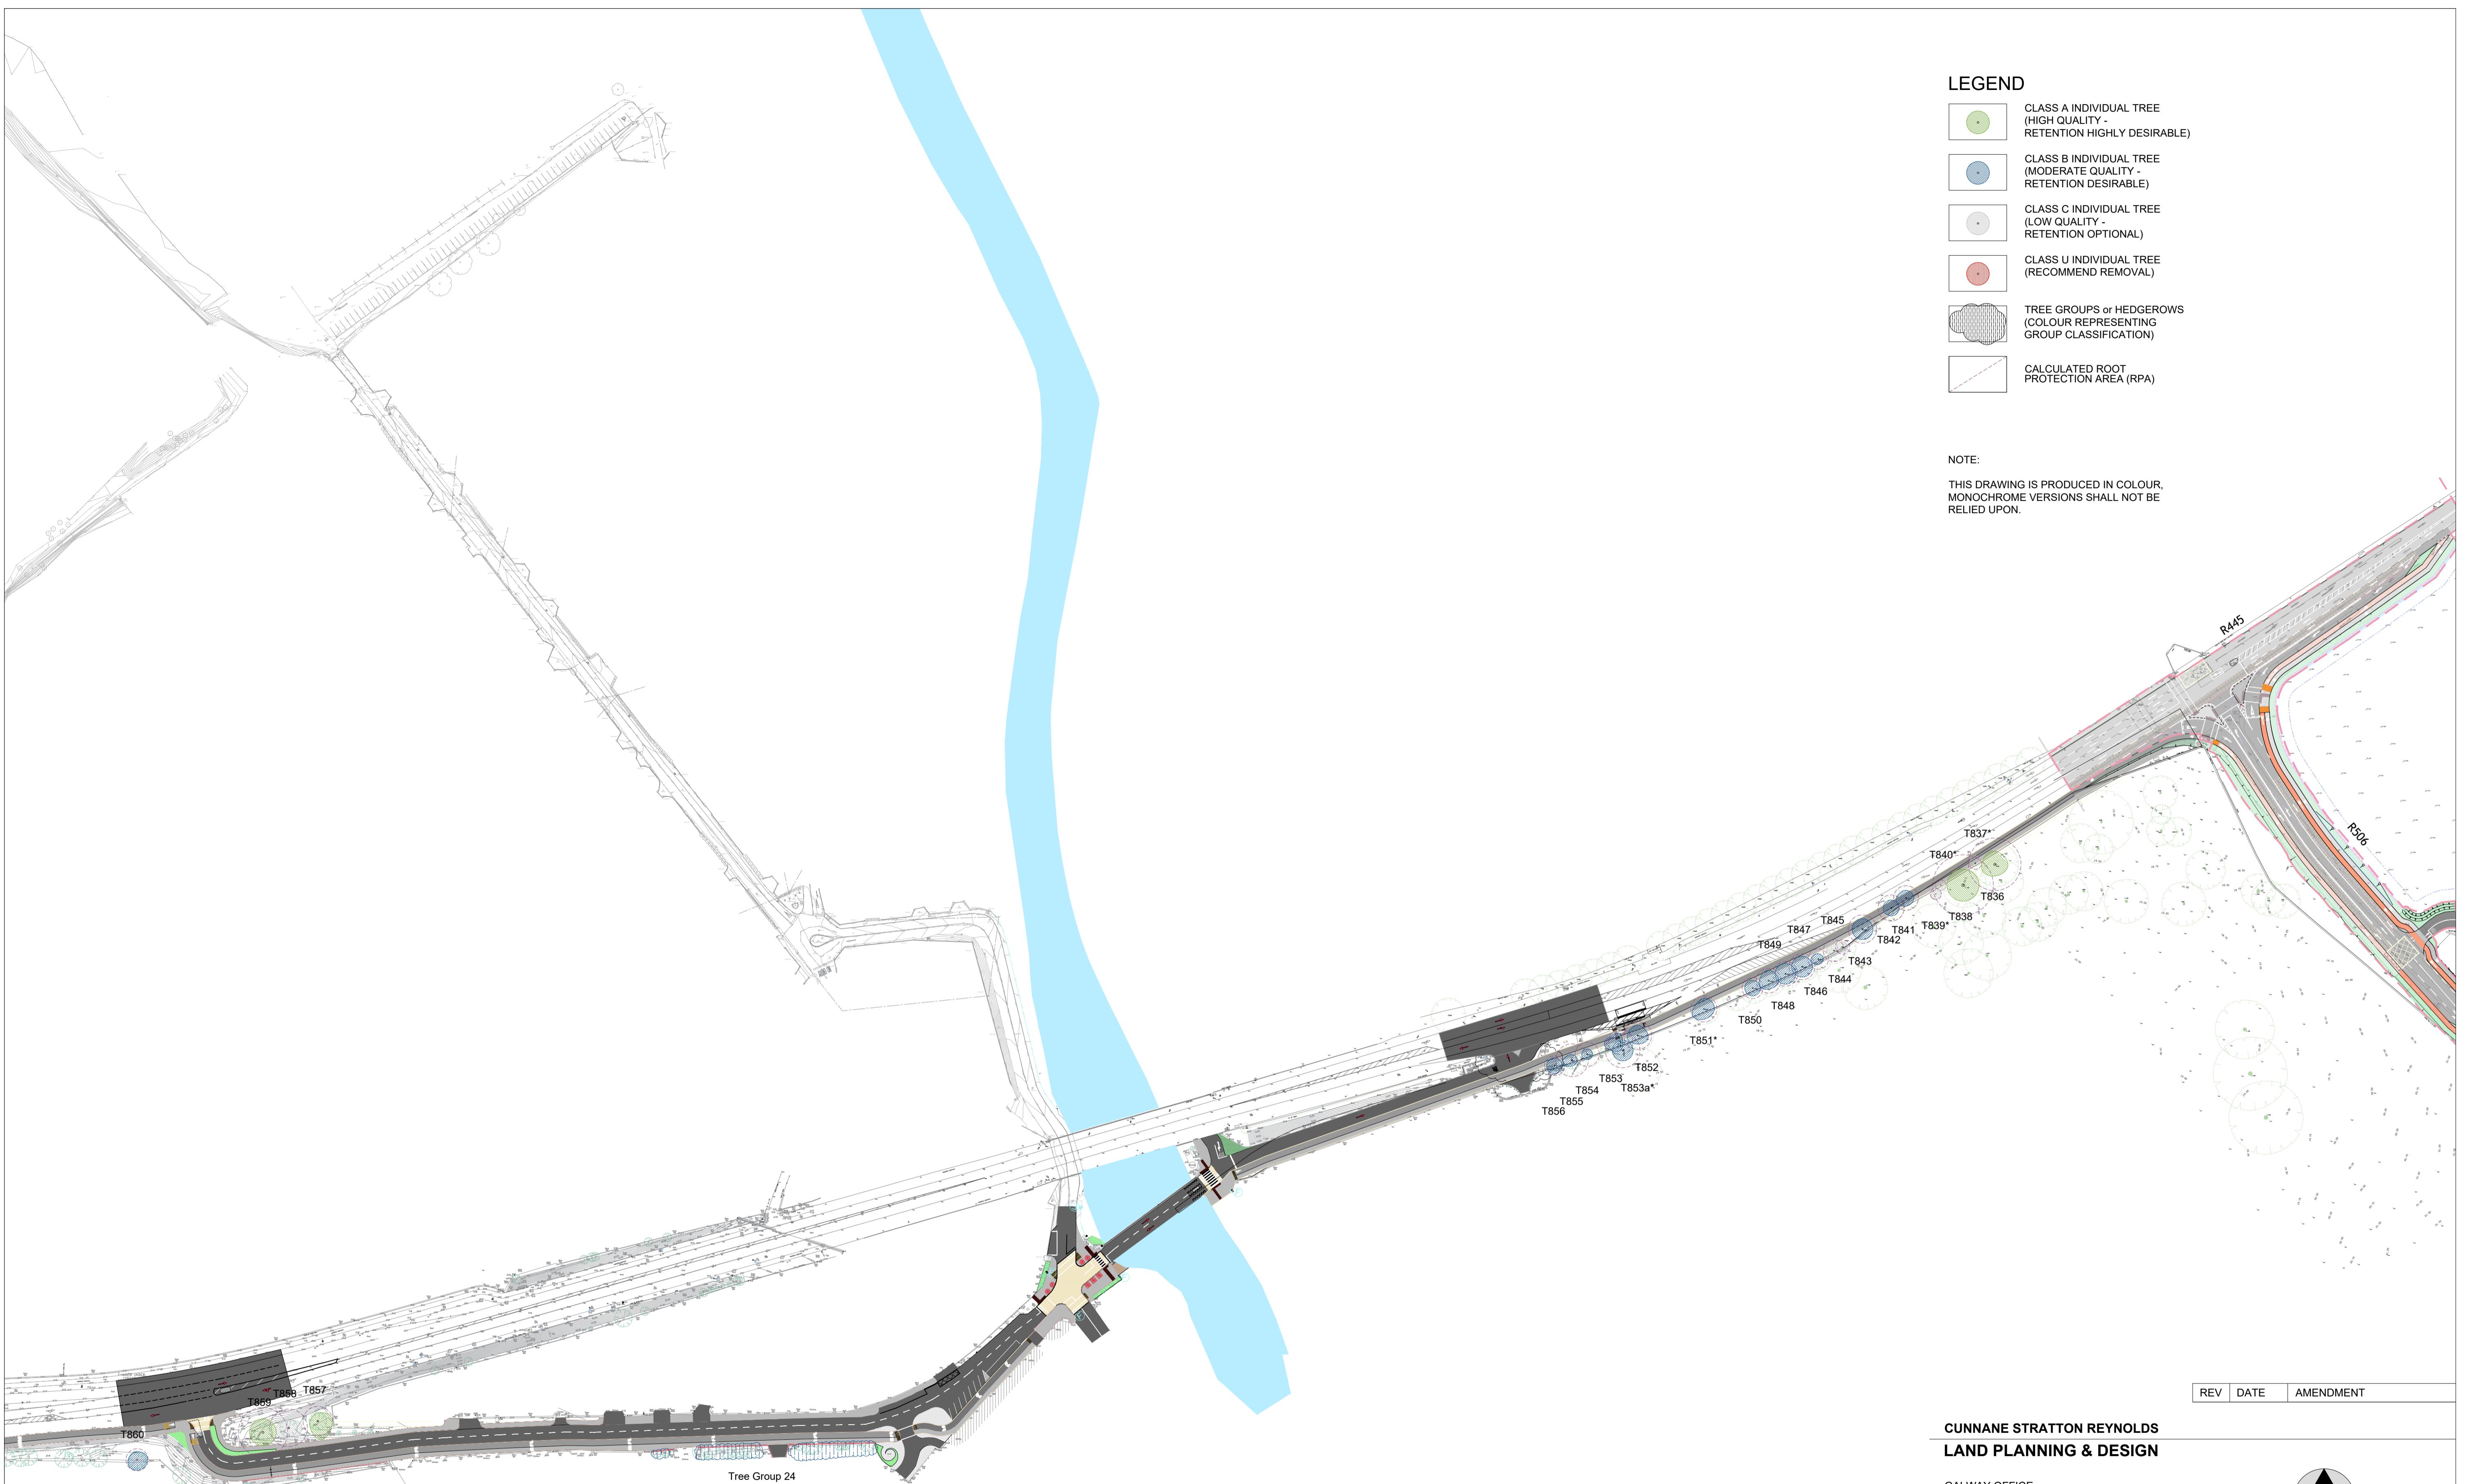
PROJECT:	DATE:	JUNE 2024
UL to ANNACOTTY PROPOSED CYCLEWAY	SCALE:	1:1,250@A1
DRAWING:	DRAWN:	KM
TREE CLASSIFICATION & CONSTRAINTS (Sheet 4 of 4)	CHECKED:	KM
	DRAWING NO:	21537_T_101

The significant size of many of these trees means that their root zones are likely to extend for significant distances as illustrated in the Classification & Constraints Dwg 21537_T_101.

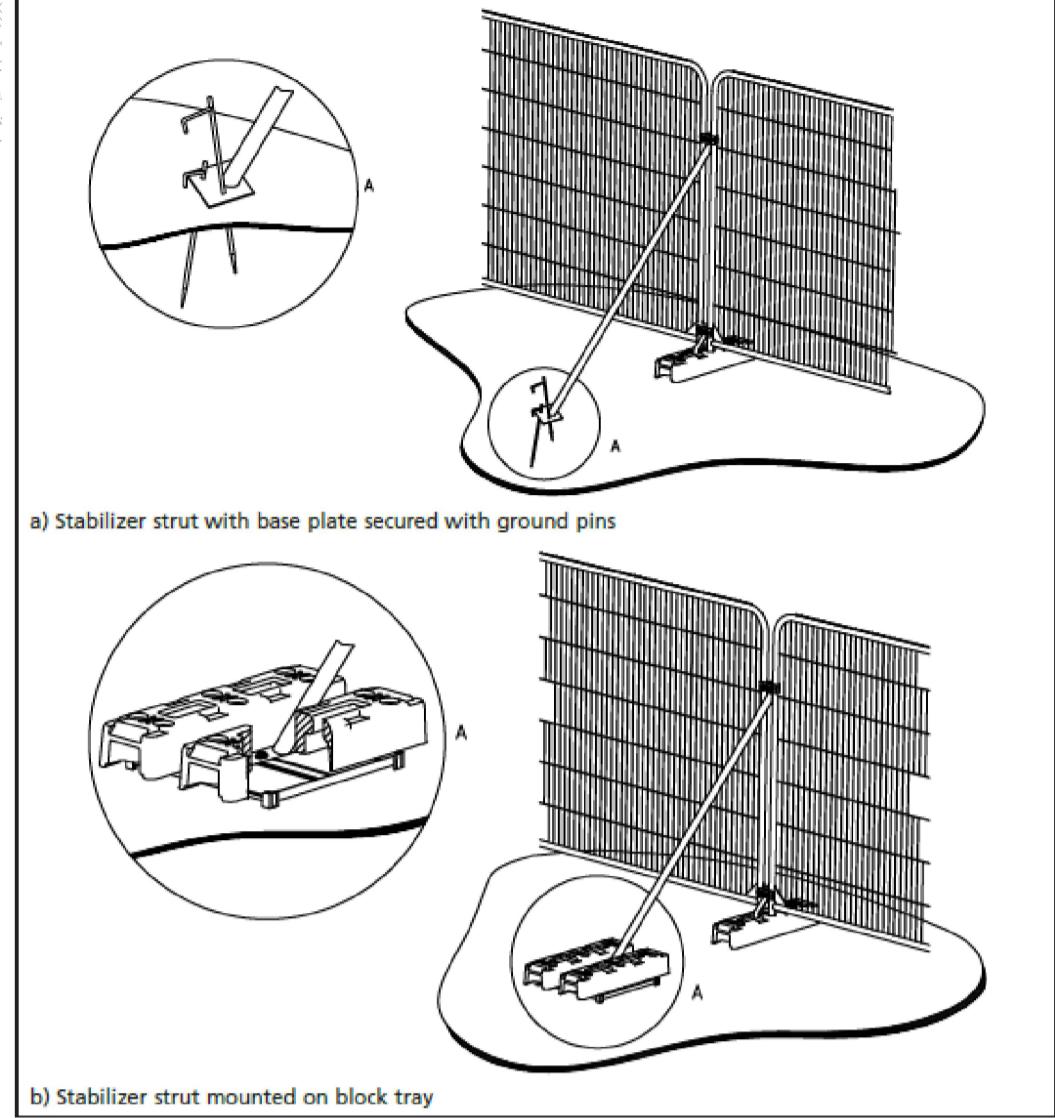
TREE PROTECTION FENCE - TYPICAL DETAIL

Figure 3 Examples of above-ground stabilizing systems
