Limerick City Greenway (UL to NTP)

Preliminary WFD Assessment

APEM Ref: P00006118

July 2024

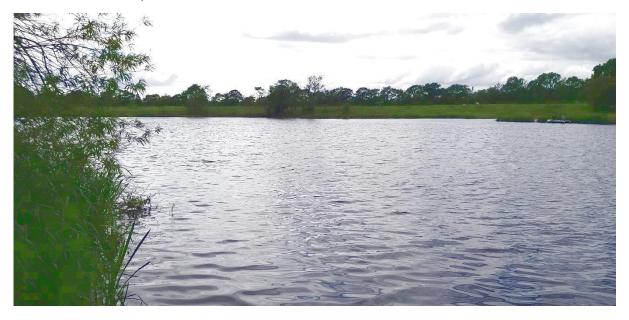
Figure 2-1 The River Shannon at the location of Bridge 1 and Bridge 2 (view downstream)

There are three proposed locations along the bank of the River Shannon at which construction works will be required. Two locations are sited downstream (Figure 2-1) from the University of Limerick boat house. At this location, the River Shannon is very wide (approximately 90 m), with glide flow typology and densely vegetated banks. Where visible, substrate includes gravels which may be suitable for lamprey spawning, as well as large woody debris providing habitat diversity and enrichment for fish and macroinvertebrate species.

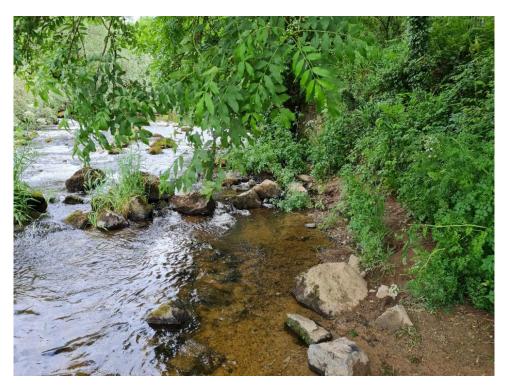
Figure 2-2 The River Shannon at the location of the proposed Bridge 5 and Ramp at Plassey Beach (view upstream)

The third proposed construction location is at the site of the proposed Bridge 5 and proposed ramp at Plassey Beach (Figure 2-2). The River Shannon at this location has a shallow-to-moderate gradient, with a cobble/ boulder bed river, with riffle flow typology. The channel here is split into two distinct halves, with a large island in the middle of the channel, populated by dense shrub and tree cover.

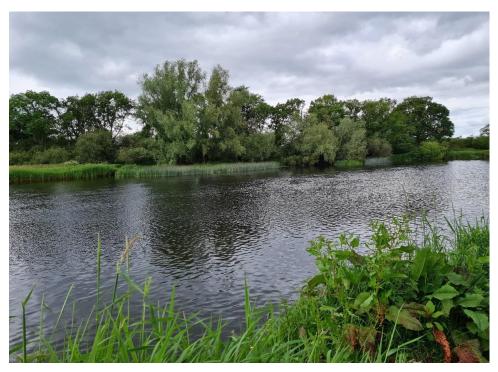
Figure 2-3 The River Shannon upstream of the proposed Bridge 5 and ramp at Plassey Beach (view upstream)

Further upstream, the river returns to a singular, wide channel, with glide flow typology and moderate flow with a shallow gradient (Figure 2-3). Although not part of the surveyed reach, areas of riffle habitat were visible in the channel upstream from the confluence between the River Shannon and the River Mulkear.
