# Stage 1 Structural Assessment Report

Mayo County Council

# N59 CARROWREVAGH BRIDGE REHABILITATION WORKS

Document title: MO-N59-053.50 Carrowrevagh Bridge Stage 1 Assessment

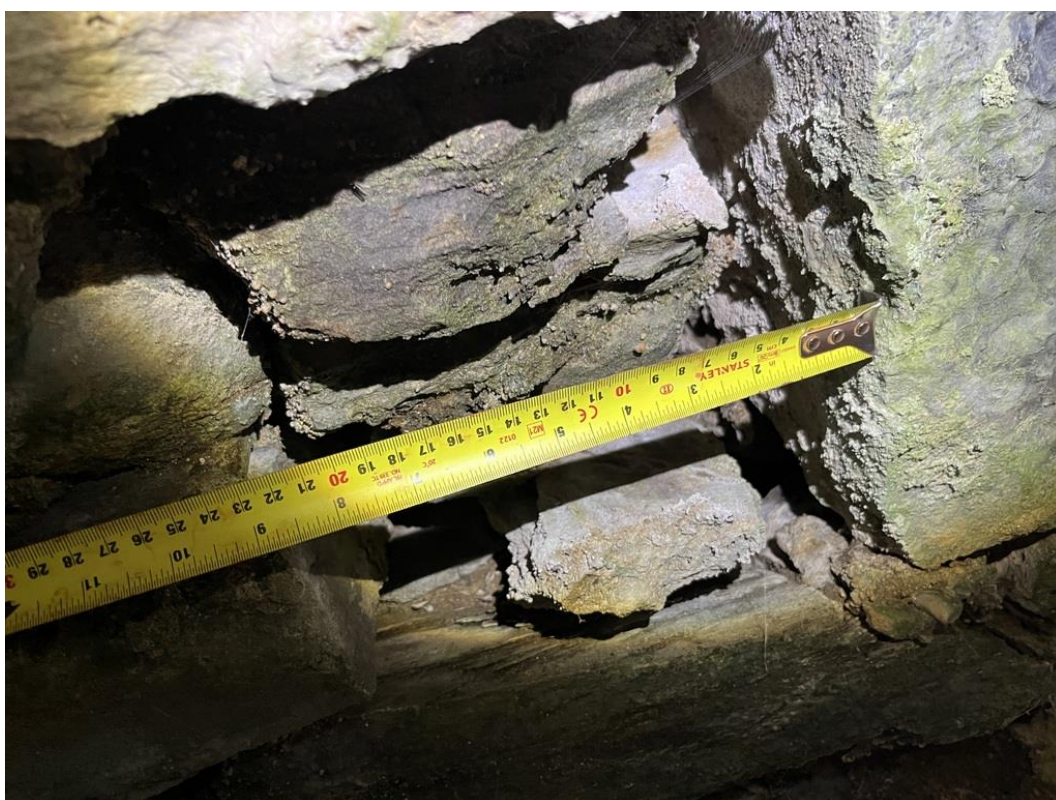
- Extensive pointing loss across the crown of the arch barrel with maximum depth of 250mm recorded.
- 3no. areas of missing masonry to the arch barrel
  - Area 1 – Inside the southern arch ring measuring 250mm x 230mm x 240mm
  - Area 2 – 0.5m in from the south elevation measuring 200mm x 140mm x 500mm
  - Area 3 – 3m in from the south elevation measuring 100mm x 120mm x 160mm
- Broken voussoir stone to the north elevation of the masonry arch.
- Cracked voussoir stones to the south elevation of the masonry arch.

Photograph B-18 – View of the missing masonry to the arch barrel (Area 1)

Based on the findings of the assessment no further assessment measures are deemed required for the structure, providing that the necessary repairs are undertaken to the arch barrel to return it to good condition. As there is no evidence of failure or excess deformation of the arch barrel, a load restriction is not recommended at this time however monitoring of the structure should be taken annually to check for any evidence of deformation or failure of the arch until the repairs are carried out.

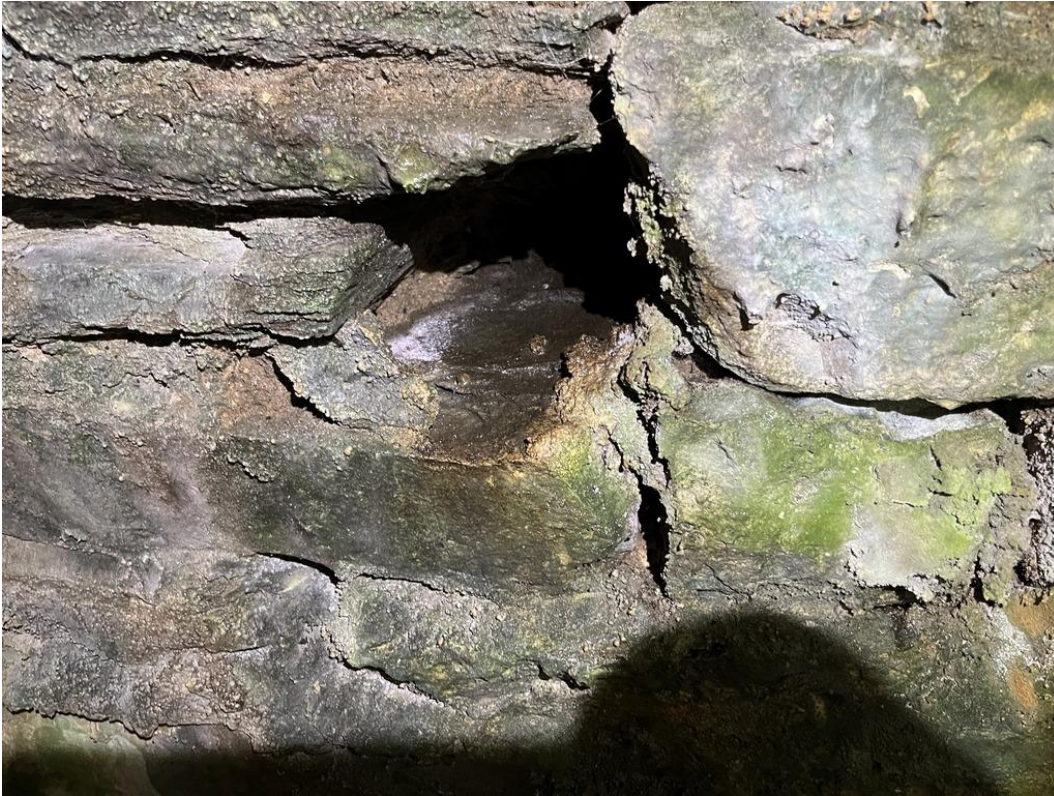
**Photograph B-19 – View of the missing masonry to the arch barrel (Area 2)**

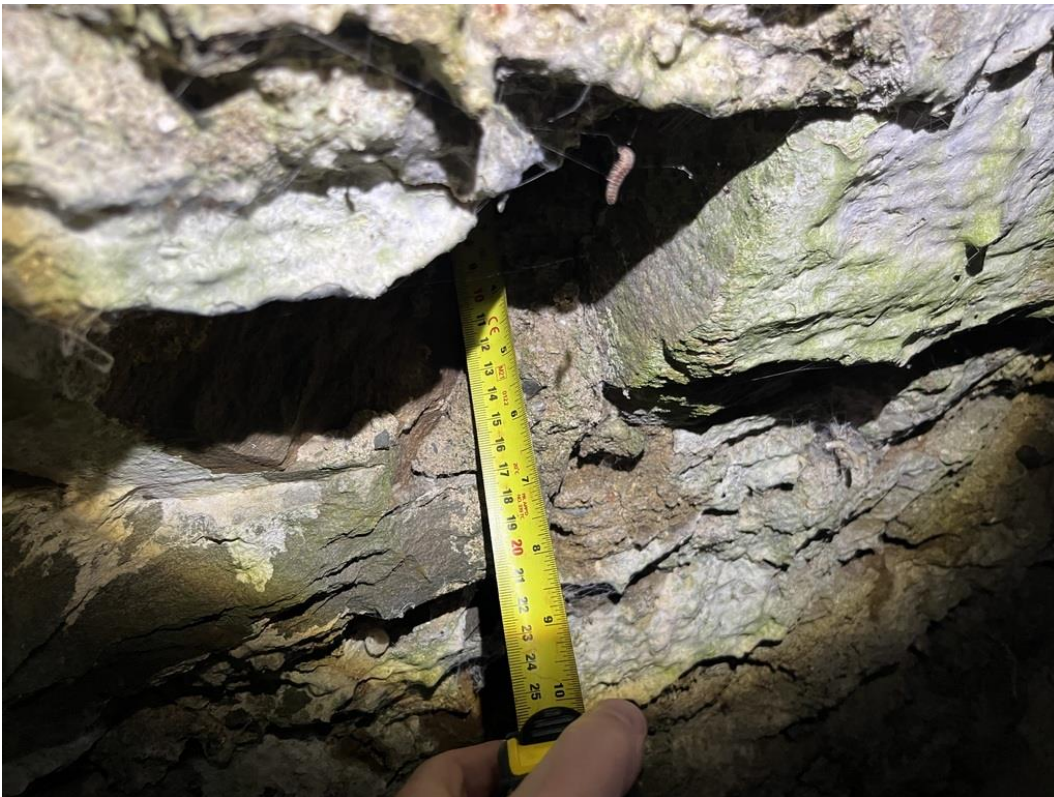
**Photograph B-20 – View of the missing masonry to the arch barrel (Area 3)**

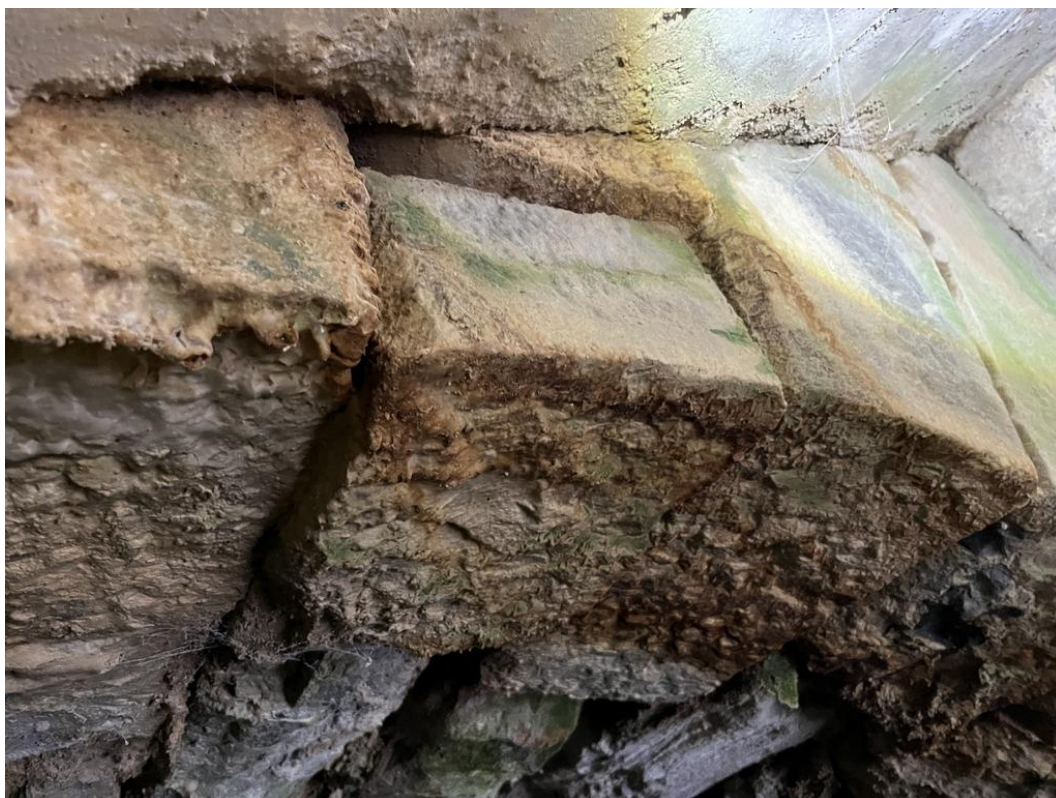
**Photograph B-21 – View of the cracked voussoir stone at the northern end of the arch barrel**

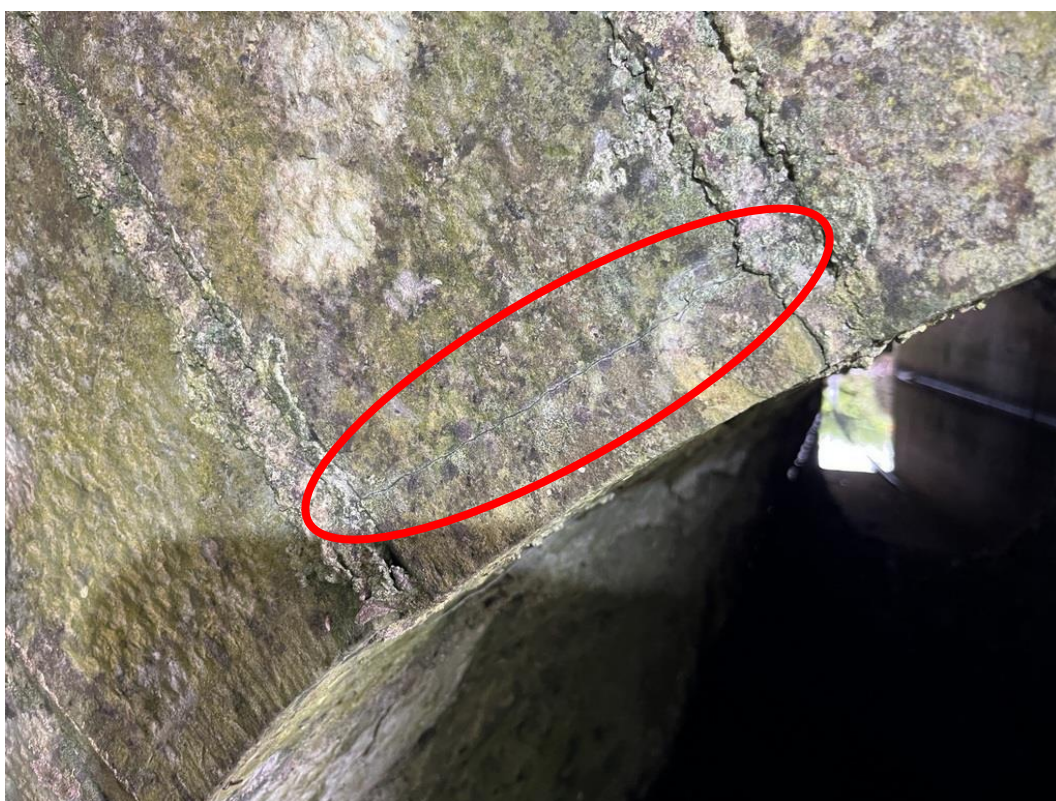
**Photograph B-22 – View of the cracked voussoir stone at the south elevation**

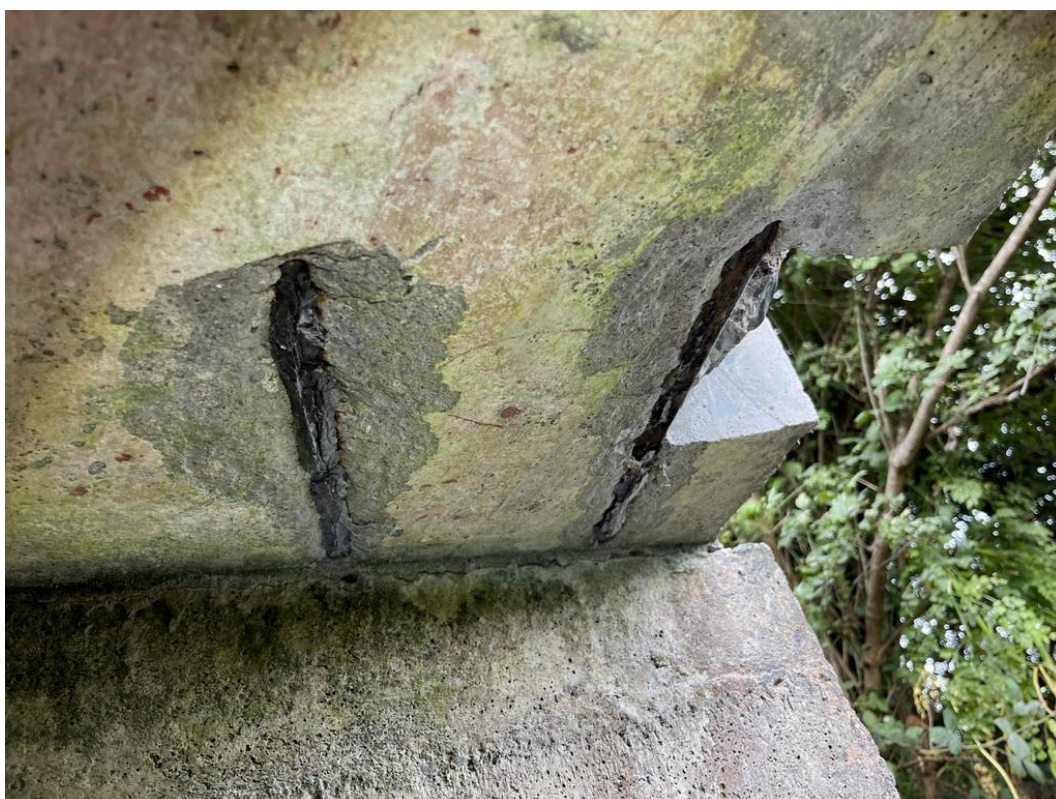
The reinforced concrete slab extension to the north end of the structure is in fair condition overall with 3no. areas of spalling to the concrete deck as follows.

**Photograph B-24 – View of the spalling to the concrete deck at the northern fascia (Area 1)**

The concrete spalling in the soffit of the deck should also be repaired, with the corroded reinforcement cleaned, treated with anti-corrosion paint, and the concrete cover reinstated. The recommended works for the structure are as follows:

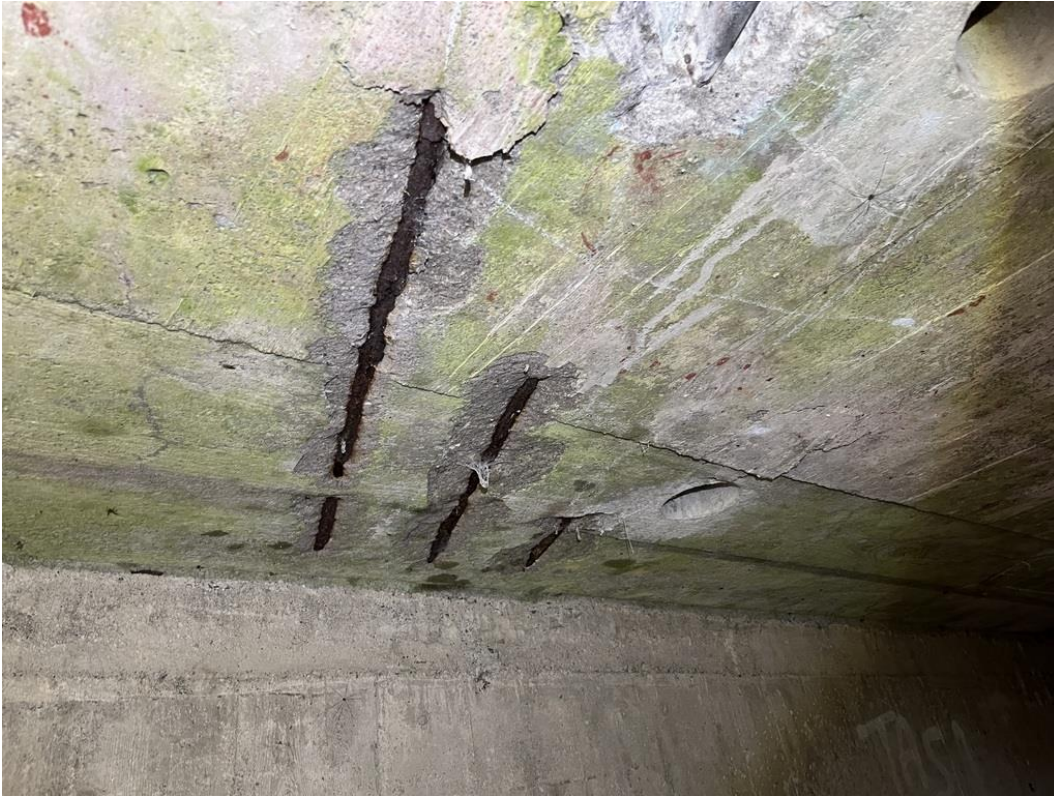
**Photograph B-25 – View of the spalling to the concrete deck 0.8m from the north elevation (Area 2)**

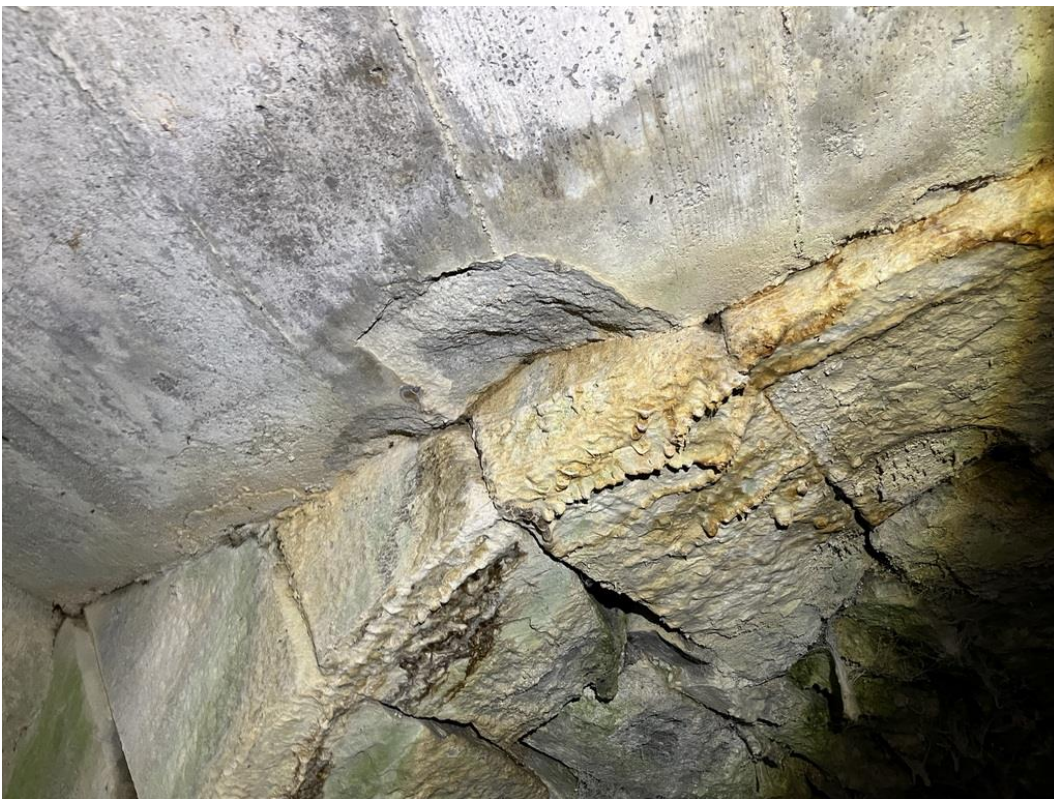
**Photograph B-26 – View of the spalling to the concrete deck at the south end of the deck (Area 3)**

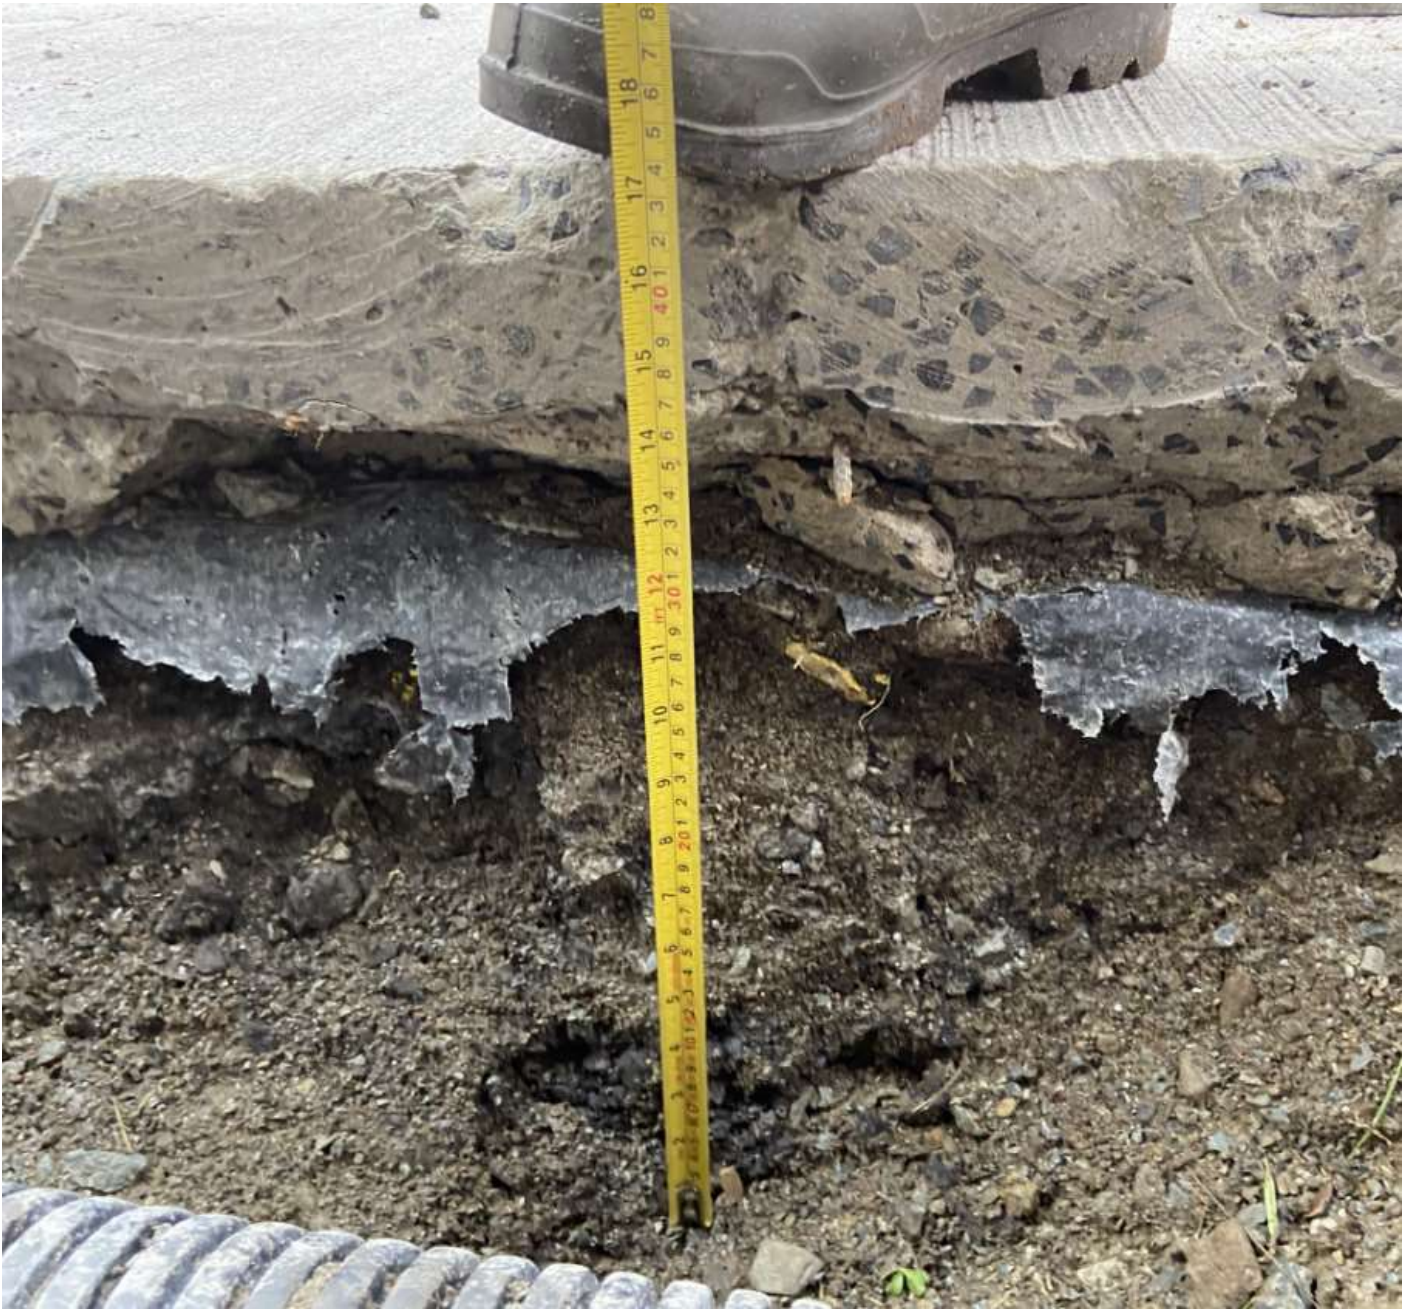
The trial pit to the footway over the masonry arch structure found a depth of fill of 290mm to the crown of the arch barrel from the footway surface with a clay material evident within the trial pit i.e. no backing found. The depth of fill above the carriageway was subsequently calculated as 180mm.

*Figure 14: Fill layers above arch*

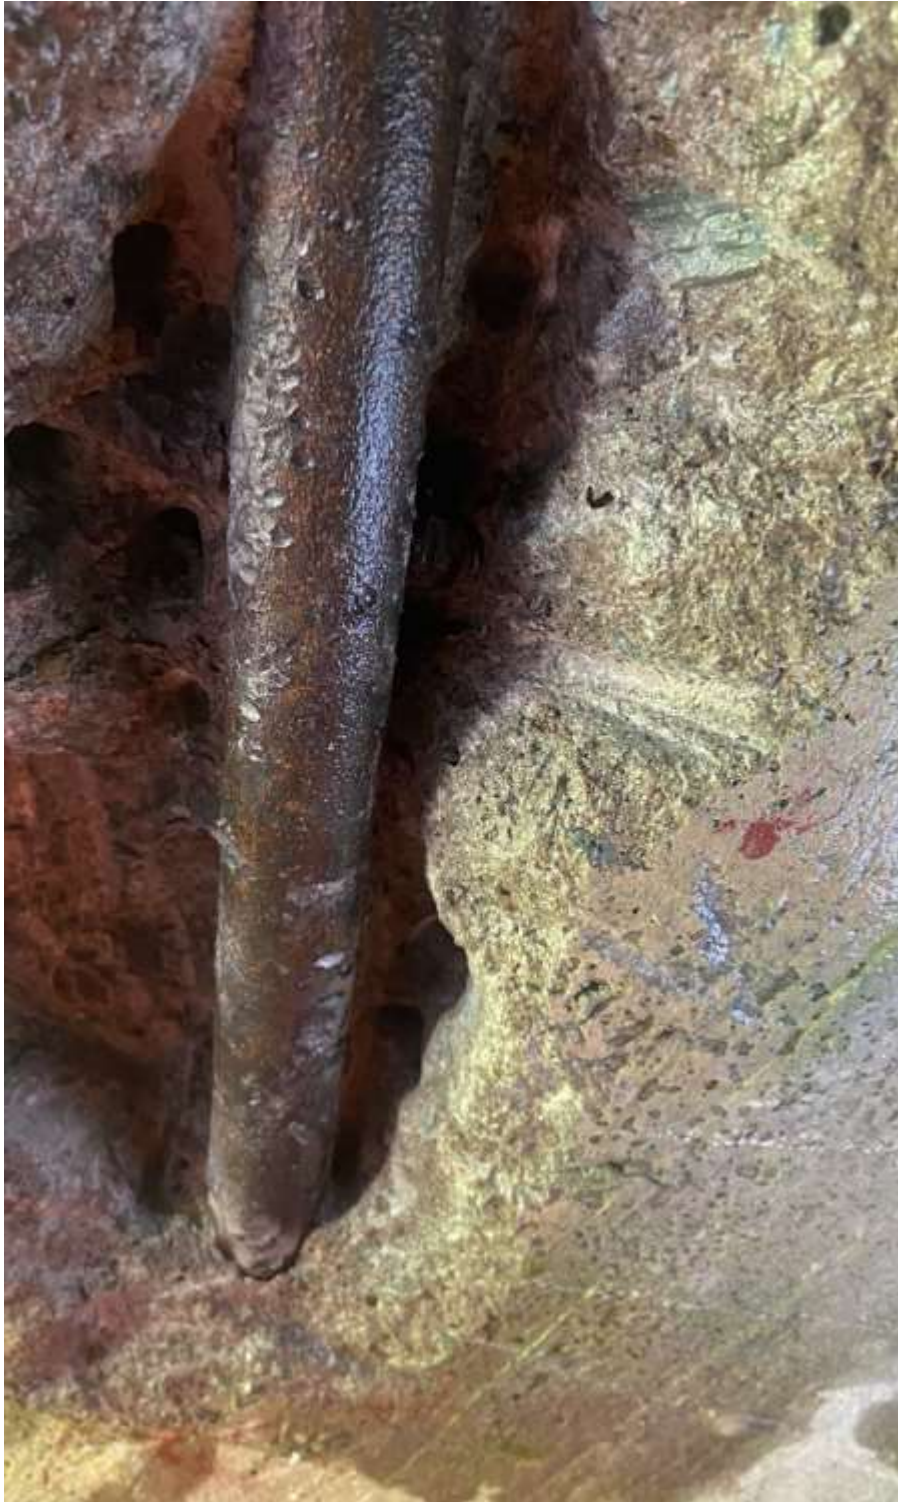
from 236mm to 253mm in depth. The reinforcement in the deck slab comprised 25mm longitudinal reinforcement at 160mm spacing and 12mm transverse reinforcement at 200mm spacing. The concrete strength of the slab varied between 56.2 N/mm<sup>2</sup> and 68.1N/mm<sup>2</sup>. No reinforcement was found in either the top of the deck slab or the abutments with the support conditions assumed to be simply supported as a result.

*Figure 21: Longitudinal and Transverse Reinforcement*

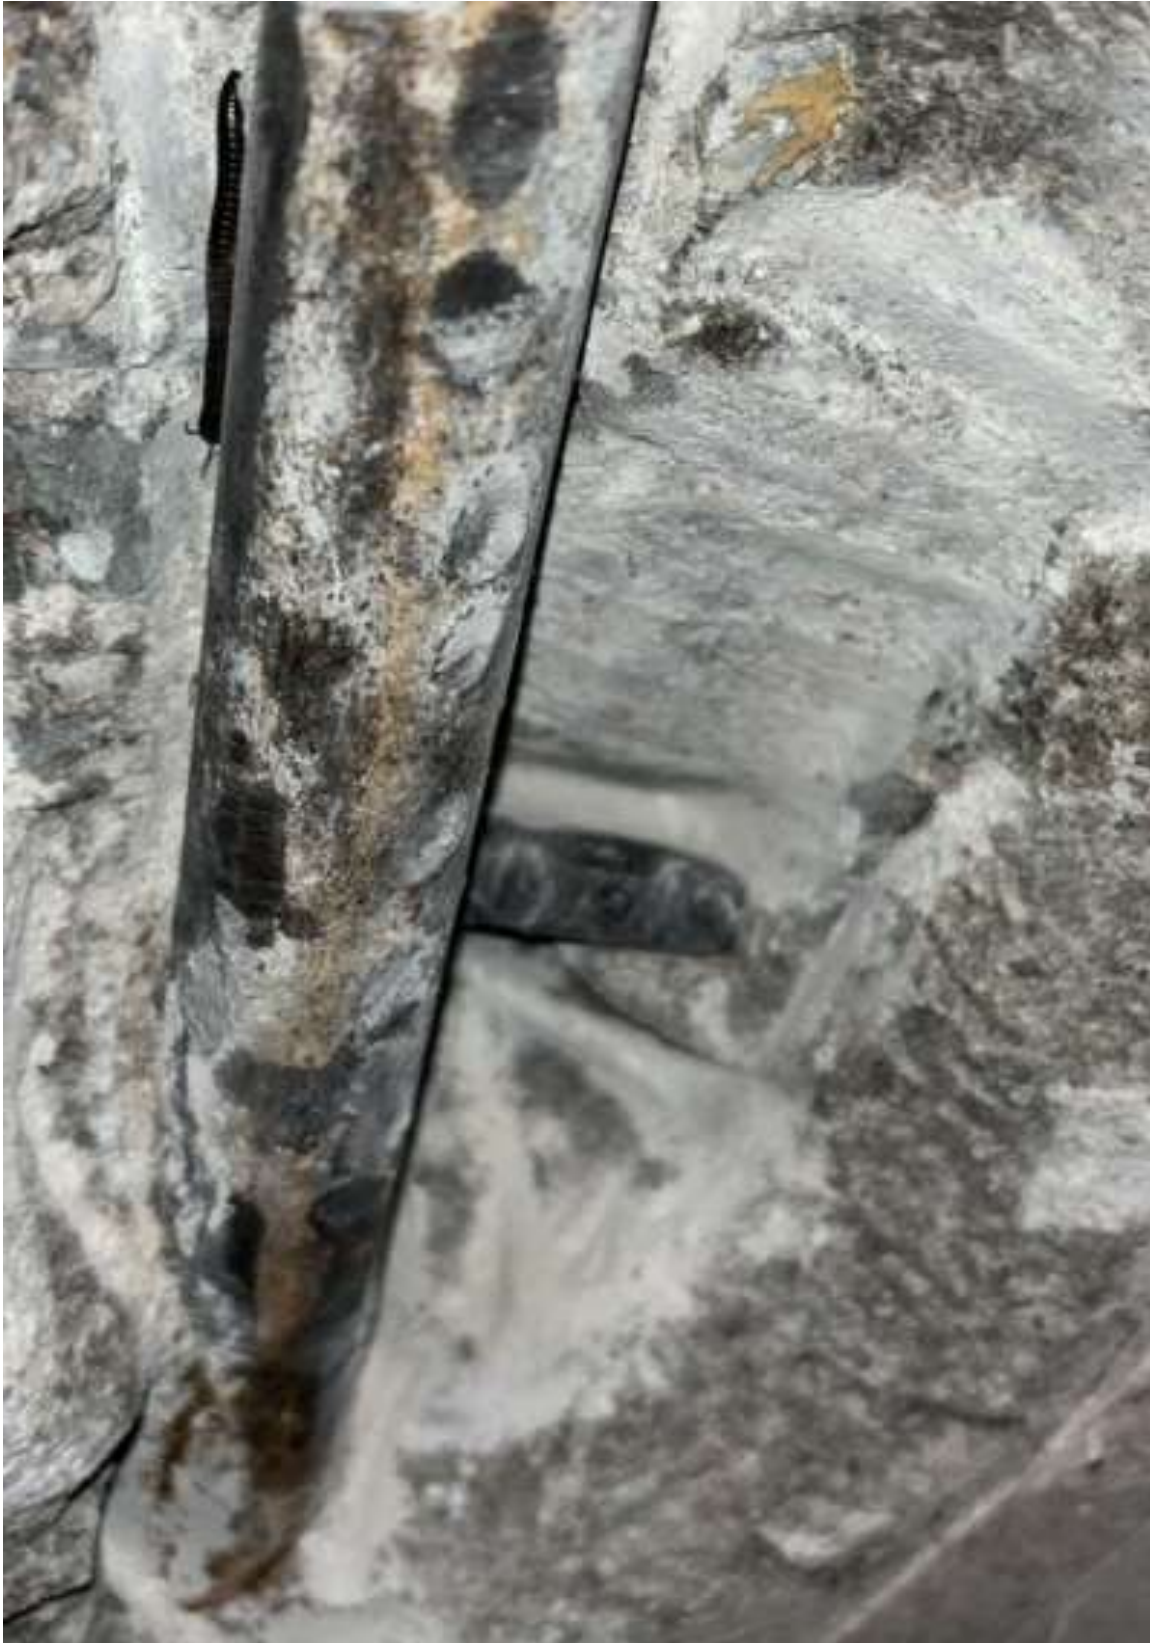
Due to visible defects near the north elevation, a condition factor of 0.9 was assumed in the assessment of the reinforced deck slab. The site investigations identified that the reinforcement bars in the deck slab are smooth bars which indicates mild steel, as a conservative measure a reduced steel strength of 230 N/mm<sup>2</sup> has been assumed for the purpose of assessment. The worst credible strength of concrete was taken as 54.5 N/mm<sup>2</sup>. The structure was assessed using the strip method for HA loading, single axle and single wheel loads. The live load capacity of the RC deck slab was 40 tonnes Gross Vehicle Weight (GVW) in bending and 40T Gross Vehicle Weight (GVW) in shear. The results are summarised in Table 5-5 below.

*Figure 28: Transverse and Longitudinal smooth bar*
