Appendix 6-2 – Bat Survey Report

Cooloo Wind Farm, Co. Galway

Project Title: Cooloo Wind Farm, Co. Galway

Document Title: Bat Survey Report

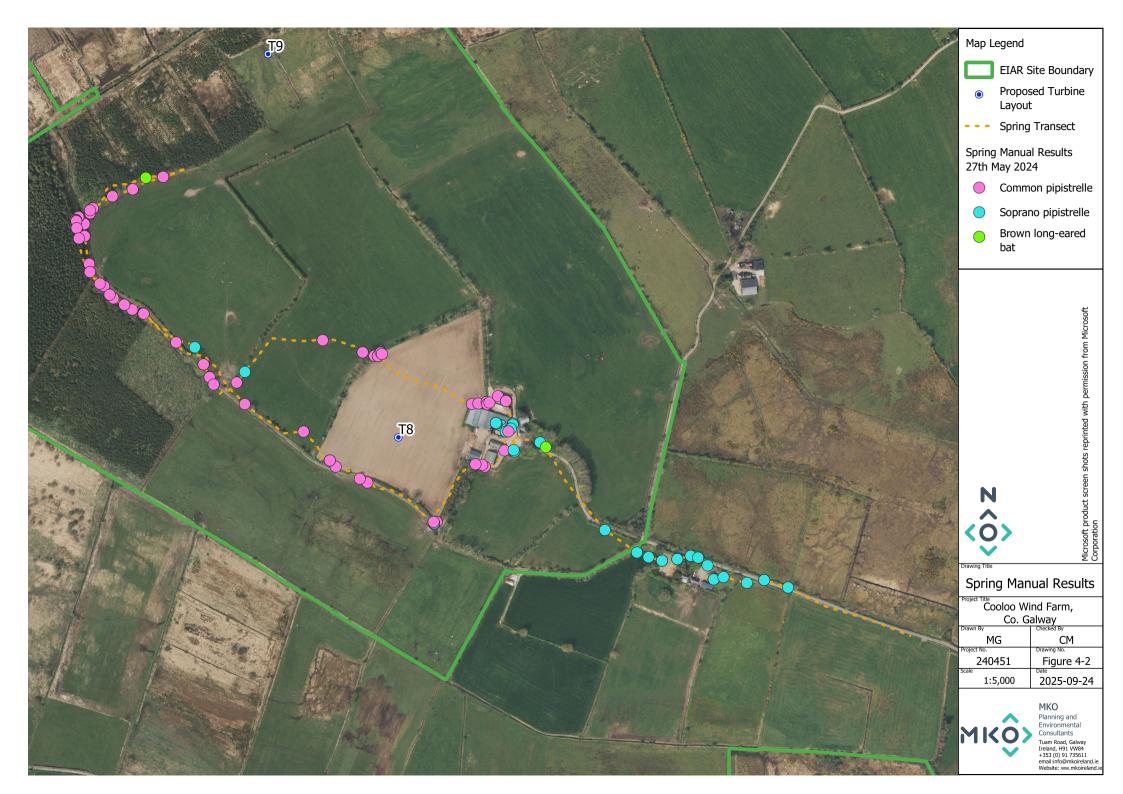
Plate 4-30 2024 Transect Results - Species Composition Per Survey Period

Species composition and activity levels varied between survey periods. To account for differences in survey effort, results were expressed as bat passes per kilometre surveyed. Plate 4-30 presents results for

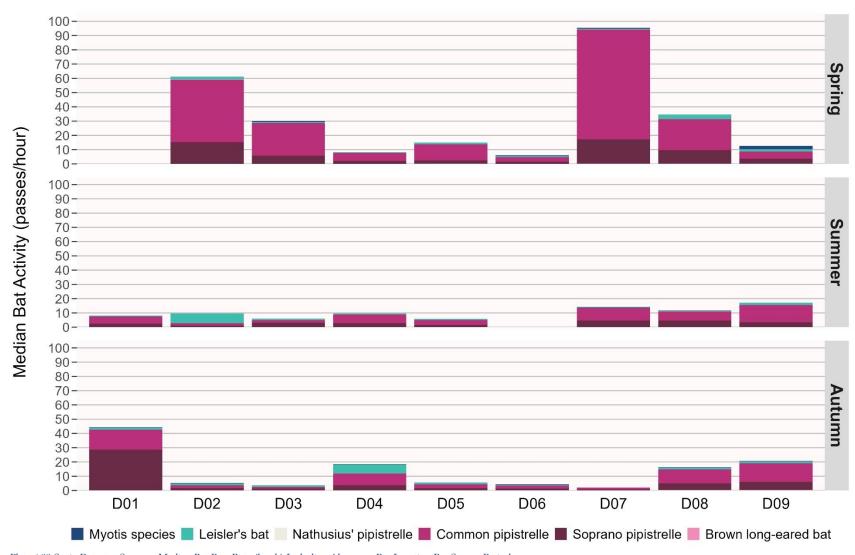
Plate 4-33 Static Detector Surveys: Median Bat Pass Rate (bpph) Including Absences, Per Location Per Survey Period.

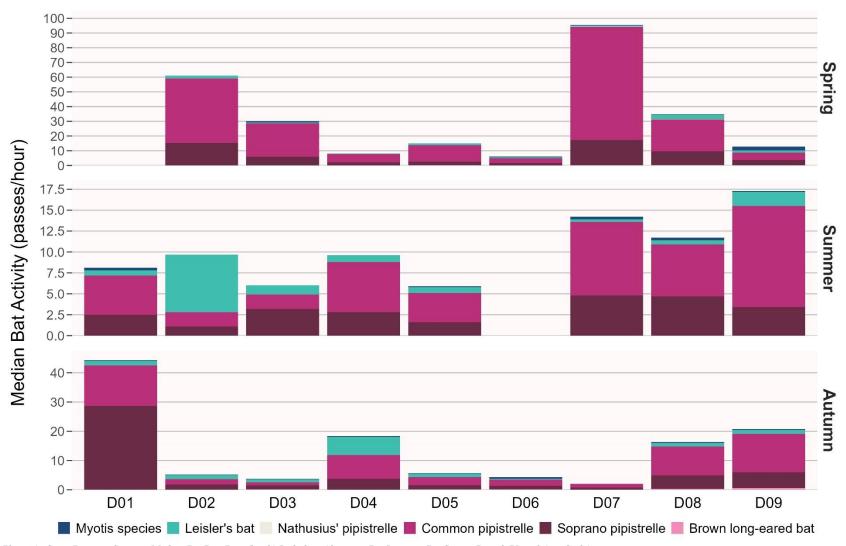
Plate 4-34 Static Detector Surveys: Median Bat Pass Rate (bpph) Including Absences, Per Location Per Survey Period (Varied Axis Scale).
