PEAT STABILITY RISK ASSESSMENT

Document Ref. 22098-R01-02

Project Title Cooloo Wind Farm

Report Title: Peat Stability Risk Assessment

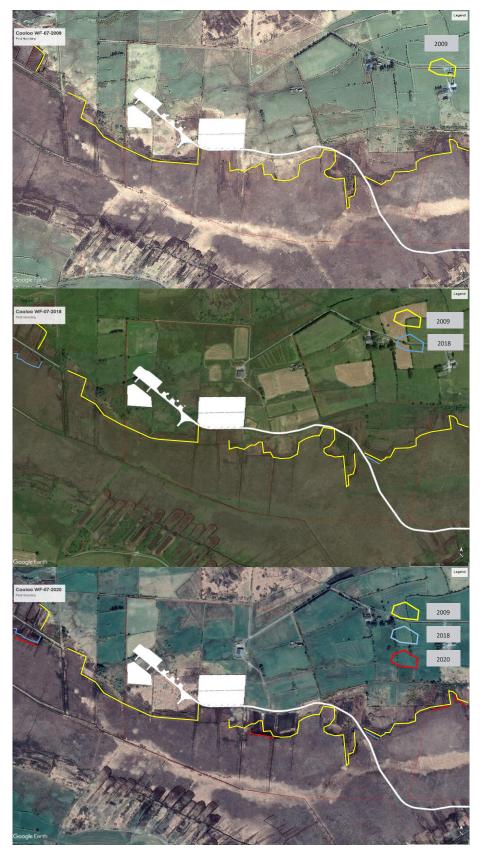
Figure 2-2: Raised peat at T07 receding due to turbary peat extraction between 2009-2020 (Google Earth, 2009-2020)

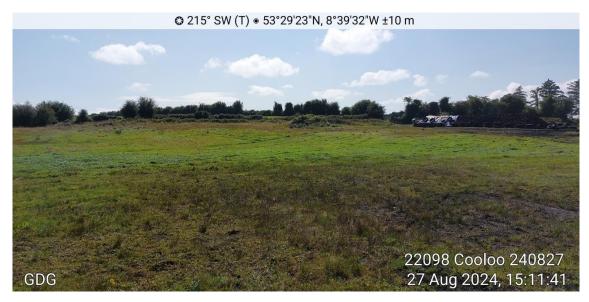
Figure 3-1: View from T5 hardstand towards prominent drumlin/bedrock ridge, showing cut-over peat in foreground.

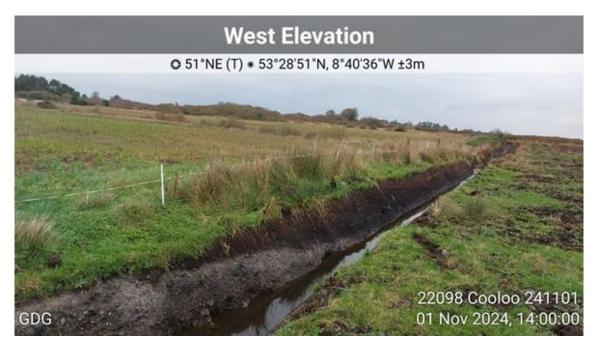
Figure 3-2: Peat and subsoil transition exposed in open drain - east of Substation location

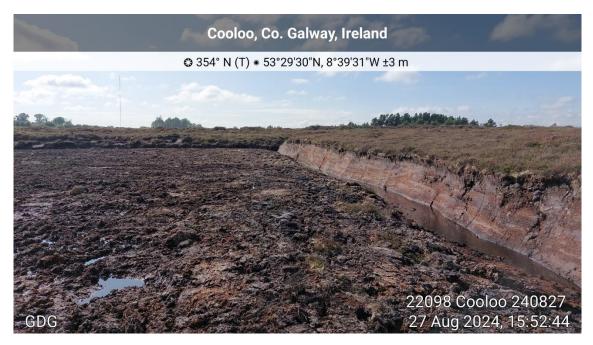
Figure 3-3: Raised peat adjacent to T05 hardstand

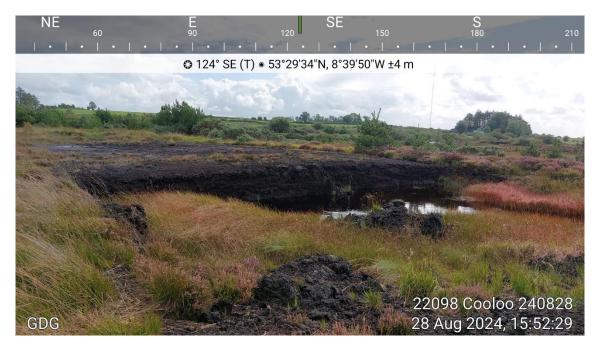
Figure 3-4: Raised peat close to the access track to T06

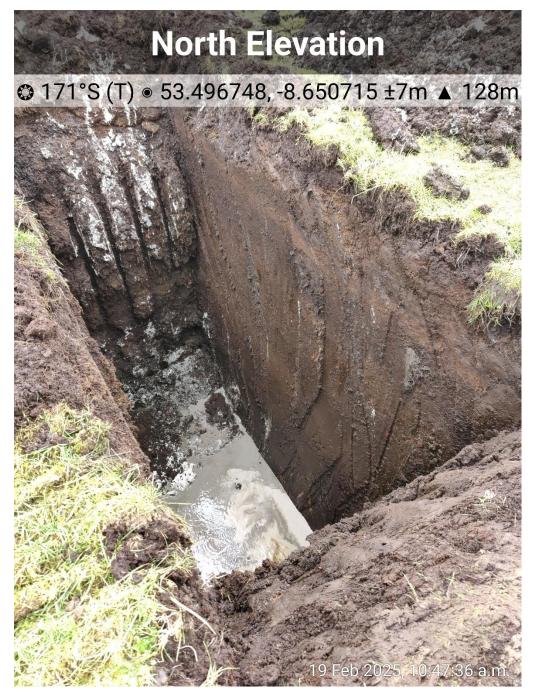
Figure 3-6: Moderately humified peat (H5) in TP07, overlying soft clay.

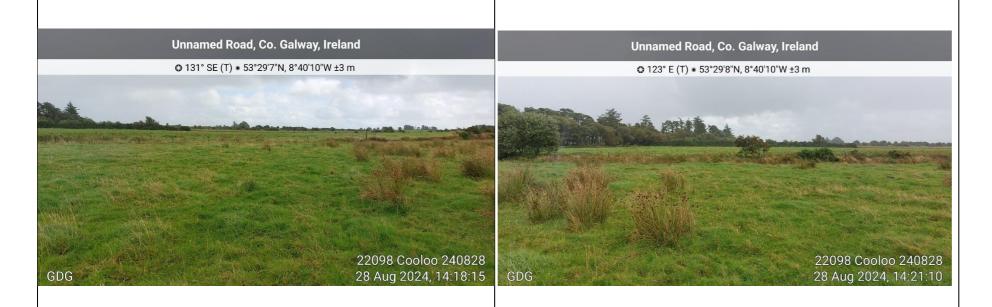
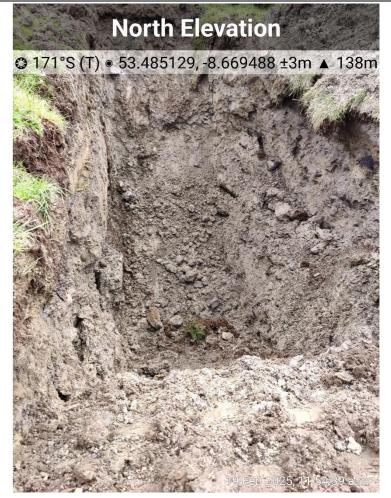
Geomorphology: T3 is located on mixed flat farmland and peat area.

Peat: The peat depth at T03 is range from 0m to 1.0 m and slope angle of 0.5 degrees.

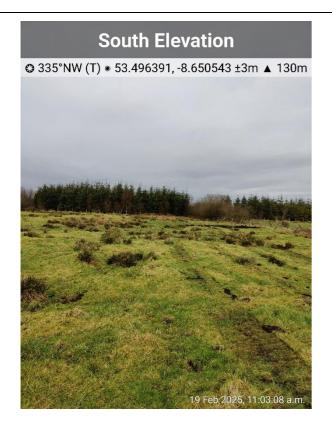
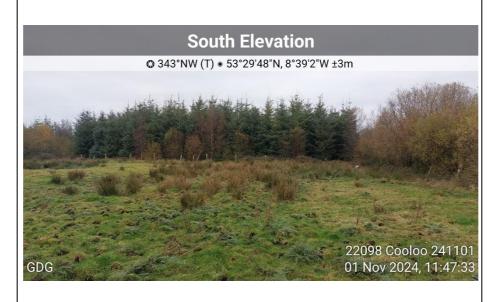
Date of the ground-based pictures: 1st November 2024 and the 19th of February 2025 [GDG]. **Geomorphology**: T9 is located in peat dominant farmland. Coniferous forest 20m away.

Peat: Peat depth: ~ 2.34 to 3.3m. Slope angle: 0.9º
