# FIRE SAFETY ASSESSMENT & ADVICE REPORT

Tirawley BESS Facility, Co. Mayo

| <b>Project</b> | Fire Safety Assessment and Advice Report for a proposed Battery Energy Storage System (BESS) facility in Tirawley, Co. Mayo |

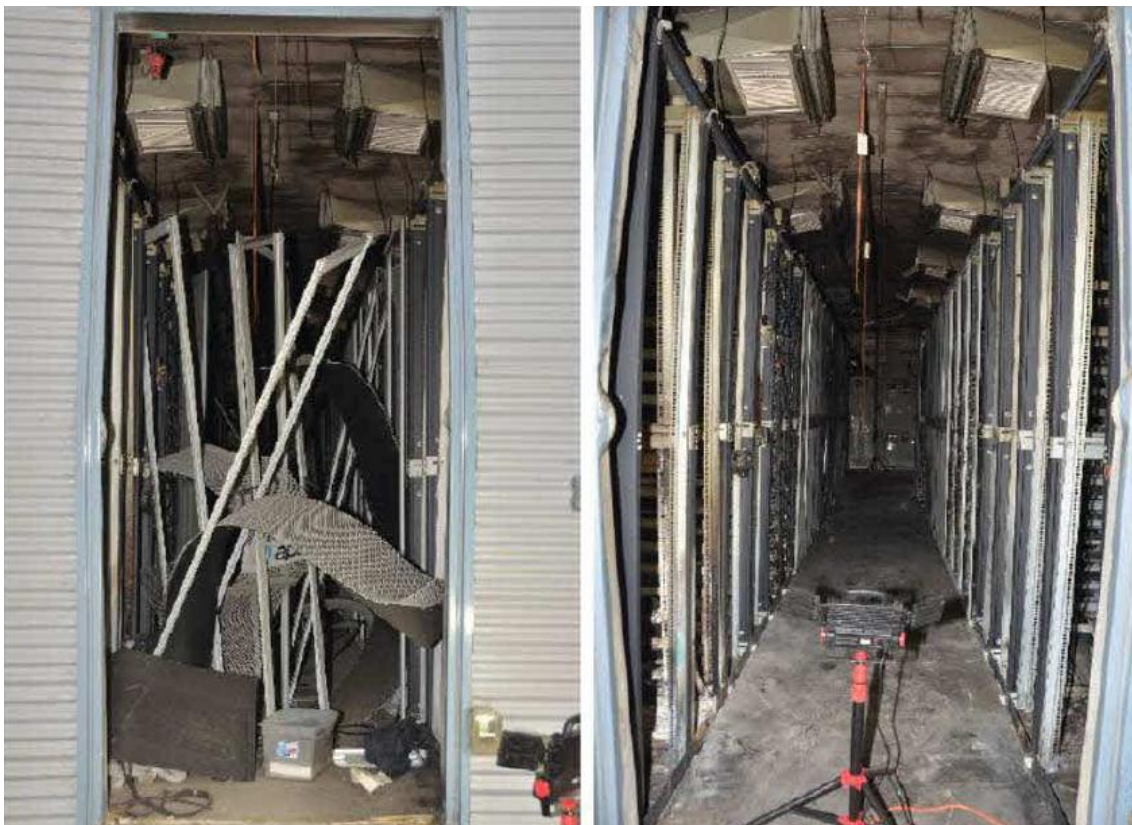
Figure 4 – BESS contained post deflagration event<sup>7</sup>

At circa 1700 hours on 19 April 2019, smoke was reported to be issuing from a building which housed the energy storage system at the McMicken facility. First responders arrived to investigate at circa 1748 hours. At approximately 2004 hours, responders attempted to enter the unit by opening the door. This resulted in a deflagration (explosion) event which seriously injured 4 of the first responders who attempted to enter. An image of the incident container is included below in Figure 4.

Following in-depth investigations into the incident, it was established that the cause of the incident was a single lithium-ion battery cell failure which transitioned into a cascading thermal runaway event, spreading to other cells in the module. From there, the thermal runaway event continued cascading to involve all modules on rack 15 in the container. The incident was first detected when a voltage drop occurred at circa 1654 hours on 19 April in a battery cell in module 2 of rack 15. Cell 7 module 2 entered thermal runaway phase shortly thereafter. As a result, the cell experienced off-gassing which generated smoke, activating the smoke detection and discharge of the suppression agent (Novec 1230). While the suppression agent operated as it was supposed to, it did not prevent cascading thermal runaway to the adjoining cells and adjoining modules. The continued off-gassing of lithium-ion battery cells created a flammable atmosphere within the BESS container. When first responders opted to enter the BESS container circa 3 hours after the first alarm, the flammable atmosphere was still present. Ignition occurred within 2 to 3 minutes of the door into the container being opened, agitating the flammable gas/air mixture. The specific ignition source was not known, but a deflagration occurred which caused BESS container doors and other internal materials/components to be violently discharged from the container, thus causing the injuries sustained by the 4 first responders.

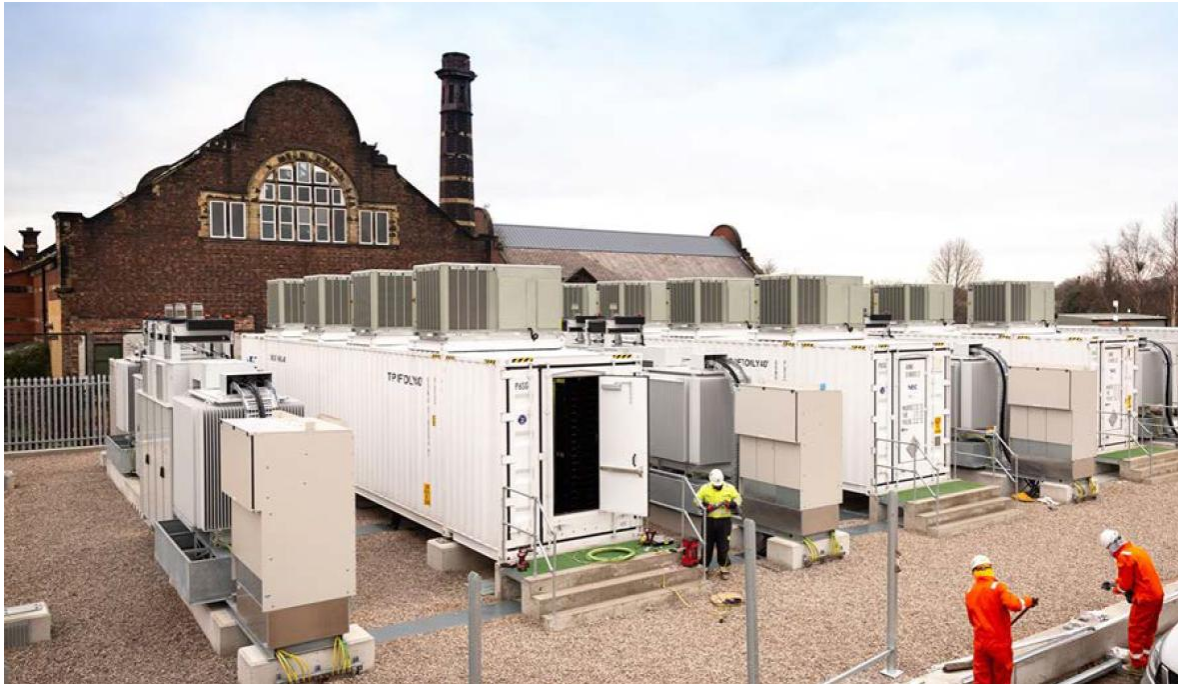
**Figure 5 – Carnegie Road BESS facility <sup>10</sup>**

The BESS facility at Carnegie Road is located in Liverpool England and was first energised in December 2018. The facility was fully commissioned in May 2019 and is interconnected to the Scottish Power Energy Network at 33kV. At the time of the incident, the facility consisted of 3 containerised BESS enclosures capable of charging/discharging up to 20MW of stored power for up to 30 minutes. The BESS enclosures housed a total of 2142 lithium-ion modules over 126 racks. An image of the facility is included below in Figure 5 for reference.

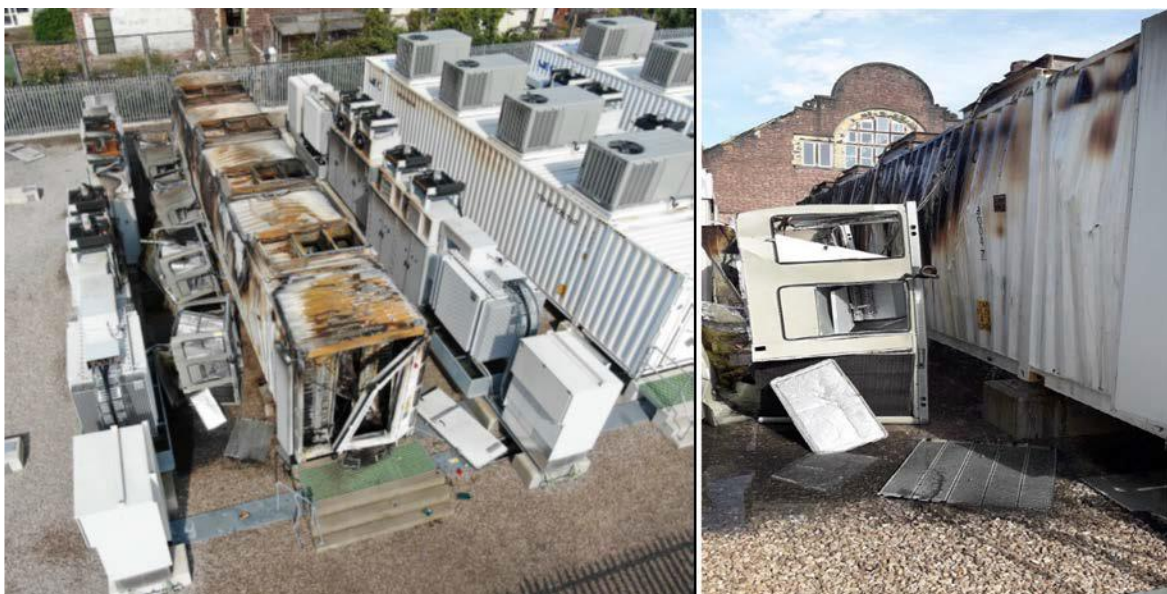
**Figure 6 – Post incident photographs <sup>11</sup>**

At approximately 1249 hours on 15 September 2020, the local Fire and Rescue Service were alerted to a fire at the facility. 5 appliances attended and found Container 1 of the 3 containers well alight. Post incident photographs taken by Merseyside FRS are shown below in Figure 6 and Figure 7. The extent of damage sustained by the container was consistent with that of a fire and explosion (deflagration).

The investigation was significantly hampered by the extent of damage sustained to Container 1. The overarching theory on cause was considered to be an internal failure of a lithium-ion battery cell. However, the investigation was hampered by several factors including the COVID-19 pandemic and lack of understanding/knowledge as to the potential for stranded energy to still exist in a container post incident.

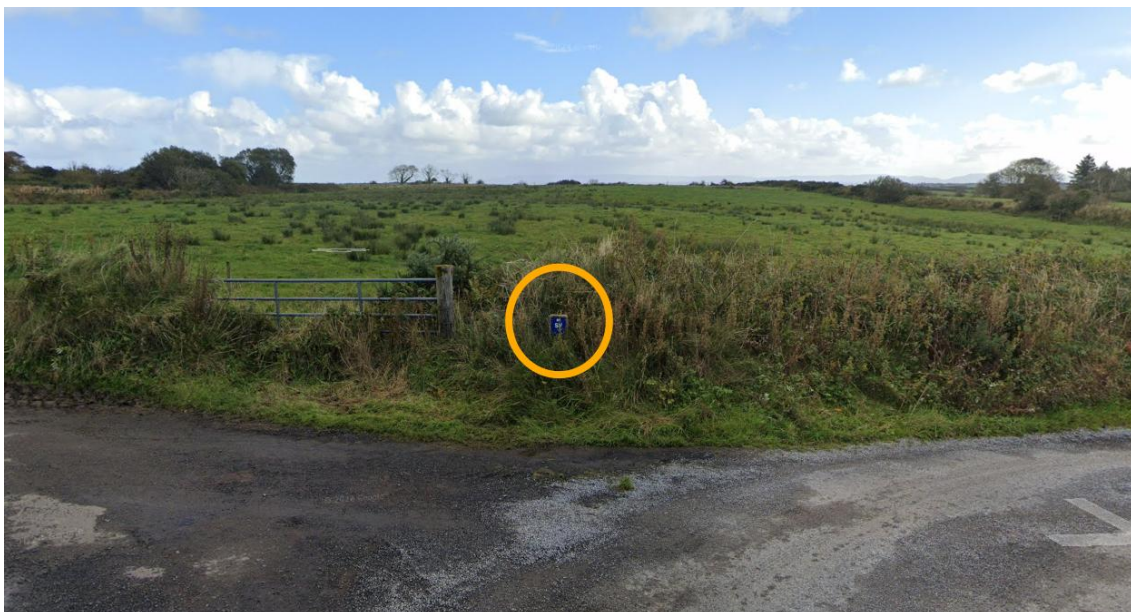
**Figure 13 – Sluice valve marker post on road adjoining site <sup>18</sup>**

The proposed BESS site is located in a rural setting in Co. Mayo. Existing facilities for the Fire and Rescue Service (e.g. provision of public fire hydrants) are yet to be confirmed albeit there does appear to be a public watermain in the adjoining road (see Figure 13 below of SV marker post on adjoining road). It is noted that modern BESS containers are fitted with a combination of continuous monitoring and passive/active fire protection measures such that the design intent is to intercept faults before they transition to a fire/explosion hazard or, where a fire occurs, contain the fire to the incident container. Nevertheless, as this is an unmanned site, it is possible that the presence of the local Fire and Rescue Service may be requested in reaction to an incident.
