# South – North Access Road

Stage 2 Road Safety Audit

Kilkenny County Council

September 2024

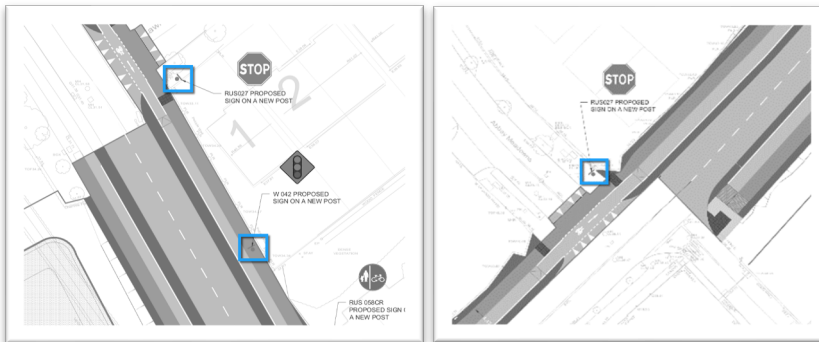
**Location:** Various Sign Locations at Scheme Tie-Ins

Pedestrians (especially those who are blind or partially sighted) are likely to come into direct conflict with signs positioned within the footpath or at mid-footpath.

**Figure 2.1 – Signs Placed Mid-Footpath Leading to Pedestrian Strikes**

Signs should be positioned to the back of the footpath, at suitable locations where the risk of pedestrian strikes can be minimized.

| Problem Reference<br>(Section 2) | Designer Response Section | | | Audit Team Response Section |
|---|---|---|---|---|
| 2.1 | Yes | Yes | | |

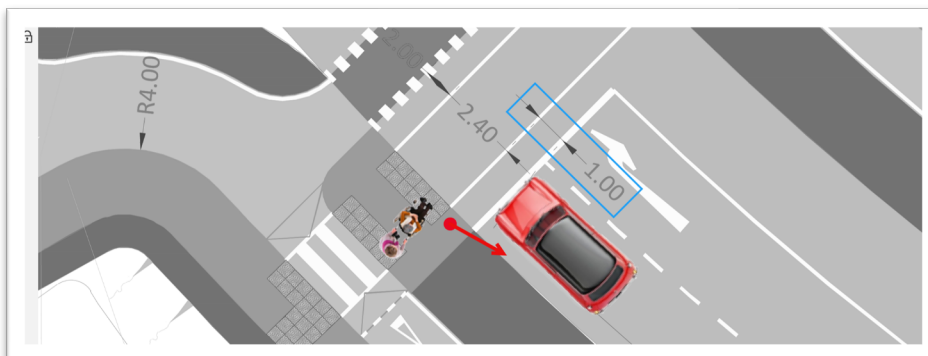
**Location:** All Signal Controlled Junctions

The unusually small set-back between the stop lines and the pedestrian crossing lines can increase the risk of conflicts between vehicles and crossing pedestrians (by way of drivers rolling past the stop line on a red light). It may also prevent the driver in the lead vehicle from having a direct line of sight to the primary traffic signal head.

**Figure 2.2 – Limited Set Back of Stop Line from Primary Traffic Signal (Example)**

The set-back between the stop lines and the pedestrian crossing lines should be increased to mitigate the risks described.

| Problem Reference<br>(Section 2) | Designer Response Section | | | Audit Team Response Section |
|---|---|---|---|---|
| 2.2 | Yes | Yes | | |

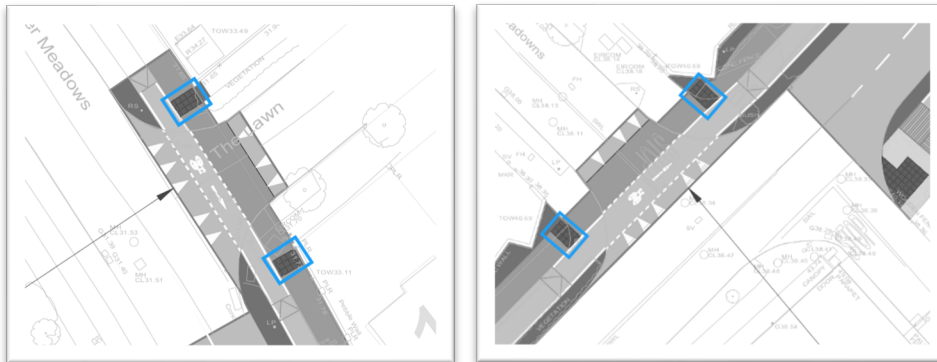
**Location:** Junction with The Lawn (North) & Junction with Abbeygate (South)

The tactile paving appears to be positioned to the rear of the footpaths. This may create confusion for blind or partially sighted road users, leading to poor decision making and conflicts with other road users.

**Figure 2.3 – Tactile Paving Indicating Longer Crossings for Blind or Partially Sighted Person**

The tactile paving should be re-positioned to the leading edge of the footpath, beside the interface with the adjacent traffic lane.

| Problem Reference<br>(Section 2) | Designer Response Section | | | Audit Team Response Section |
|---|---|---|---|---|
| 2.3 | Yes | Yes | | |

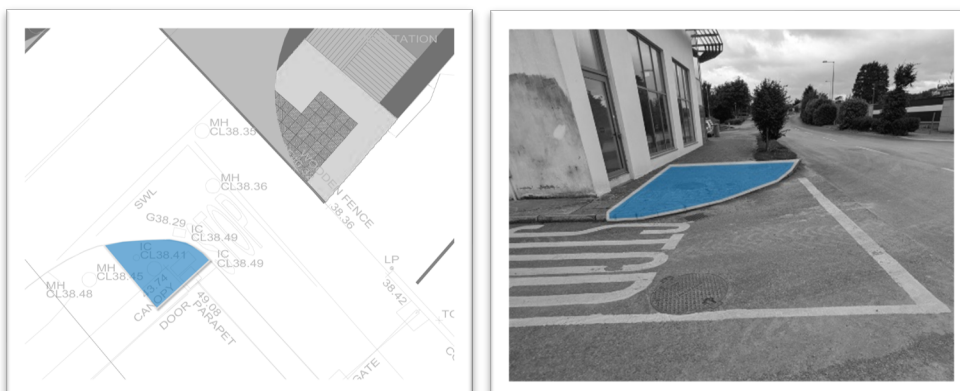
**Location:** Southern Scheme Tie-In – Service Road to Rear of Retail Units

Failing to provide an opposing set of tactile paving on the other side of the pedestrian crossing is likely to lead to confusion and progression issues for blind or partially sighted road users.

**Figure 2.4 – Single Sided Tactile Paving Creating Confusion for Blind or Partially Sighted Person**

An opposing set of tactile paving should be provided on the other side of the pedestrian crossing.

| Problem Reference<br>(Section 2) | Designer Response Section | | | Audit Team Response Section |
|---|---|---|---|---|
| 2.4 | Yes | Yes | Tactile on the opposite side will be provided through discussion and agreement with the relevant landowner at detailed design stage. | |

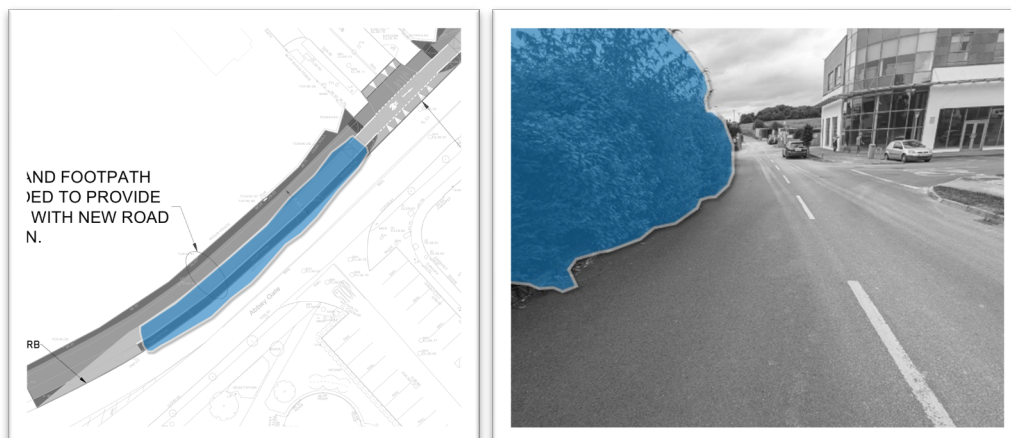
**Location:** Southern Scheme Tie-In – Commencement of Off-Road Cycle Track

The overgrown verge planting was observed to reduce the effective width of the existing cycle track and the adjacent traffic lane. It also obscured sightlines at the junction serving Abbeygate.

**Figure 2.5 – Planting Impacting on Operation of Road / Footpath & Cycletrack**

The overgrown verge planting should be removed.

| Problem Reference<br>(Section 2) | Designer Response Section | | | Audit Team Response Section |
|---|---|---|---|---|
| 2.5 | Yes | Yes | Planting to be removed and appropriately reinstated in the verge at detailed design stage. | |
