Limerick City & County Council in partnership with Limerick Twenty Thirty DAC

Cleeves Riverside Quarter

Structural Report

Reference: CRQMP-ARUP-ZZ-ZZ-RP-SE-0001

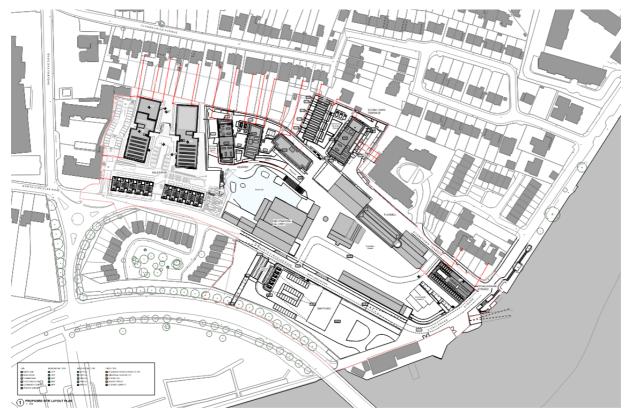
Figure 2: CRQ Proposed Phase II Site Development

The Geotechnical investigation undertaken as part of this report examines the wider Masterplan area while the structural scheme and the assessment of the foundations considers the Phase II proposed development. See Figure 2 below outlining the proposed Phase II development.

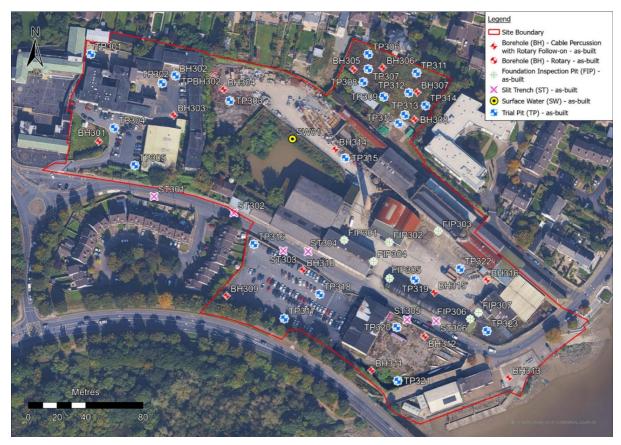
Figure 3: As-built exploratory locations undertaken during the PGL 2025 GI.

- Seven Foundation Inspection Pits to record the foundations of the adjacent buildings
- Three groundwater level monitoring dataloggers in the bedrock installations (BH308, BH311, BH314)

- Geotechnical sampling and laboratory testing
- Geo-environmental sampling and testing
- Groundwater sampling and testing (for all the installations)
- Surface water sampling and testing; and

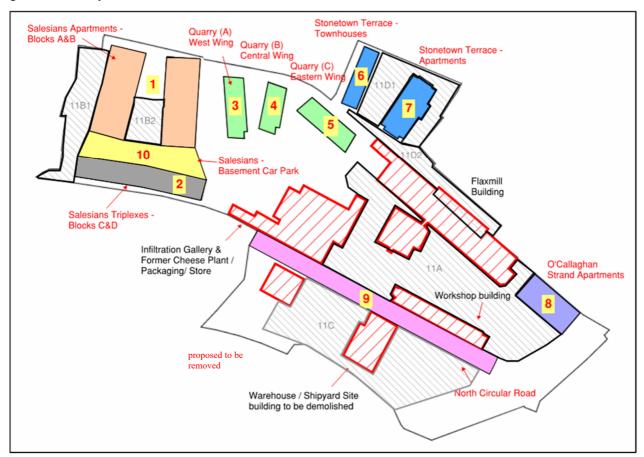
Figure 4: CRQ Zones Considered for Cut / Fill

A preliminary cut and fill exercise to determine volumes of excavated material and back fill required as part of the works was carried out. It was noted during the GI that made ground observed across the site typically contained >2% anthropogenic materials and would therefore not be considered suitable for reuse. Based on our observations during the GI, the made ground will require disposal off-site.

The initial ground model suggests that approximately 52% of the total excavation (~51,000 t) is expected to consist of made ground and will therefore require off-site disposal. 48% (~47,000 t) is expected to be natural ground and may be suitable for reuse.

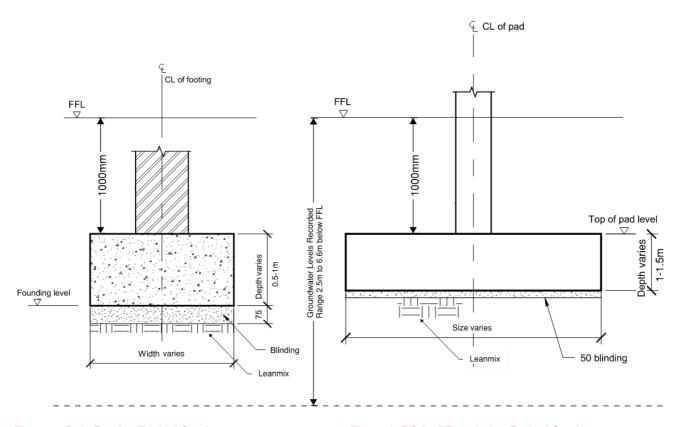
Figure 5: Strip Footing Typical Section

Pad foundations and strip footings will be used to support columns, superstructure walls and or core walls. Lean mix upfill will be required from the underside of the pad foundations down to competent bearing stratum or rock. The formation level for the foundations will be 1m below the ground floor level of the buildings to allow sufficient space for the buildup to the ground floor slab and for services coming into the building. The figures below show typical sections through strip and pad footings. From the latest monitoring, groundwater levels recorded, range from 2.5m (Salesian Apartments) to 6.6m (Stonetown Terrace) below FFL. Groundwater levels vary seasonally and are likely to be 0.5 to 1.0 metres higher during winter months. Continuous groundwater level monitoring is ongoing with standpipe installation data loggers installed to determine tidal and seasonal fluctuations in the groundwater regime.

Figure 6: RC Pad Foundation Typical Section

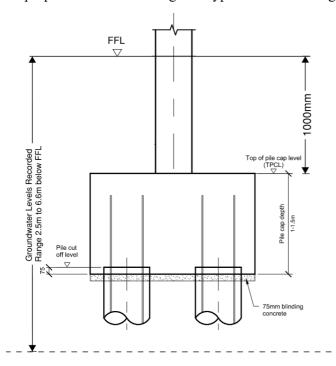
Figure 7: Pile Cap Typical Section

Based on the information received from the latest ground investigation, the only building that will require a piled solution is Stonetown Terrace Apartments. Ground beams, pile caps and cores supported by bored piles are proposed for this building. See typical section through pile cap below.

An assessment of the proposed structures has been undertaken based on the ground conditions encountered during the PGL 2025 GI. The stratigraphy and properties of the ground conditions encountered, indicate that piled foundations bearing in the underlying competent limestone bedrock are required for the apartment block. Ground beams, pile caps and cores supported by bored piles are proposed. Bedrock noted at a range of 11mOD to -1mOD. Piles are to be end bearing on rock, with a 0.5m embedment.

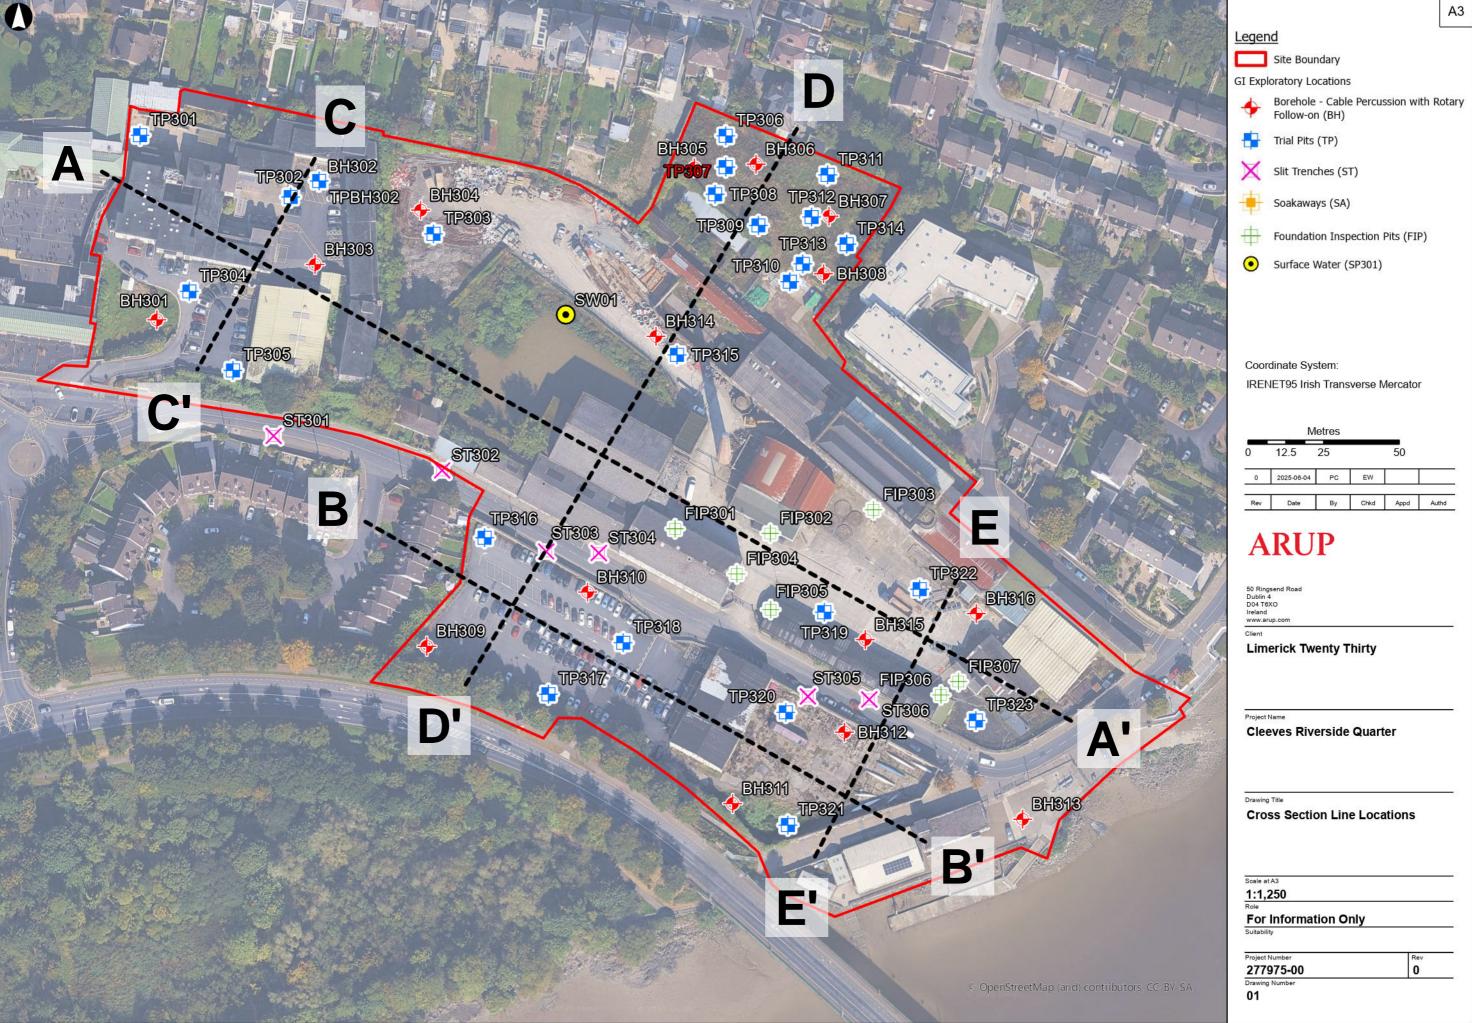
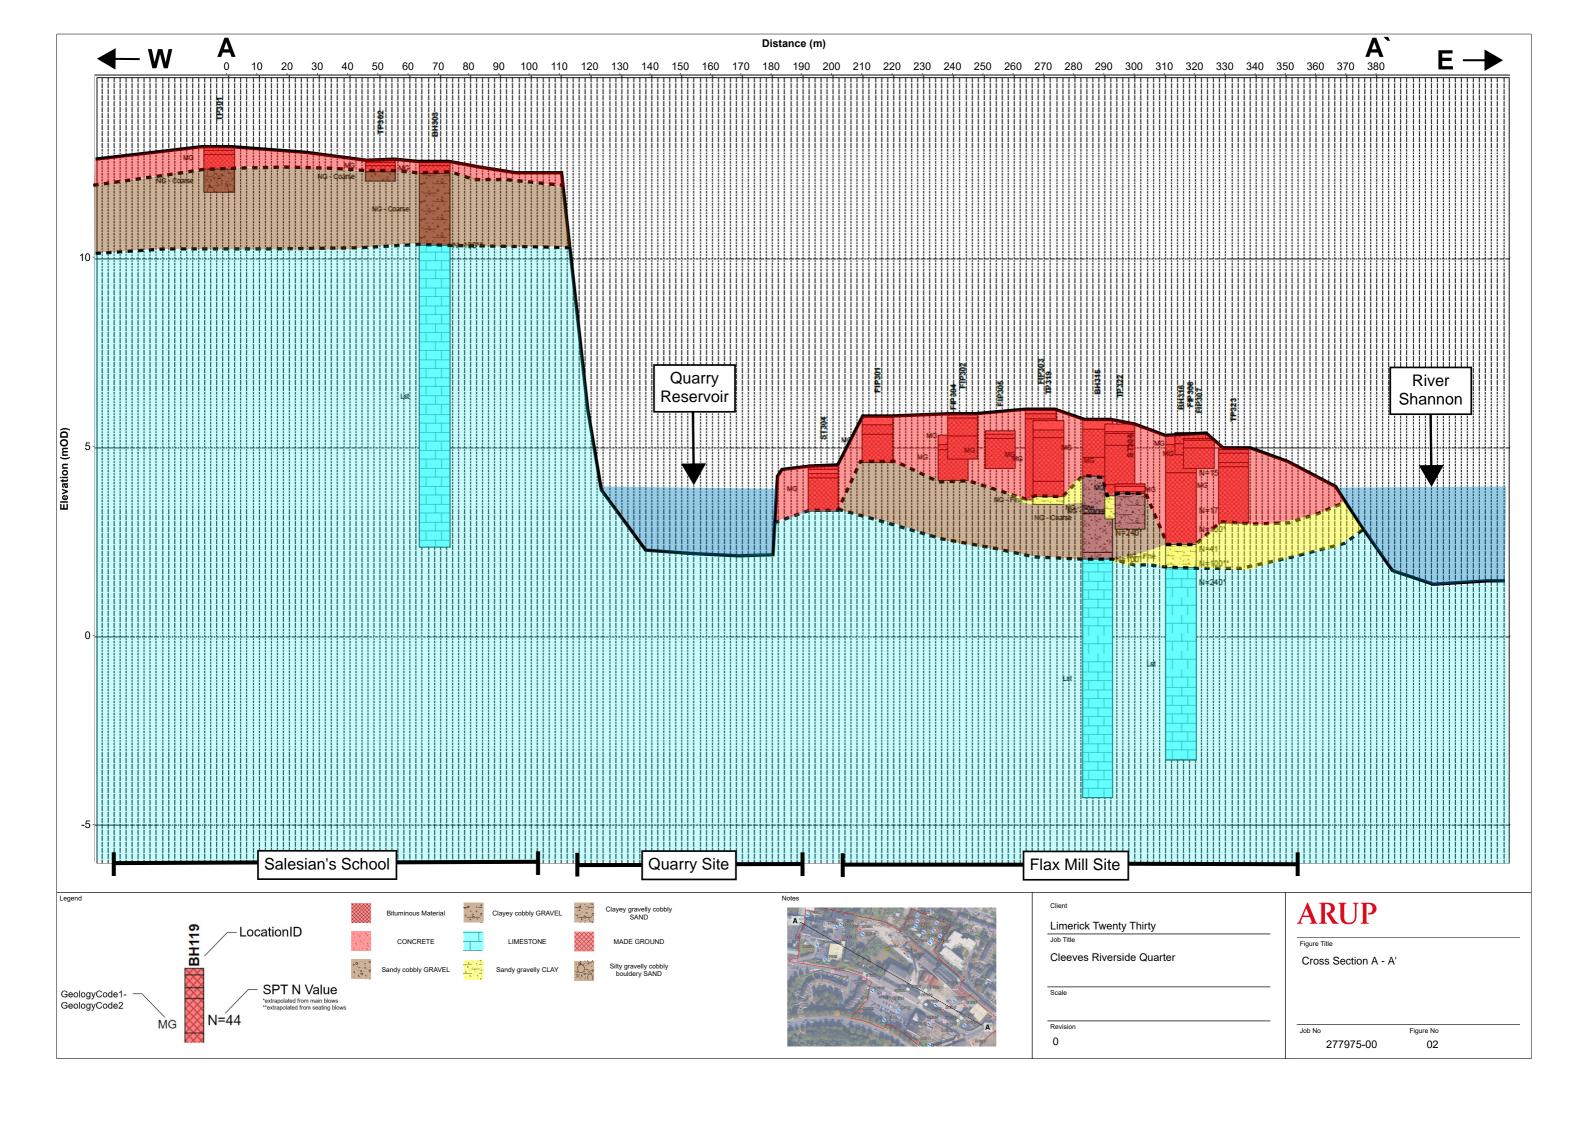
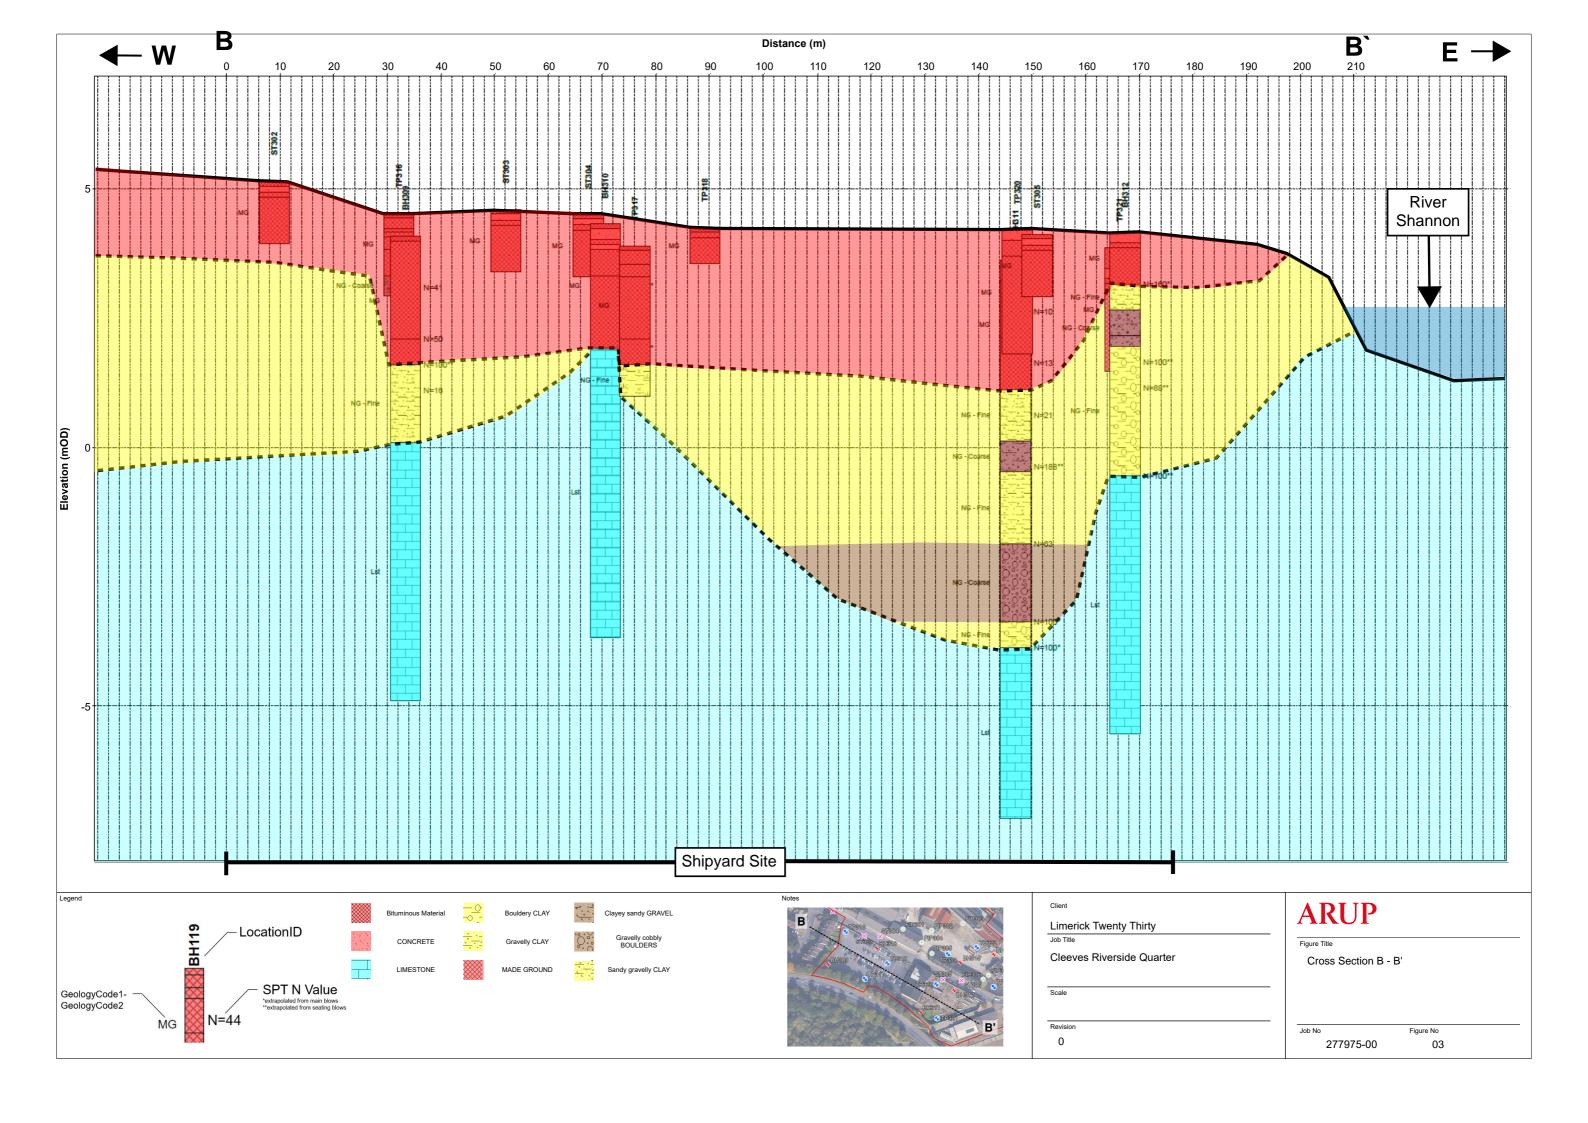
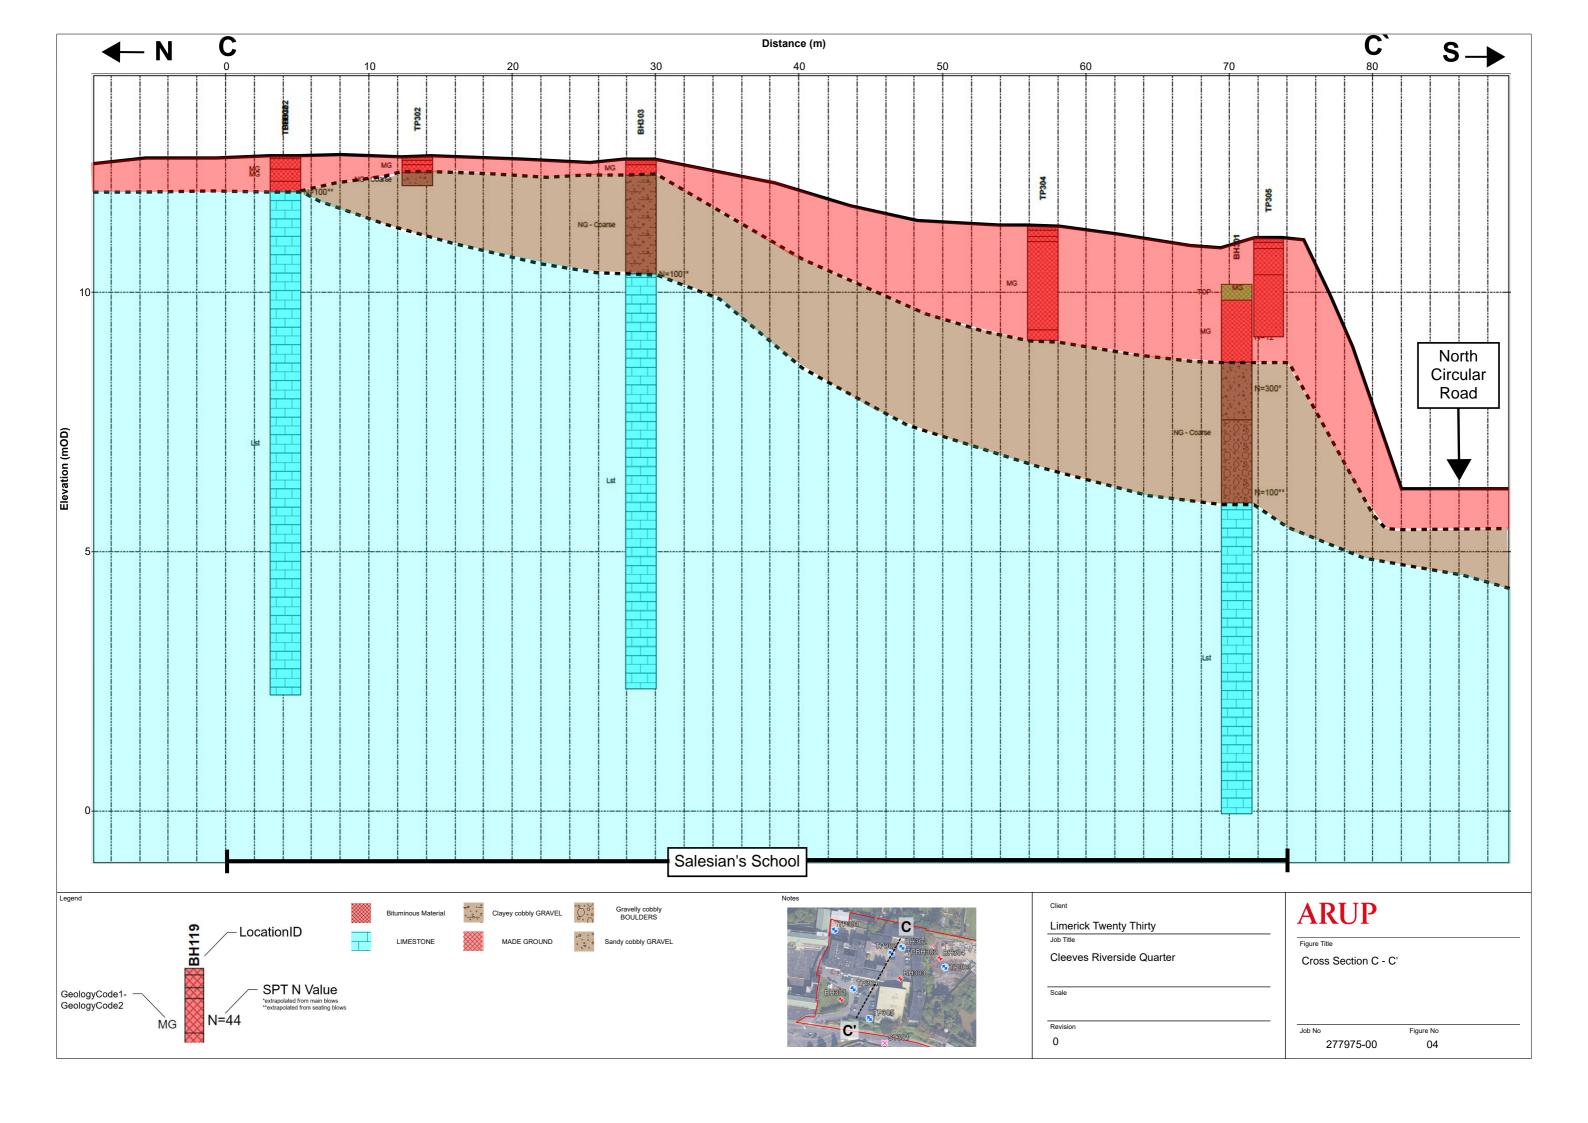
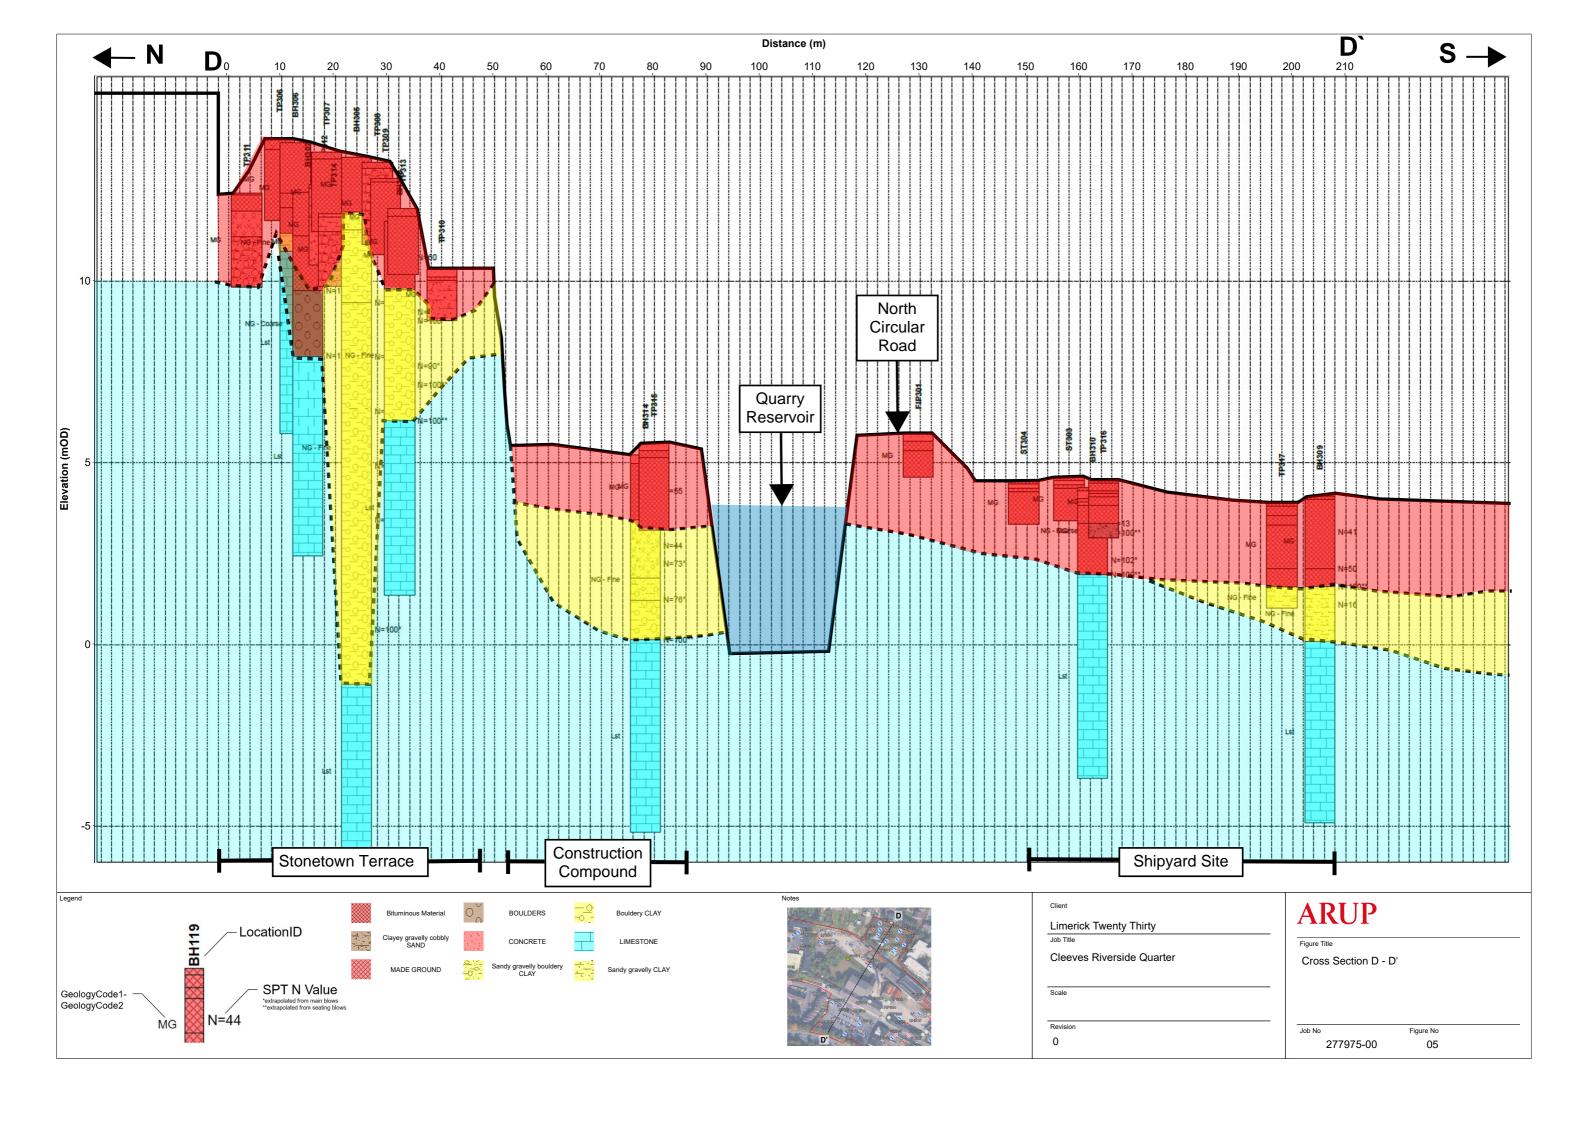
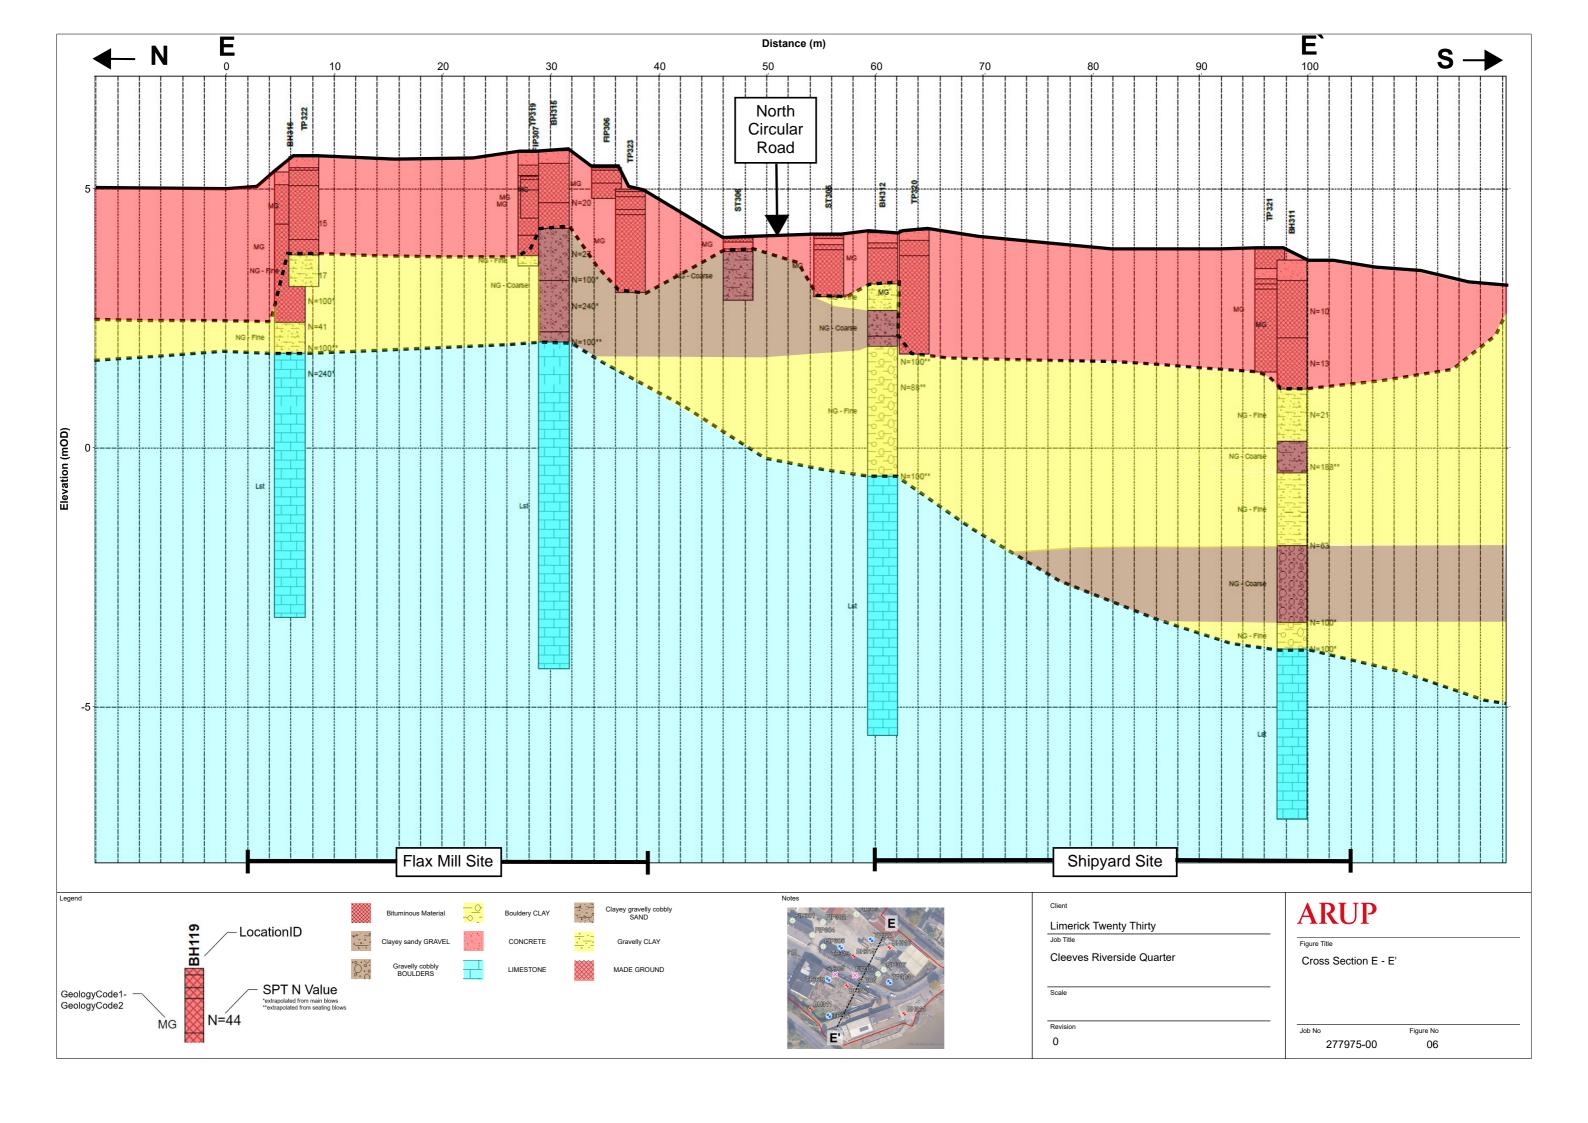
Geological Cross Sections

The stratigraphy of ground conditions encountered in each subsection of the site is outlined below. Geological cross sections for the site are presented in Appendix A (Geological Cross Sections).
