## CHAPTER NINE CULTURAL HERITAGE - ARCHITECTURE

This chapter of the Environmental Impact Assessment Report (EIAR) is concerned with the cultural and architectural heritage of the development site known as Cleeves, inclusive of the protected structures within and those deemed within the curtilage of the 'early industrial complex'.

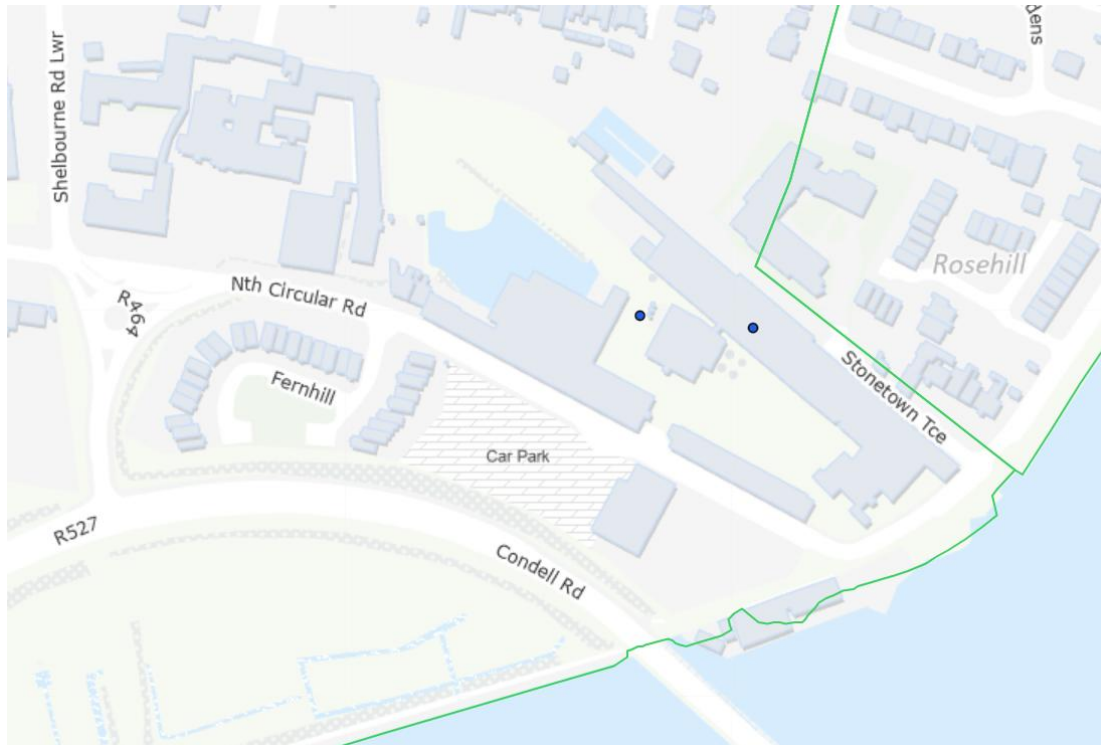
**Figure 6** - Map extract from National Built Heritage Service website.  
Green line indicates the extent of a 'Townlands' district. The Flaxmill Complex is within Farranshone More  
Blue dots indicate assets included on the NIAH Record

Structures that are not included on the National Inventory of Architectural Heritage may still be of heritage value because they are considered as having some level of interest under one or more of the eight fields. Such structures may be afforded some degree of local consideration and protection. These would be listed on the Record of Protected Structures maintained locally. Limerick's Development Plan includes a record under section 3A covering the areas in and around the development site. This identifies the Chimneystack (RPS 3264) and Former Golden Vale Factory (RPS 3265), but does not identify any of the other structures or features within the development site.

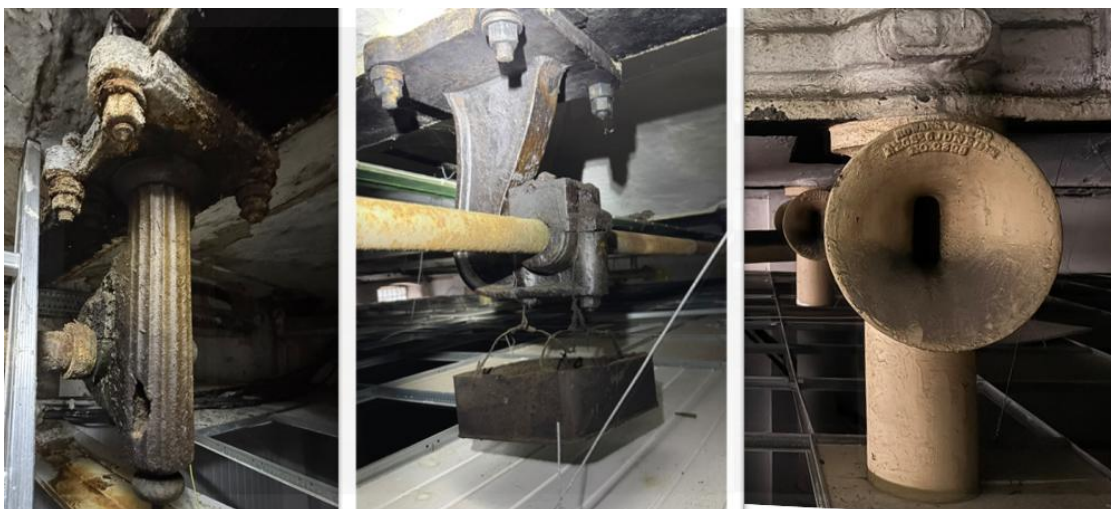
**Figure 11 - Rare surviving flax phase features within the Main Mill.**

In consideration of significance, where substantial interior fabric remains, there is greater interest and potential for higher significance. Features of interest could include original staircase, early timber joinery, plasterwork to ceilings, historic machinery and fittings, etc. While most of the flax phase fittings, furniture and equipment were disposed of in the 1870s, there are fragments of original fittings still present in the main mill. These have not been found in the other Phase I structures. These features will not fall within the scope of change that is proposed within Phase II. They will be further assessed to inform the detailed designs for Phase III which will ensure their retention as key features of the building's historic use.

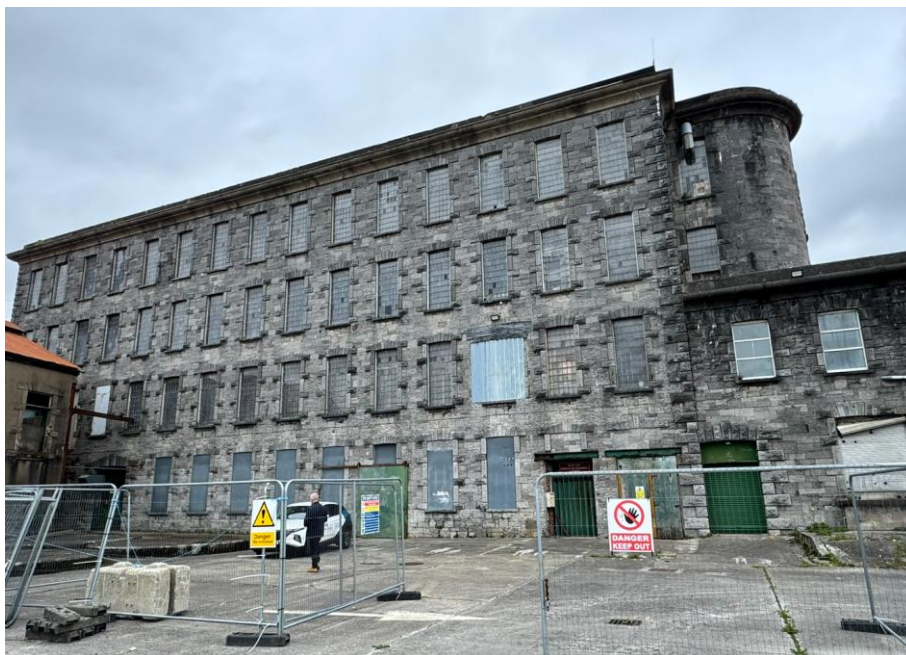
**Figure 12** – South aspect, principal elevation of the Main Mill.

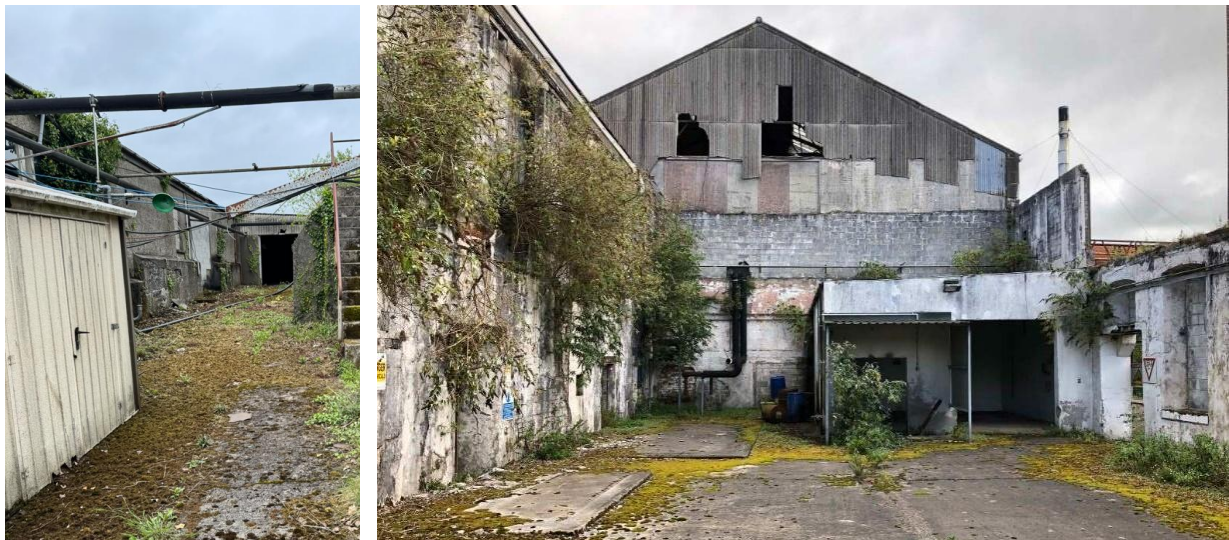
**Figure 13** – North, upper aspect of the lean-to addressing the Stonetown Terrace site and a view from within.

| Building | | Description | Significance |
|---|---|---|---|
| 11a.<br>11b.<br>11c. | <b>Weaving Mill-</b> 1855<br>Rear lean-to 1960s<br>1 <sup>st</sup> Floor and roof | <p><u>Summary</u> - Single storey, 13 bays structure attached to the flaxmill and used to weave linen. Built in the same form as the main mill with provision for a second storey that did not emerge until a later phase in the mid 1900s. Much altered with the addition of a portal roof structure in the 1950s and rear extensions.</p> <p><u>Condition</u> – Derelict. Ground floor storey lined out in plastic. First floor formed of 1950s concrete over original flat roof. Roof lantern no longer visible. 1950's portal frame clad in asbestos and dairy processing equipment present but largely unsafe.</p> | 1851 – High<br>1950s - Negative |

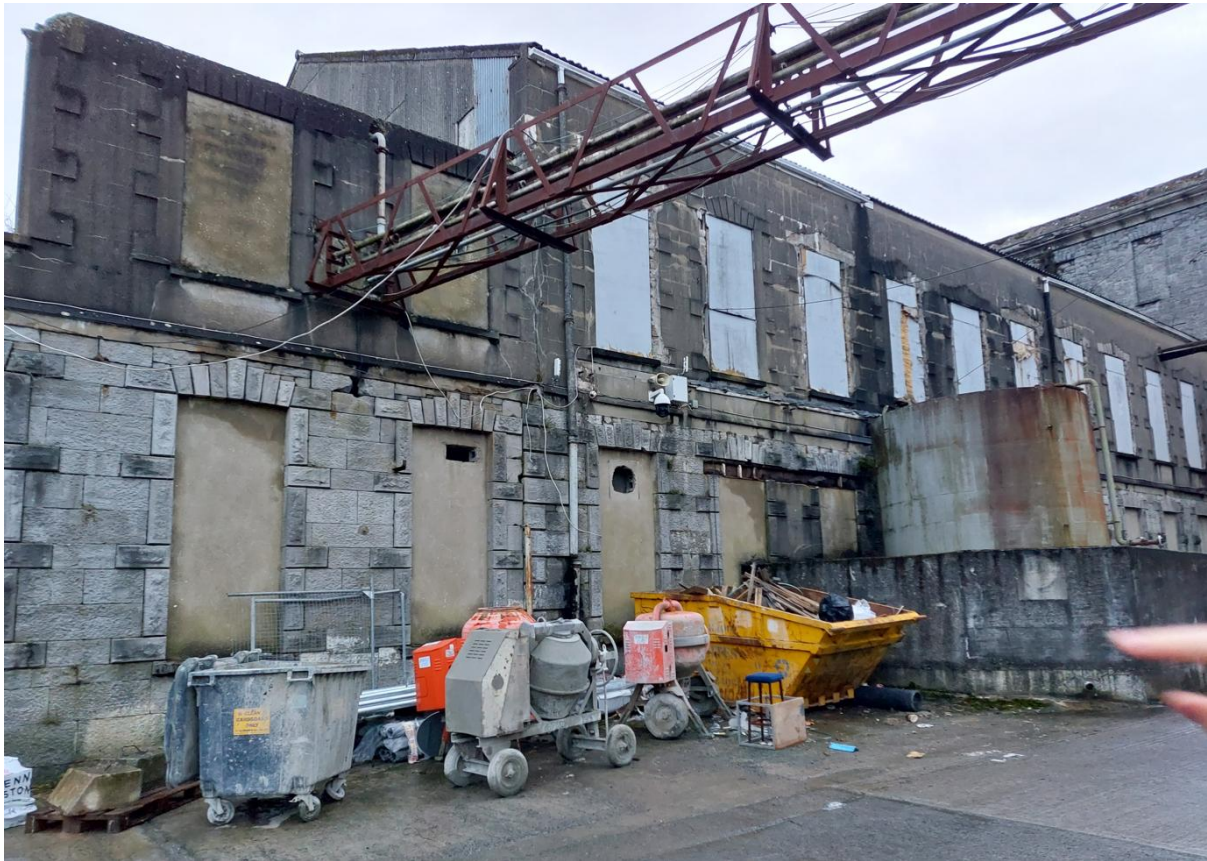
**Figure 14** - Elevation addressing the mill yard.

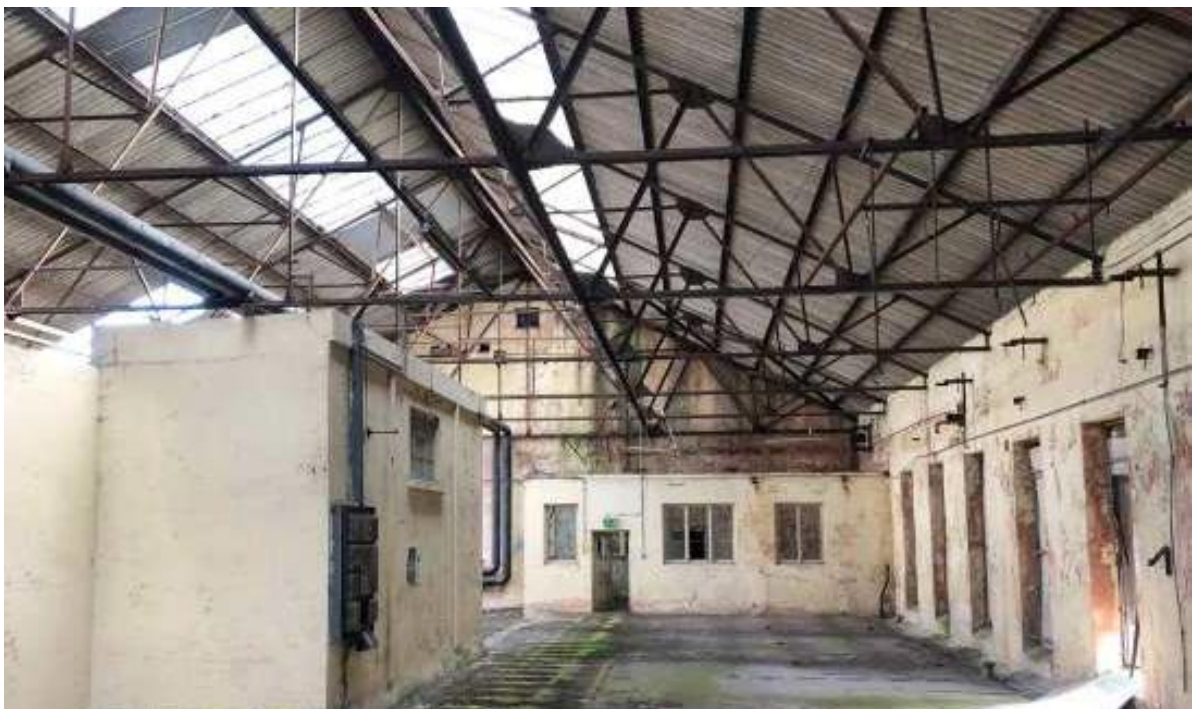
**Figure 15** - Interior of the first floor, over the former Weaving Mill.

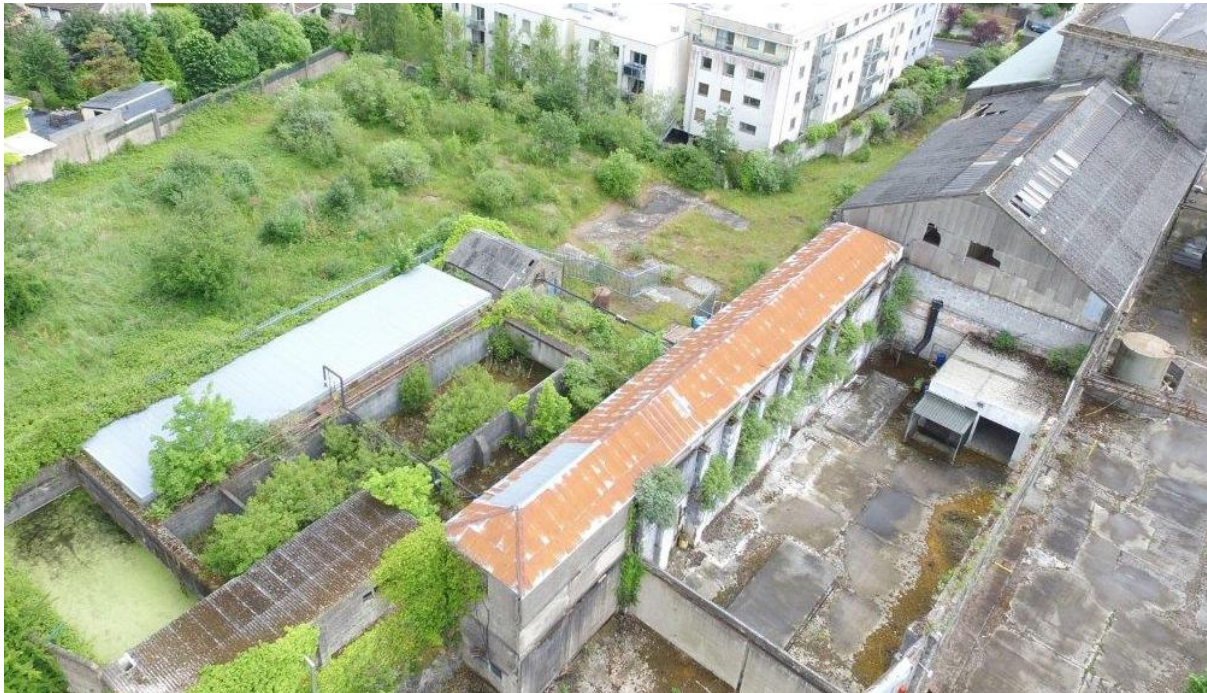
**Figure 16** - Aerial view showing the long lean-to at the rear of the derelict cold store below the upper reservoir.

| Building | | Description | Significance |
|---|---|---|---|
| 11a.<br>11b. | <b>Cold Store</b> - 1855<br>Lean-to - 1960s | <p><u>Summary</u> – external front and rear walls, seven bays long. Front wall is of stone and appears to match the construction of the Weaving Mill. Possibly built to allow for the expansion of the weaving but not used. The rear wall appears much altered and may have been rebuilt to form the plant room extension linked to the upper reservoir.</p> <p><u>Condition</u> – Derelict. Currently an open structure without a roof.</p> | Front Wall 1850s –<br>Hight<br>Rear Wall and Slab<br>– negative. |

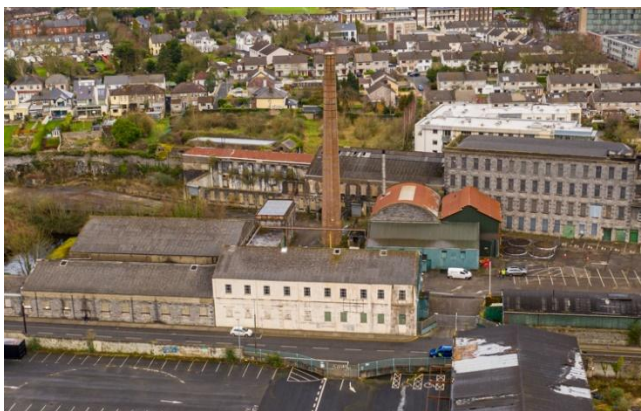
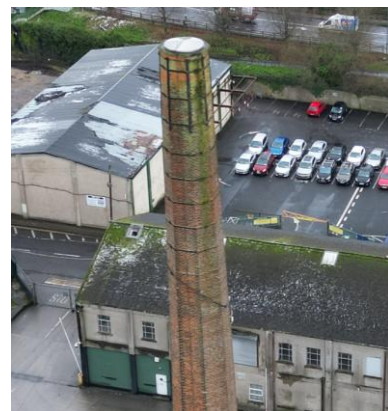
**Figure 17** - Aerial views of the chimney from the south and north.

| Building | | Description | Significance |
|---|---|---|---|
| 02. | <b>Chimney Stack</b><br>NIAH 21512069 | <p><u>Summary</u> – Rebuilt 1853. Brick, 120ft, reduced from 150ft in 2000 to address concerns of instability. Capped with a stainless steel roof. Adaption to receive different flues during the operation of the site in the C20th.</p> <p><u>Condition</u> – Stable. In need of pointing and the refixing of a loose iron band.</p> | High |

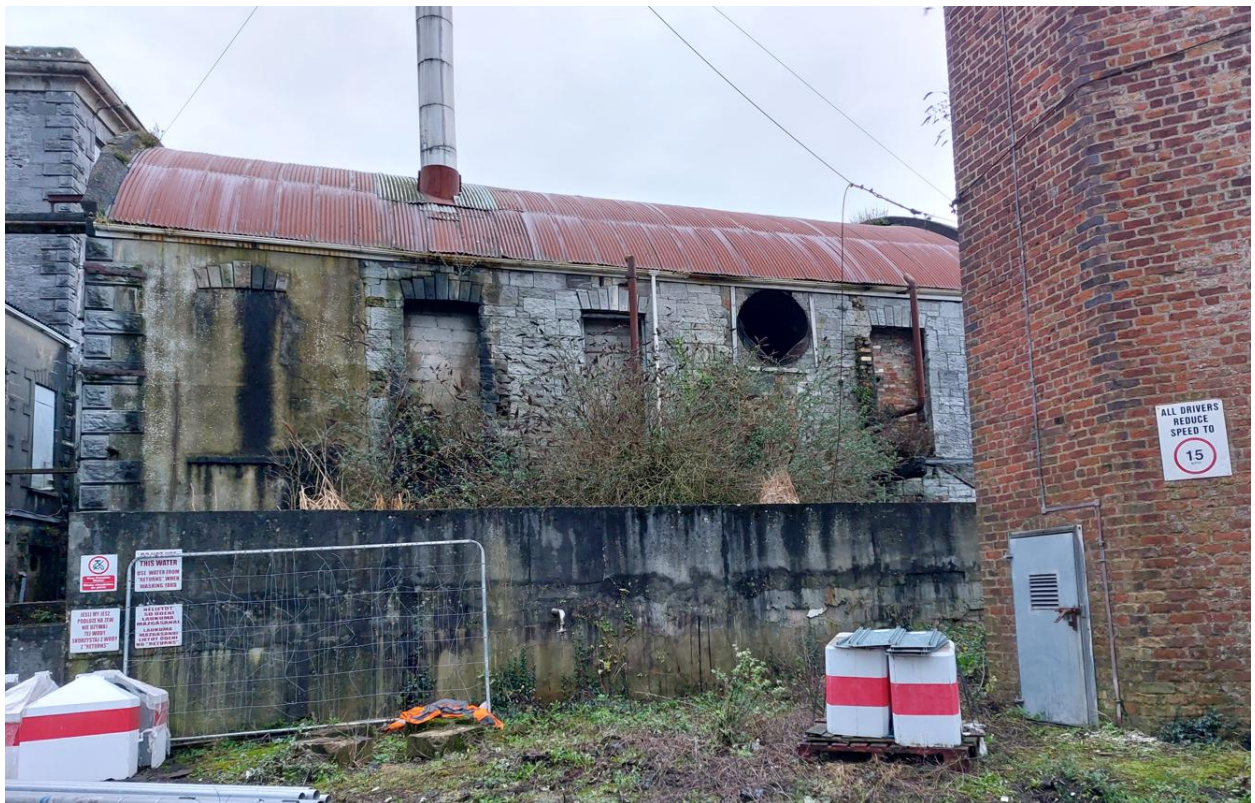
**Figure 18** – Rear (northwest) aspect of the former boiler house.

| Building | | Description | Significance |
|---|---|---|---|
| 03a.<br>03b.<br>03c. | <b>Boiler House</b> 1853<br>Gable Extension 1930<br>Side Extension 1947 | <p><u>Summary</u> – Large two storey with a barrel roof. Built in phases and adapted. Original masonry elements may have survived the 1869 fire that destroyed the engine and roof. The original barrel roofed structure had window openings that match those of the main mill. C20th extensions have greatly expanded the building form and concealed the east and south elevations. The large east extension is poorly built, a combination of found materials and lightweight steel with a single skin of masonry and metal.</p> <p>The interior of the original structure is open to the roof. No historic equipment is present. The later extensions are also largely empty.</p> <p><u>Condition</u> – Poor condition, semi derelict. The assessment in 2024 highlighted the deteriorated nature of the fabric and need for investigations and intervention.</p> | 1850s – High<br>1900s – Low /<br>Negative |

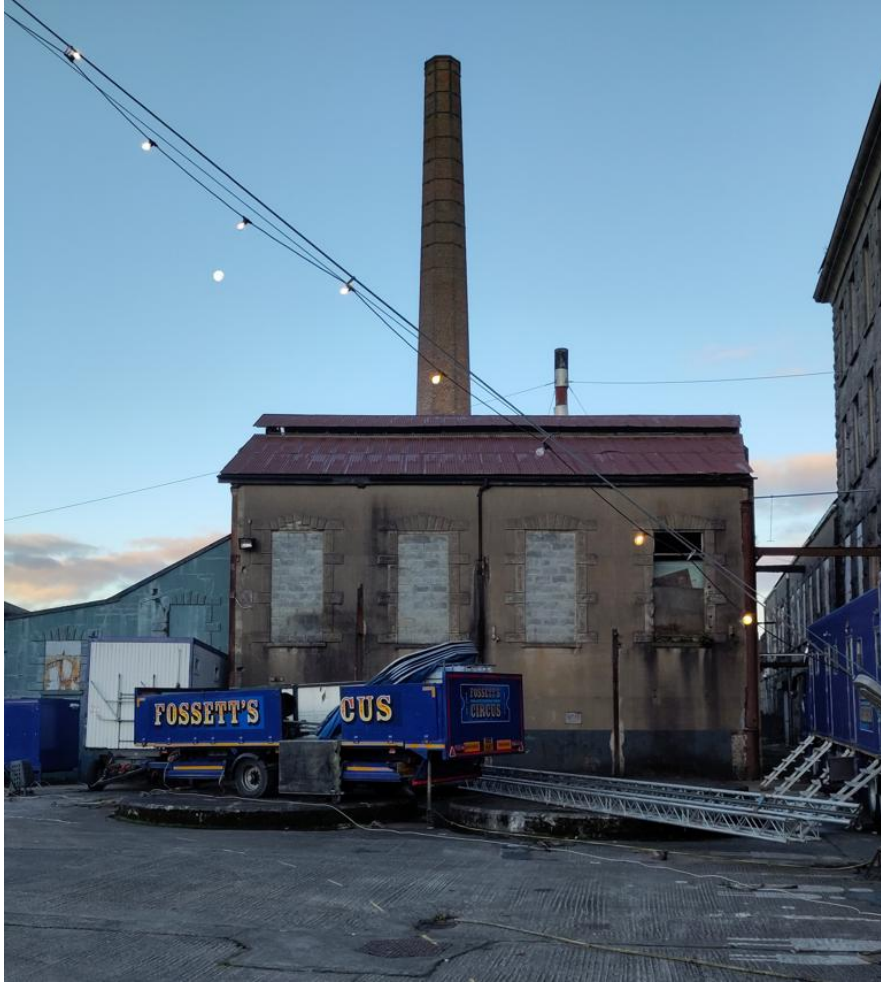
**Figure 19** – Front (southeast) aspect of the former boiler house, showing the 1930s extension.

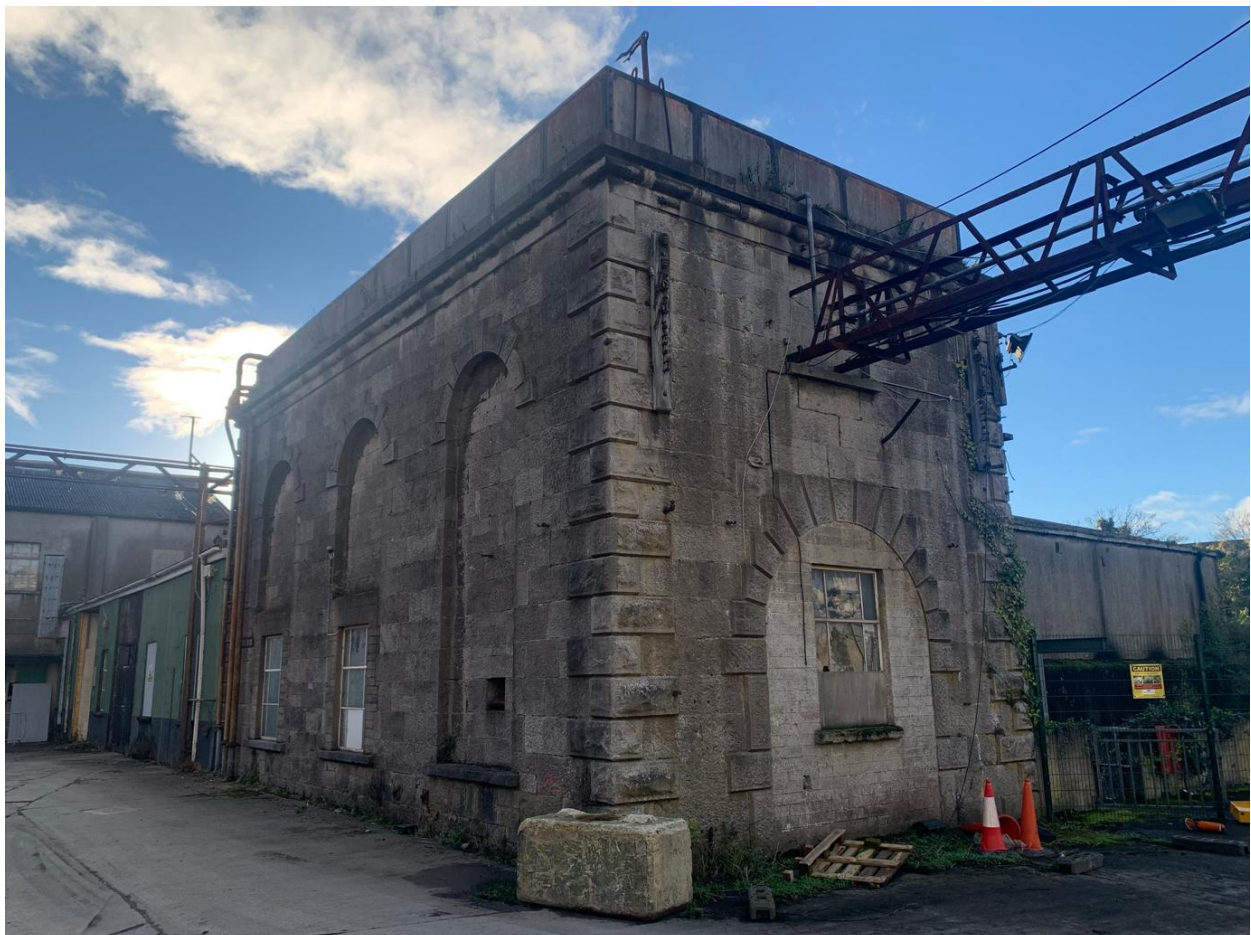
**Figure 21 – Watertank building viewed from the north aspect looking south.**

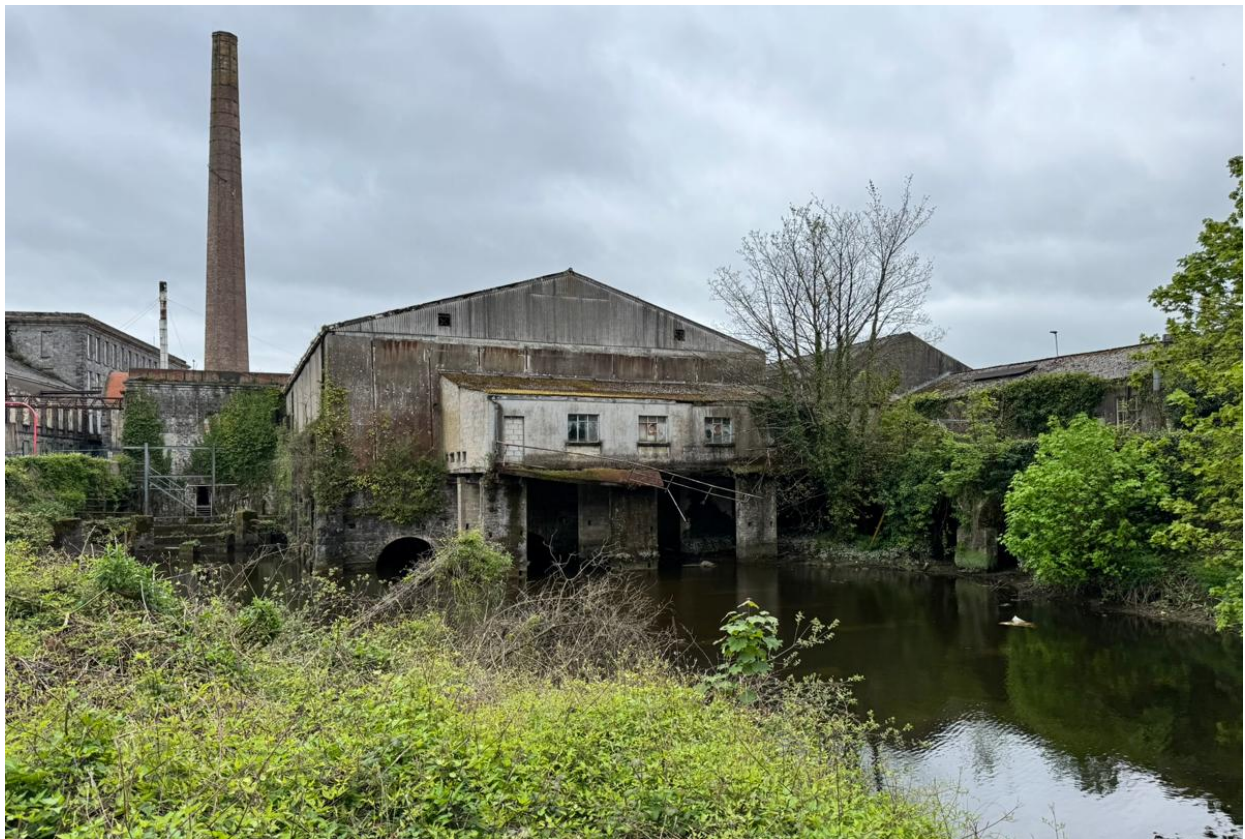
**Figure 22** - View across the reservoir to the rear of the infiltration gallery.

| Building | | Description | Significance |
|---|---|---|---|
| 05a. | <b>Infiltration Gallery</b> | <p><u>Summary</u> – Arched stone and brick plinth constructed in 1851 over the excavations in the base of the quarry to form the reservoir. Piers in the wider reservoir hint at an intention to expand. Originally the dye-house would have been located over the gallery. This was of iron and glass. The upper structure was removed some time in the early C20th and replaced by an RC portal building around 1950 which was used as a cold store.</p> <p><u>Condition</u> – The plinth is in good repair. The later RC structure is deteriorating. A rear outrigger is becoming unstable. The building is presently used for storage.</p> | Plinth 1851 – High RC Portal Shed - Negative |

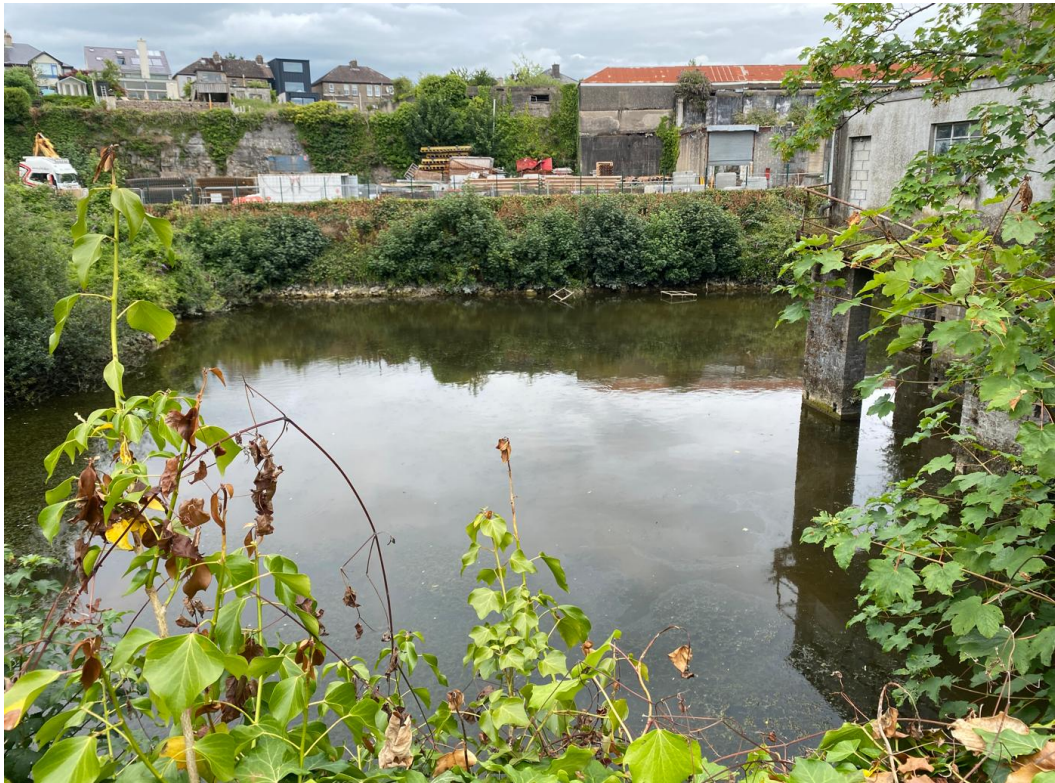
**Figure 23** - View across the reservoir from the rear of the Cheese Plant long building, looking north toward the quarry wall.

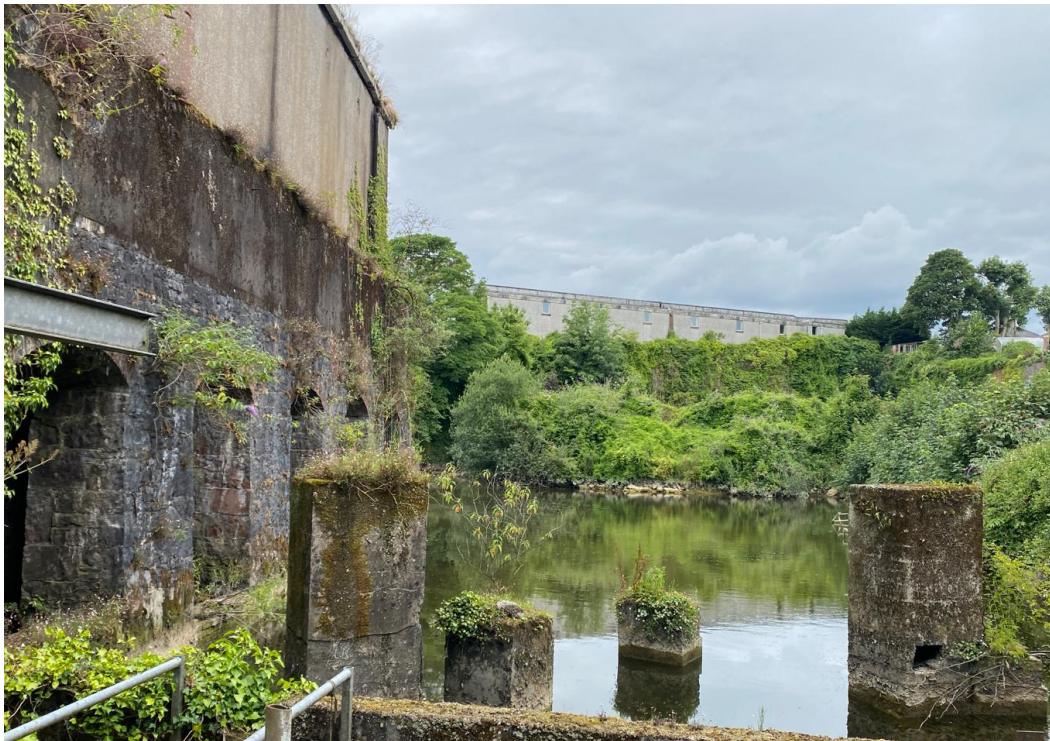
**Figure 24** - View across the reservoir from the rear of the water tank, looking west toward the quarry wall and the rear of Former Salesians Secondary School on the higher ground above.

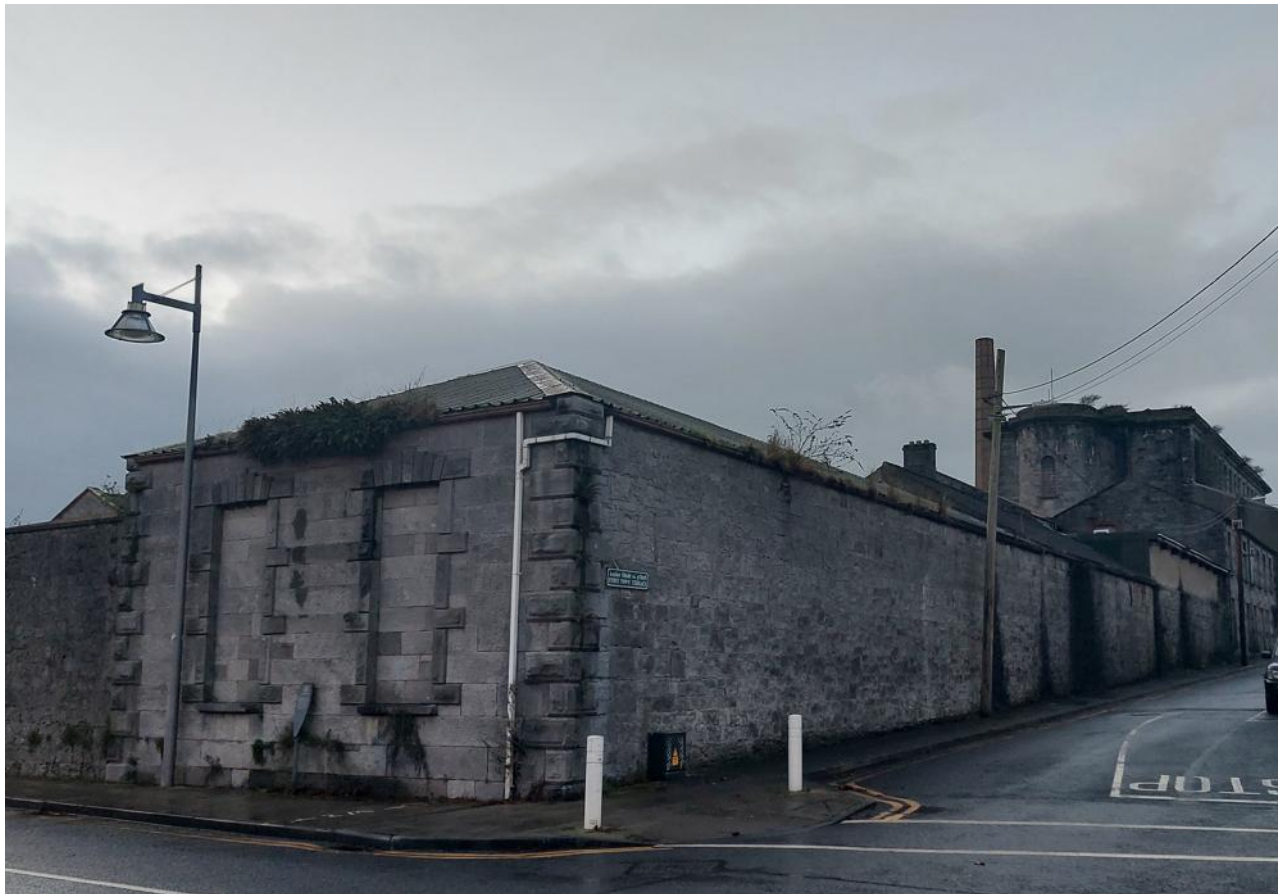
**Figure 25** - Former Linen Store, external walls as seen from O’Callaghan Strand.

| Building | | Description | Significance |
|---|---|---|---|
| 07c. | Linen Store 1855 | <p><u>Summary</u> – A simple single storey structure built of limestone and originally with a slate roof located at the east extent of the site. The external walls form the site boundary onto Stonetown Terrace and O’Callaghan Strand. Two false windows and rusticated quoins characterise the east gable. Queen post trusses present in part of the roof. The other part appears to have been adapted.</p> <p><u>Condition</u> – Adapted for storage. The roof has been renewed in profiled metal sheet. The internal elevation has been opened-up into a late C20th storage building. The masonry is in reasonable condition with some deterioration due to saturation.</p> | Linen Store - Medium<br>Late C20th<br>Structures - Negative |

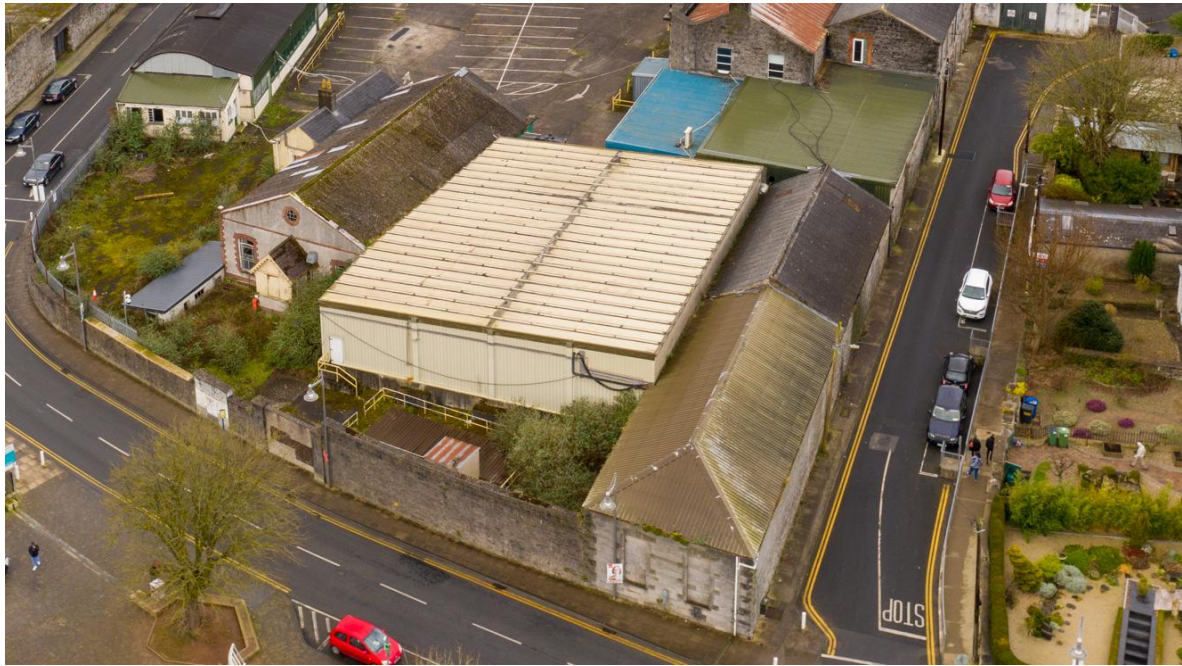
**Figure 26** - Linen Store from above. Modern cold store abutting and the alterations to the northern cells in the form of a raised and replaced roof.

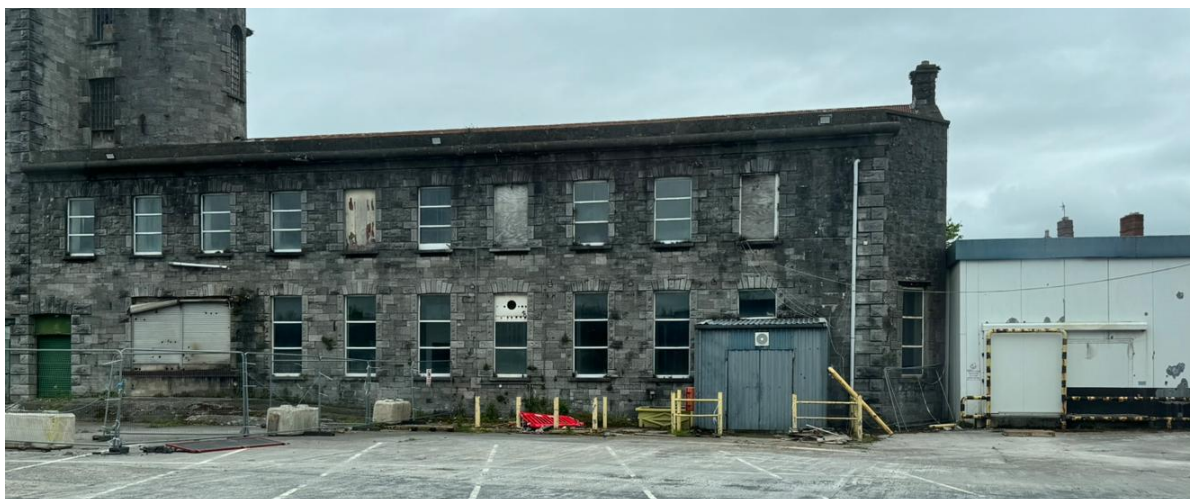
**Figure 28** – 1905 front extension to the former Offices and Counting House.

| Building | | Description | Significance |
|---|---|---|---|
| 07a.<br>07b. | Dairy Buildings<br><b>Office</b> 1855<br>Front Extension<br>1905 | <p><u>Summary</u> – Original 1850s building known as the ‘Counting House’ where the workers entered the site. An envelope of limestone, seven bays long and two storeys. Built as a heavy weight structure in the same form and materials as the main mill. Iron beams and columns appear to be from the same Belfast foundry and scaled to suit the smaller building.</p> <p>Later 1905 extension onto the mill yard has obscured the original counting house and closed the gap between the buildings linking the counting house to the mill. The extension seeks to emulate the earlier building although the windows are overly tall and narrow and the cornice is unconvincing.</p> <p><u>Condition</u> – Stable. Counting House – No original windows or doors survive. Nothing survives of the original interior. Upper floor has been adapted for storage. Ground floor has been opened-up to adjacent spaces and to allow vehicles to enter.</p> <p>Extension – Windows have been renewed. Alterations have been made for vehicle docking bays. Interior is largely altered to suit use as a storage space. Roof is lined with a tin roof with a spray foam coating.</p> | Office – High<br>1906 Extension –<br>Low<br>Late C20th<br>Structures –<br>Negative |

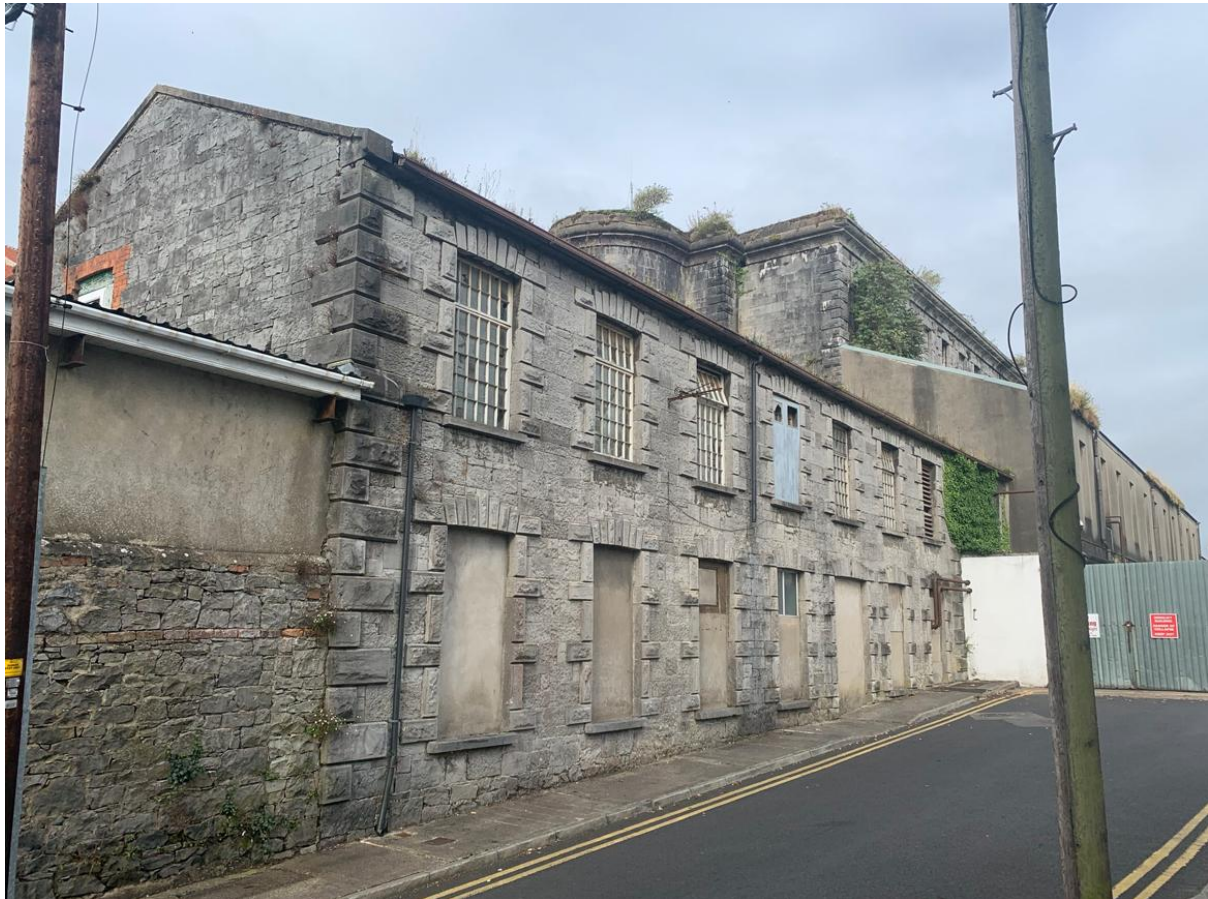
**Figure 29** – 1855 Office + Counting House addressing Stonetown Terrace. Original staff entrance 5th bay along.

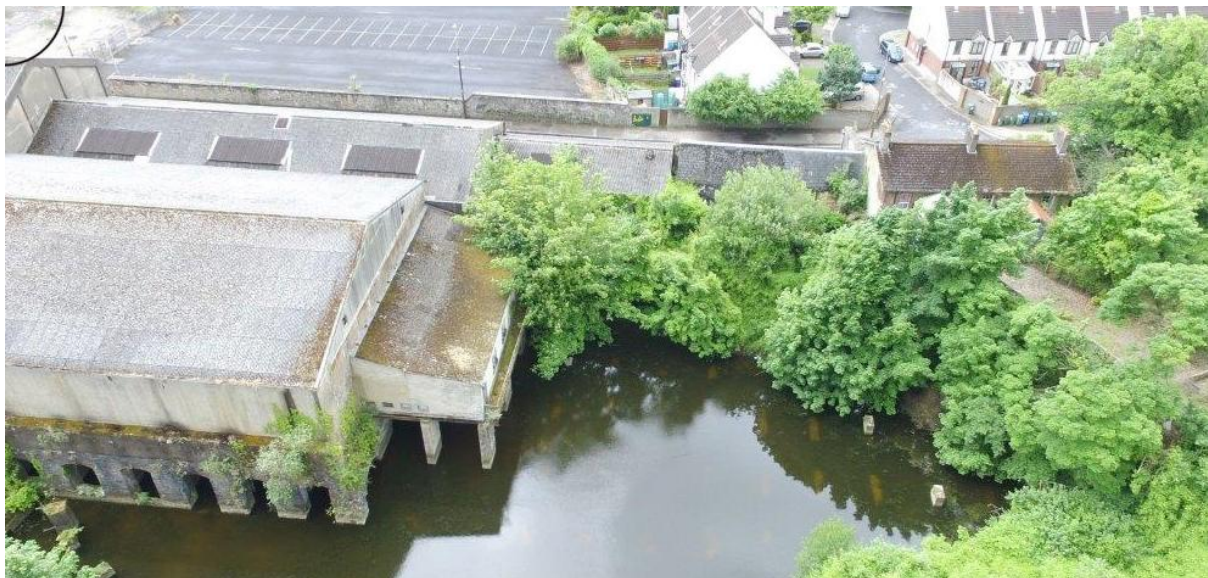
**Figure 31** - Aerial view of the Cheese Plant range, between the North Circular Road and the reservoir.

| Building | | Description | Significance |
|---|---|---|---|
| 09a. | Cheese Plant<br><b>Long Building</b><br>1853 | <p><u>Summary</u> – Single storey shed once thought to have an asymmetrical roof with a north light. The external wall addresses the North Circular Road and retains a series of blocked window openings. The original building had a long narrow plan. This has been largely compartmentalised by phases of reconstruction.</p> <p><u>Condition</u> – Poor to derelict. The building is present in different forms. The west most room is derelict with the original floor collapsed. A few of the roof trusses remain with modern metal roof coverings in place. The adjacent rooms appear to have been rebuilt in the 1950s. Brick and concrete walls with steel windows define spaces known as the shop and cheese plant. These are semi-derelict. The entrance to the shop allowed access from the street. This was formed from a former window. Further to the east 1950s RC structures sit behind part of the earlier façade. This is largely obscured by render and paint.</p> | 1850s Masonry Façade – medium 1850s building (if still present) – medium Vaulted plinth – high 1950s Building – negative |
| 09b.<br>09c. | Cheese Plant<br><b>Shop</b><br><b>Packing Store and Office</b> | <p><u>Summary</u> – Masonry and concrete replacement of earlier structures to provide facilities for making cheese and a shop.<br/>At the east end is a c.1960 RC building known as the Packing Store and Office. This replaced the earlier historic structures that were present.</p> <p><u>Condition</u> – 09b. Partially derelict. 09c. Stable.</p> | Negative. |

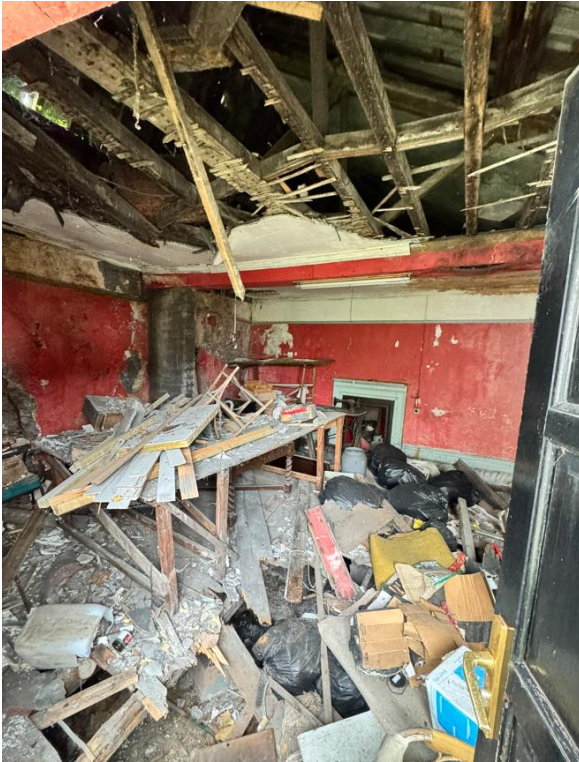
**Figure 32** - Left – Interior of the derelict room at the end of the long building. Right – Interior of the adjacent cell.

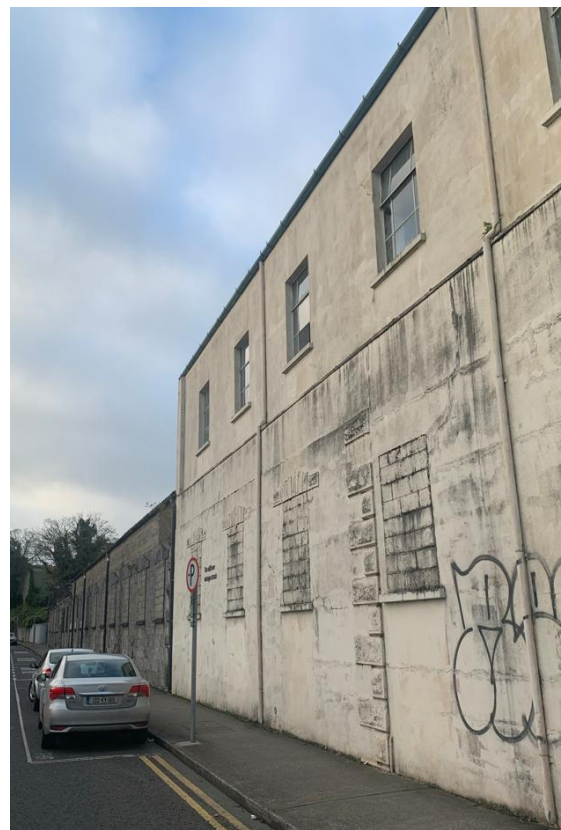
**Figure 33** - Left – Altered façade of the Cheese Plant range. Right – Element of former façade apparently incorporated into the 1960s warehouse structure.

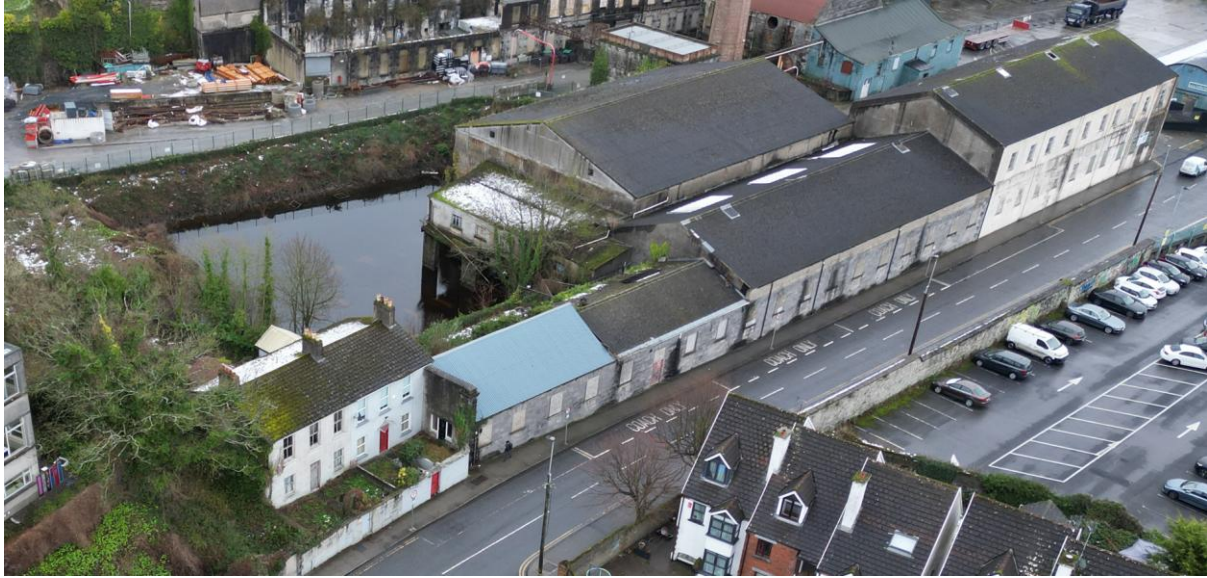
*Figure 34 – Aerial of the Cheese Plant range as seen from the west.*

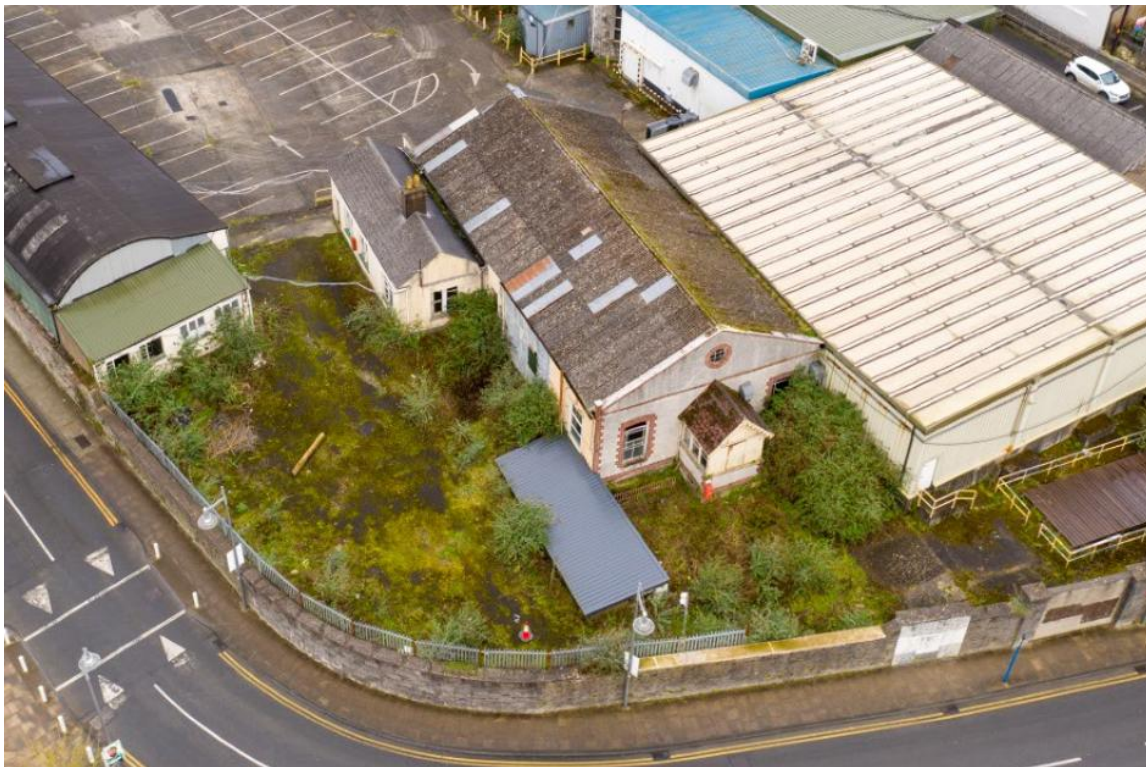
**Figure 35** – Aerial of the former Offices and Laboratory.

| Building | | Description | Significance |
|---|---|---|---|
| 10 | Office and Laboratory<br>1905 | <p><u>Summary</u> – c.1900 single storey building, domestic in scale and aesthetic. Built masonry with smooth face red brickwork to the corners and window openings. The wall panels lined in rough cast render. Roof shallow pitch originally lined in slate. The windows are sliding sash. Steeply pitched roof porch projects from the middle of the southeast gable with decorative painted verge over a glazed timber frame. This building addresses the revised pedestrian entrance to the site which had previously served as the cart entrance. Two room extension added 1955. The addition is a rendered building with sliding sash windows, a chimney and slate roof.</p> <p><u>Condition</u> – Disused and in poor repair. The building does not relate well to the wider setting.</p> | <p>1905 – Low</p> <p>1955 – Negative</p> |

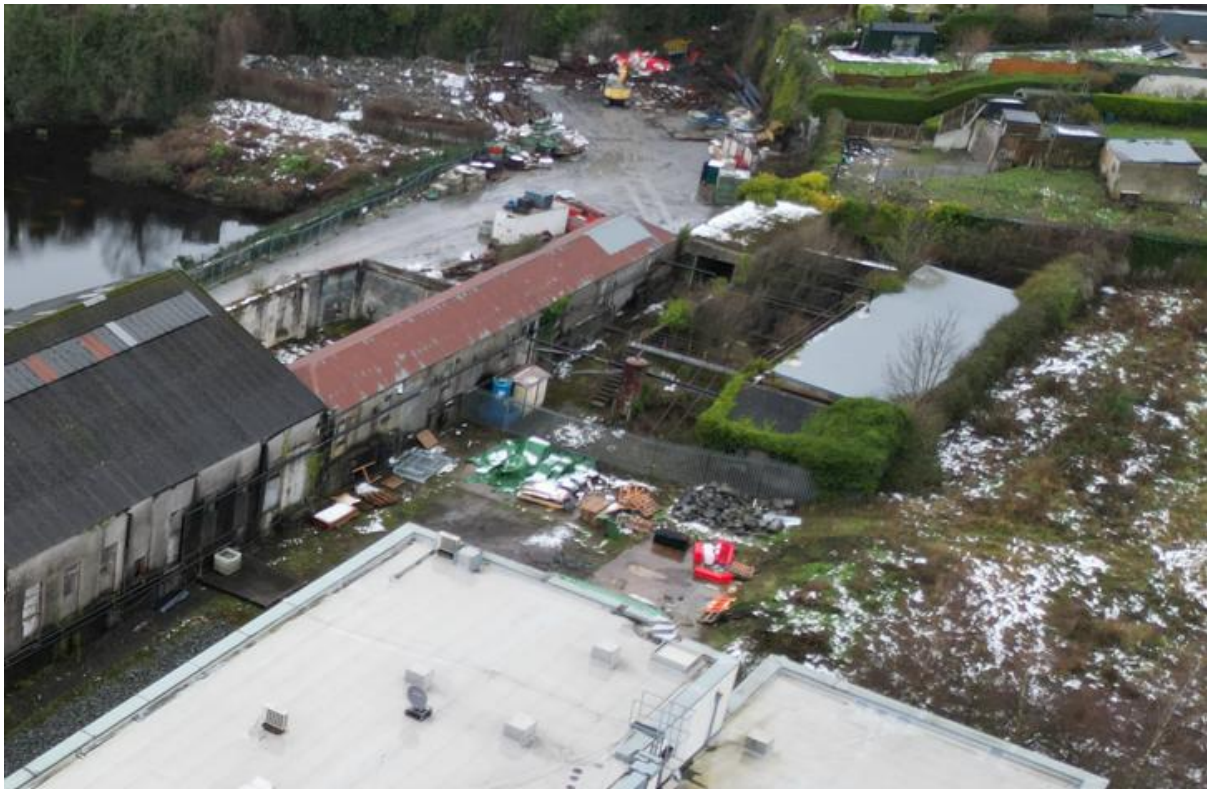
**Figure 37** – Aerial of the upper reservoir.

| Building | | Description | Significance |
|---|---|---|---|
| 12 | <b>Upper Reservoir</b><br>1947 | <p><u>Summary</u> – The land above the site does not appear to have been used for the operation of the site in its first 100 years. The structures to the north of the Main Mill were built in the C20th during a phase of modernisation. Aerial photos from 1947 and 1951 show a series of concrete reservoirs partially set into the ground. By 1952 a pump house had been added.</p> <p><u>Condition</u> – Poor / Derelict – These are modern industrial structures that have not been in use for many years.</p> | Negative |
