## CHAPTER NINE CULTURAL HERITAGE - ARCHITECTURE

This chapter of the Environmental Impact Assessment Report (EIAR) is concerned with the cultural and architectural heritage of the development site known as Cleeves, inclusive of the protected structures within and those deemed within the curtilage of the 'early industrial complex'.

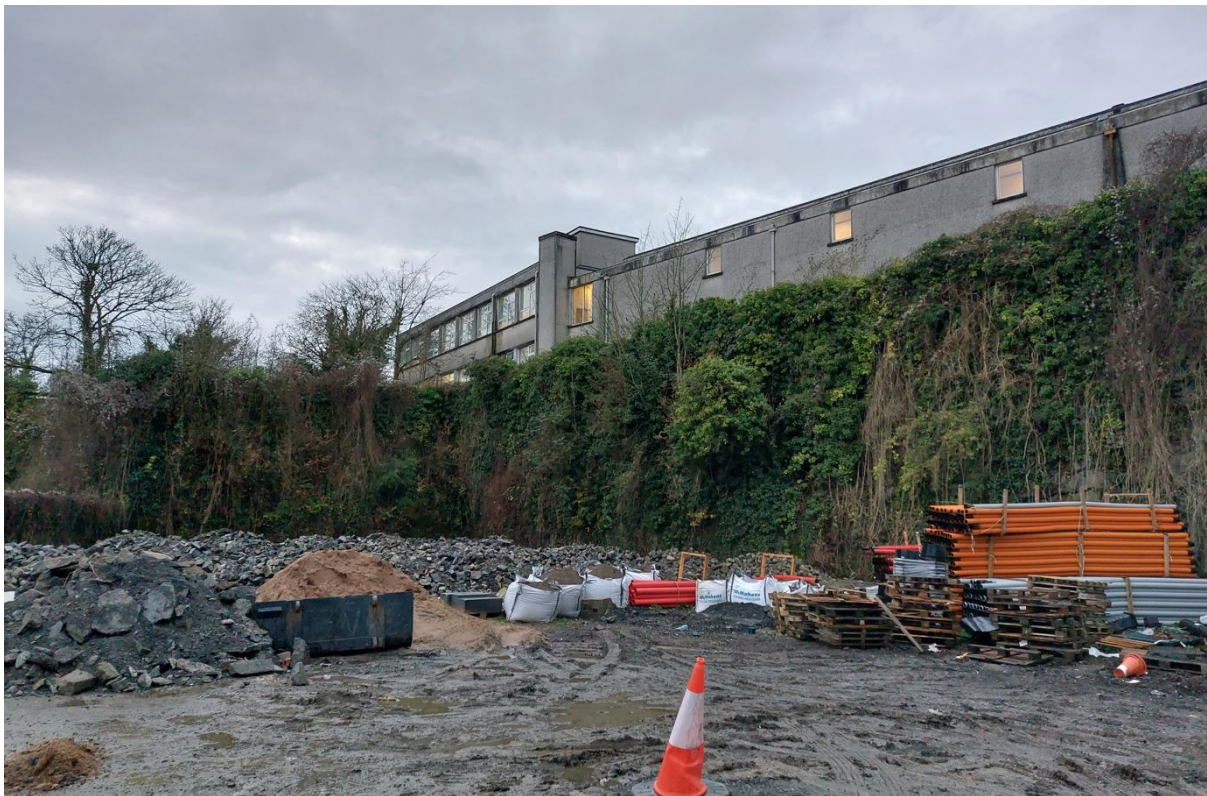
**Figure 40** – back wall of the quarry with Former Salesians Secondary School above.

| Building | | Description | Significance |
|---|---|---|---|
| 15 | Quarry 1833-55 | <p><u>Summary</u> – The quarry was almost certainly used as the source of building stone for the flaxmill. This allowed for the base to be lowered to form the reservoir. At the rear, the quarry floor formed a shelf that during historic operation of the site had buildings on it. These were demolished at some time in the second half of the C20th.</p> <p><u>Condition</u> – Disused and overgrown. Currently used as a building depot to support construction projects in the city.</p> | High |

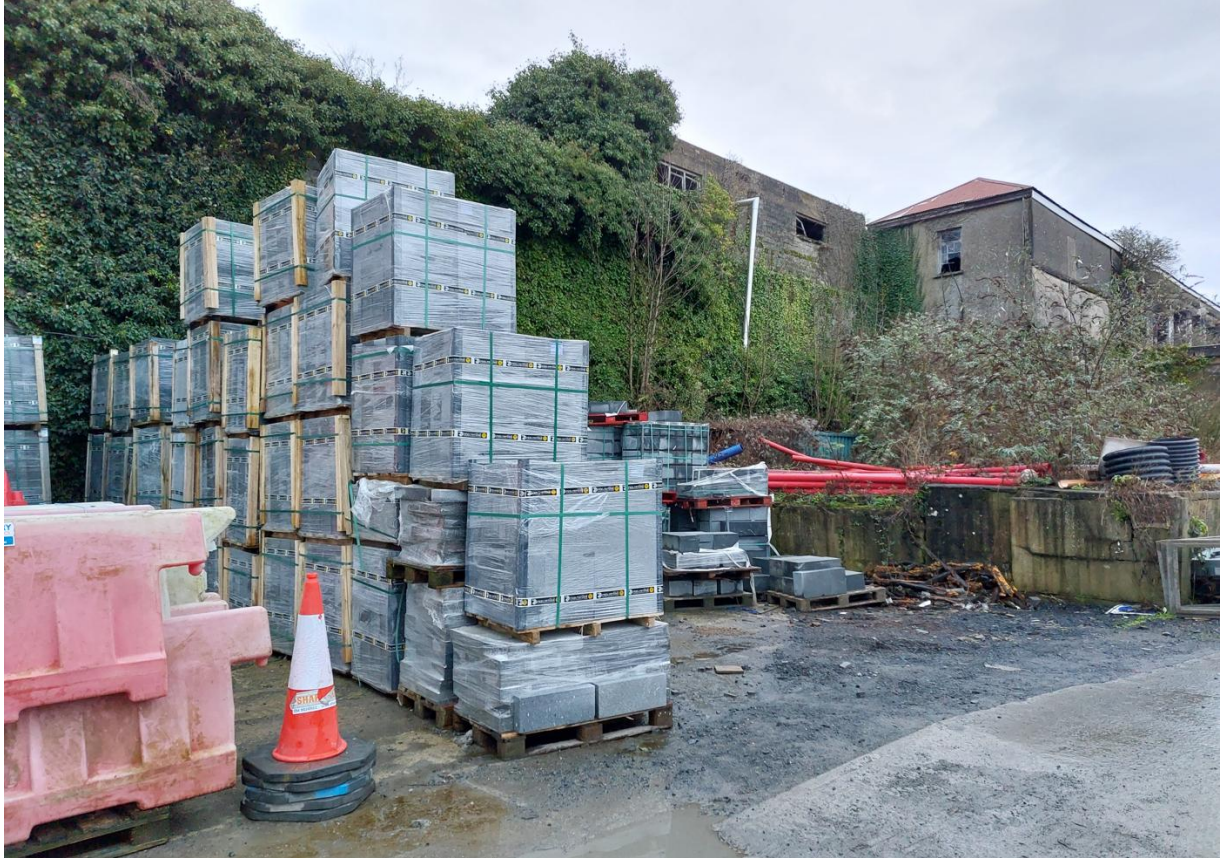
**Figure 41** – wall of the quarry toward the former cold store and upper reservoir.

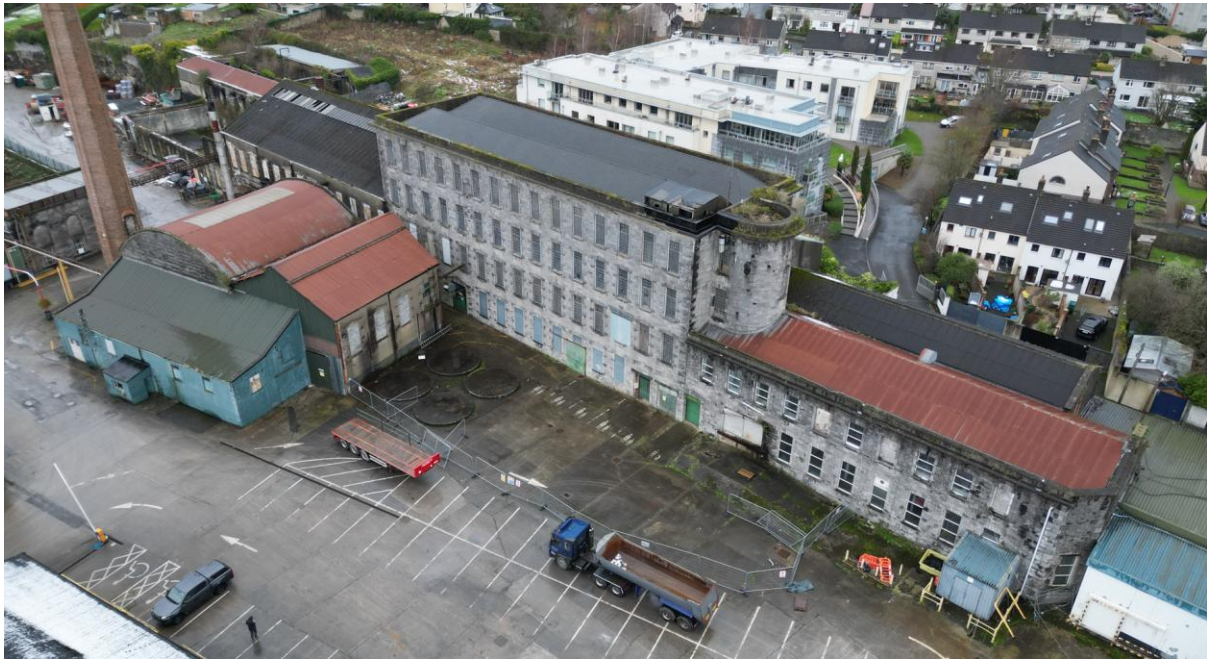
**Figure 43** – aerial view of the mill yard.

| Building | Description | Significance |
|---|---|---|
| Mill yard | <p><u>Summary Description</u> – The yard is formed by an enclosing wall and characterised by the buildings that address it. Most of the buildings with a relationship to the yard are set at the edge of the complex with their inner aspect addressing the yard. The yard was originally characterised by the enclosing boundary wall, main mill, linen store, engine house and to the northwest the dye-house over the infiltration gallery (demolished 1950s) and the long sheds addressing the North Circular Road (largely demolished 1950s).</p> <p>The yard was gated and secure, accessed by horse and cart from the south with workers entering off Stonetown Terrace through the office / counting house. Developments encroaching into the yard continued broadly as follows:</p> <p>1890s the Office and Laboratory</p> <p>1906 - two storey addition to the range known as the Dairy Buildings.</p> <p>1930s - Workshops</p> <p>1930s – Engine House, lean-to additions</p> <p>1947s – Engine House large extension</p> <p>1950s</p> <ul style="list-style-type: none"> <li>• Replacement of the dye house with a cold store over the infiltration gallery plinth</li> <li>• lean-to range stepping into the yard</li> <li>• replacement of the long building with an RC Office and packing store</li> </ul> <p>1970s – silo bases and concrete across the yard</p> <p>1990s – single storey cold store between the Dairy Buildings and former Office and Lab.</p> <p><u>Condition</u> - The mill yard as found today is substantially impacted by the creeping additions of the C20th. The loss of the late C20th surfaces and furniture reduces the historic sense of the space.</p> | <p>Varies</p> <p>As a space – high</p> <p>Fabric – low / negative</p> |

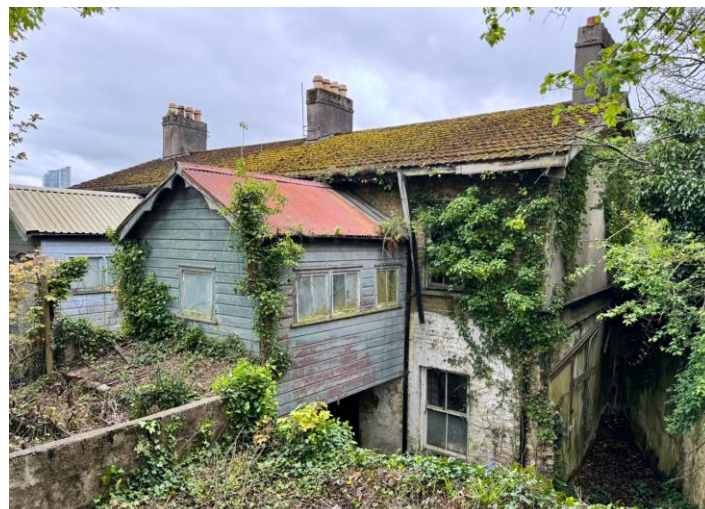
*Figure 45 – Rear of the houses.*

| Building | | Description | Significance |
|---|---|---|---|
| 14. | <b>Semi-detached Houses</b> - 1854 | <p><u>Summary</u> – 1854, the houses are set back from the street and cut into a shelf in the rock. The back gardens are similarly terraced. The buildings are of two storeys with rendered façades, interlocking concrete tiles roofs and deep overhanging eaves.</p> <p>Each is of three bays with a central entrance. The windows are 2 over 2 horned sliding sashes over projecting stone cills. The rear walls are buff bricks laid in Flemish bond with 6 over 6 sliding sashes. The rear first floor elements are horizontally boarded with timber casement windows and a tin roof. The west house is substantially intact in form and material. The east house has been much altered although still retains its plan form.</p> <p><u>Condition</u> – Both houses are vacant and in poor condition although the fabric is robust and structurally sound. The west has not been well maintained and has suffered from occupation by squatters. The east has been modernised in phases resulting in loss of historic features.</p> | West – Medium<br>East - Low |

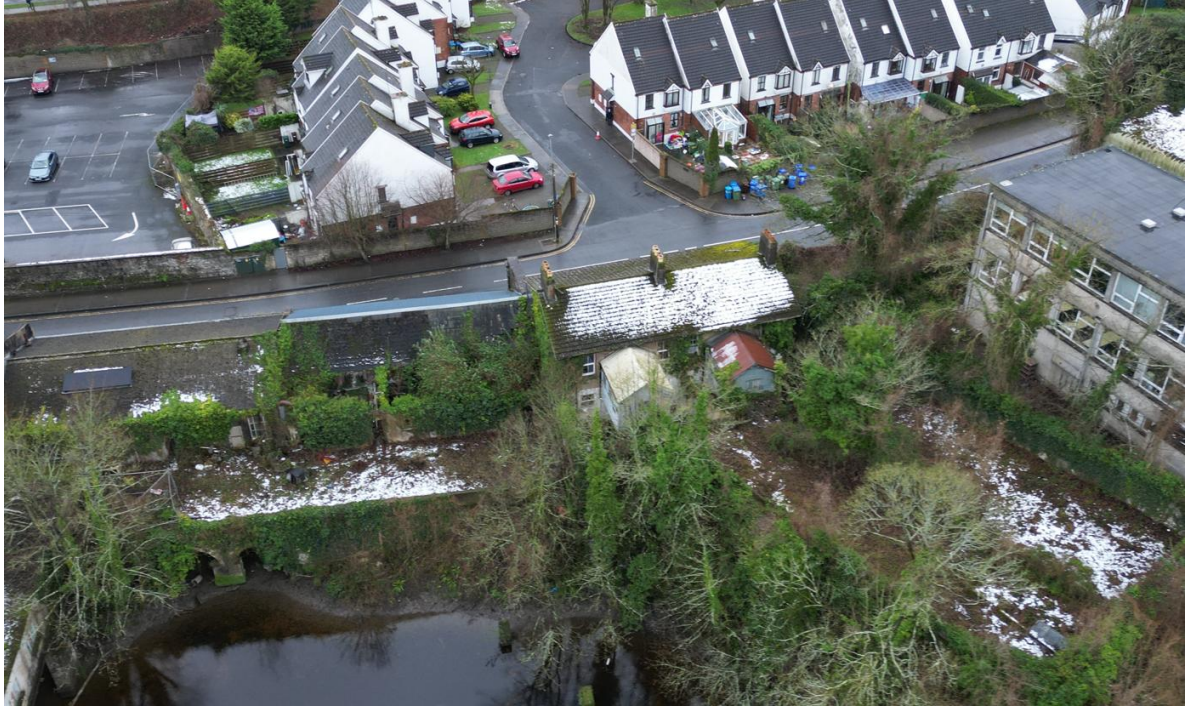
**Figure 46** – Aerial view of the house with Former Salesians Secondary School above and the reservoir behind.

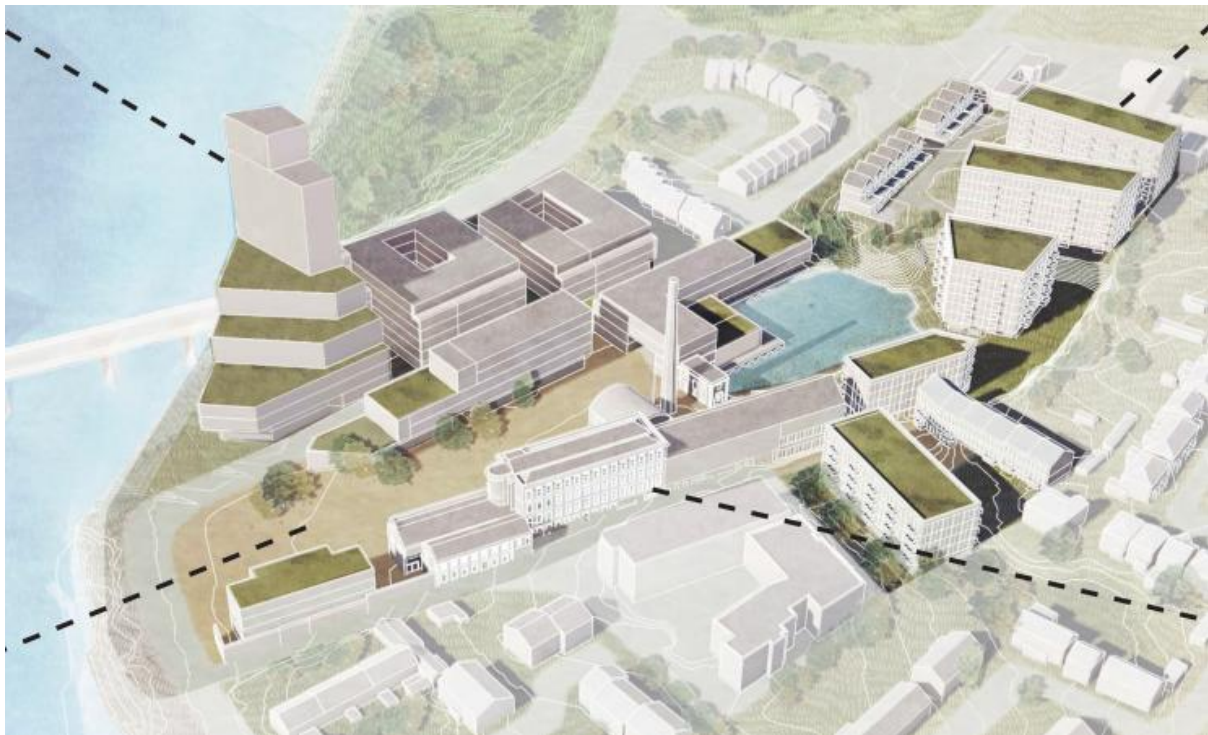
**Figure 52 – Use Principles, extract from the Illustrative Masterplan - Vision Document.**

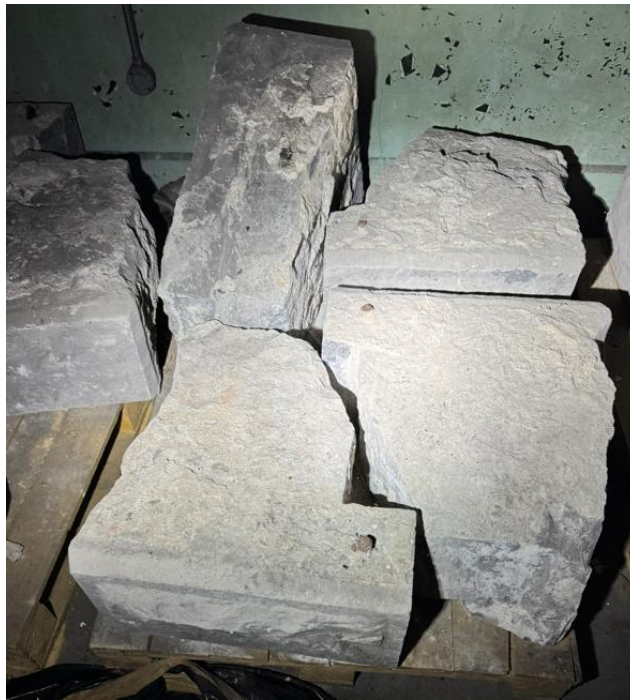
**Figure 53** – Images from salvage survey record prepared as part of Phase I works. Example of future approach for Phase II.

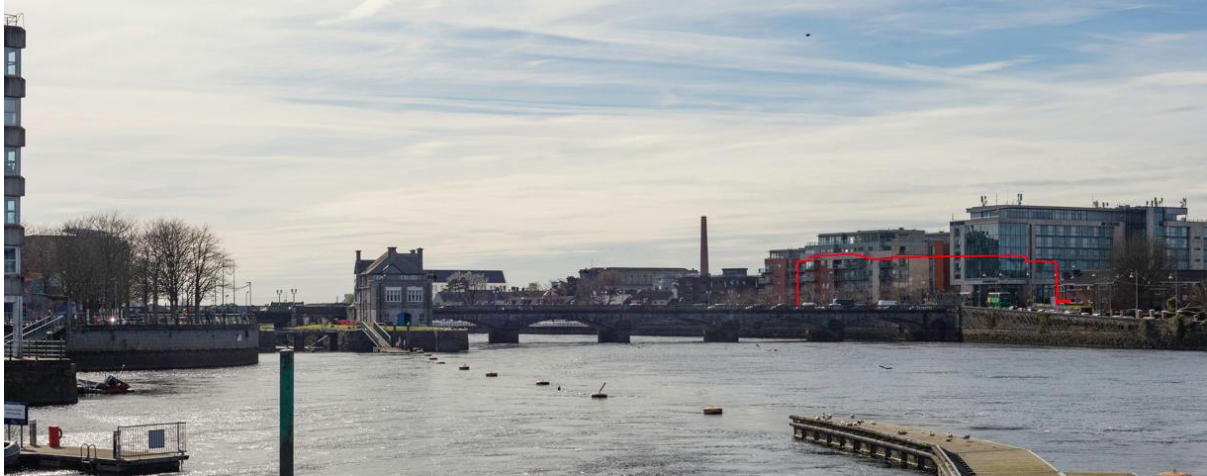
From the east, north and west, when the proposed buildings are visible. They blend in with the wider development setting (Views 08 and 10). The Main Mill and Chimney retain clear presence with the Chimney projecting above the building line.

**Figure 56** – Phase II outcome (View 08).

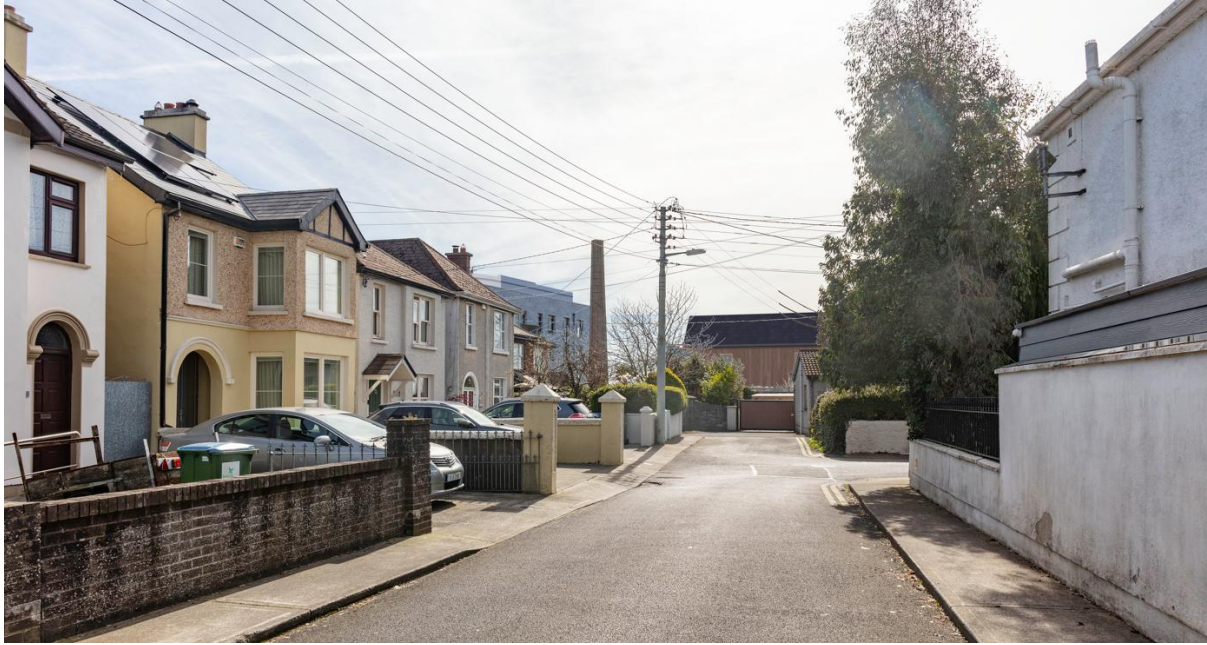
From the north and west when approaching the site it is possible to see the buildings from the surrounding streets. From Clanmaurice Avenue, the apartment block on Stonetown Terrace appears as a block beyond the end of the houses (View 13). The Chimney is visible in the space between the proposed apartment block and town house. Oddly, the existing power pole has a dominating presence.

**Figure 58** – Phase II outcome (View 13).

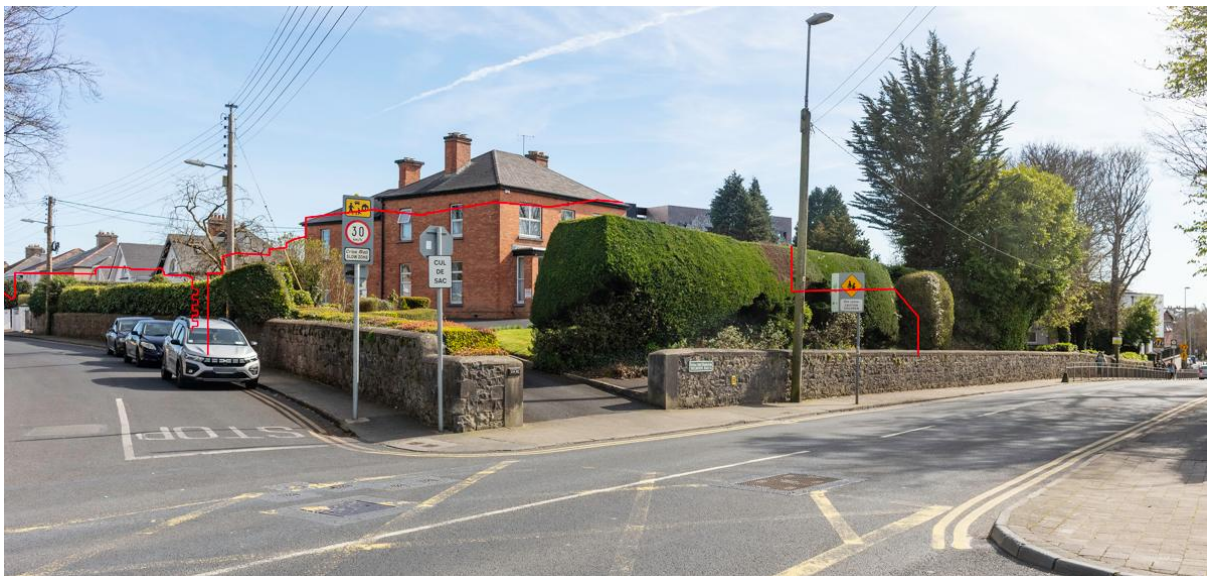
From Shelbourne Road Lower and Clanmaurice Avenue, it is possible to see the block on Salesians rising up behind, but not exceeding the level of the roofs of the houses. It is not possible to see the Flaxmill Complex (View 14).

**Figure 59** – Phase II outcome (View 14).

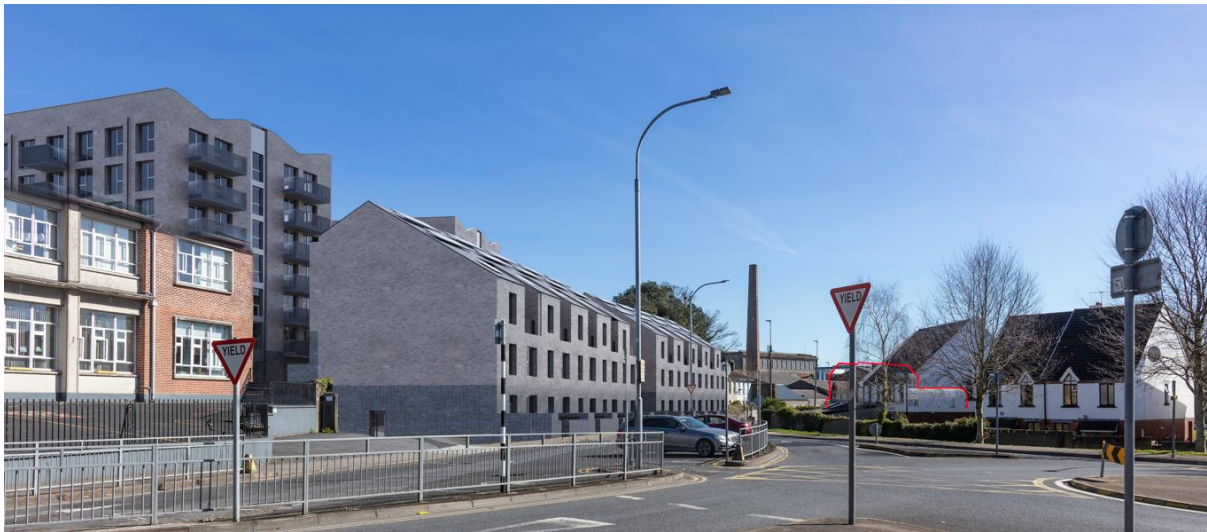
From the roundabout at the junction of Shelbourne Road Lower and the North Circular, the town houses redefine the development edge near the road. The domestic aesthetic of these buildings responds to the steep roof houses of Fernhill. Behind the proposed townhouses, the new apartment blocks of Salesians rise up (View 17). The Chimney and Main Mill remain visible in the distance.

**Figure 60** – Phase II outcome (View 17).

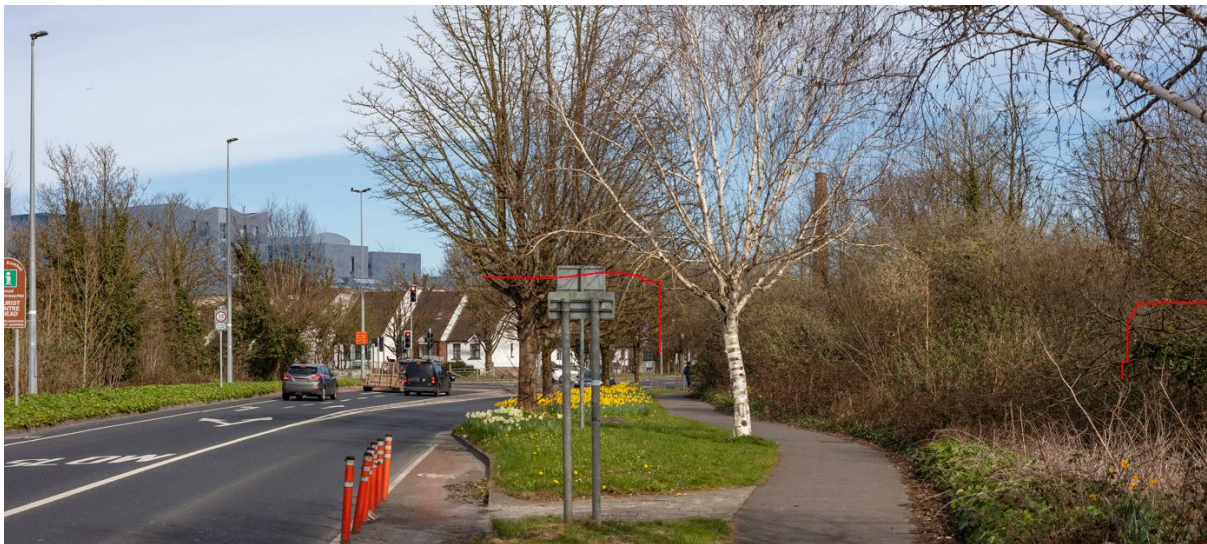
Moving away from the site along the Condell Road, the larger scale building of Salesians and Stonetown Terrace become more visible. Fernhill establishes a lower scale at the road edge, set slightly below the road. The roofs of the proposed townhouses can be seen just beyond. The proposed buildings are visible within the context of the Mill Chimney (View 19).

**Figure 61** – Phase II outcome (View 19).

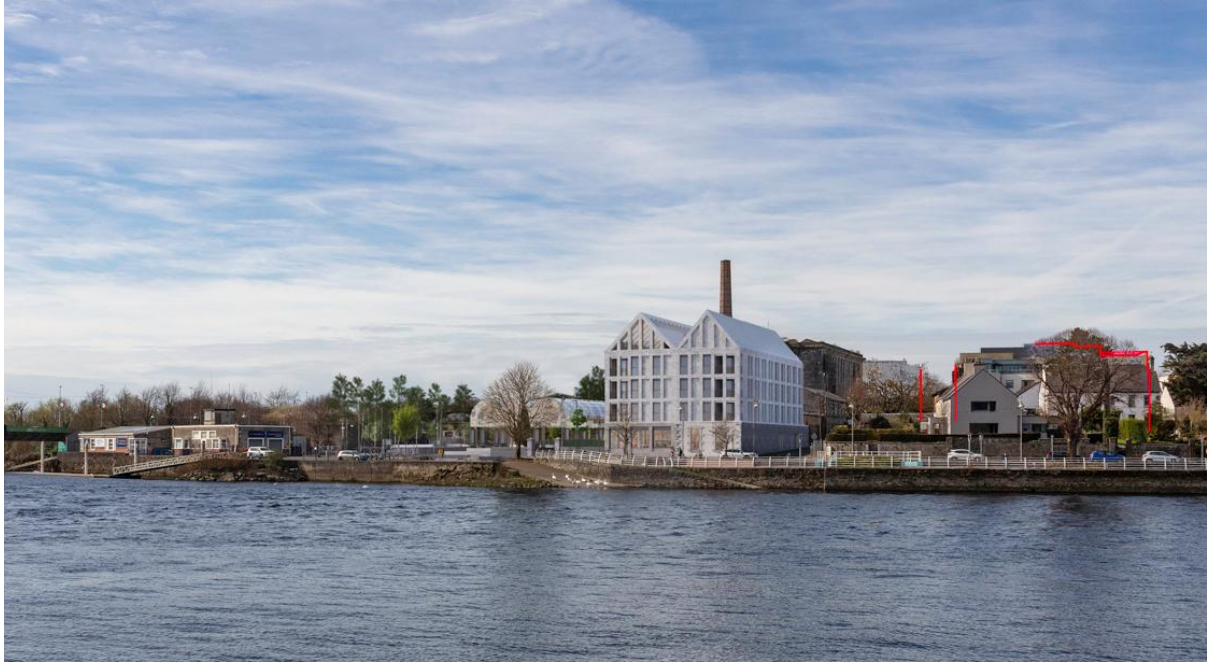
O'Callaghan Strand – The new building within the curtilage of the complex will redefine the views of the Main Mill. Its designs, while sympathetic will result in permanent changes to the view of the mill. From the northeast aspect across the Shannon, view 05, the visual dominance of the new building is very significant. Views from the south (views 01 and 02), east (view 03) and further north (views 06 and 07) the visual impact of the new building on the Main Mill is much less. Here the impact on views of the Main Mill will be moderate, negative and permanent. The architectural treatment of the building is sensitive to the materials and architecture of the mill complex and significantly diminishes the visual impact. **The reuse of the site is, however, positive.** Consideration of the potential scale of development within Phase IV provides future context placing the Main Mill and Chimney in a broader development setting. Here the mill complex can be read as the core of a substantial development. The prominence of both of the protected structure would be impacted as they become cultural features within a redefined setting.

**Figure 62** – Phase II outcome (View 05).

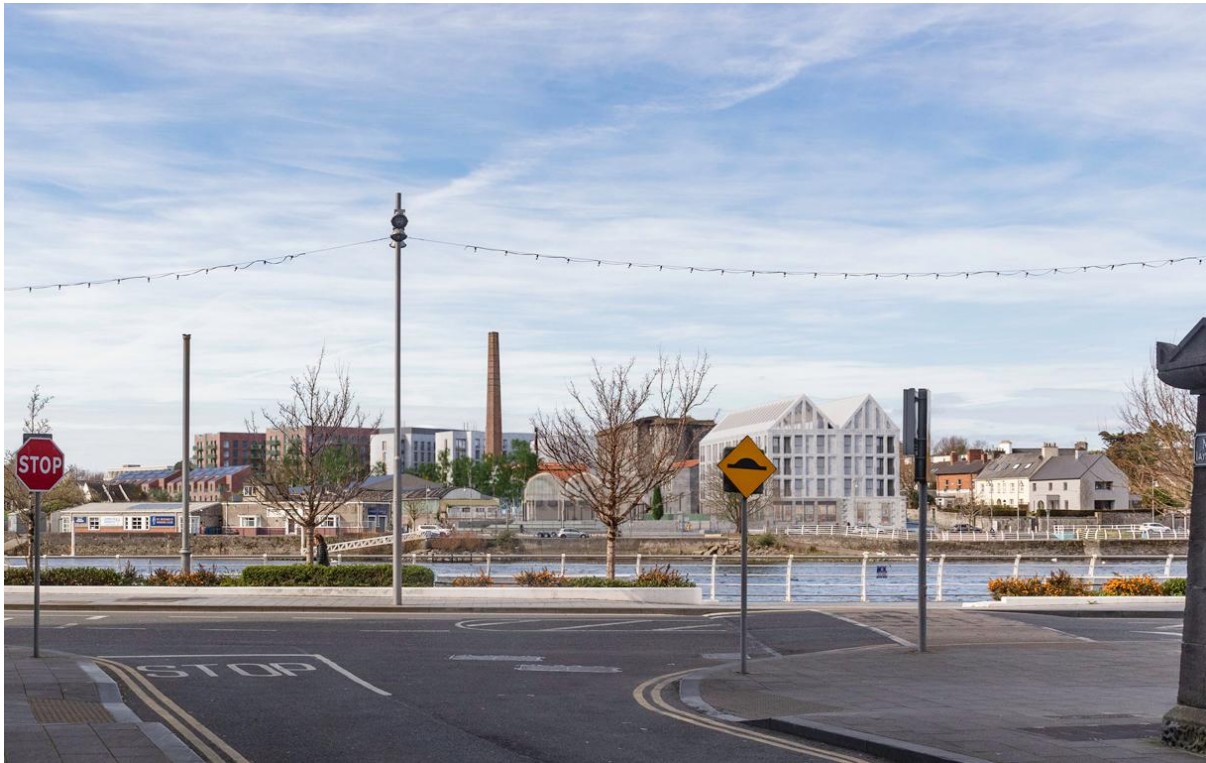
**Figure 65** – Phase II outcome (View 03).

Salesians – The site is not within the curtilage of the protected structures of the mill complex. Redevelopment of the Salesians site has greatest potential to give rise to negative impact through changes in the setting of the mill complex. Views from the west and north are largely occupied by existing buildings with little if any visual connection to the mill structures. ***When viewed from the east and south, the replacement of the school buildings will result in an increase in the scale of building visible beyond the mill. This will alter the setting giving rise to moderate, negative, cumulative effects.***
