## CHAPTER EIGHT CULTURAL HERITAGE - ARCHAEOLOGY

The proposed application site (Phase II) is part of a phased development proposal for a significant city centre, regeneration area or Masterplan Site (MS). This MS is divided into four different phases of delivery as detailed in Section 1.6.3 in Chapter 1.0 Introduction. The overall MS layout which illustrates the indicative layout of the subject site and adjoining lands in the ownership of the applicant as displayed in Chapter 1.0, Figure 1.4 and full details of the proposed development phases are provided in Chapter 2.0, Section 2.2.4. This assessment takes a holistic approach and examines the MS whilst focusing on any areas of significance within the proposed application site (Phase II) and the likely impacts arising from the development proposal.

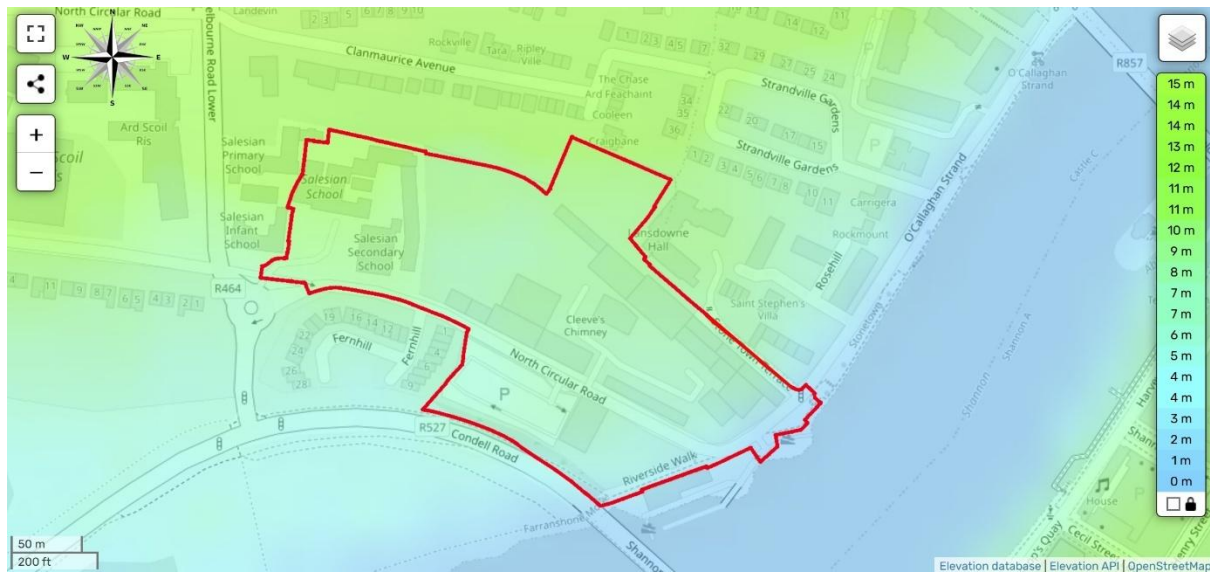
**Figure 8.3:** Site detail in relation to the topographical profile of the receiving environment (after County Limerick topographic map, elevation, terrain)

The gradiometer survey assessed accessible areas and did not extend to the full site of development. The landfill at Stonehouse Terrace requires significant removal of its soil to assess its archaeological potential. The Victorian Terrace and Salesians School are in an elevated position relative to the overall development and may thus have received the least ground impacts from previous development. Consequently, these locations could retain greater archaeological potential.

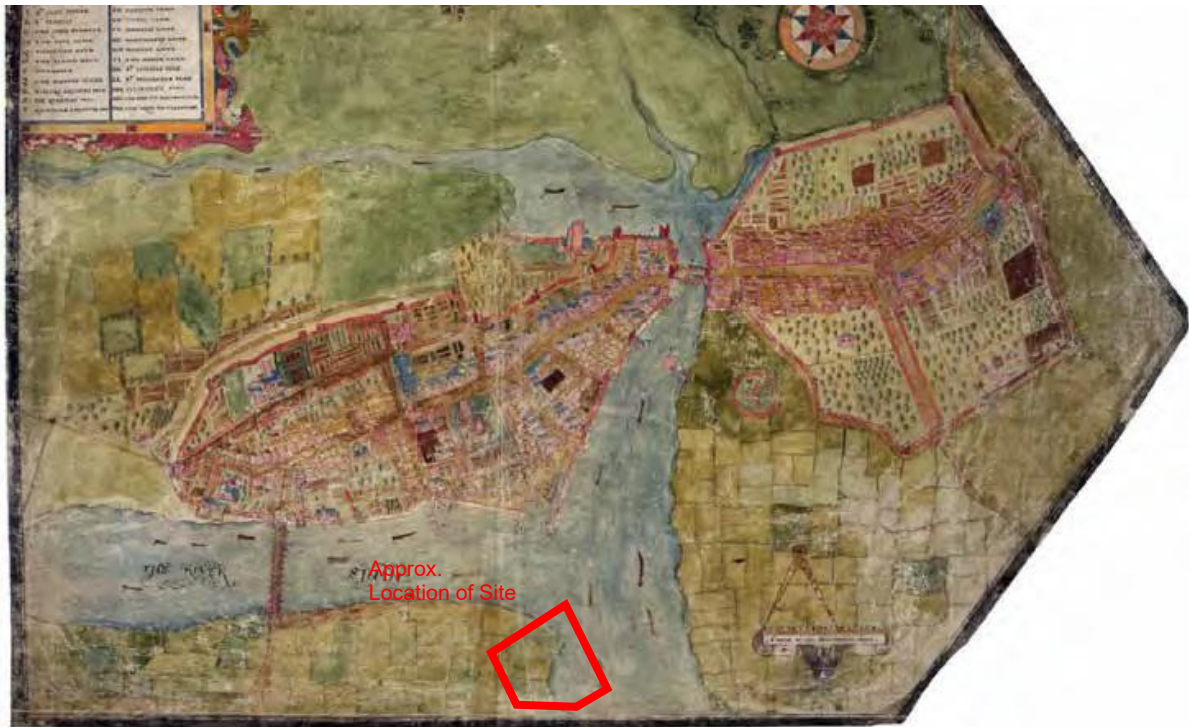
**Figure 8.4:** c.1590 Map of Limerick (after feilden clegg bradley studios + bucholz mcevoy)

The c.1590 map of Limerick depicts the Medieval town with the original Island settlement on the north bank of the Abbey River and Irishtown to the south. Baal's Bridge, later called Thomond Bridge, connects the town to the northwest bank of the River Shannon. The site of development is shown as a rural landscape opposite the medieval town.

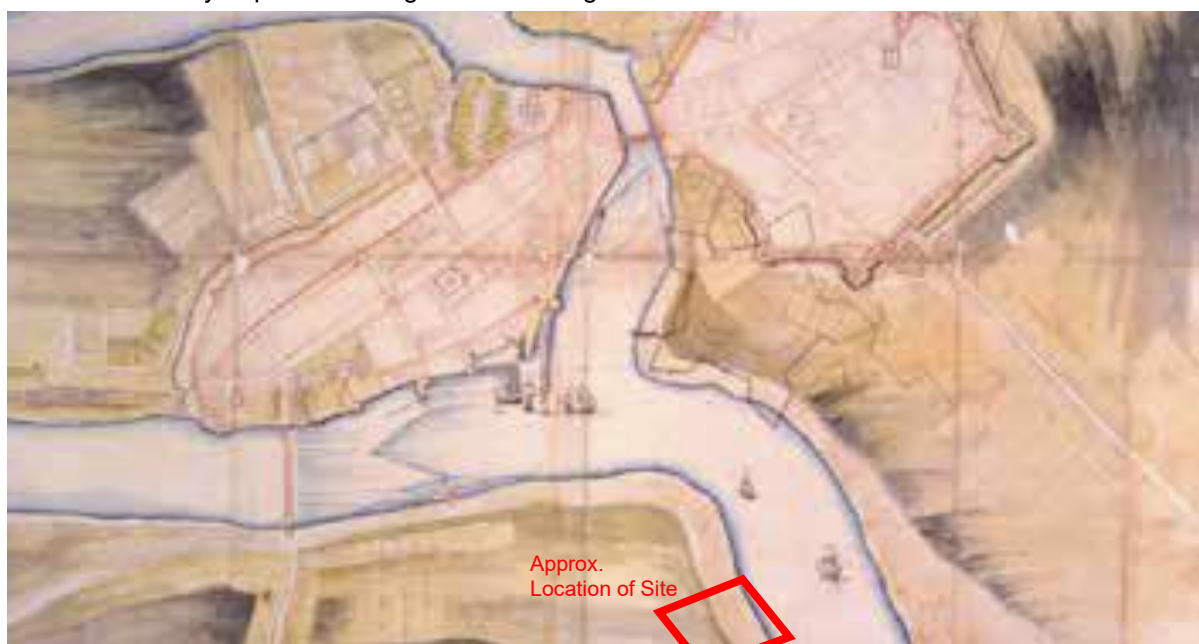
**Figure 8.7:** Extract of c.1685 Map of Limerick (after feilden clegg bradley studios + bucholz mcevoy)

By *circa* 1685 the site remains as a rural hinterland. A road leading from the western approach to Limerick is clearly depicted leading to Baal's Bridge.

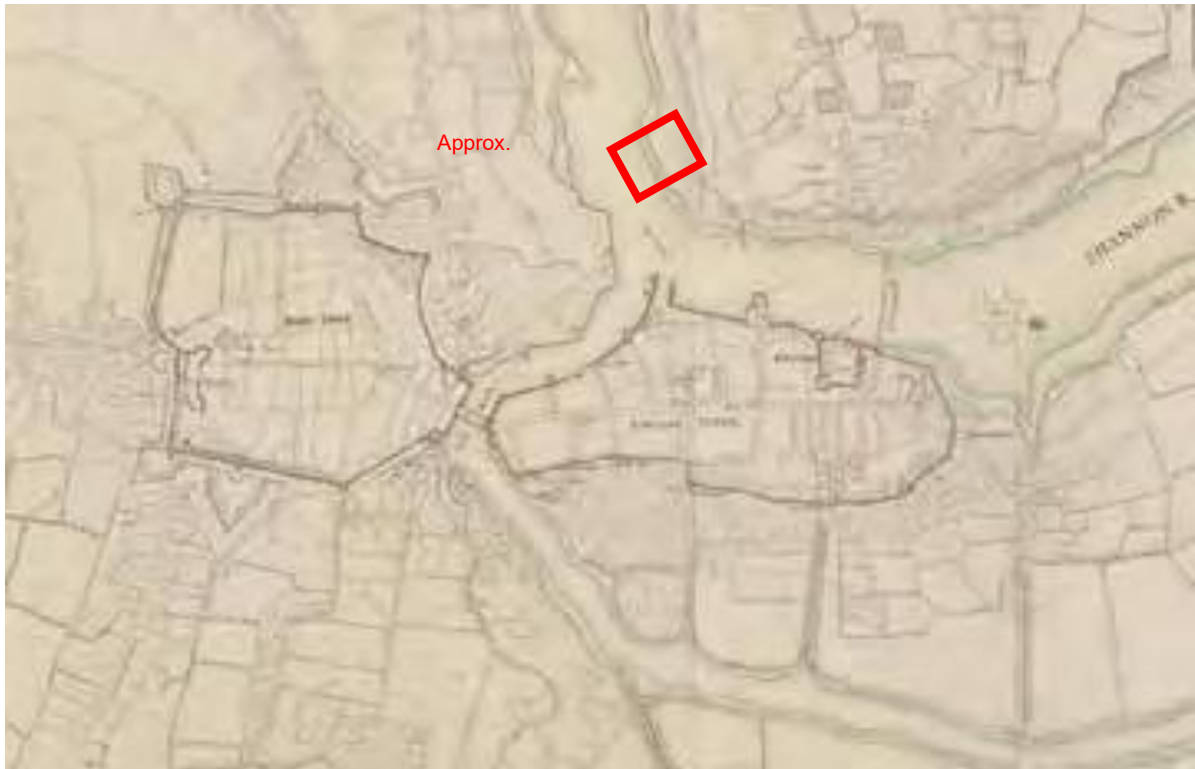
**Figure 8.8:** Extract of c.1752 Map of Limerick (after feilden clegg bradley studios + bucholz mcevoy)

In *circa* 1752, the site is depicted as an inter-tidal zone set on the foreshore. Some settlement activity appears to have occurred to the north of the site.

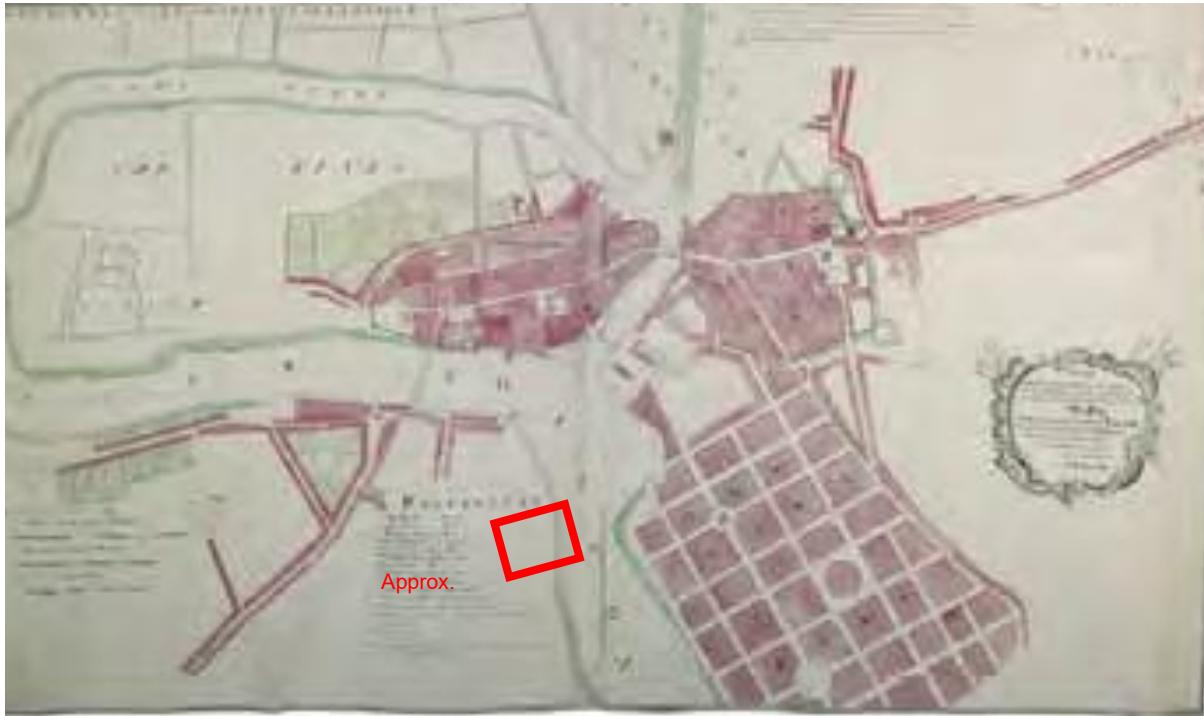
**Figure 8.9:** Extract of the c.1769 Map of Limerick (after feilden clegg bradley studios + bucholz mcevoy)

While the site remains a rural shoreline and intertidal zone on the *circa* 1769 map, the suburbs of city have extended across to Stonetown as a formally laid out streetscape that fans out from Thomond Bridge. It appears that the bastion fort (LI005-009) is now enclosed by a triangular arrangement of terraced dwellings to the northwest of the bridge.

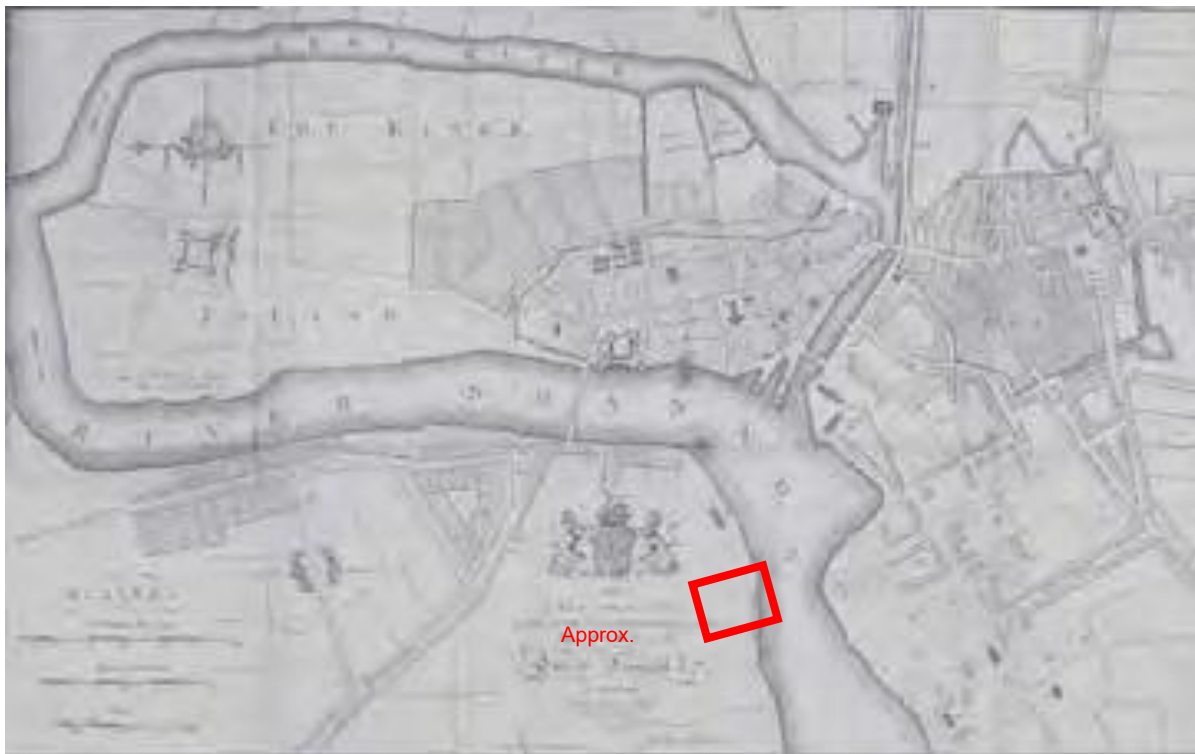
**Figure 8.10:** Extract of the c.1786 Map of Limerick (after feilden clegg bradley studios + bucholz mcevoy)

Seven years later, the *circa* 1786 map shows the same layout. However, the bastion fort no longer appears extant. It appears that the expansion of garden plots to the rear of the terraced dwellings have effectively truncated the fort.

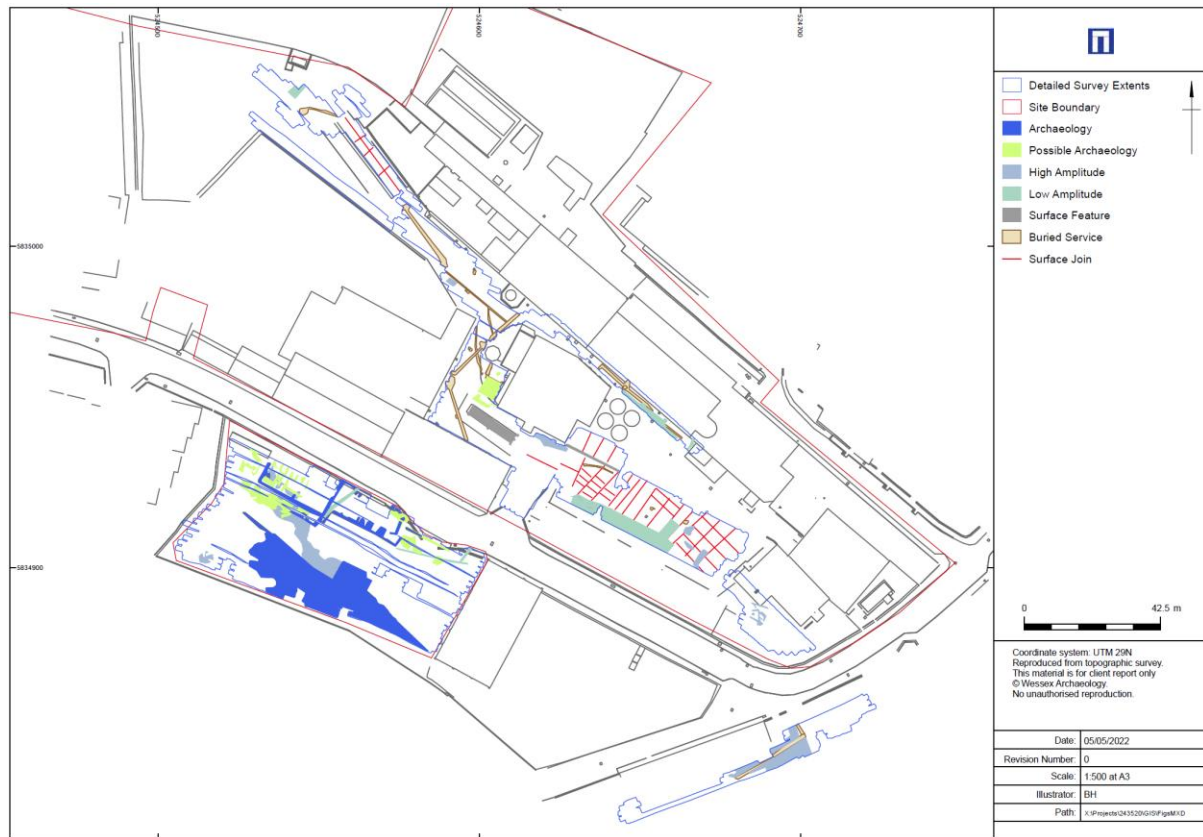
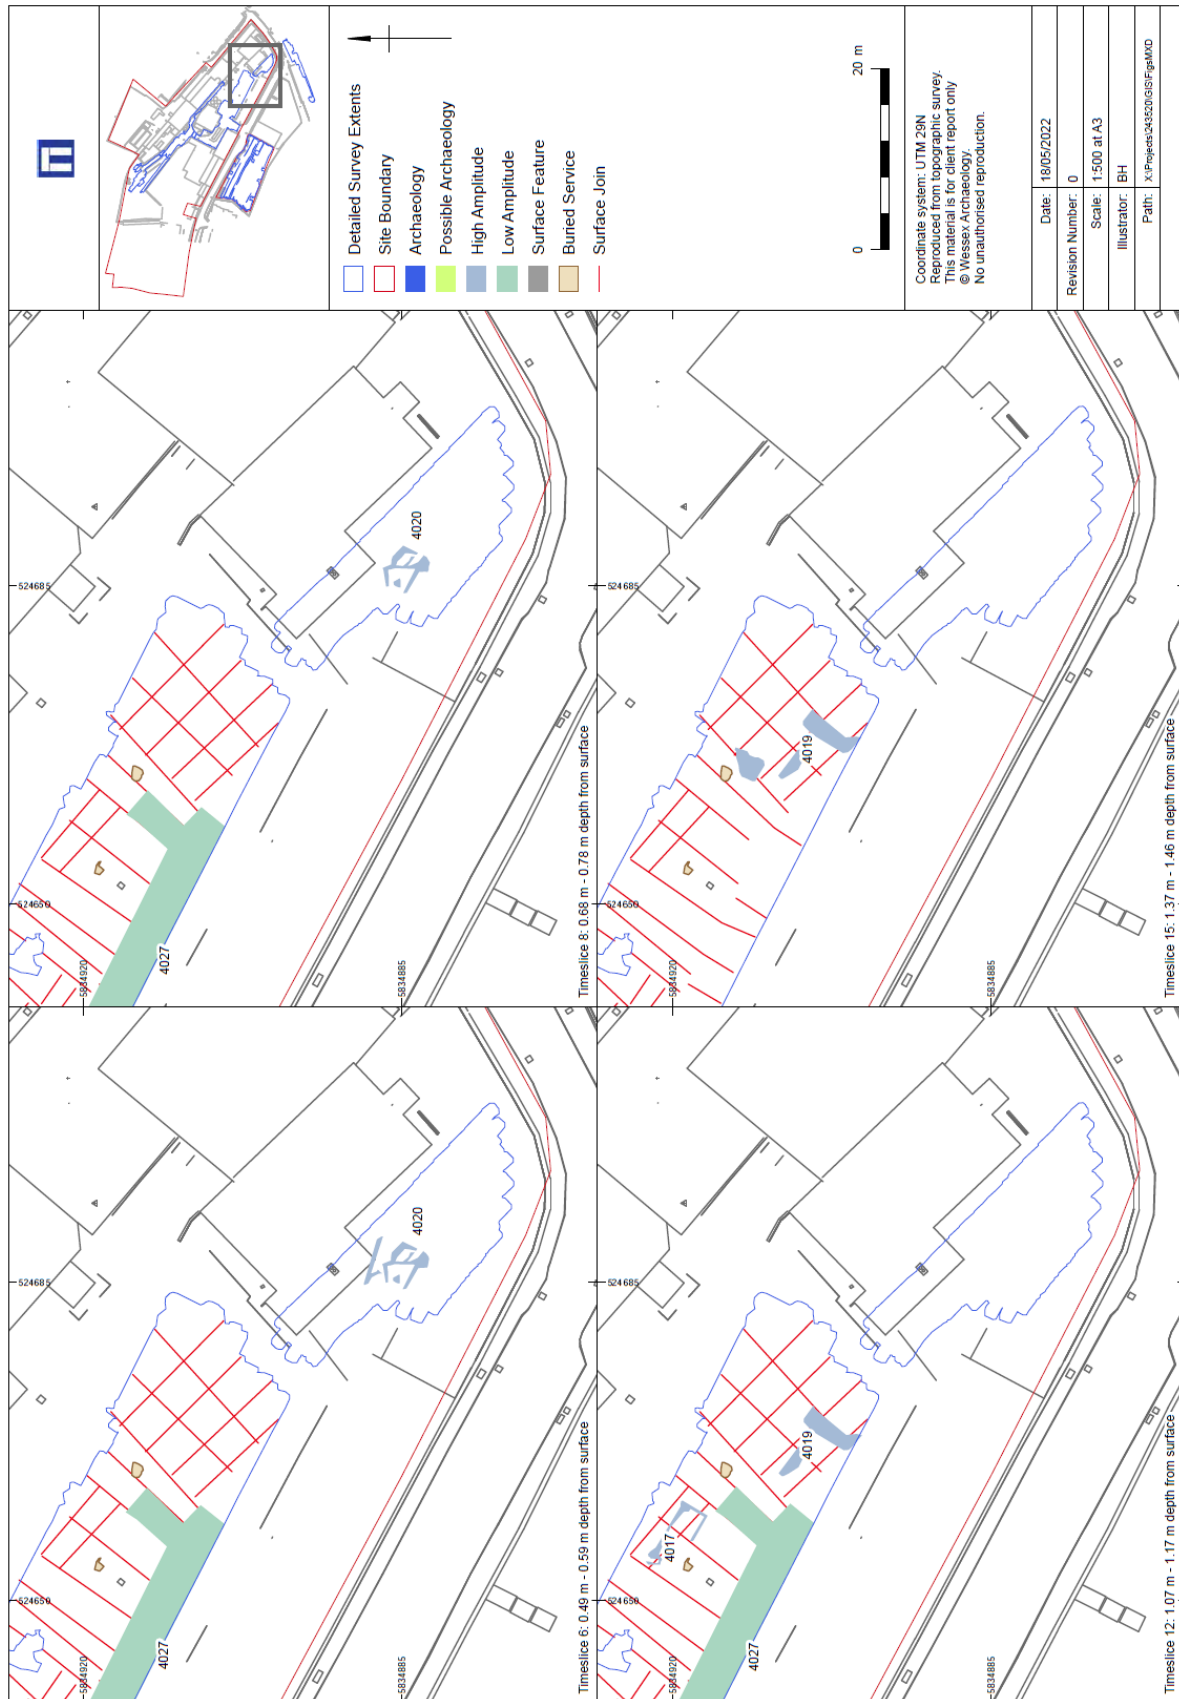
Figure 8.17: Survey results (after Howard)

Anomalies 4000 to 4009 relate to subsurface remains of a structural nature associated with the former shipyard and factory area. While extant 19<sup>th</sup> century buildings survive on the site, ancillary structures remain at a foundation level. No buildings survive above ground within the shipyard. However, they remain at a deeper level and form part of the built heritage record.

| Anomaly No | Classification | Date Period | Area / ITM | Dimensions / Depth |
|---|---|---|---|---|
| 4010 to 4024 | Unknown anomalies. Possible foundations or ancillary elements. | | Factory Area, Shipyard & Rowing Club. Open spaces between buildings. Predominantly E of Rowing Club, SE & NW area of Shipyard, Central & SE Factory Area. | 33 x 9m (4010)<br>/ 0.5-0.6m<br>11 x 2m (4015)<br>/ 0.2-0.3m<br>27 x 10m (4021-4023) / 0.1-0.2m |

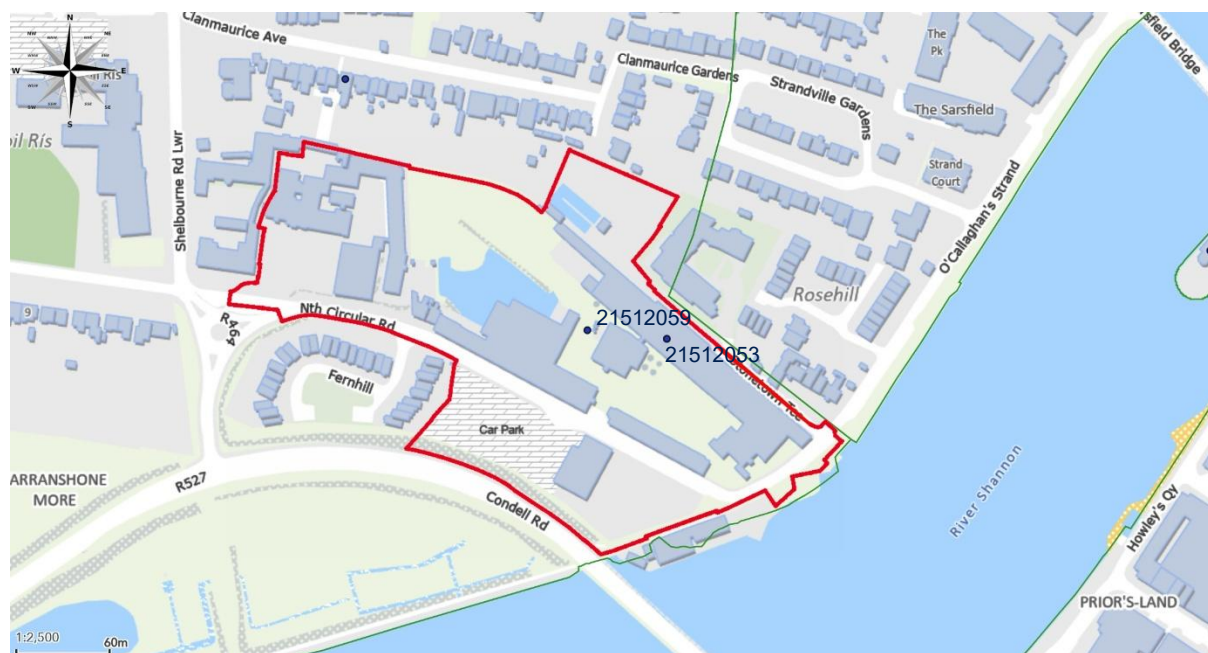
**Figure 8.25:** Extract of map with NIAH sites (after archaeology.ie)

NIAH 21512053 (Factory) – Cleeve's Condensed Milk Factory originally Lansdowne Spinning Mill – is described as 'Detached fifteen-bay four-storey stone factory building, built in 1853, facing west with a full-height bow end to south side elevation, and prolonged to south by a ten-bay two-storey block, and to north by a twenty-three bay single- and two-storey block, to which various twentieth-century alterations and interventions have been made. Roof hidden behind parapet wall with emphatic limestone ashlar parapet entablature. Pitched corrugated tin roof to ten-bay block. Squared, snecked and coursed tooled limestone walls with rock-faced rusticated quoins to sides. Rendered section to north. Camber-arched window openings with cut limestone sills, rusticated voussoirs and sides, having multiple-paned metal-framed windows. Blind window openings to east elevation, may be a later alteration. Round-arched window openings to bow end with rusticated surround, limestone ashlar sills and metal-framed windows. Round-arched door opening with vigorously rusticated surround, with timber doorframe set in deep recess, forming central glazed panelled timber door with sidelights and large spoke wheel fanlight over profiled timber lintel.'

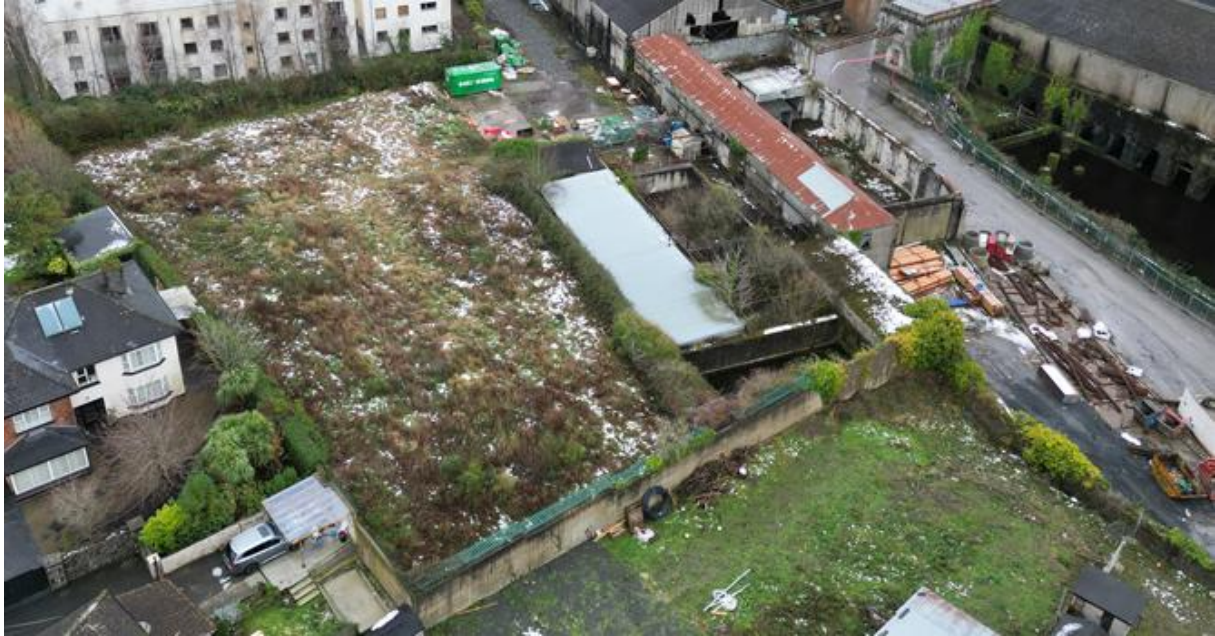
**Plate 8.6:** Drone view of grass / brownfield area 10/1/25 (from NE)

A grassed over, brown field area of *circa* 3000m<sup>2</sup> was situated in the northern aspect of the site. It was found that this location had a partially mounded aspect, which infers that the grass most likely obscured some degree of infill, landscaping or alteration. The long grass and brambles precluded any visual assessment.

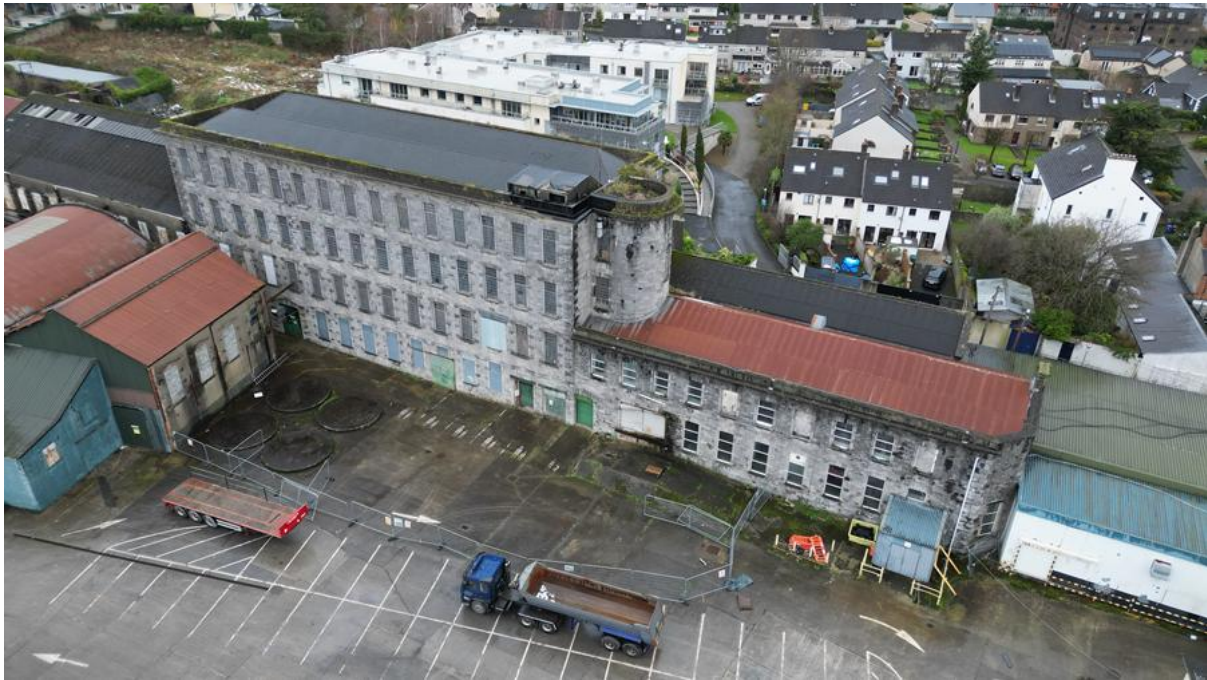
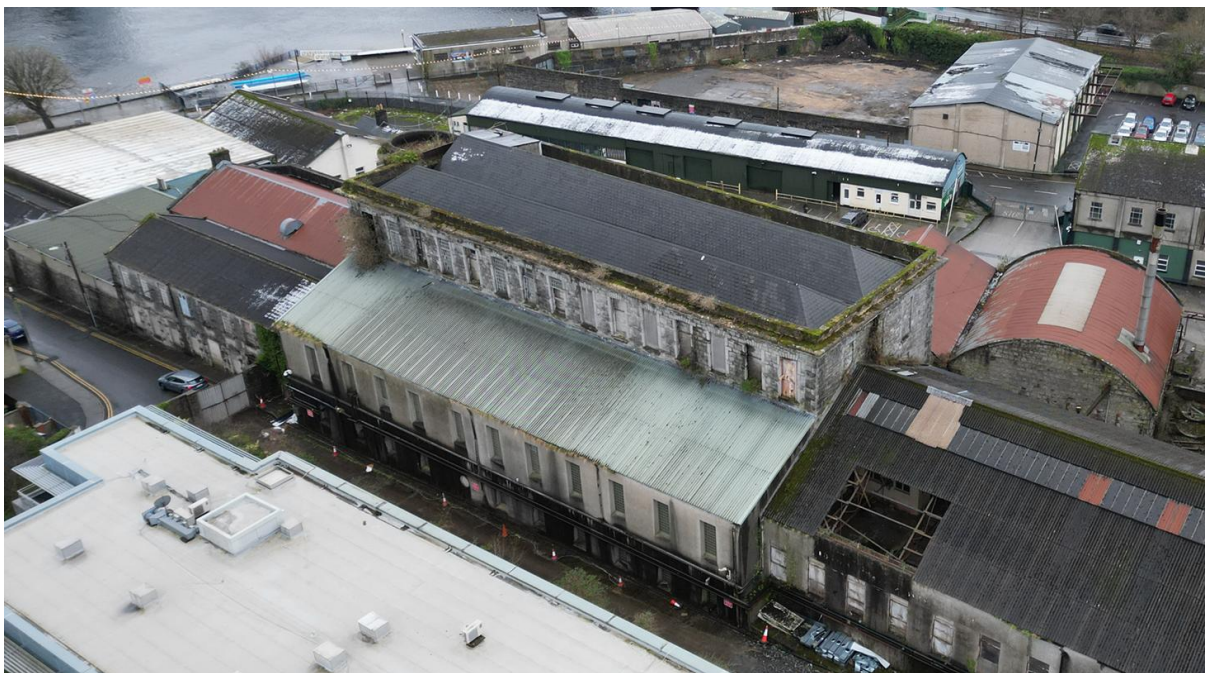
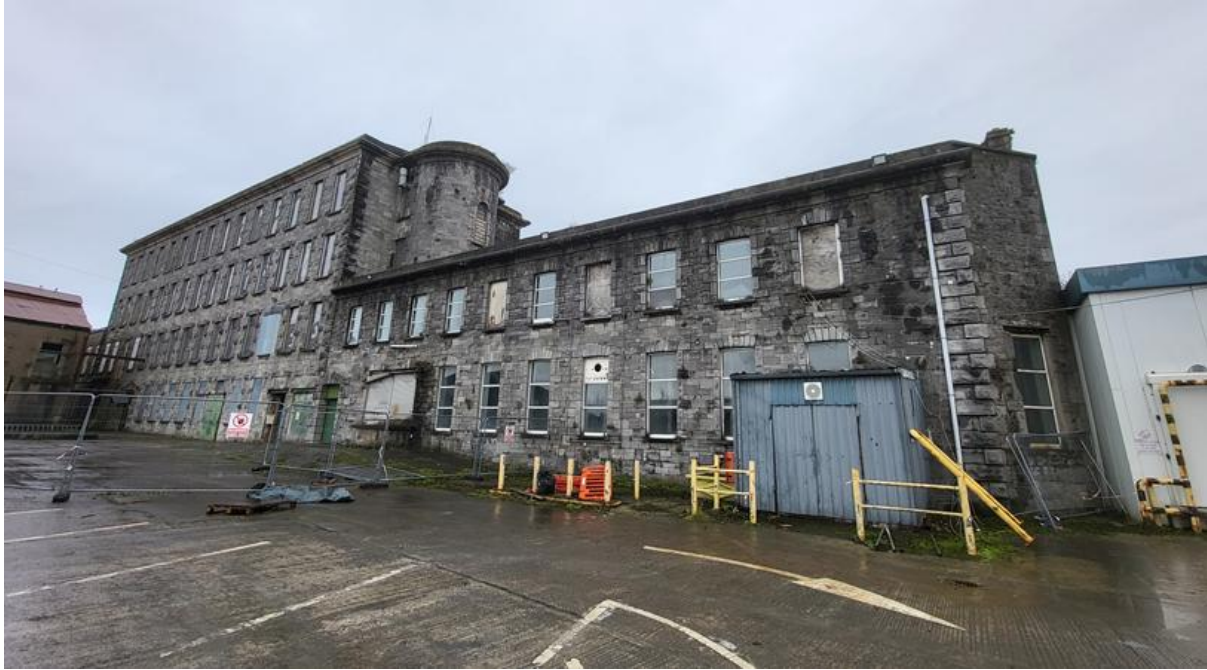
entrance doorway is a pseudo-Gibbsian affair, with a half-rounded archway, dressed with rusticated cut limestone blocks. The ground and first floor levels are currently used for the milk processing operation [at the time of Rynne's writing in 2005]. The cast iron supporting columns, however, (although some are obscured by panelling) survive throughout the mill. Those on the ground floor have foundry name plates and are date-stamped, with the formula: J. Rowan York St Foundry Belfast 1851. [Rynne noted that surviving examples of structural ironwork of this foundry and general period are extremely rare in the Republic of Ireland.] On the fire-proofing Rynne noted that the type employed in the Lansdowne mill was a standard feature of Irish linen mills constructed in the second half of the nineteenth century, where each of the internal floors of the mill was laid upon a matrix of brick, segmental arches which were supported upon tiers of cast iron girders. Jack-arched floors were the principal means by which textile mills of this period were rendered fireproof, and in some instances individual floors were also finished with fire clay tiles. The girders, in nearly all multi-storied textile mills of this period are connected by wrought-iron tie rods, and are supported along the central long axis of each floor on cast iron columns. The columns were nearly always cast with brackets to carry line shafting, which transmitted power from the mill's prime mover to individual machines, although 'union castings' (i.e., ledges and frames cast on these columns to provide support for such shafting), are not in evidence in the Lansdowne mill. However, such floors while fireproof could not withstand heavy loading, although the spinning frames were relatively light, and when in operation created little vibration.

The second-floor (former spinning room floor) support columns are dated stamped 1852, which suggested to Rynne that the ironwork was supplied by the foundry in stages. Another feature of interest of mill floors where wet spinning machinery was installed, noted by Rynne, were metal drains running along the inner edge of the main walls, while the floors sloped downwards from the centre to allow moisture and condensate falling from the wet spinning frames to be collected. The contents of the drains were then discharged into pipes positioned on the outer walls, but within the present structure these features have been almost completely obscured by the levelling off of each floor, in the twentieth century, with concrete.

The roof was an M-shaped profile, with sections hipped. Rynne noted it had been refurbished with asbestos slates. Cast iron gullies, with foundry stamps of Lee's of Limerick, are laid between each roof sections and on the allure formed by the parapet and lower, outer edges of each roof section. The plates and the roof structure itself would appear to date to the refurbishment of the site by the Cleeve brothers in the mid-1880s. The roof trusses are, indeed, of a later nineteenth-century kingpost form, which have scissor straps on their outer extremities, while the flitch plates fixing the kingposts to the collar beams are also likely to date to this period.' (Collins and Coyne, 2021: 17-18)

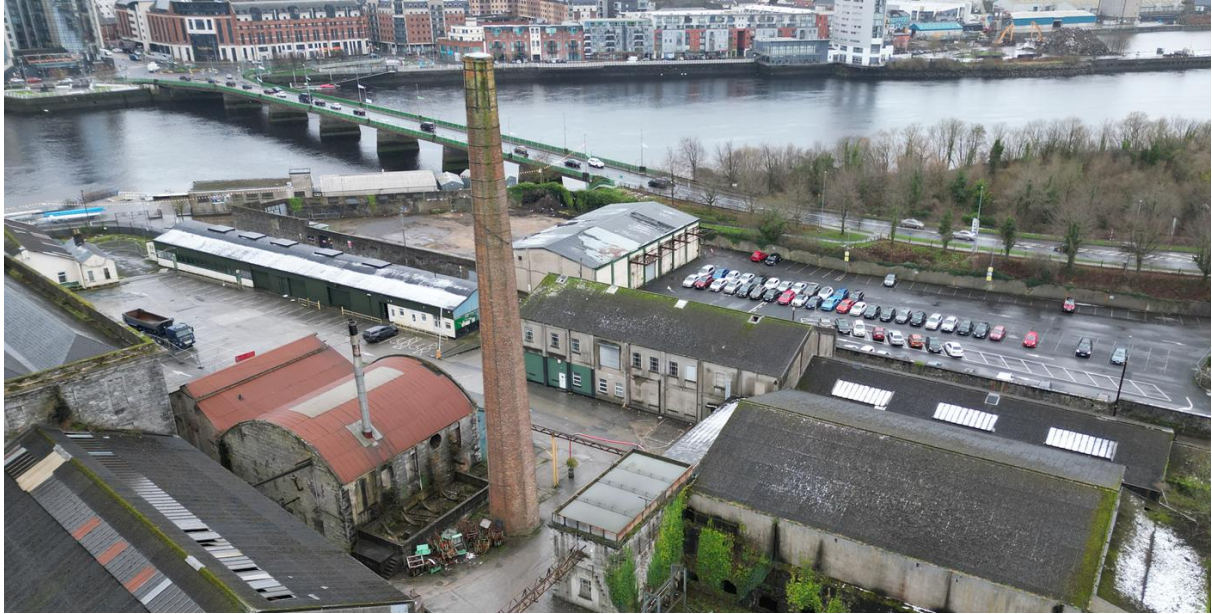
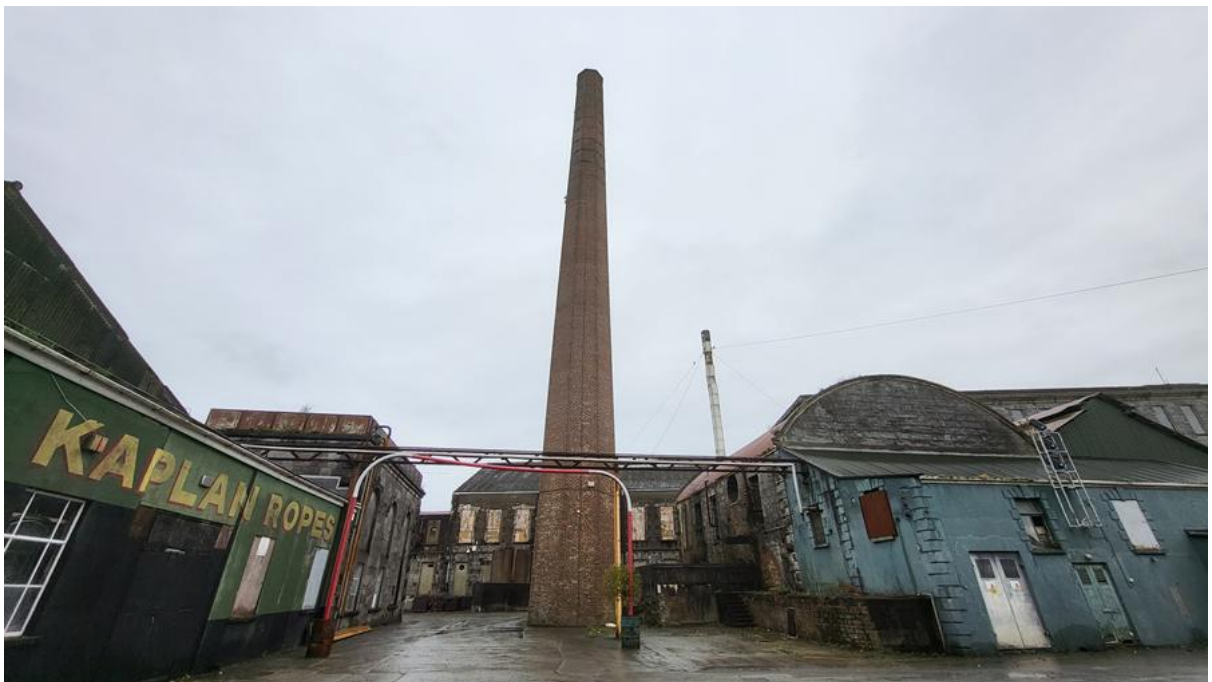
'The stack itself, is six-sided [sic, should read eight] and built with brick throughout. The most dominant feature of many nineteenth-century industrial sites, the mill chimney was designed to both disperse the exhaust fumes from the boiler furnaces whilst helping to create a draught for the furnace. Early chimneys tended to be square-sectioned, built with either cut or rubble stone, with quoins being employed at the corners to emphasis their verticality, but these could later be of polygonal or circular in plan for decorative effect. Brick became the most common building material used in their construction in the second half of the nineteenth century, when engine sizes became bigger and the height of chimneys was increased to accommodate them. In early engines chimneys tended to be small, although at least one Irish example, at Stein and Browne's Distillery at Limerick, was 115 ft (c.35 m) high in 1822. The Cork Waterworks stack is the most elaborate nineteenth-century stack to survive in Ireland. According to Rynne this chimney at Limerick is the best-preserved example of its type and date in the Republic of Ireland.' (Collins and Coyne, 2021: 19)

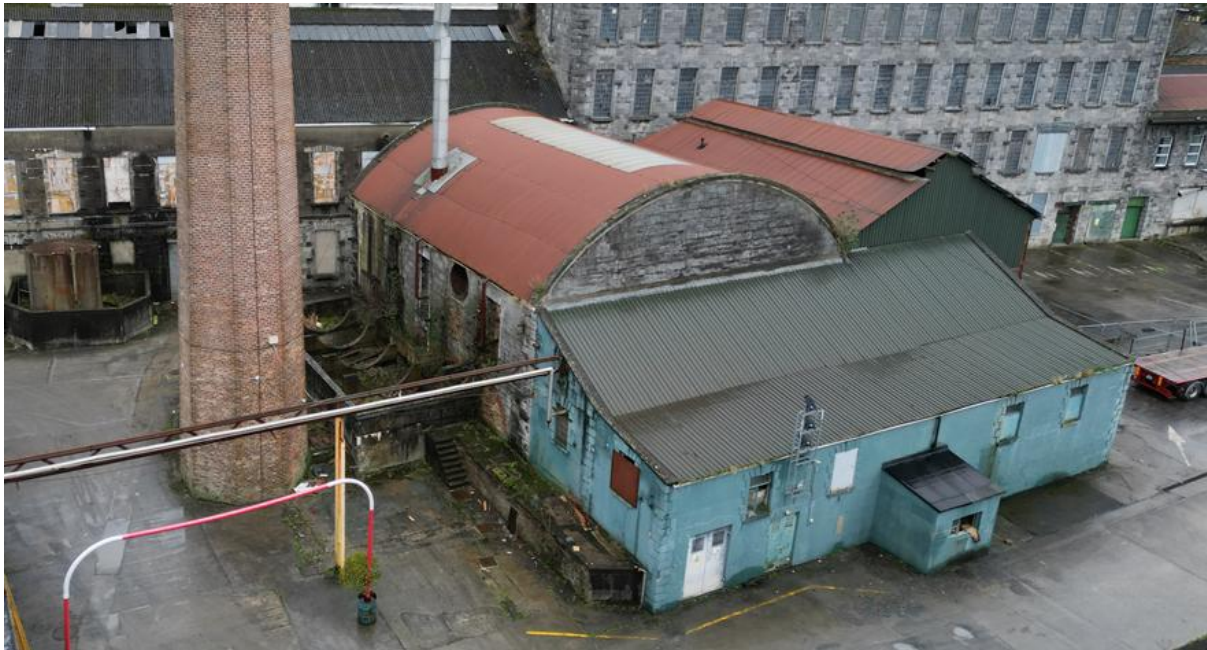
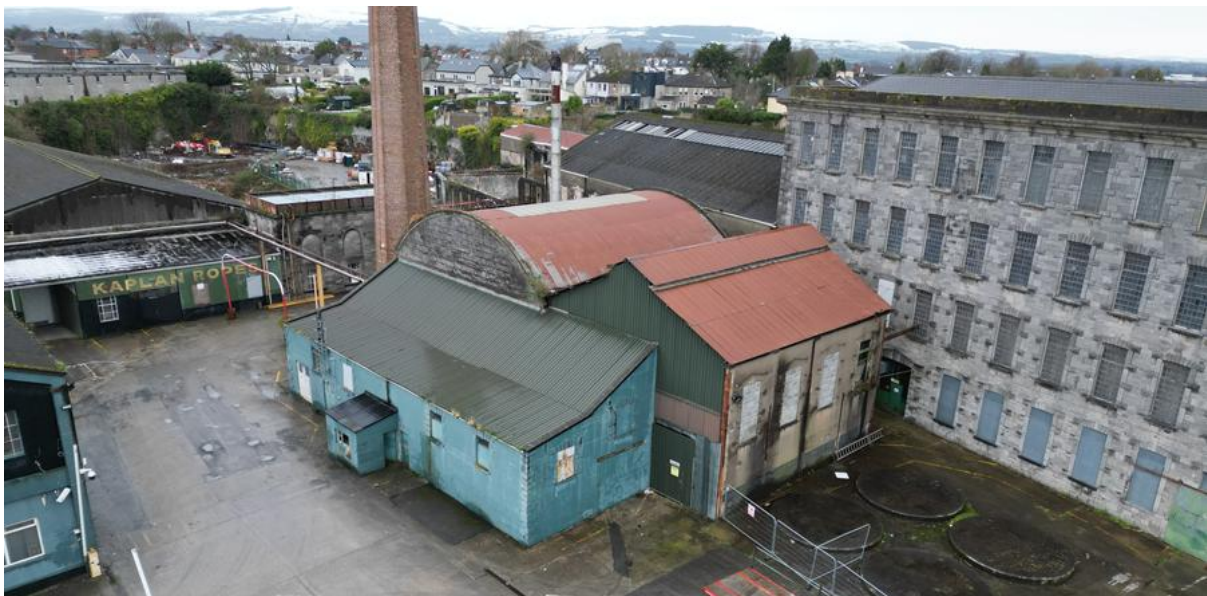
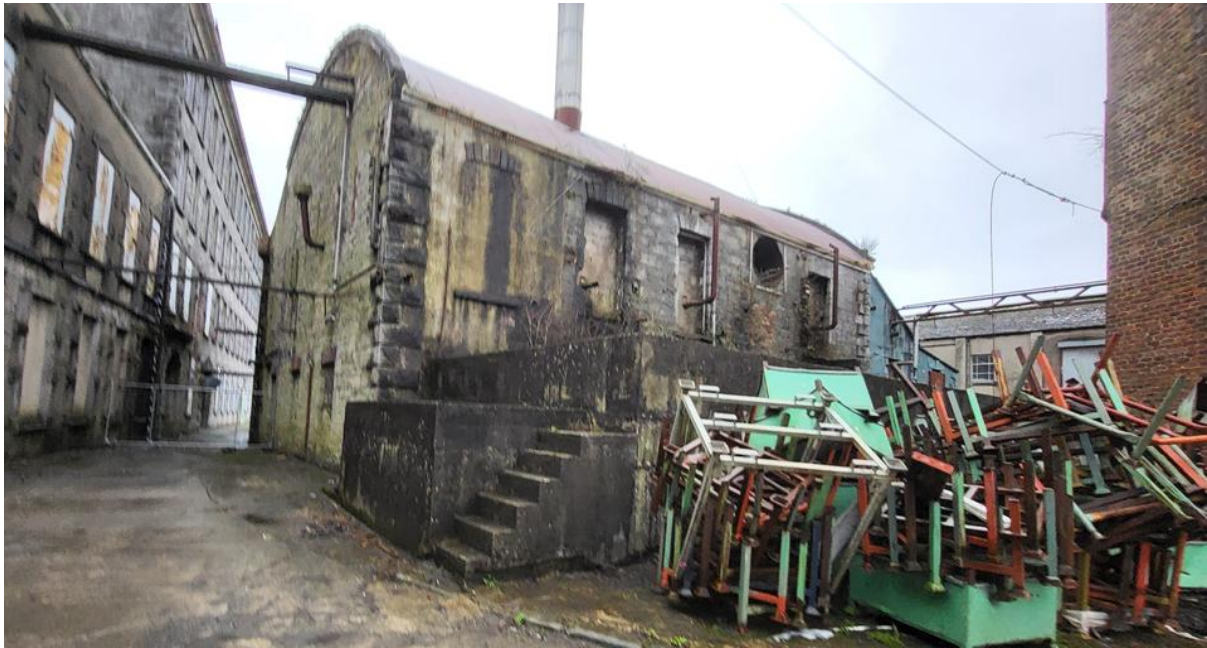
'Rynne recorded that this structure was one of three (along with stack and infiltration gallery) that were of industrial archaeology interest related to the condensed milk factory. The engine house powered machines of the flax mill and buildings to the west of it. The structure housing the engines has a rounded roof profile, probably with a Belfast truss roof form originally. Vertical triple expansion engines would have been employed here, which, according to an account of 1892 were fed by Galloway boilers.

Rynne interestingly noted that the engine house was built to mimic the early flax mill buildings, with matching windows at ground and first floor level.' (Collins and Coyne, 2021: 20)

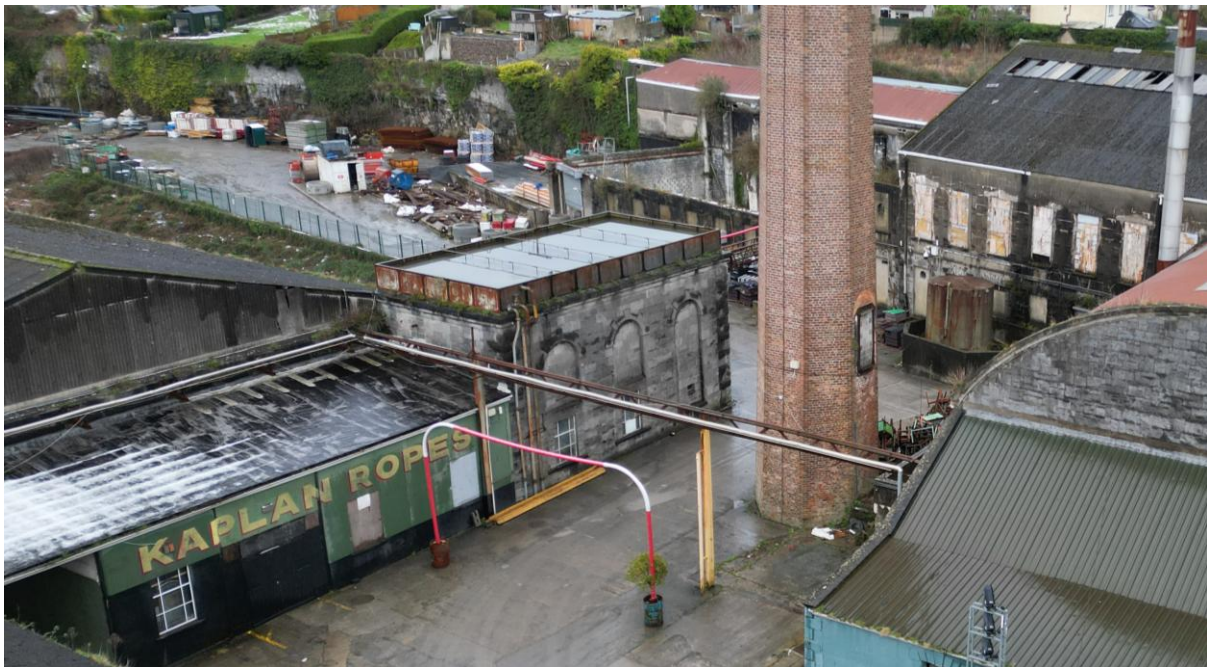
**Plate 8.16:** Drone view of Water Tank Building (from SW)

'The finely carved limestone facades are amongst the finest in the complex and of artistic and architectural interest. The steel abutting structures and interiors.' (Collins and Coyne, 2021: 21)

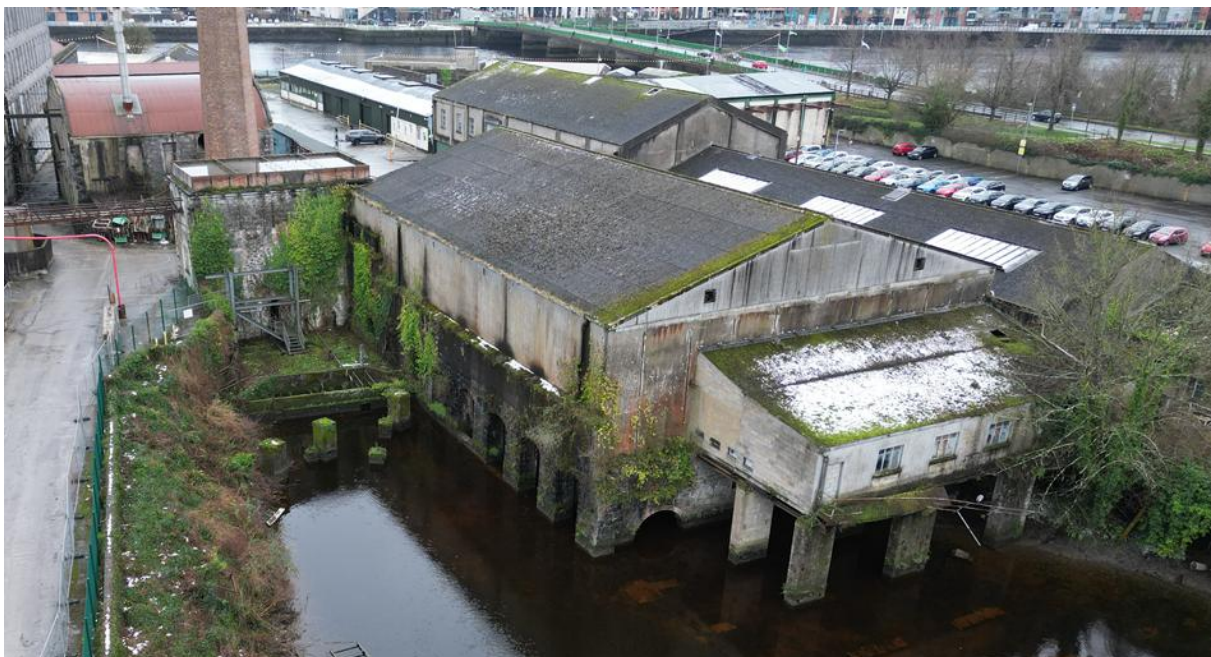
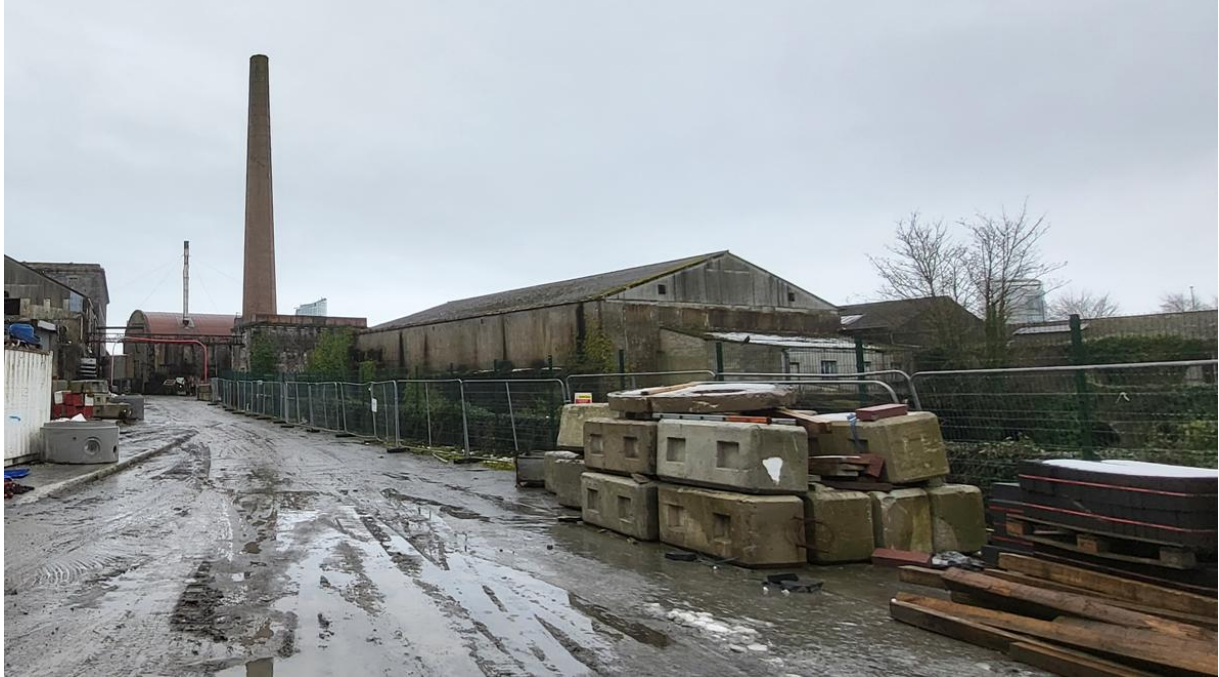
'It is positioned immediately beneath what appears to have been the original vathouse, consists of a series of brick arches. through which an infiltration gallery (operating on the slow sand filter principle) was run. The north facing elevation of this feature also has a series of brick. arches which open directly on to the adjacent reservoir. The latter was the main source of process water for the milk factory. A cut stone storage tank building associated with this operation survives at the north east corner of the vathouse.' (Collins and Coyne, 2021: 22)

The removal of stone piers associated with the adjacent Infiltration Gallery in the Lower Reservoir have been mapped. They most likely exemplify how the Infiltration Gallery was intended to continue further into the Lower Reservoir but was discontinued for whatever reason. As the same piers extend into the Infiltration Gallery and thus survive as a more complete representation, their removal from the reservoir is considered neutral, but may require more detailed record of their heritage value.

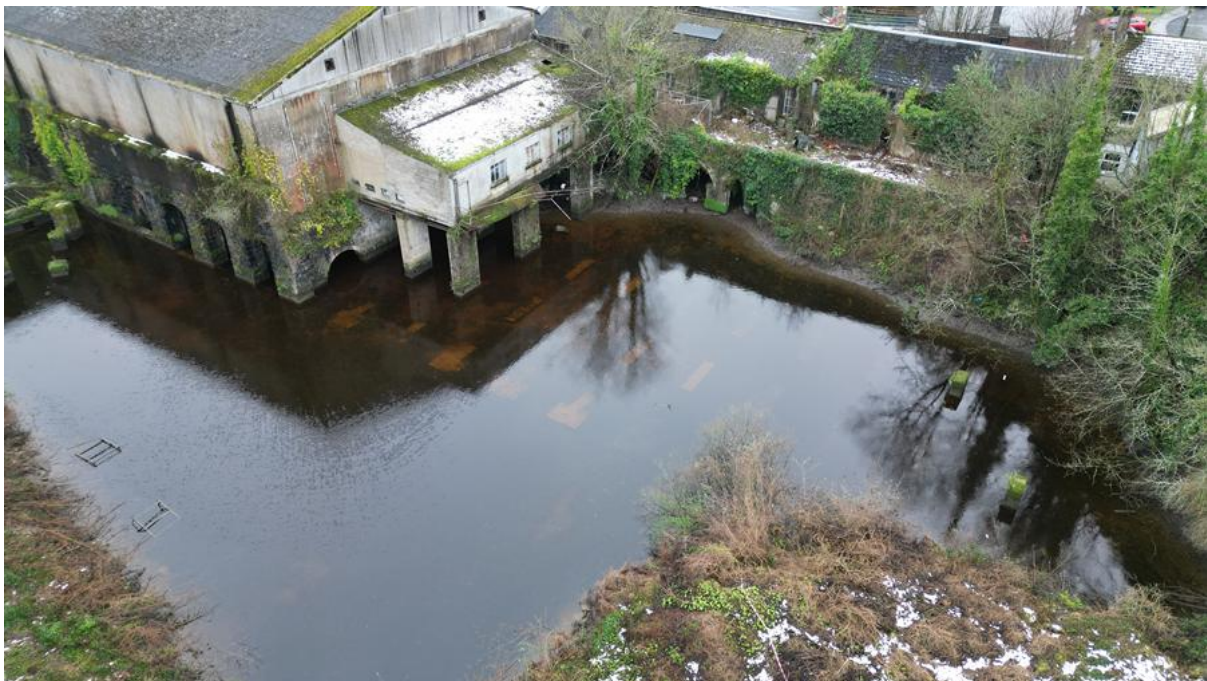
**Plate 8.20:** Drone view of Lower Reservoir (from NE)

‘Currently water filled. This appears to be a quarry, marked on the Ordnance Survey 1st Edition map (c. 1840), and depicted as ‘reservoir’ on the 25 inch (c. 1900)...’ (Collins and Coyne, 2021: 23). Its water drains into the River Shannon.
