## CHAPTER EIGHT CULTURAL HERITAGE - ARCHAEOLOGY

The proposed application site (Phase II) is part of a phased development proposal for a significant city centre, regeneration area or Masterplan Site (MS). This MS is divided into four different phases of delivery as detailed in Section 1.6.3 in Chapter 1.0 Introduction. The overall MS layout which illustrates the indicative layout of the subject site and adjoining lands in the ownership of the applicant as displayed in Chapter 1.0, Figure 1.4 and full details of the proposed development phases are provided in Chapter 2.0, Section 2.2.4. This assessment takes a holistic approach and examines the MS whilst focusing on any areas of significance within the proposed application site (Phase II) and the likely impacts arising from the development proposal.

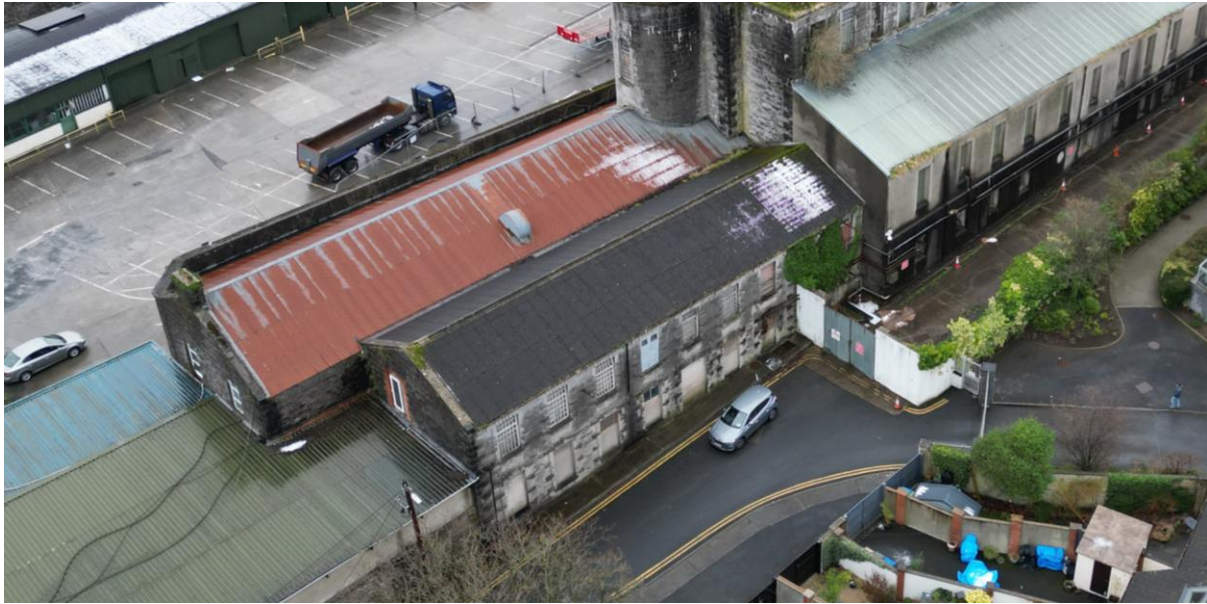
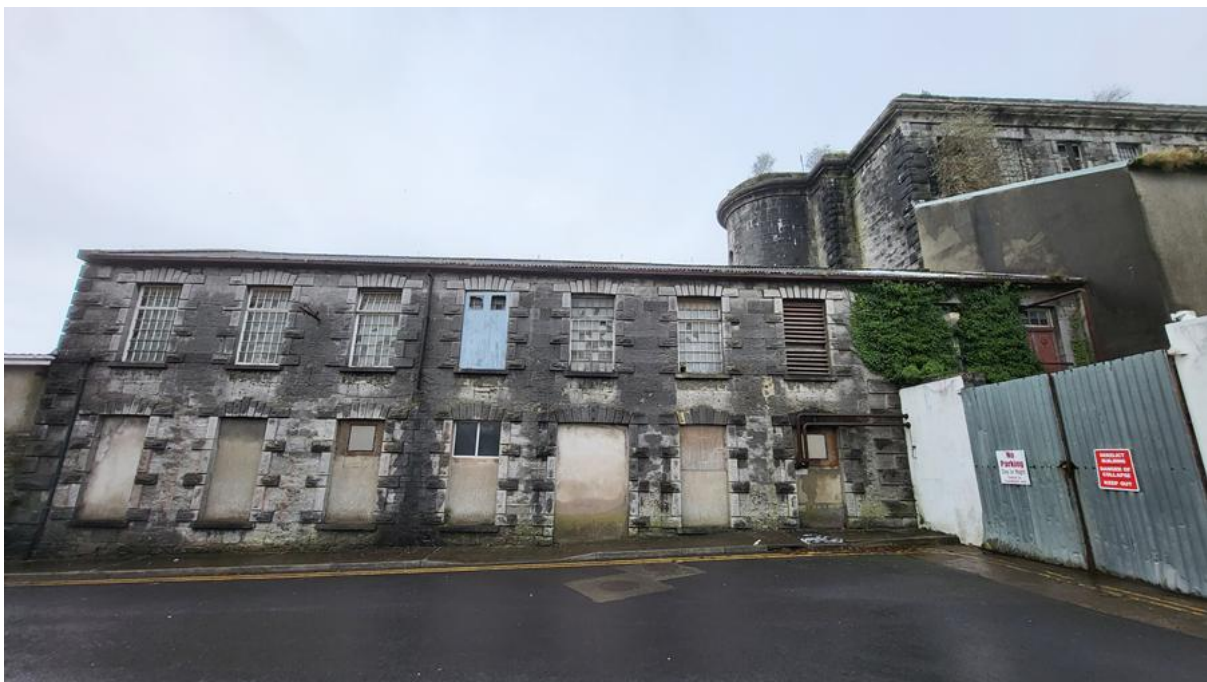
'The building...was not originally constructed as an extension to the Flax building but has been linked over time through an extension to the north and then an extension to the west. The cut stone elevations and multi-pane windows are high quality of architectural and artistic interest...Modern internal and external finishes of no significance. The snecked limestone boundary wall is significant for architectural reasons and an older building of some significance may be buried within...The exterior of the building is significant for architectural, technical, artistic and historical reasons. Truss roof structure and floor finishes may be of interest, requires further survey investigations.' (Collins and Coyne, 2021: 24)

**Plate 8.21:** Drone view of Former Linen Store (from SE)

**Plate 8.22:** Former Linen Store (from E)

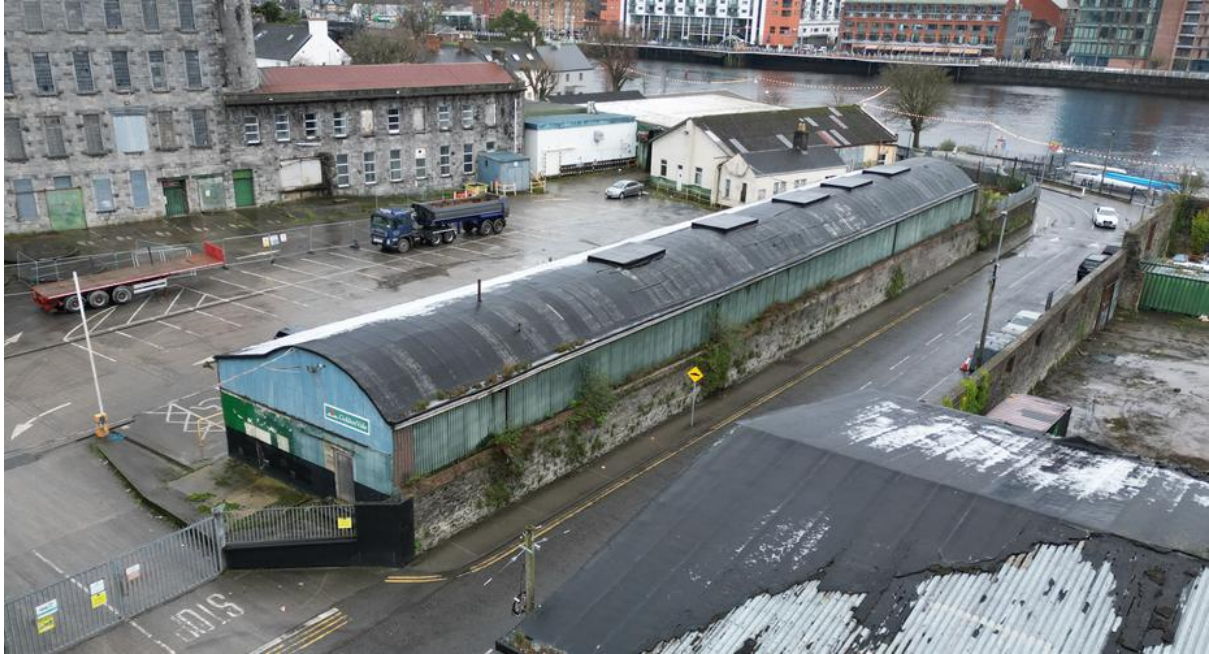
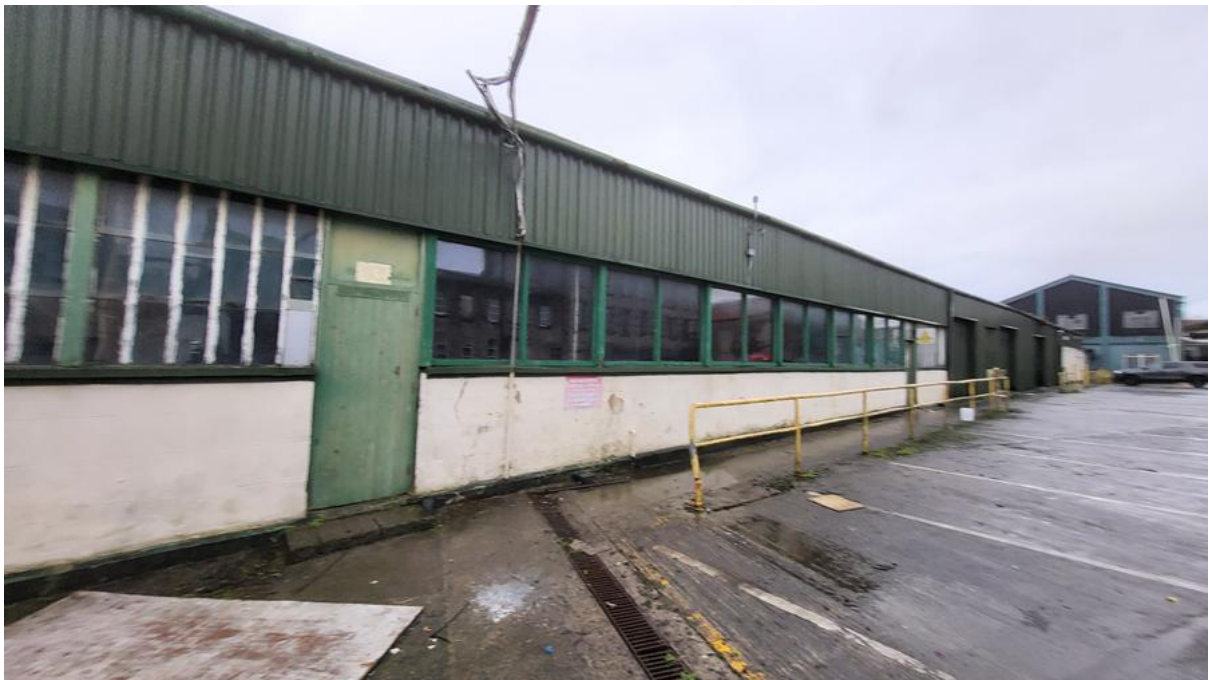
‘Constructed on site post-1924...The roof structure and steel windows are of some Interest.’ (Collins and Coyne, 2021: 25)

**Plate 8.23:** Drone view of Workshop (from NW)

**Plate 8.24:** Workshop (from SE)

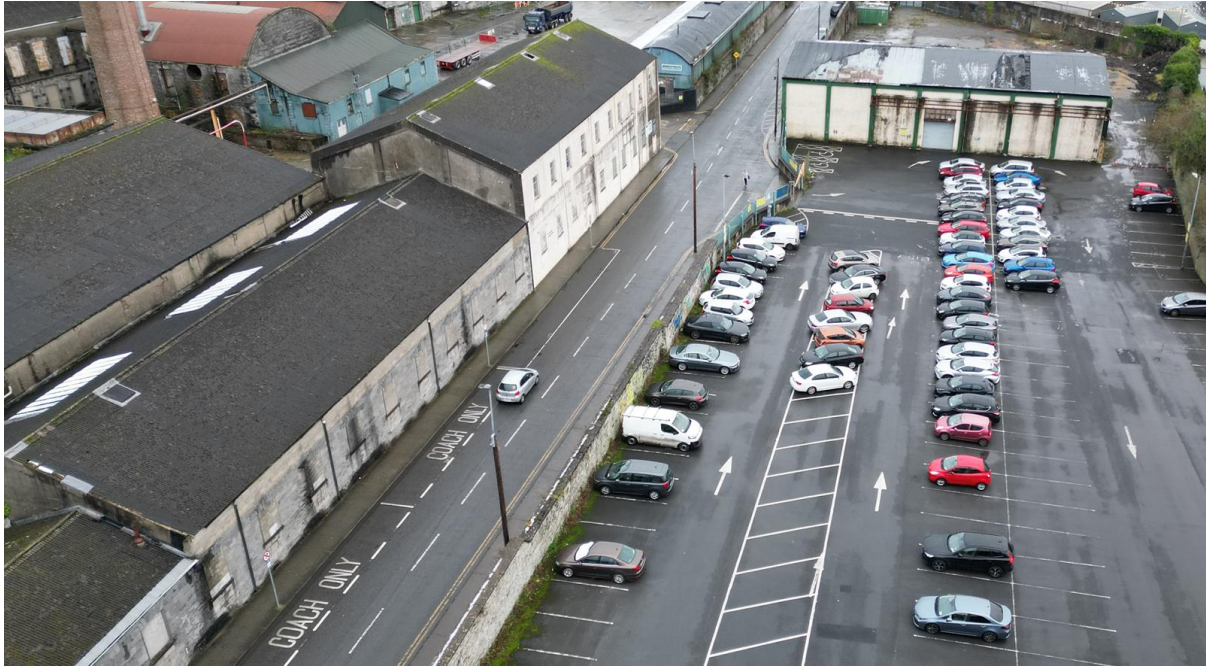
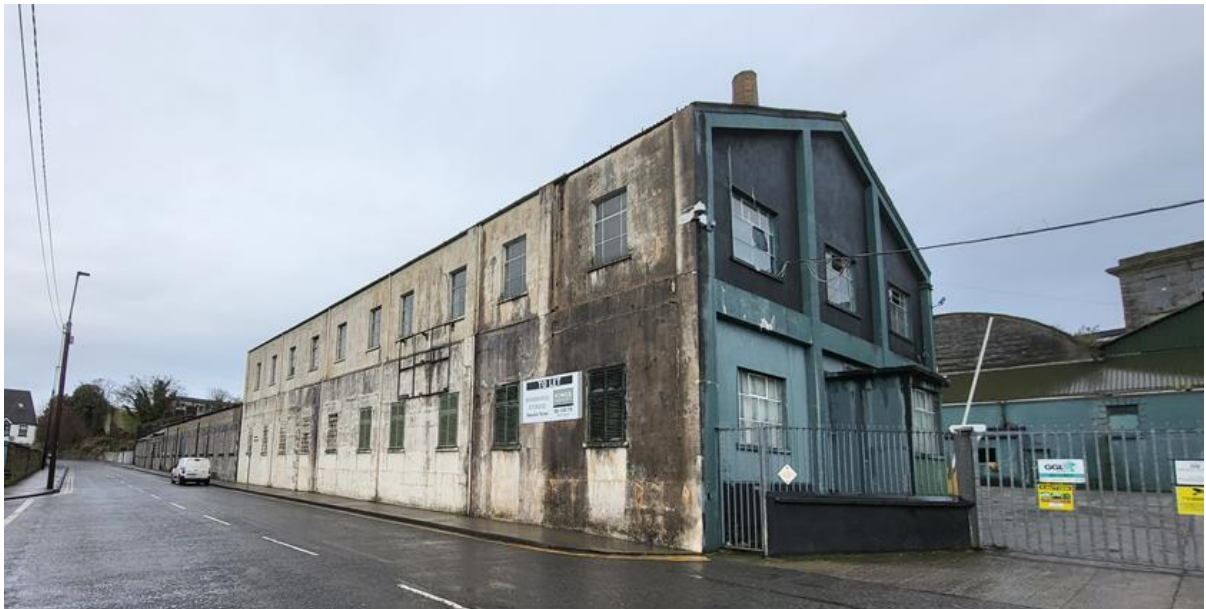
'The modern building...is of no significance, parts of a historic building appear to be retained within the modern fabric which require further investigation...Modern internal linings may conceal historic fabric of some interest. The façade to the west is of architectural interest...It's not clear how much of the original buildings survive but the fine cutstone west elevations are of architectural and artistic interest.'

**Plate 8.25:** Drone view of Cheese Plant / Packing Store (from NNW)

**Plate 8.26:** Cheese Plant / Packing Store (from SW)

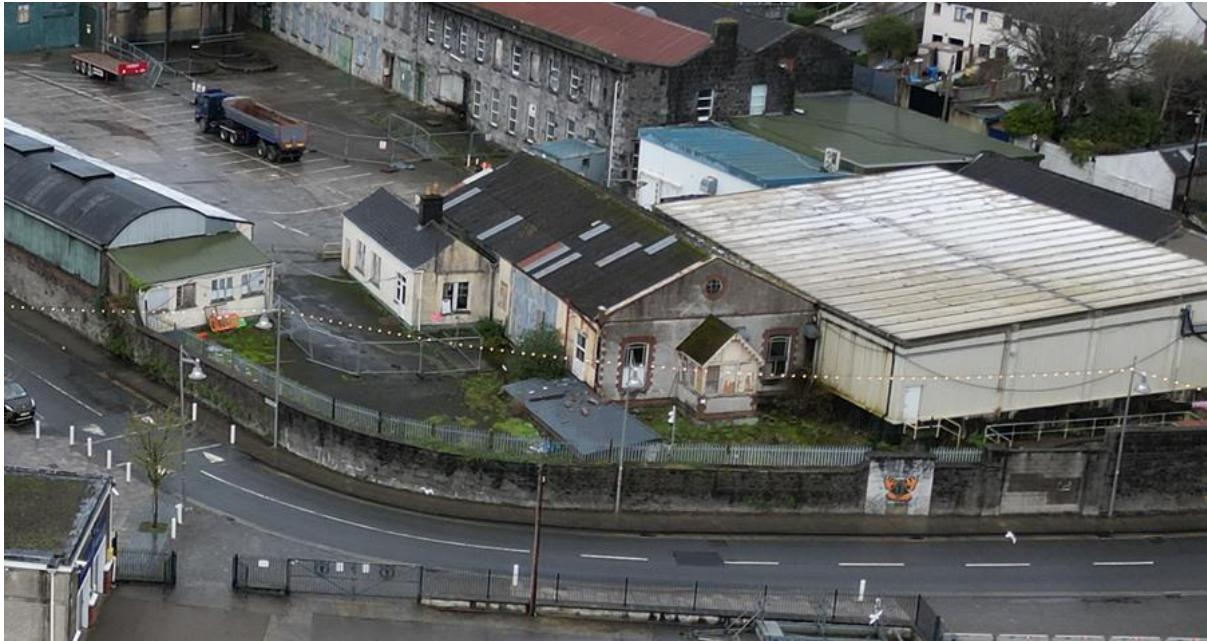
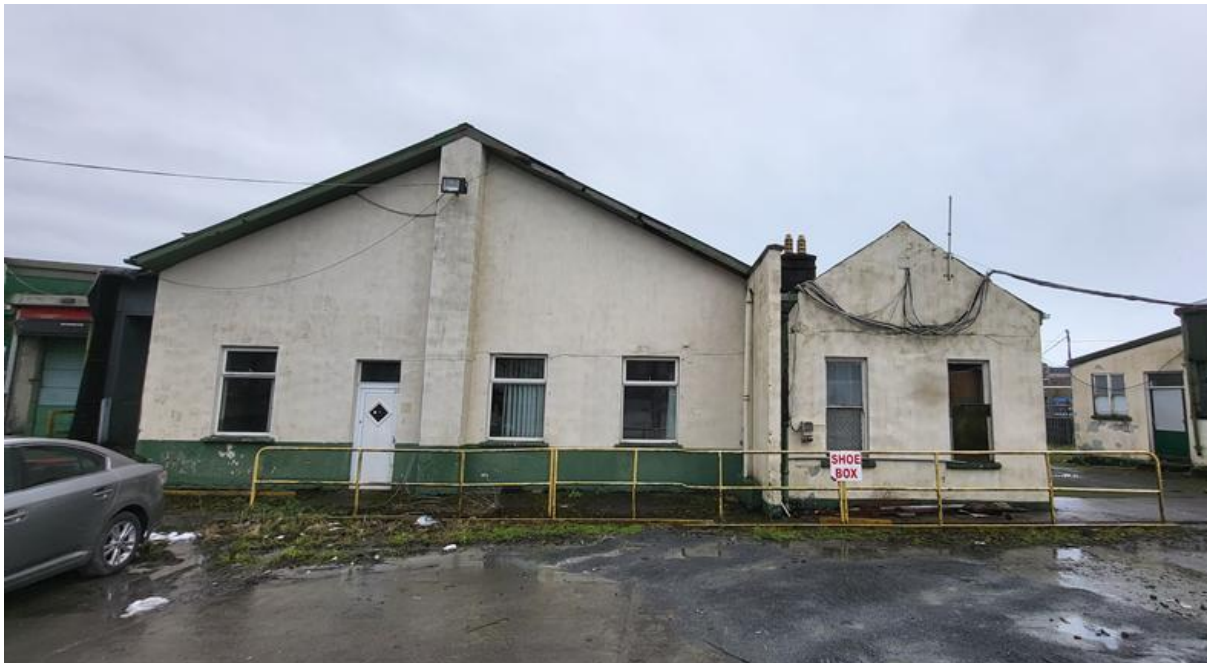
'No significance, a building is first shown in the position of Building 8 on Goad's 1897 map, it is also on the 1907 OS and integrated into buildings to the south...The south east elevation and porch are of some architectural interest.' (Collins and Coyne, 2021: 27)

**Plate 8.27:** Drone view of Offices and Warehouses (from SSW)

**Plate 8.28:** Offices and Warehouses (from N)

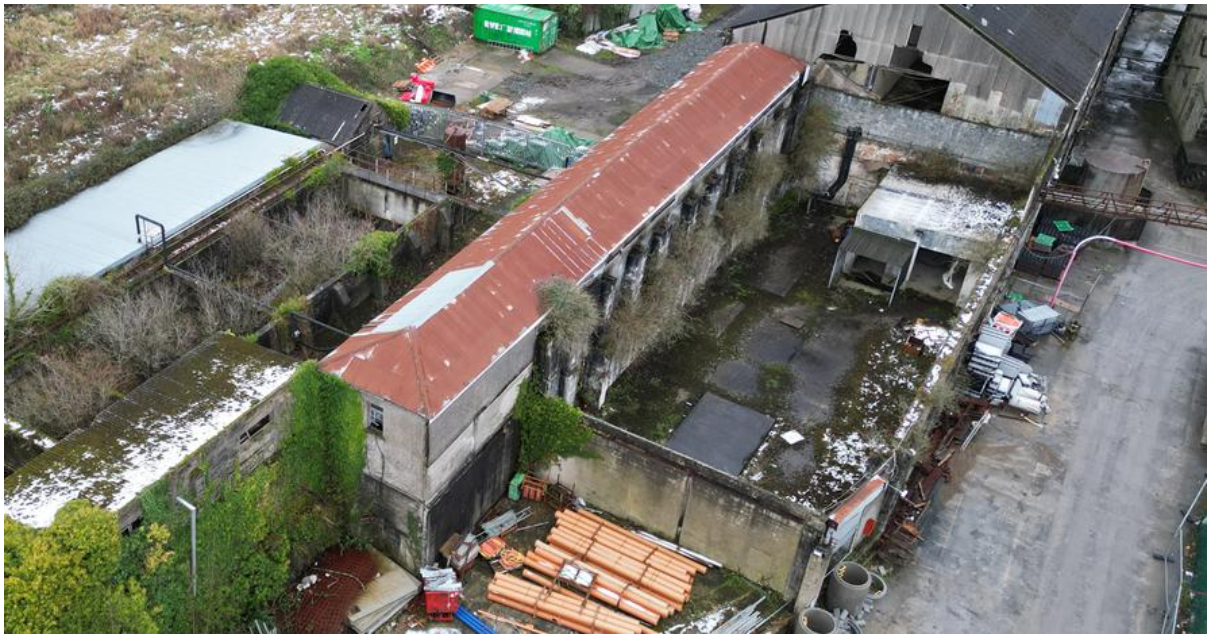
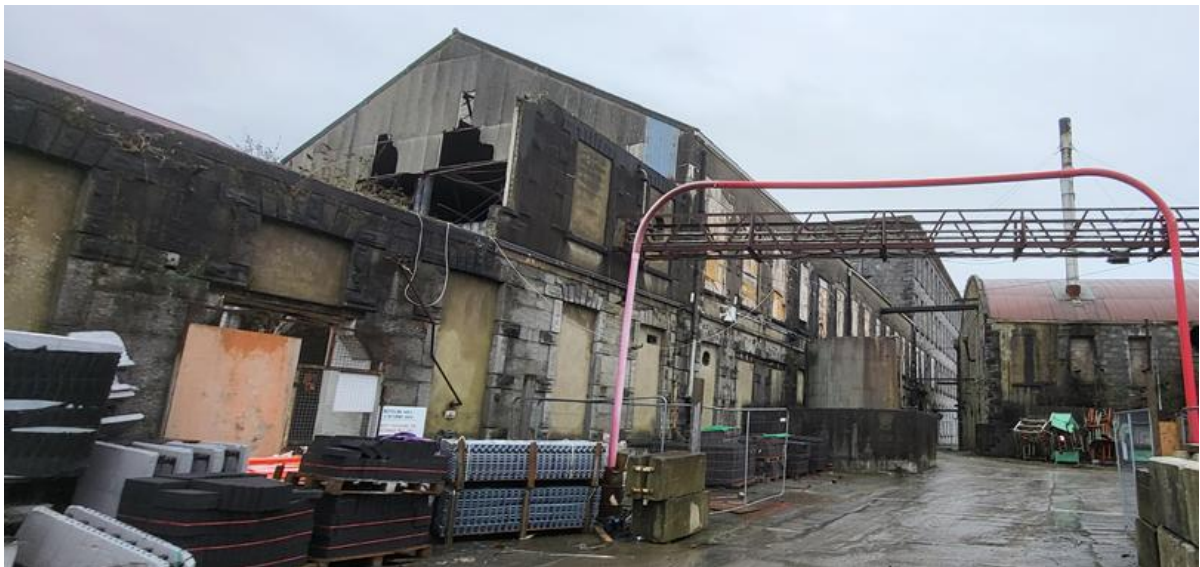
'At Rynne's time of writing he noted that there were no surviving traces of weaving sheds on the site. He suggested that they may have been built to the east [west?] of the flax mill...He also noted that Campbell described the steam engine at the site, in 1859, as taking up two bays and two storeys at one end of the building. This was evidently at the western end, close to the reservoir (for boiler feed water) and it is one would expect to find weaving sheds, taking power, via line shafting, from the mill's engine. Structure No. 11 has been interpreted as the location for the weaving...The standing walls should be treated part of the protected structure (a high-quality early extension of the Flax Mill). The infill building appears of no significance although the walls at low level.' (Collins and Coyne, 2021: 28)

**Plate 8.29:** Drone view of Weaving Mill / Cold Stores (from NW)

**Plate 8.30:** Weaving Mill / Cold Stores (from NW)

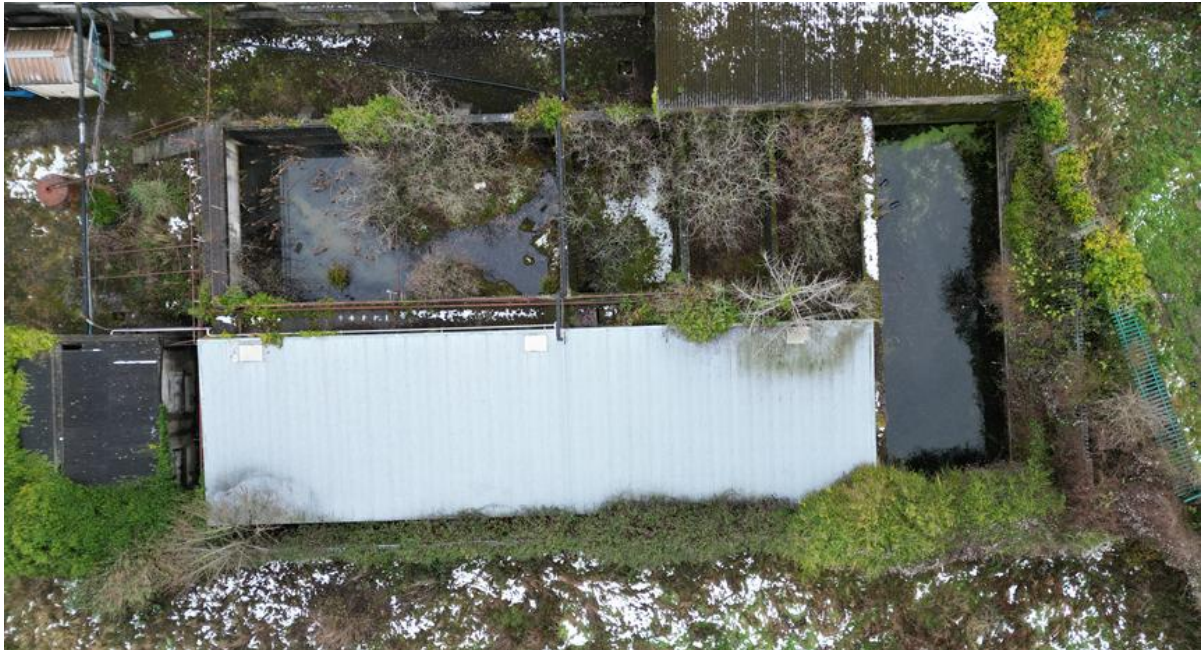
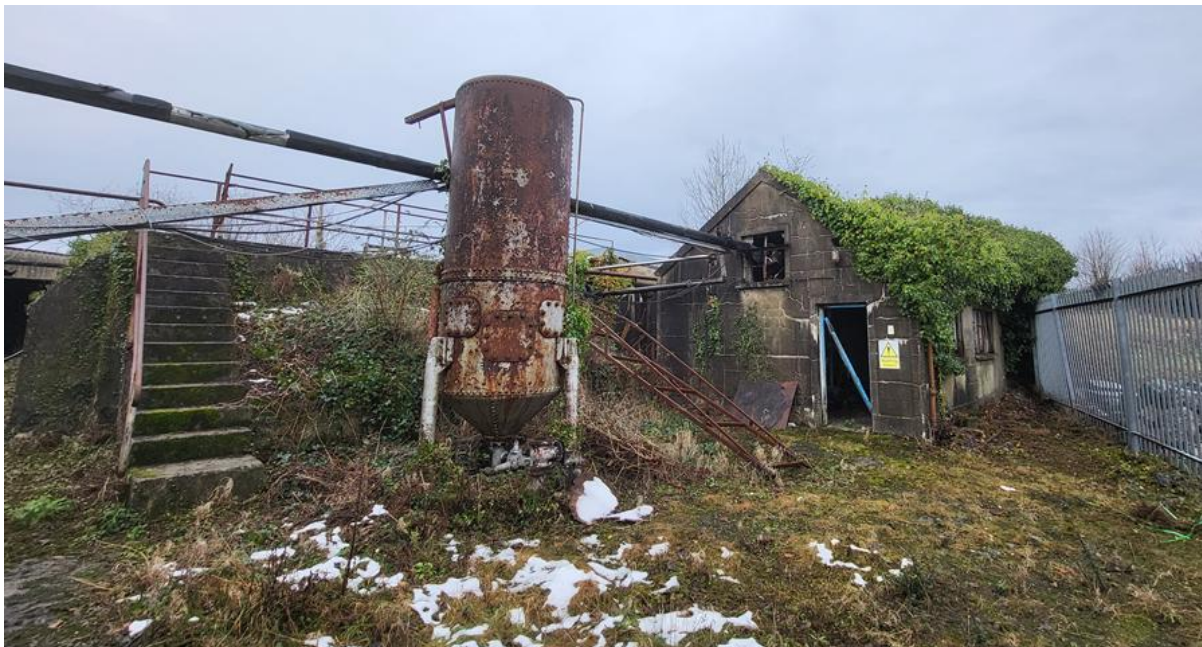
'Cast iron cylinder (boiler) on site, worthy of further examination. Reservoir appears to be concrete built...Probably modern and of no architectural significance but further surveys are required to confirm this.' (Collins and Coyne, 2021: 29)

Plate 8.31: Vertical drone view of Upper Reservoir (W to top)

Plate 8.32: Upper Reservoir (from SW)

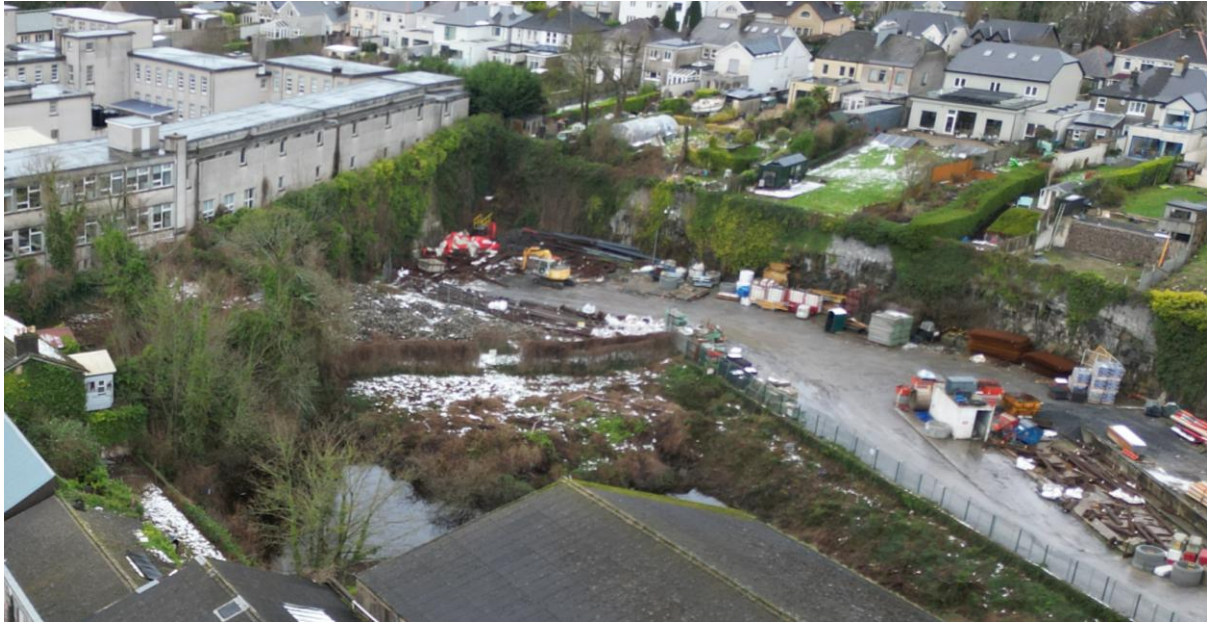
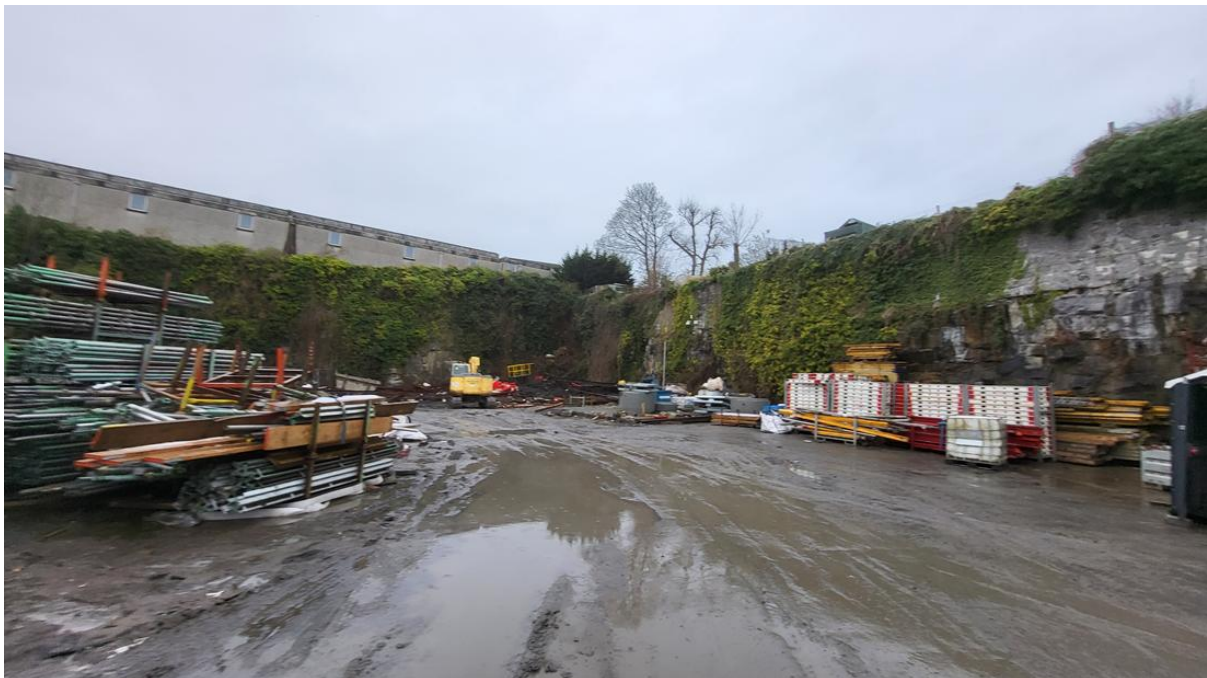
'Remnants of 19th century quarry. Quarry face overgrown, base of quarry now concrete slab. Vegetation should be removed, and the quarry face examined for evidence of tooling/extraction processes...[I]t is historically related to the reservoir...as part of the original quarry works on site,...' (Collins and Coyne, 2021: 31)

**Plate 8.37:** Drone view of Quarry Face (from SW)

**Plate 8.38:** Quarry Face (from SW)

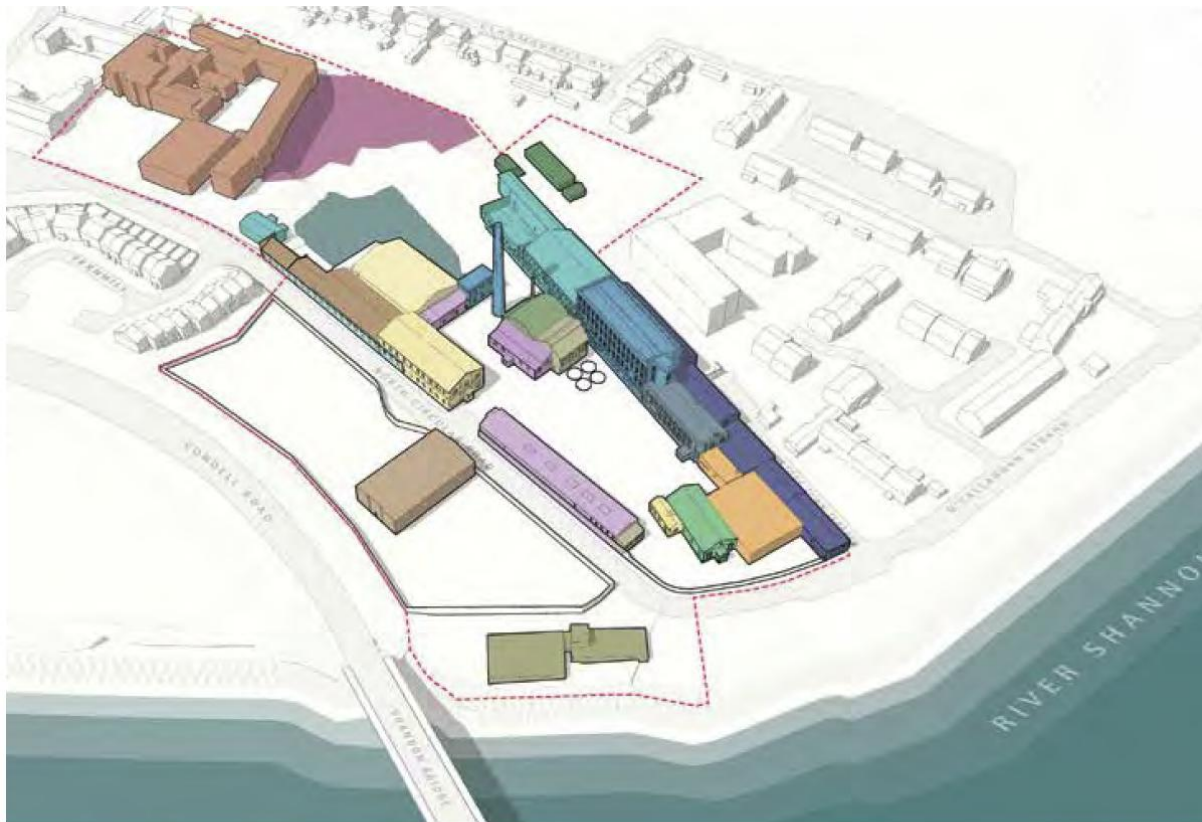
Fig.5 Diagram identifying the age of the existing buildings on the site
